**LAKELAND
LINDER REGIONAL
AIRPORT (LAL)**

DISTRICT 1
REGIONAL RELIEVER
AIRPORT
JUNE 2015

STATEWIDE
**Airfield
Pavement
Management**
PROGRAM

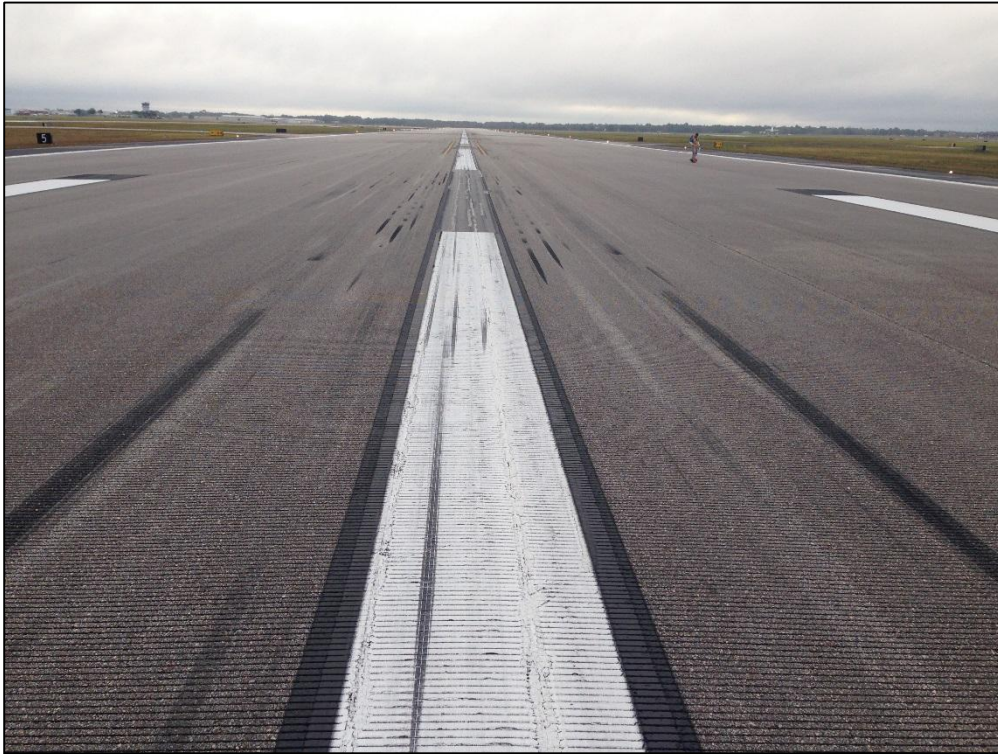
Runway 9-27, Section 6115, Sample Unit 360 – Low Severity (48) Longitudinal and Transverse Cracking, Low Severity (52) Raveling, Low Severity (57) Weathering

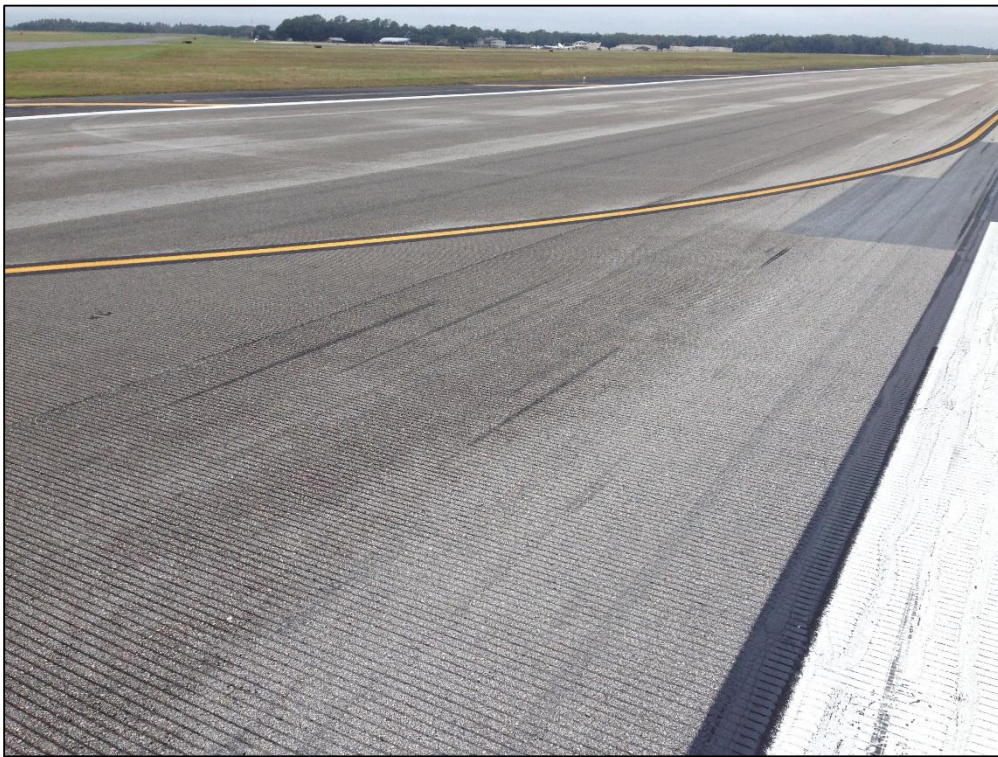
Runway 9-27, Section 6150, Sample Unit 414 – Low Severity (48) Longitudinal and Transverse Cracking, Low Severity (52) Raveling, Low Severity (57) Weathering

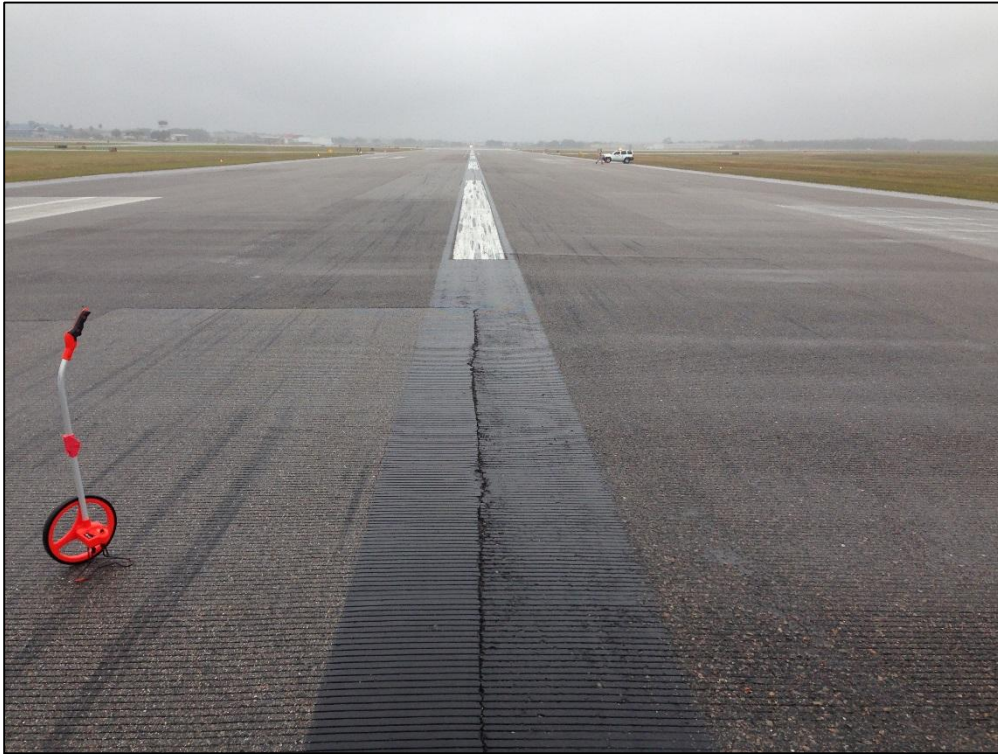
Runway 5-23, Section 6215, Sample Unit 322 – Low and Medium Severity (48) Longitudinal and Transverse Cracking, Low Severity (52) Raveling, Medium Severity (57) Weathering

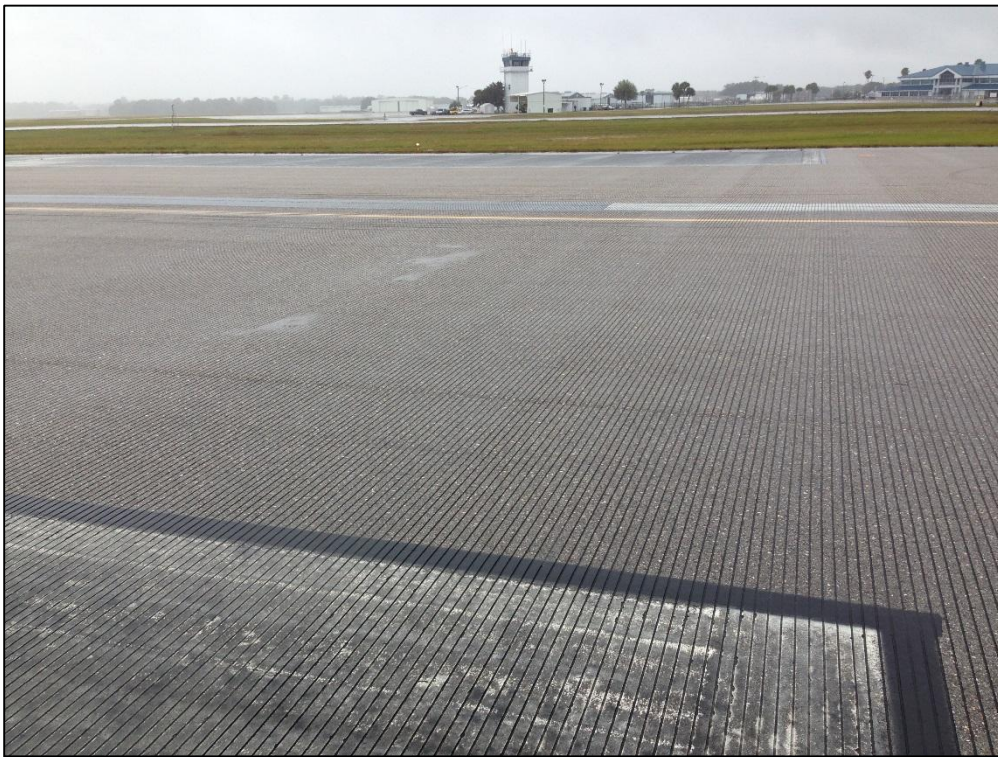
Runway 5-23, Section 6245, Sample Unit 379 – Low Severity (48) Longitudinal and Transverse Cracking, Medium Severity (57) Weathering

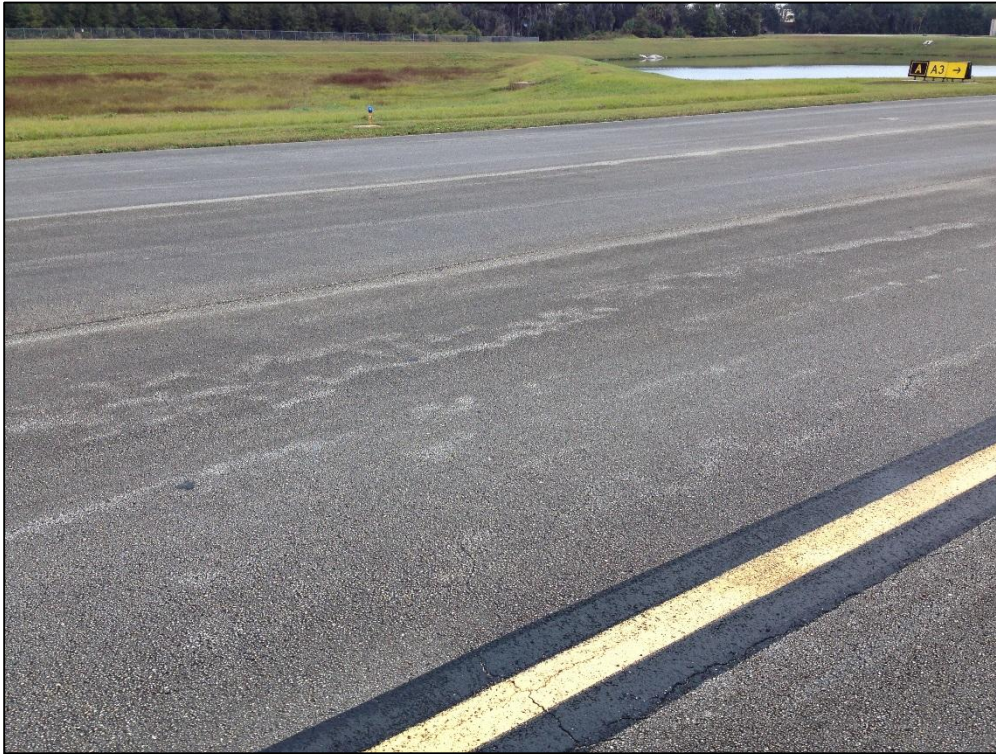
Taxiway Alpha, Section 105, Sample Unit 121 – Low Severity (48) Longitudinal and Transverse Cracking, Low Severity (52) Raveling, Low Severity (56) Swelling, Low Severity (57) Weathering

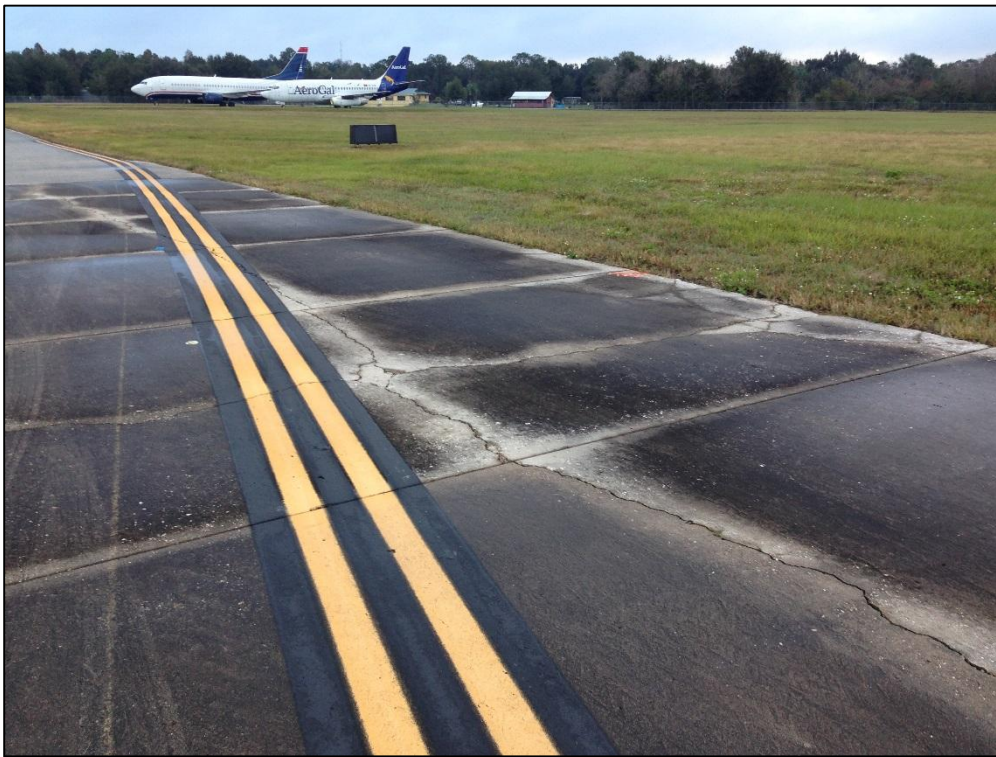
Taxiway Echo, Section 520, Sample Unit 125 – Medium Severity (63) Longitudinal, Transverse, and Diagonal Cracking, High Severity (65) Joint Seal Damage, High Severity (72) Shattered Slab

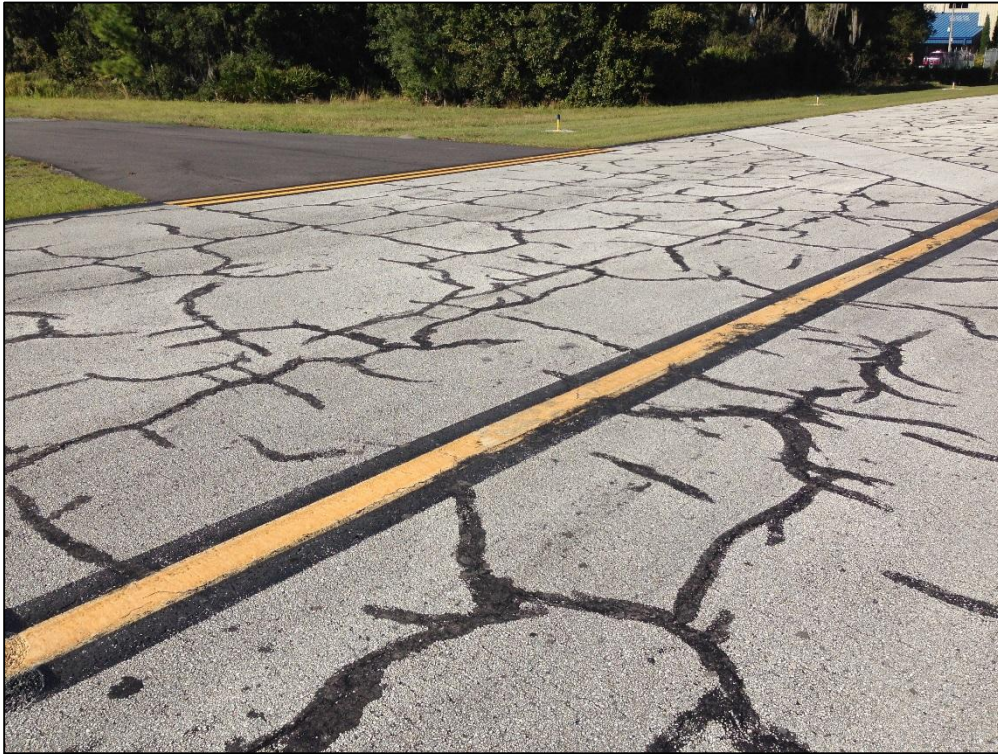
Taxiway Hotel, Section 805, Sample Unit 122 – Low Severity (43) Block Cracking, Low Severity (50) Patching, Low Severity (52) Raveling

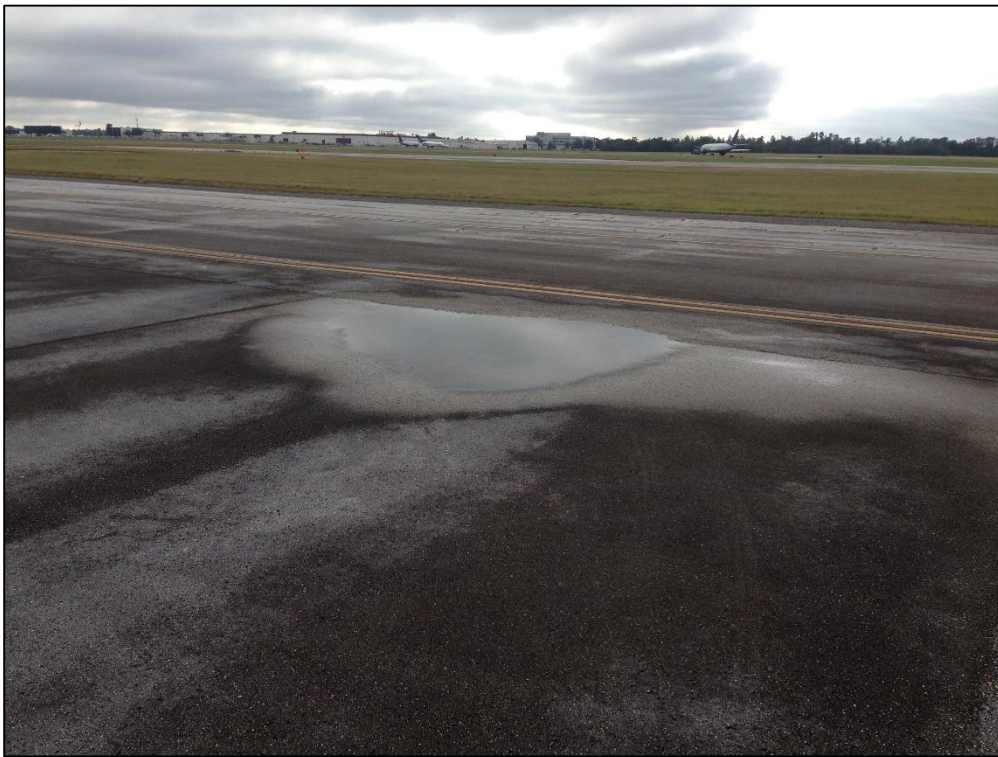
Taxiway Delta, Section 415, Sample Unit 200 – High Severity (45) Depression, Low Severity (48) Longitudinal and Transverse Cracking, Low Severity (52) Raveling, High Severity (52) Raveling

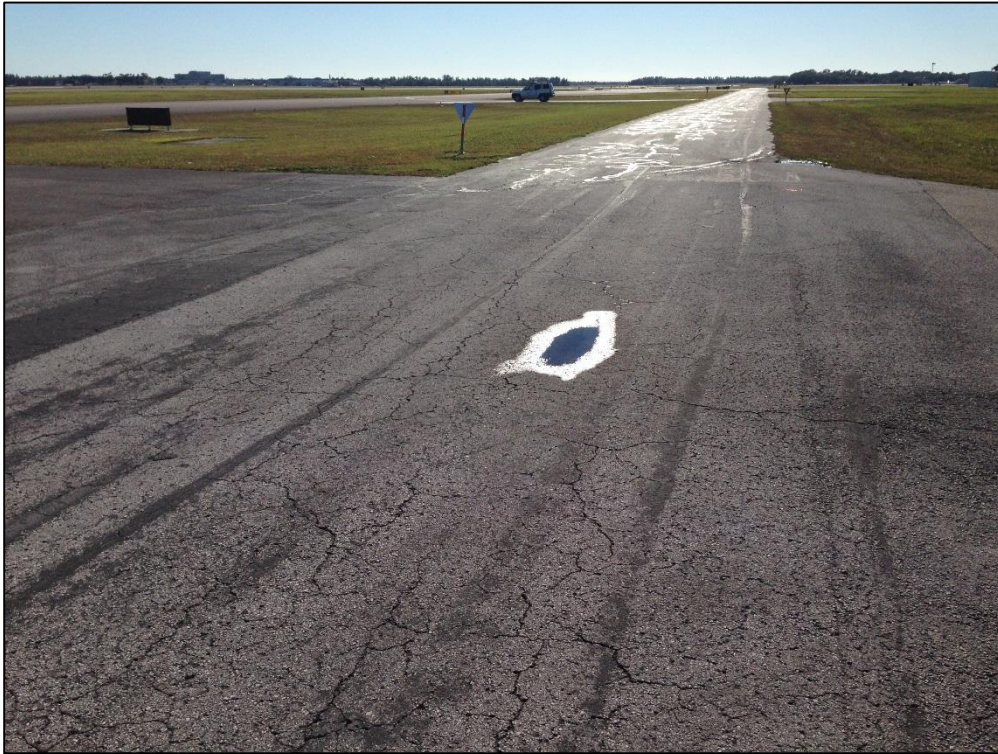
Apron NE, Section 4215, Sample Unit 200 – Low Severity (43) Block Cracking, Low Severity (52) Raveling, Medium Severity (53) Rutting, Low Severity (57) Weathering

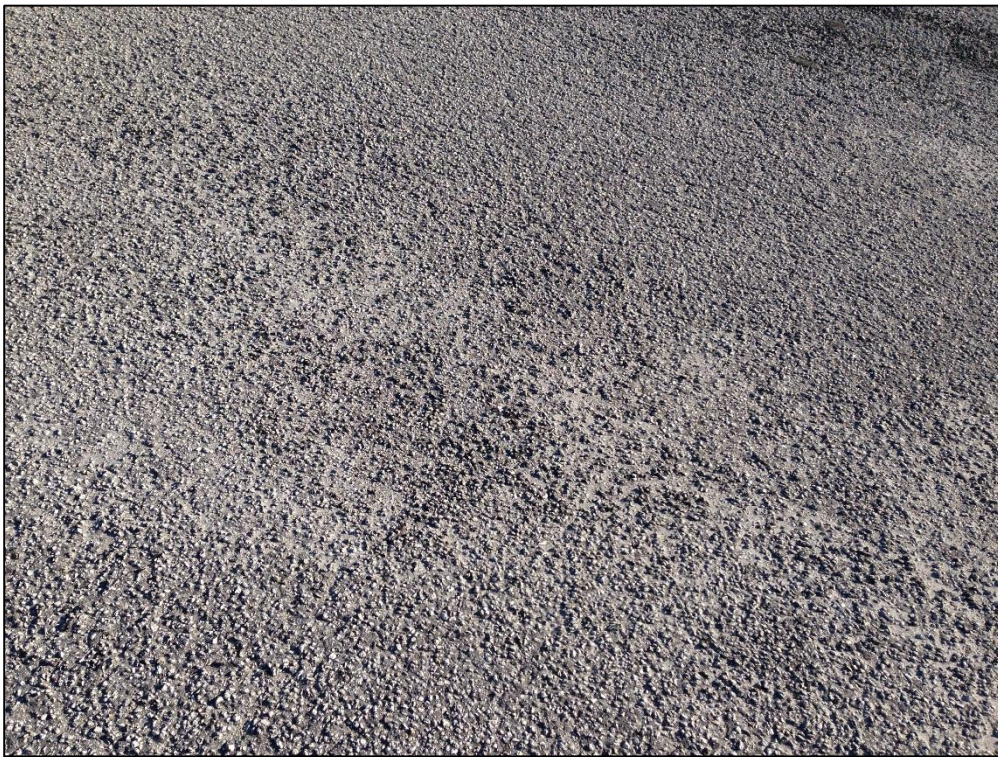
Apron North, Section 4125, Sample Unit 103 – High Severity (52) Raveling

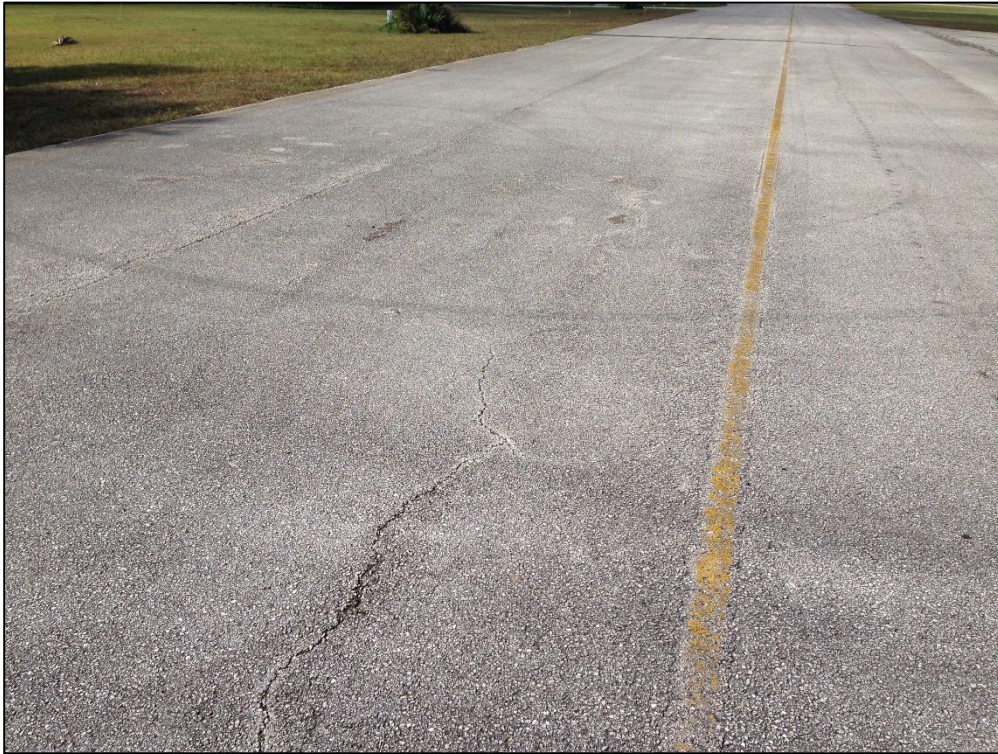
Taxiway Sierra, Section 905, Sample Unit 901 – Low Severity (48) Longitudinal and Transverse Cracking, Low Severity (52) Raveling, Medium Severity (52) Raveling

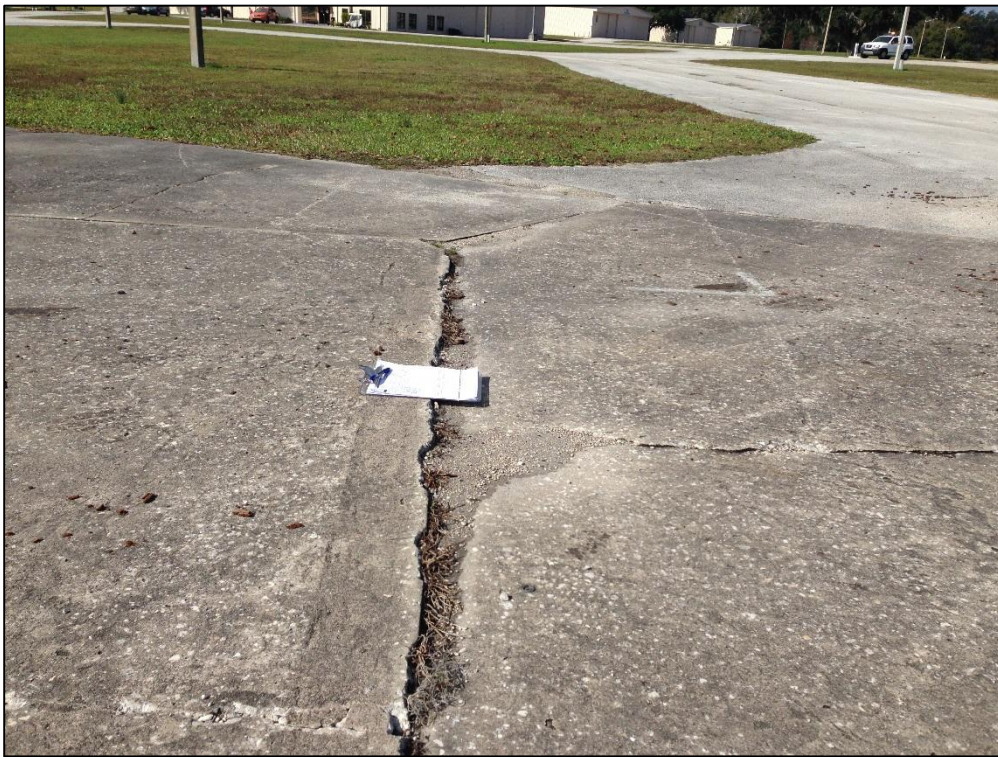
Taxiway Sierra, Section 922, Sample Unit 601 – Medium Severity (63) Longitudinal, Transverse, and Diagonal Cracking, High Severity (71) Faulting, Medium Severity (75) Corner Spalling
