**LEESBURG
INTERNATIONAL
AIRPORT (LEE)**

DISTRICT 5

JUNE 2015

STATEWIDE
**Airfield
Pavement
Management**
PROGRAM

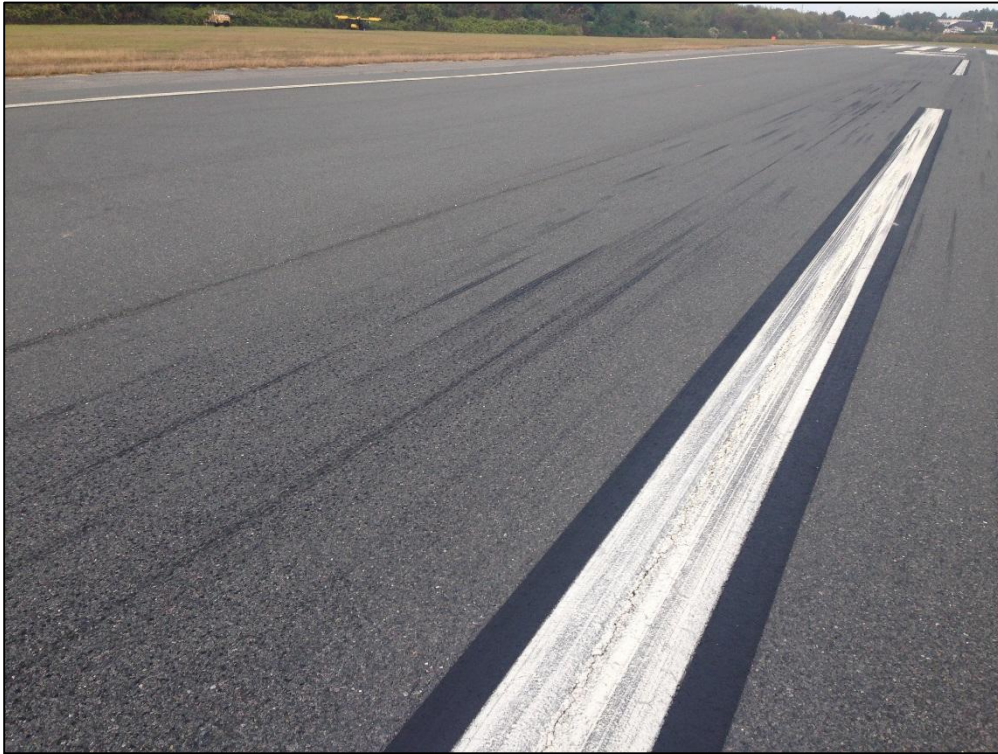
Runway 13-31, Section 6105, Sample Unit 354 – (42) Bleeding, Low Severity (48) Longitudinal and Transverse Cracking, Low Severity (57) Weathering

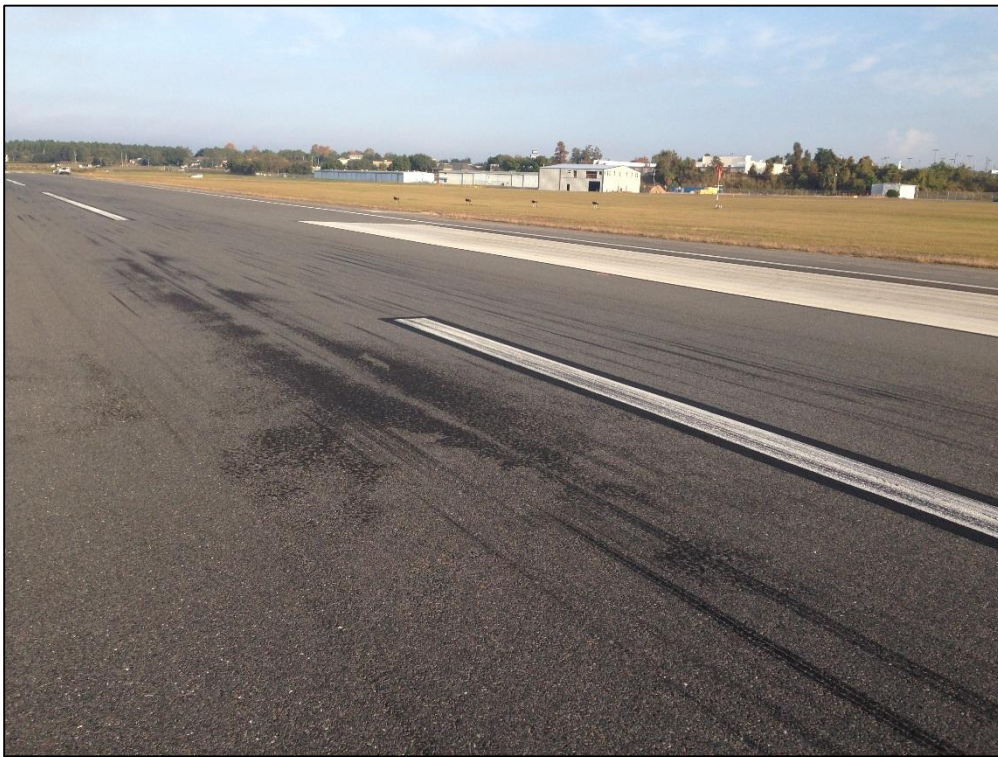
Runway 13-31, Section 6105, Sample Unit 348 – (42) Bleeding, Low Severity (48) Longitudinal and Transverse Cracking, Low Severity (57) Weathering

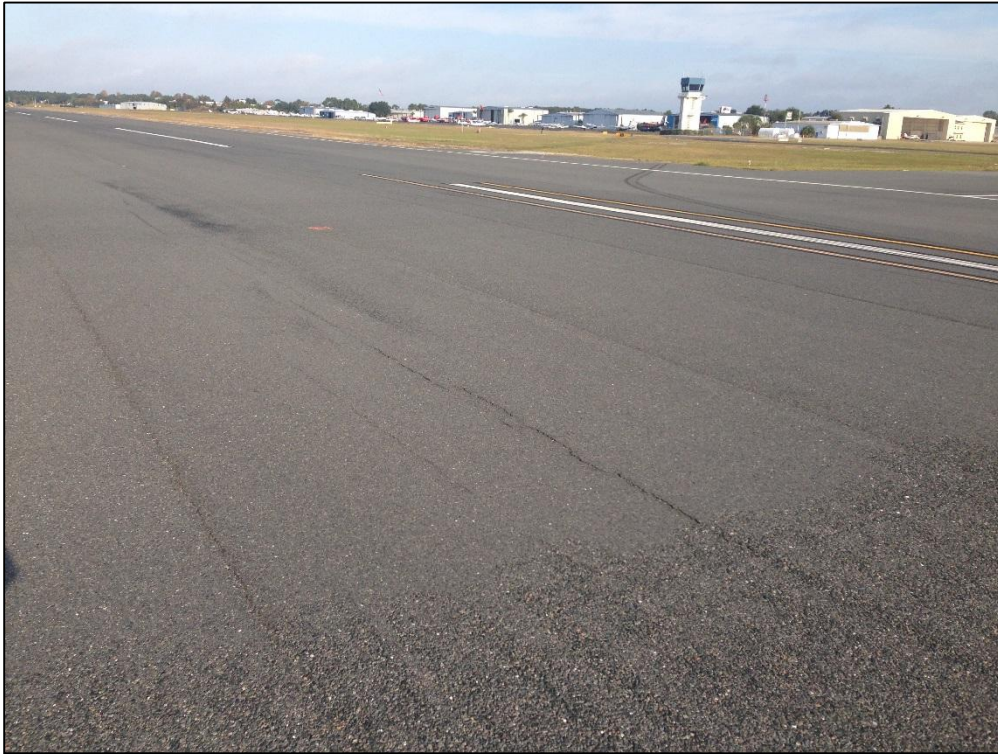
Runway 13-31, Section 6110, Sample Unit 120 – (42) Bleeding, Low Severity (48) Longitudinal and Transverse Cracking, Medium Severity (52) Raveling

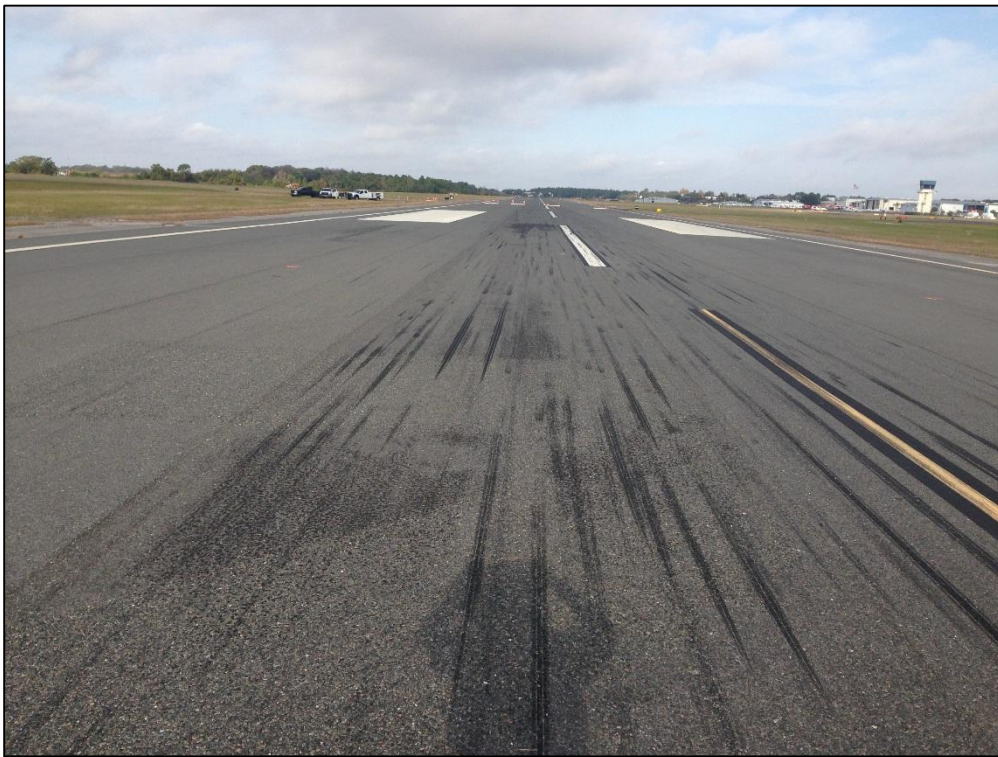
Runway 13-31, Section 6105, Sample Unit 312 – (42) Bleeding, Low Severity (52) Raveling, Medium Severity (52) Raveling

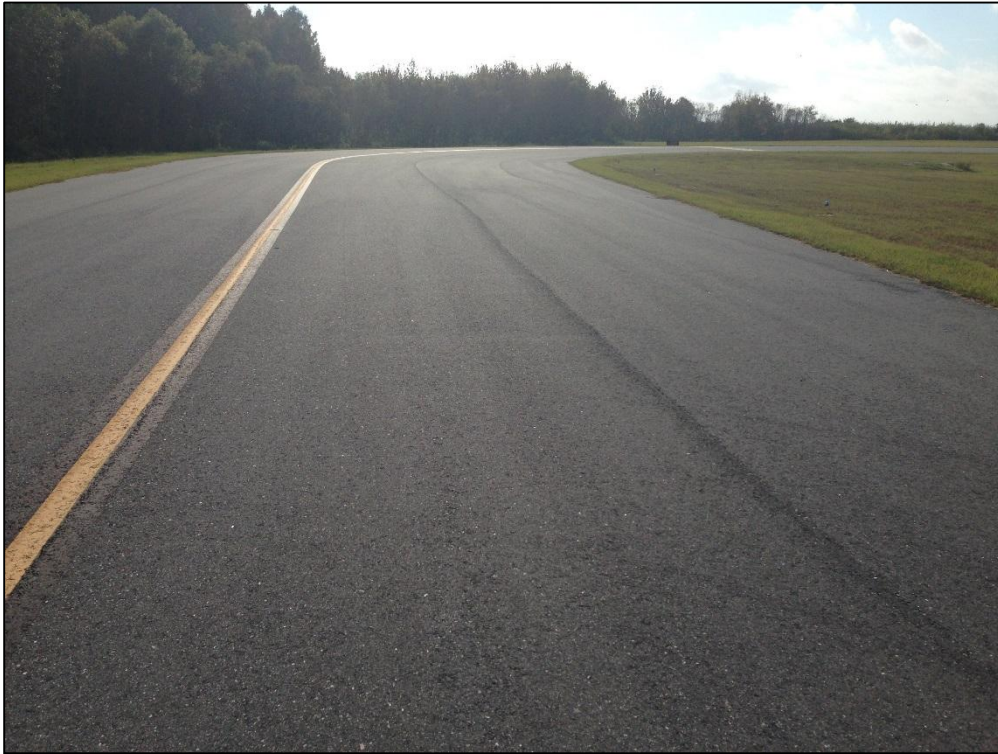
Taxiway Alpha, Section 100, Sample Unit 255 – Low Severity (57) Weathering

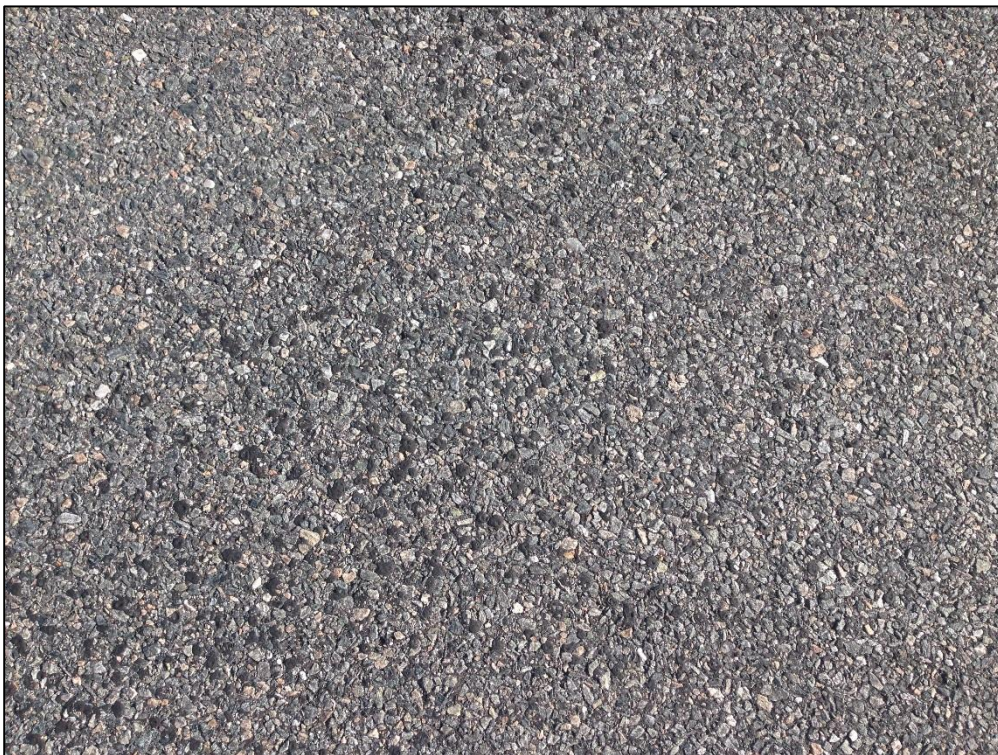
Taxiway Bravo, Section 205, Sample Unit 106 – (42) Bleeding, Low Severity (52) Raveling

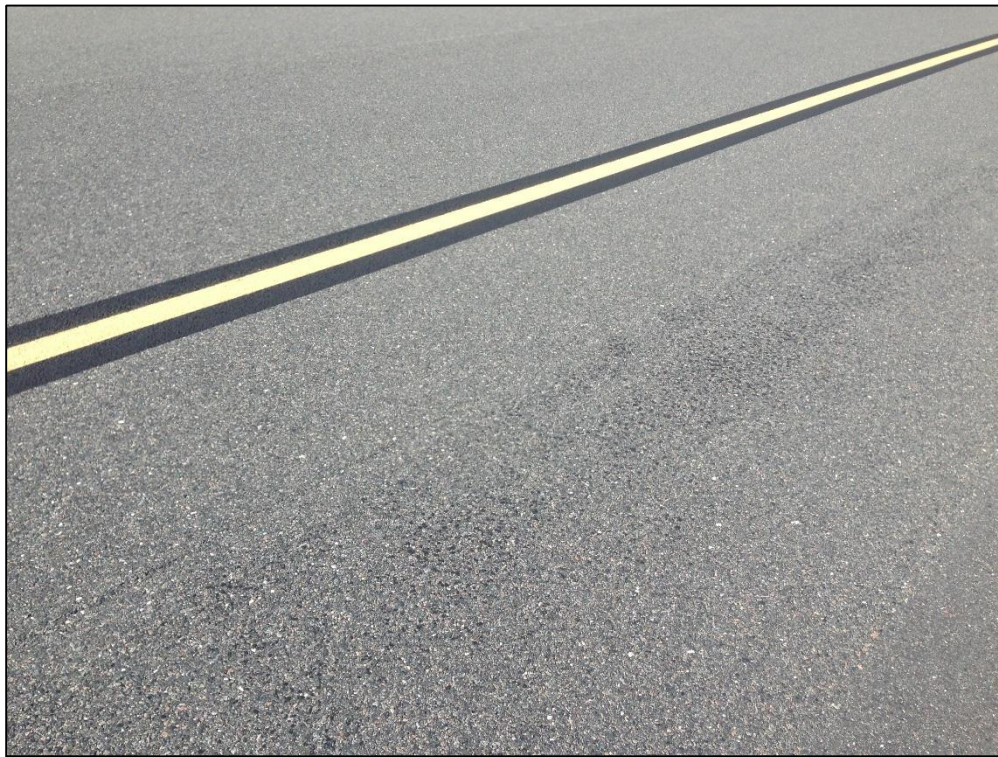
Taxiway Alpha, Section 110, Sample Unit 228 – (42) Bleeding, Low Severity (48) Longitudinal and Transverse Cracking, Low Severity (57) Weathering

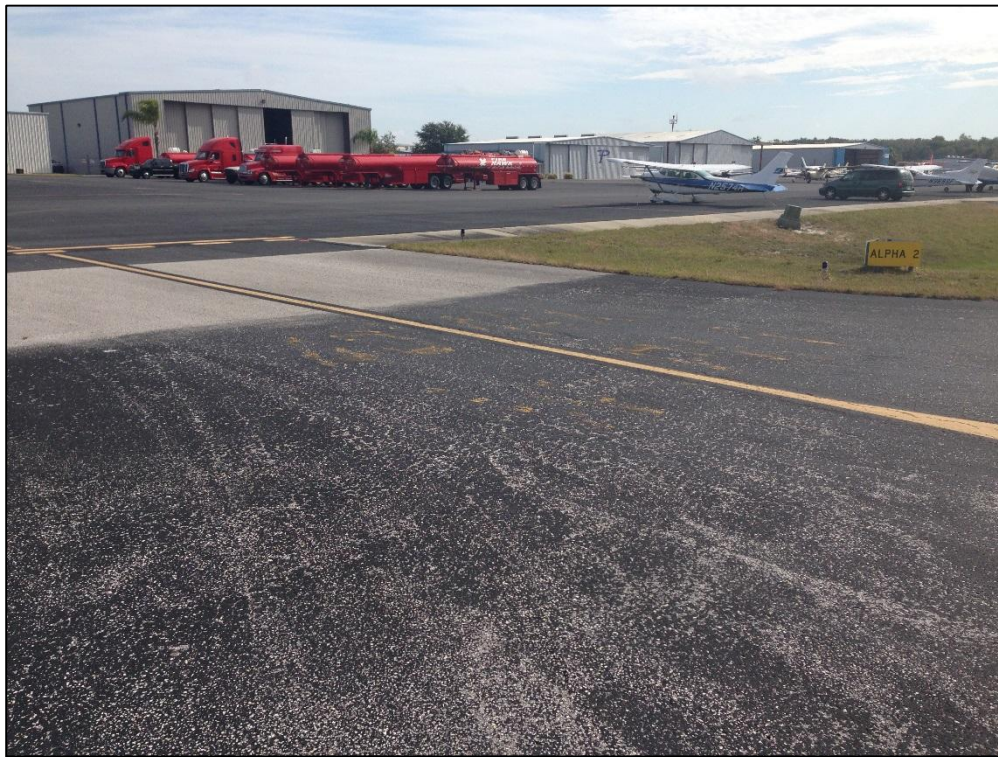
Taxiway A2, Section 130, Sample Unit 501 – Low Severity (48) Longitudinal and Transverse Cracking, Low Severity (52) Raveling

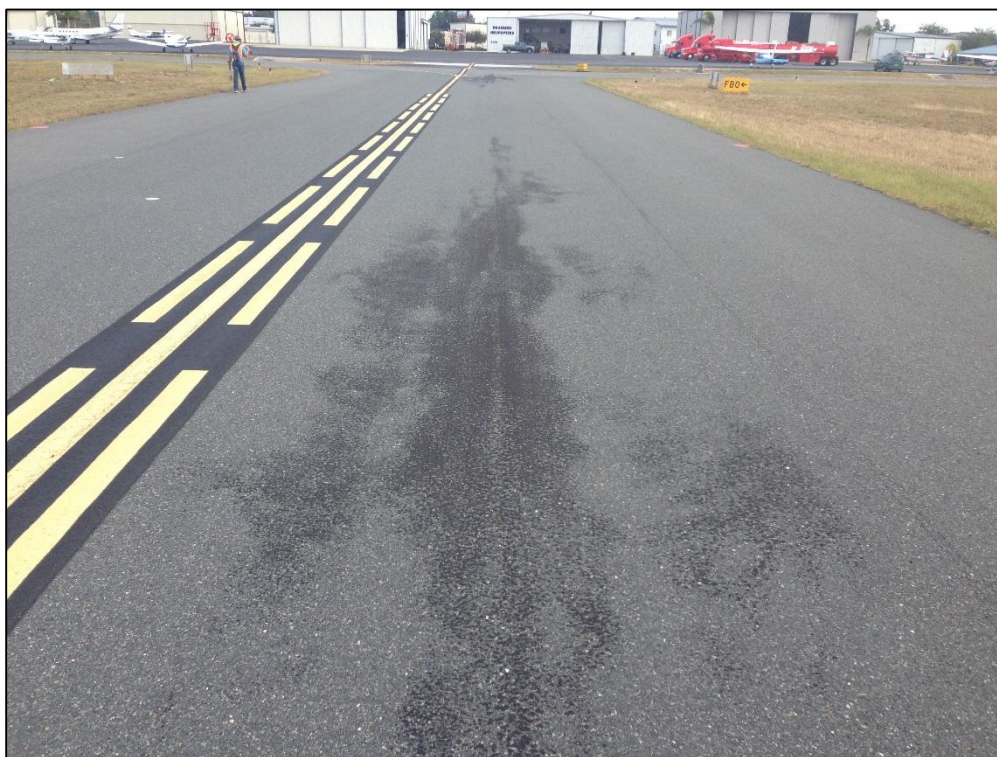
Taxiway Delta, Section 400, Sample Unit 252 – (42) Bleeding, Low Severity (57) Weathering

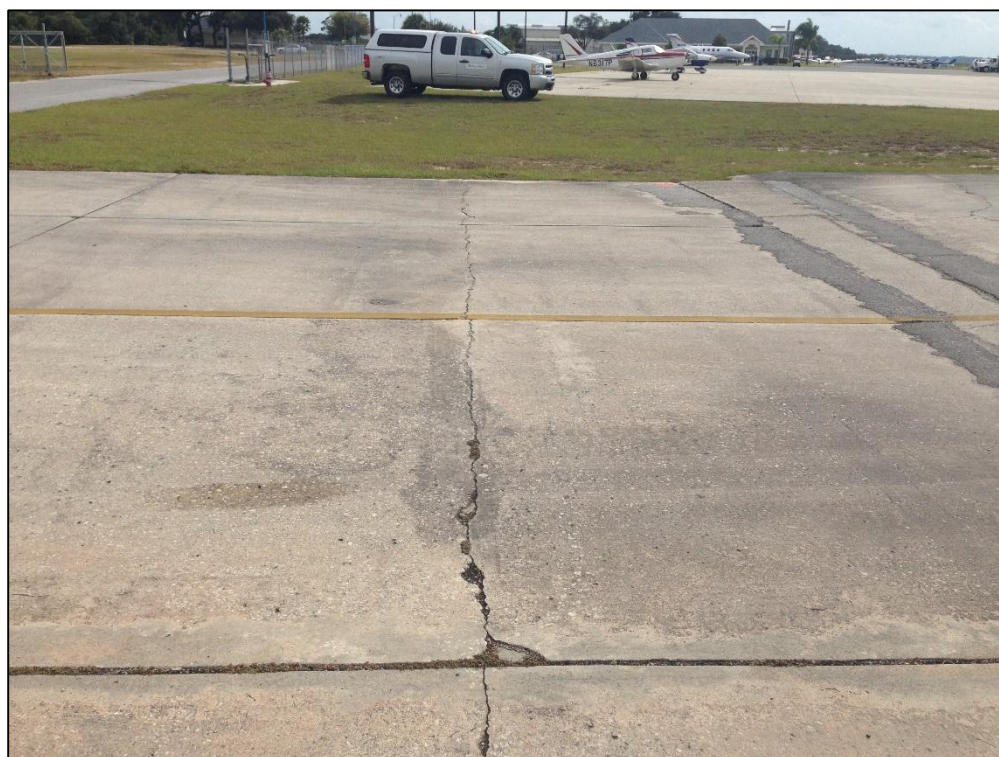
Apron North, Section 4135, Sample Unit 604 – Low Severity (63) Longitudinal, Transverse, and Diagonal Cracking, Low Severity (65) Joint Seal Damage, Low Severity (74) Joint Spalling,

- ⦿ North Apron – Section 4105
 - Mill and Overlay attributed to load, climate, and age of pavement.
- ⦿ North Apron – Sections 4120, 4135, and 4140
 - PCC Restoration and Reconstruction attributed to structural, climate, and age of pavement.
- ⦿ Re-Fueling Apron – Section 4505
 - Reconstruction attributed to load, climate, and age of pavement.
- ⦿ Taxilane Apron – Section 4305
 - Reconstruction attributed to load, climate, and age of pavement.
- ⦿ Taxiway A1 – Section 120
 - Mill and Overlay attributed to climate and age of pavement.
- ⦿ Taxiway D – Section 400
 - Mill and Overlay attributed to climate and age of pavement.

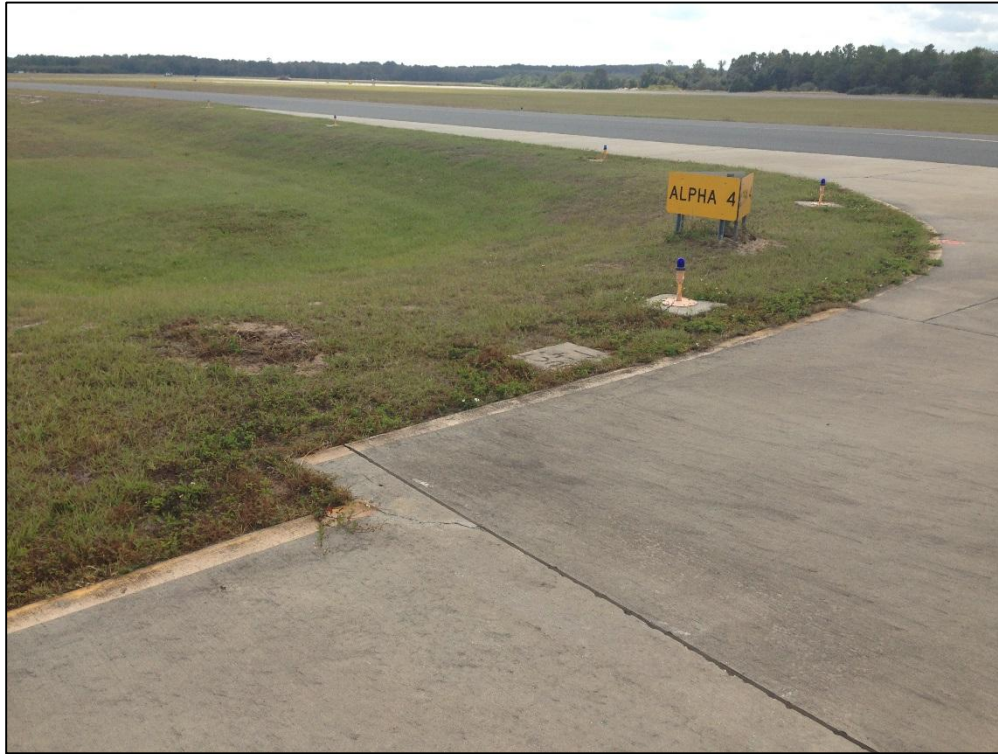
Apron North, Section 4130, Sample Unit 101 – Low Severity (62) Corner Break

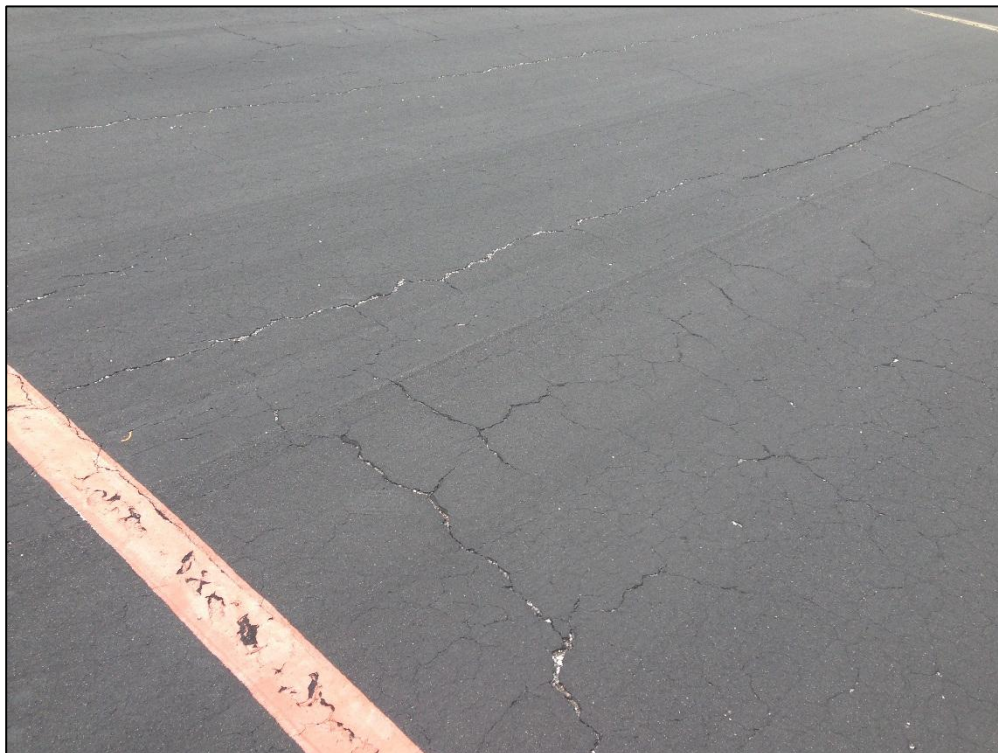
Apron North, Section 4105, Sample Unit 112 – Low Severity (48) Longitudinal and Transverse Cracking, Medium Severity (57) Weathering

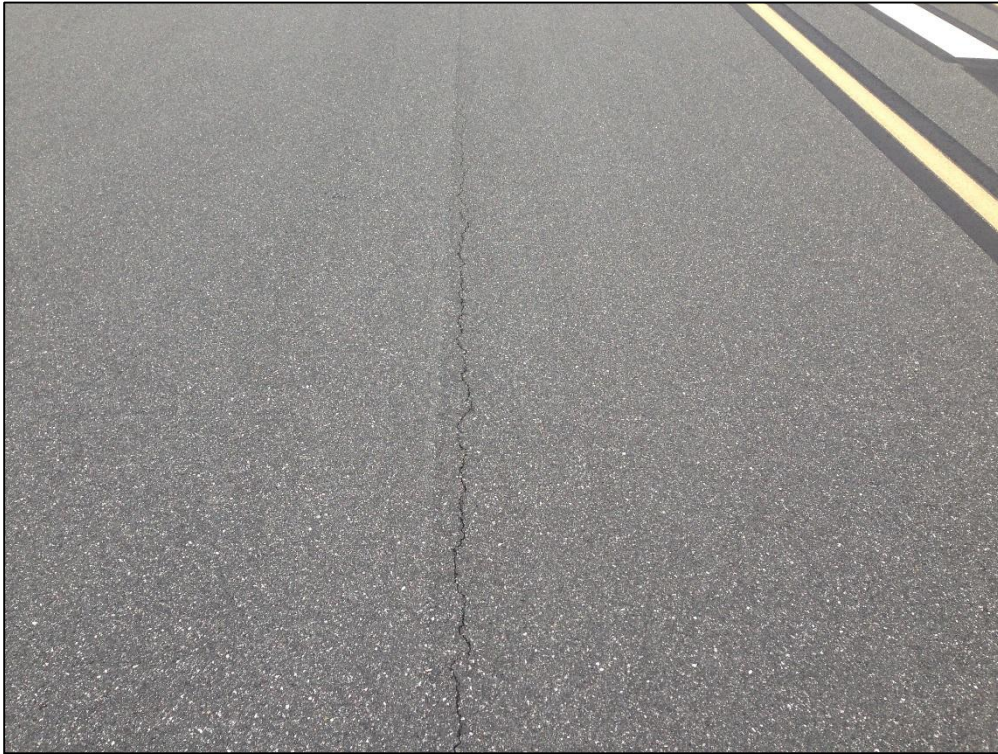
Runway 03-21, Section 6205, Sample Unit 301 – Low Severity (48) Longitudinal and Transverse Cracking

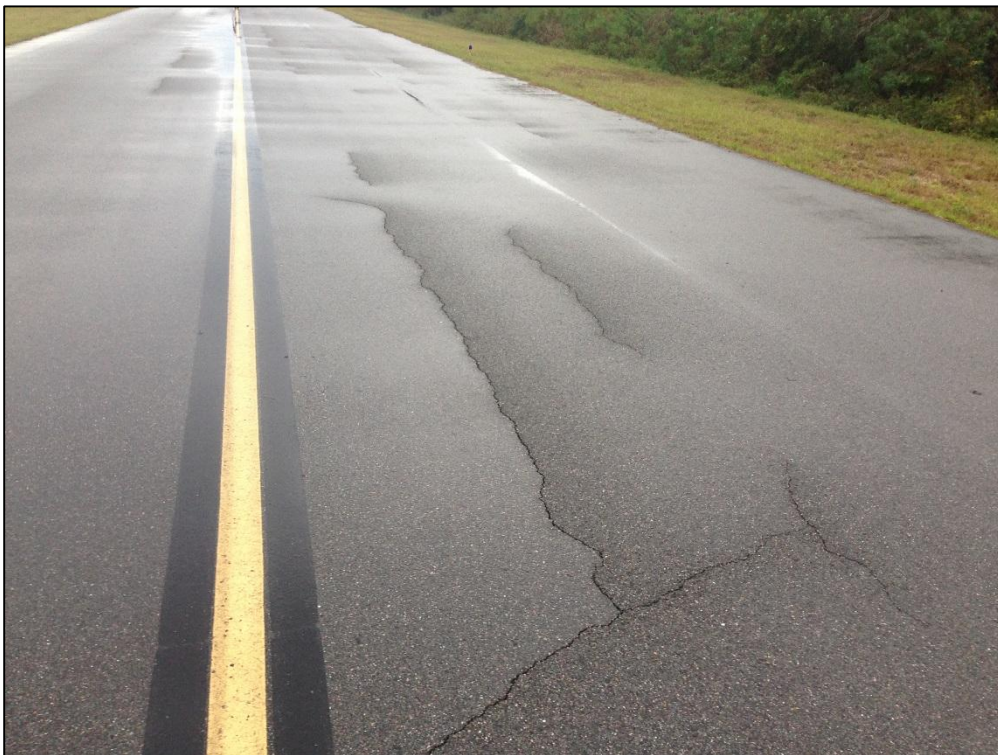
Taxiway Kilo, Section 700, Sample Unit 111 – Low Severity (48) Longitudinal and Transverse Cracking, Low Severity (57) Weathering

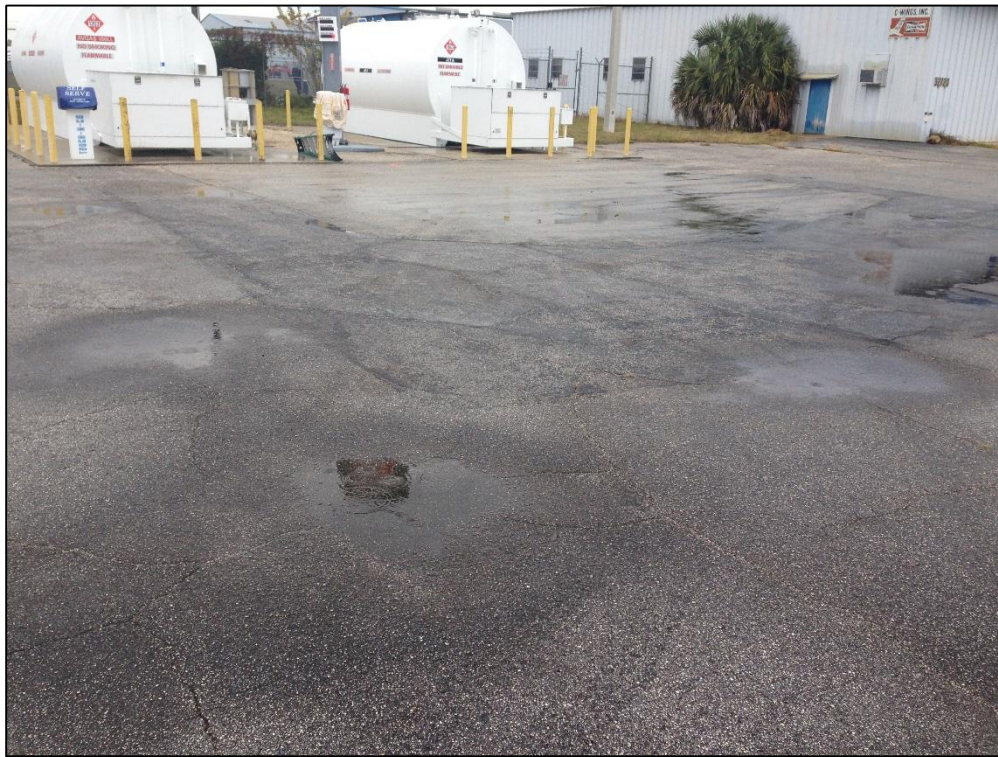
Re-Fueling Apron, Section 4210, Sample Unit 301 – Low Severity (43) Block Cracking, Low Severity (45) Depression, Low Severity (50) Patching, Low Severity (52) Raveling

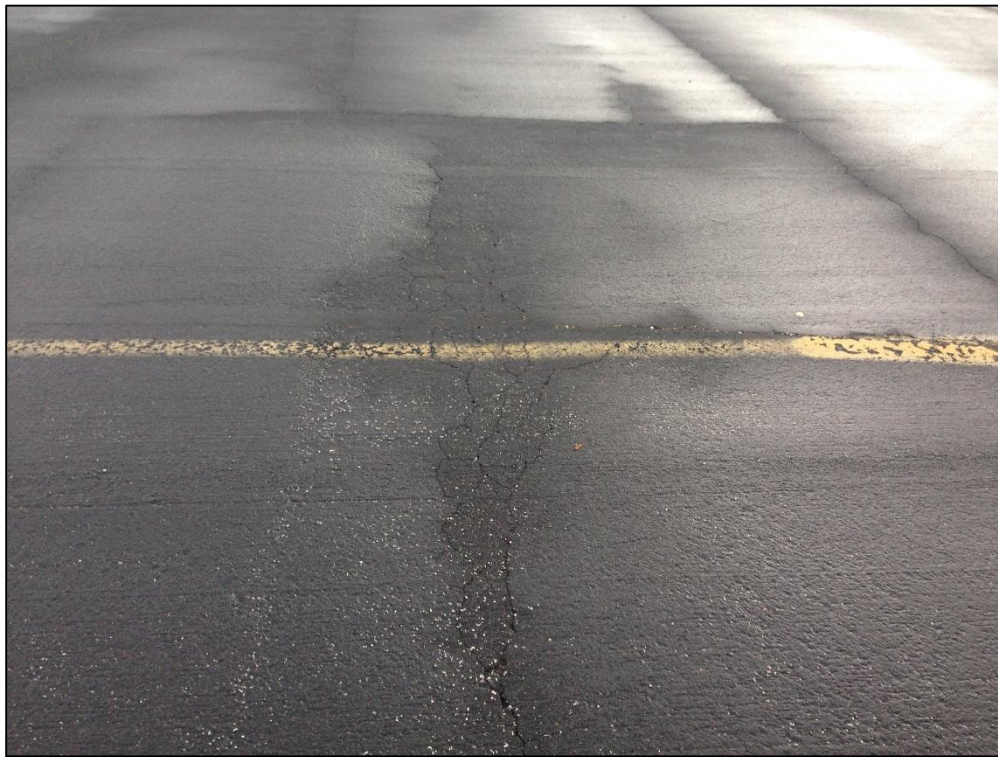
Apron North, Section 4105, Sample Unit 158 – Low Severity (41) Alligator Cracking, Medium Severity (41) Alligator Cracking
