**PALM BEACH
COUNTY PARK
AIRPORT (LNA)**

DISTRICT 4
REGIONAL RELIEVER
AIRPORT
JUNE 2015

STATEWIDE
**Airfield
Pavement
Management**
PROGRAM

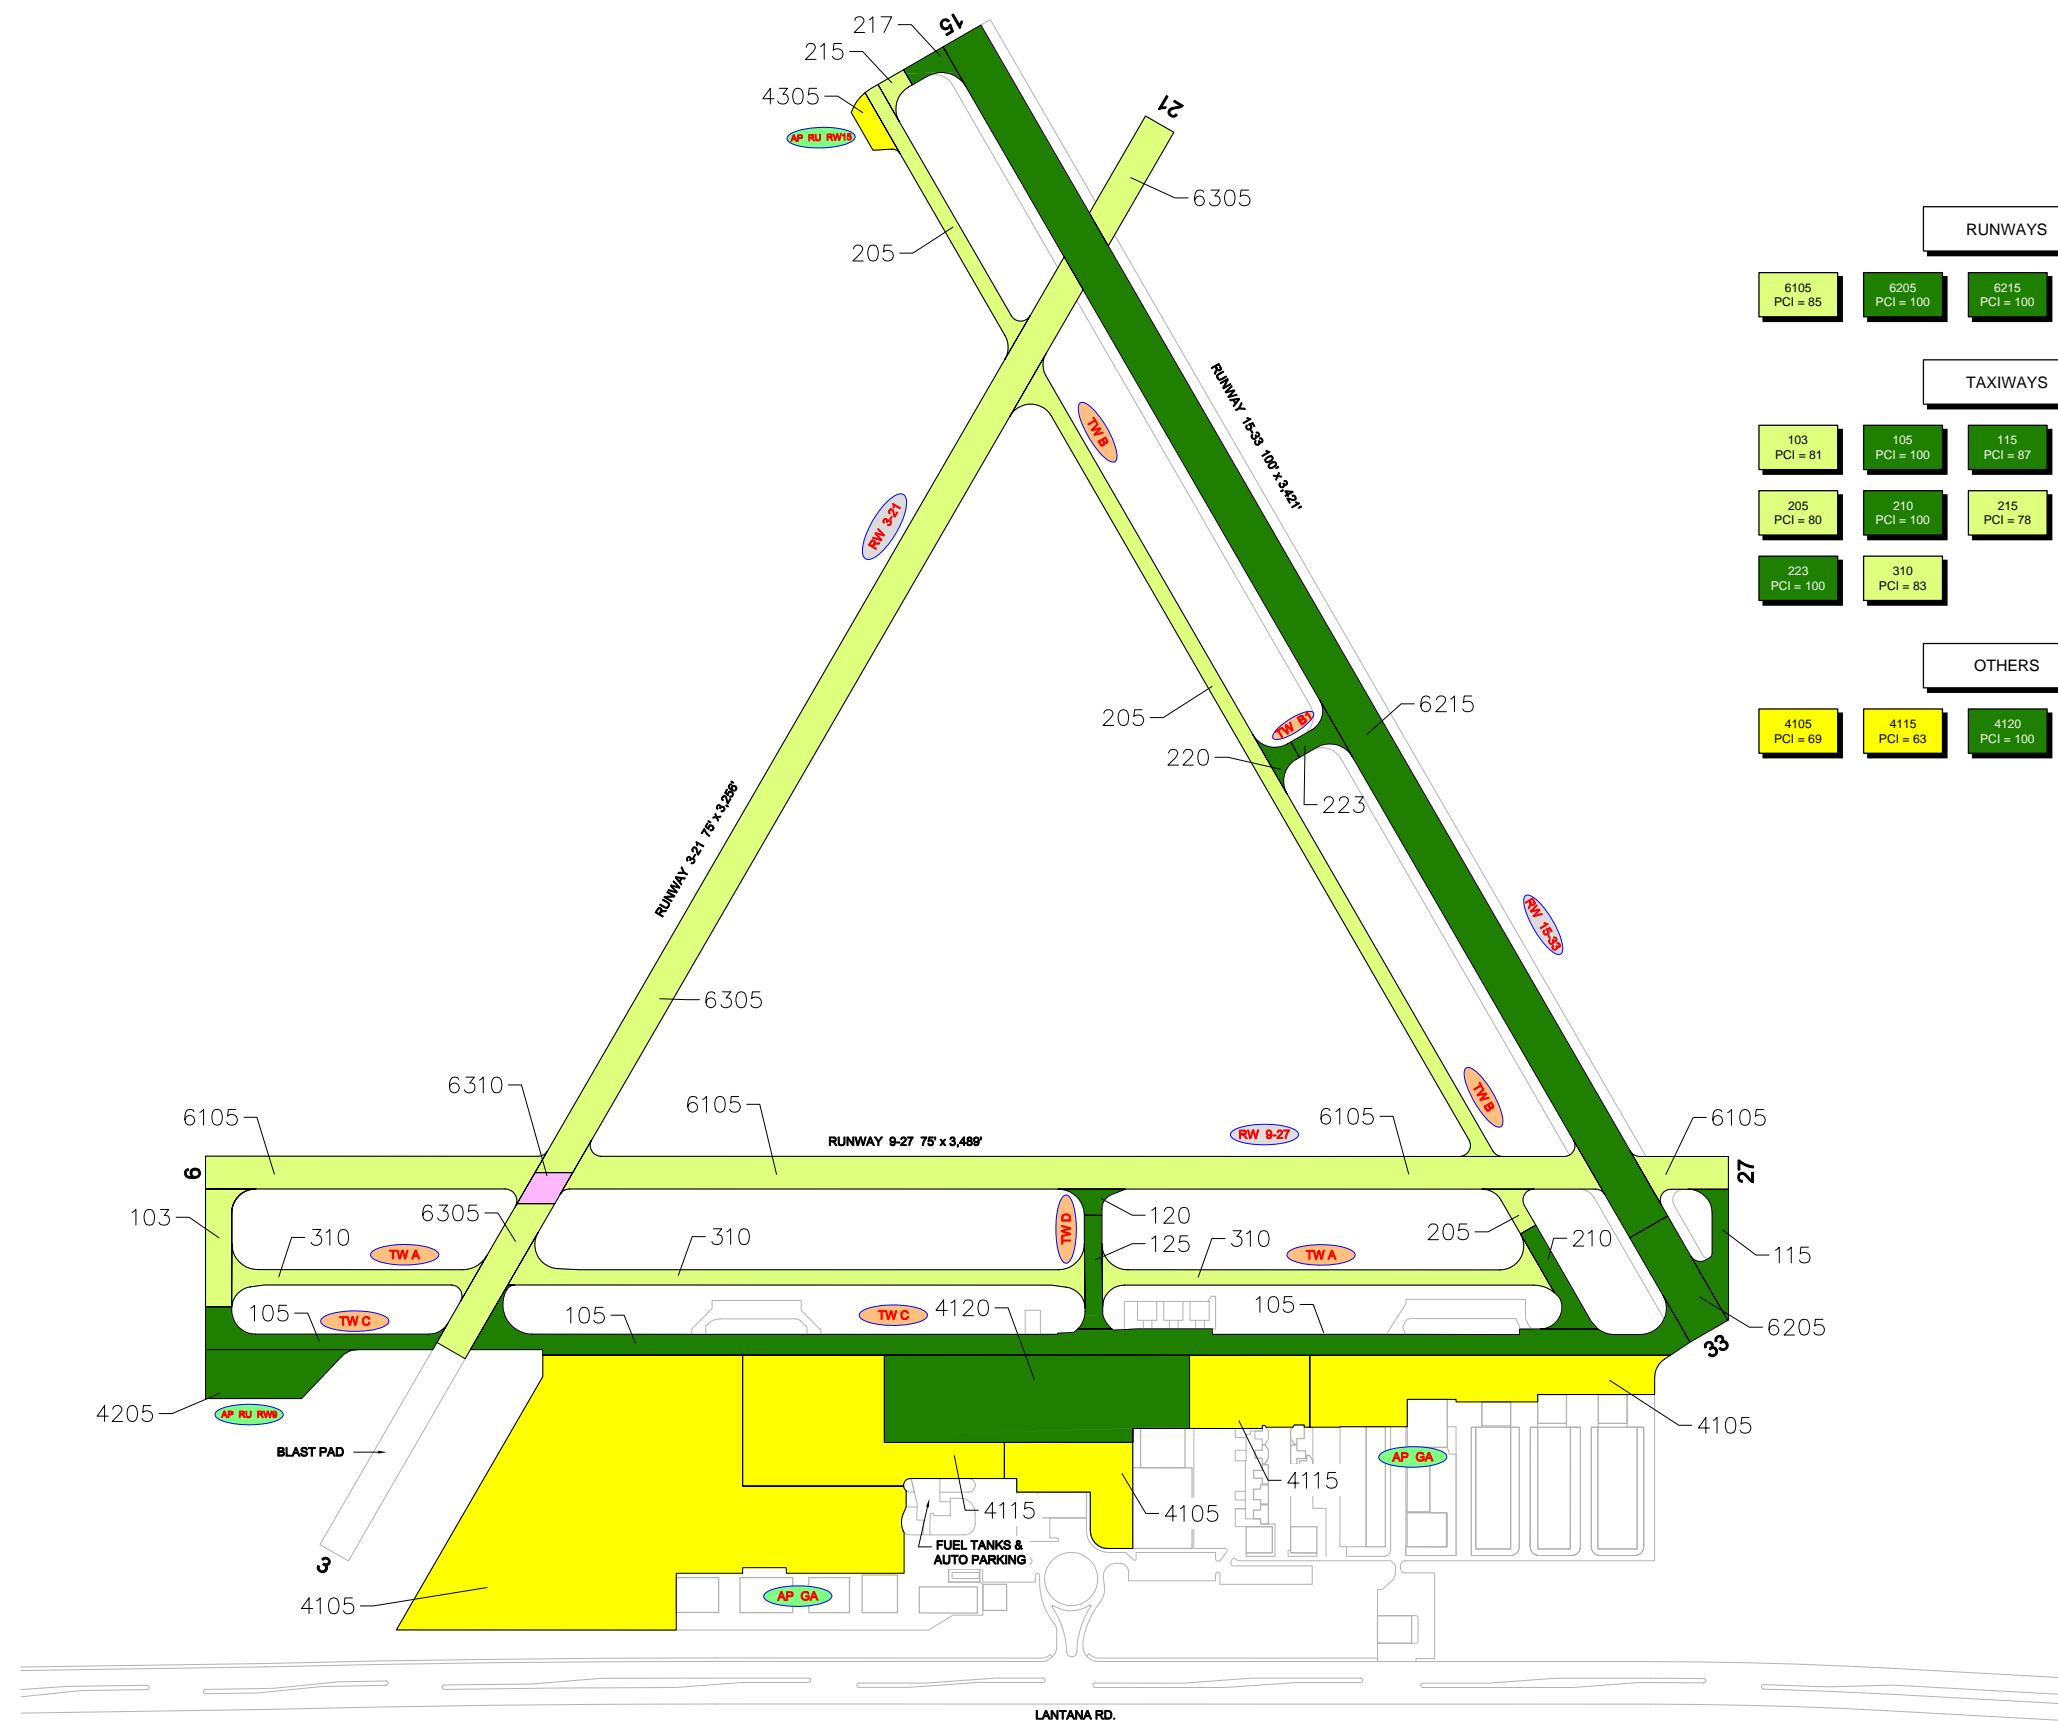
RUNWAYS				
6105 PCI = 85	6205 PCI = 100	6215 PCI = 100	6305 PCI = 77	6310 PCI = 37
TAXIWAYS				
103 PCI = 81	105 PCI = 100	115 PCI = 87	120 PCI = 87	125 PCI = 100
205 PCI = 80	210 PCI = 100	215 PCI = 78	217 PCI = 100	220 PCI = 93
223 PCI = 100	310 PCI = 83			
OTHERS				
4105 PCI = 69	4115 PCI = 63	4120 PCI = 100	4205 PCI = 100	4305 PCI = 65

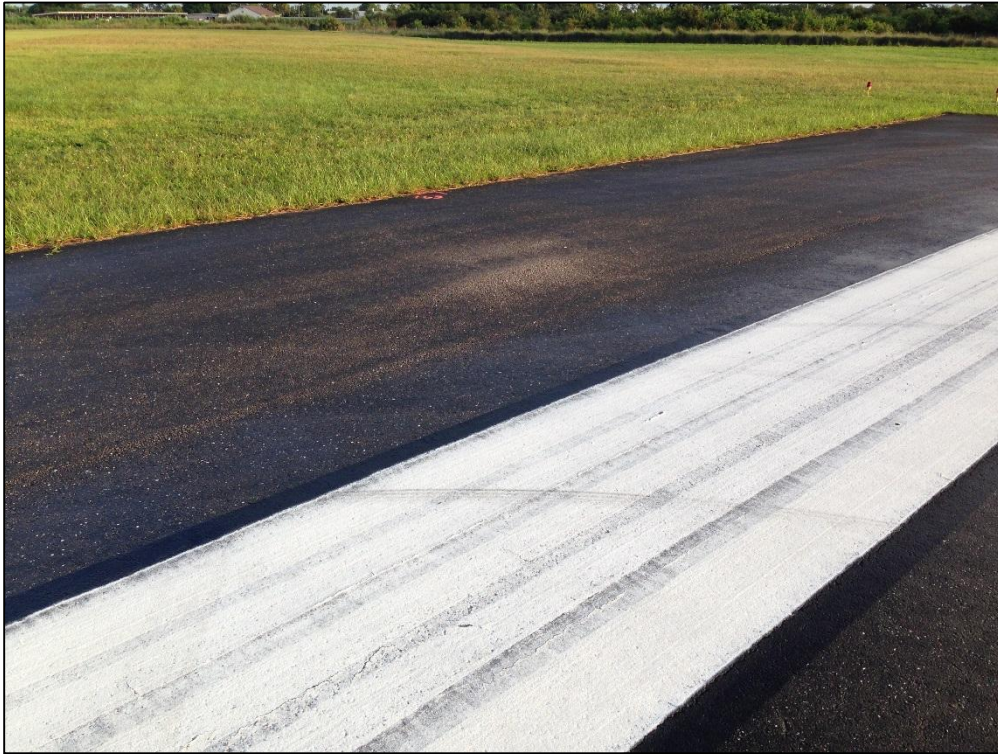
Runway 3-21, Section 6305, Sample Unit 163 – Low Severity (48) Longitudinal and Transverse Cracking, Low Severity (52) Raveling

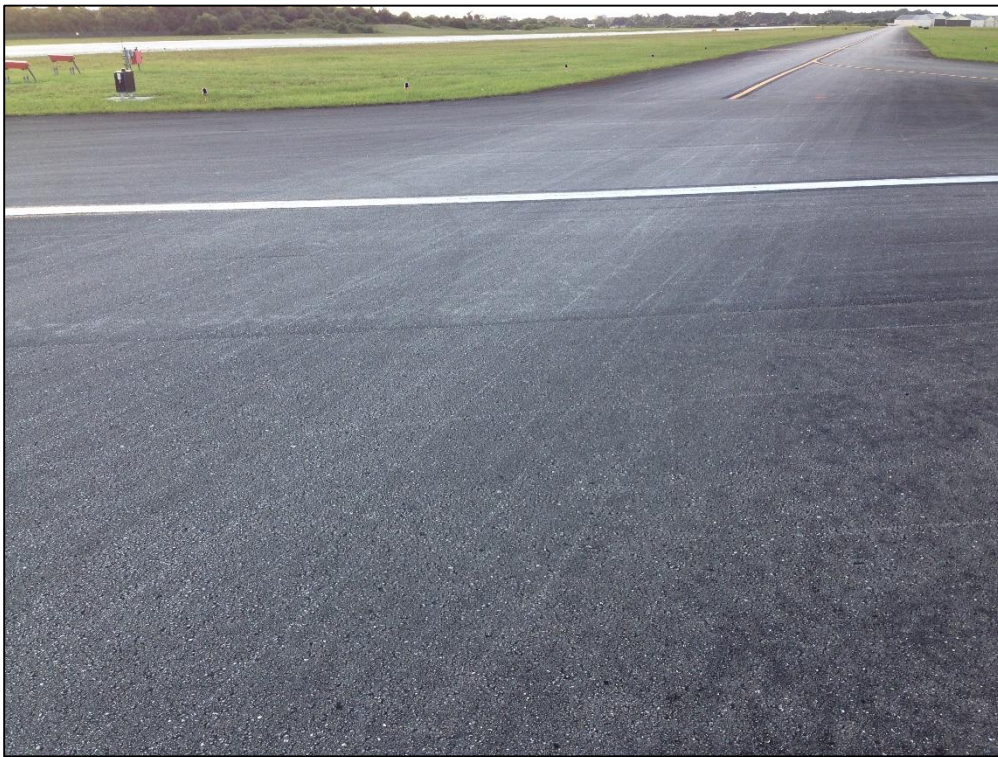
Runway 3-21, Section 6305, Sample Unit 152 – Low Severity (48) Longitudinal and Transverse Cracking, Low Severity (52) Raveling, Low Severity (57) Weathering

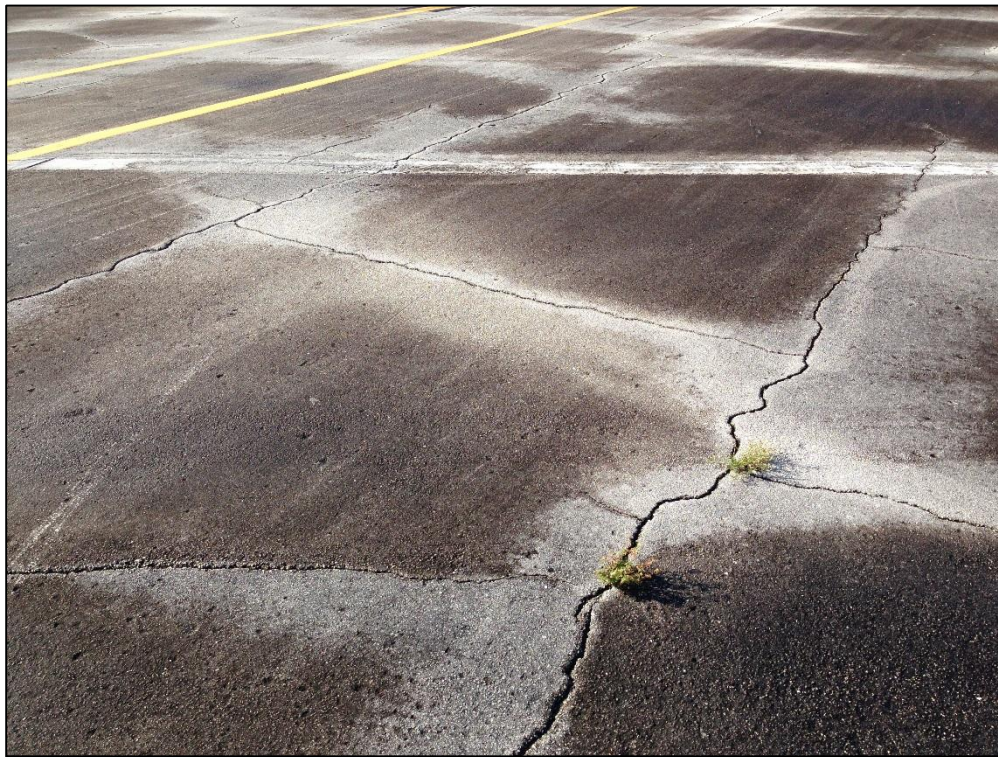
- Runway 3-21 – Section 6310.
 - Reconstruction attributed to load, climate, and age of pavement.
- Run-up Apron RW 15 – Section 4305.
 - Mill and Overlay attributed to climate and age of pavement.
- General Aviation Apron – Section 4115
 - Mill and Overlay attributed to climate and age of pavement.

Runway 3-21, Section 6310, Sample Unit 109 – Low Severity (43) Block Cracking, Medium Severity (43) Block Cracking, Low Severity (52) Raveling

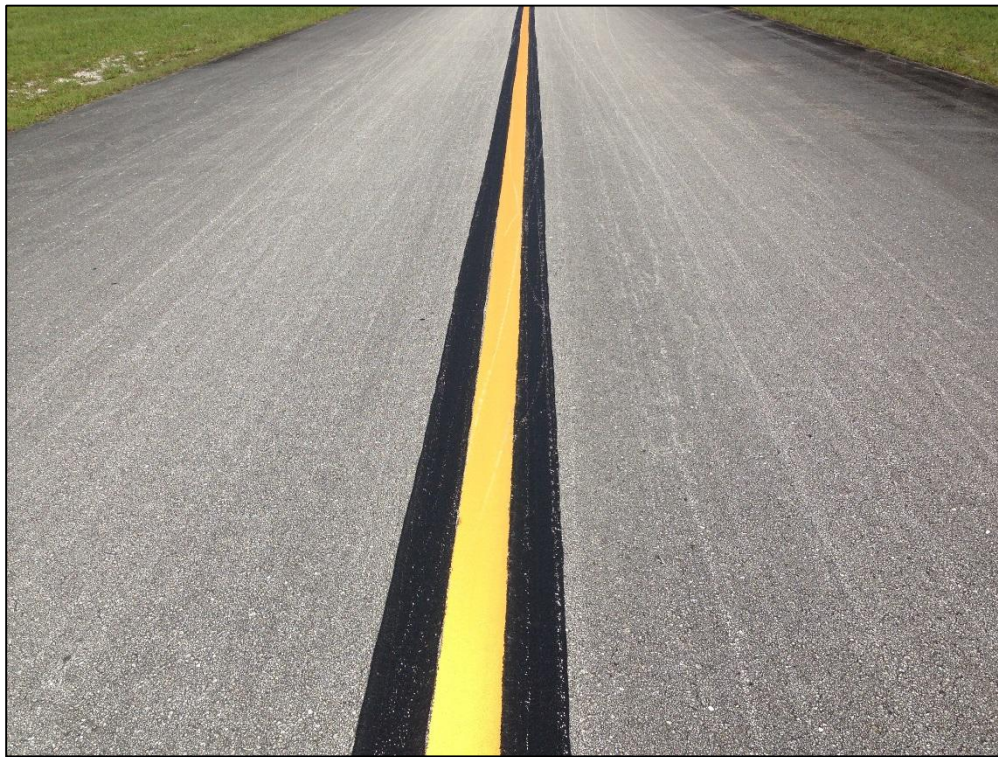
Taxiway B, Section 205, Sample Unit 109 – Low Severity (48) Longitudinal and Transverse Cracking, Low Severity (52) Raveling, Low Severity (57) Weathering

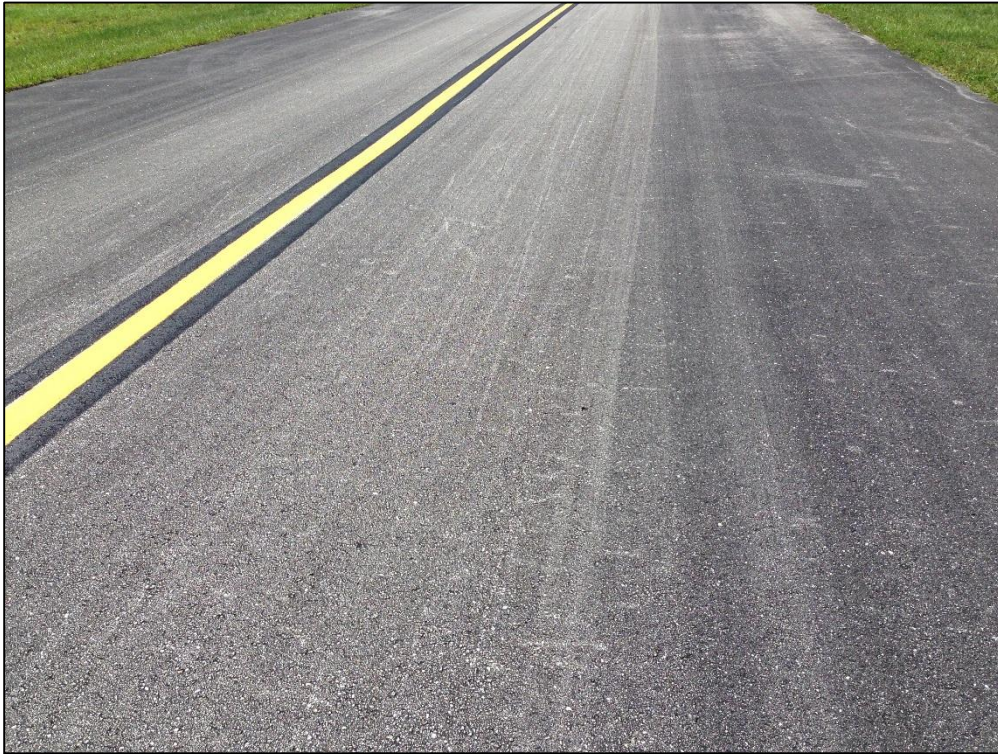
Taxiway A, Section 310, Sample Unit 302 – Low Severity (52) Raveling, Low Severity (57) Weathering

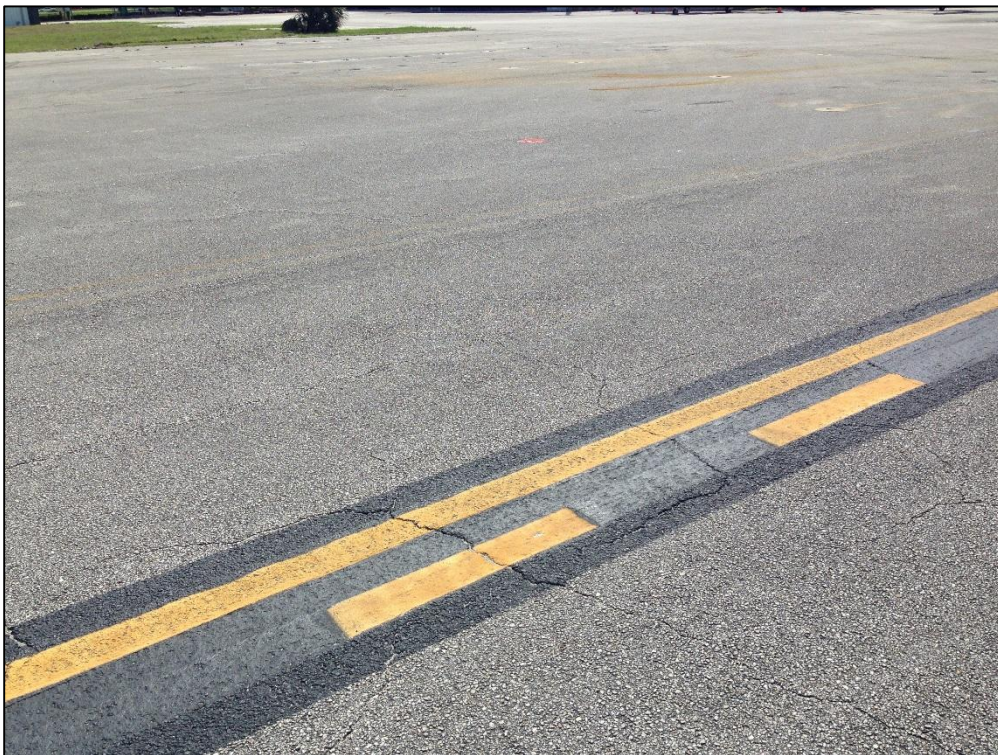
Apron GA, Section 4115, Sample Unit 720 – Low Severity (43) Block Cracking, Low Severity (48) Longitudinal and Transverse Cracking, Low Severity (52) Raveling

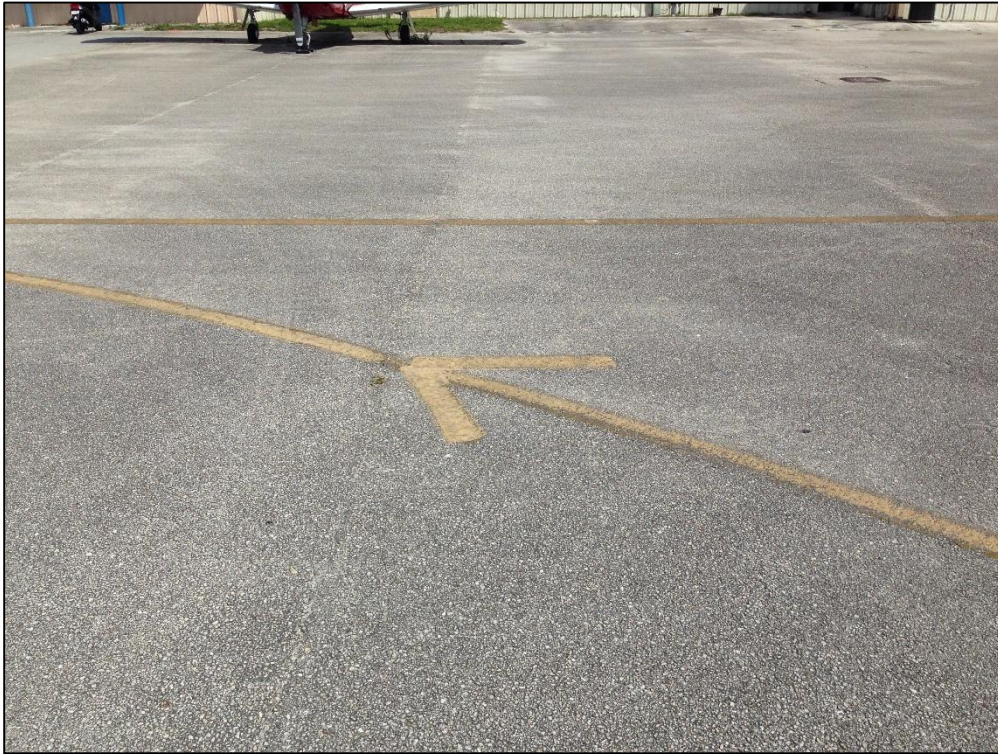
Apron GA, Section 4105, Sample Unit 516 – Low Severity (48) Longitudinal and Transverse Cracking, Low Severity (52) Raveling, Low Severity (57) Weathering

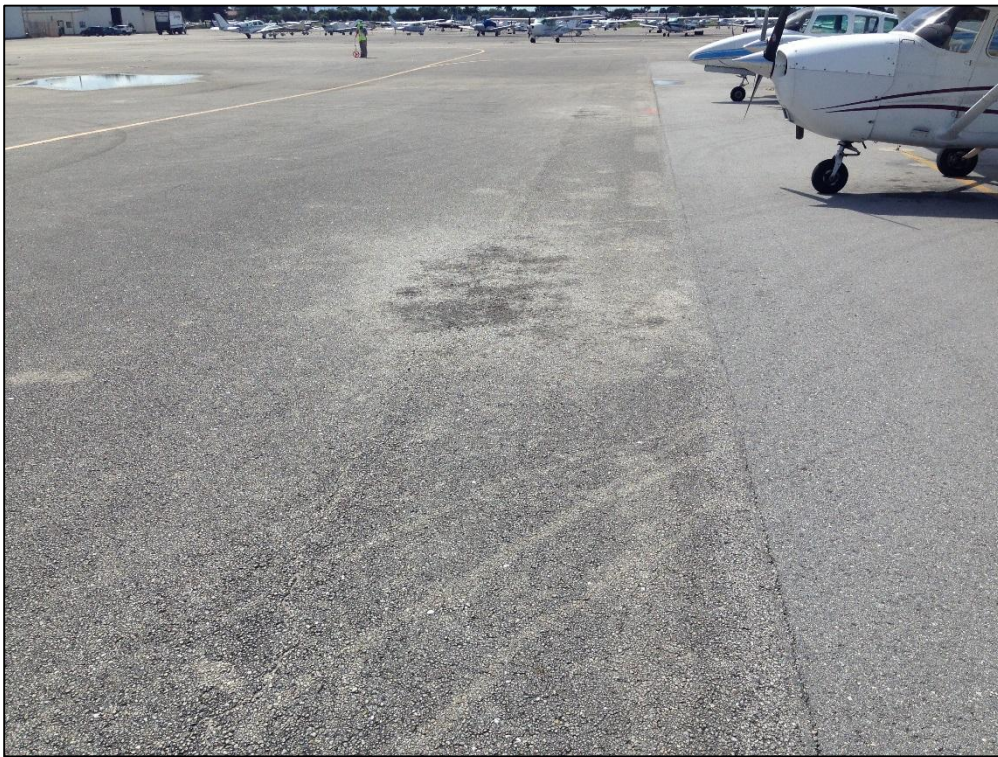
Apron GA, Section 4115, Sample Unit 512 – Low Severity (48) Longitudinal and Transverse Cracking, (49) Oil Spillage, Low Severity (52) Raveling
