FLORIDA DEPARTMENT OF TRANSPORTATION
AVIATION AND SPACEPORT OFFICE

**MELBOURNE
INTERNATIONAL
AIRPORT (MLB)**

JUNE 2015

STATEWIDE
**Airfield
Pavement
Management**
PROGRAM

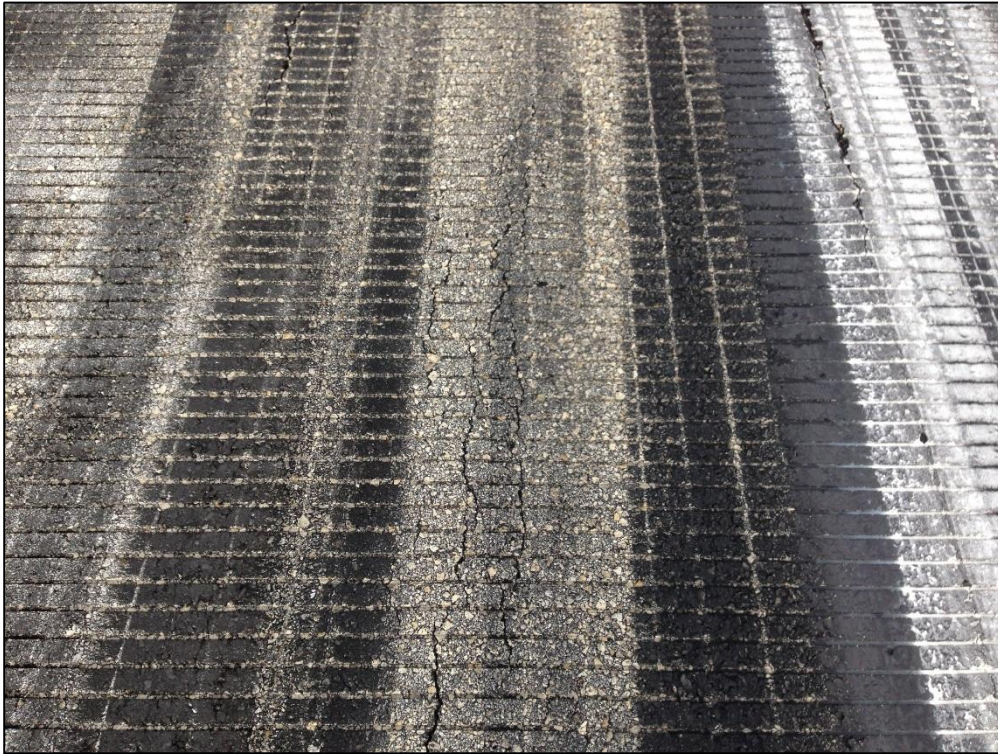
Runway 9R-27L, Section 6105, Sample Unit 326 – Low Severity (41) Alligator Cracking, Low Severity (48) Longitudinal and Transverse Cracking, Low Severity (52) Raveling, Low Severity (56) Swelling, Low Severity (57) Weathering

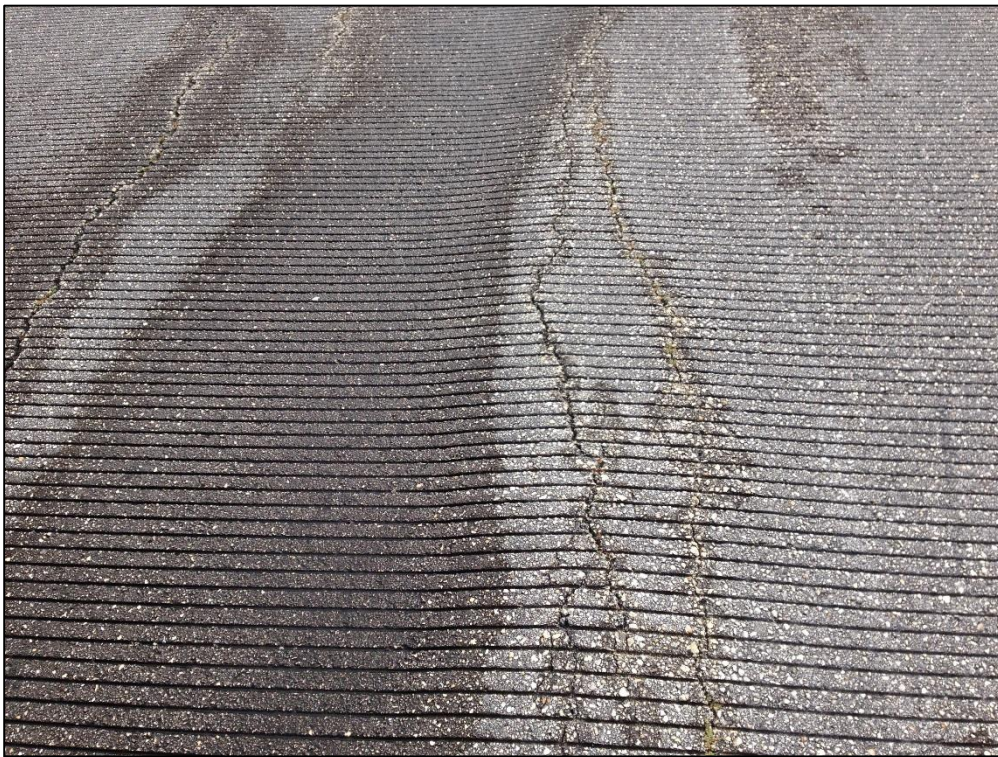
Runway 9R-27L, Section 6105, Sample Unit 382 – Low and Medium Severity (48) Longitudinal and Transverse Cracking, Low Severity (56) Swelling, Low Severity (57) Weathering

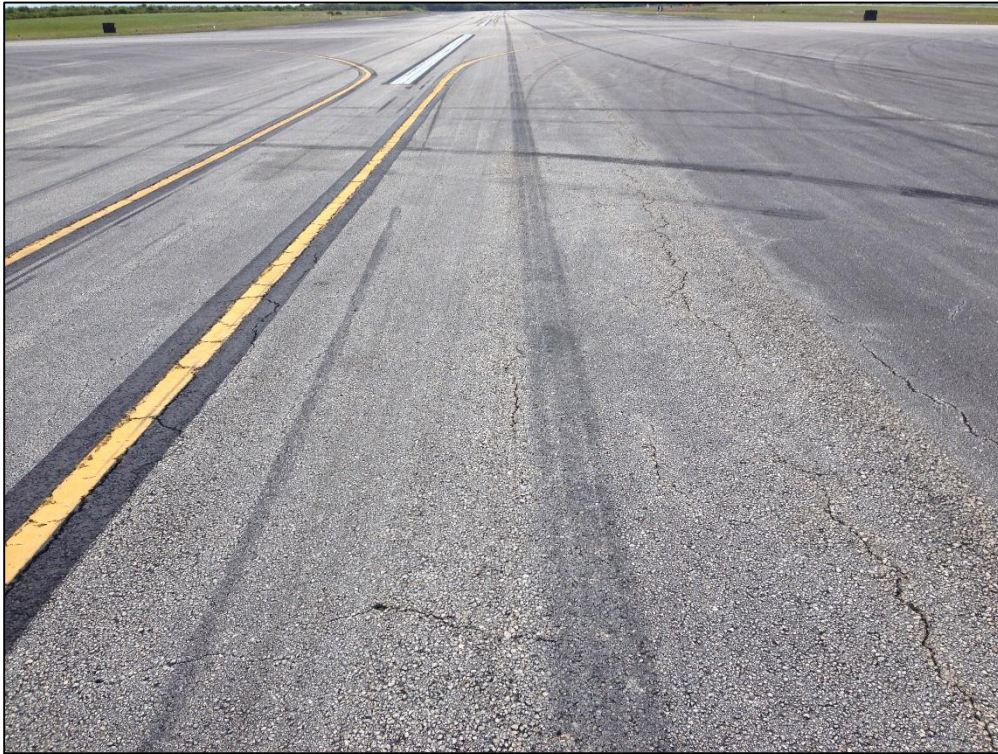
Runway 9L-27R, Section 6210, Sample Unit 377 – Low and Medium Severity (48) Longitudinal and Transverse Cracking, Low Severity (56) Swelling, Low Severity (52) Raveling, Low Severity (57) Weathering

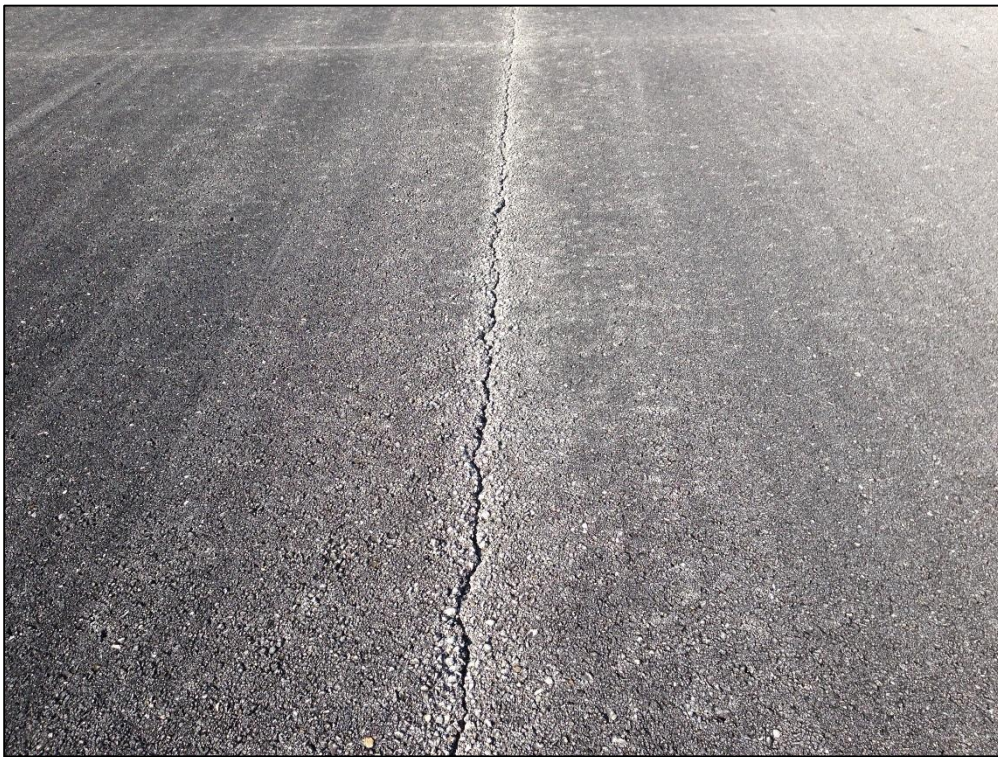
Runway 5-23, Section 6310, Sample Unit 108 – Low Severity (48) Longitudinal and Transverse Cracking, Low Severity (52) Raveling, Low Severity (57) Weathering

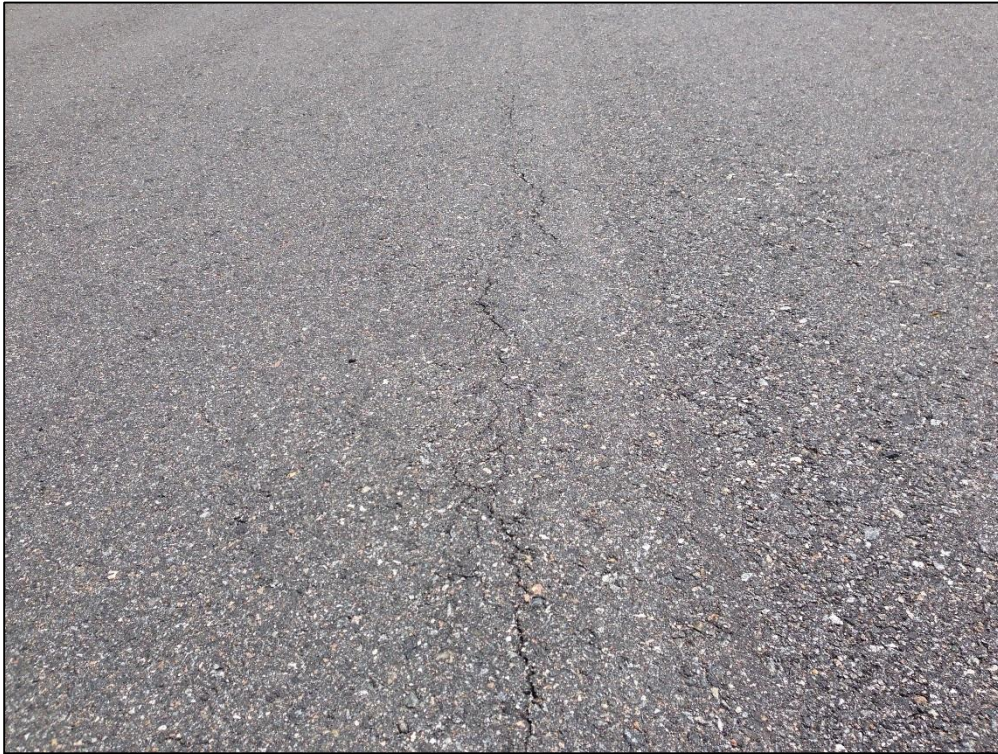
Taxiway Alpha, Section 120, Sample Unit 209 – Low Severity (48) Longitudinal and Transverse Cracking, Low Severity (52) Raveling, Low Severity (56) Swelling, Low Severity (57) Weathering

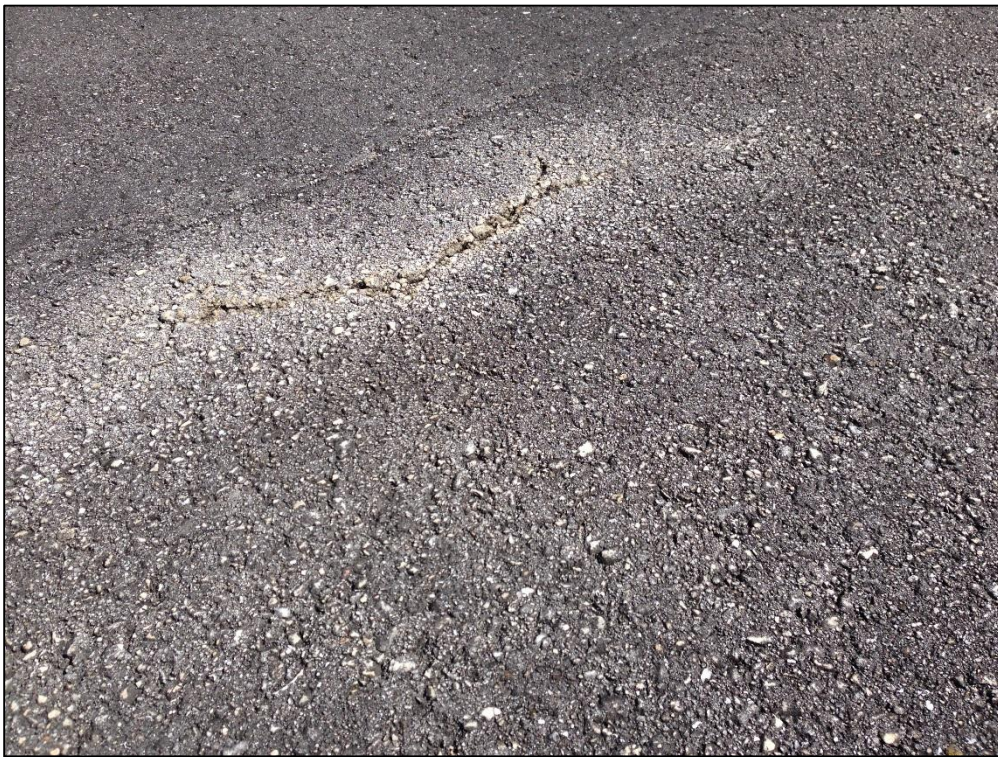
Taxiway Charlie, Section 305, Sample Unit 310 – Low Severity (48) Longitudinal and Transverse Cracking, Low Severity (52) Raveling, Low Severity (56) Swelling, Low Severity (57) Weathering

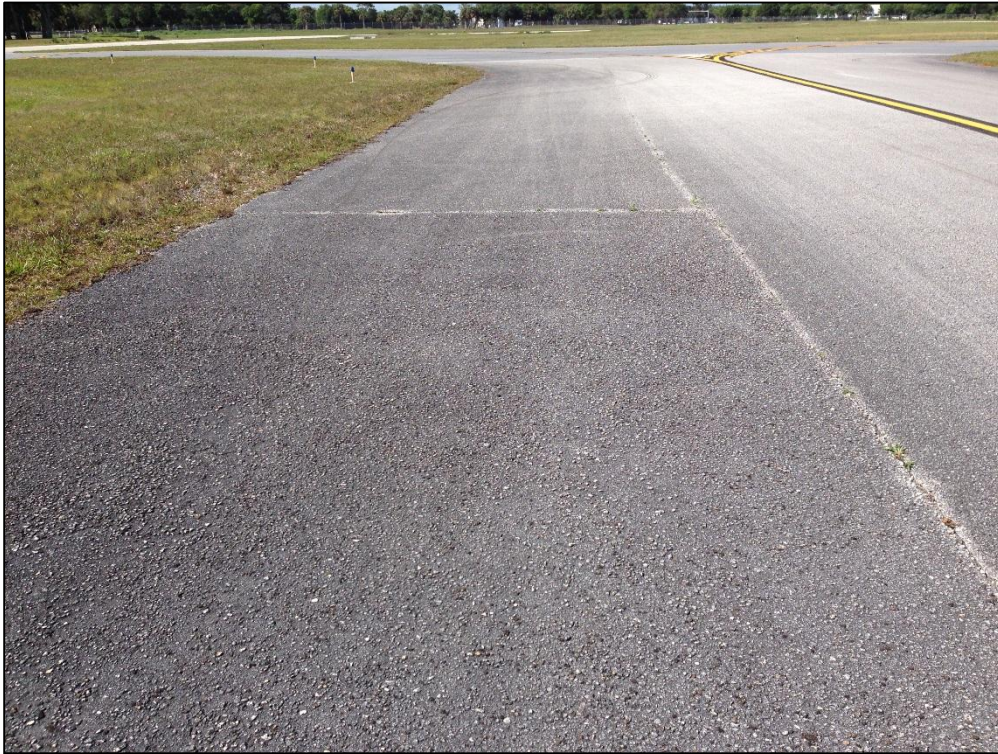
Taxiway Delta, Section 410, Sample Unit 102 – Low Severity (48) Longitudinal and Transverse Cracking, Low Severity (52) Raveling, Medium Severity (52) Raveling

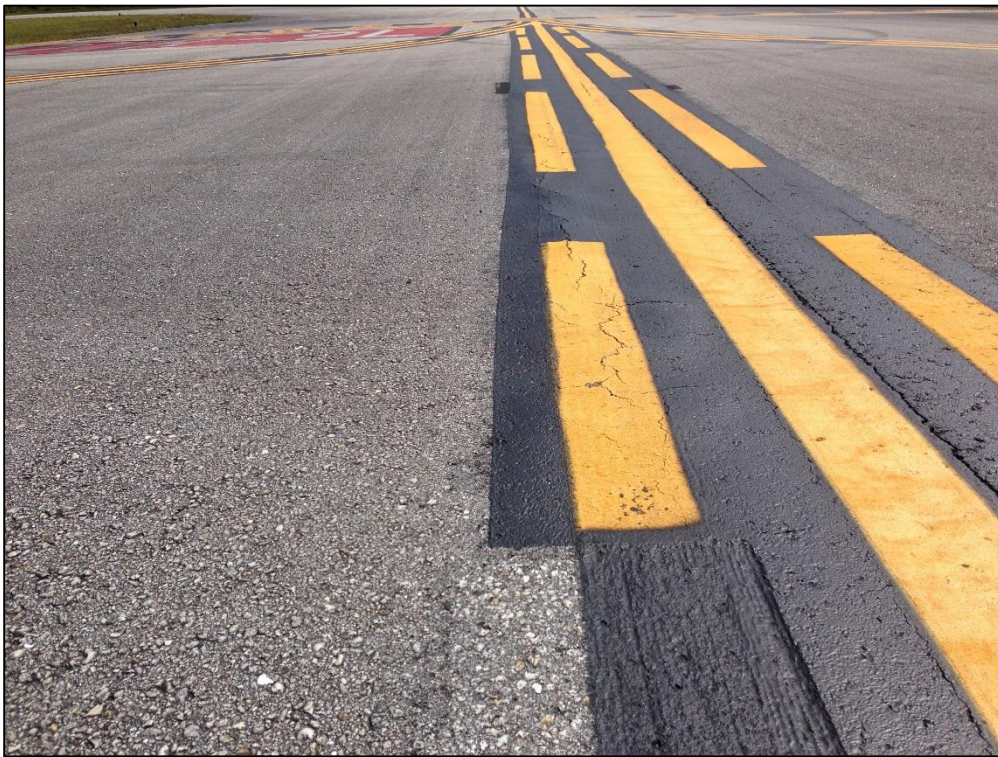
Taxiway Kilo, Section 1116, Sample Unit 125 – Low Severity (48) Longitudinal and Transverse Cracking, Low Severity (52) Raveling, Low Severity (56) Swelling, Low Severity (57) Weathering

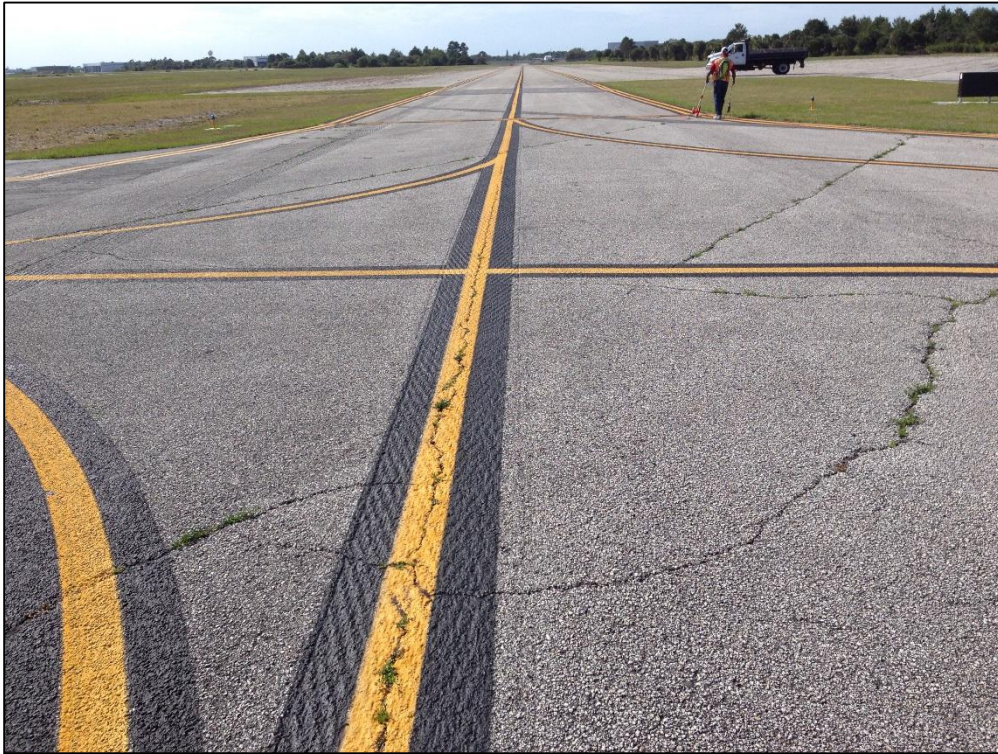
Taxiway Sierra, Section 510, Sample Unit 120 – Low and Medium Severity (48) Longitudinal and Transverse Cracking, Low Severity (52) Raveling, Low Severity (57) Weathering

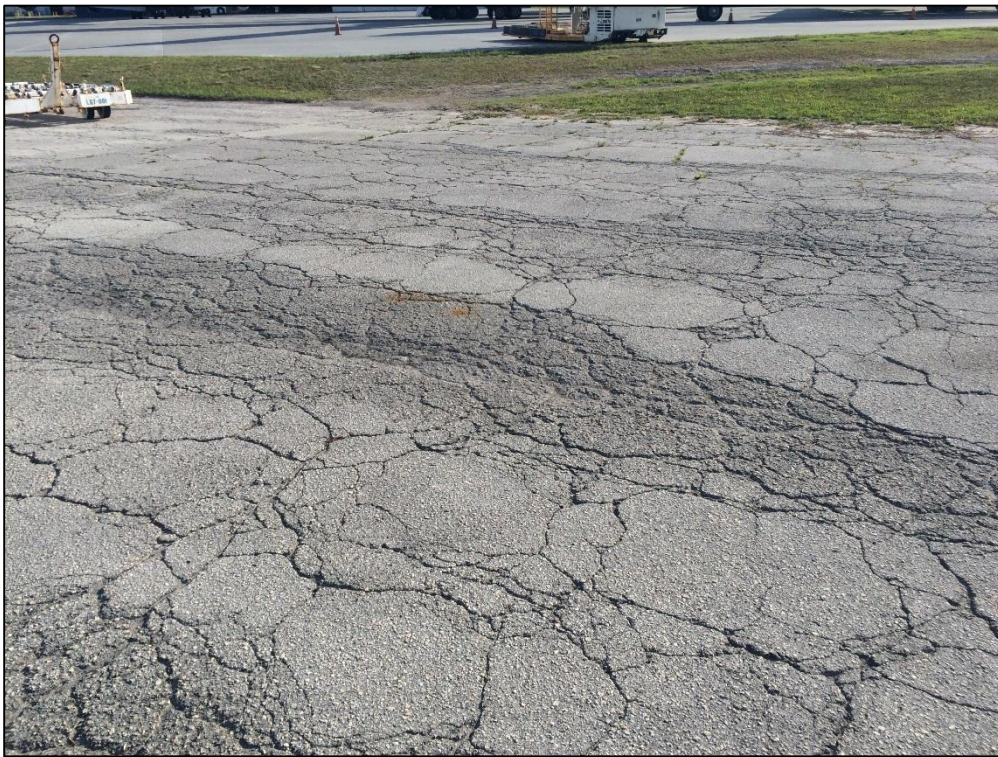
East Apron, Section 4410, Sample Unit 801 – Medium Severity (43) Block Cracking, High Severity (43) Block Cracking, Low Severity (52) Raveling, Medium Severity (52) Raveling

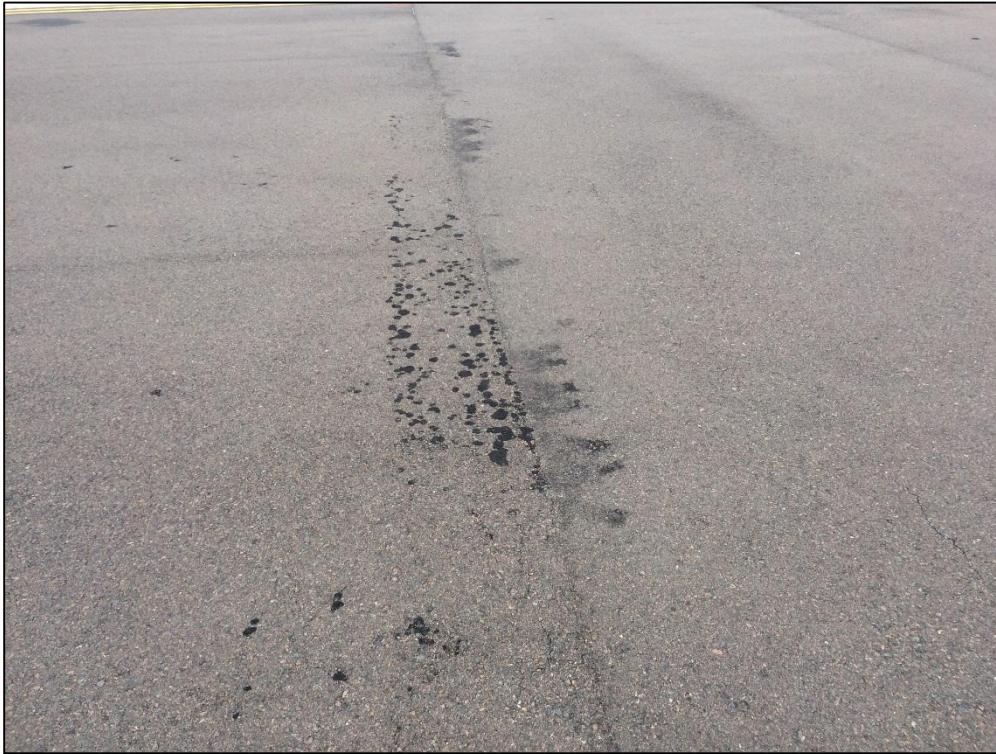
Terminal Apron, Section 4210, Sample Unit 250 – (42) Bleeding, Low Severity (57) Weathering

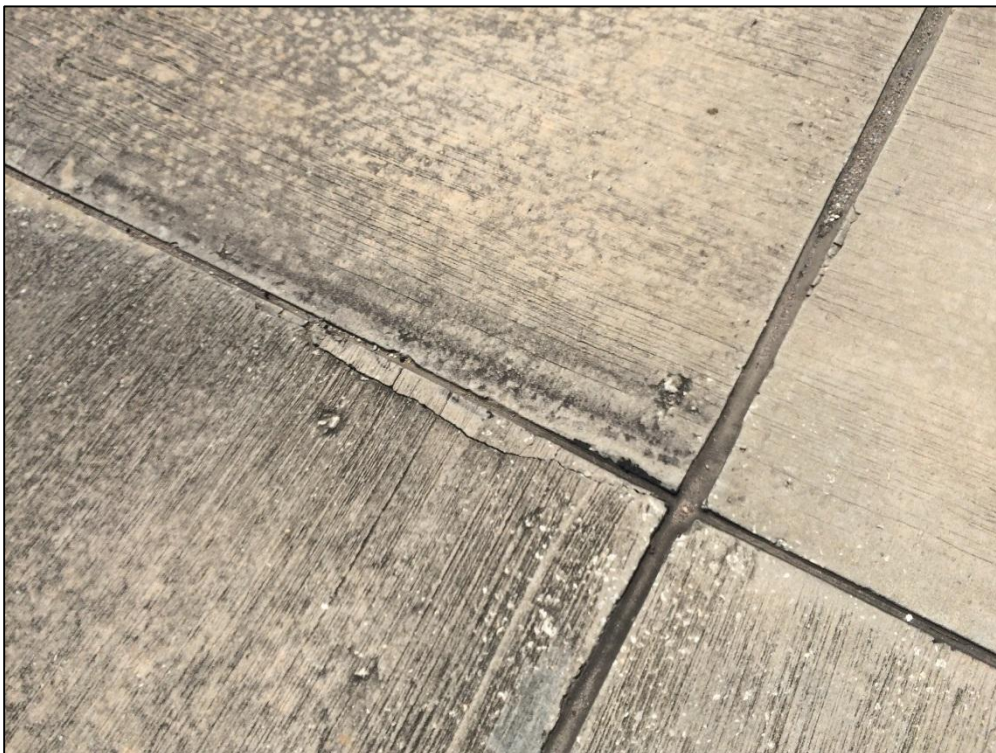
Terminal Apron, Section 4205, Sample Unit 202 – Low Severity (74) Joint Spalling

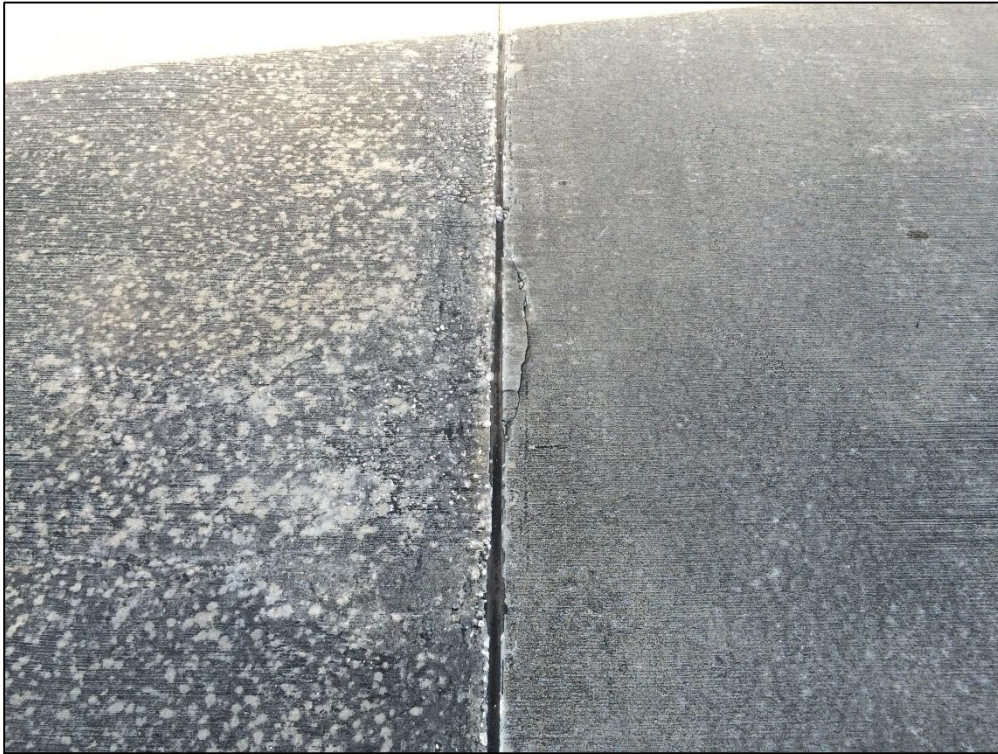
Center Apron, Section 4998, Sample Unit 103 – Low Severity (70) Scaling, Map Cracking, Crazing, Low Severity (74) Joint Spalling

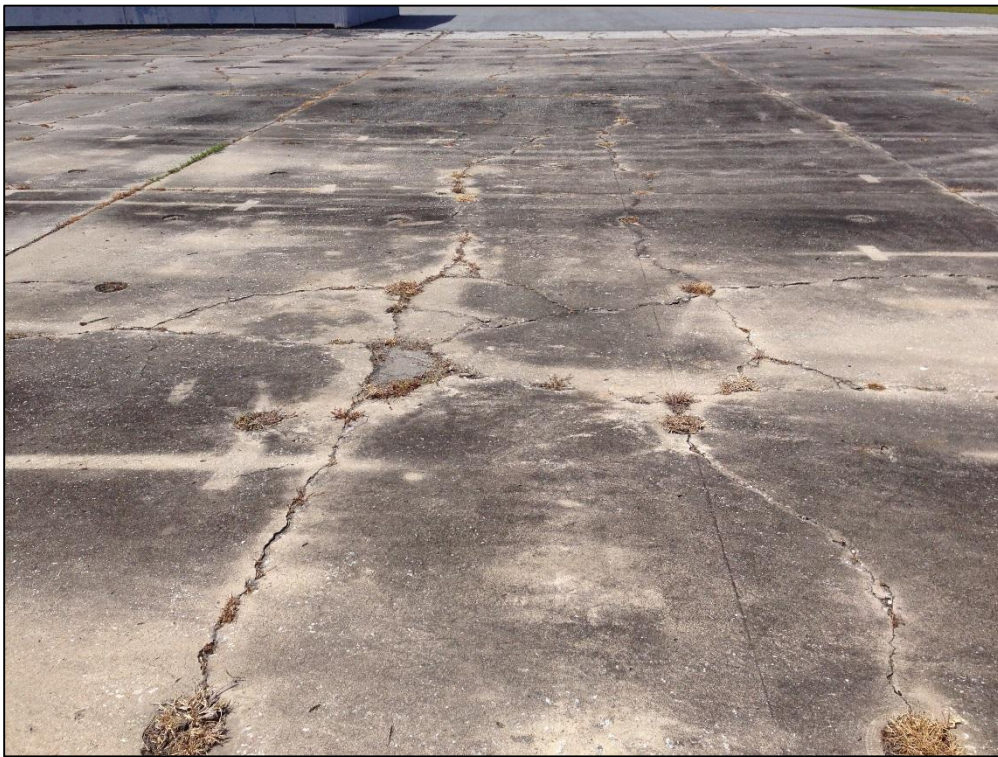
West Apron, Section 4325, Sample Unit 301 – Medium Severity (65) Joint Seal Damage, Medium Severity (72) Shattered Slab

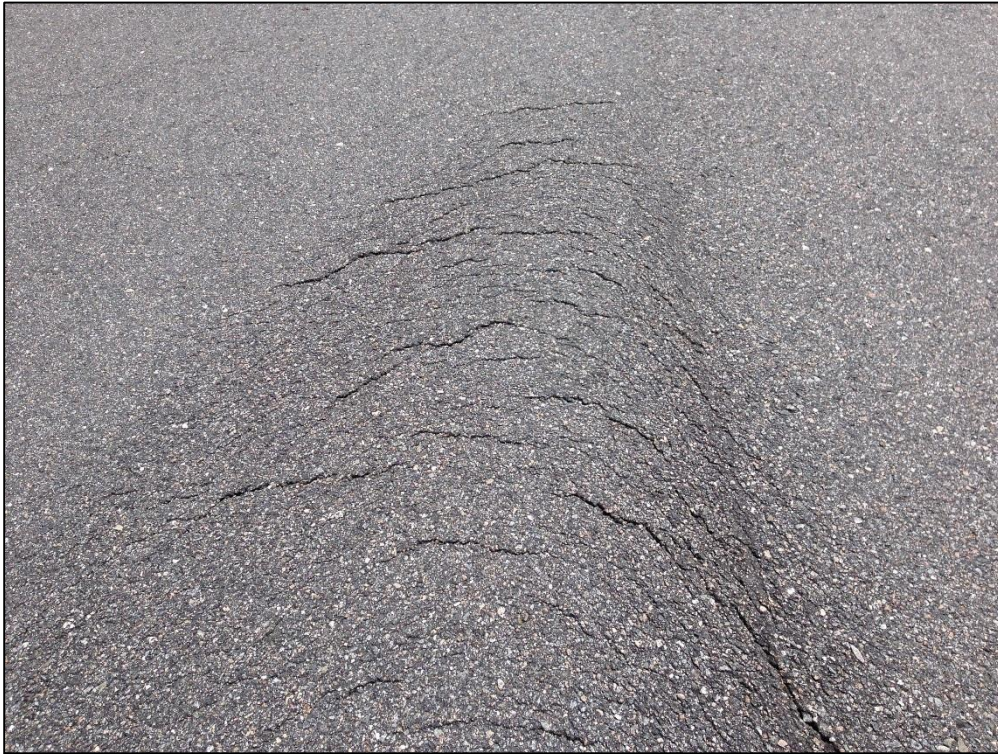
Taxiway Alpha, Section 120- (55) Slippage Cracking (*Not an inspected sample.)
