**THE FLORIDA KEYS
MARATHON AIRPORT
(MTH)**

JUNE 2015

STATEWIDE Airfield Pavement Management PROGRAM

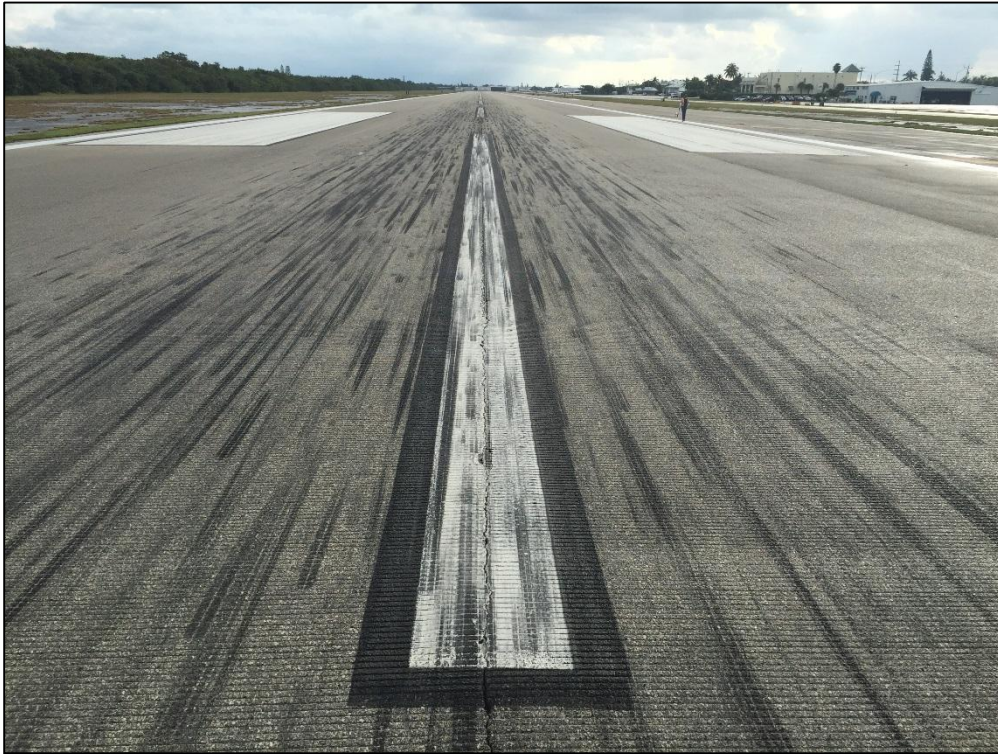
Runway 7-25, Section 6105, Sample Unit 118 – Low and Medium Severity (48) Longitudinal and Transverse Cracking, Medium Severity (52) Raveling

- Runway 7-25 – Sections 6105 and 6110
 - Mill and Overlay attributed to climate/age.
- East Apron – Section 4510
 - Mill and Overlay attributed to climate/age.
- Jet Center Apron – Sections 4305, 4315, and 4320
 - Reconstruction and Mill and Overlay attributed to climate/age and construction quality.
- Jet Center Apron – Section 4310
 - Reconstruction attributed to structural, climate/age, and construction quality.
- Terminal Apron – Section 4220
 - PCC Restoration attributed to structural, climate/age, and construction quality.
- Terminal Apron – Sections 4205 and 4210
 - Mill and Overlay attributed to climate/age and construction quality.
- Flight Center Apron – Sections 4105, 4115, and 4120

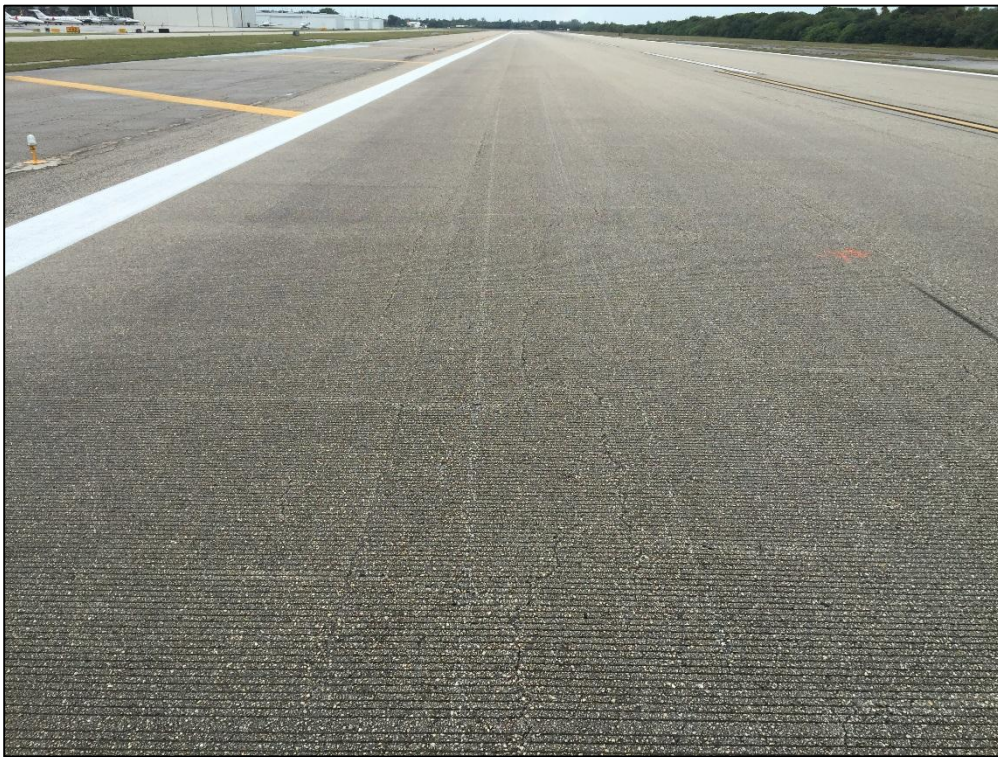
Runway 7-25, Section 6110, Sample Unit 310 – Low Severity (48) Longitudinal and Transverse Cracking, Low Severity (52) Raveling, Low Severity (57) Weathering

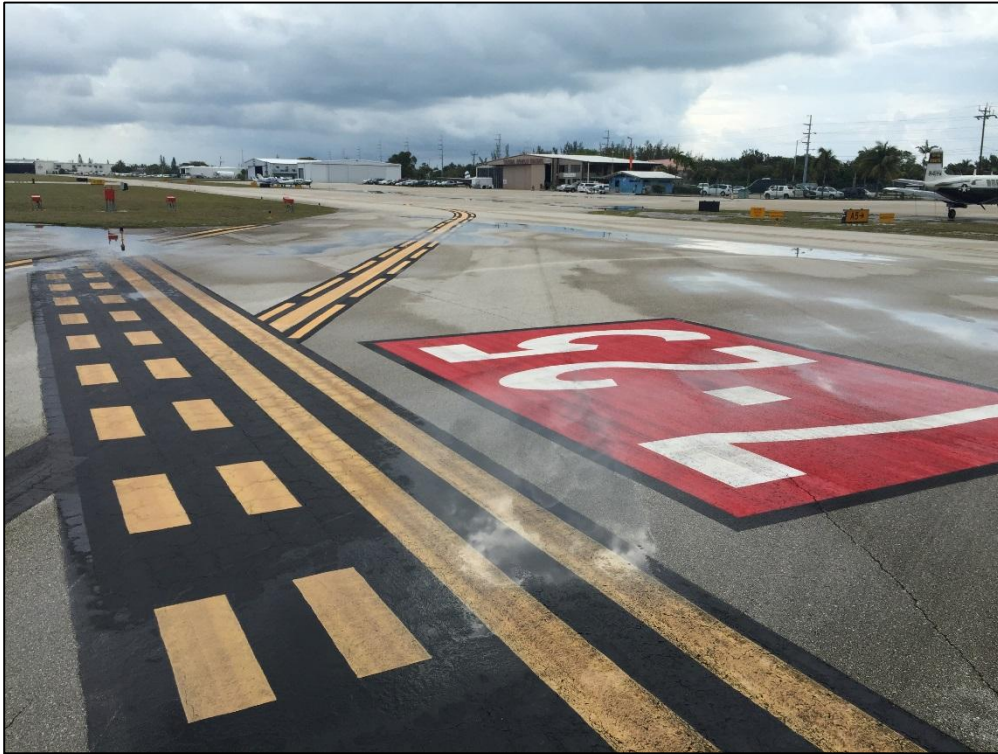
Taxiway Delta, Section 305, Sample Unit 301 – Low Severity (48) Longitudinal and Transverse Cracking, Low Severity (45) Depression, Low Severity (57) Weathering

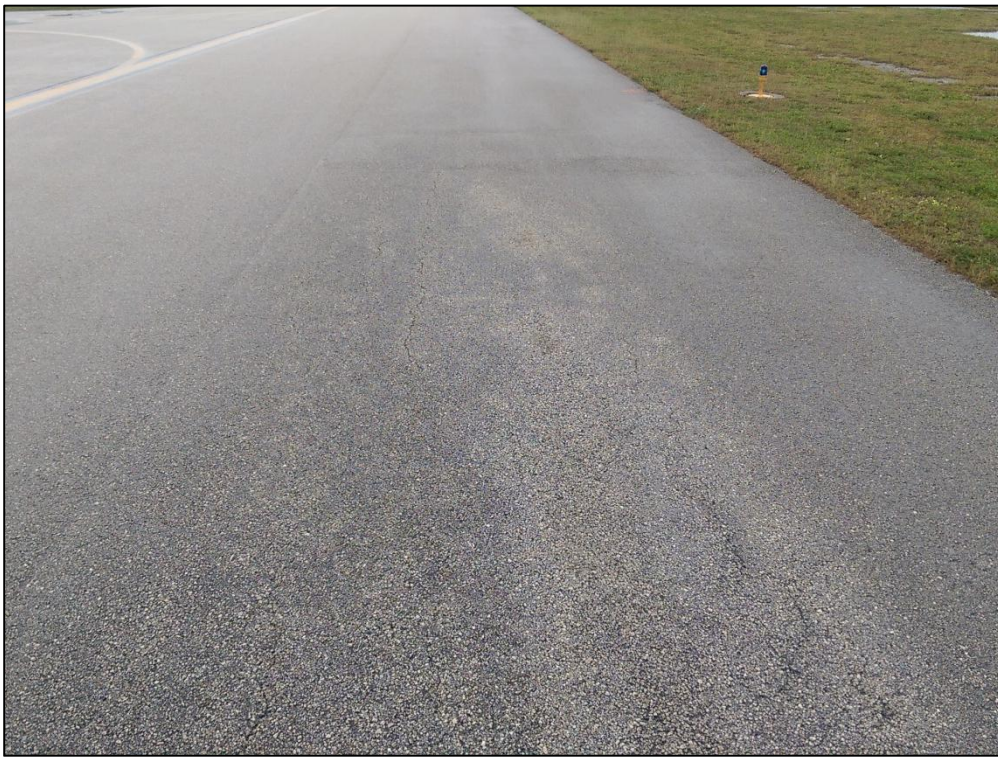
Taxiway Alpha, Section 105, Sample Unit 111 – Low Severity (48) Longitudinal and Transverse Cracking, Low Severity (52) Raveling, Medium Severity (52) Raveling

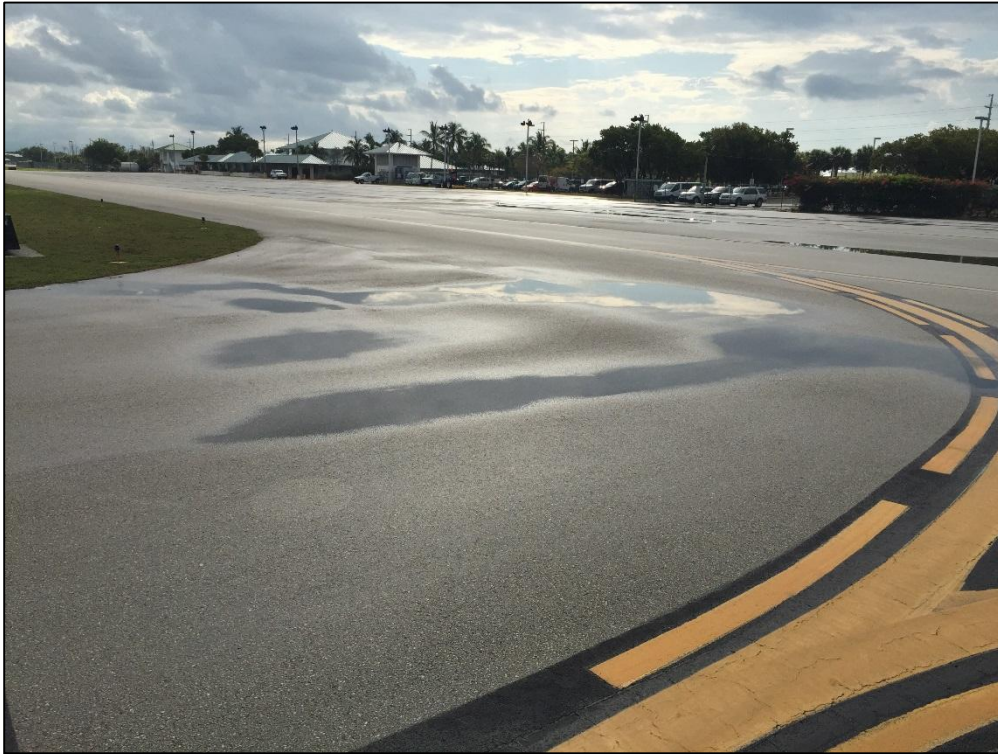
Taxiway Charlie, Section 205, Sample Unit 201 – Low Severity (45) Depression, Low Severity (57) Weathering

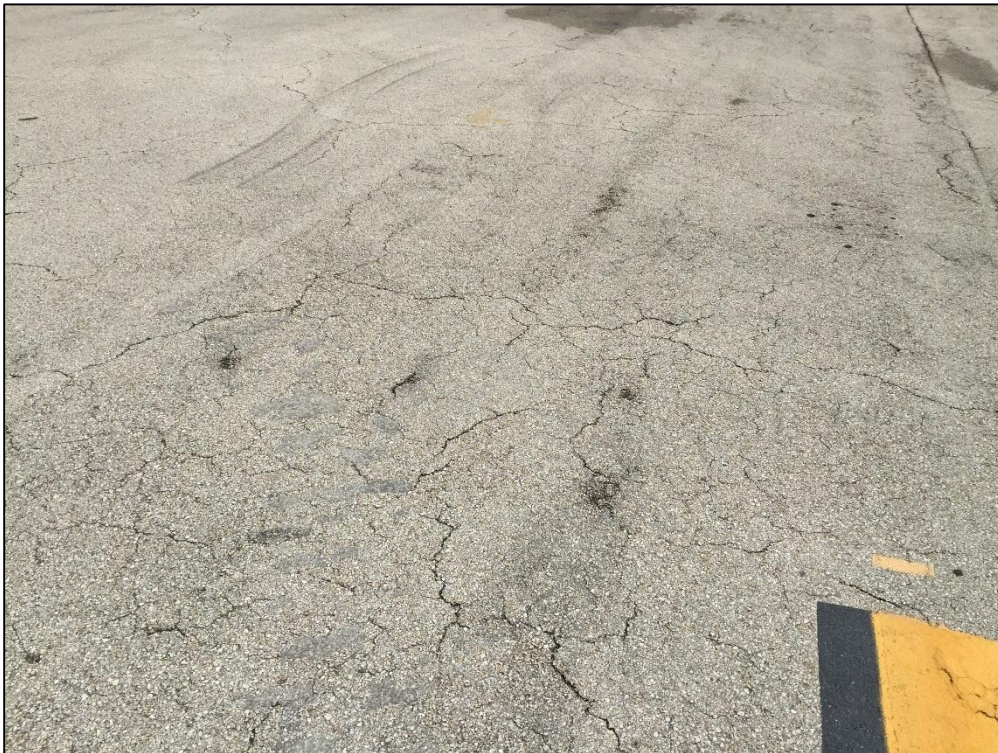
Apron East, Section 4510, Sample Unit 102 – Low Severity (43) Block Cracking, Low Severity (48) Longitudinal and Transverse Cracking, Low Severity (52) Raveling

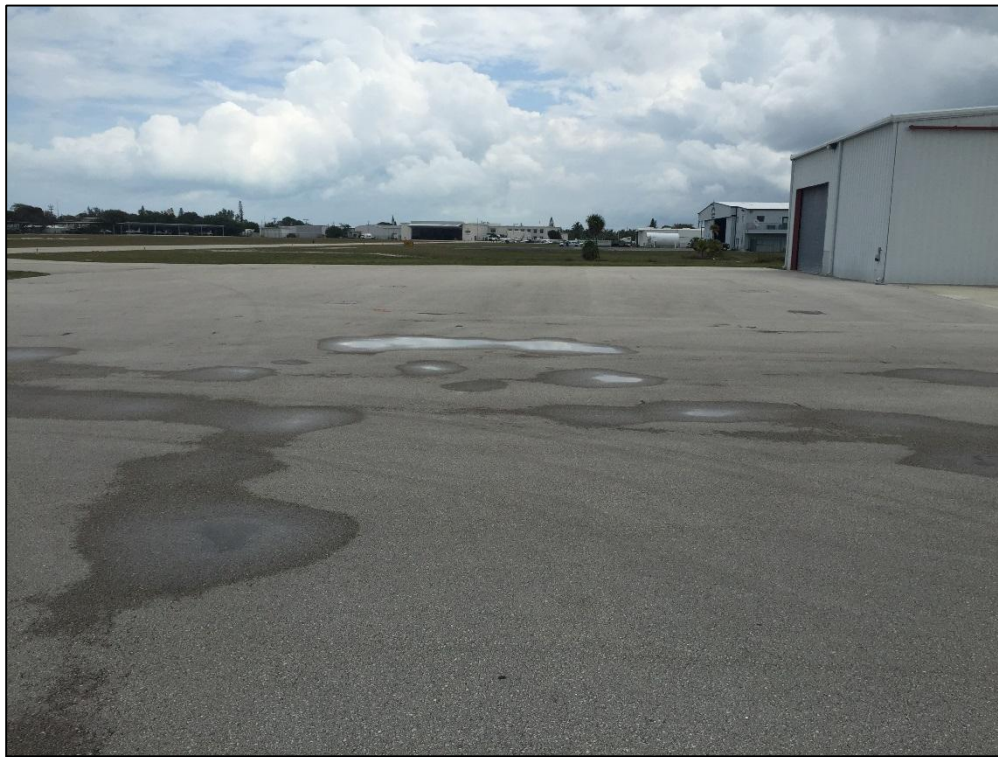
Apron Flight Center, Section 4115, Sample Unit 414 – Low Severity (45) Depression, Low Severity (52) Raveling

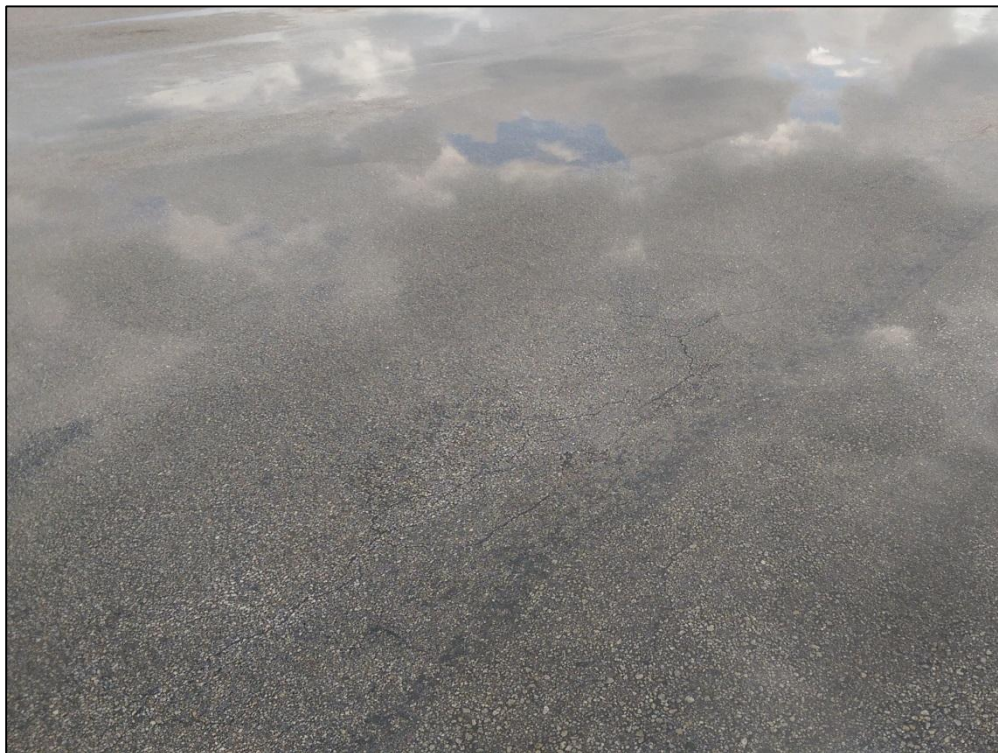
Apron Jet Center, Section 4315, Sample Unit 151 – Low Severity (45) Depression, Low Severity (48) Longitudinal and Transverse Cracking, Low Severity (57) Weathering

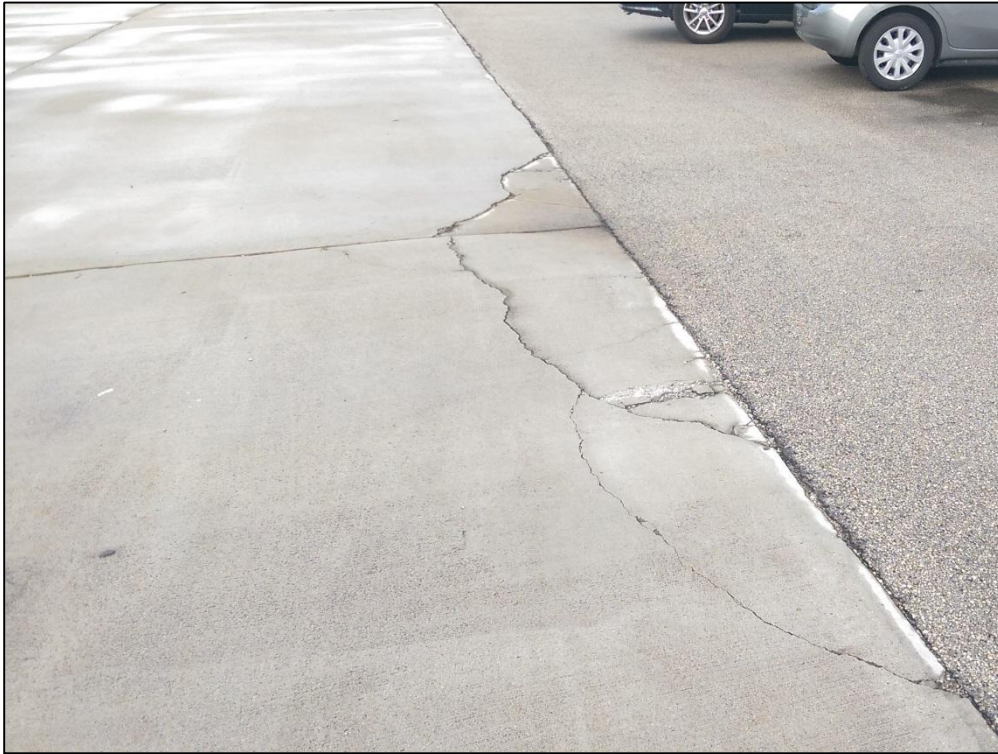
Apron Jet Center, Section 4310, Sample Unit 120 – Medium Severity (65) Joint Seal Damage, Medium Severity (74) Joint Spalling, Low Severity (62) Corner Break, Low Severity (75) Corner Spalling

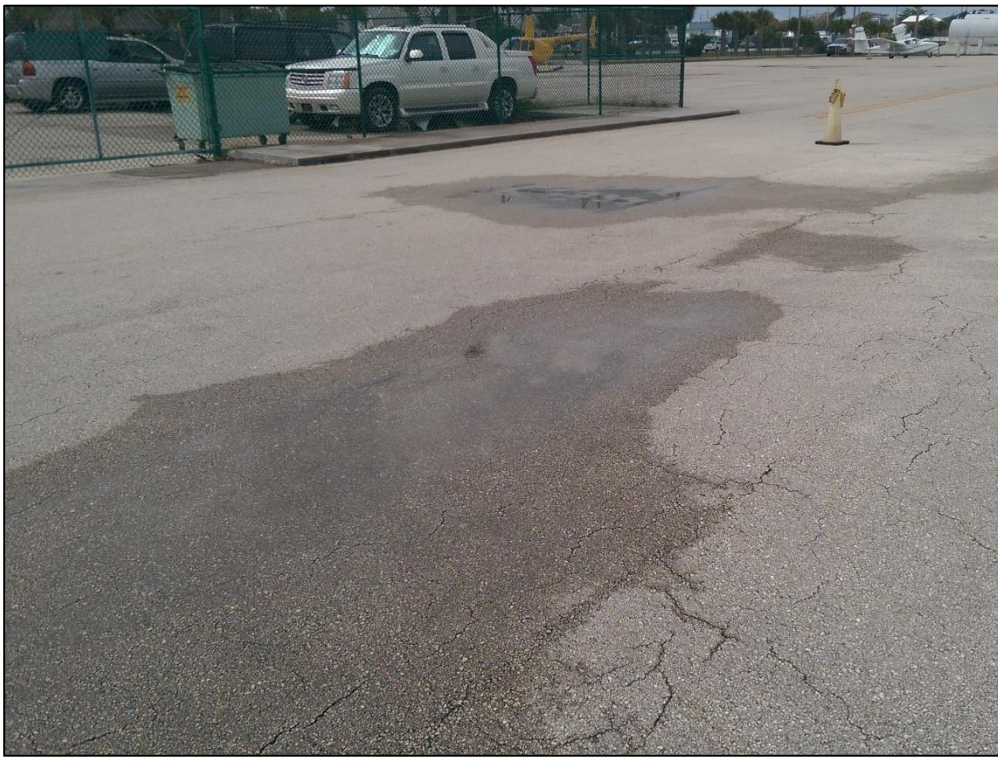
Apron Flight Center, Section 4105, Sample Unit 409 – Low Severity (43) Block Cracking, Low Severity (45) Depression, Low Severity (56) Swelling, Low Severity (57) Weathering

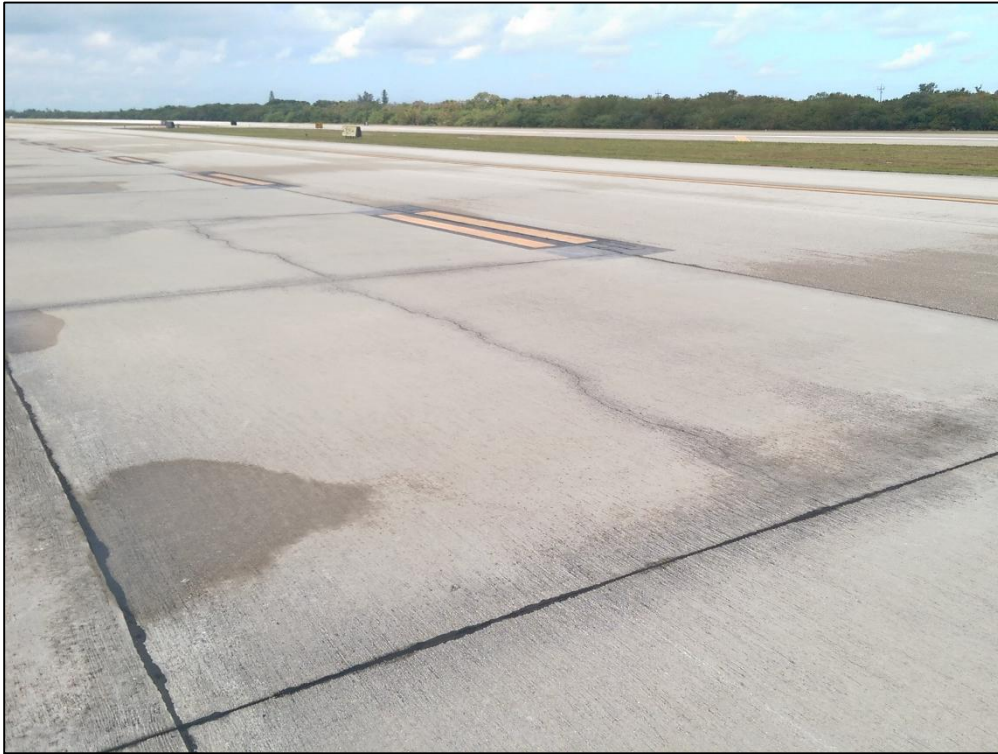
Apron Terminal, Section 4220, Sample Unit 305 – Low Severity (63) Longitudinal, Transverse, and Diagonal Cracking, Low Severity (65) Joint Seal Damage
