**OCALA
INTERNATIONAL-
JIM TAYLOR FIELD
(OCF)**

DISTRICT 5
PRIMARY AIRPORT
JUNE 2015

STATEWIDE
**Airfield
Pavement
Management**
PROGRAM

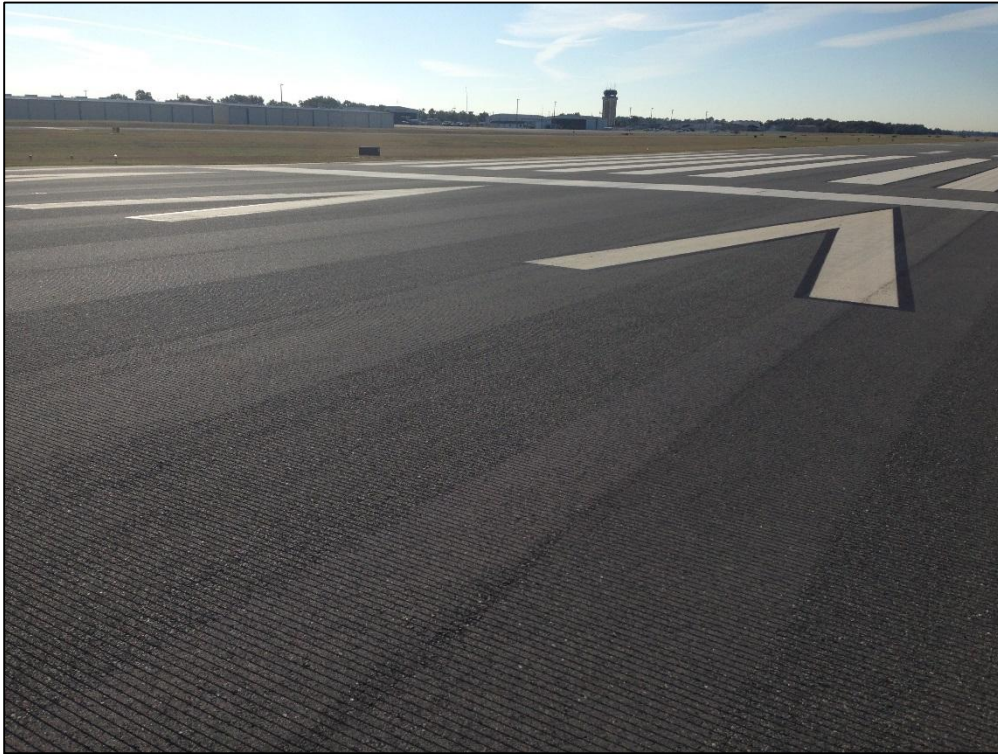
Runway 18-36, Section 6105, Sample Unit 422 – Low Severity (57) Weathering

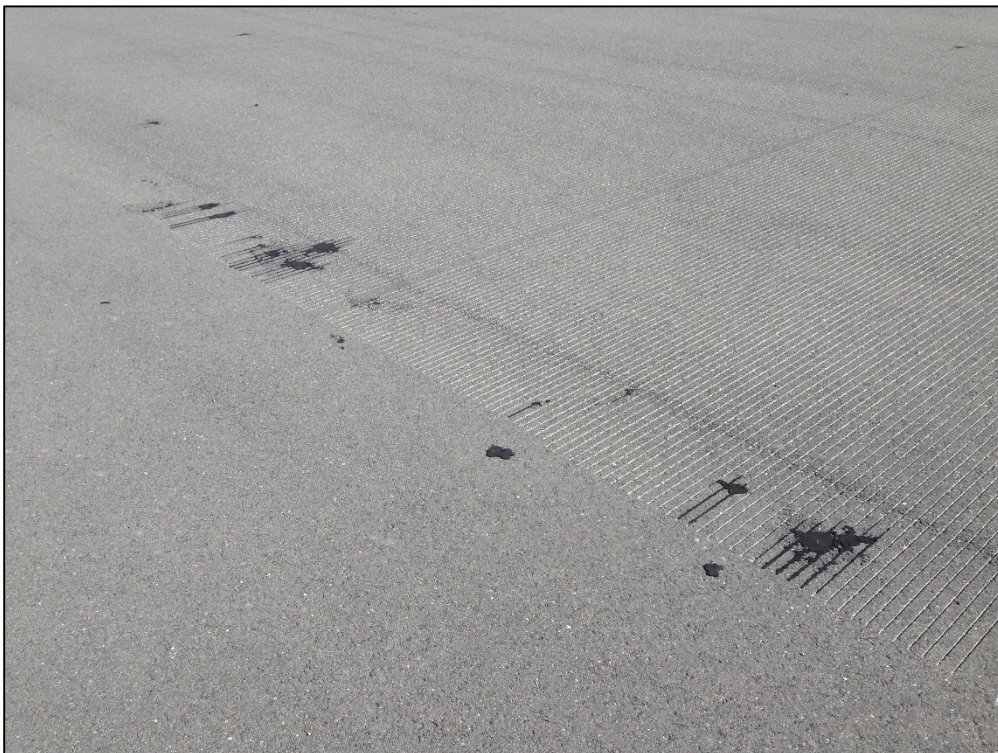
Runway 18-36, Section 6110, Sample Unit 176 – (42) Bleeding, Low Severity (57) Weathering

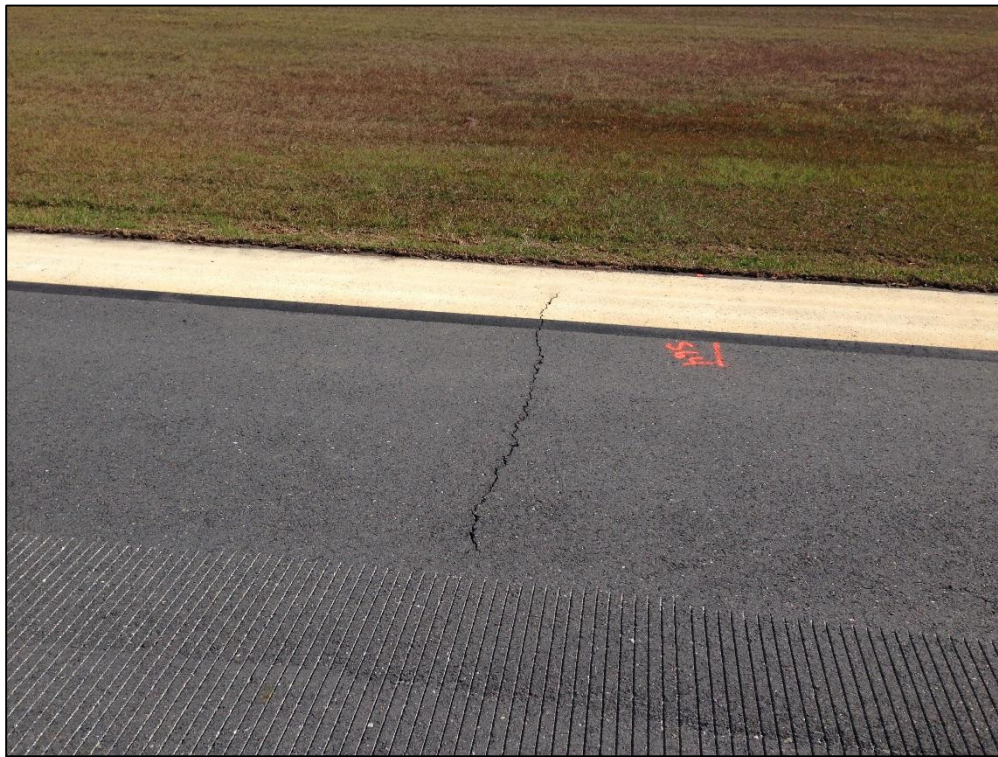
Runway 18-36, Section 6110, Sample Unit 564 – Low Severity (48) Longitudinal and Transverse Cracking, Low Severity (57) Weathering

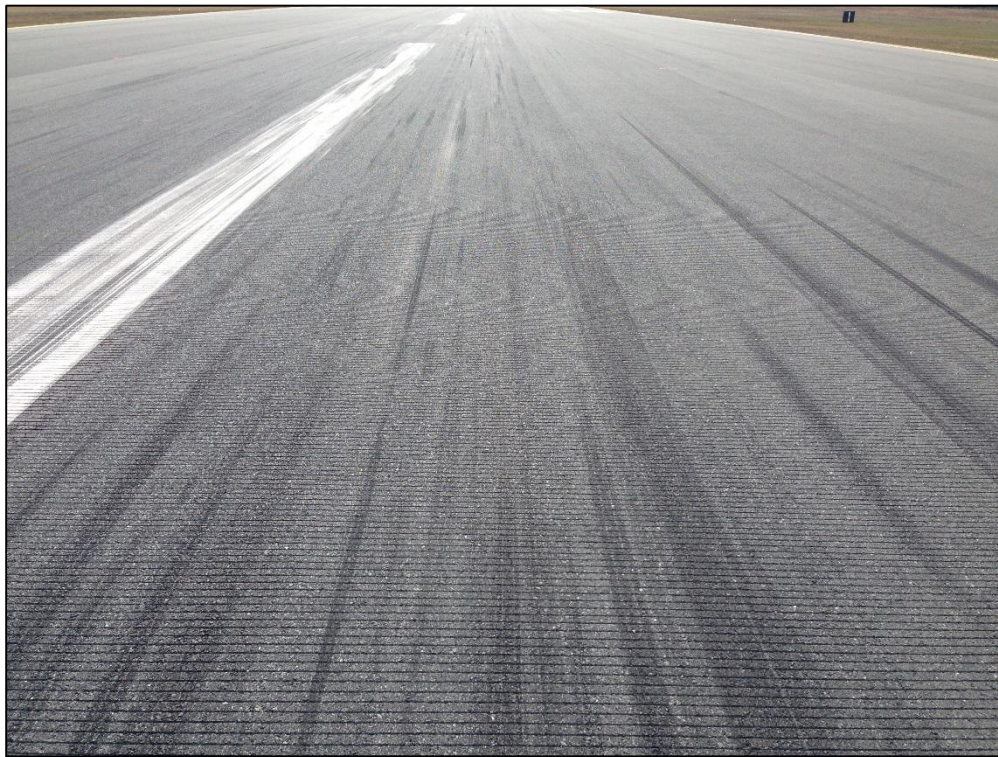
Runway 18-36, Section 6125, Sample Unit 315 – Low Severity (57) Weathering

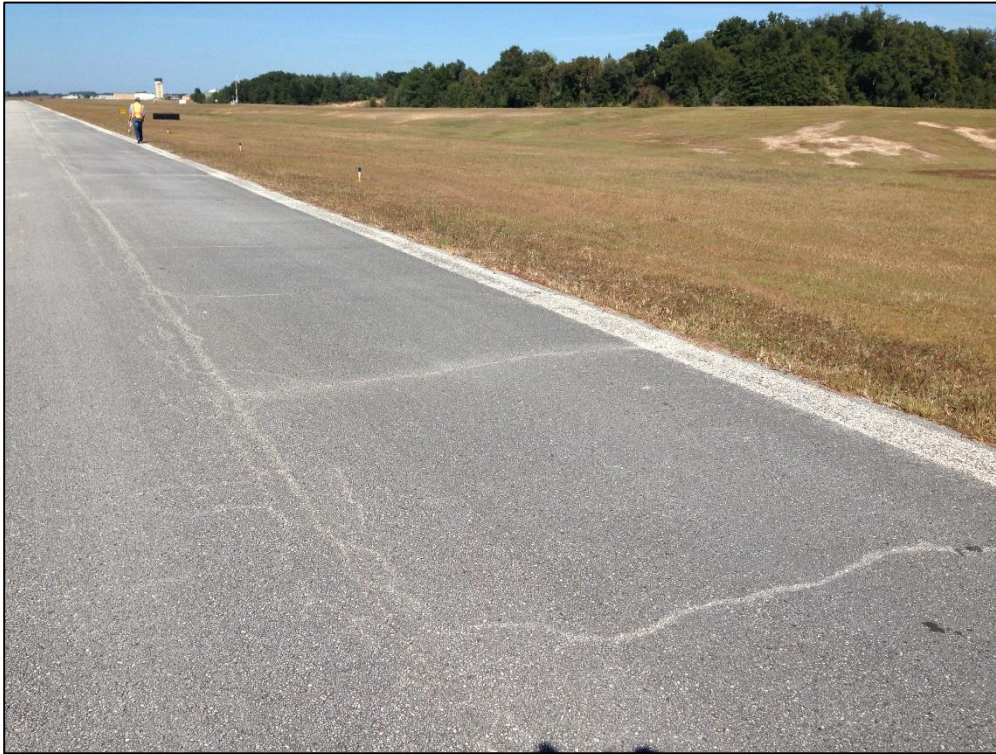
Taxiway Alpha, Section 540, Sample Unit 104 – Low Severity (43) Block Cracking, Low Severity (48) Longitudinal and Transverse Cracking, Low Severity (52) Raveling, High Severity (52) Raveling

- T-Hanger Taxiway– Sections 580 and 585
 - Mill and Overlay attributed to climate and age of pavement.
- Taxiway A – Sections 505 and 540
 - Mill and Overlay and Reconstruction attributed to load, climate, and age of pavement.
- Taxiway A9 – Section 545
 - Reconstruction attributed to load, climate, and age of pavement.
- Taxiway A8 – Section 535
 - Reconstruction attributed to load, climate, and age of pavement.
- Taxiway A6 – Section 530
 - Reconstruction attributed to load, climate, and age of pavement.
- Taxiway A3 – Section 515
 - Mill and Overlay attributed to climate and age of pavement.
- Taxiway B – Sections 105 and 106
 - Mill and Overlay attributed to climate and age of pavement.

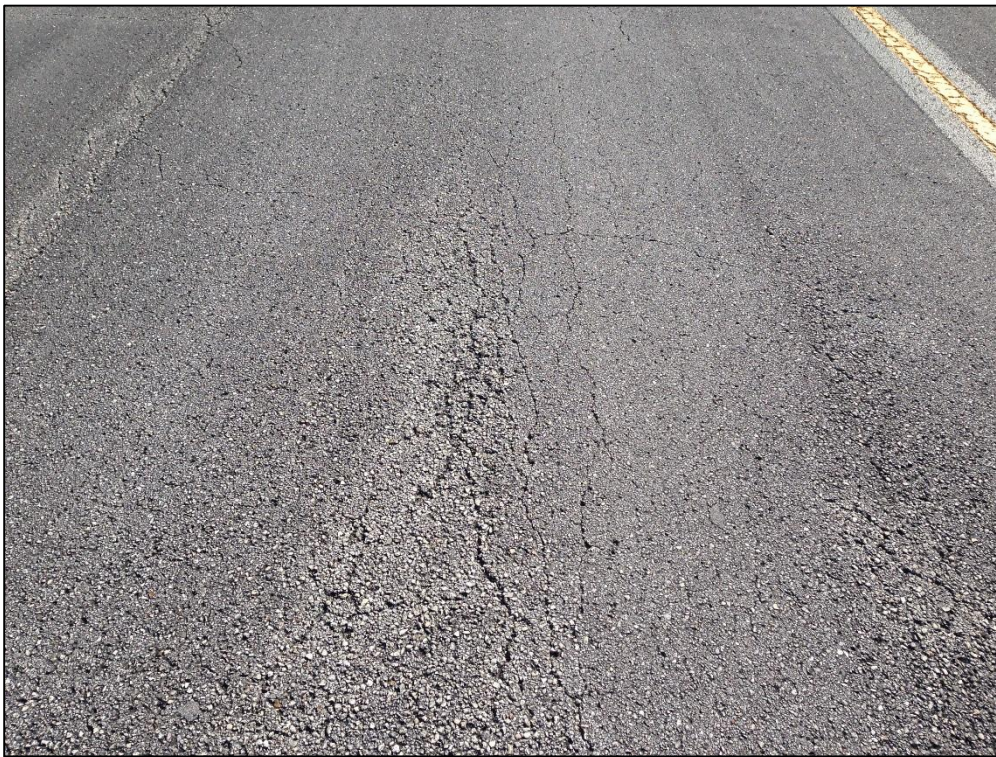
Taxiway Alpha, Section 540, Sample Unit 112 – Low Severity (41) Alligator Cracking, Low Severity (48) Longitudinal and Transverse Cracking, Low Severity (52) Raveling

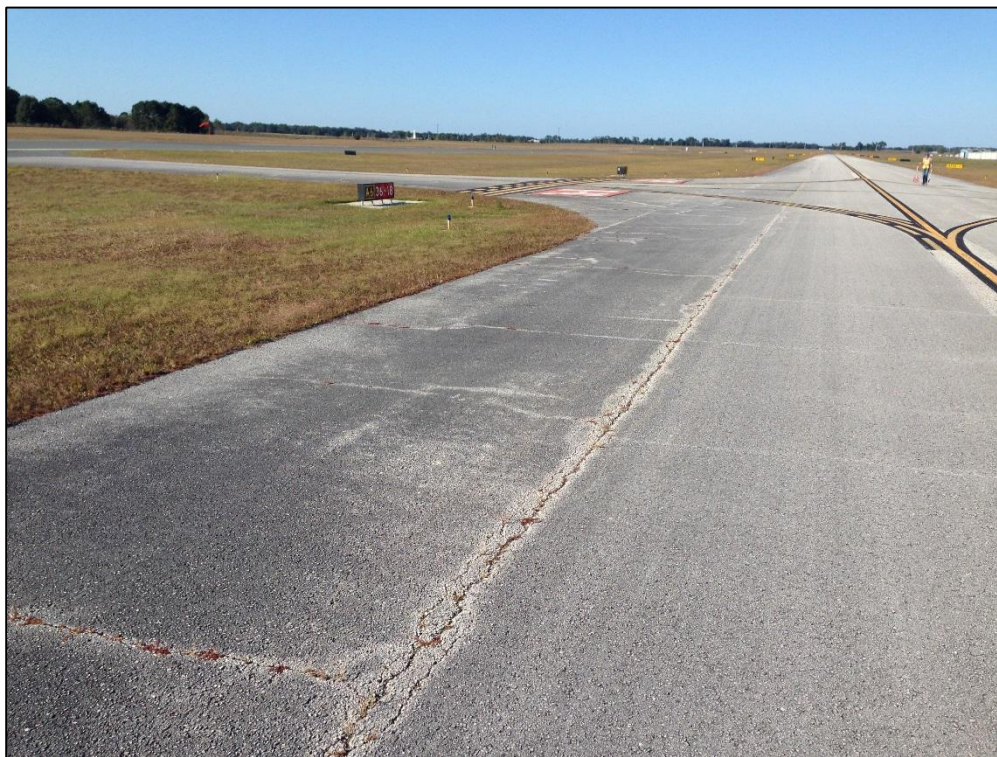
Taxiway Alpha, Section 505, Sample Unit 137 – Low Severity (43) Block Cracking, Low Severity (48) Longitudinal and Transverse Cracking, Low Severity (52) Raveling, Medium Severity (52) Raveling

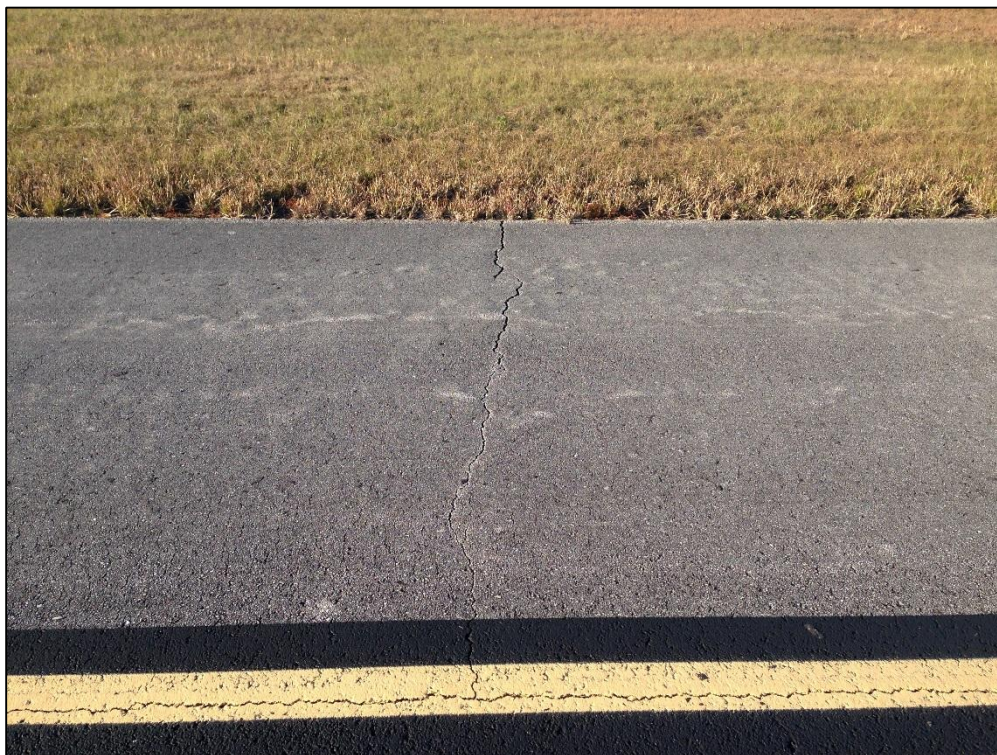
Taxiway Bravo, Section 105, Sample Unit 102 – Low Severity (48) Longitudinal and Transverse Cracking, Low Severity (52) Raveling, Low Severity (56) Swelling

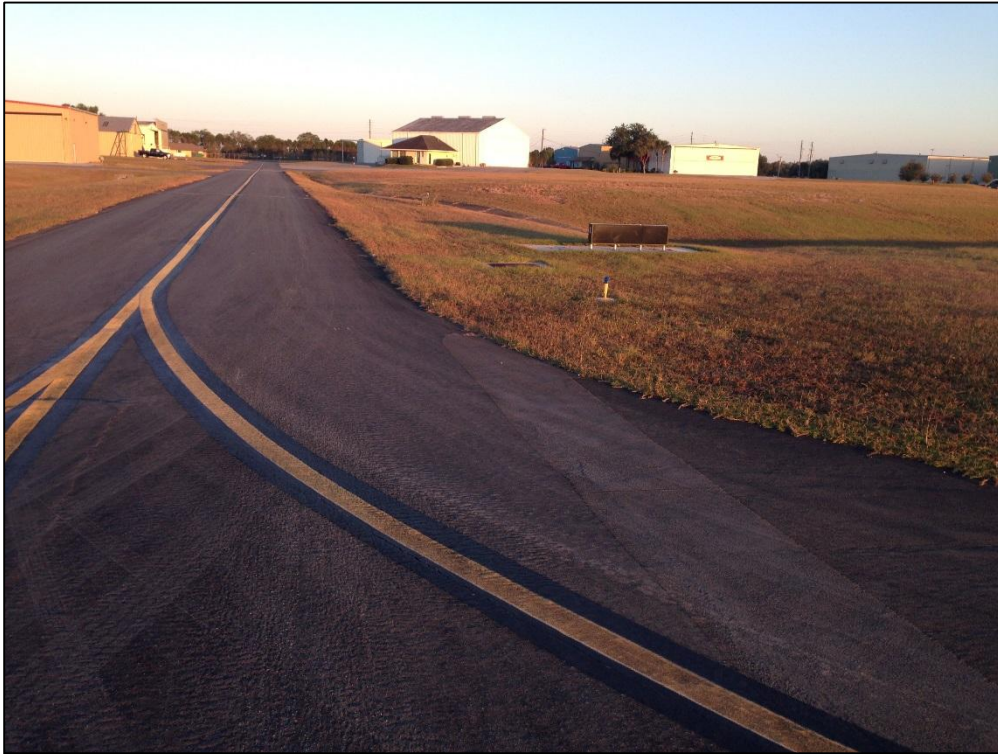
Taxiway A6, Section 560, Sample Unit 500 – Low Severity (48) Longitudinal and Transverse Cracking, Low Severity (50) Patching, Low Severity (57) Weathering

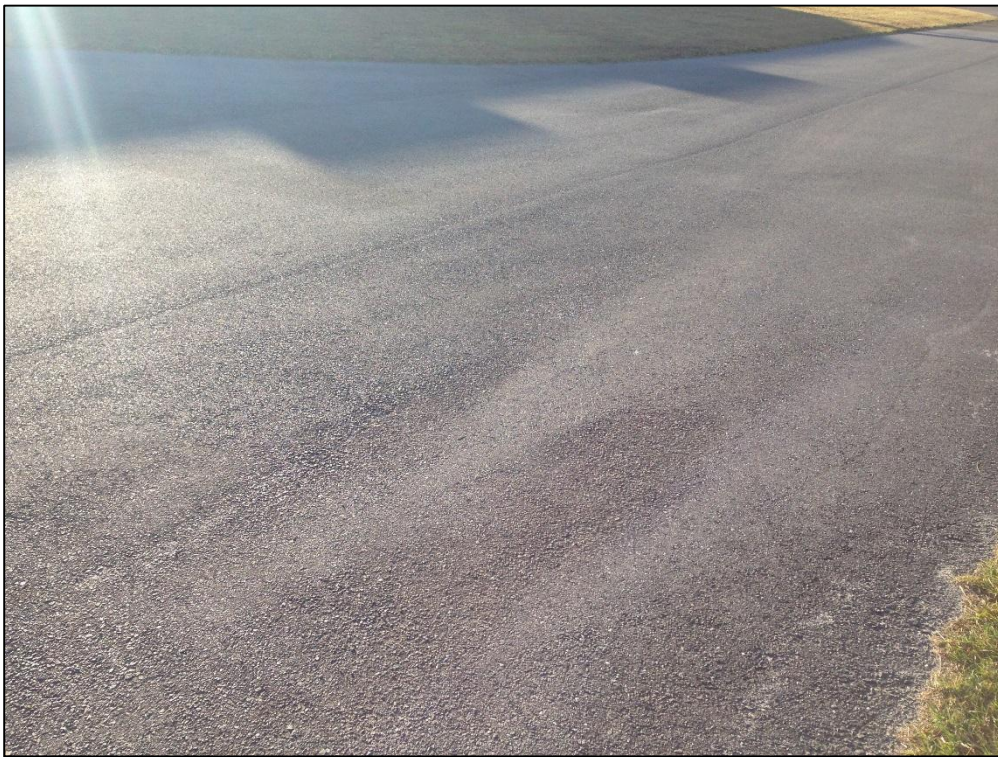
Taxiway A6, Section 575, Sample Unit 601 – Low Severity (52) Raveling, Low Severity (57) Weathering

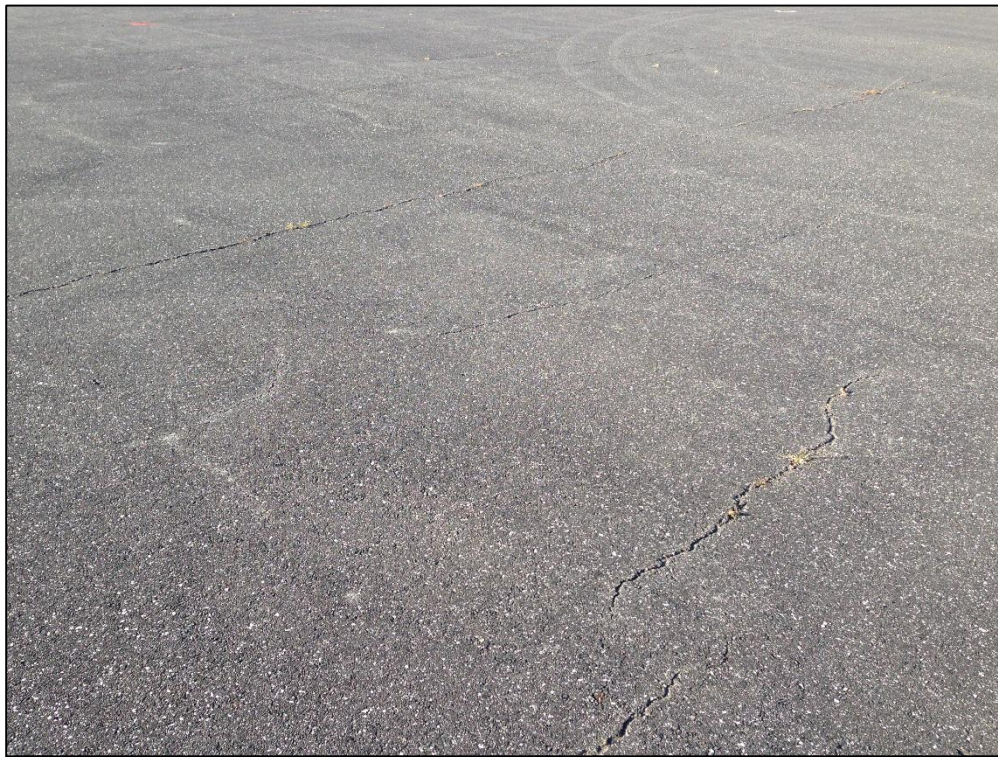
Center Apron, Section 4105, Sample Unit 303 – Low Severity (48) Longitudinal and Transverse Cracking, Medium Severity (48) Longitudinal and Transverse Cracking, Medium Severity (57) Weathering

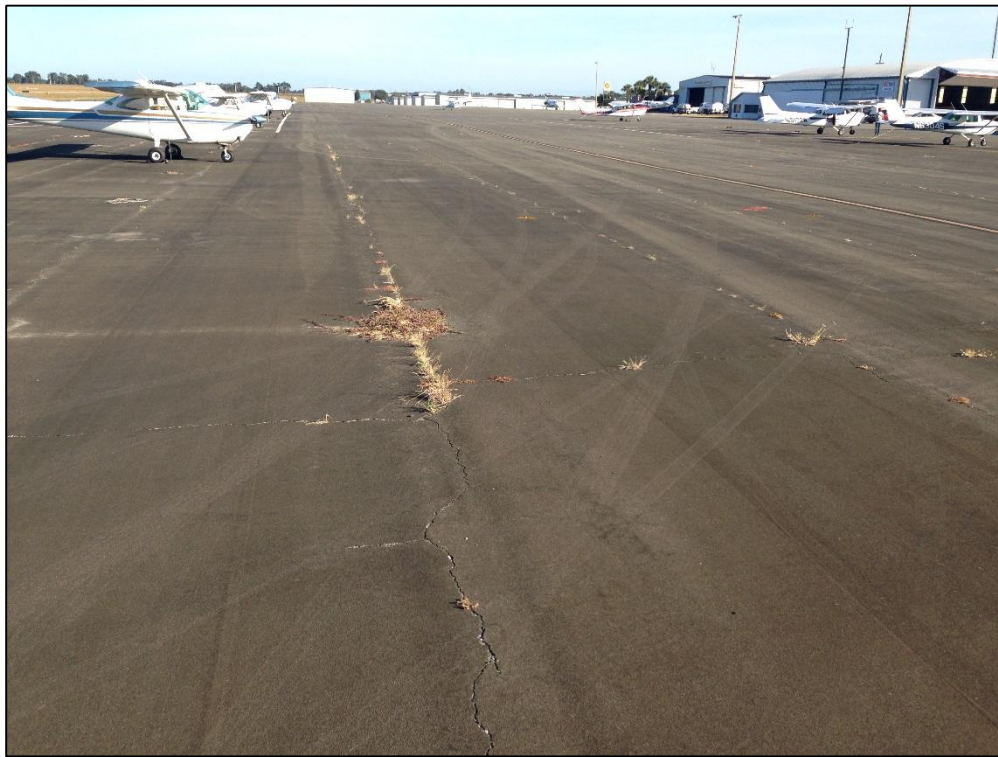
Center Apron, Section 4110, Sample Unit 206 – Low Severity (48) Longitudinal and Transverse Cracking

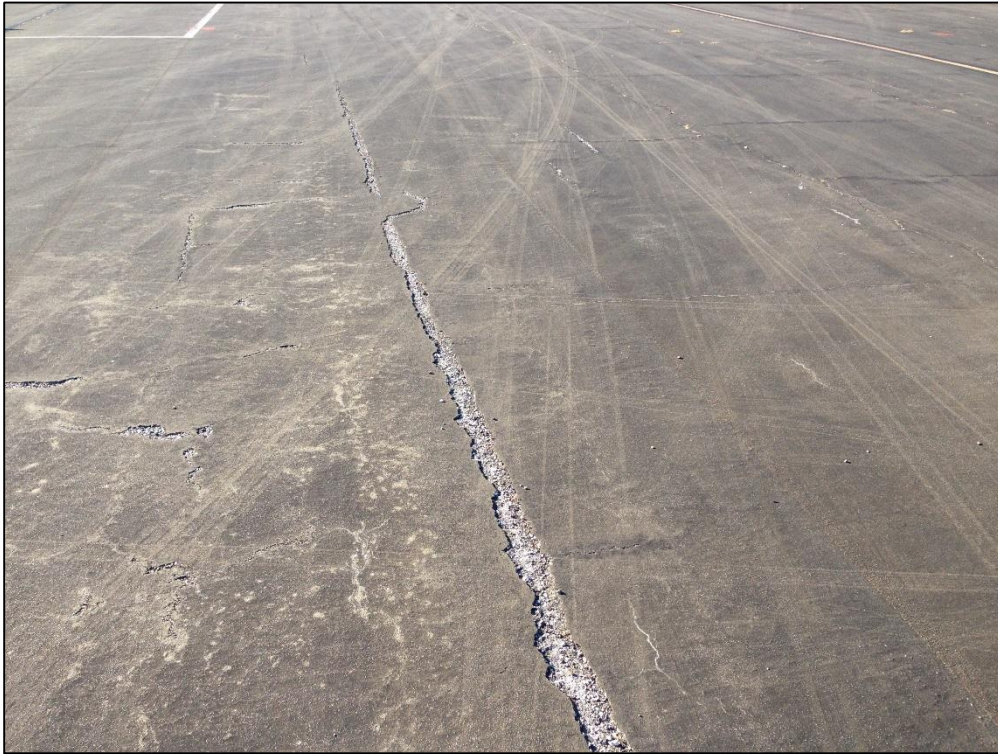
Center Apron, Section 4115, Sample Unit 310 – Low Severity (43) Block Cracking, Low Severity (48) Longitudinal and Transverse Cracking, High Severity (52) Raveling

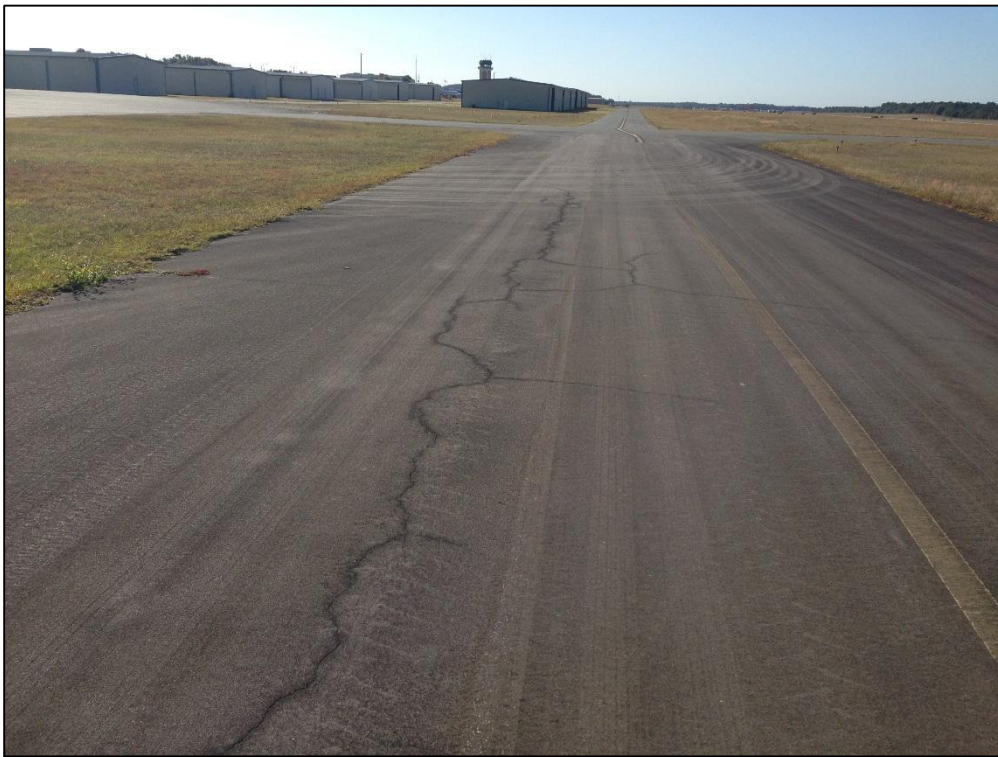
Taxiway North Apron, Section 595, Sample Unit 301 – Low Severity (48) Longitudinal and Transverse Cracking

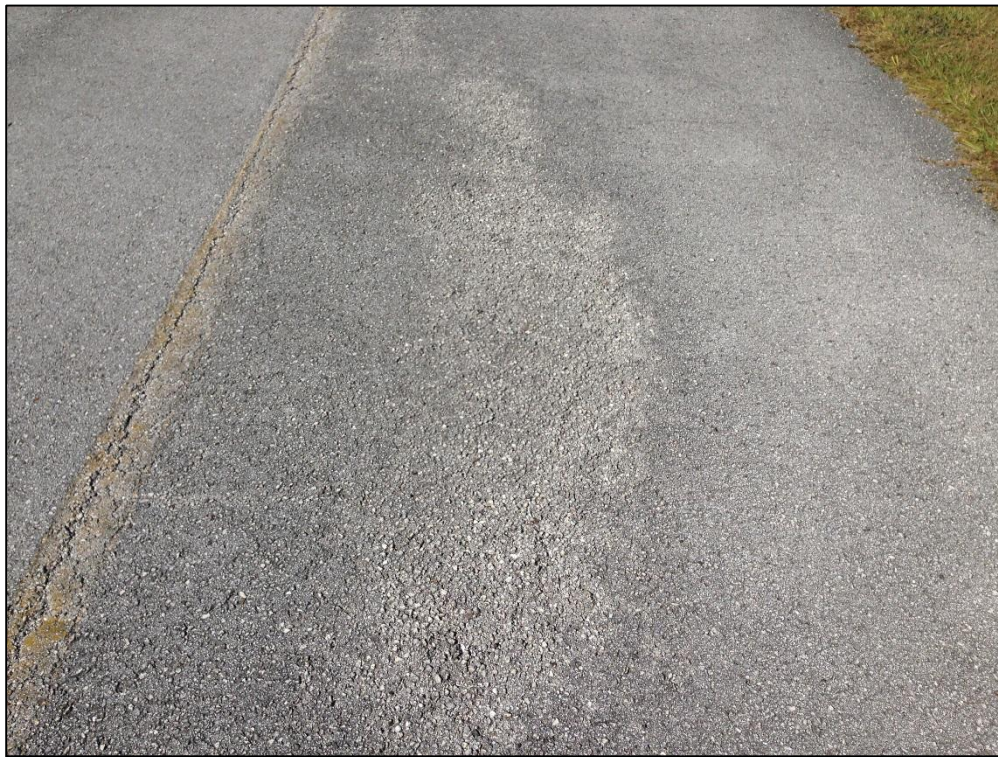
Taxiway T-Hangar, Section 585, Sample Unit 201 – Low Severity (48) Longitudinal and Transverse Cracking, Low Severity (52) Raveling, High Severity (52) Raveling
