**ORLANDO
EXECUTIVE
AIRPORT (ORL)**

DISTRICT 5
REGIONAL RELIEVER
AIRPORT
JUNE 2015

STATEWIDE
**Airfield
Pavement
Management**
PROGRAM

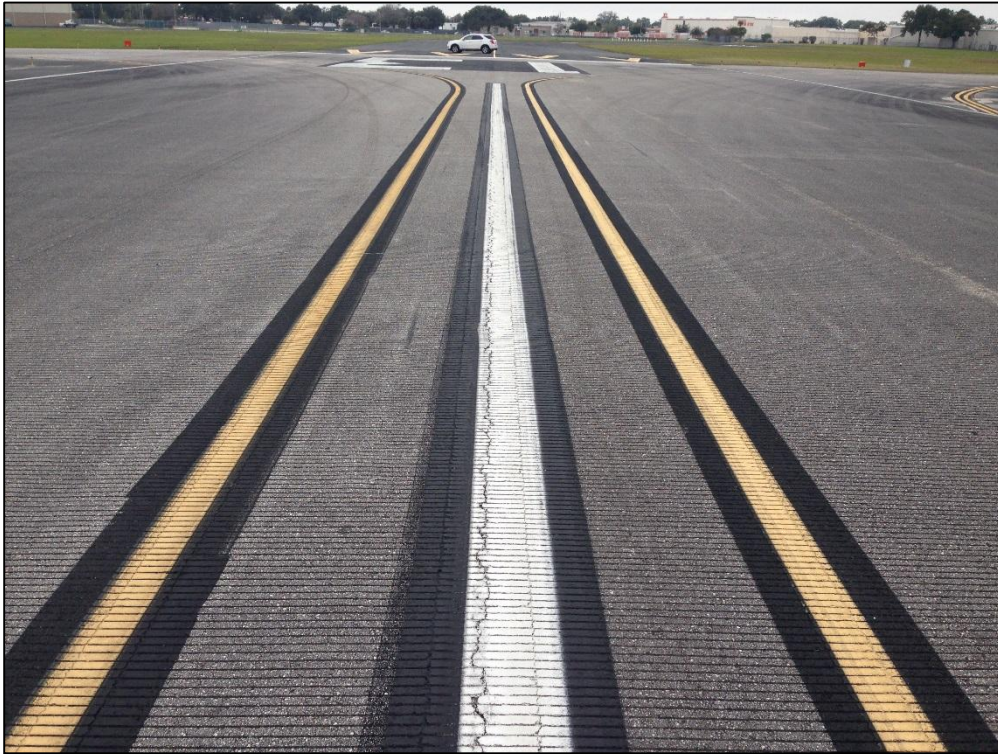
Runway 13-31, Section 6205, Sample Unit 195 – Low Severity (48) Longitudinal and Transverse Cracking, Low Severity (57) Weathering

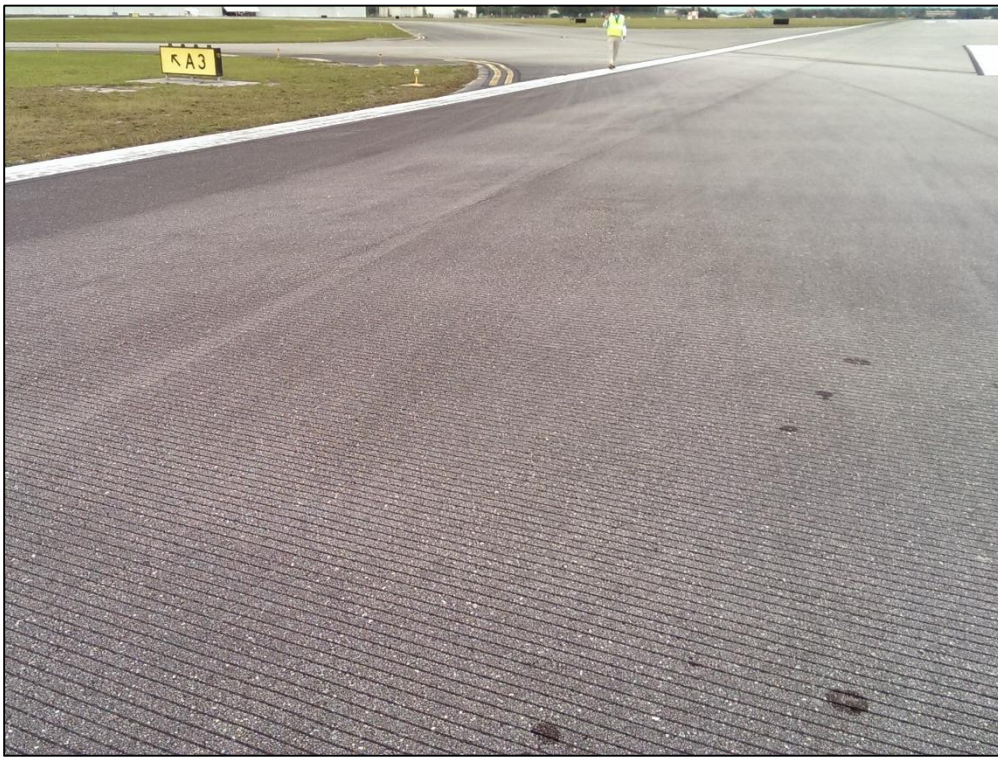
Runway 7-25, Section 6110, Sample Unit 176 – Low Severity (48) Longitudinal and Transverse Cracking, Low Severity (57) Weathering

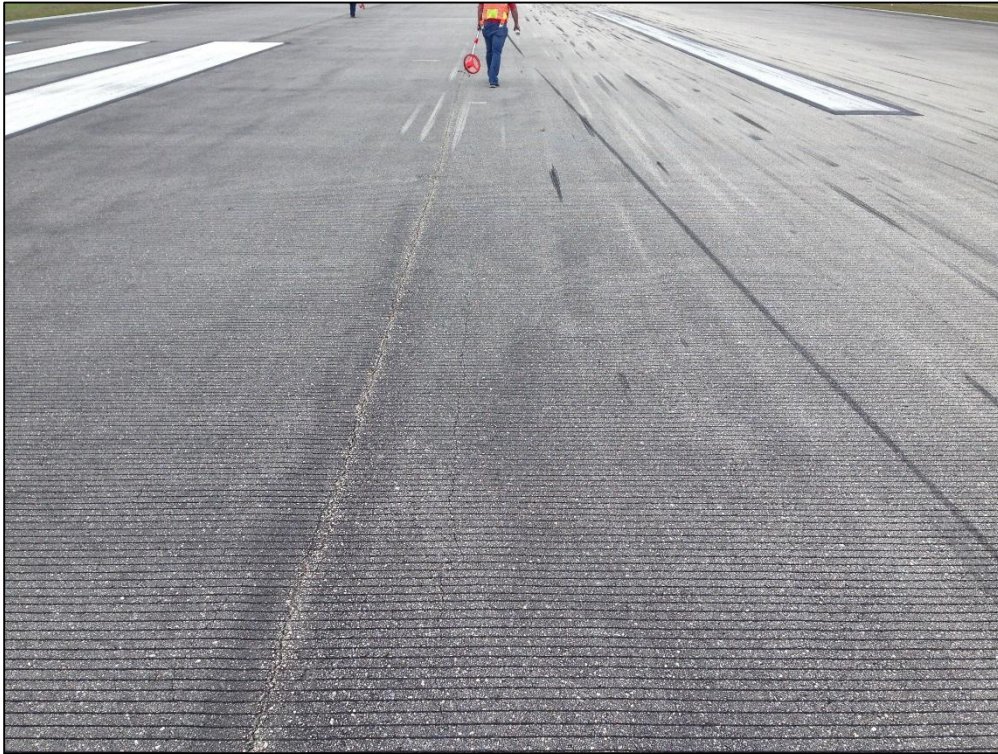
Runway 7-25, Section 6105, Sample Unit 409 – Low Severity (48) Longitudinal and Transverse Cracking, Low Severity (56) Swelling, Low Severity (57) Weathering

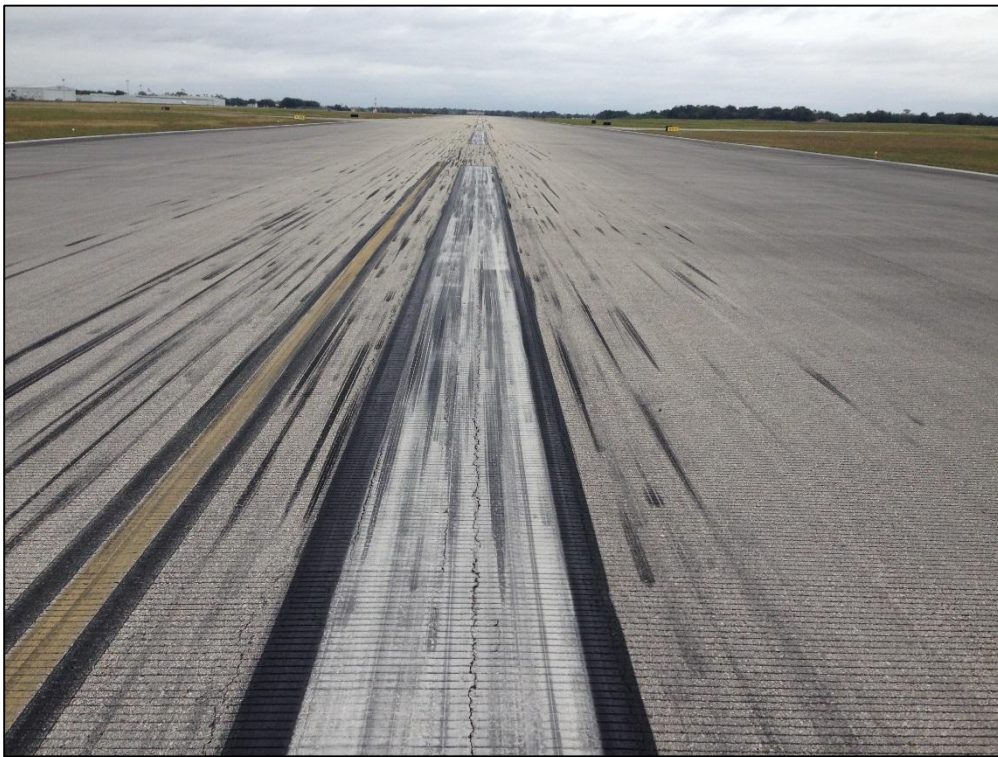
Runway 7-25, Section 6105, Sample Unit 342 – Low Severity (48) Longitudinal and Transverse Cracking, Low Severity (57) Weathering

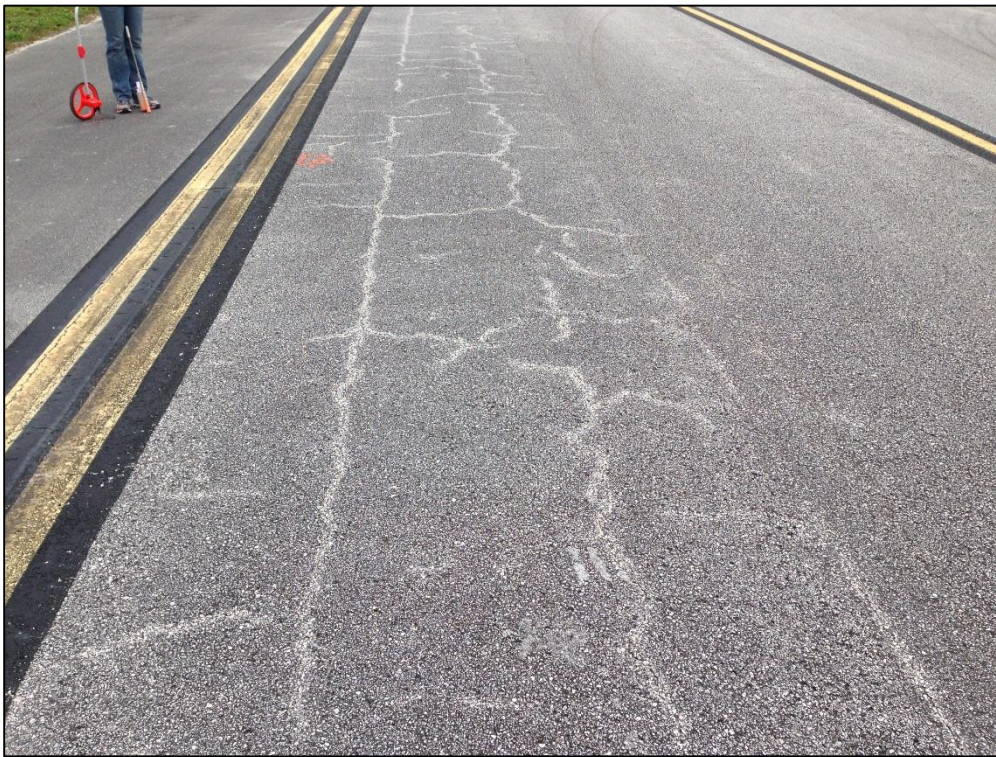
Taxiway Golf, Section 705, Sample Unit 701 – Low Severity (43) Block Cracking, Low Severity (52) Raveling, Low Severity (56) Swelling

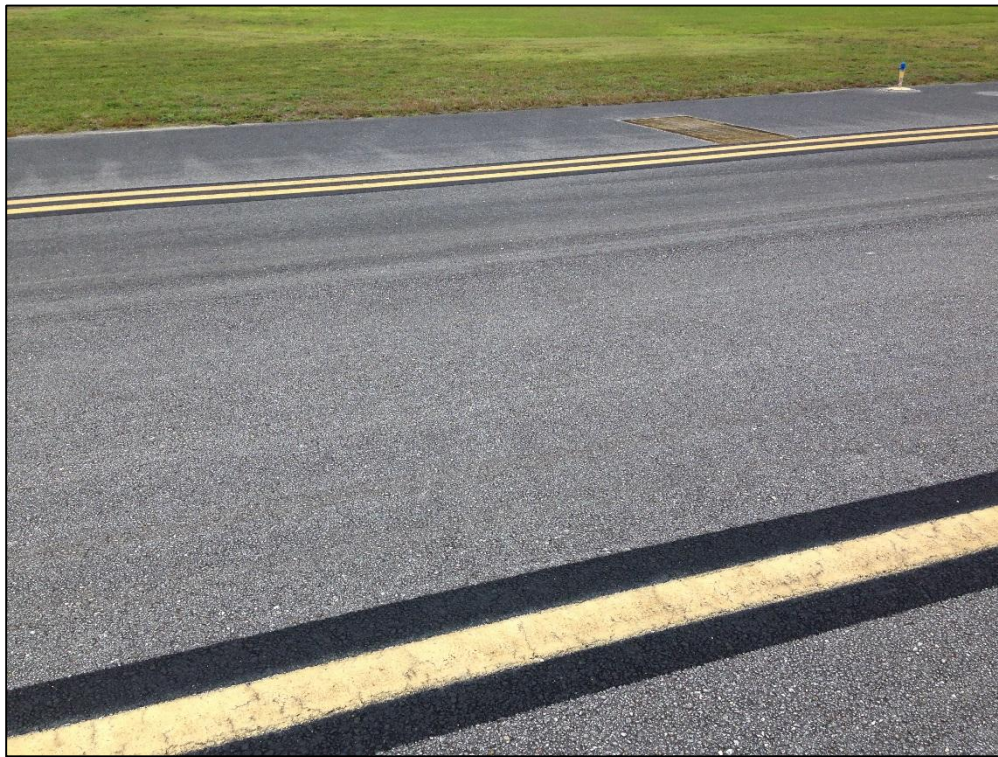
Taxiway E5, Section 560, Sample Unit 101 – Low Severity (52) Raveling, Low Severity (57) Weathering

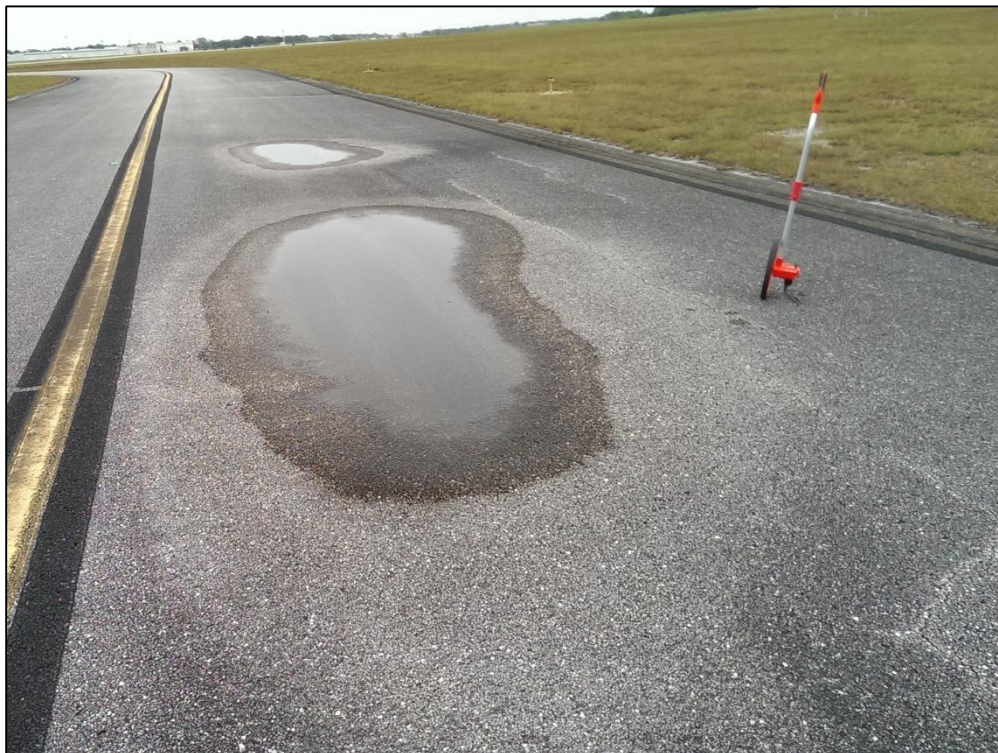
Taxiway E3, Section 420, Sample Unit 405 – Medium Severity (45) Depression, Low Severity (48) Longitudinal and Transverse Cracking, Low Severity (52) Raveling, Low Severity (57) Weathering

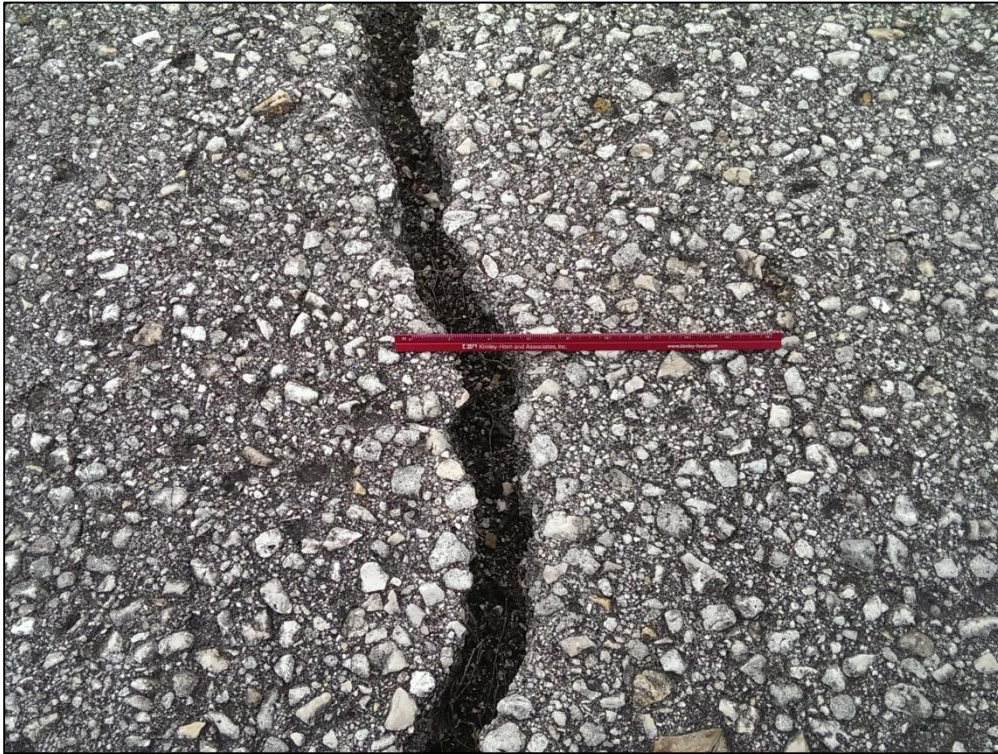
Taxiway E6, Section 805, Sample Unit 801 – High Severity (48) Longitudinal and Transverse Cracking, Low Severity (52) Raveling

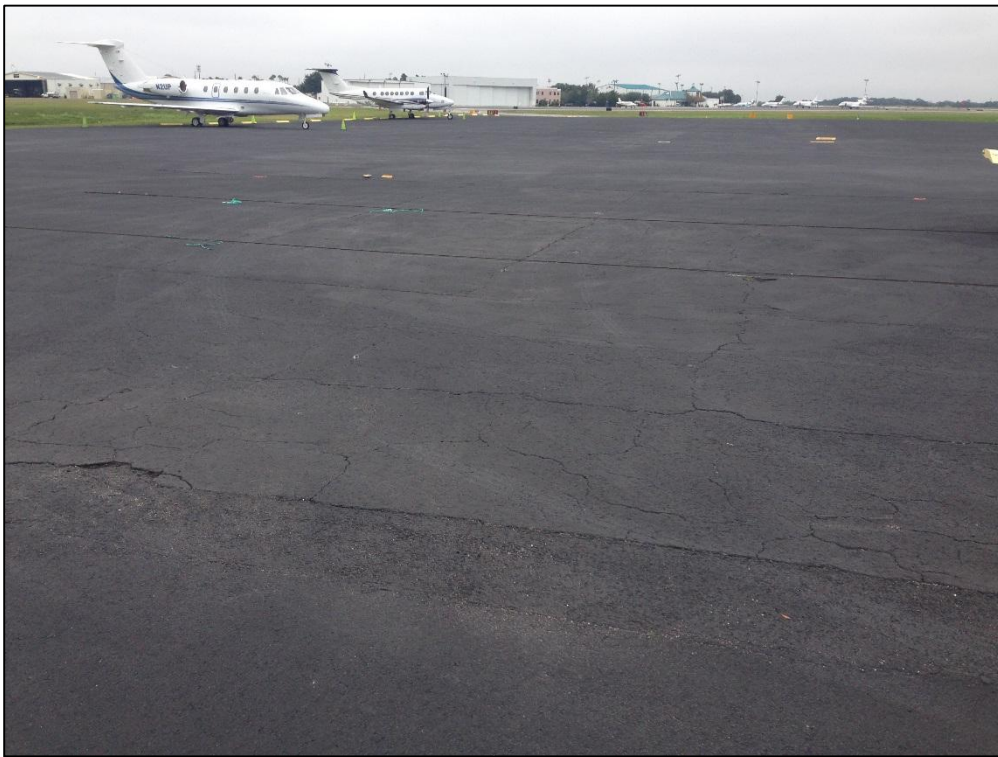
Apron West, Section 4660, Sample Unit 507 – Medium Severity (43) Block Cracking, Low Severity (52) Raveling

- ⦿ West Apron – Sections 4660 and 4665
 - Reconstruction attributed to load, climate, and age of pavement.
- ⦿ West Apron – Sections 4610, 4640, and 4650
 - Mill and Overlay attributed to climate and age of pavement.
- ⦿ Northeast Apron – Sections 4305 and 4312
 - Mill and Overlay attributed to climate and age of pavement.
- ⦿ General Aviation Apron – Section 4205
 - Mill and Overlay attributed to climate and age of pavement.
- ⦿ North Apron – Sections 4105, 4125, 4140, 4145, 4158, 4165, 4167, and 4168
 - Reconstruction attributed to load, climate, and age of pavement.
- ⦿ North Apron – Section 4155
 - Mill and Overlay attributed to climate and age of pavement.
- ⦿ Taxiway E4 – Sections 1070 and 1080
 - Mill and Overlay attributed to climate and age of pavement.
- ⦿ Taxiway H – Section 806
 - Mill and Overlay attributed to climate and age of pavement.
- ⦿ Taxiway E6 – Section 805

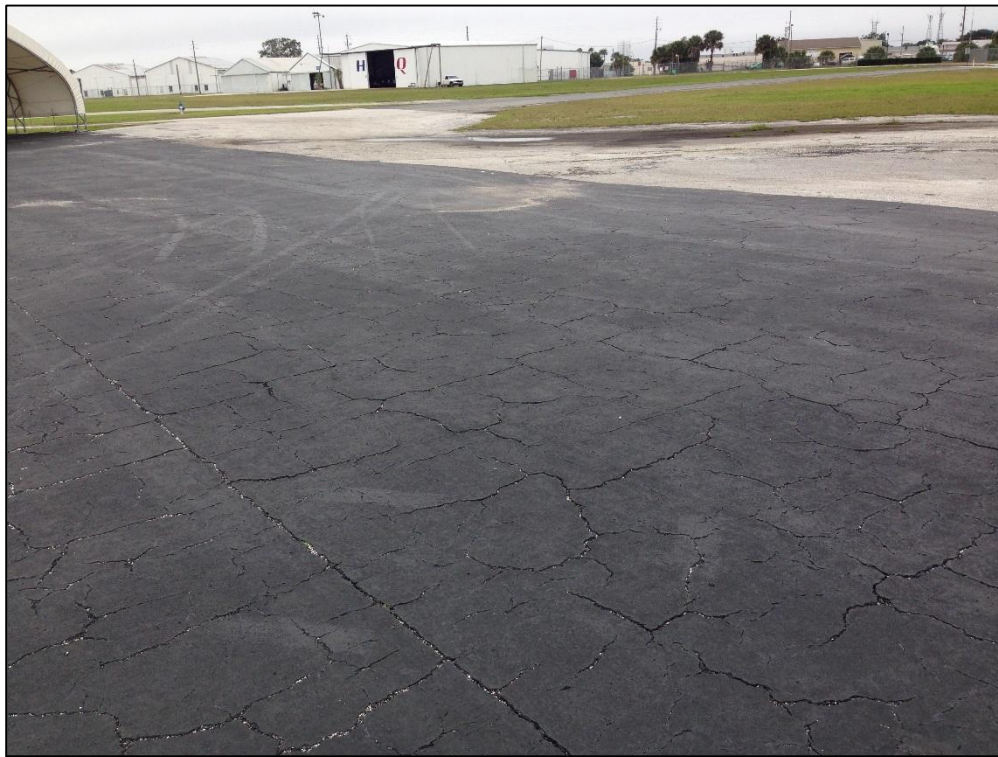
Apron North, Section 4158, Sample Unit 651 – High Severity (43) Block Cracking, Medium Severity (52) Raveling

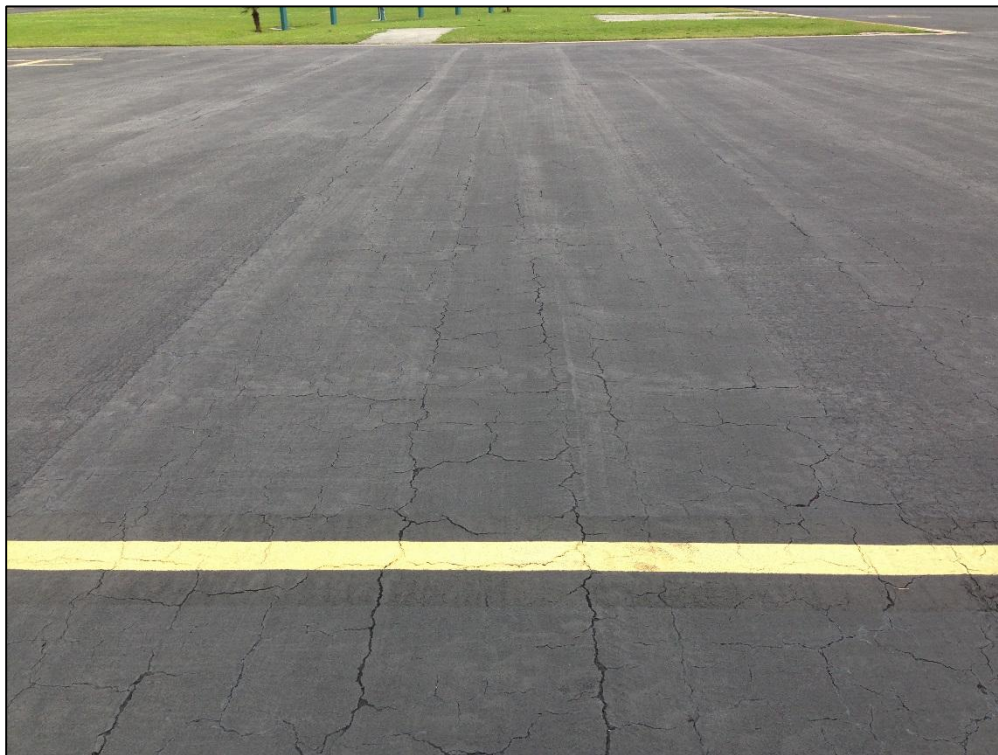
Apron North, Section 4145, Sample Unit 416 – Medium Severity (43) Block Cracking, Low Severity (57) Weathering, Medium Severity (57) Weathering
