**PUNTA GORDA
AIRPORT (PGD)**

JUNE 2015

STATEWIDE
**Airfield
Pavement
Management**
PROGRAM

In March 2015, a PCI survey inspection was performed at Punta Gorda Airport. The results of the inspection indicate that, based on ASTM D 5340-12, the airport's airfield pavement facilities had an overall area-weighted average PCI of 71, representing a Satisfactory overall network condition. Table I summarizes the overall condition summary by network level branch in comparison to the FDOT recommended minimum service level and action recommendations for either major rehabilitation or maintenance level activities.

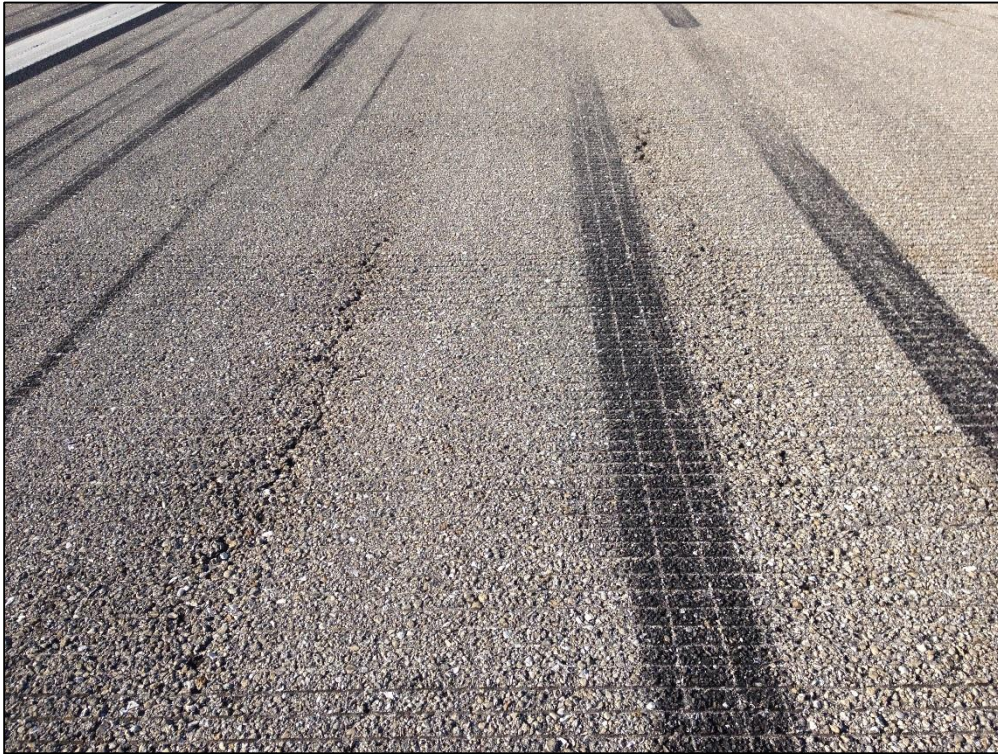
Runway 4-22, Section 6105, Sample Unit 377 – Low Severity (48) Longitudinal and Transverse Cracking, Low Severity (52) Raveling, Low Severity (57) Weathering

- ⦿ Runway 15-33 – Section 6210
 - Mill and Overlay attributed to climate/age and construction quality.
- ⦿ Runway 4-22 – Section 6105
 - Mill and Overlay attributed to structural, climate/age, and construction quality.
- ⦿ Taxiway To T-Hangars – Sections 4420 and 4410
 - Mill and Overlay attributed to climate/age.
- ⦿ North Apron – Sections 4320 and 4305
 - Mill and Overlay attributed to climate/age and construction quality.
- ⦿ Main Apron – Section 4208
 - PCC Restoration attributed to construction quality.
- ⦿ South Apron – Section 4105
 - Mill and Overlay attributed to climate/age and construction quality.
- ⦿ Taxiway To North T-Hangars – Section 210

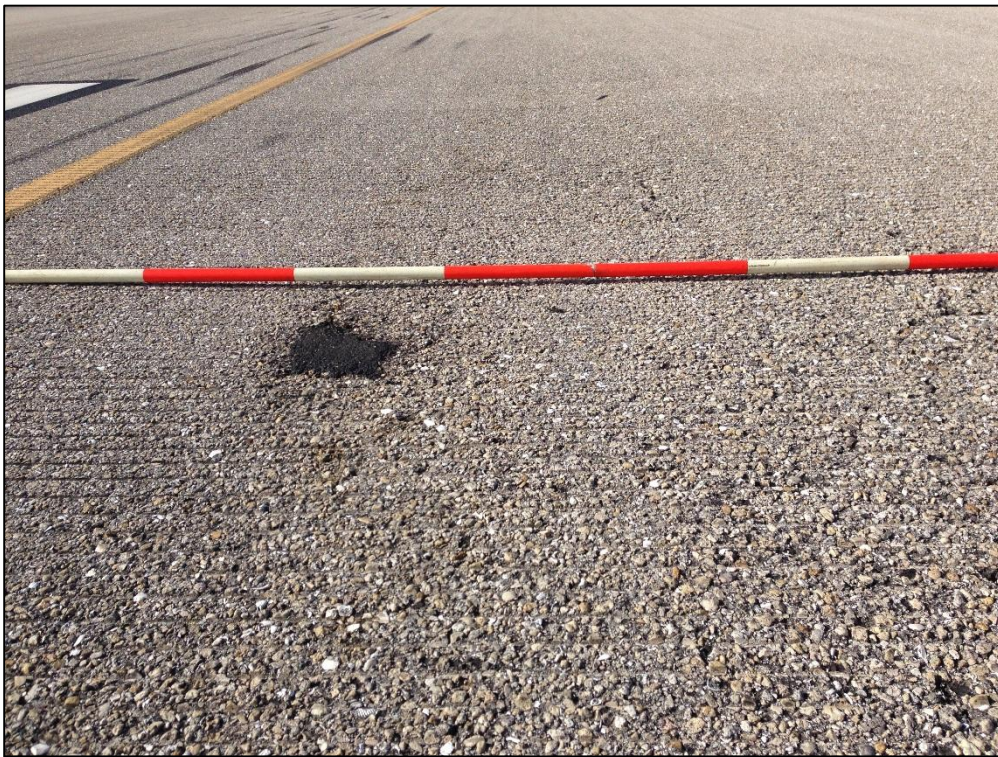
Runway 4-22, Section 6105, Sample Unit 355 – Low Severity (48) Longitudinal and Transverse Cracking, Medium Severity (50) Patching, Low Severity (52) Raveling, Medium Severity (52) Raveling, Low Severity (53) Rutting

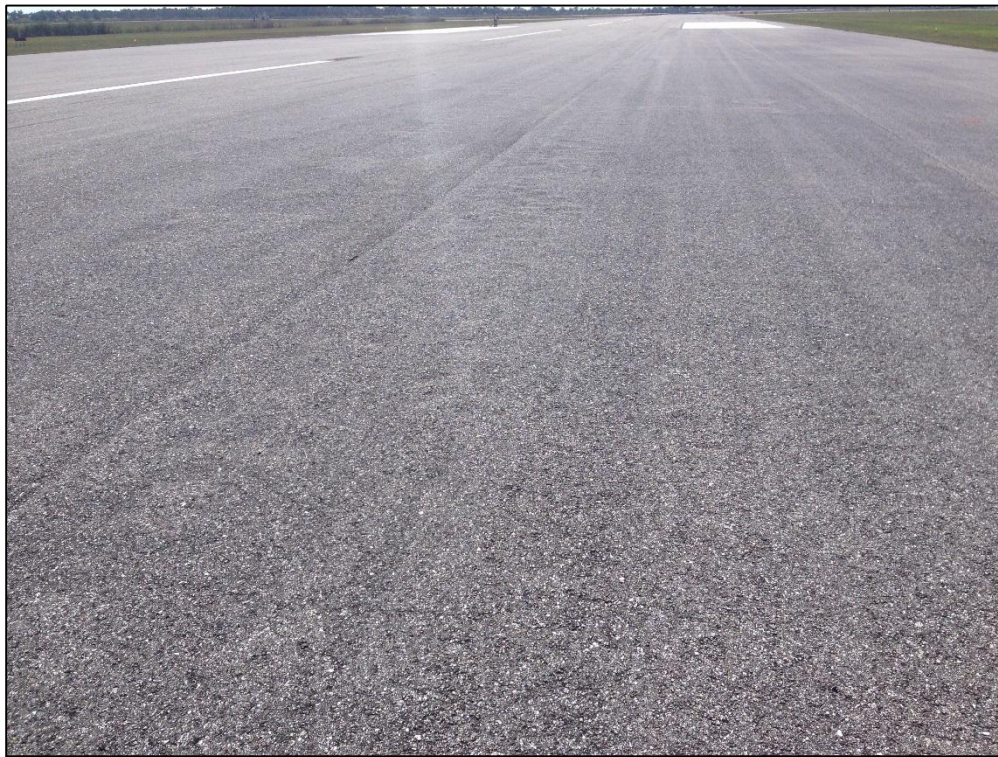
Runway 15-33, Section 6210, Sample Unit 372 – Low Severity (48) Longitudinal and Transverse Cracking, Low Severity (52) Raveling, Low Severity (56) Swelling, Low Severity (57) Weathering

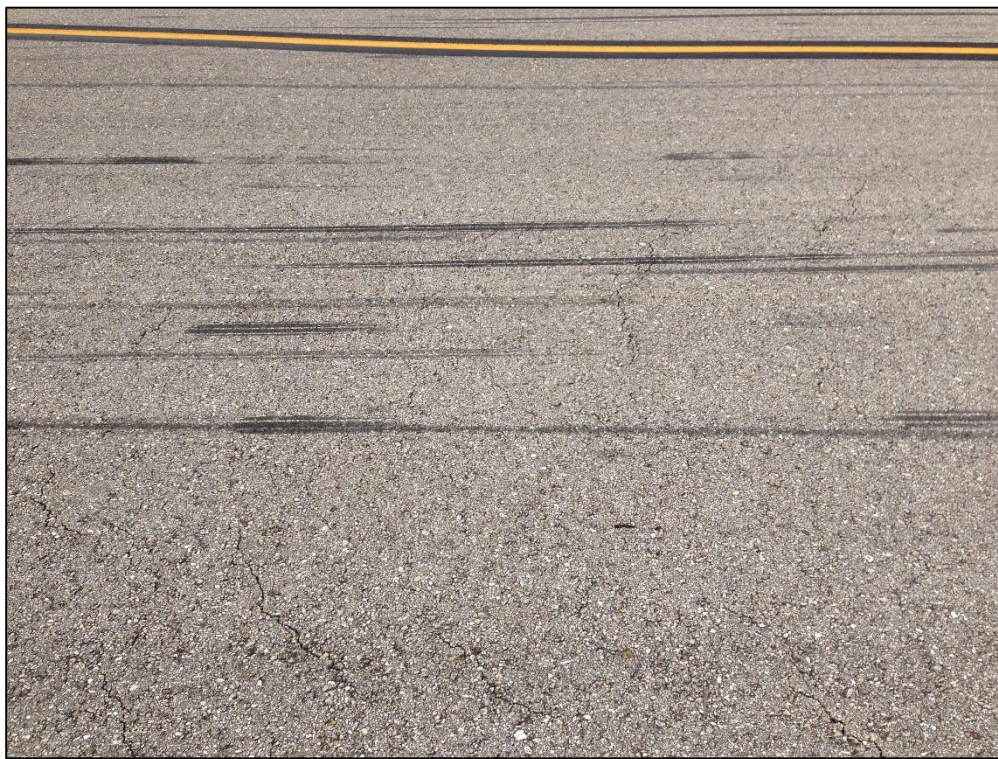
Runway 15-33, Section 6210, Sample Unit 306 – Low Severity (48) Longitudinal and Transverse Cracking, Low Severity (52) Raveling, Low Severity (57) Weathering

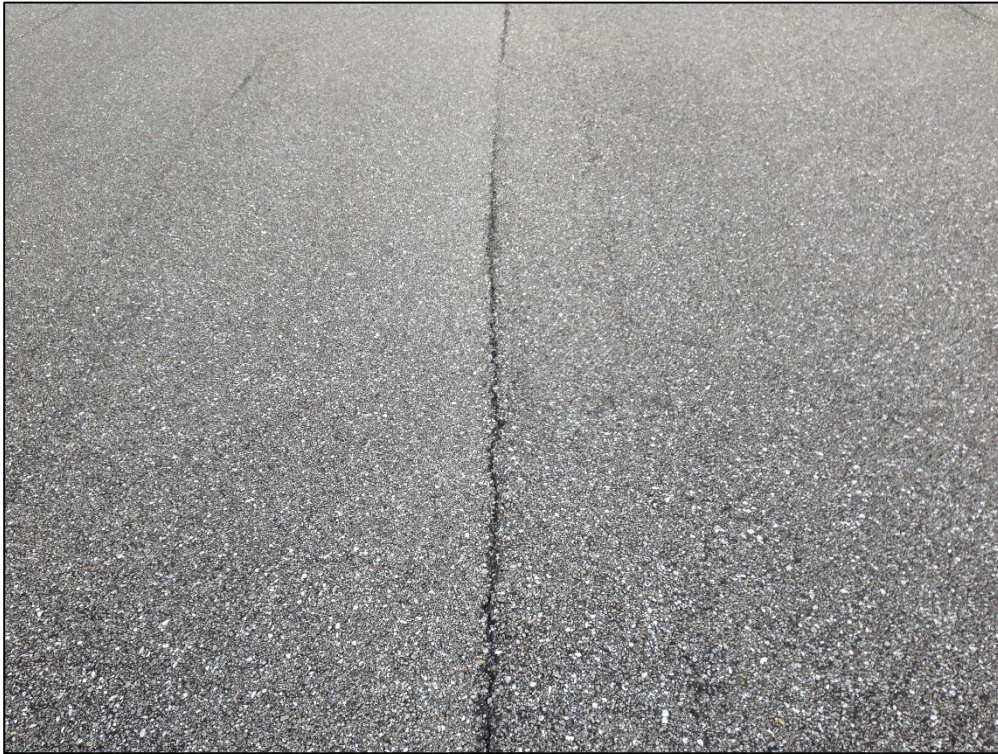
Runway 9-27, Section 6305, Sample Unit 312 – Low Severity (48) Longitudinal and Transverse Cracking, Low Severity (52) Raveling, Medium Severity (57) Weathering

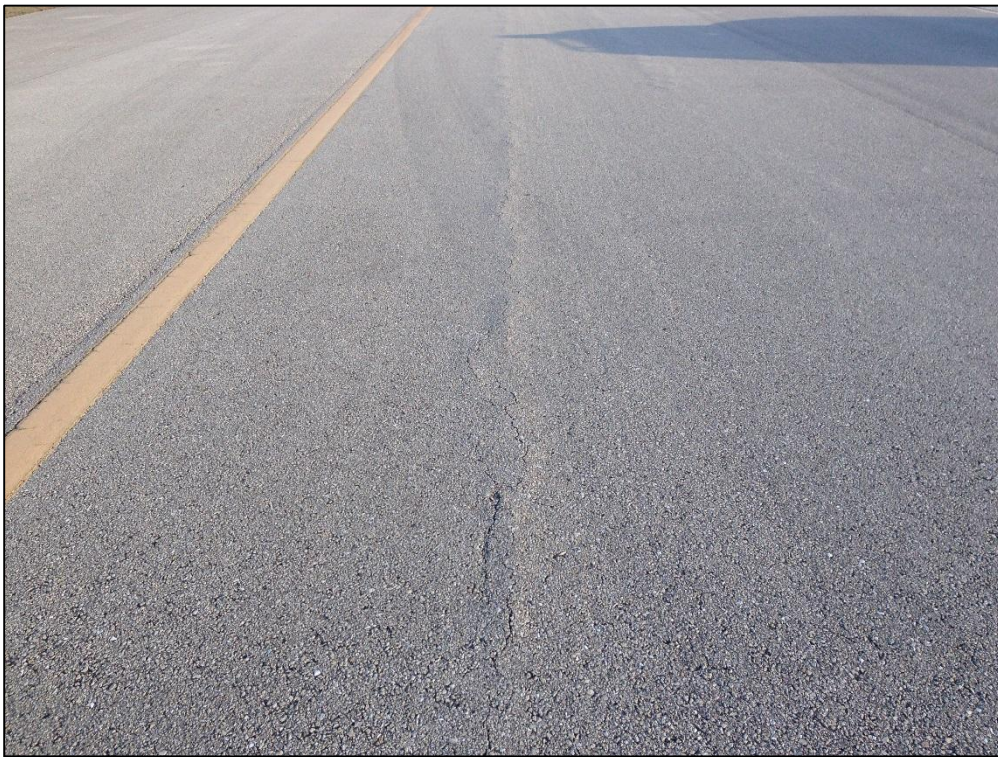
Taxiway Delta, Section 115, Sample Unit 134 – Low Severity (48) Longitudinal and Transverse Cracking, Low Severity (56) Swelling, Low Severity (57) Weathering

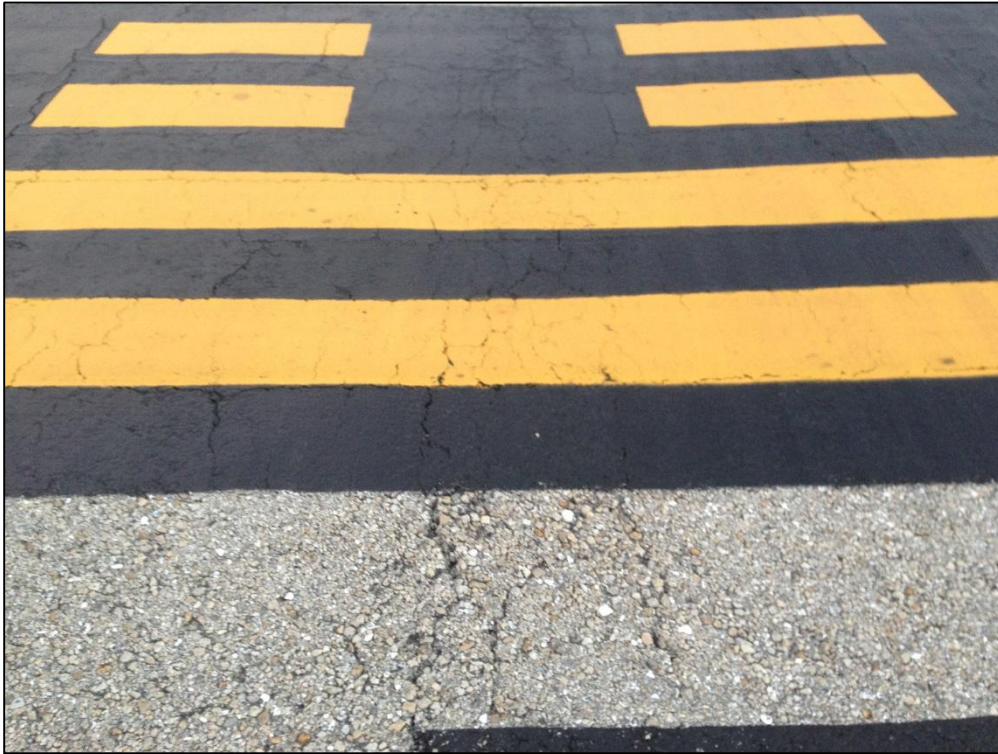
Taxiway Delta, Section 102, Sample Unit 96 – Low Severity (41) Alligator Cracking, Low Severity (52) Raveling, Low Severity (53) Rutting, Low Severity (57) Weathering

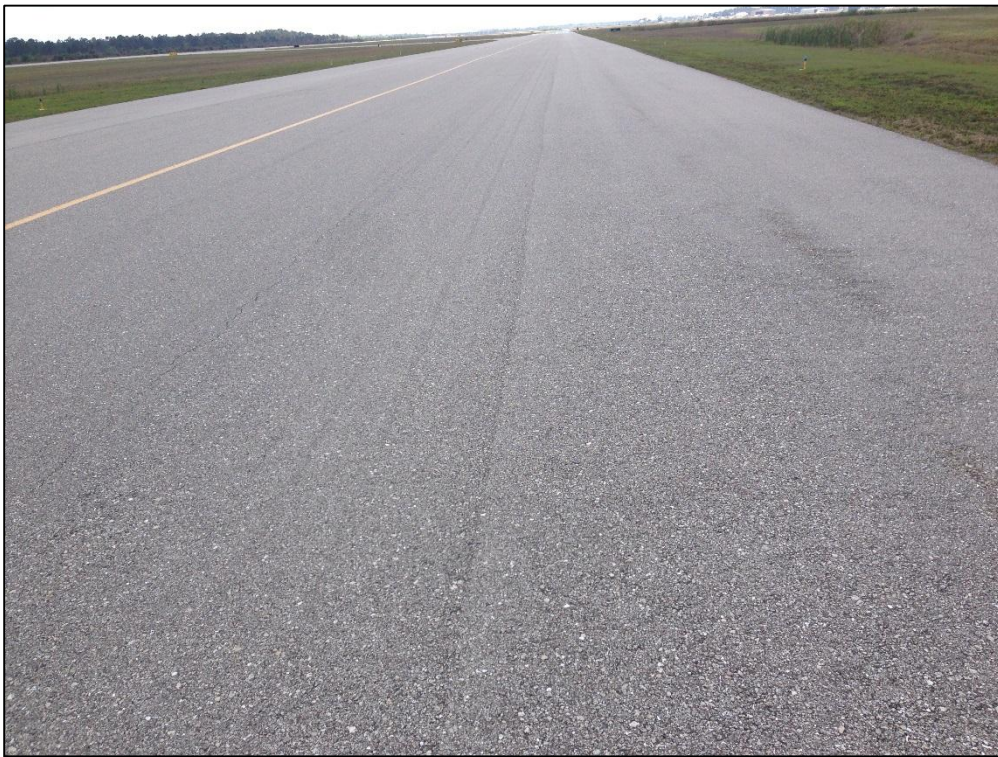
Taxiway Alpha, Section 330, Sample Unit 218 – Low Severity (48) Longitudinal and Transverse Cracking, Low Severity (52) Raveling, Low Severity (57) Weathering

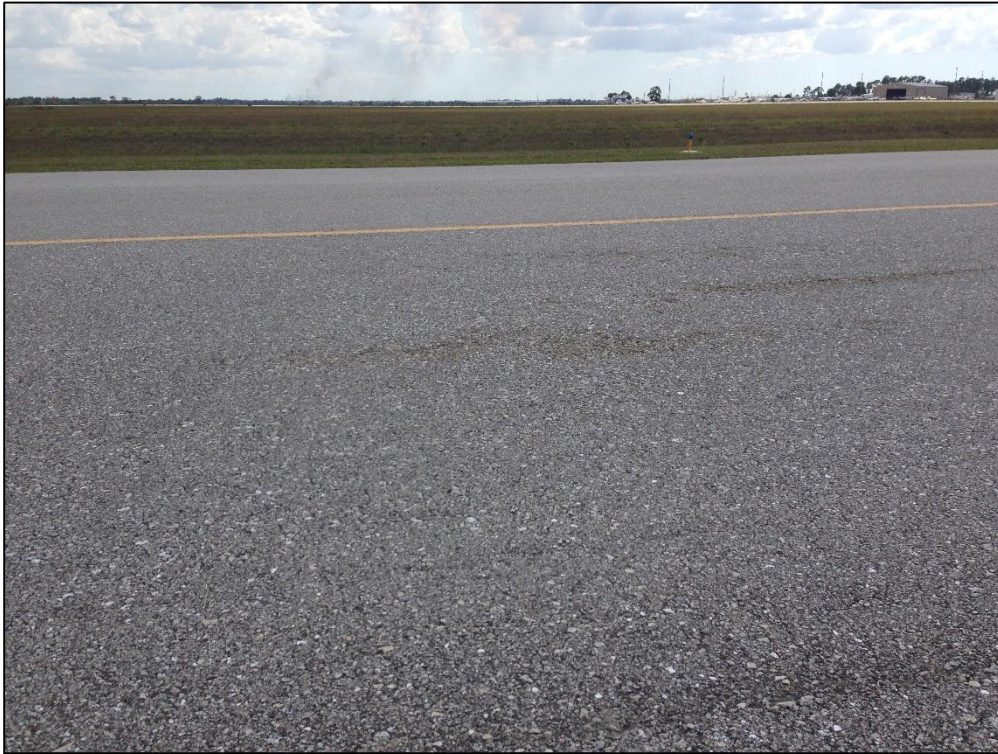
Taxiway Charlie, Section 310, Sample Unit 308 – Low Severity (48) Longitudinal and Transverse Cracking, Low Severity (52) Raveling, Low Severity (57) Weathering

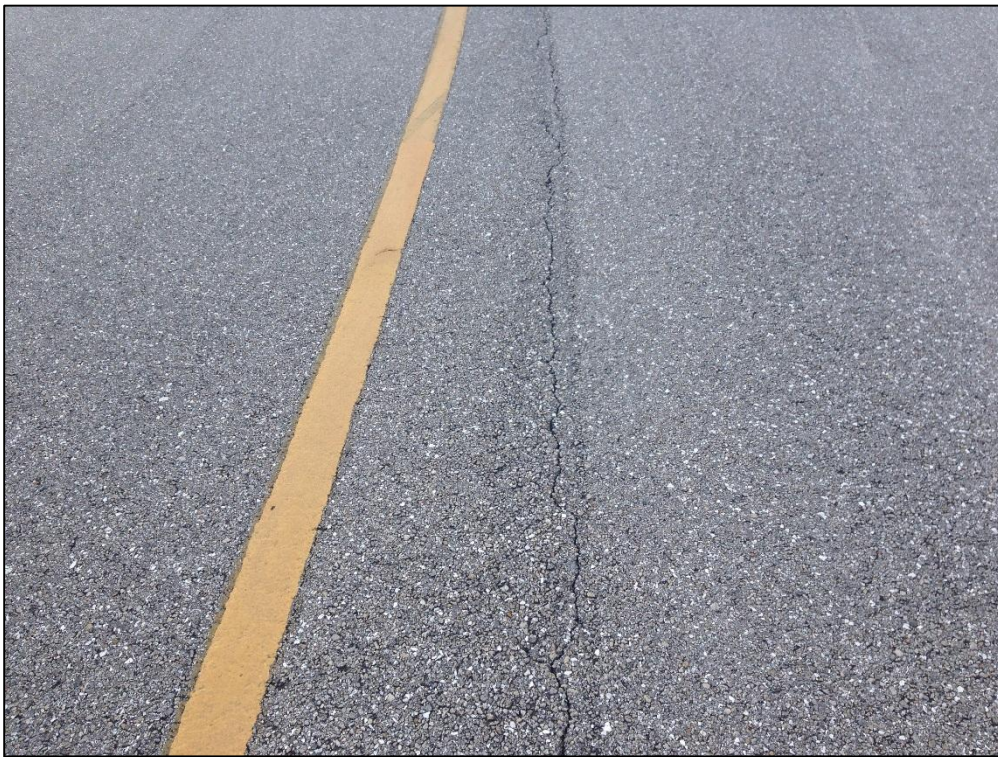
Taxiway Foxtrot, Section 1105, Sample Unit 107 – Low Severity (48) Longitudinal and Transverse Cracking, Low Severity (57) Weathering

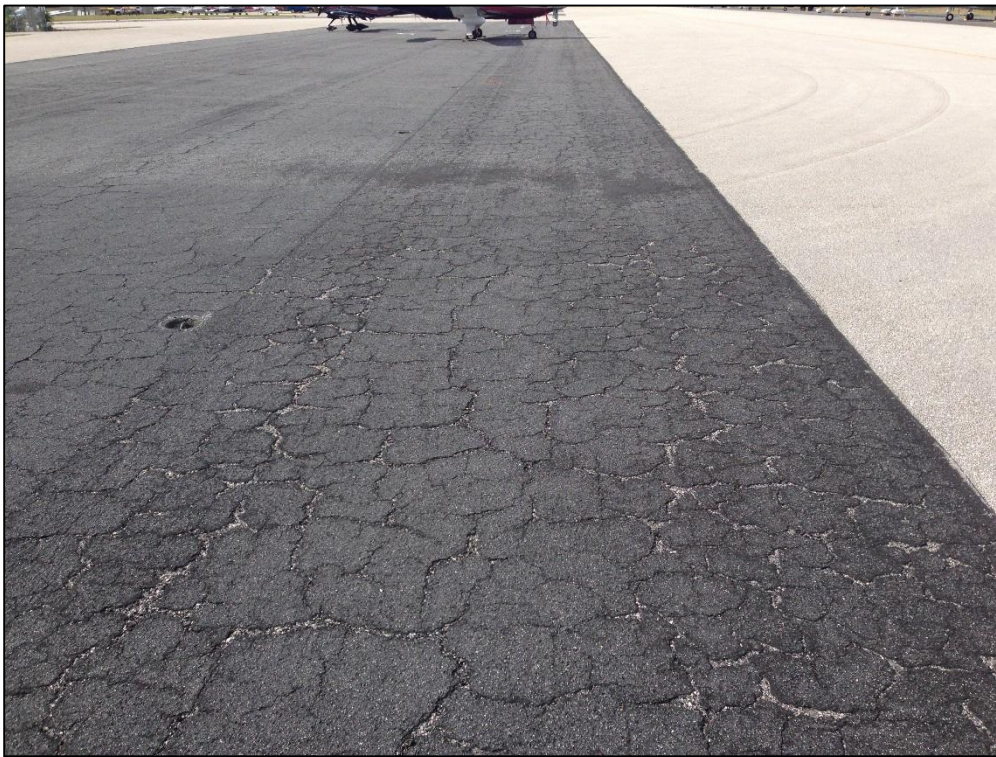
Apron South, Section 4105, Sample Unit 152 – Low Severity (43) Block Cracking, Low Severity (57) Weathering, Medium Severity (57) Weathering

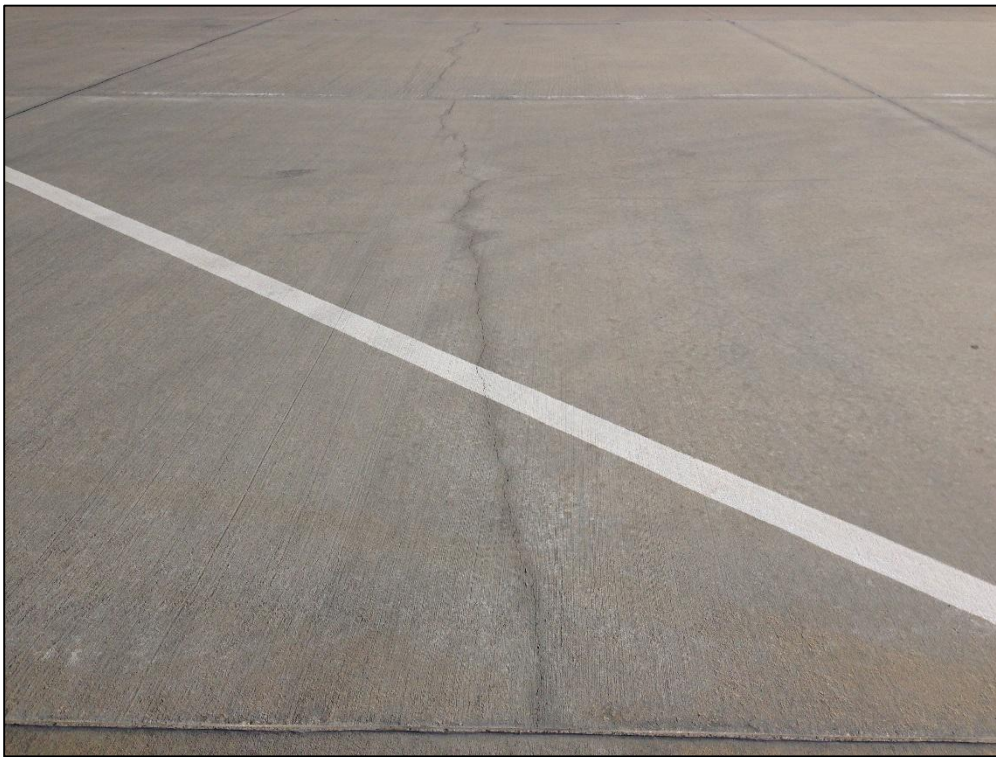
Apron Main, Section 4205, Sample Unit 200 – Low Severity (63) Longitudinal, Transverse, and Diagonal Cracking, (73) Shrinkage Cracks

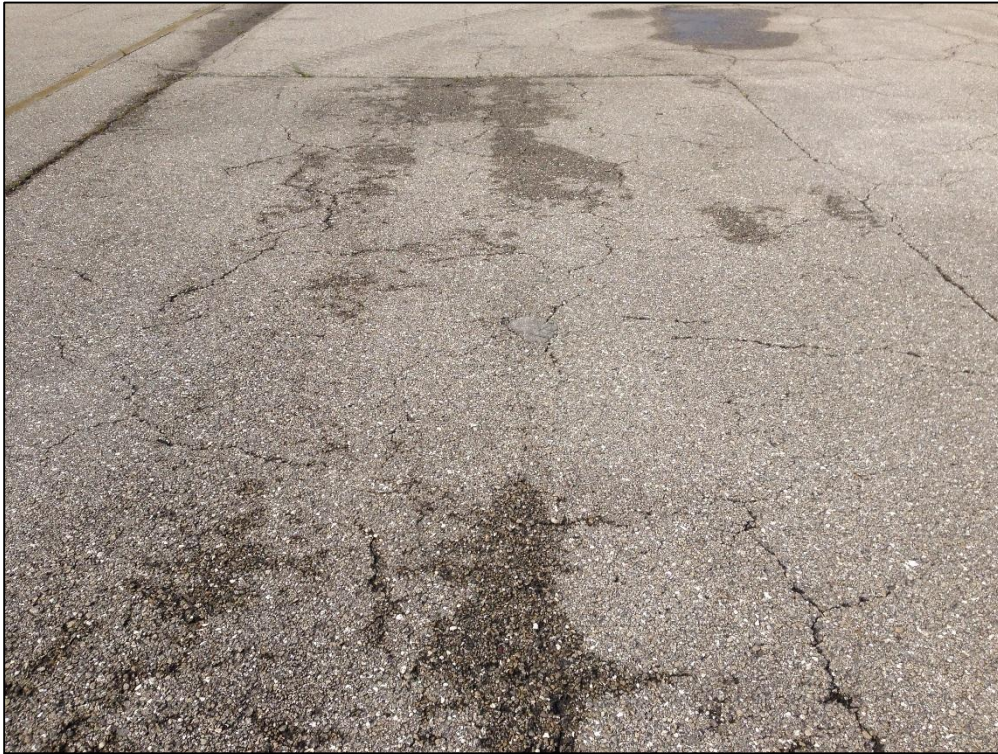
Apron North, Section 4305, Sample Unit 151 – Low Severity (43) Block Cracking, Low Severity (48) Longitudinal and Transverse Cracking, Low Severity (52) Raveling, Medium Severity (57) Weathering

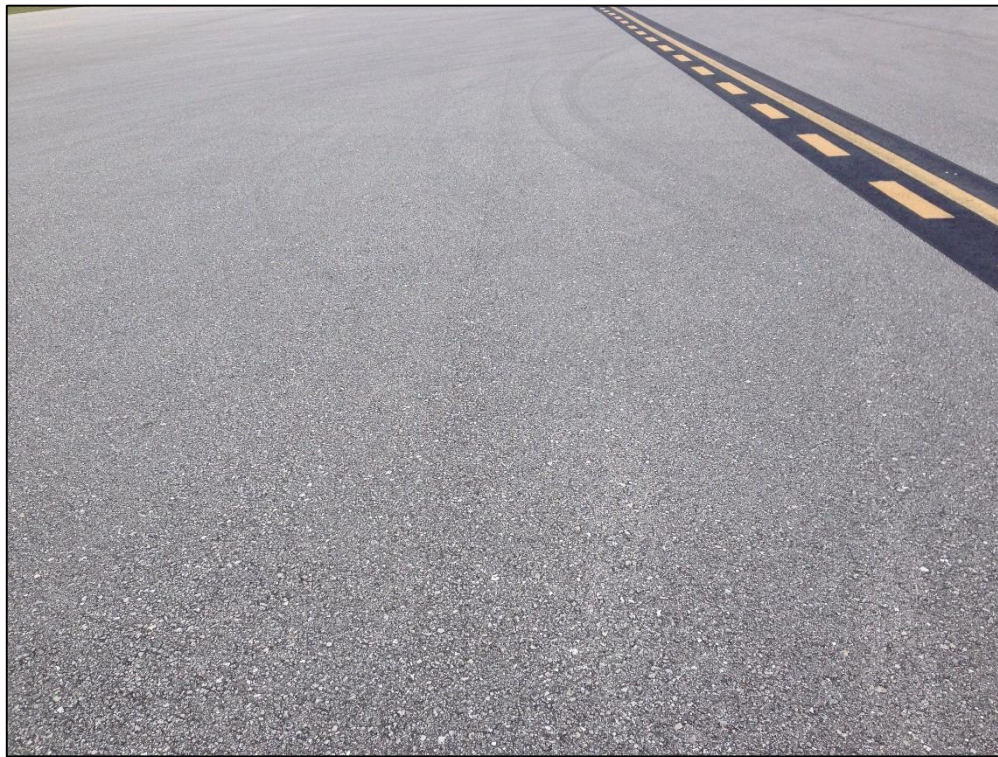
Apron Main, Section 4206, Sample Unit 93 – Low Severity (52) Raveling, Low Severity (57) Weathering
