FLORIDA DEPARTMENT OF TRANSPORTATION
AVIATION AND SPACEPORT OFFICE

**ORLANDO
SANFORD
INTERNATIONAL
AIRPORT (SFB)**

JUNE 2015

STATEWIDE
**Airfield
Pavement
Management**
PROGRAM

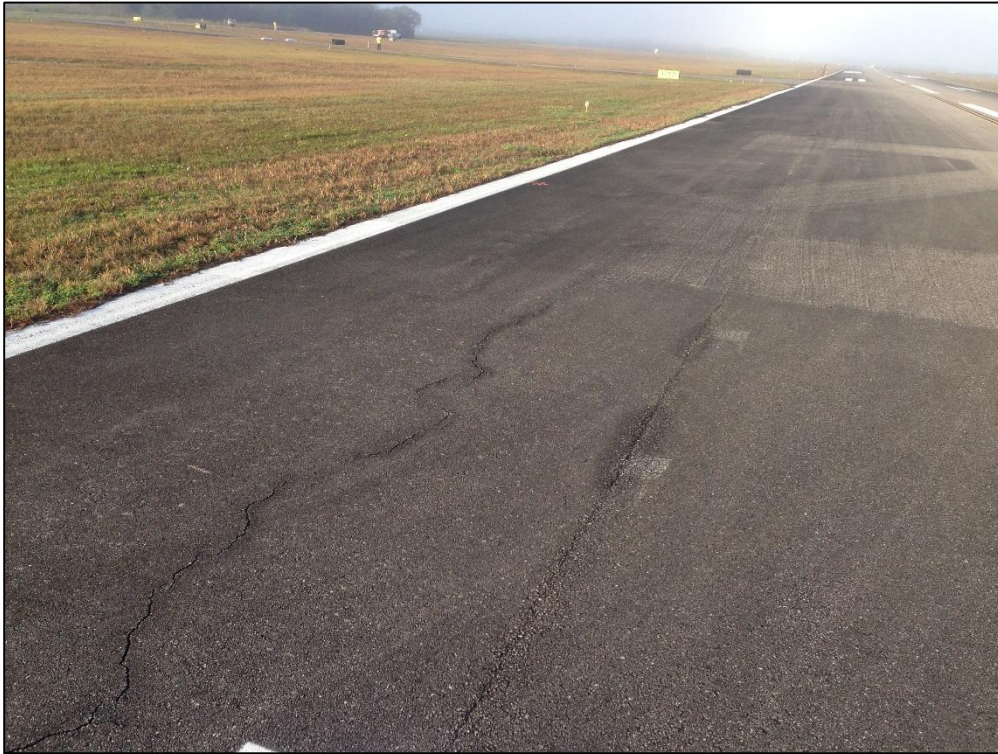
Runway 9R-27L, Section 6405, Sample Unit 172 – Low Severity (48) Longitudinal and Transverse Cracking, Low Severity (52) Raveling, Medium Severity (52) Raveling, Low Severity (57) Weathering

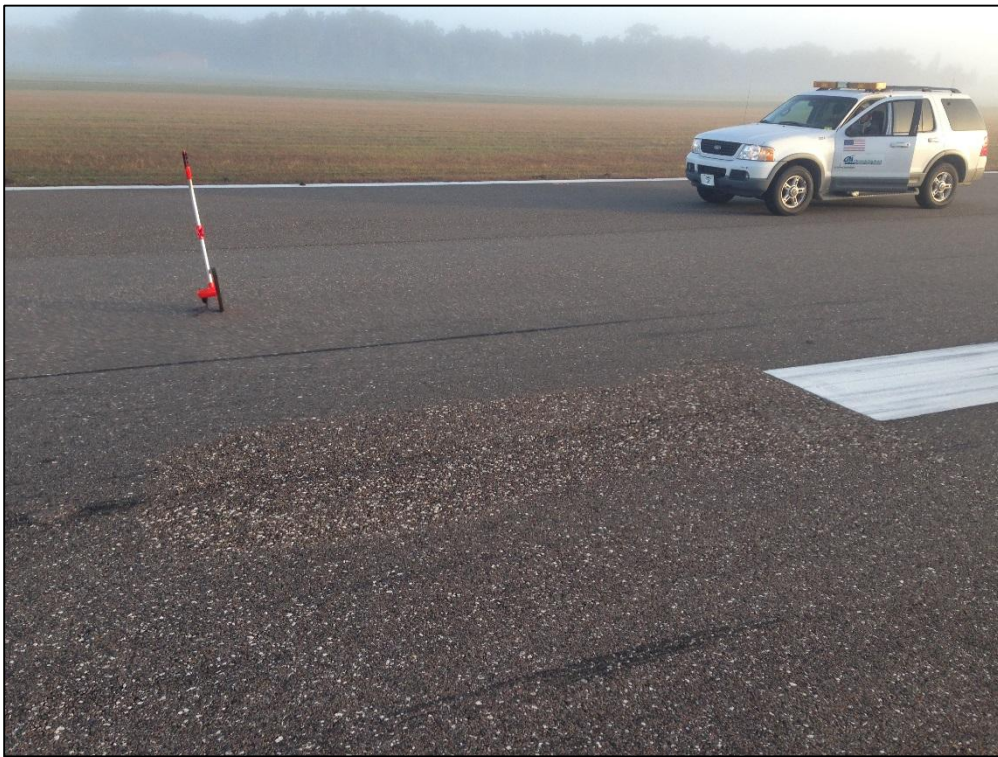
Runway 9R-27L, Section 6410, Sample Unit 221 – Low Severity (52) Raveling, Low Severity (57) Weathering

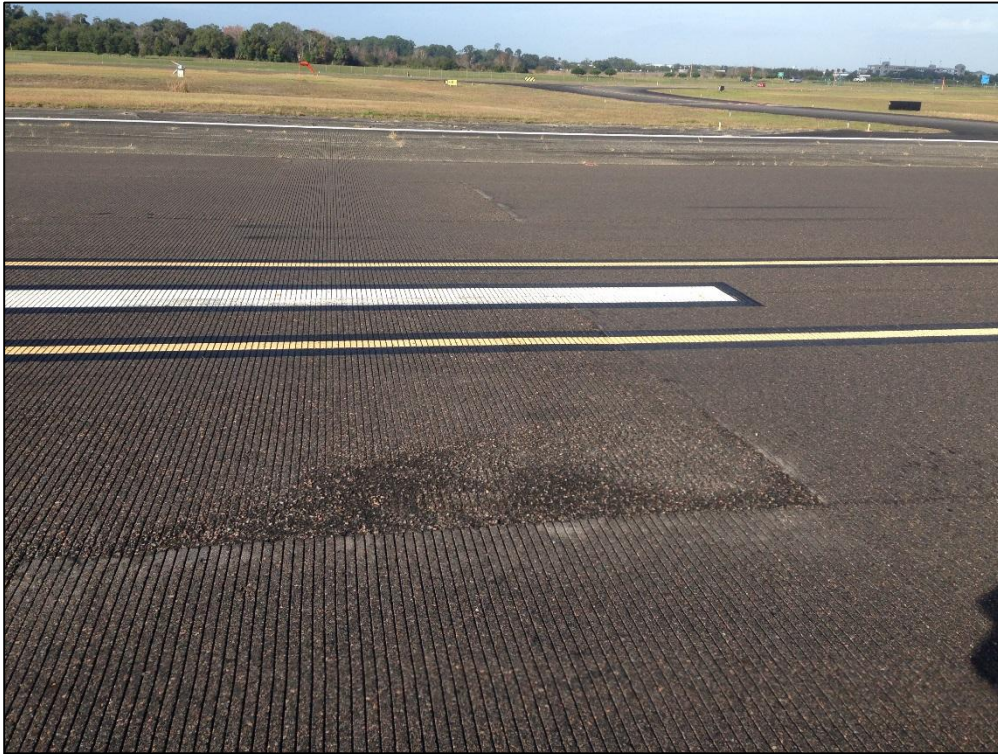
Runway 18-36, Section 6205, Sample Unit 312 – Low Severity (48) Longitudinal and Transverse Cracking, Low Severity (52) Raveling, High Severity (52) Raveling

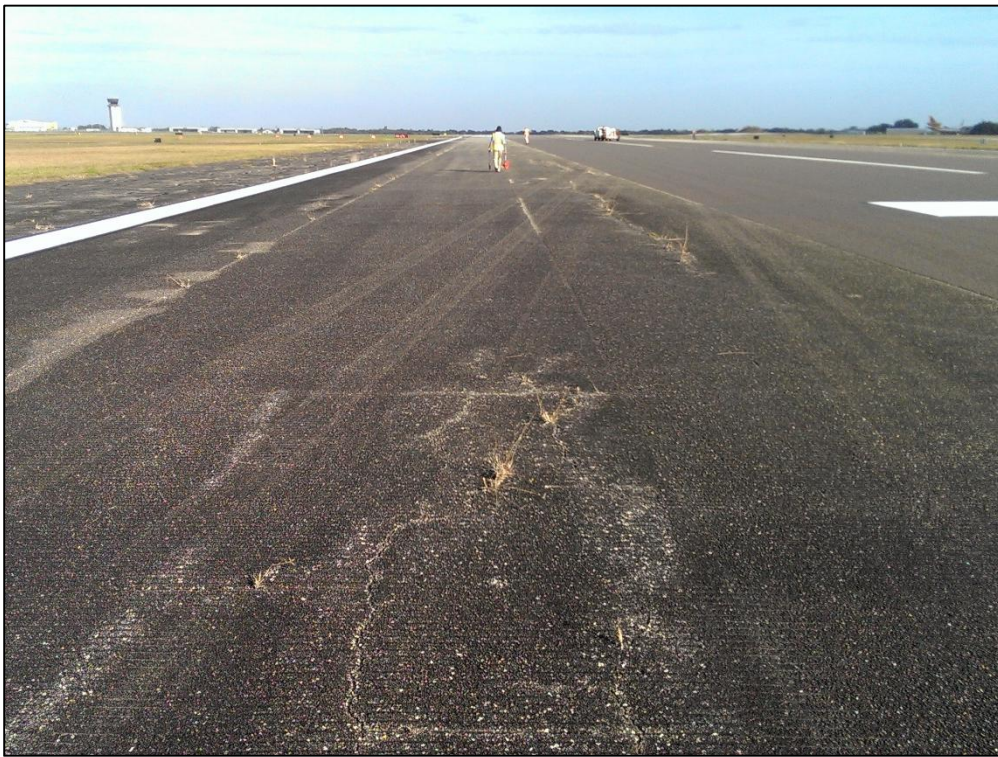
Runway 18-36, Section 6210, Sample Unit 104 – Low Severity (48) Longitudinal and Transverse Cracking, Low Severity (52) Raveling, Low Severity (56) Swelling, Low Severity (57) Weathering

- Runway 18-36 – Sections 6210 and 6233
 - Mill and Overlay attributed to climate and age of pavement.
- East Apron – Sections 4505 and 4510
 - Reconstruction and PCC Restoration attributed to load, climate, and age of pavement.
- West Apron – Section 4405 and 4410
 - Reconstruction and PCC Restoration attributed to load, climate, and age of pavement.
- FBO Apron – Section 4305
 - Mill and Overlay attributed to climate and age of pavement.
- Southwest Apron – Sections 4250 and 4270
 - Reconstruction and Mill and Overlay attributed to load, climate, and age of pavement.
- Southwest Apron – Sections 4227 and 4240
 - PCC Restoration attributed to structural, climate, and age of pavement.
- Taxiway R – Sections 1805, 1810, and 1820

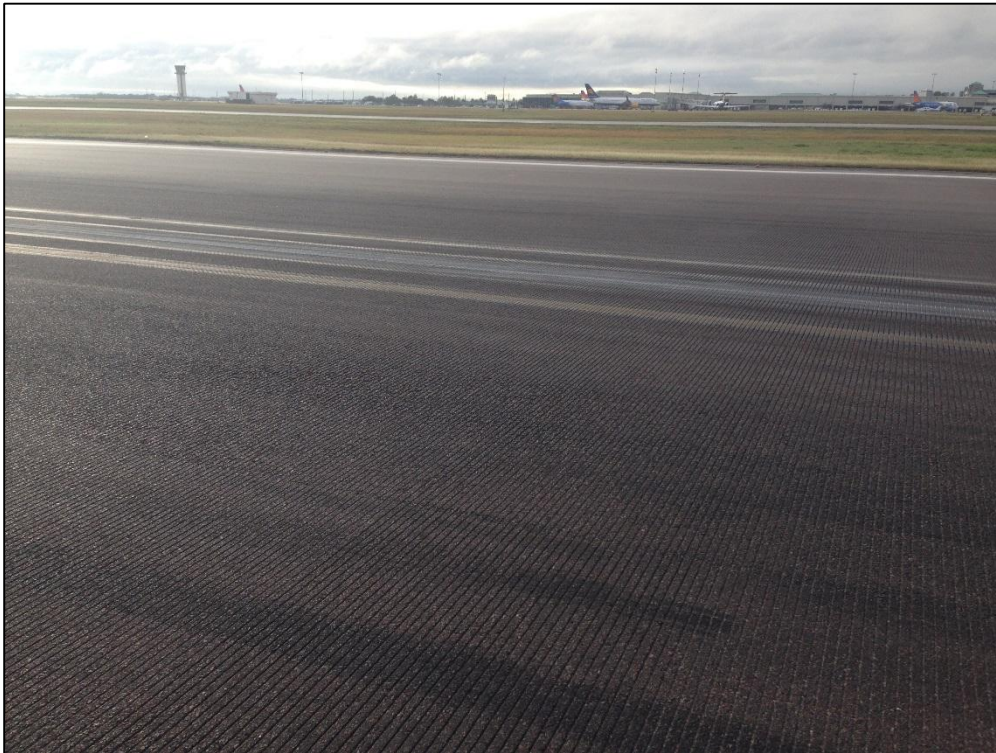
Runway 9L-27R, Section 6105, Sample Unit 352 – Low Severity (57) Weathering, High Severity (57) Weathering

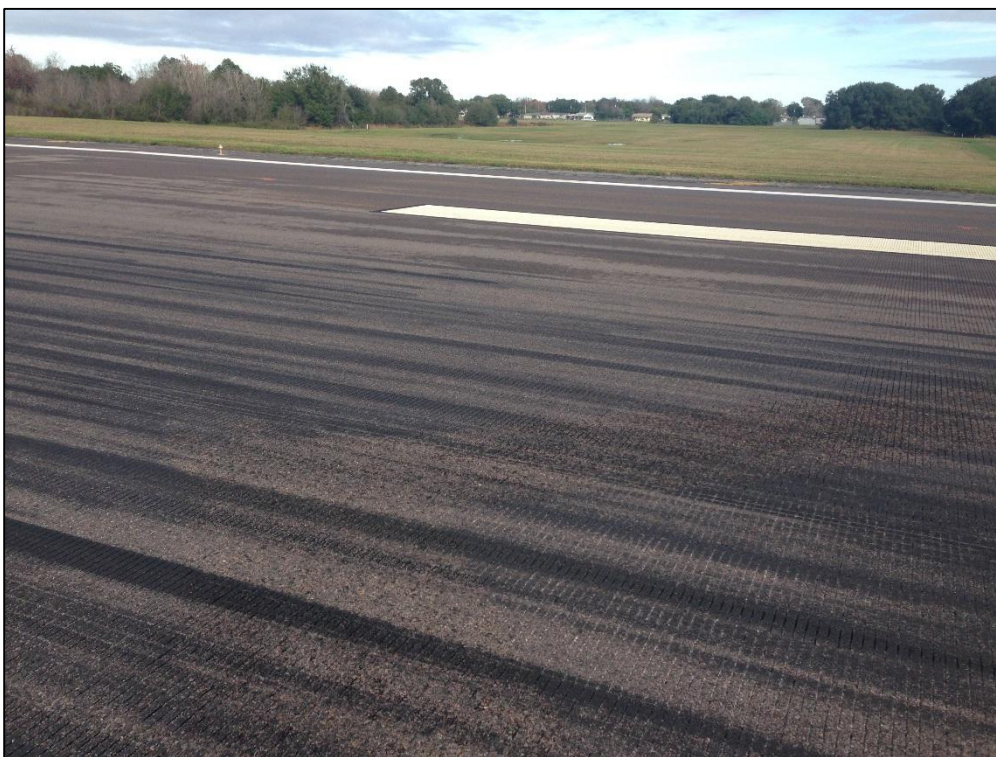
Runway 9L-27R, Section 6105, Sample Unit 448 – Low Severity (52) Raveling, Low Severity (57) Weathering

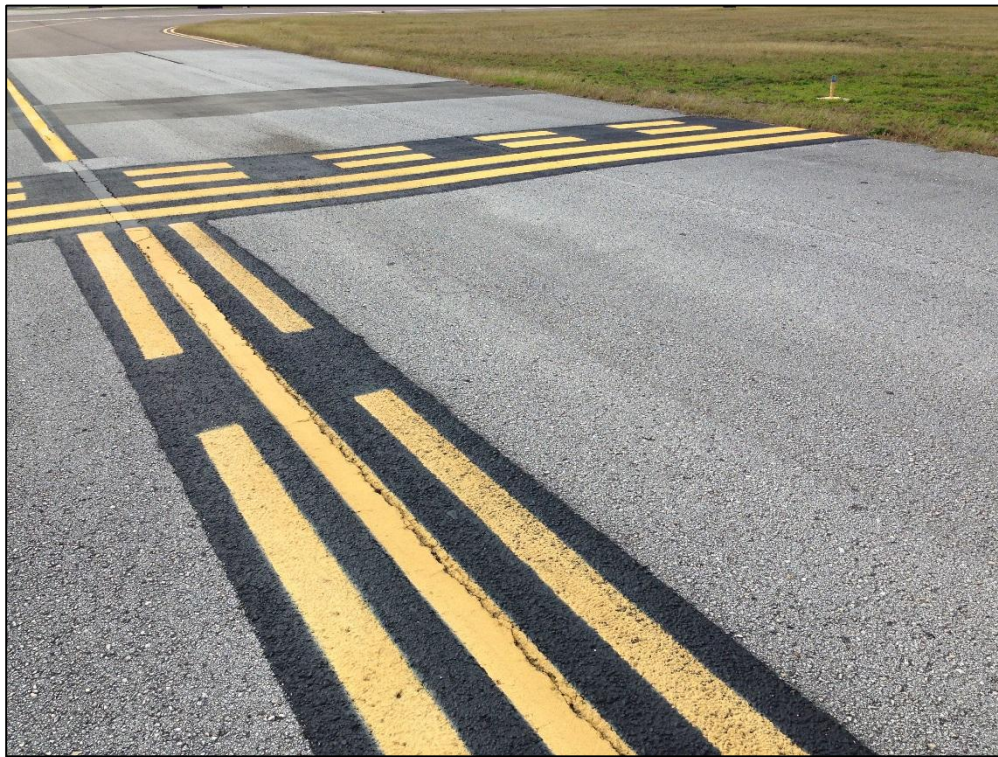
Taxiway Romeo, Section 1820, Sample Unit 180 – Low Severity (48) Longitudinal and Transverse Cracking, Low Severity (52) Raveling, Low Severity (53) Rutting, Low Severity (56) Swelling

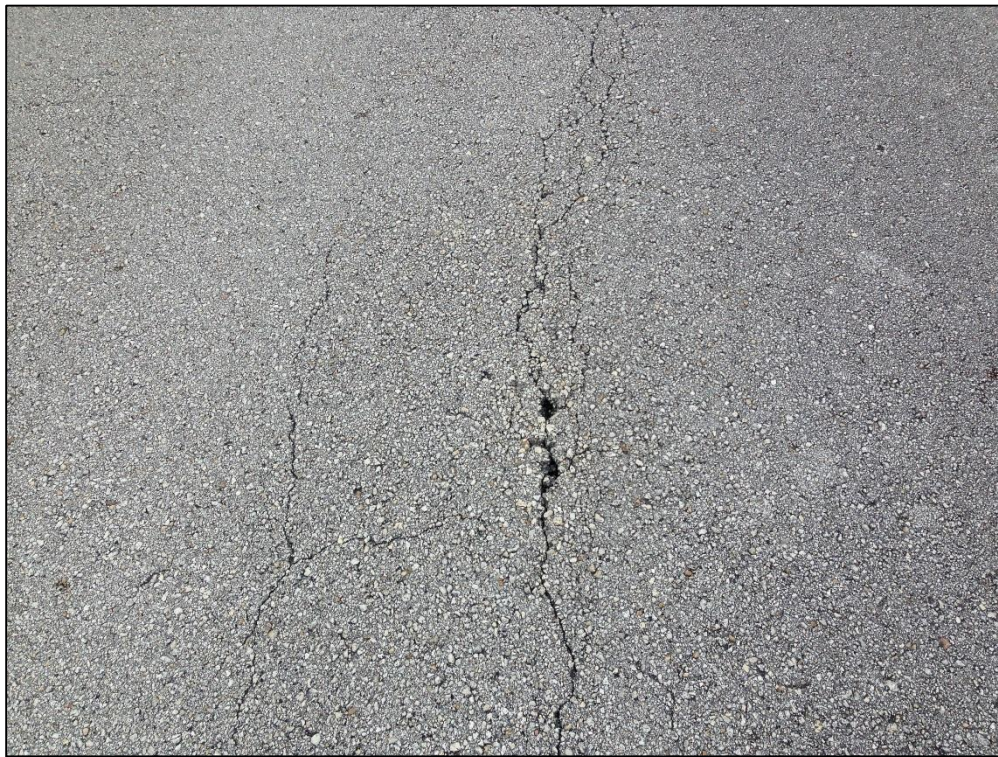
Taxiway Charlie, Section 315, Sample Unit 308 – Low Severity (41) Alligator Cracking, Low Severity (48) Longitudinal and Transverse Cracking, Low Severity (57) Weathering

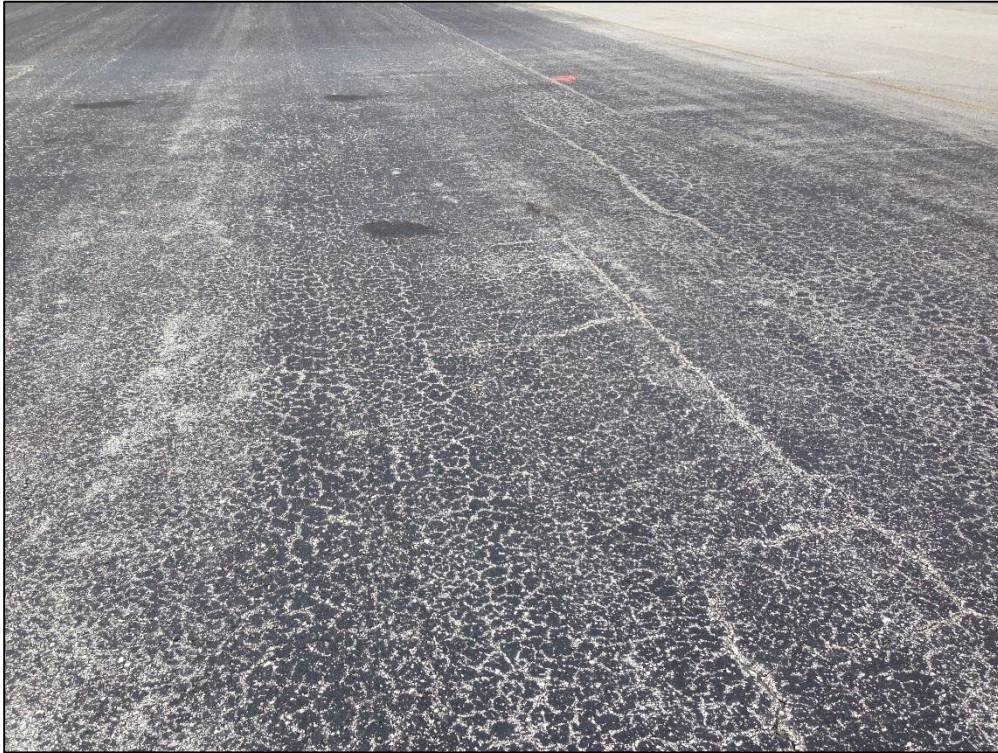
FBO Apron, Section 4305, Sample Unit 305 – Low Severity (43) Block Cracking, Low Severity (52) Raveling

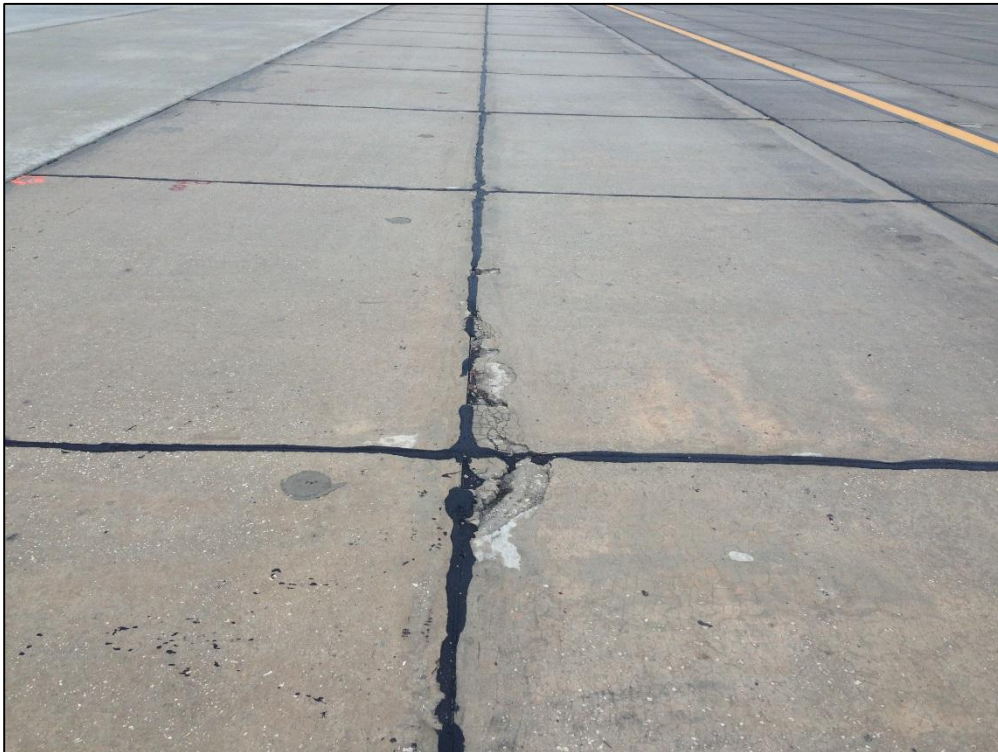
Apron SW, Section 4227, Sample Unit 510 – Low Severity (65) Joint Seal Damage, Low Severity (70) Scaling, Map Cracking, Cracking, Medium Severity (74) Joint Spalling, High Severity (74) Joint Spalling, High Severity (75) Corner Spalling

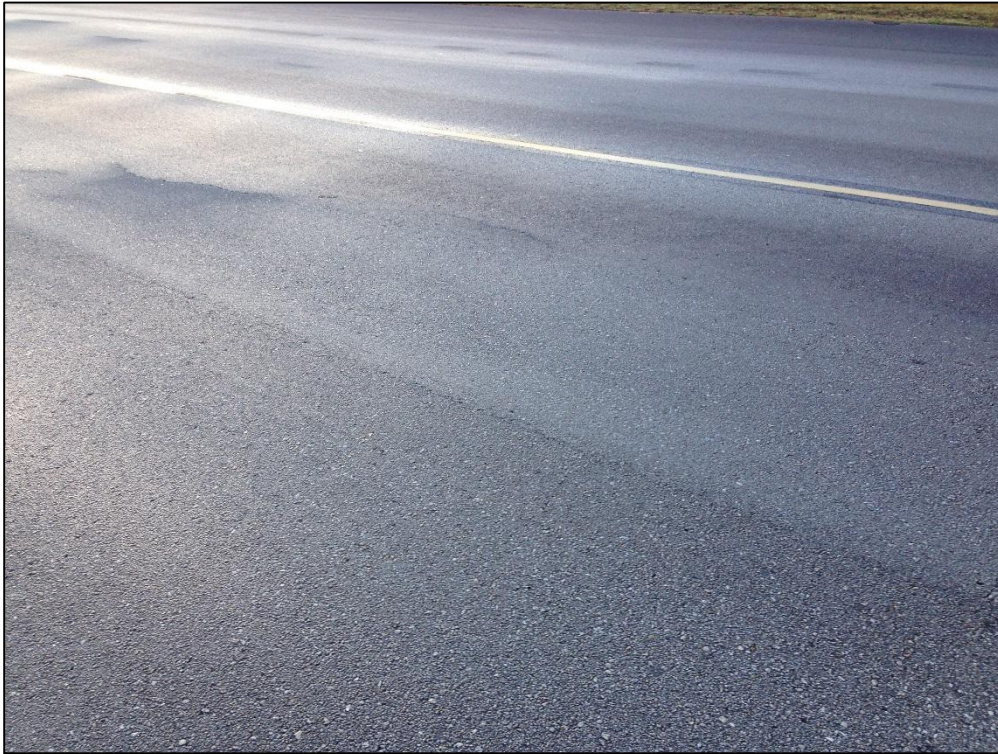
Taxiway Bravo, Section 204, Sample Unit 317 – Low Severity (48) Longitudinal and Transverse Cracking, Low Severity (57) Weathering

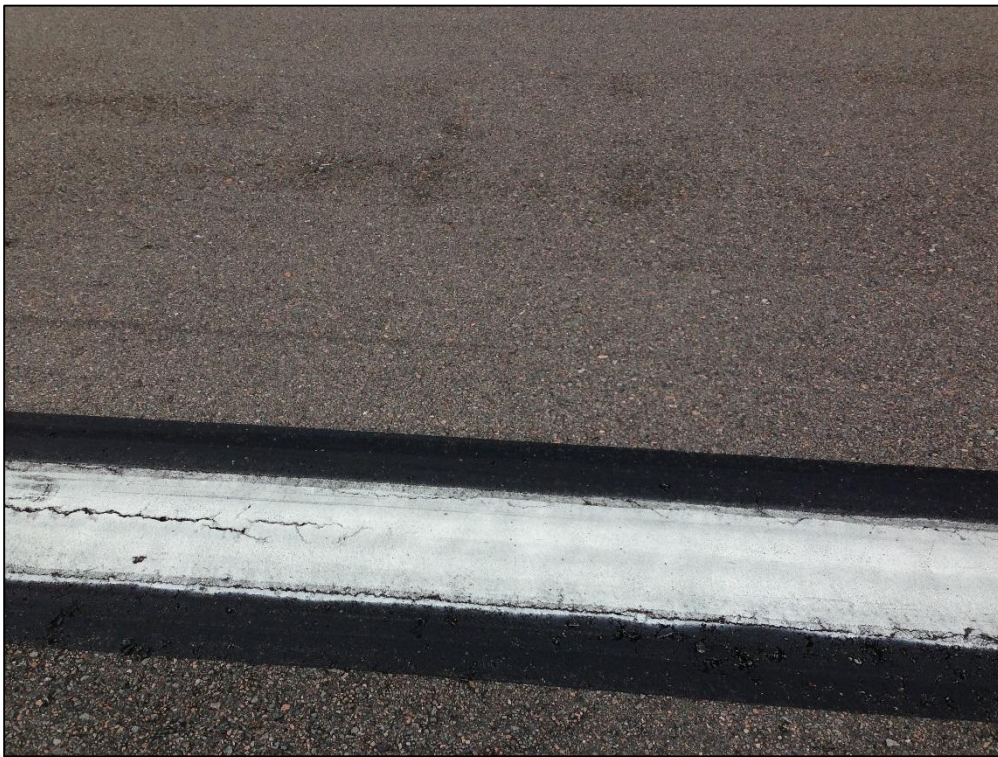
Runway 9C-27C, Section 6305, Sample Unit 104 – Low Severity (48) Longitudinal and Transverse Cracking, Low Severity (57) Weathering, Medium Severity (57) Weathering

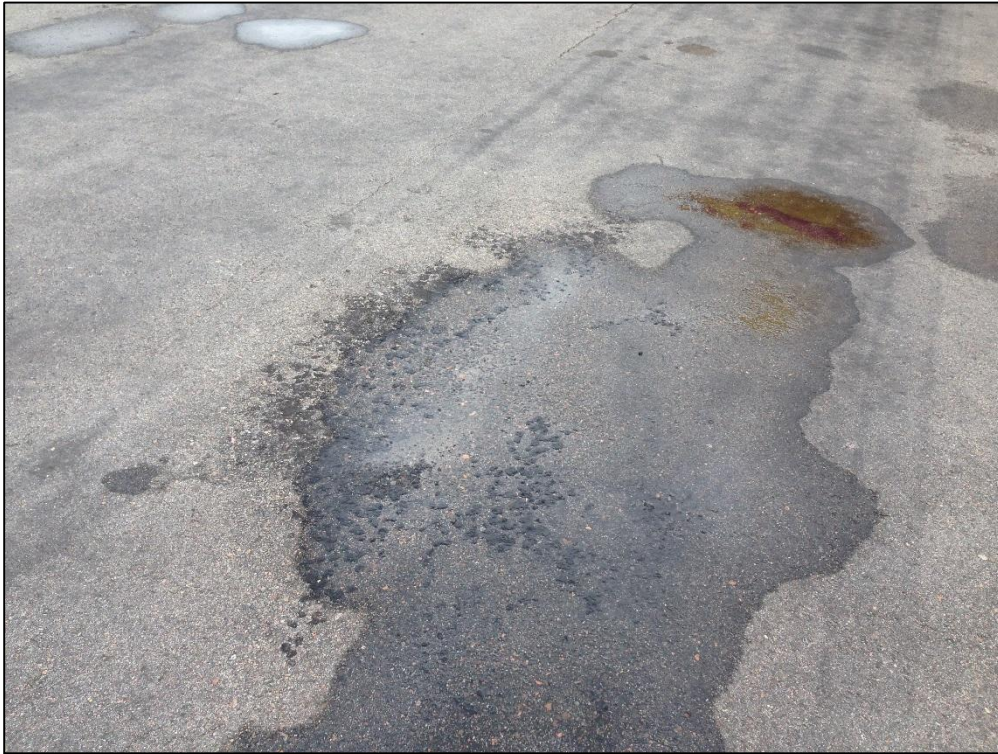
Apron North, Section 4310, Sample Unit 355 – (42) Bleeding, Low Severity (48) Longitudinal and Transverse Cracking, (49) Oil Spillage, Low Severity (57) Weathering

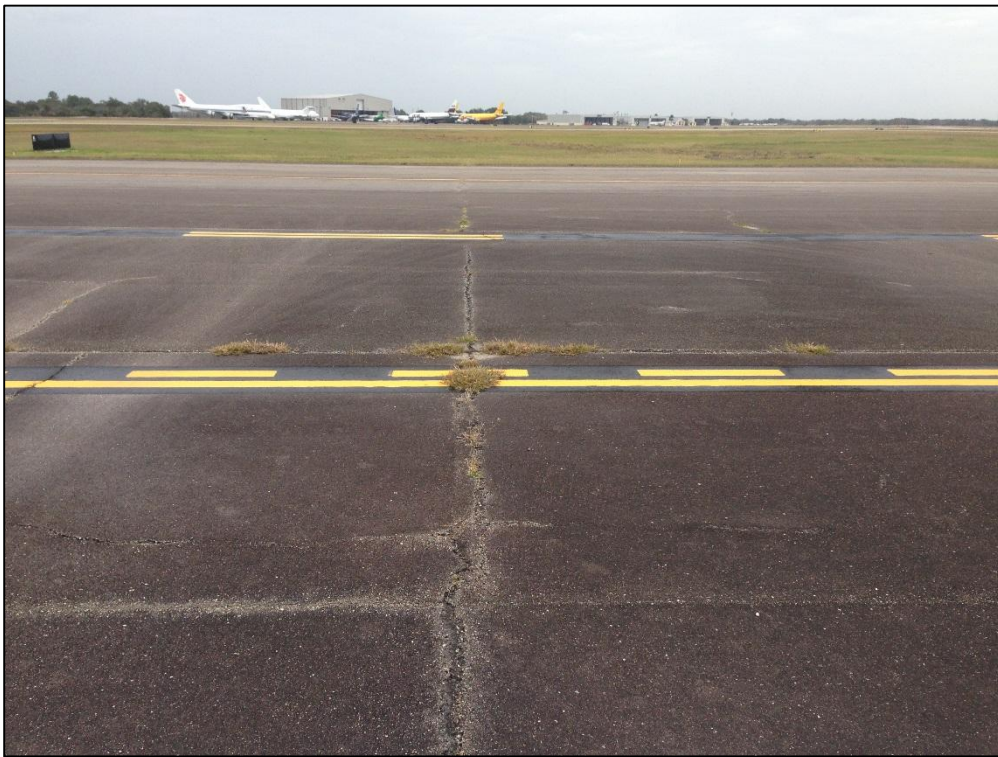
Apron Southwest, Section 4270, Sample Unit 100 – Low and Medium Severity (48) Longitudinal and Transverse Cracking, Low Severity (52) Raveling, Low Severity (57) Weathering
