**ALBERT WHITTED
AIRPORT (SPG)**

DISTRICT 7
REGIONAL RELIEVER
AIRPORT
JUNE 2015

STATEWIDE
**Airfield
Pavement
Management**
PROGRAM

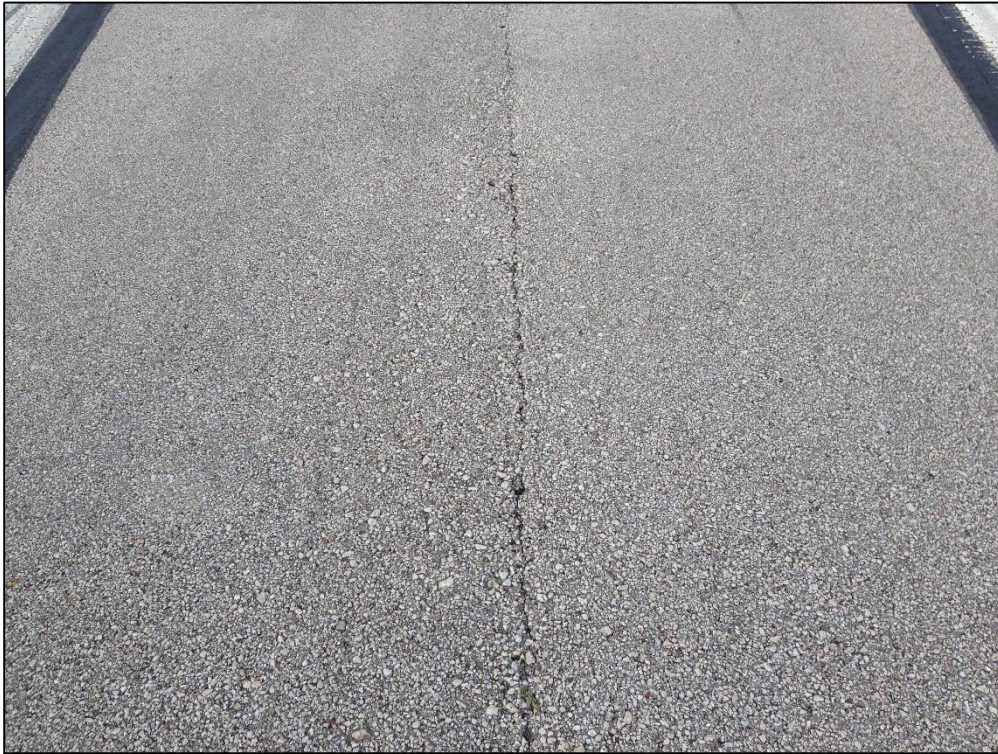
Runway 7-25, Section 6215, Sample Unit 101 – Low Severity (48) Longitudinal and Transverse Cracking, Low Severity (52) Raveling

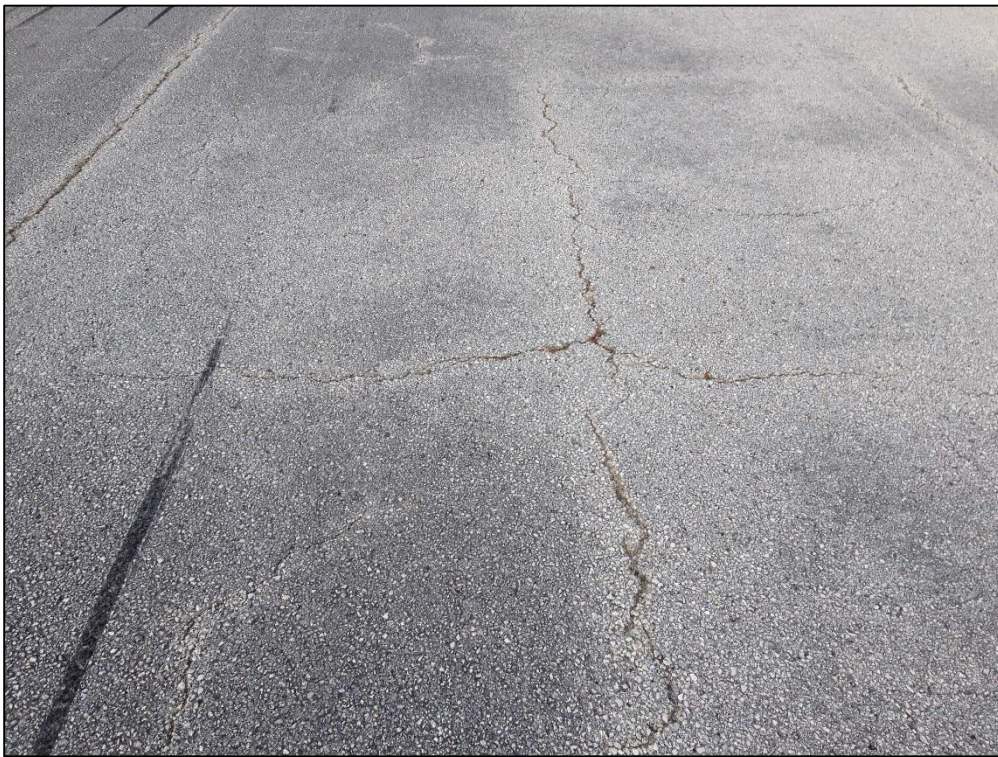
Runway 7-25, Section 6210, Sample Unit 114 – Low Severity (43) Block Cracking, Low Severity (48) Longitudinal and Transverse Cracking, Low Severity (52) Raveling

- ⦿ Runway 7-25 – Sections 6210, 6207, and 6205
 - Reconstruction and Mill and Overlay attributed to load, climate, and age of pavement.
- ⦿ Runway 18-36 – Sections 6110 and 6105
 - Mill and Overlay attributed to climate and age of pavement.
- ⦿ Apron – Sections 4145, 4135, 4120, and 4110
 - Mill and Overlay attributed to climate and age of pavement.
- ⦿ North Taxiway – Section 720
 - Mill and Overlay attributed to climate and age of pavement.
- ⦿ Taxiway A1 – Section 610
 - Reconstruction attributed to load, climate, and age of pavement.
- ⦿ Taxiway A2 – Section 410
 - Mill and Overlay attributed to climate and age of pavement.

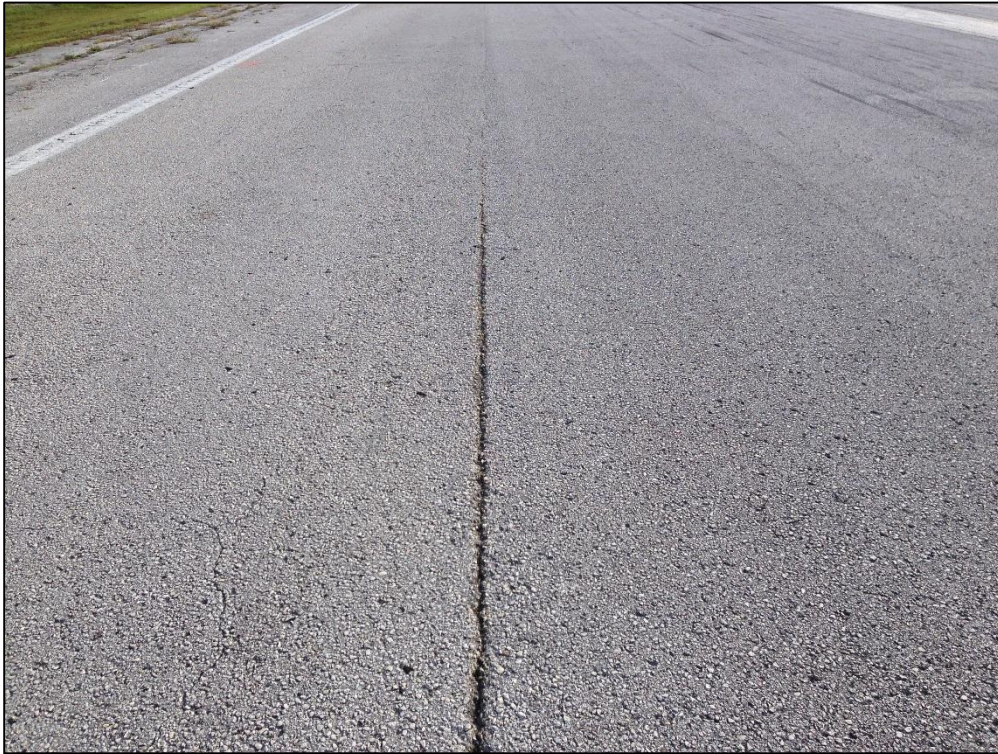
Runway 7-25, Section 6210, Sample Unit 151 – Low Severity (48) Longitudinal and Transverse Cracking, Medium Severity (48) Longitudinal and Transverse Cracking, Low Severity (52) Raveling

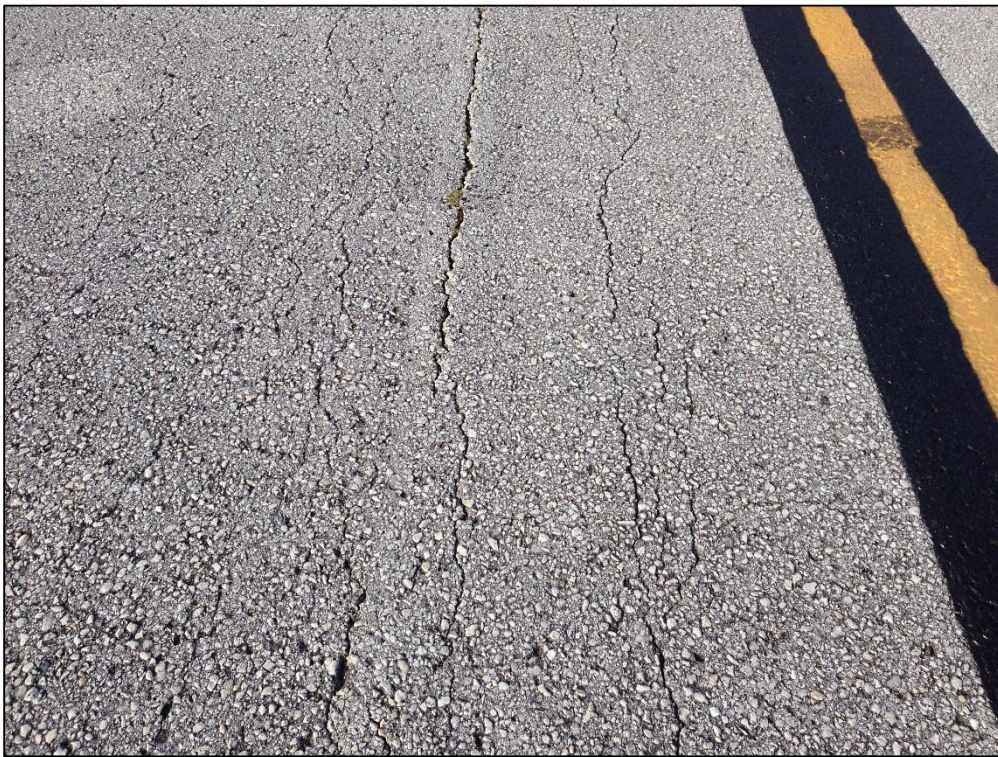
Runway 7-25, Section 6207, Sample Unit 166 – Low Severity (41) Alligator Cracking, Low Severity (48) Longitudinal and Transverse Cracking, Low Severity (52) Raveling

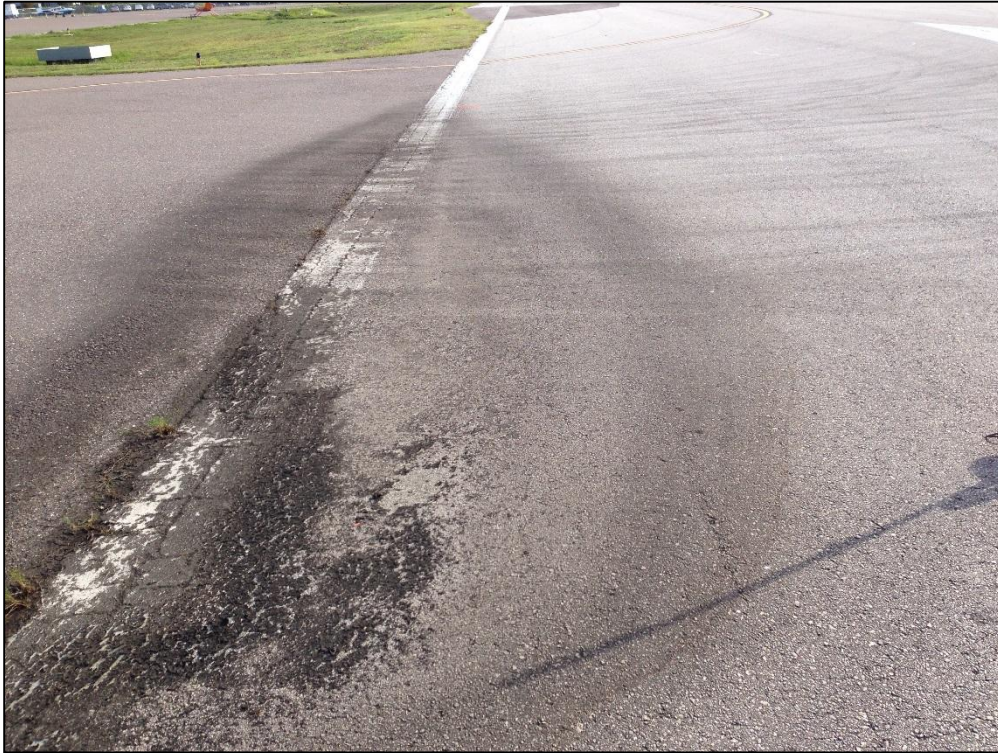
Runway 7-25, Section 6205, Sample Unit 173 – Low Severity (45) Depression, Low Severity (52) Raveling

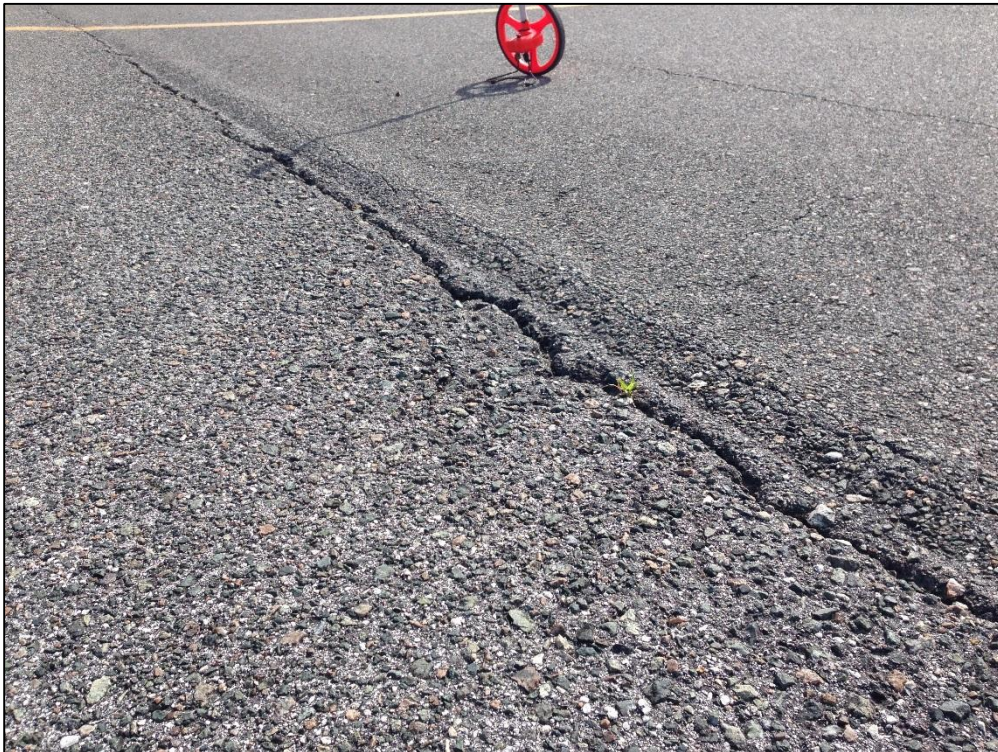
Taxiway Alpha, Section 105, Sample Unit 103 – Medium Severity (48) Longitudinal and Transverse Cracking, High Severity (48) Longitudinal and Transverse Cracking, Low Severity (52) Raveling, Low Severity (56) Swelling

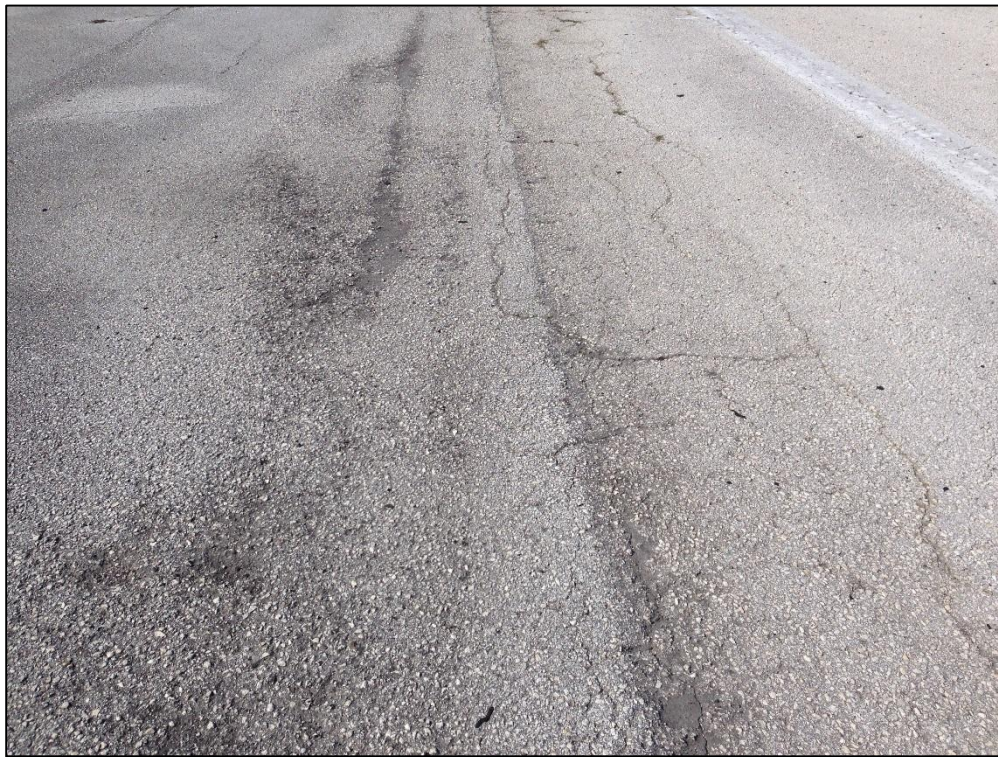
Taxiway Charlie, Section 310, Sample Unit 101 – Low Severity (43) Block Cracking, Low Severity (48) Longitudinal and Transverse Cracking, Low Severity (52) Raveling, Medium Severity (52) Raveling

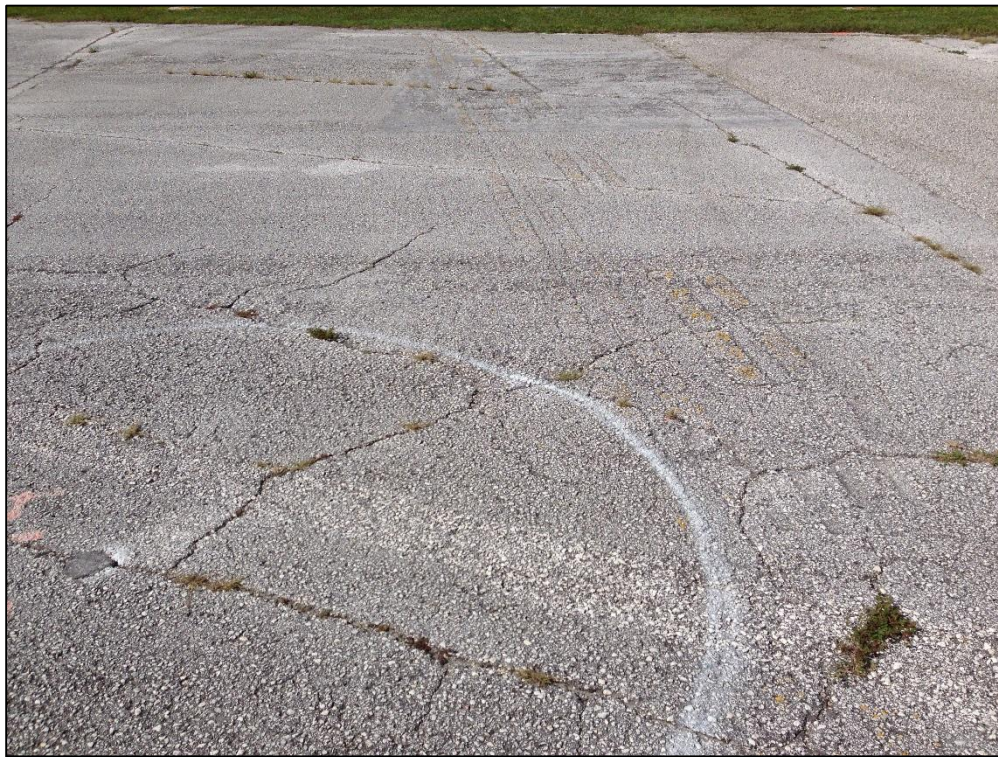
Taxiway A1, Section 610, Sample Unit 101 – Low Severity (43) Block Cracking, Low Severity (50) Patching, Low Severity (52) Raveling, Medium Severity (52) Raveling

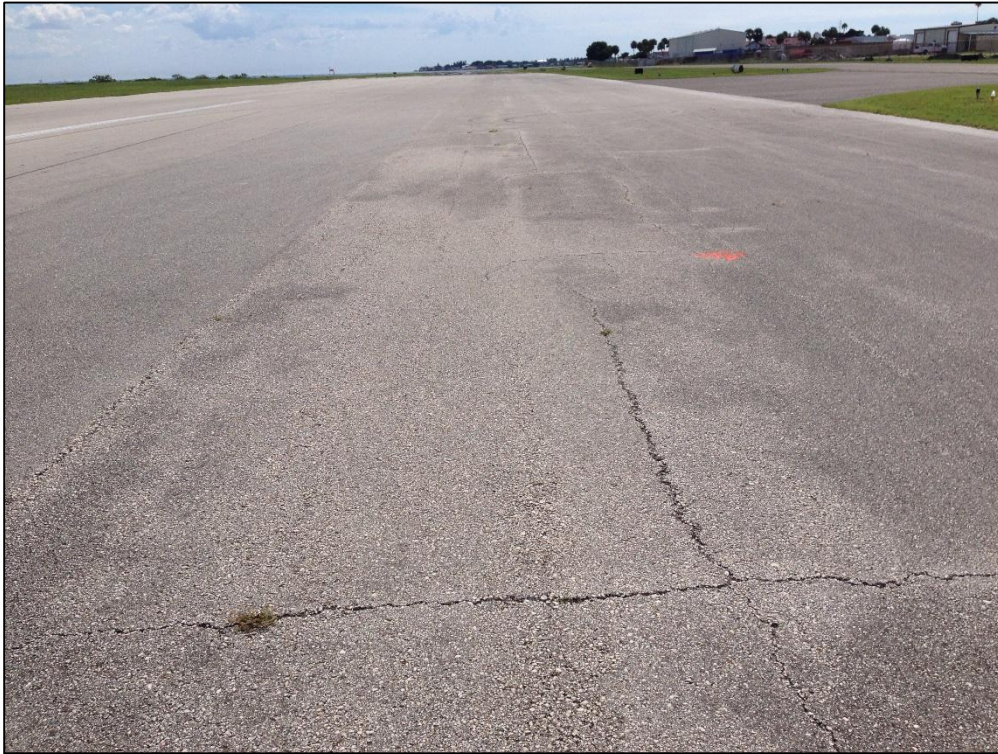
Runway 18-36, Section 6105, Sample Unit 330 – Low Severity (43) Block Cracking, Low Severity (48) Longitudinal and Transverse Cracking, Low Severity (52) Raveling

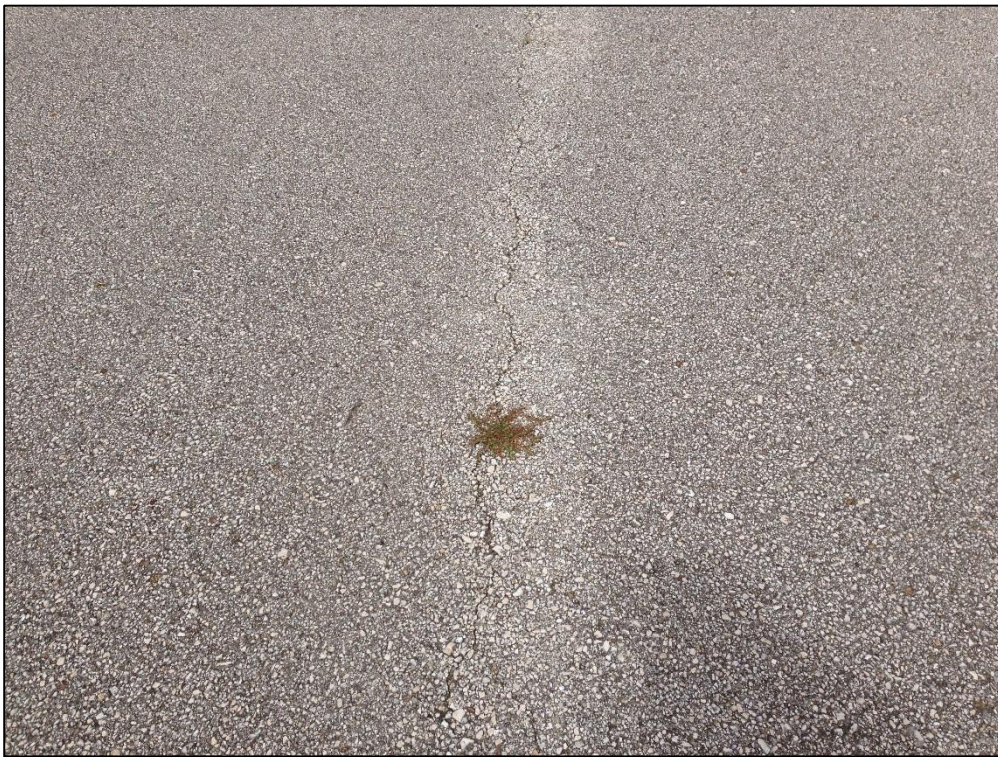
Runway 18-36, Section 6110, Sample Unit 504 – Low Severity (48) Longitudinal and Transverse Cracking, Low Severity (52) Raveling

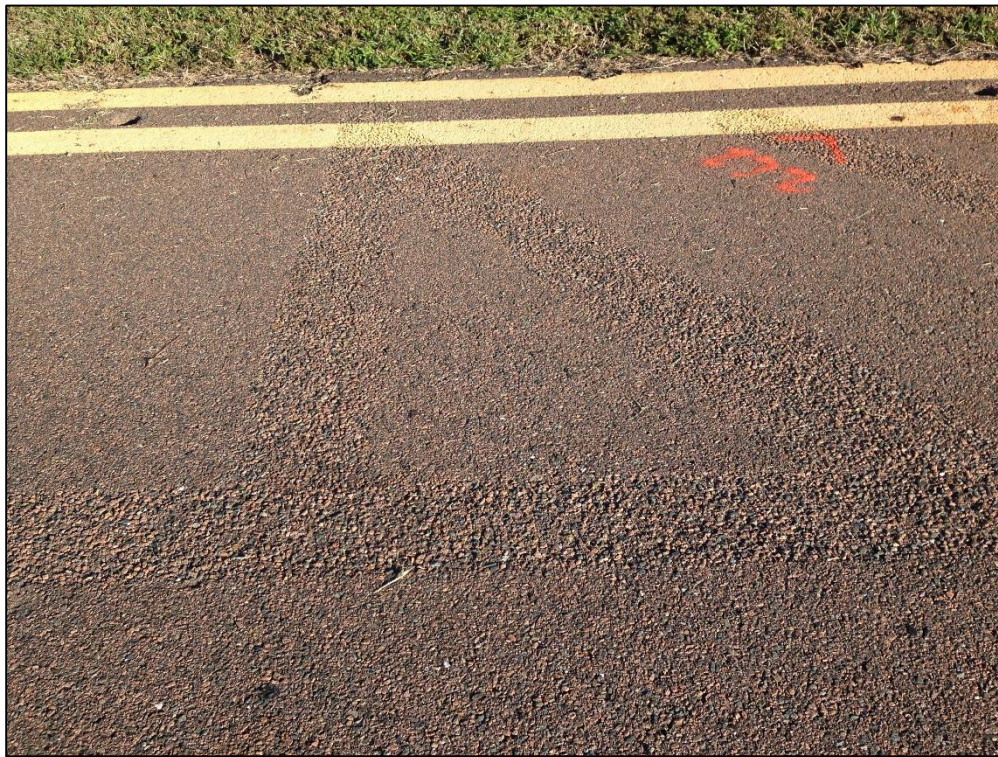
Taxiway Delta, Section 510, Sample Unit 232 – Low Severity (52) Raveling

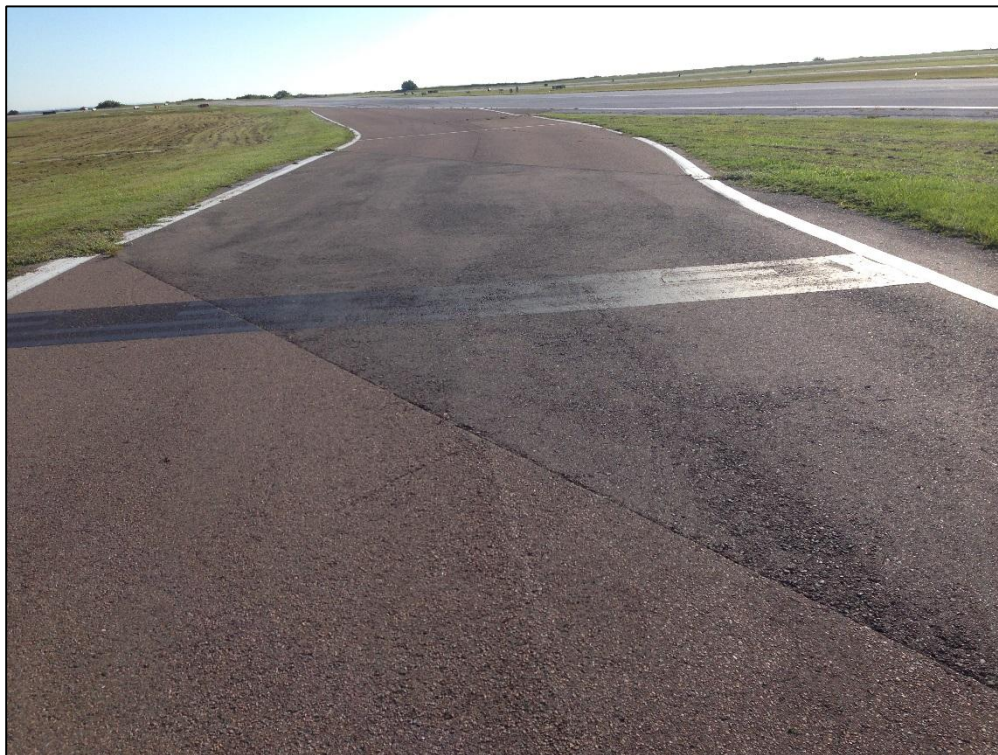
Taxiway November, Section 720, Sample Unit 103 – Low Severity (48) Longitudinal and Transverse Cracking, Low Severity (50) Patching, Low Severity (52) Raveling

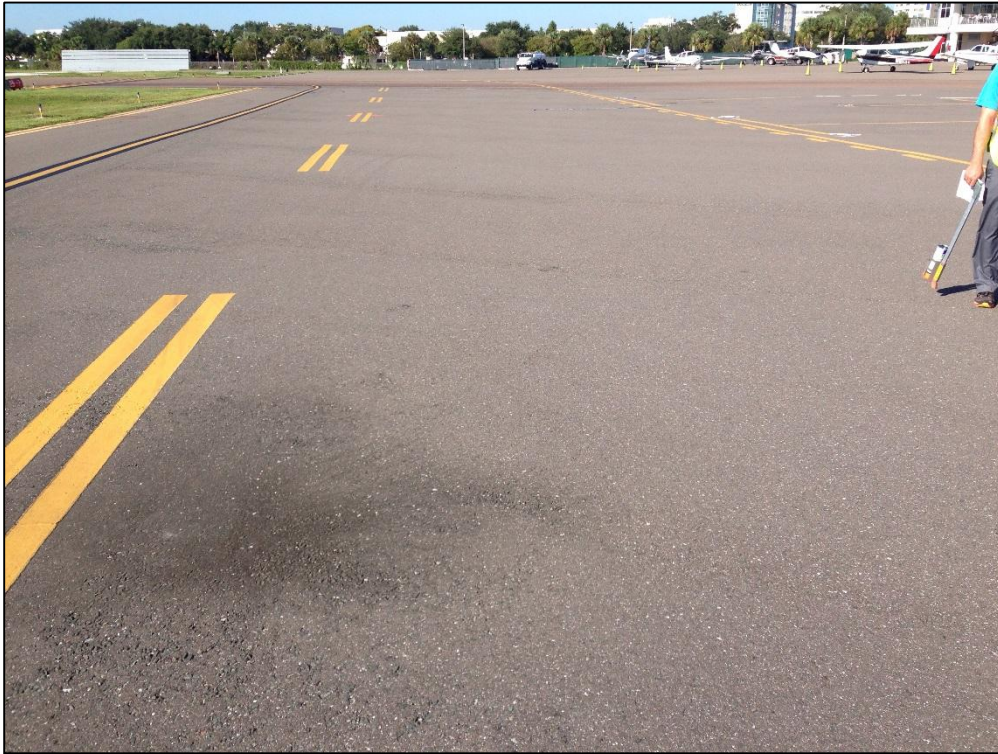
Apron NW, Section 4315, Sample Unit 249 – Low Severity (45) Depression, Low Severity (57) Weathering

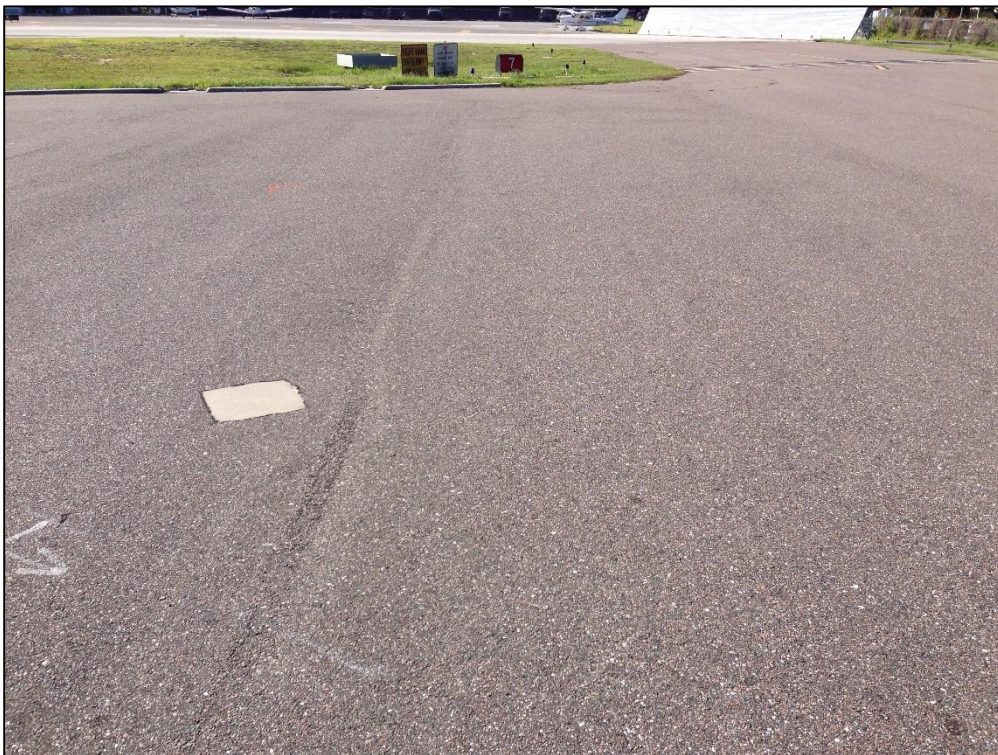
Apron NW, Section 4310, Sample Unit 603 – Low Severity (56) Swelling, Low Severity (57) Weathering

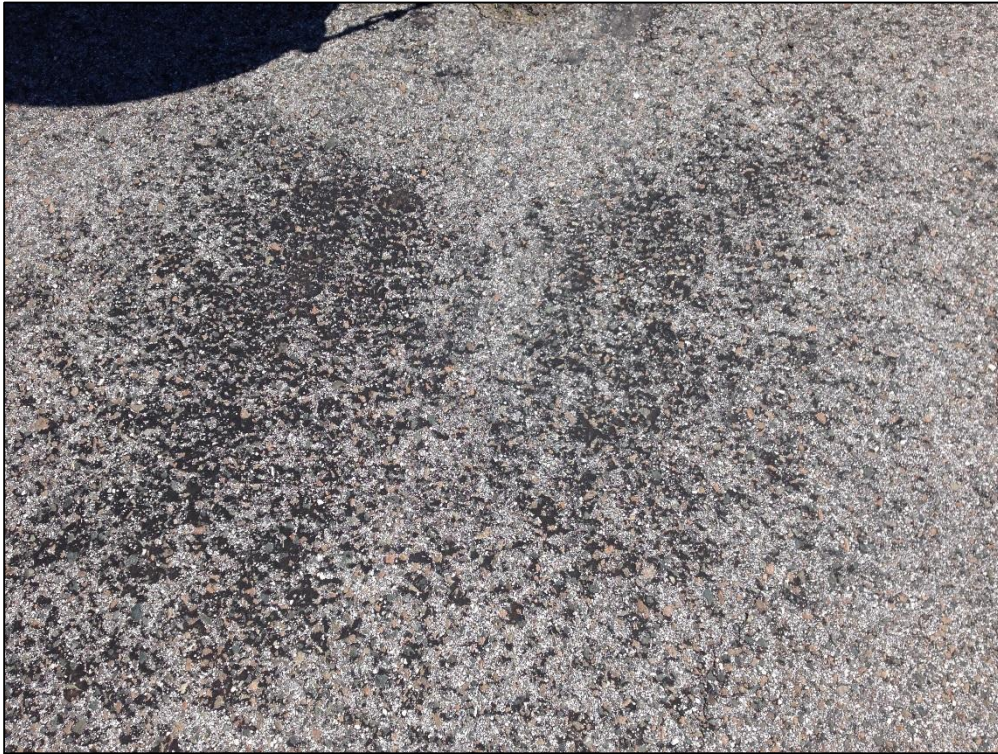
Apron, Section 4110, Sample Unit 204 – (42) Bleeding, Low Severity (52) Raveling

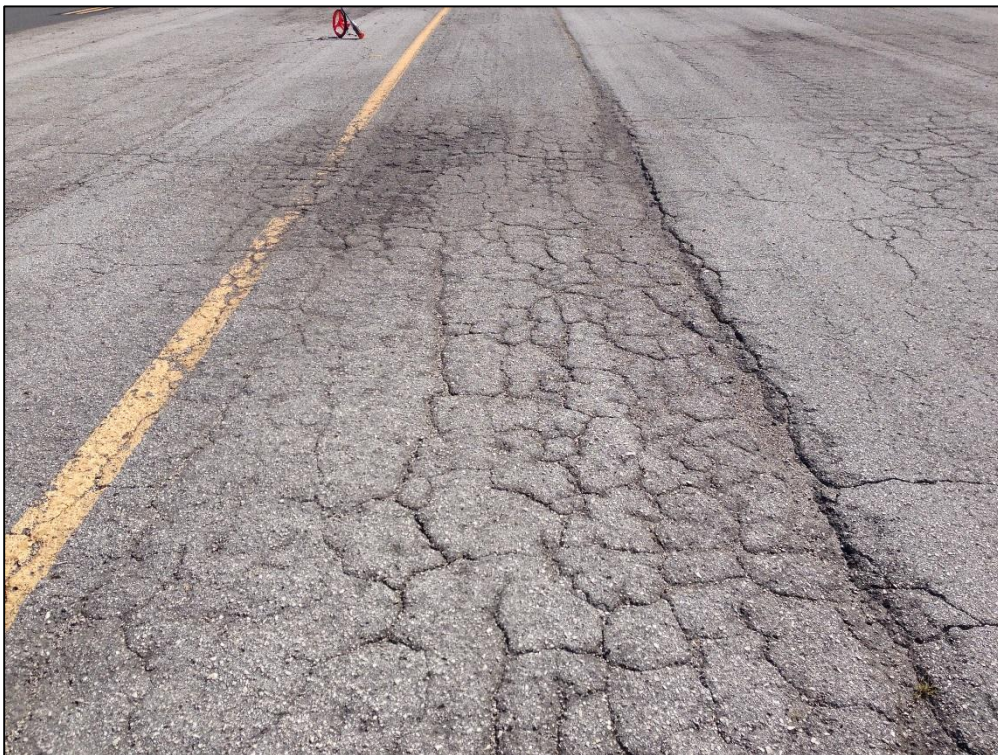
Taxiway Charlie, Section 305, Sample Unit 107 – Medium Severity (41) Alligator Cracking, Medium Severity (45) Depression, Low Severity (52) Raveling, Medium Severity (52) Raveling, High Severity (52) Raveling
