**SPACE COAST
REGIONAL AIRPORT
(TIX)**

JUNE 2015

STATEWIDE
**Airfield
Pavement
Management**
PROGRAM

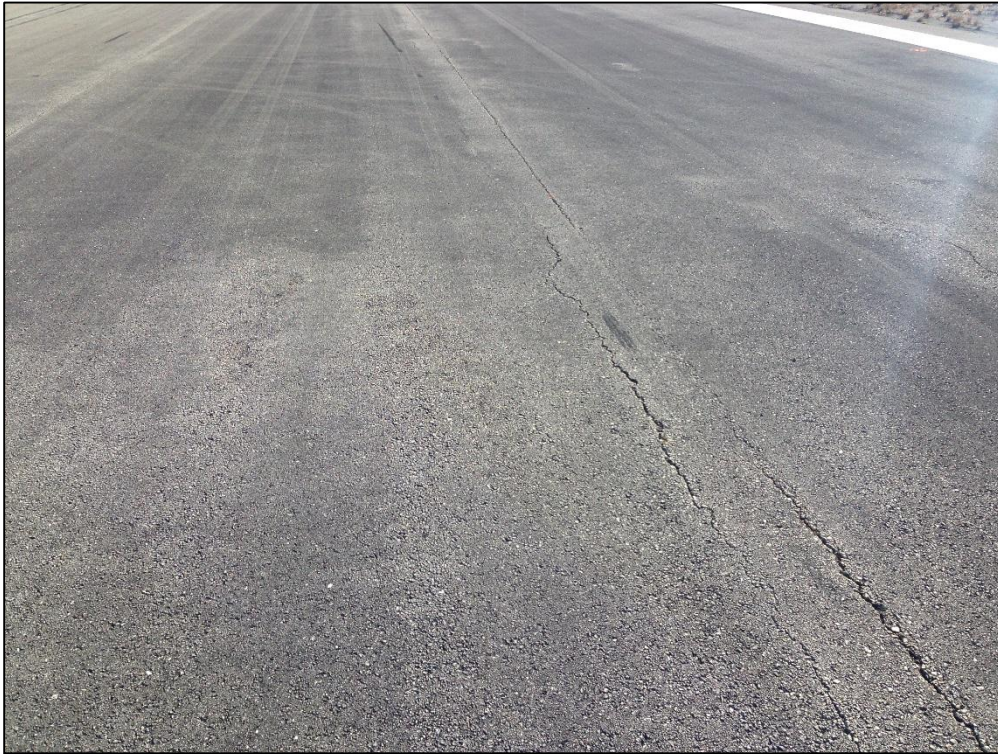
Runway 9-27, Section 6210, Sample Unit 130 – Low Severity (48) Longitudinal and Transverse Cracking, Low Severity (52) Raveling, Low Severity (56) Swelling, Low Severity (57) Weathering, Medium Severity (57) Weathering

- Runway 9-27 – Sections 6205 and 6210
 - Mill and Overlay attributed to climate and age of pavement.
- South Apron – Sections 4205 and 4215
 - Mill and Overlay attributed to climate and age of pavement.
- Taxiway F – Section 605
 - Reconstruction attributed to load, climate, and age of pavement.
- Taxiway B – Section 205
 - Mill and Overlay attributed to climate and age of pavement.

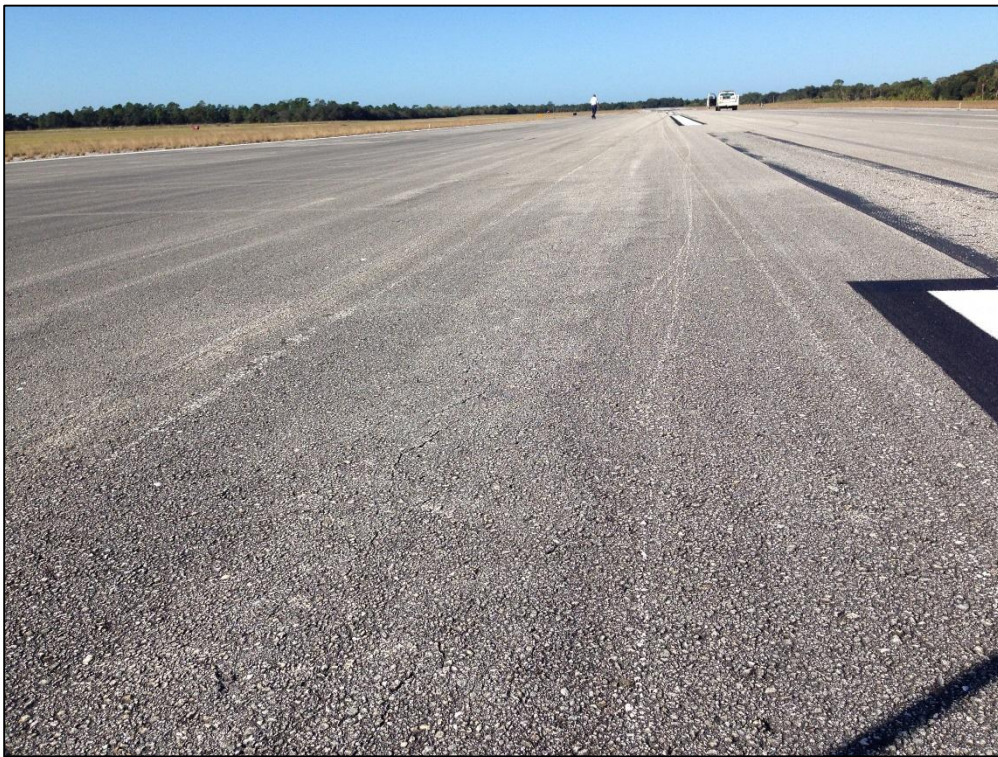
Runway 9-27, Section 6210, Sample Unit 136 – Low Severity (48) Longitudinal and Transverse Cracking, Low Severity (52) Raveling, Low Severity (56) Swelling, Medium Severity (57) Weathering

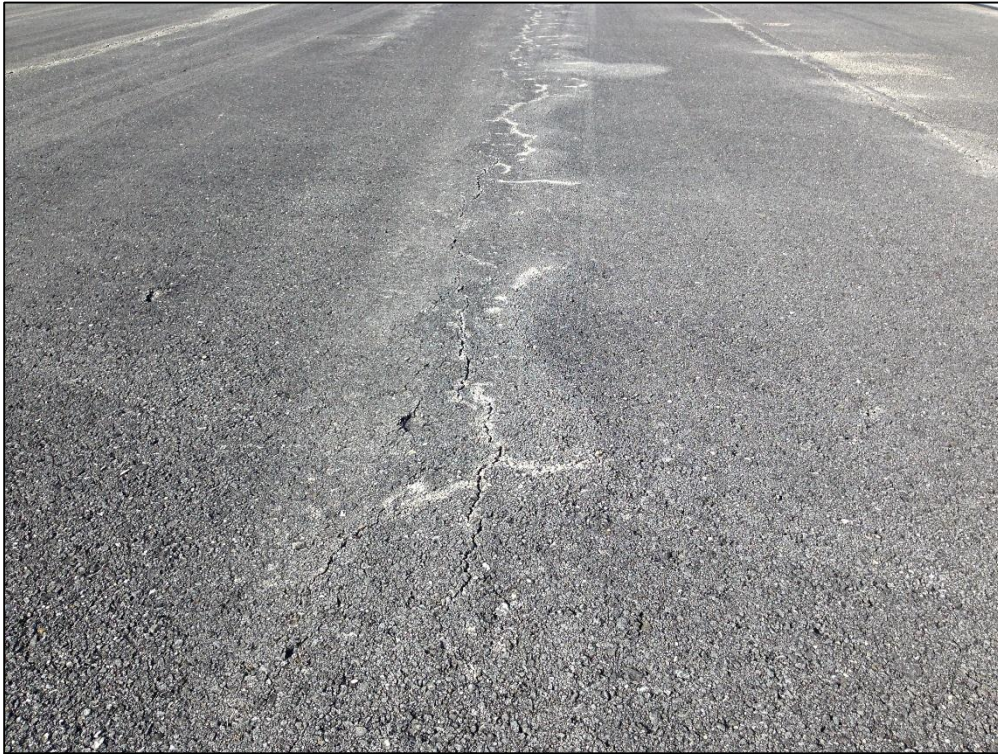
Runway 9-27, Section 6210, Sample Unit 155 – Low Severity (48) Longitudinal and Transverse Cracking, Low Severity (52) Raveling, Low Severity (56) Swelling, Medium Severity (57) Weathering

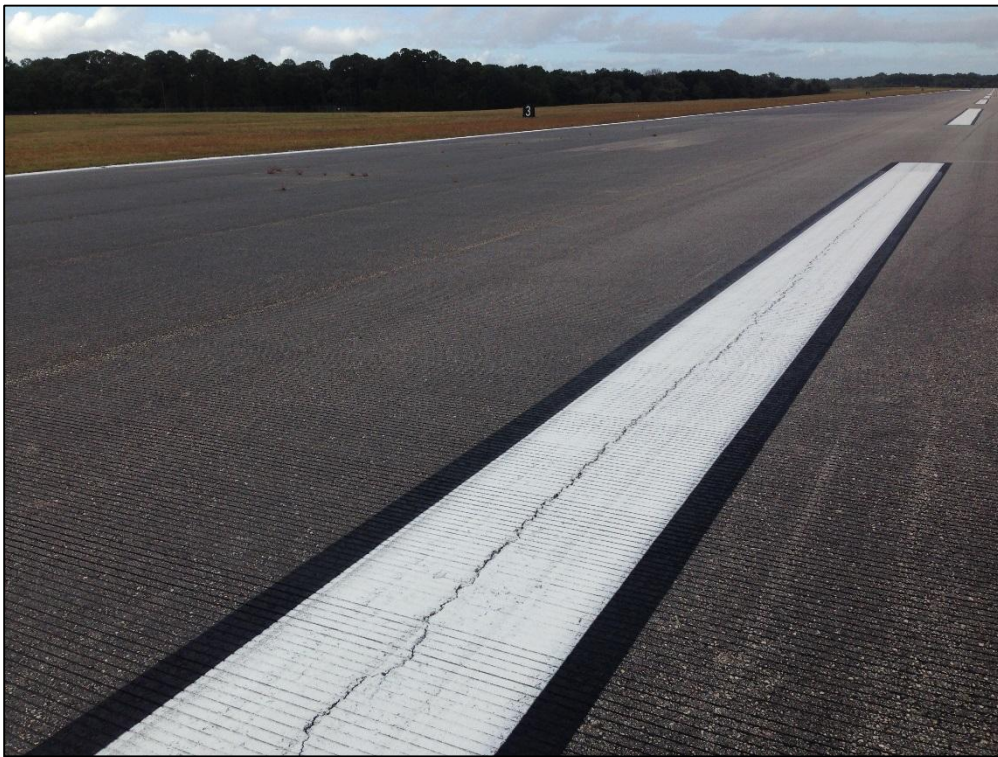
Runway 18-36, Section 6105, Sample Unit 380 – Low Severity (48) Longitudinal and Transverse Cracking, Low Severity (52) Raveling, Low Severity (57) Weathering, Medium Severity (57) Weathering

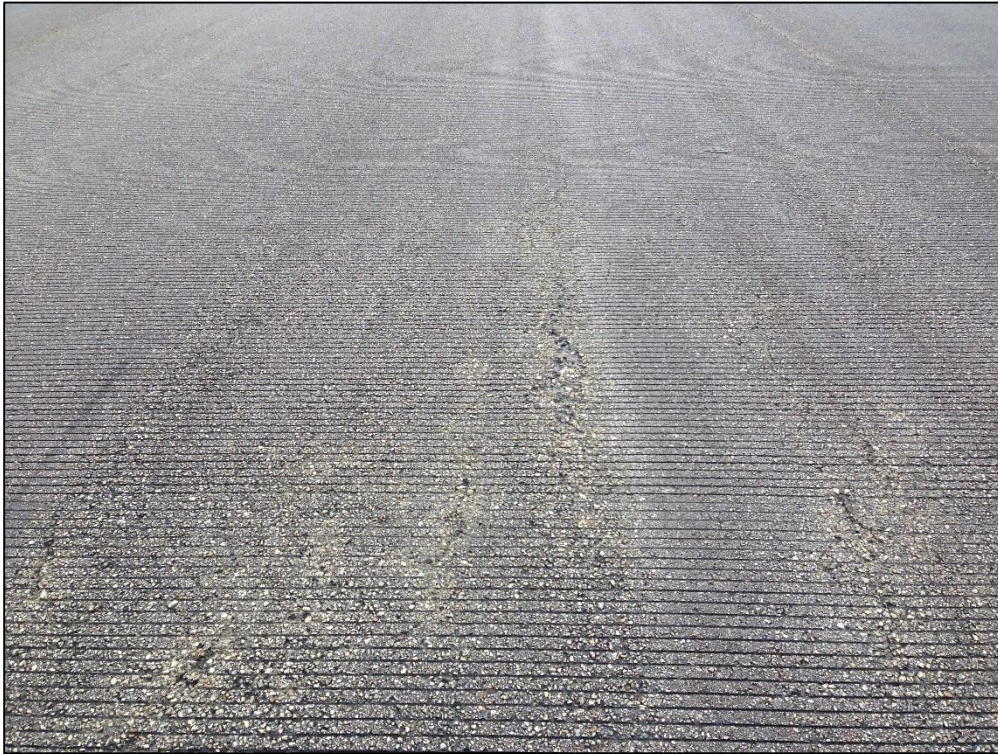
Runway 18-36, Section 6105, Sample Unit 360 – Low Severity (48) Longitudinal and Transverse Cracking, Medium Severity (52) Raveling

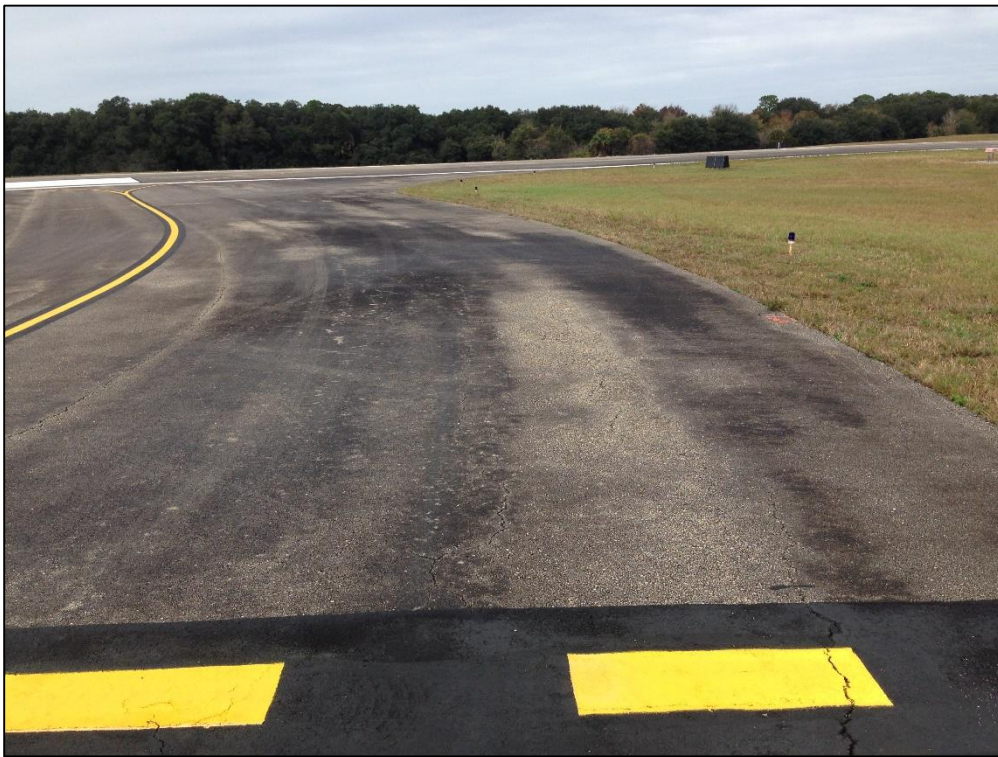
Taxiway Alpha, Section 120, Sample Unit 162 – Low Severity (48) Longitudinal and Transverse Cracking, Low Severity (52) Raveling, Low Severity (56) Swelling, Medium Severity (57) Weathering

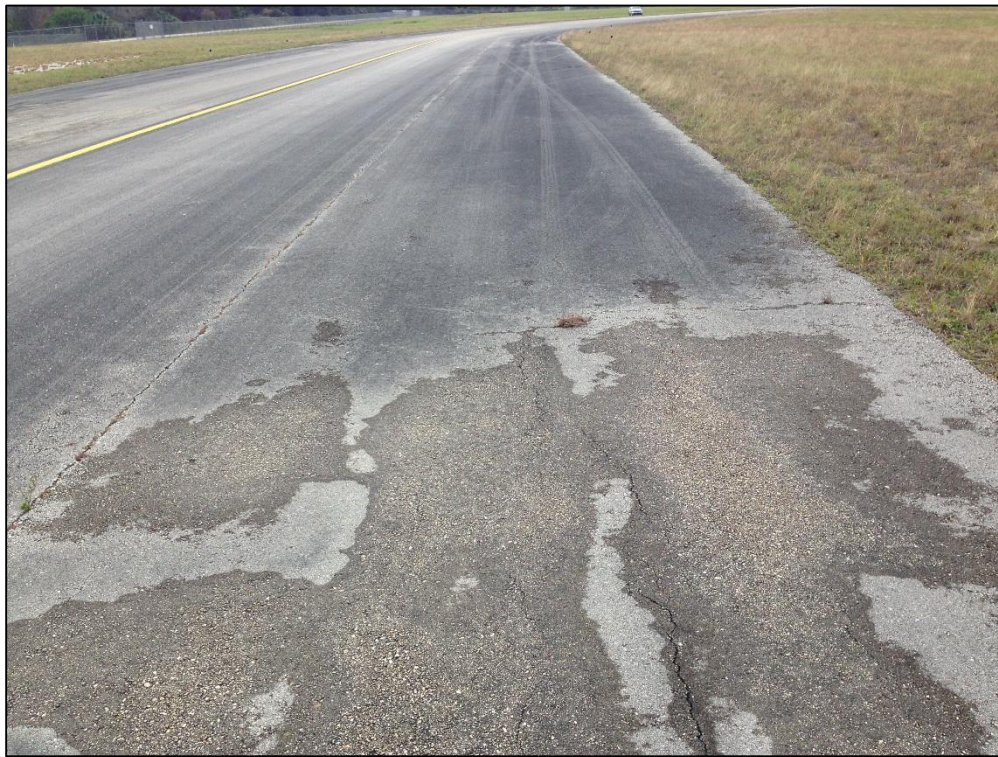
Taxiway Alpha, Section 105, Sample Unit 108 – Low Severity (48) Longitudinal and Transverse Cracking, Low Severity (56) Swelling, Medium Severity (57) Weathering

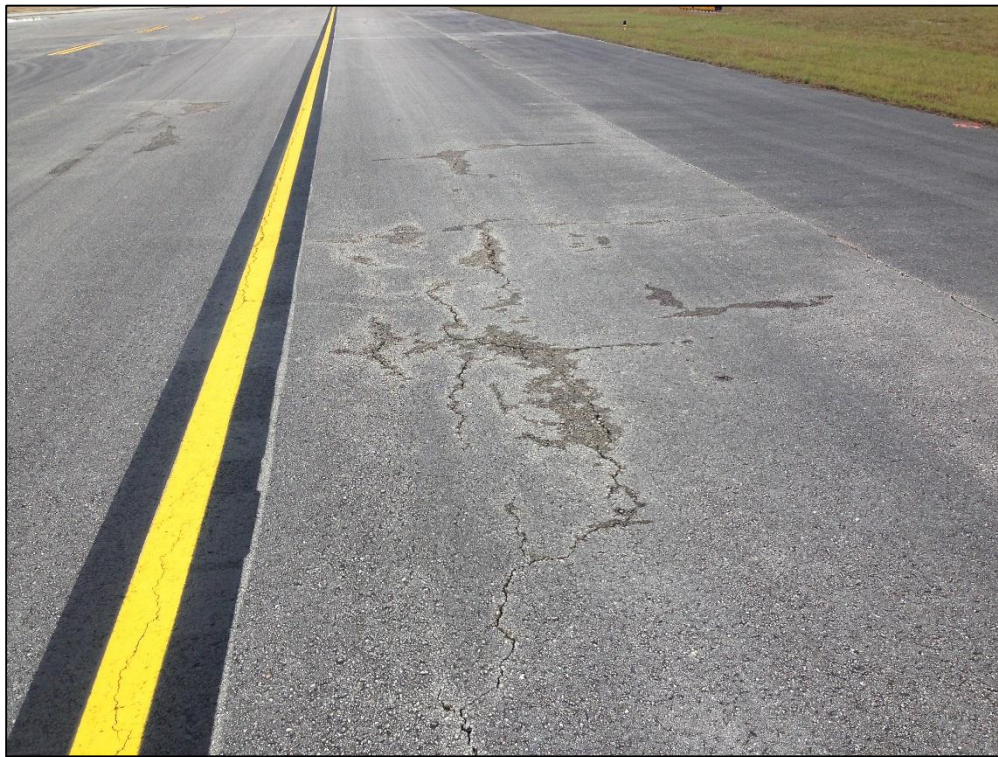
Taxiway Alpha, Section 110, Sample Unit 127 – Low Severity (43) Block Cracking, Low Severity (48) Longitudinal and Transverse Cracking, Medium Severity (57) Weathering

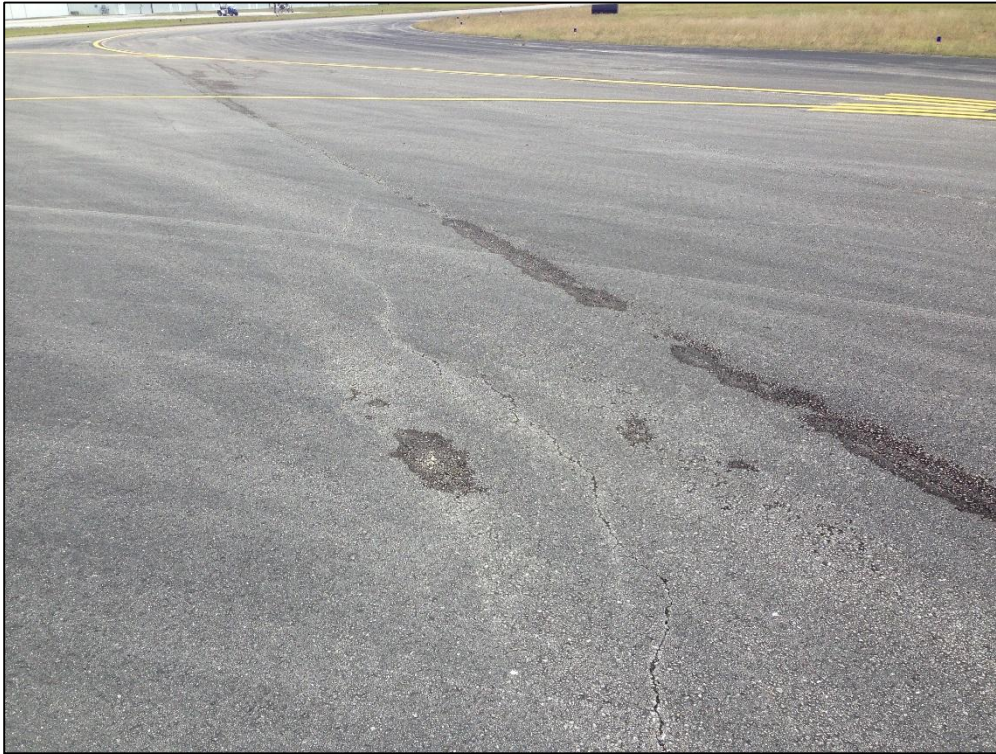
Taxiway Charlie, Section 305, Sample Unit 704 – Low Severity (48) Longitudinal and Transverse Cracking, Low Severity (50) Patching, Low Severity (52) Raveling, Medium Severity (57) Weathering

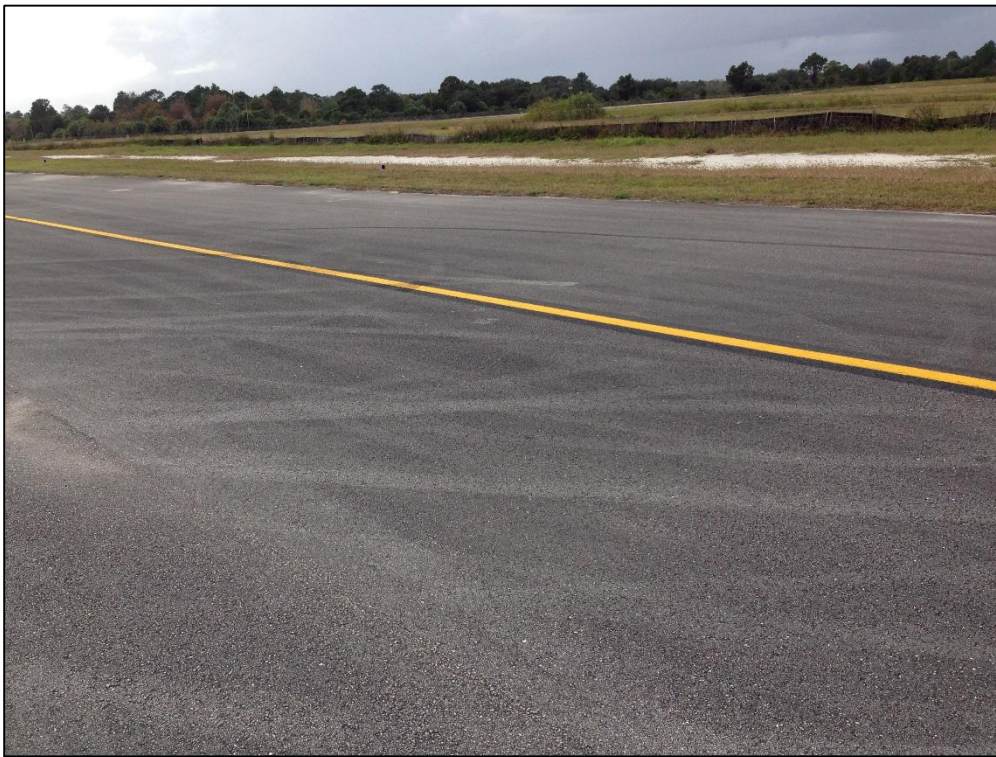
Taxiway Delta, Section 410, Sample Unit 414 – Medium Severity (57) Weathering

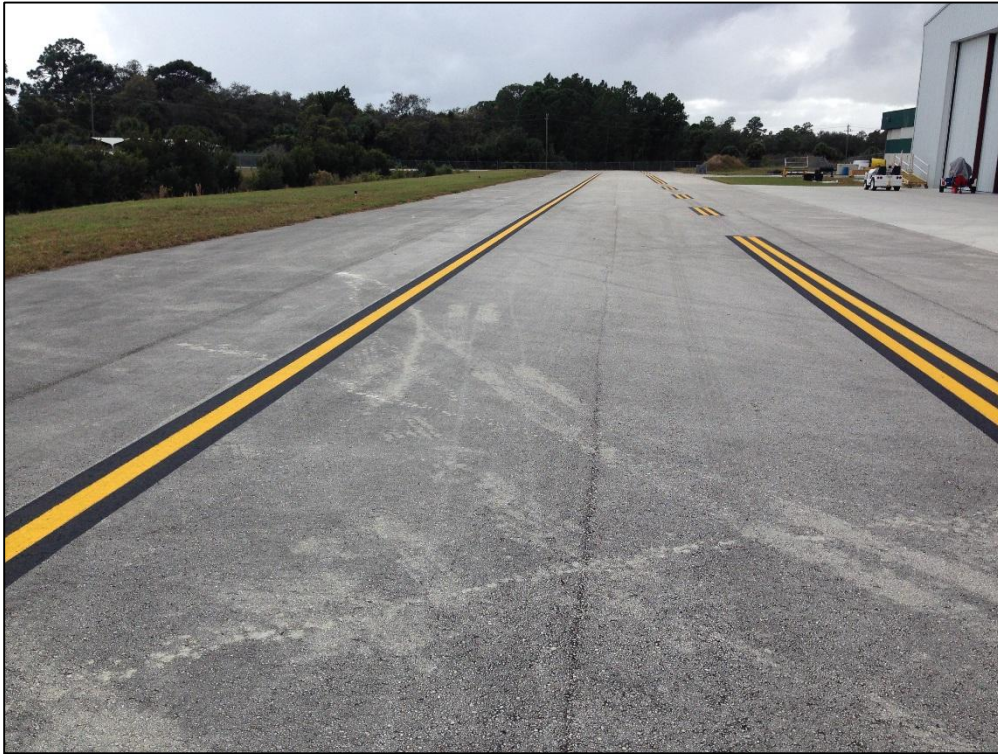
Taxiway Echo, Section 515, Sample Unit 628 – Medium Severity (57) Weathering

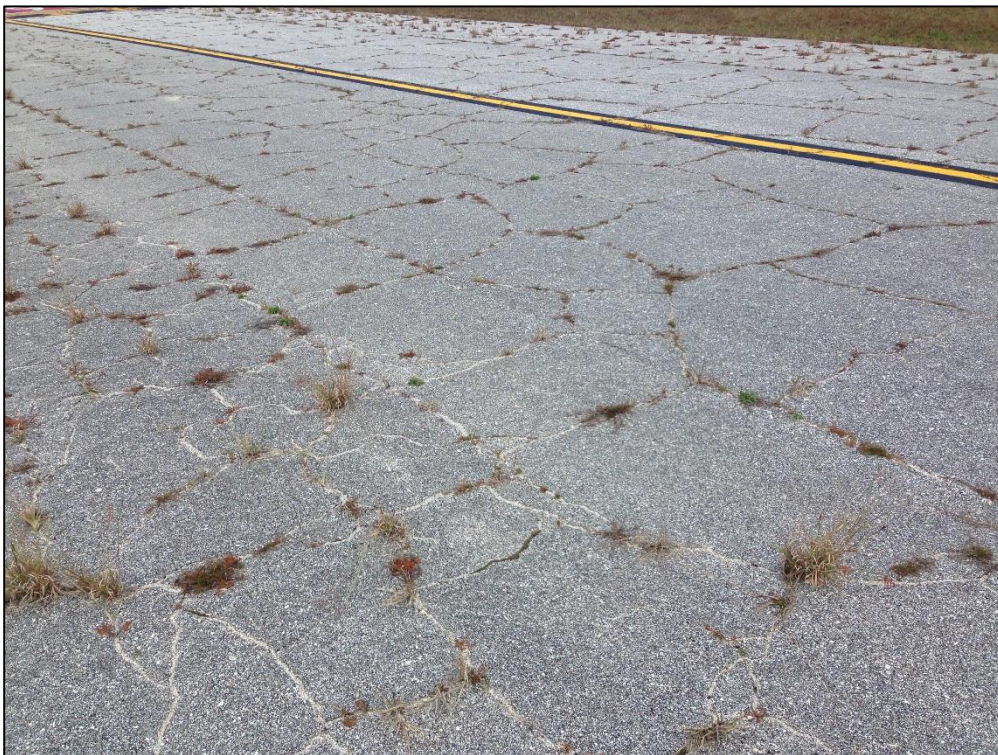
Taxiway Foxtrot, Section 605, Sample Unit 301 – Medium Severity (43) Block Cracking, Medium Severity (52) Raveling

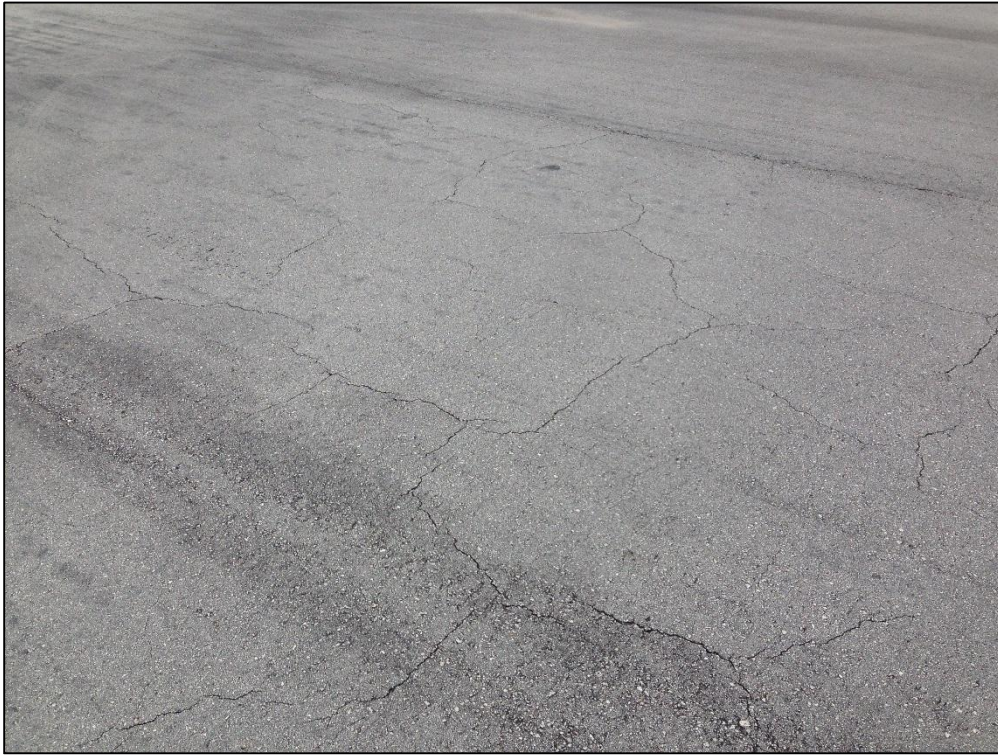
Apron South, Section 4205, Sample Unit 150 – Low Severity (43) Block Cracking, Low Severity (57) Weathering
