FLORIDA DEPARTMENT OF TRANSPORTATION
AVIATION AND SPACEPORT OFFICE

**TALLAHASSEE
REGIONAL AIRPORT
(TLH)**

JUNE 2015

STATEWIDE
**Airfield
Pavement
Management**
PROGRAM

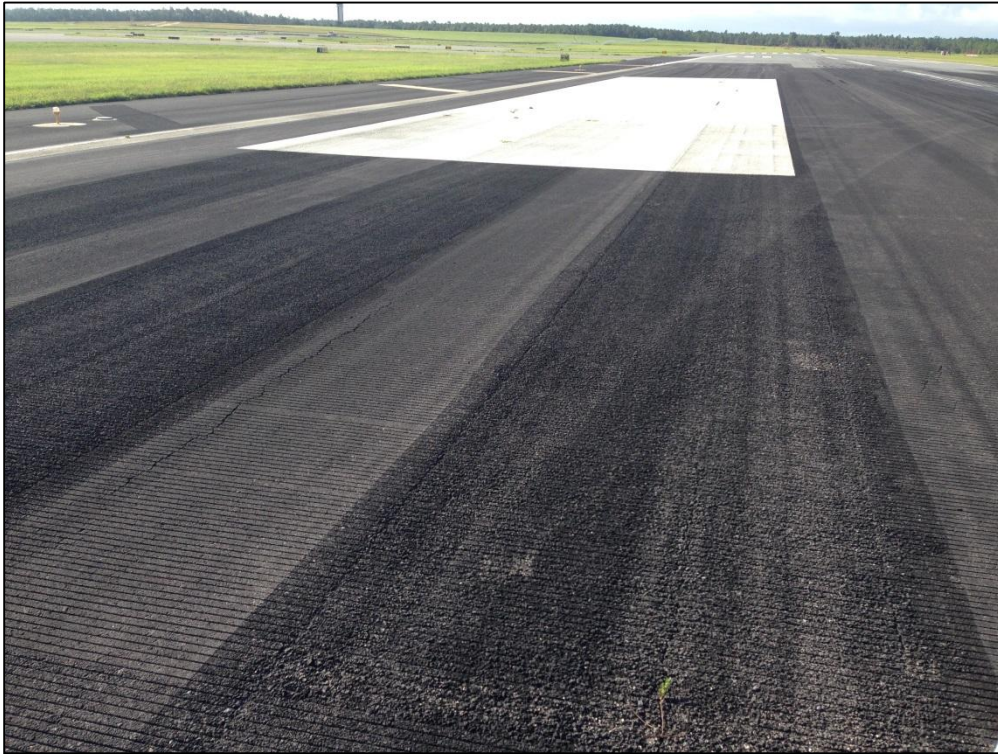
Runway 18-36, Section 6105, Sample Unit 311 – Medium Severity (52) Raveling, Low Severity (52) Raveling, Low Severity (57) Weathering, Low Severity (48) Longitudinal and Transverse Cracking

- ⦿ Runway 18-36 – Section 6105
 - Mill and Overlay attributed to load, climate, and age of pavement.
- ⦿ General Aviation Apron – Sections 4305, 4310, 4320, 4325, 4330, and 4332
 - Reconstruction and Mill and Overlay attributed to load, climate and age of pavement.
- ⦿ Taxiway Whiskey – Section 2310
 - Mill and Overlay attributed to load, climate and age of pavement.
- ⦿ Taxiway Sierra – Section 1905
 - Mill and Overlay attributed to climate and age of pavement.
- ⦿ Taxiway Romeo to Hangars – Sections 1810 and 1820
 - Mill and Overlay attributed to climate and age of pavement.
- ⦿ Taxiway Lima – Section 1215
 - Mill and Overlay attributed to climate and age of pavement.

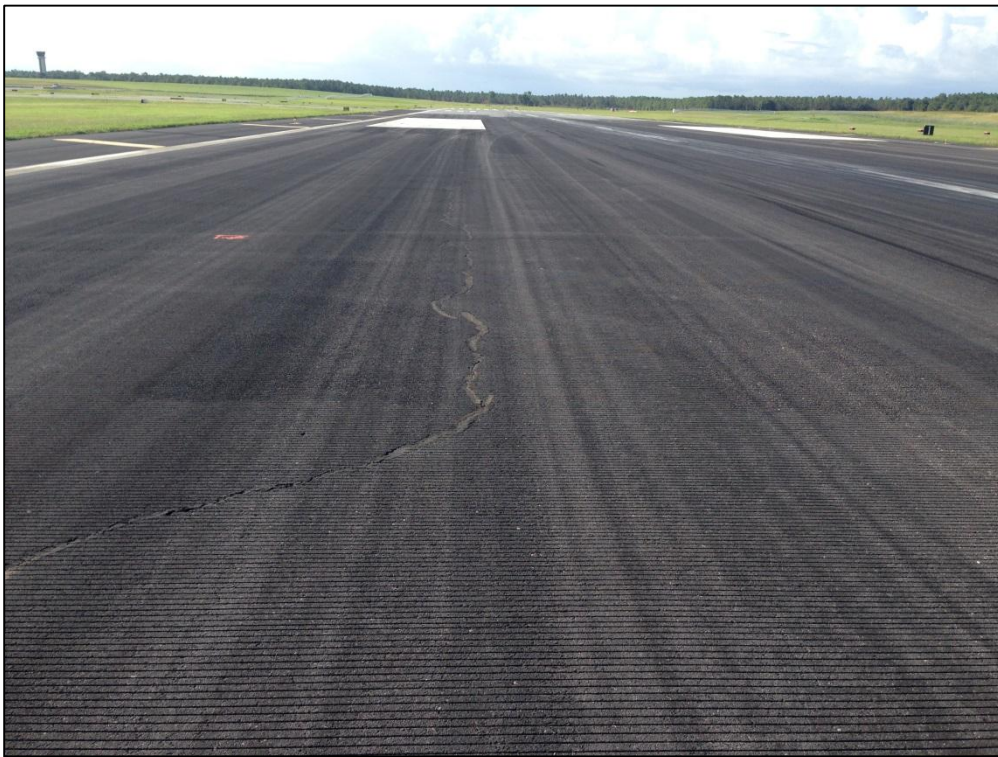
Runway 18-36, Section 6105, Sample Unit 315 – Medium Severity (48) Longitudinal and Transverse Cracking, Low Severity (52) Raveling, Low Severity (57) Weathering

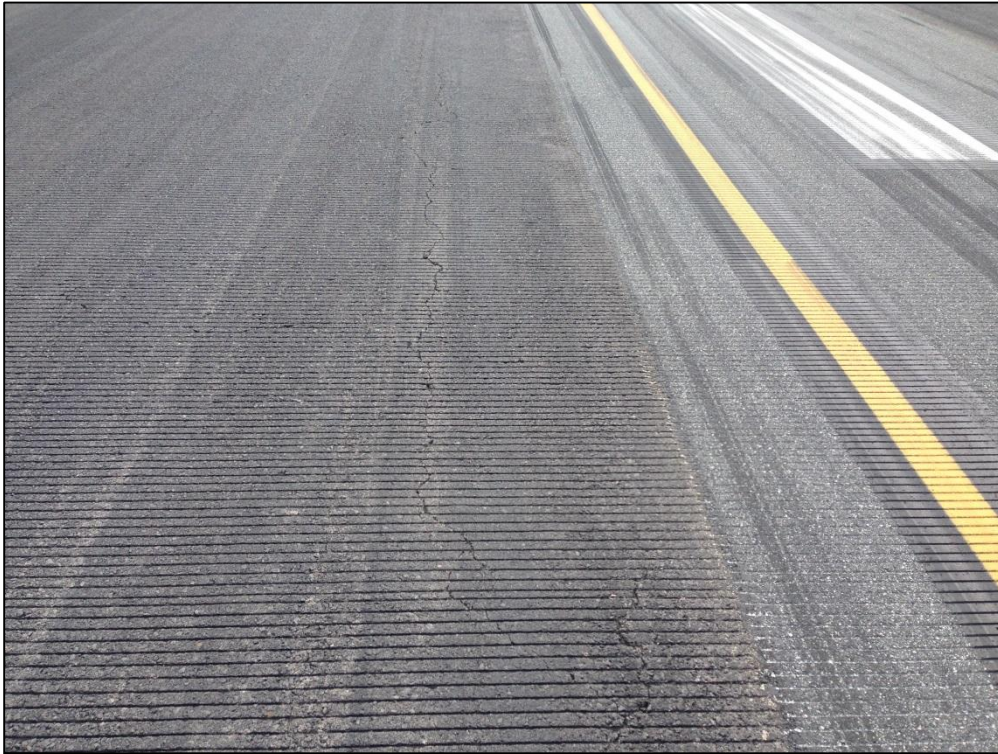
Runway 18-36, Section 6105, Sample Unit 344 – Low Severity (41) Alligator Cracking, Low Severity (48) Longitudinal and Transverse Cracking, Low Severity (50) Patching, Low Severity (57) Weathering

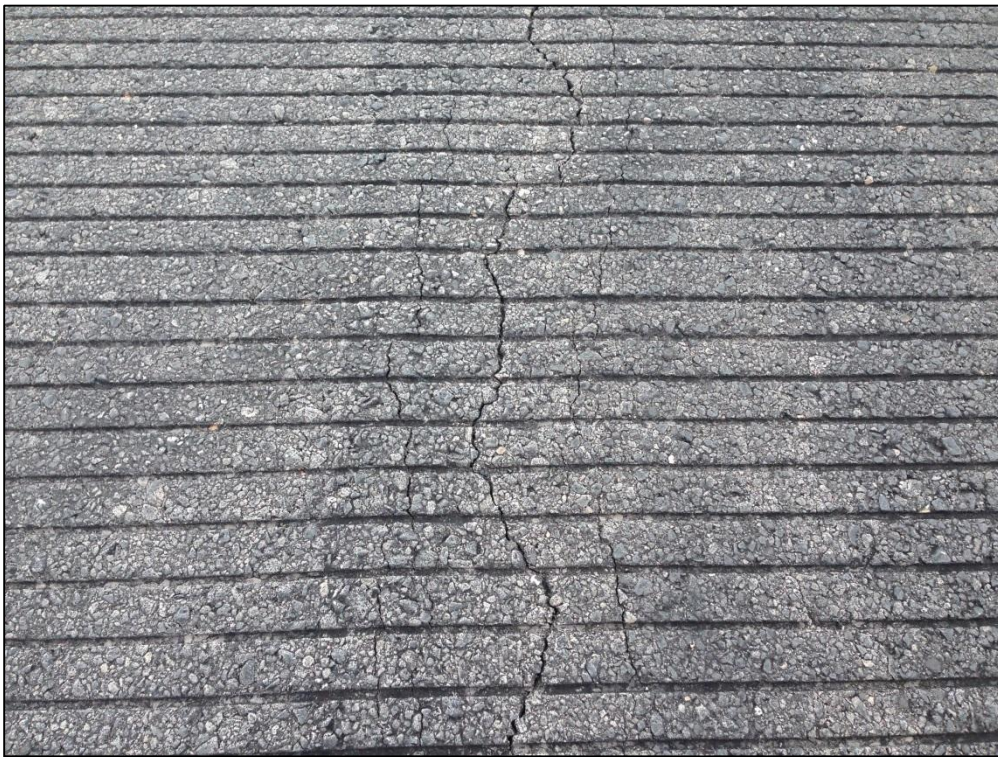
Runway 18-36, Section 6105, Sample Unit 351 – Low Severity (41) Alligator Cracking, Low Severity (57) Weathering

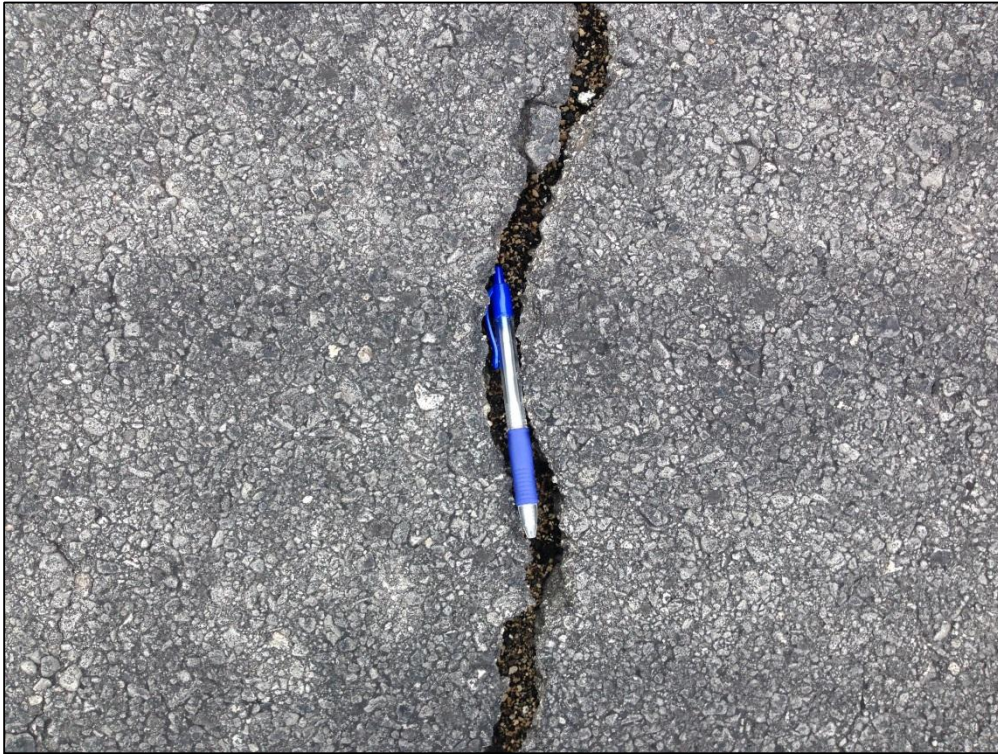
Runway18-36, Section 6110, Sample Unit 524 –Medium Severity (48) Longitudinal and Transverse Cracking, Low Severity (57) Weathering

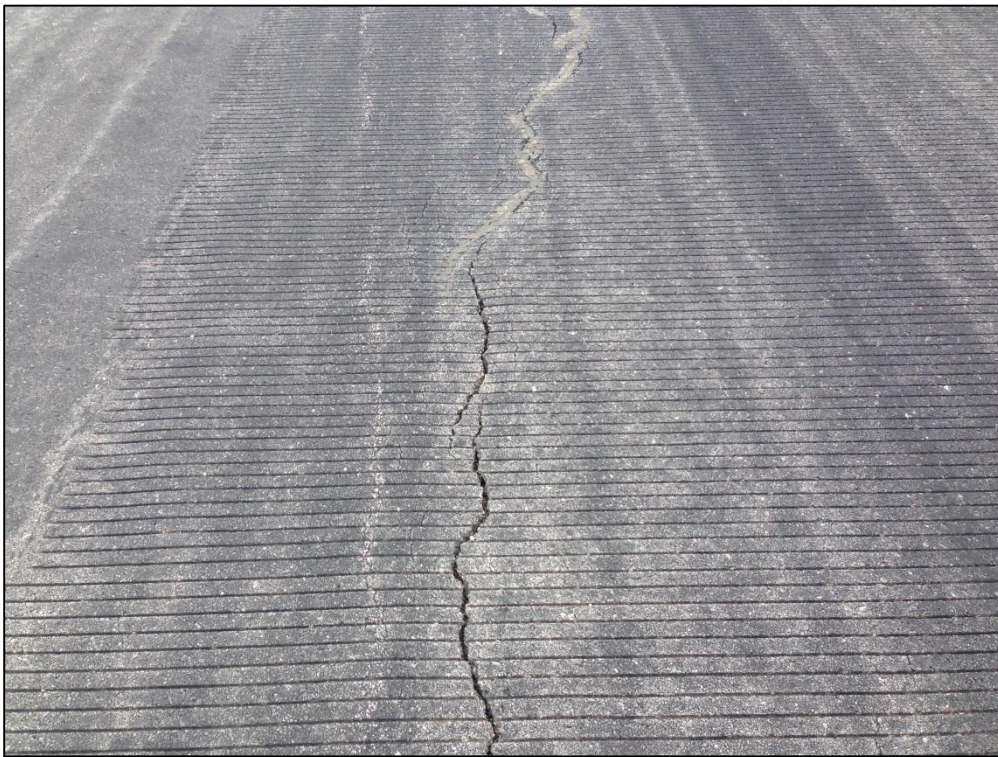
Runway 18-36, Section 6110, Sample Unit 548 –, Medium Severity (48) Longitudinal and Transverse Cracking, Low Severity (57) Weathering

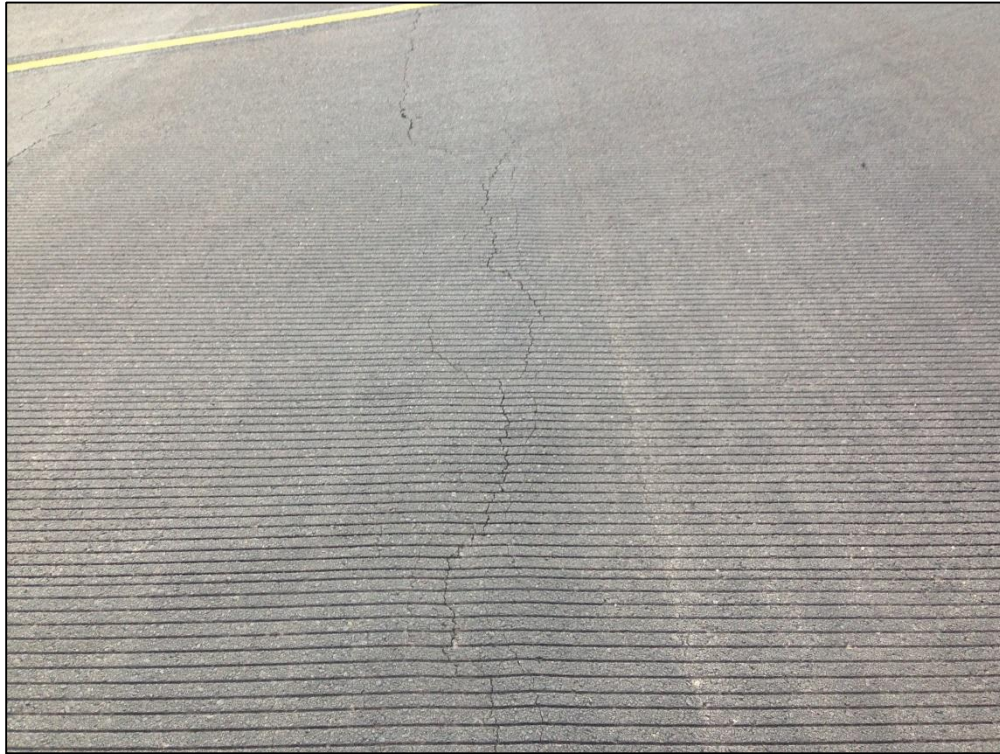
Runway 18-36, Section 6110, Sample Unit 588 – Medium Severity (48) Longitudinal and Transverse Cracking, Low Severity (48) Longitudinal and Transverse Cracking, Low Severity (57) Weathering

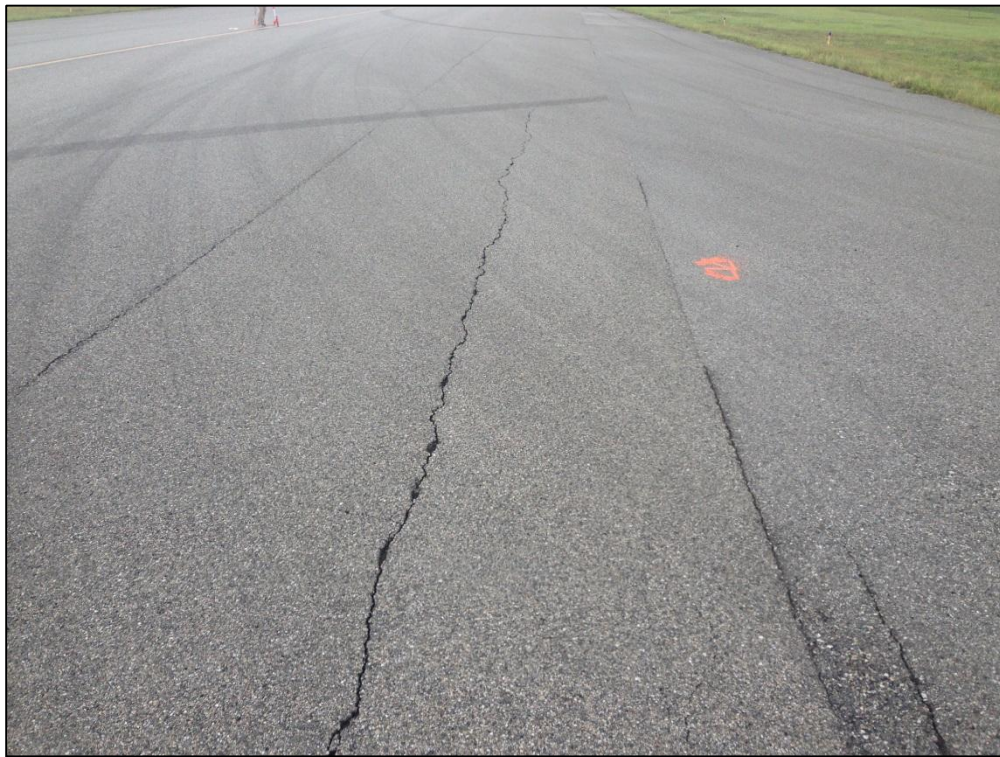
Taxiway P, Section 1605, Sample Unit 200 – Medium Severity (48) Longitudinal and Transverse Cracking, Low Severity (52) Raveling, Low Severity (57) Weathering

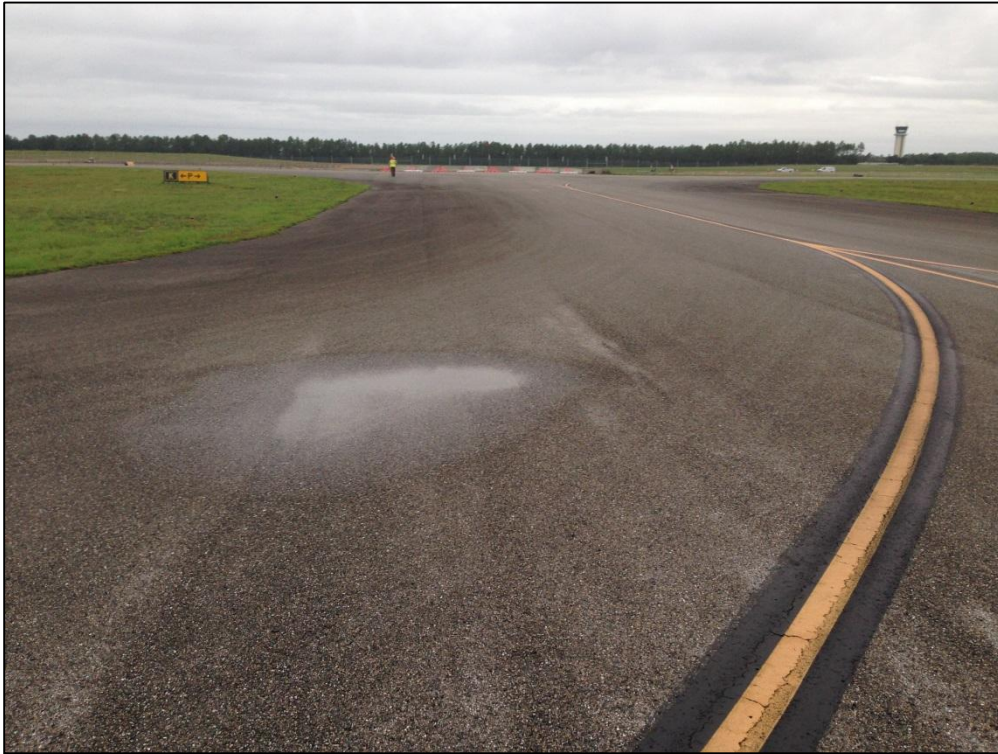
Taxiway K, Section 1110, Sample Unit 106 – Low Severity (45) Depression, Low Severity (52) Raveling, Low Severity (57) Weathering

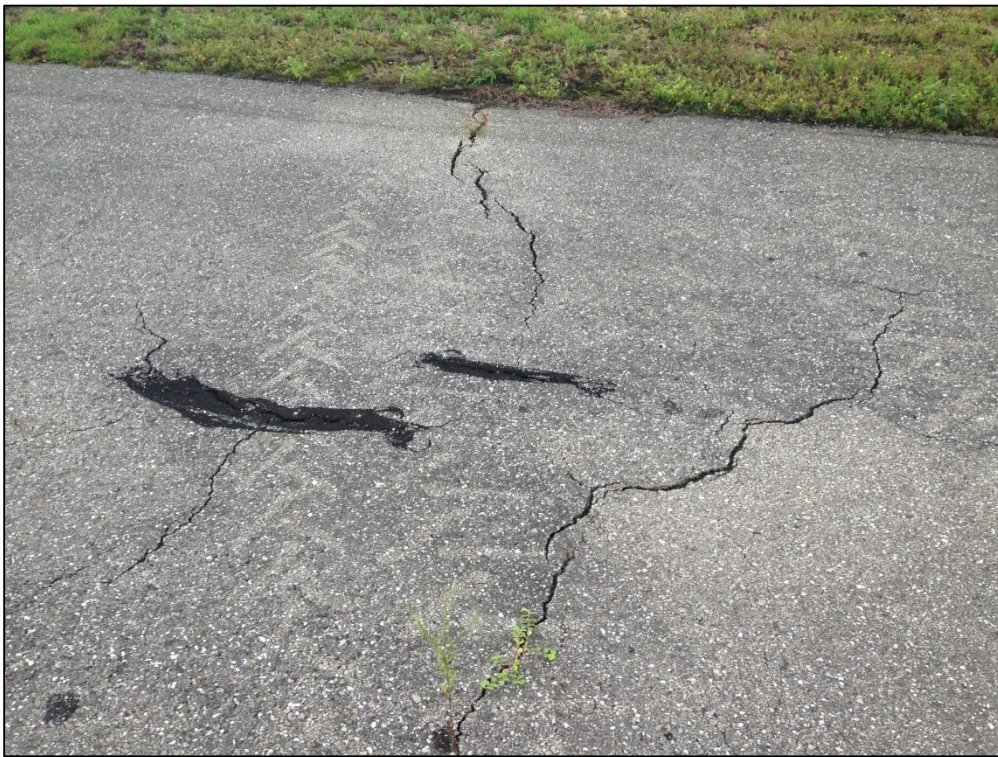
Taxiway K, Section 1120, Sample Unit 101 – Medium Severity (48) Longitudinal and Transverse Cracking, Low Severity (48) Longitudinal and Transverse Cracking, Low Severity (57) Weathering

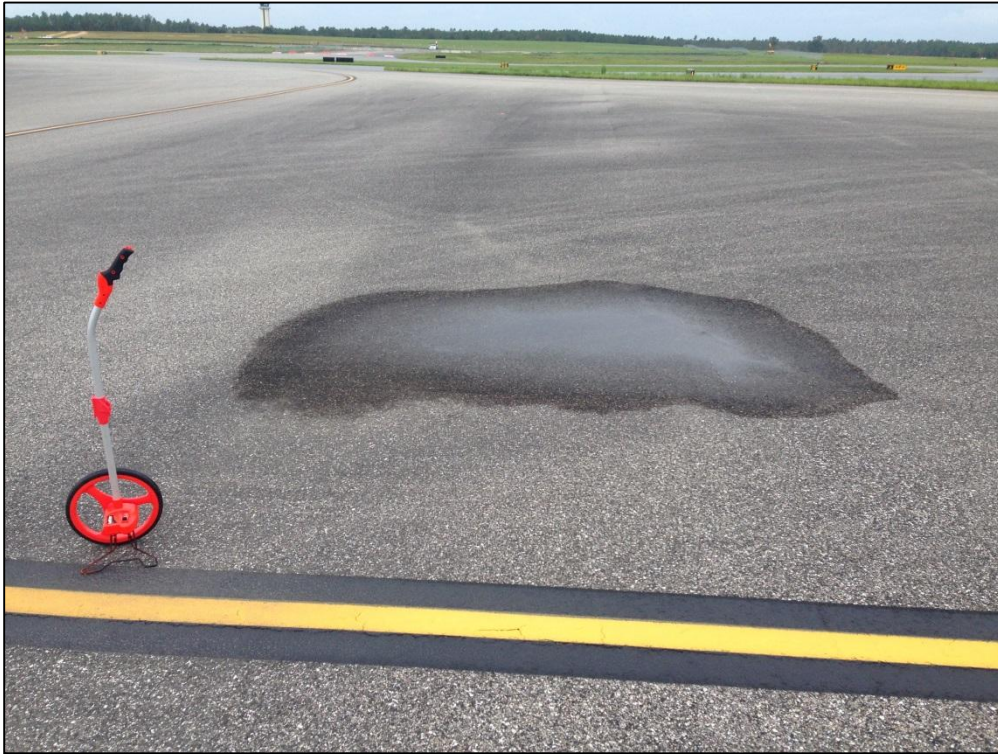
Taxiway M, Section 1325, Sample Unit 101 – Low Severity (45) Depression, Low Severity (48) Longitudinal and Transverse Cracking, Medium Severity (57) Weathering, Low Severity (57) Weathering

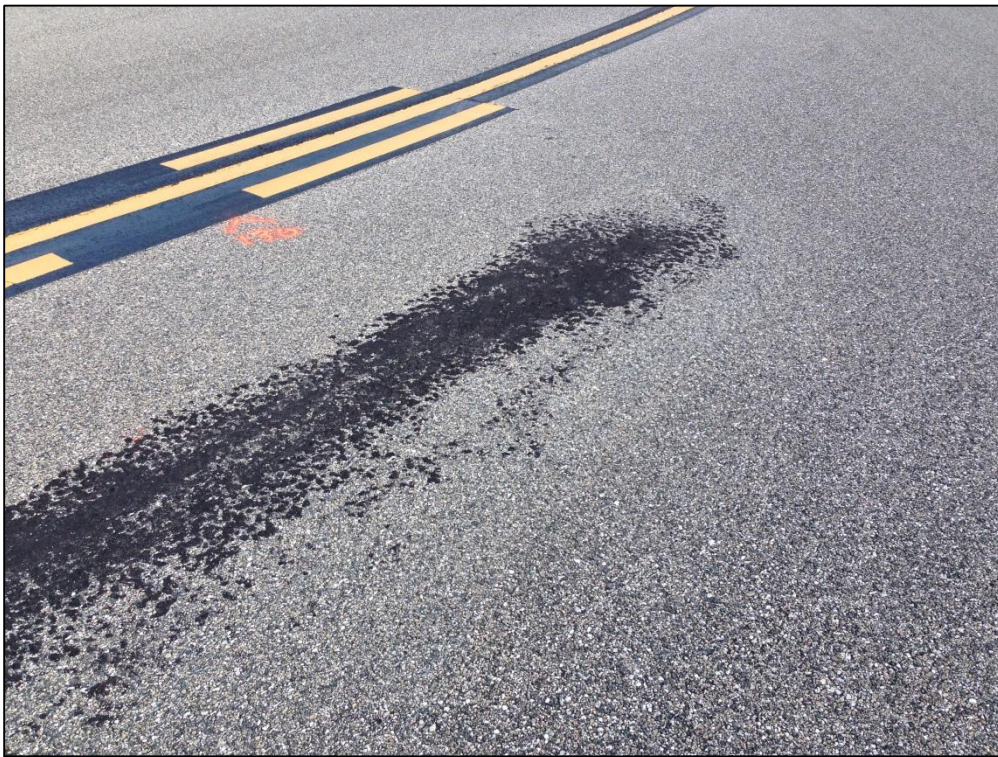
Taxiway M, Section 1315, Sample Unit 130 – (42) Bleeding, Medium Severity (57) Weathering

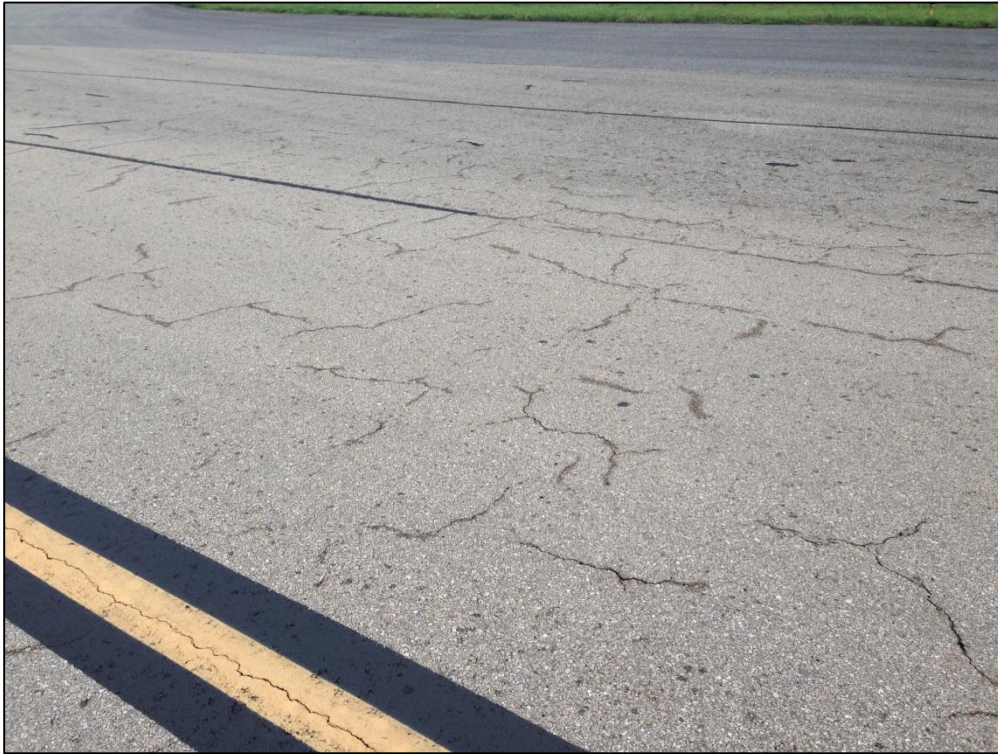
Taxiway S, Section 1905, Sample Unit 119 – Low Severity (48) Longitudinal and Transverse Cracking, Low Severity (52) Raveling, Low Severity (57) Weathering

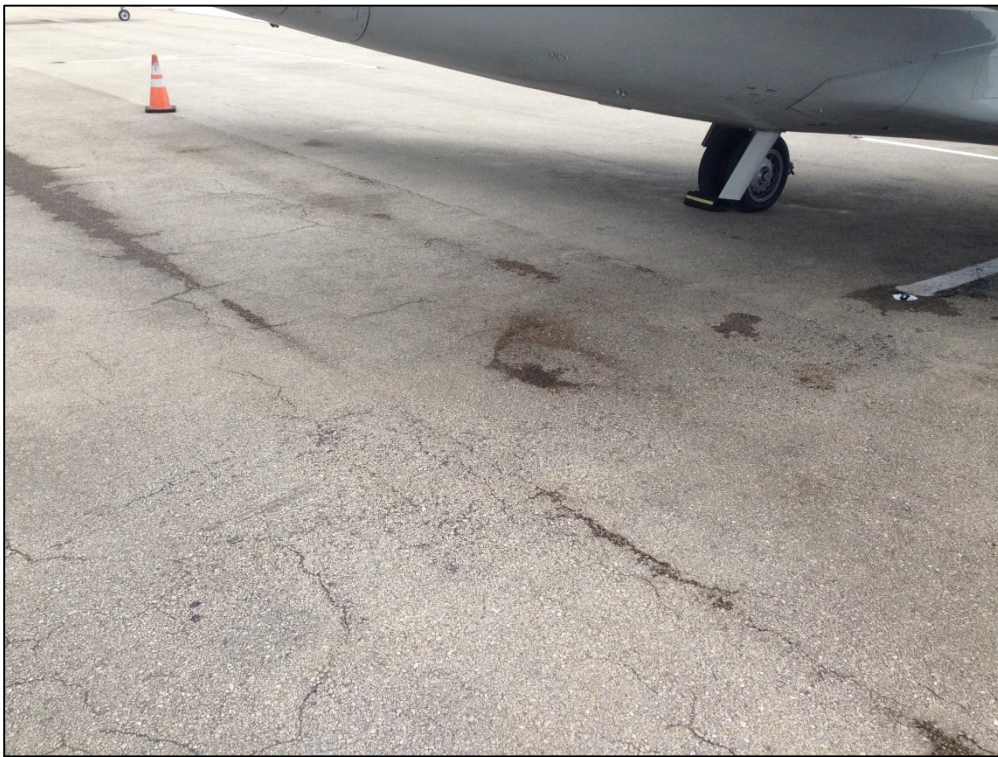
Apron GA, Section 4305, Sample Unit 303 – Low Severity (48) Longitudinal and Transverse Cracking, (49) Oil Spillage, Low Severity (52) Raveling, Low Severity (57) Weathering

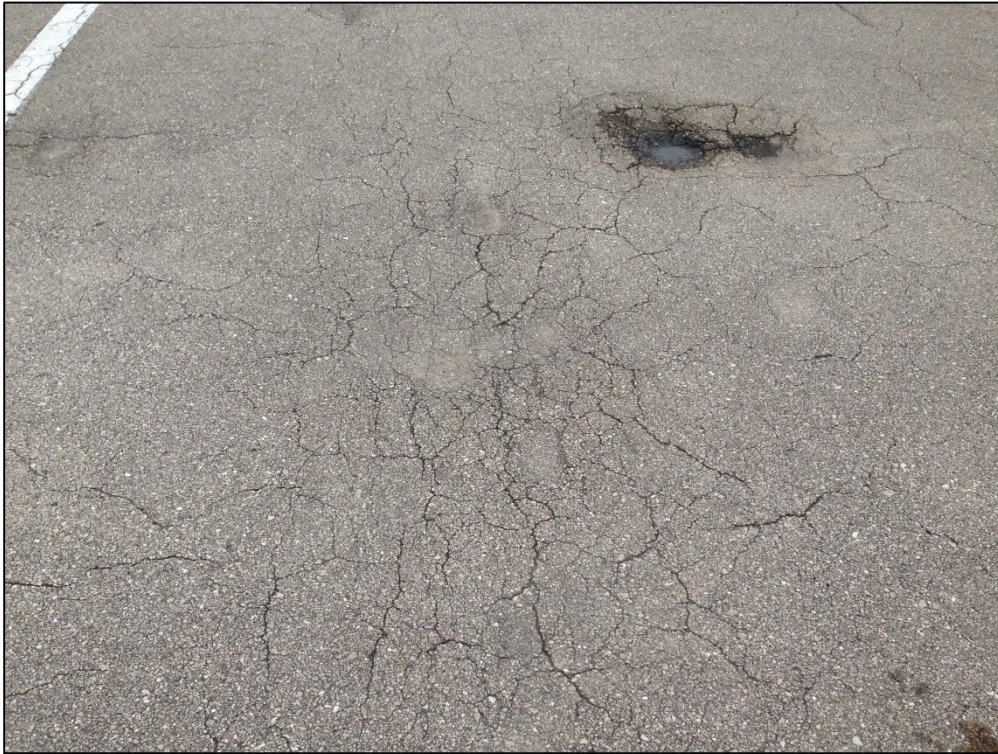
Apron GA, Section 4310, Sample Unit 306 – Low Severity (41) Alligator Cracking, High Severity (45) Depression, Low Severity (48) Longitudinal and Transverse Cracking Low Severity (52) Raveling, Low Severity (57) Weathering

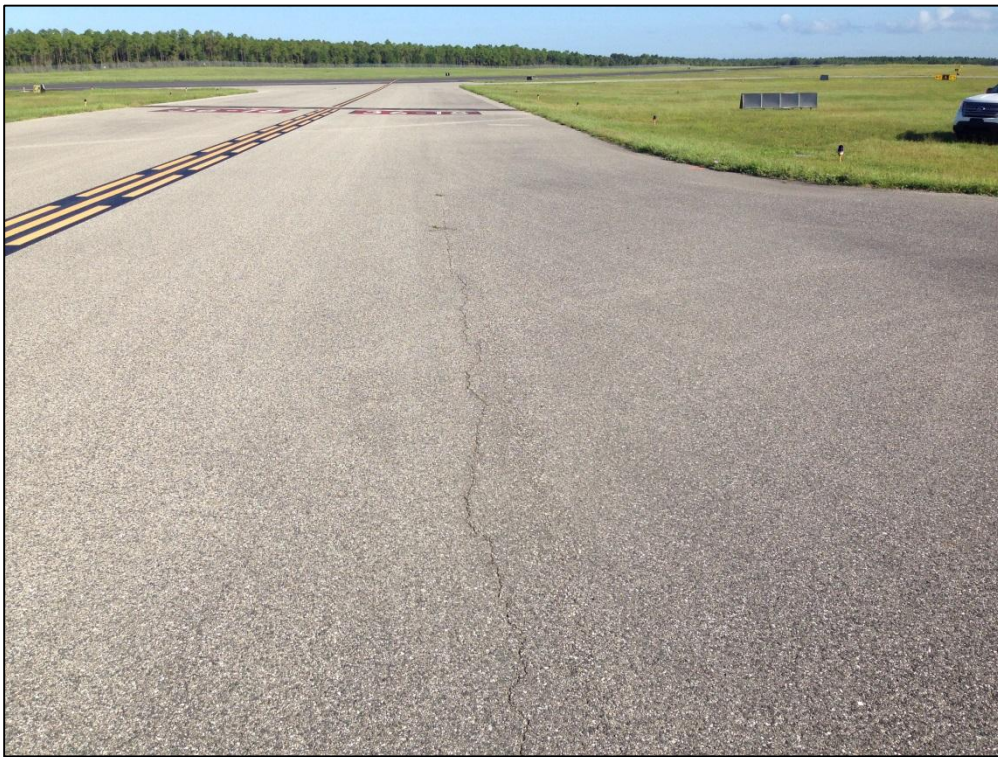
Taxiway D, Section 405, Sample Unit 109 – Low Severity (48) Longitudinal and Transverse Cracking, Low Severity (57) Weathering

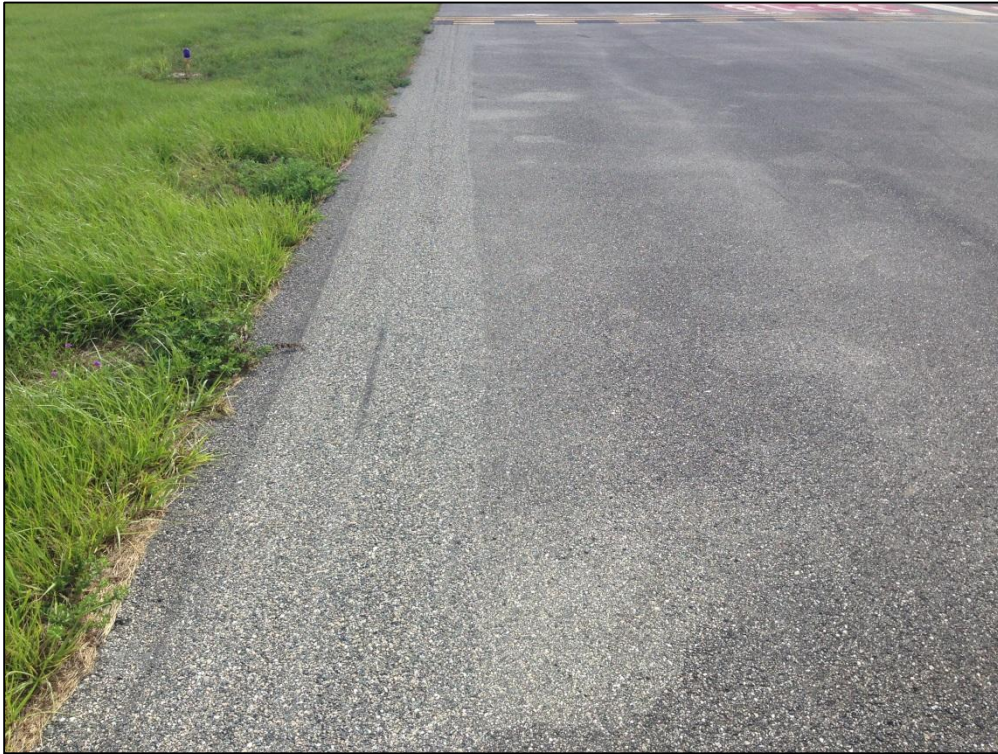
Taxiway A2, Section 125, Sample Unit 101 –Low Severity (52) Raveling, Medium Severity (57) Weathering

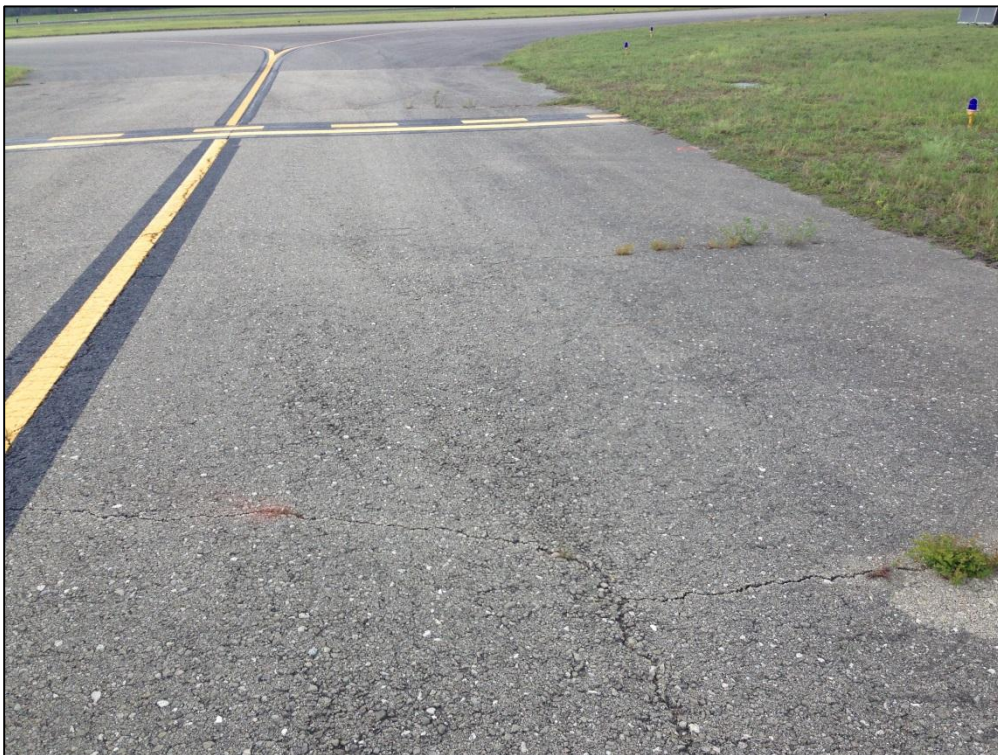
Taxiway R, Section 1810, Sample Unit 101 –Low Severity (48) Longitudinal and Transverse Cracking, Low Severity (52) Raveling

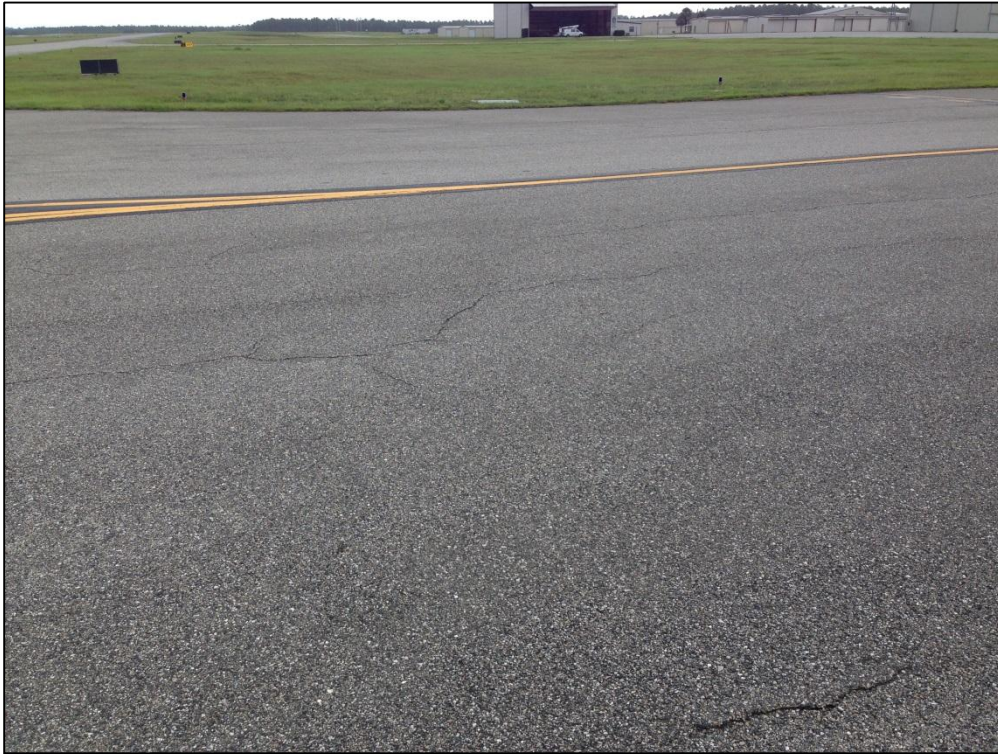
Taxiway E, Section 510, Sample Unit 101 –Low Severity (48) Longitudinal and Transverse Cracking, Low Severity (56) Swelling, Medium Severity (57) Weathering

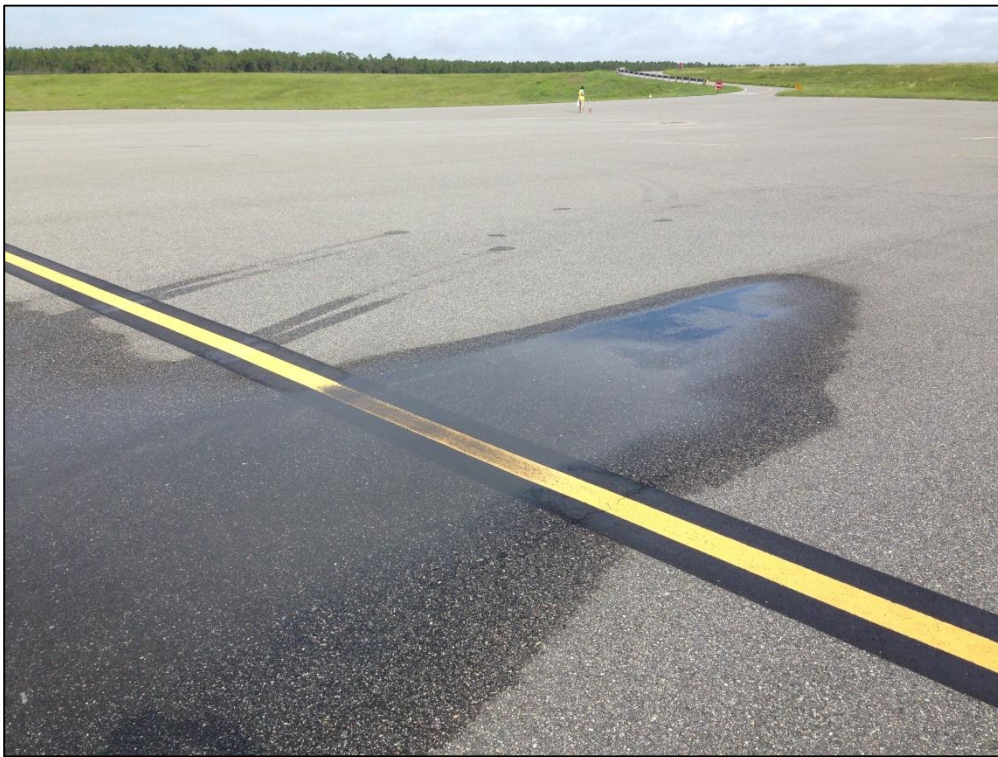
Apron at T-Hangers, Section 4505, Sample Unit 303 –Low Severity (45) Depression, Medium Severity (57) Weathering, Low Severity (57) Weathering

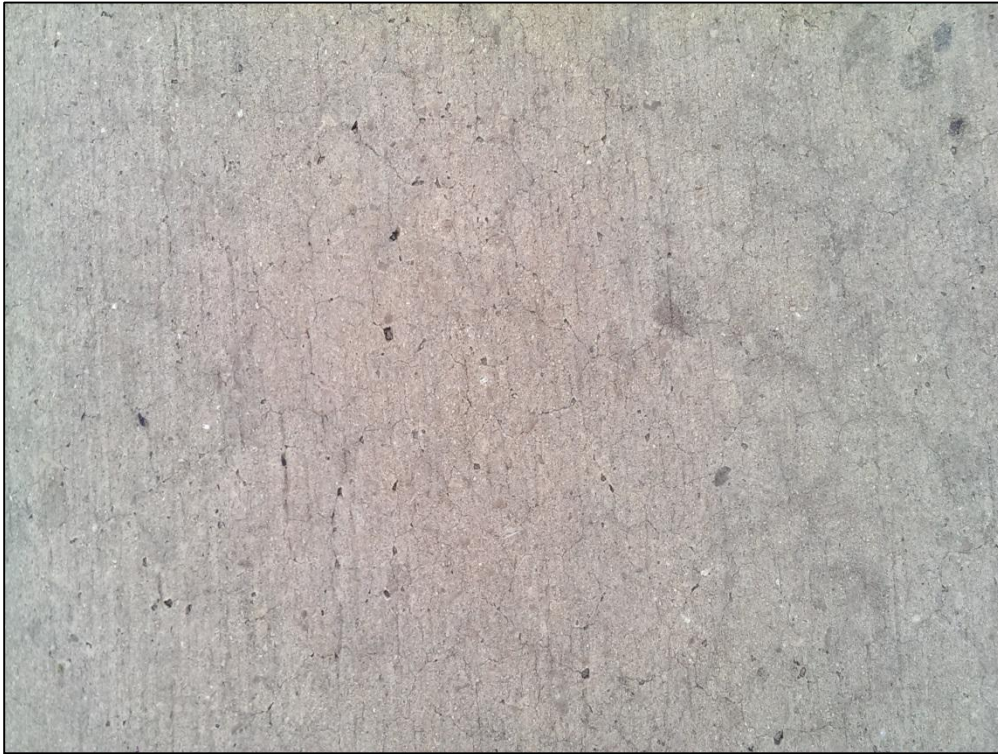
Terminal Apron, Section 4105, Sample Unit 265 –Low Severity (70) Scaling, Map Cracking, Crazing

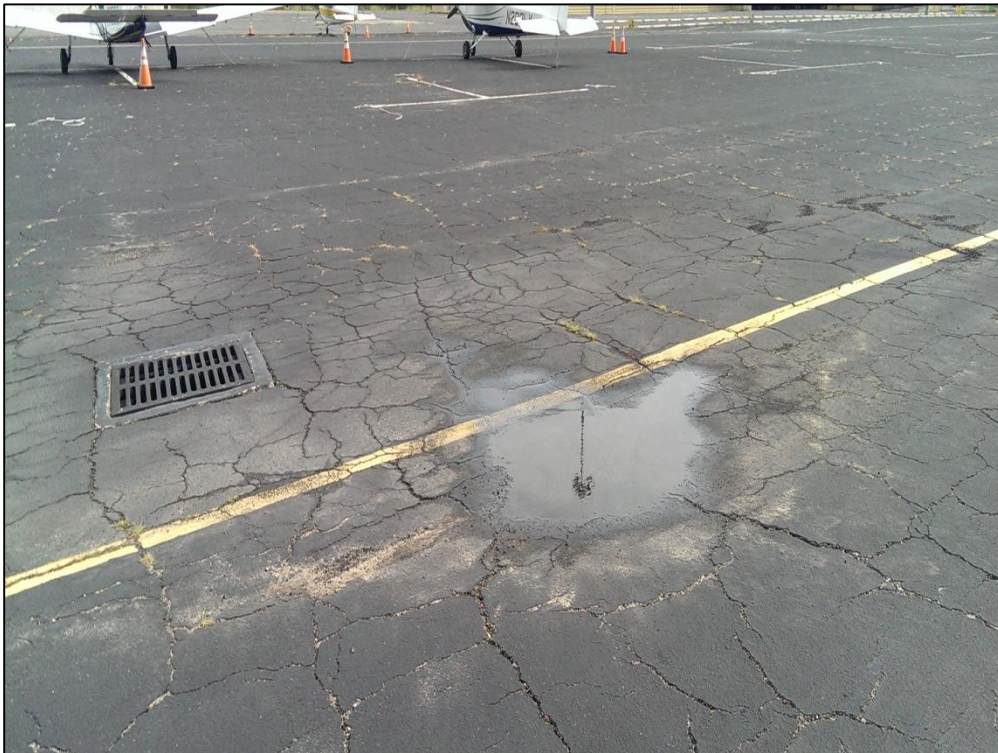
Apron GA, Section 4332, Sample Unit 359 –Low Severity (45) Depression, Low Severity (43) Block Cracking, Medium Severity (43) Block Cracking, Medium Severity (57) Weathering, and Low Severity (52) Raveling

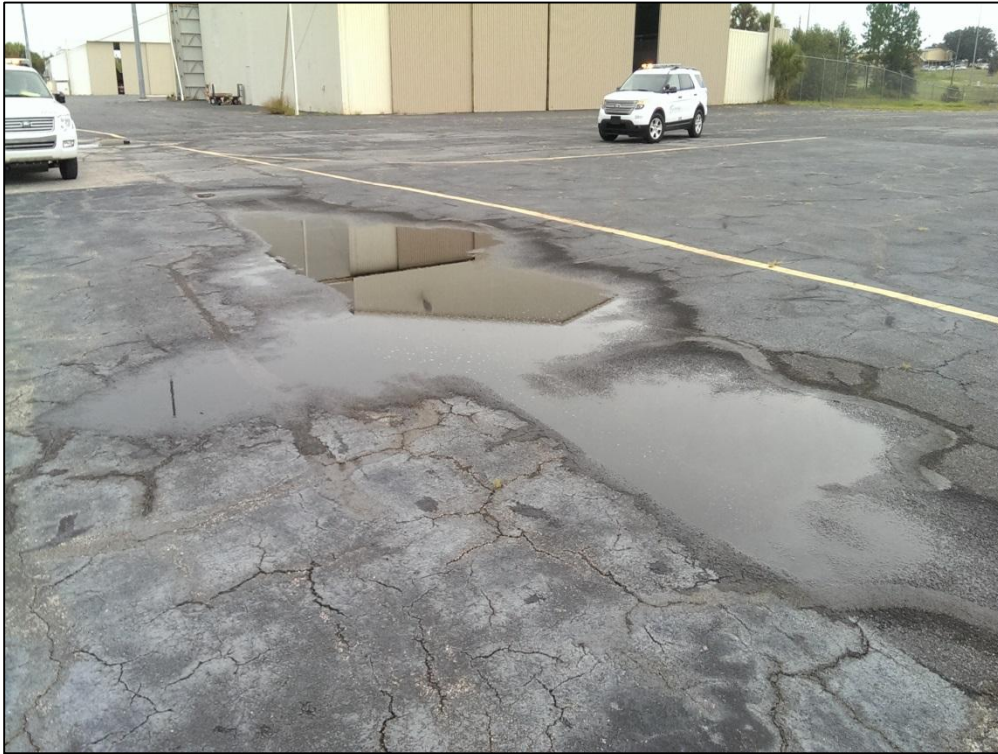
Apron GA, Section 4330, Sample Unit 661 –Medium Severity (45) Depression, Low Severity (43) Block Cracking, Medium Severity (43) Block Cracking, Medium Severity (43) Block Cracking, Medium Severity (57) Weathering, and Low Severity (52) Raveling
