FLORIDA DEPARTMENT OF TRANSPORTATION
AVIATION AND SPACEPORT OFFICE

**PETER O. KNIGHT
AIRPORT (TPF)**

JUNE 2015

STATEWIDE
**Airfield
Pavement
Management**
PROGRAM

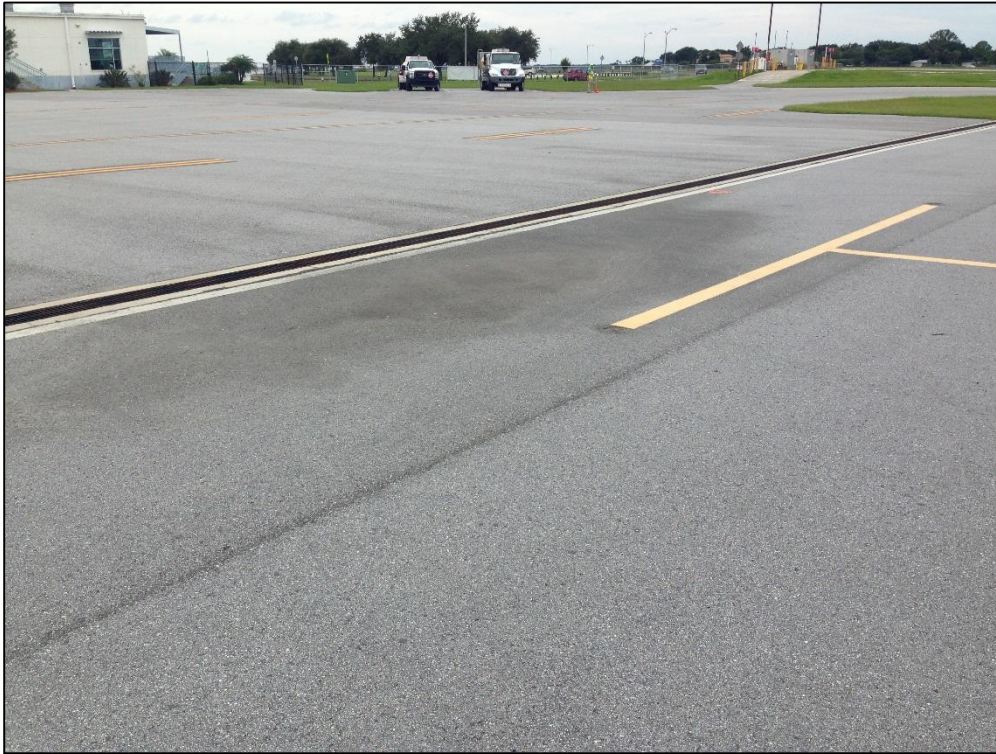
Apron, Section 4110, Sample Unit 302 – Low Severity (45) Depression, Low Severity (52) Raveling, Low Severity (57) Weathering

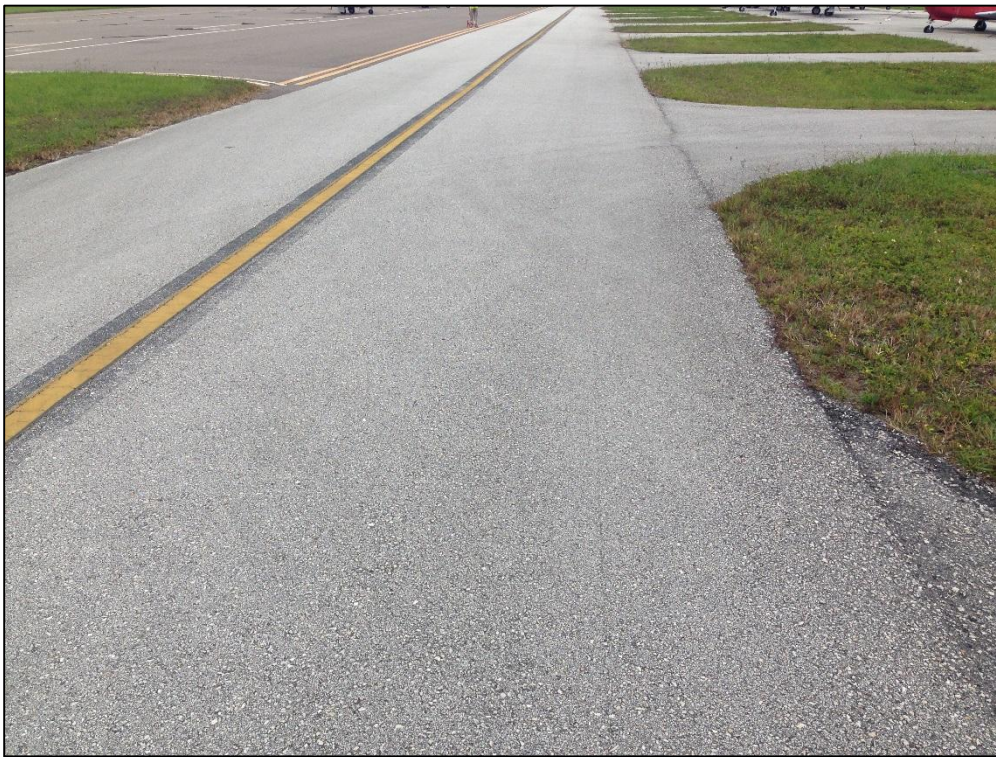
Taxiway Center, Section 315, Sample Unit 202 – Low Severity (48) Longitudinal and Transverse Cracking, Low Severity (52) Raveling, Low Severity (57) Weathering

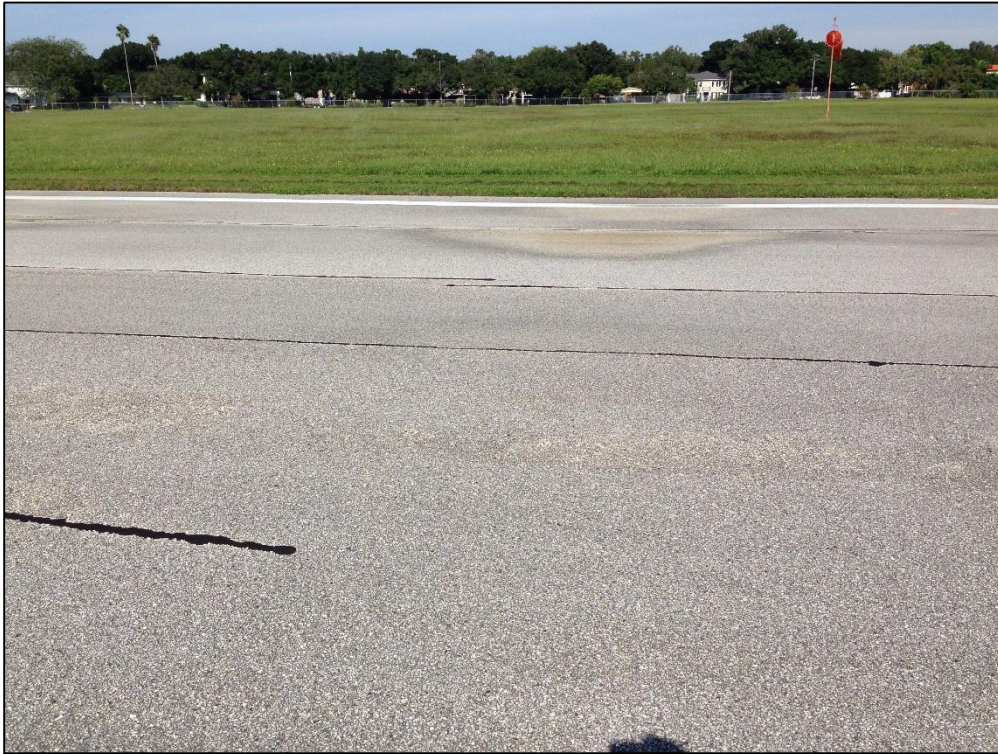
Runway 4-22, Section 6105, Sample Unit 125 – Low Severity (45) Depression, Low Severity (48) Longitudinal and Transverse Cracking, Low Severity (52) Raveling, Medium Severity (52) Raveling, Low Severity (56) Swelling

- ⦿ Runway 4-22 – Section 6105
 - Mill and Overlay attributed to climate and age of pavement.
- ⦿ Apron – Section 4140
 - Mill and Overlay attributed to climate and age of pavement.
- ⦿ Taxiway T-Hangar – Section 705
 - Mill and Overlay attributed to climate and age of pavement.
- ⦿ Taxiway E – Section 510
 - Mill and Overlay attributed to climate and age of pavement.
- ⦿ Taxiway D – Section 425
 - Mill and Overlay attributed to climate and age of pavement.
- ⦿ Taxiway C – Section 310
 - Mill and Overlay attributed to climate and age of pavement.
- ⦿ Taxiway B – Section 150
 - Mill and Overlay attributed to climate and age of pavement.
- ⦿ Taxiway A – Section 105
 - Mill and Overlay attributed to climate and age of pavement.

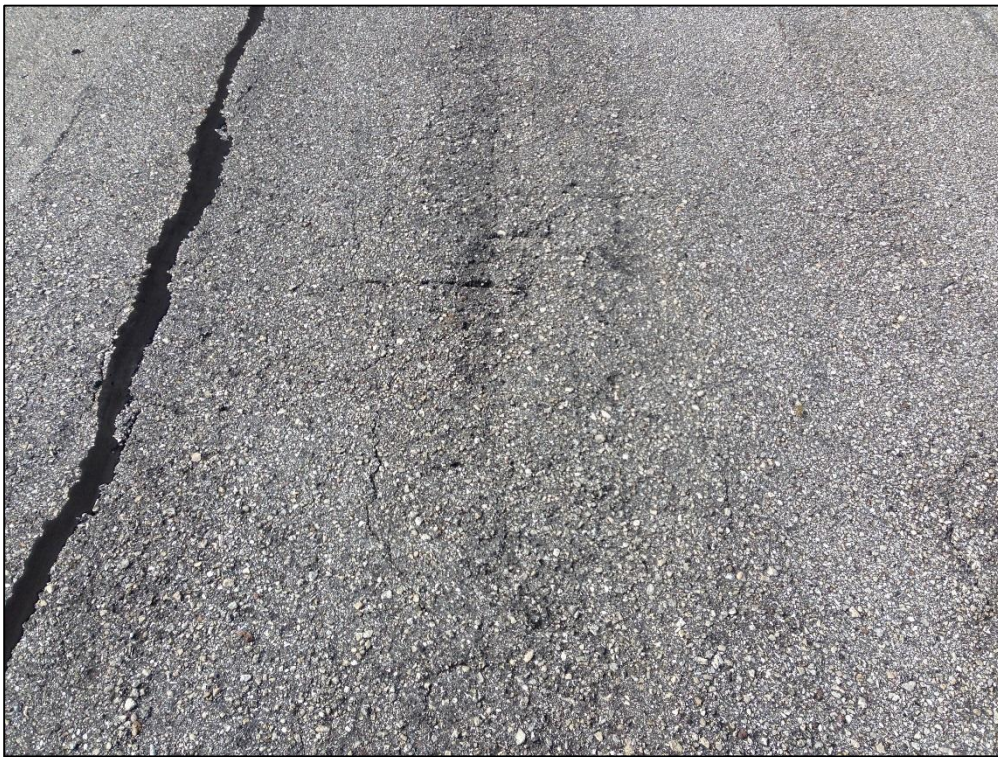
Runway 4-22, Section 6105, Sample Unit 109 – Low Severity (48) Longitudinal and Transverse Cracking, Low Severity (52) Raveling, Medium Severity (52) Raveling, Low Severity (56) Swelling

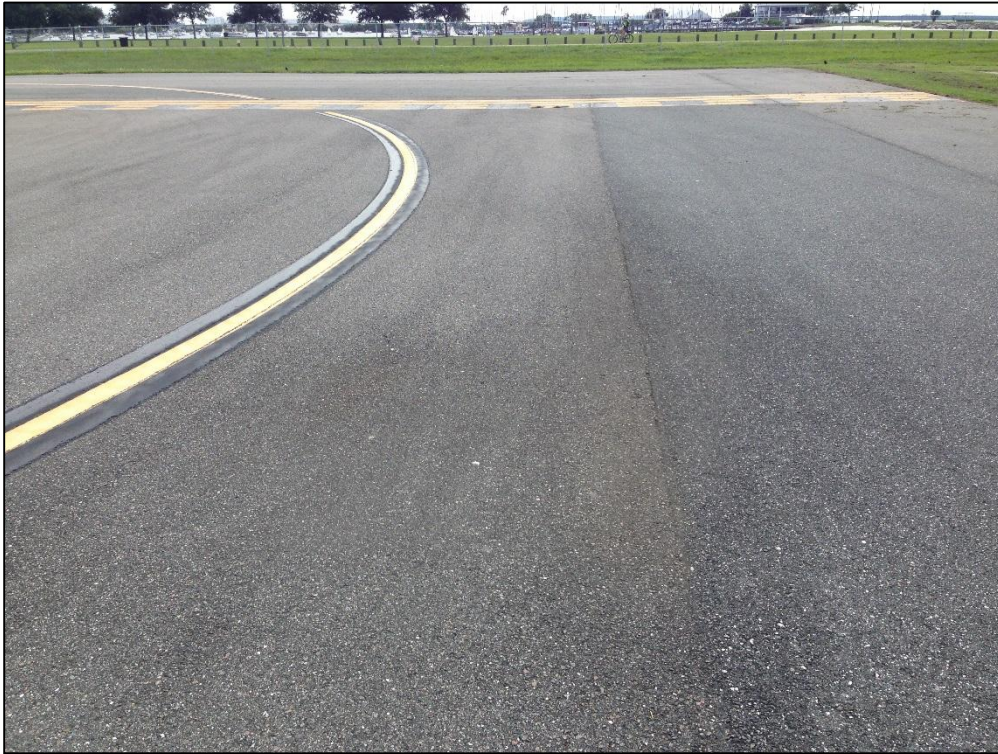
Taxiway Alpha, Section 103, Sample Unit 97 – Low Severity (45) Depression, Low Severity (48) Longitudinal and Transverse Cracking, Low Severity (57) Weathering

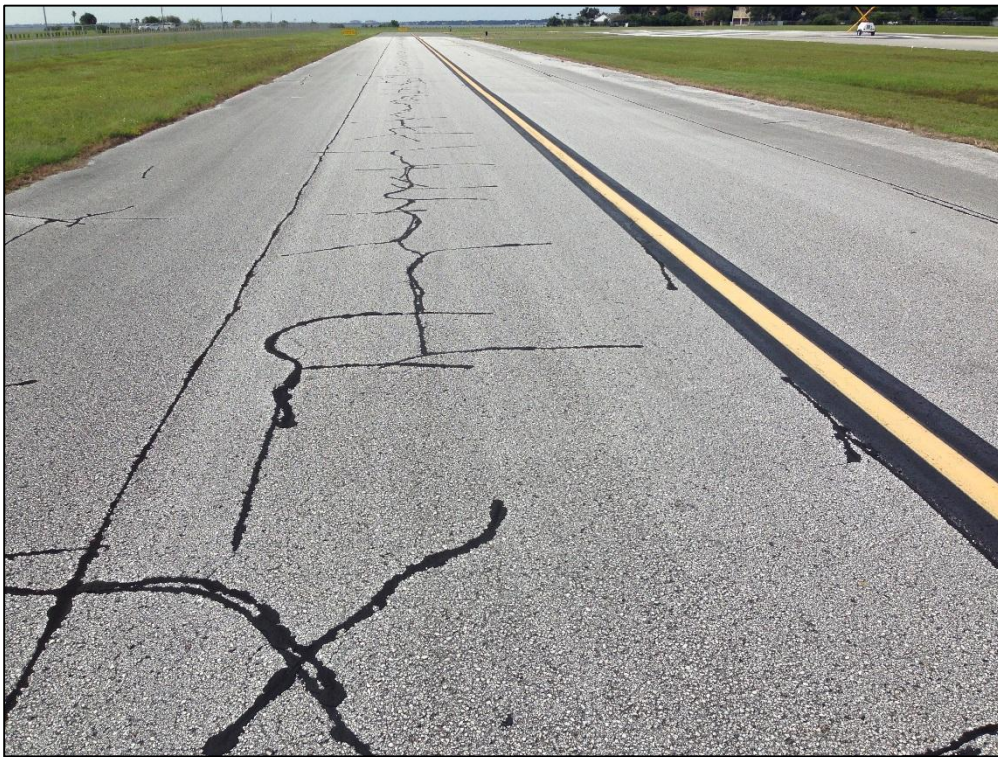
Taxiway Alpha, Section 105, Sample Unit 105 – Low Severity (48) Longitudinal and Transverse Cracking, Low Severity (52) Raveling

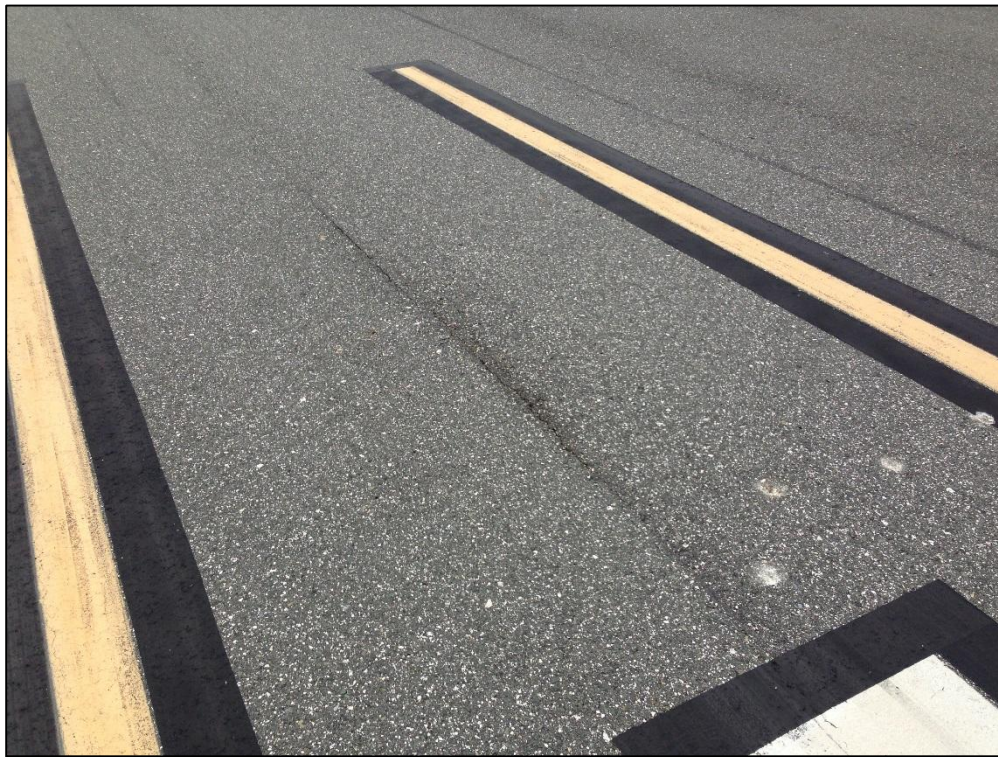
Runway 18-36, Section 6205, Sample Unit 114 – Low Severity (48) Longitudinal and Transverse Cracking, Low Severity (57) Weathering

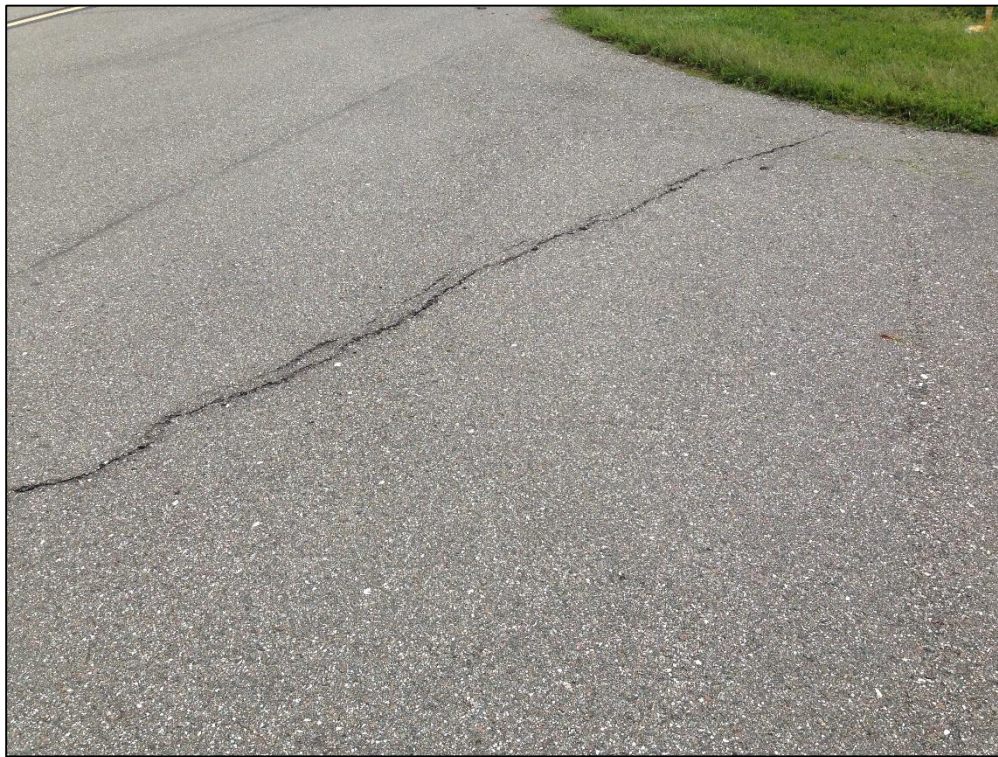
Apron Run-Up, Section 5110, Sample Unit 100 – Low Severity (48) Longitudinal and Transverse Cracking, Low Severity (57) Weathering

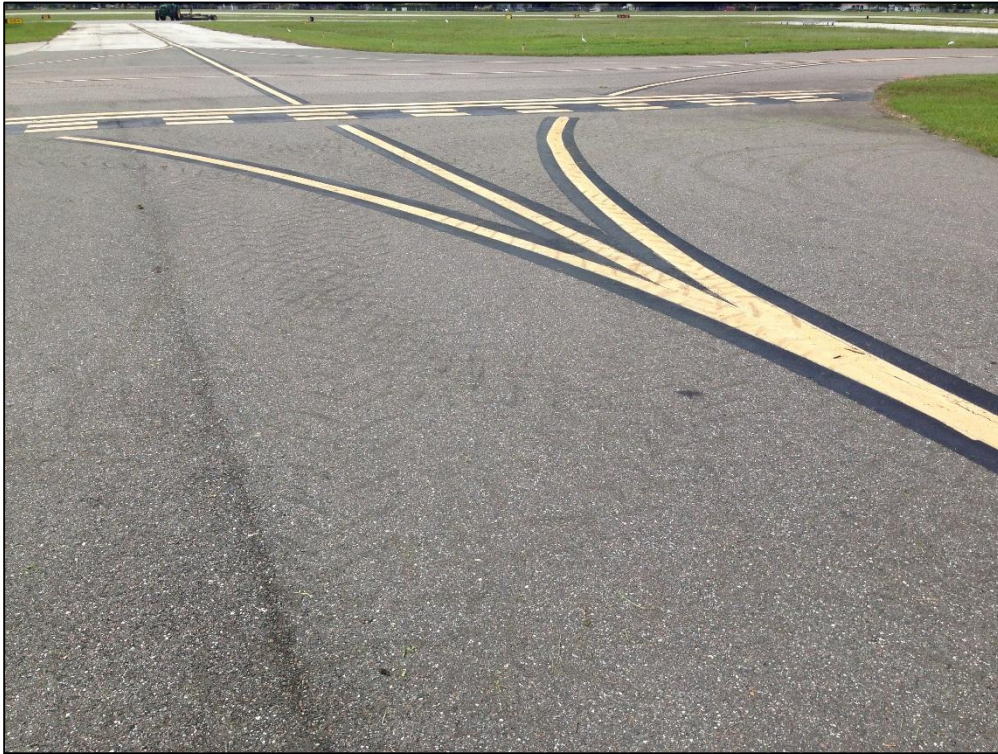
Taxiway Echo, Section 650, Sample Unit 300 – Low Severity (48) Longitudinal and Transverse Cracking, Low Severity (57) Weathering

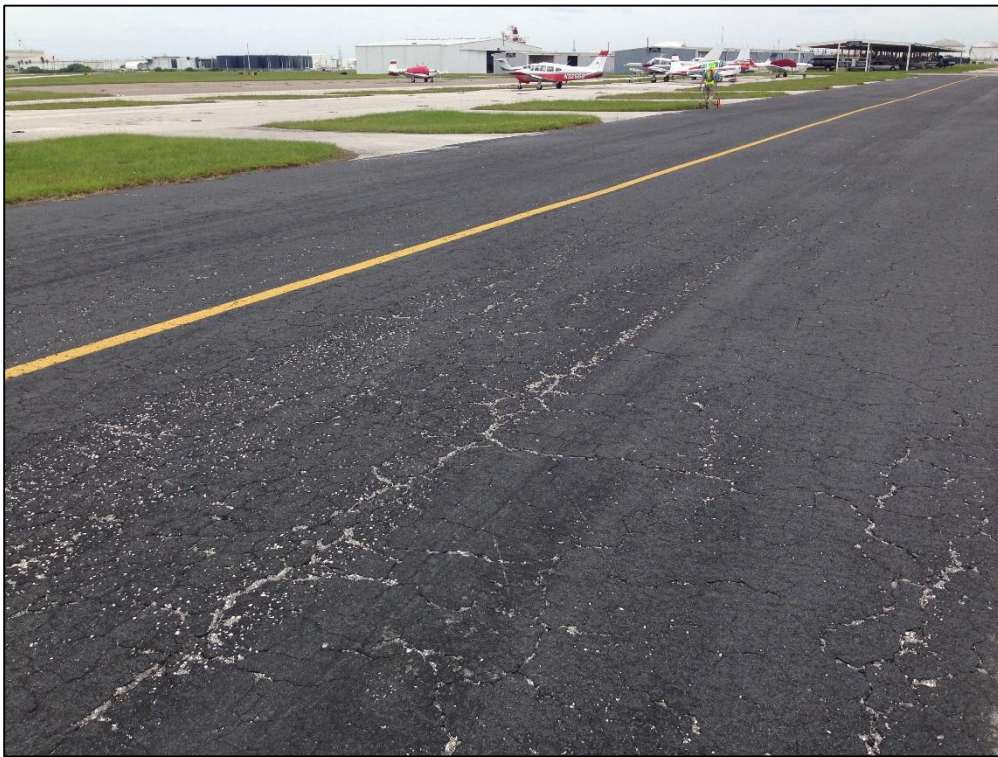
Taxiway Charlie, Section 310, Sample Unit 101 – Low Severity (43) Block Cracking, Low Severity (52) Raveling

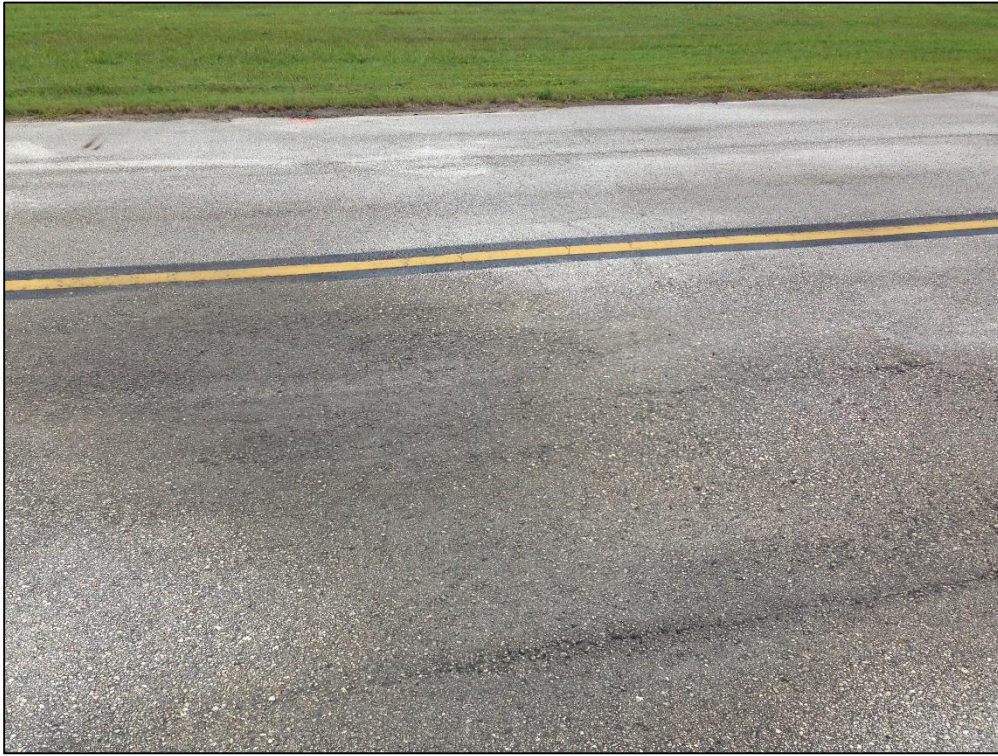
Taxiway Echo, Section 510, Sample Unit 100 – Low Severity (45) Depression , Low Severity (48) Longitudinal and Transverse Cracking, Low Severity (52) Raveling
