**TAMPA EXECUTIVE  
AIRPORT (VDF)**

DISTRICT 7

JUNE 2015

STATEWIDE  
**Airfield  
Pavement  
Management**  
PROGRAM

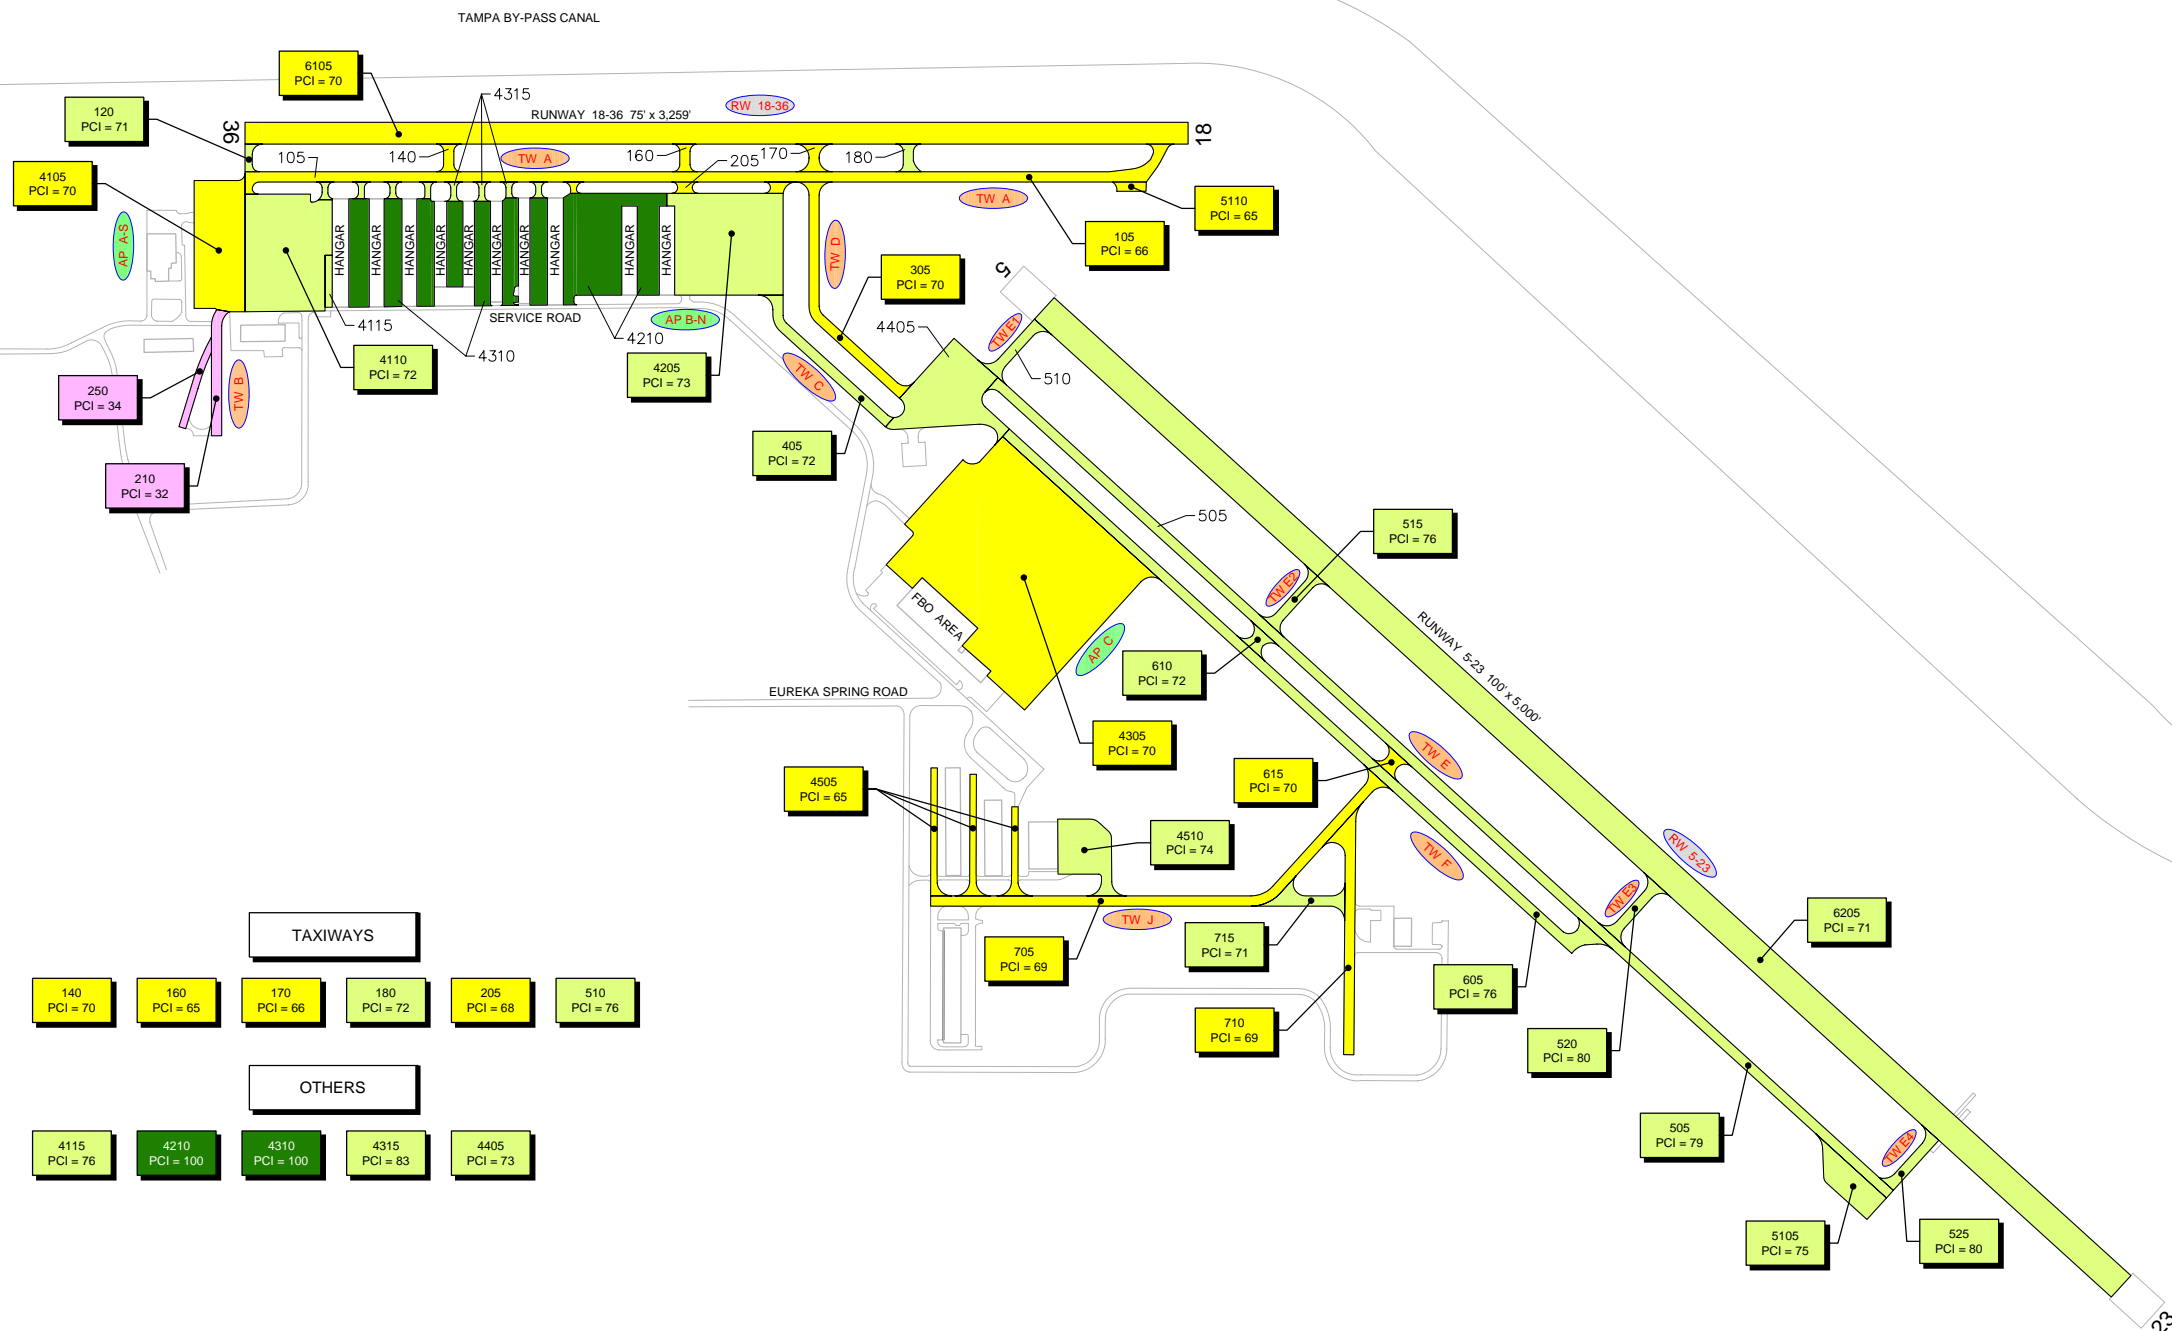
- AIRFIELD PAVEMENT CONDITION INDEX RATING EXHIBIT
- PAVEMENT CONDITION INDEX INVENTORY

TAXIWAYS					
140 PCI = 70	160 PCI = 65	170 PCI = 66	180 PCI = 72	205 PCI = 68	510 PCI = 76
OTHERS					
4115 PCI = 76	4210 PCI = 100	4310 PCI = 100	4315 PCI = 83	4405 PCI = 73

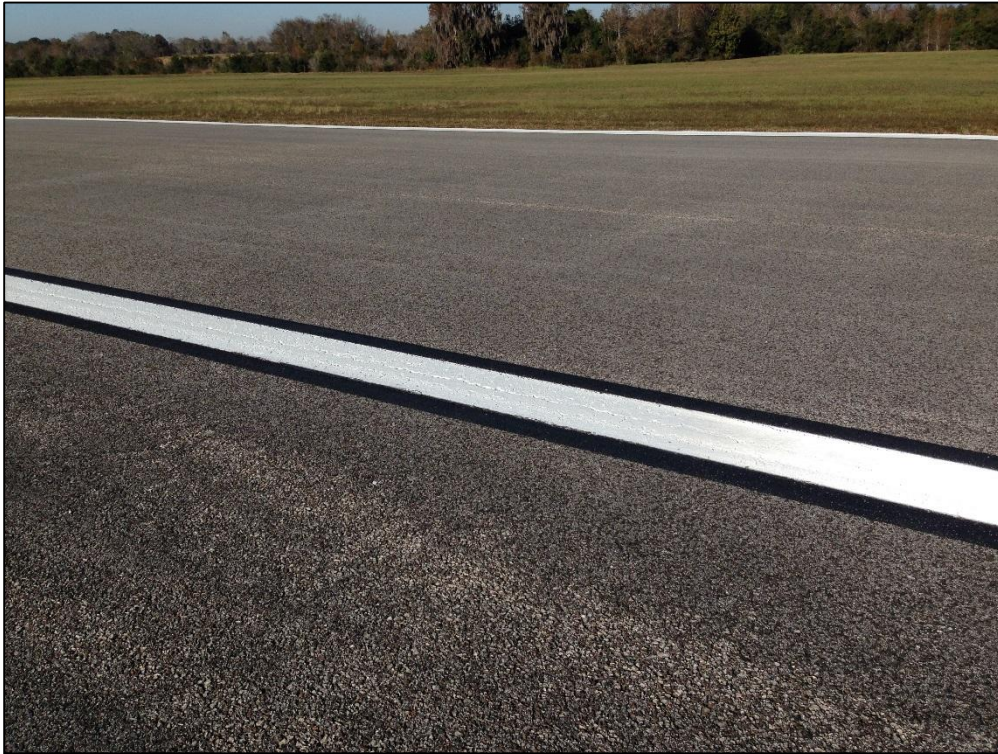
Runway 5-23, Section 6205, Sample Unit 191 – Low Severity (48) Longitudinal and Transverse Cracking, Low Severity (52) Raveling, Low Severity (57) Weathering

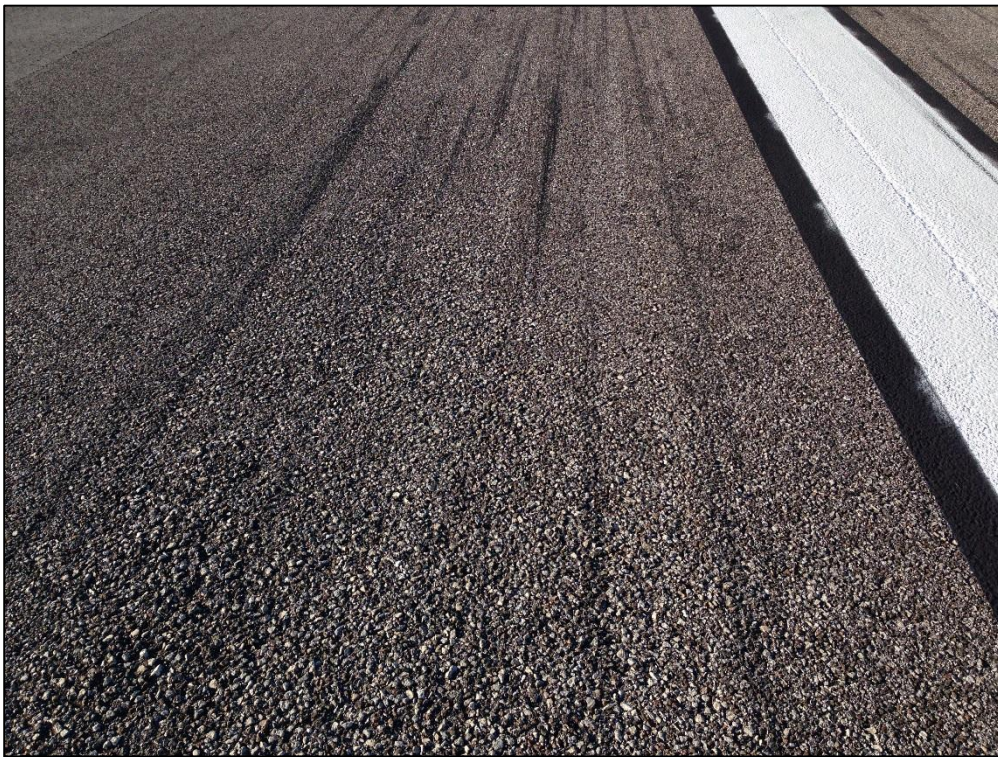
Runway 5-23, Section 6205, Sample Unit 165 – Medium Severity (52) Raveling

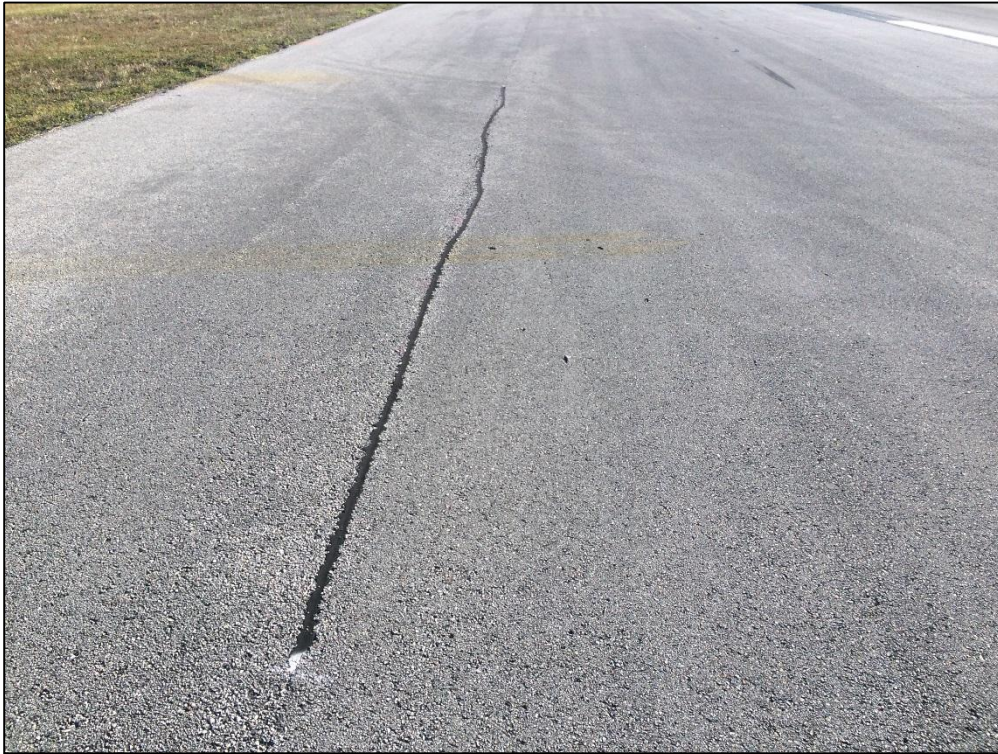
Runway 18-36, Section 6105, Sample Unit 156 – Low Severity (48) Longitudinal and Transverse Cracking, Medium Severity (57) Weathering

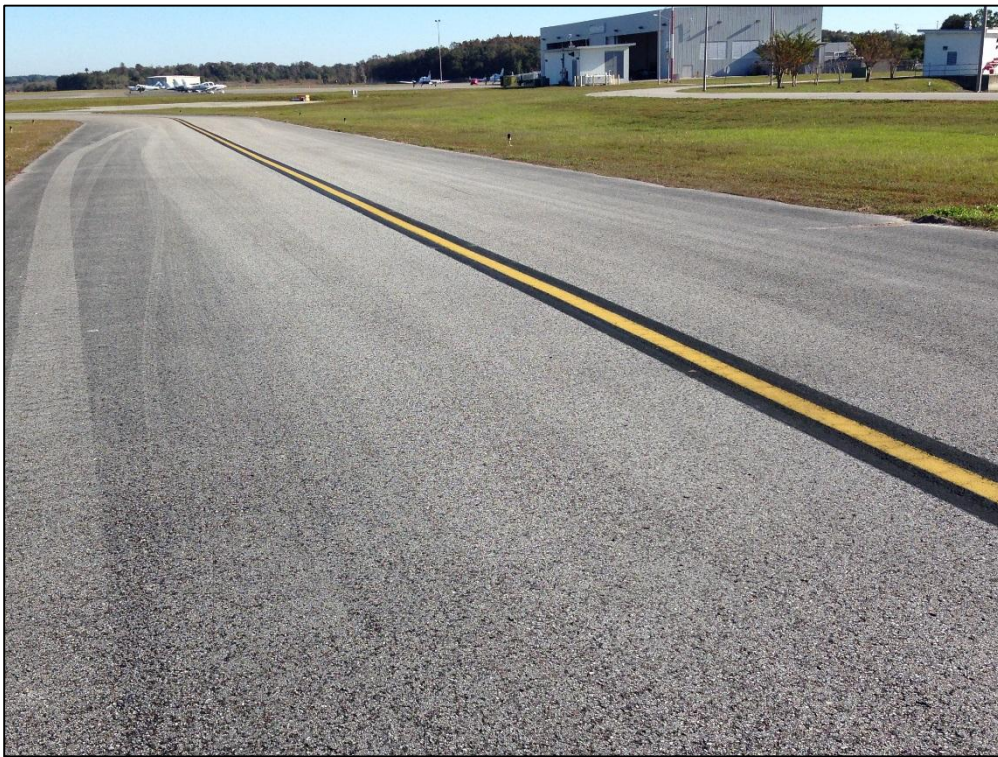
Taxiway Charlie, Section 405, Sample Unit 103 – Low Severity (52) Raveling, Medium Severity (57) Weathering

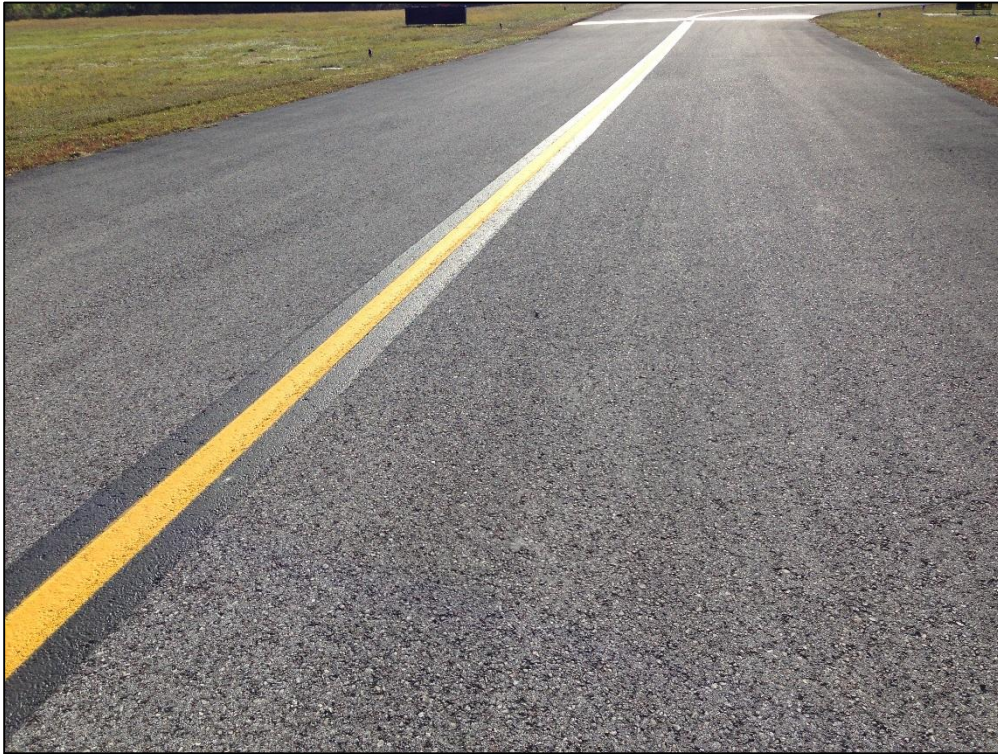
Taxiway E4, Section 525, Sample Unit 101 – Medium Severity (57) Weathering

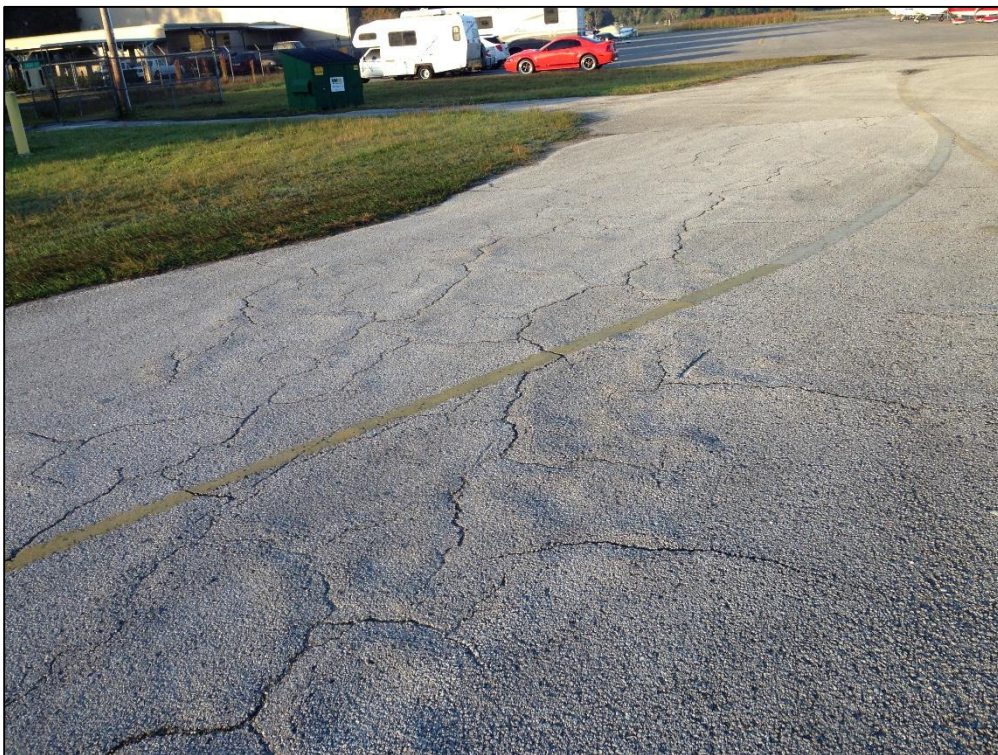
Taxiway Bravo, Section 210, Sample Unit 203 – Low Severity (43) Block Cracking, Medium Severity (52) Raveling, Low Severity (56) Swelling

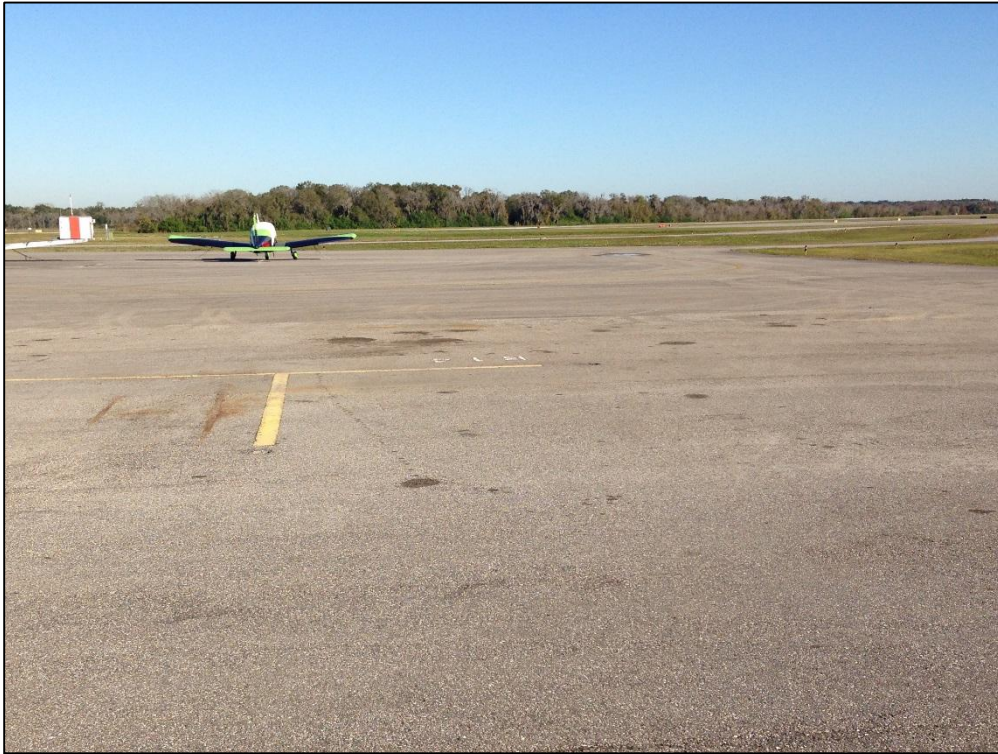
North Apron B, Section 4205, Sample Unit 352 – Low Severity (52) Raveling, Medium Severity (57) Weathering

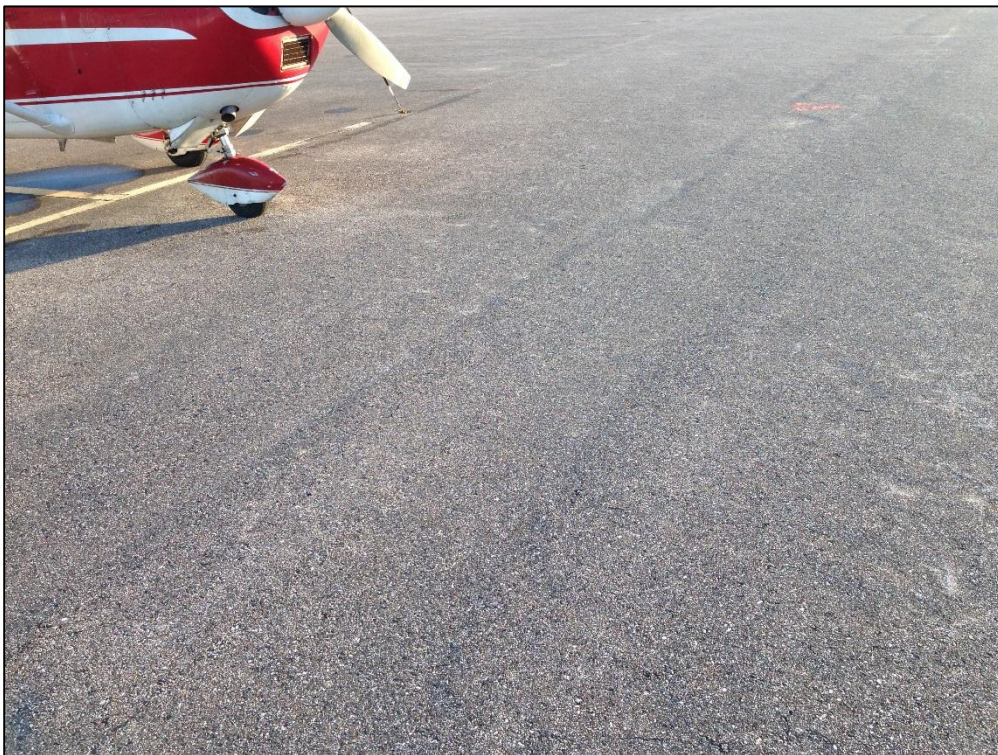
South Apron A, Section 4105, Sample Unit 400 – Low Severity (56) Swelling, Medium Severity (57) Weathering
