**WILLISTON MUNICIPAL  
AIRPORT (X60)**

JUNE 2015

STATEWIDE  
**Airfield  
Pavement  
Management**  
PROGRAM

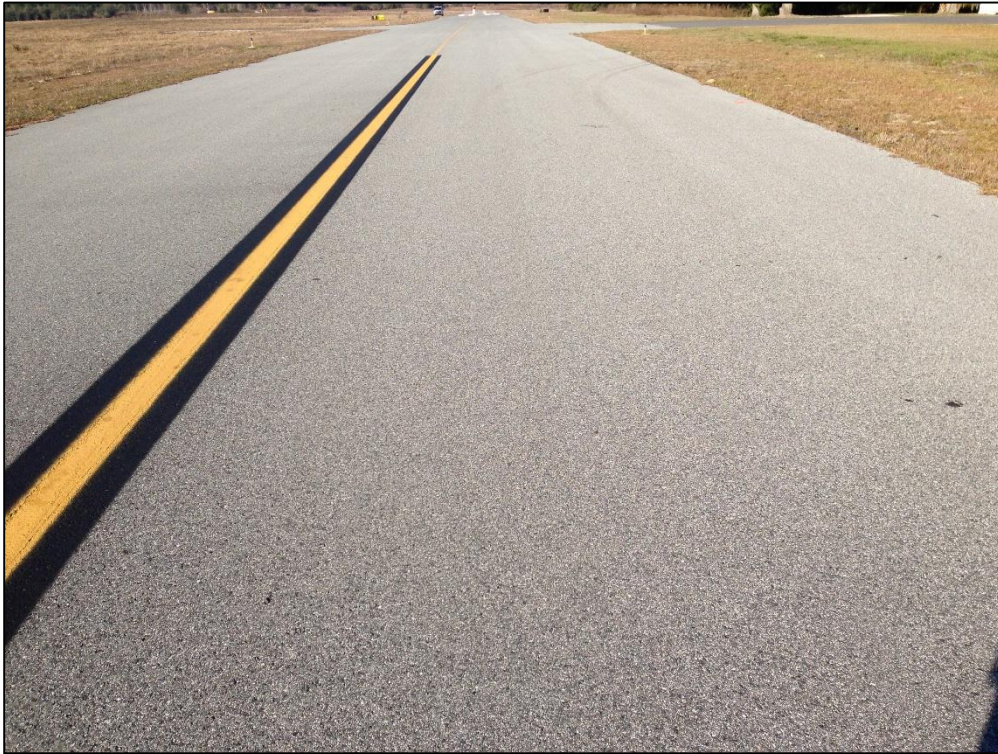
Taxiway Bravo, Section 305, Sample Unit 130 – Low Severity (57) Weathering

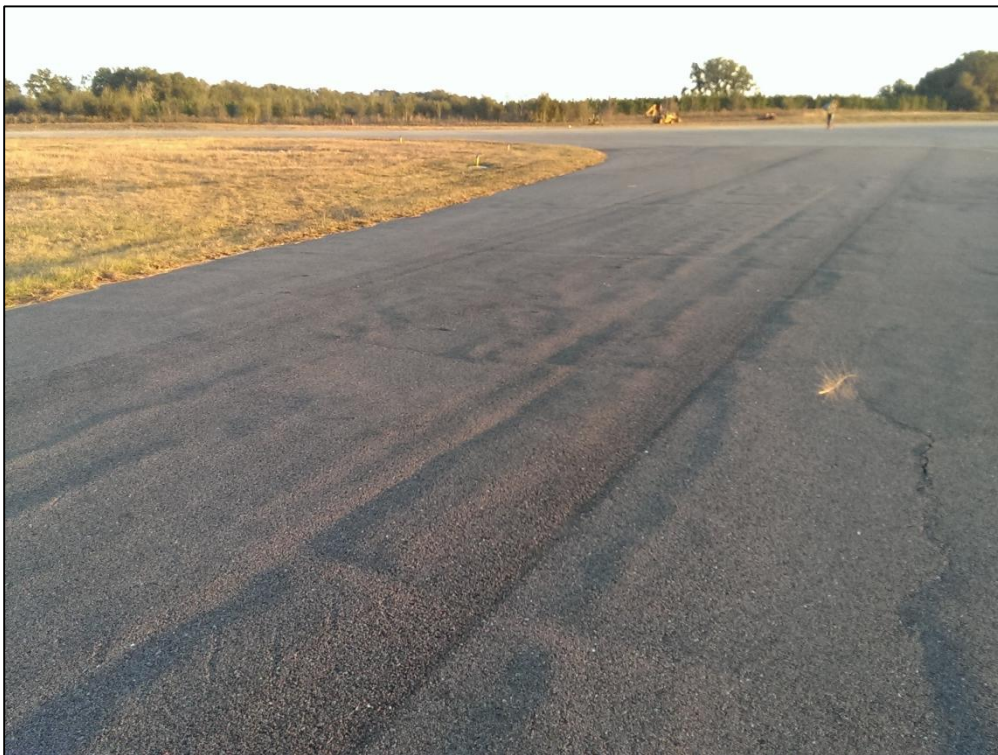
Taxiway Charlie, Section 105, Sample Unit 101 – Low Severity (48) Longitudinal and Transverse Cracking, Low Severity (56) Swelling, Low Severity (57) Weathering

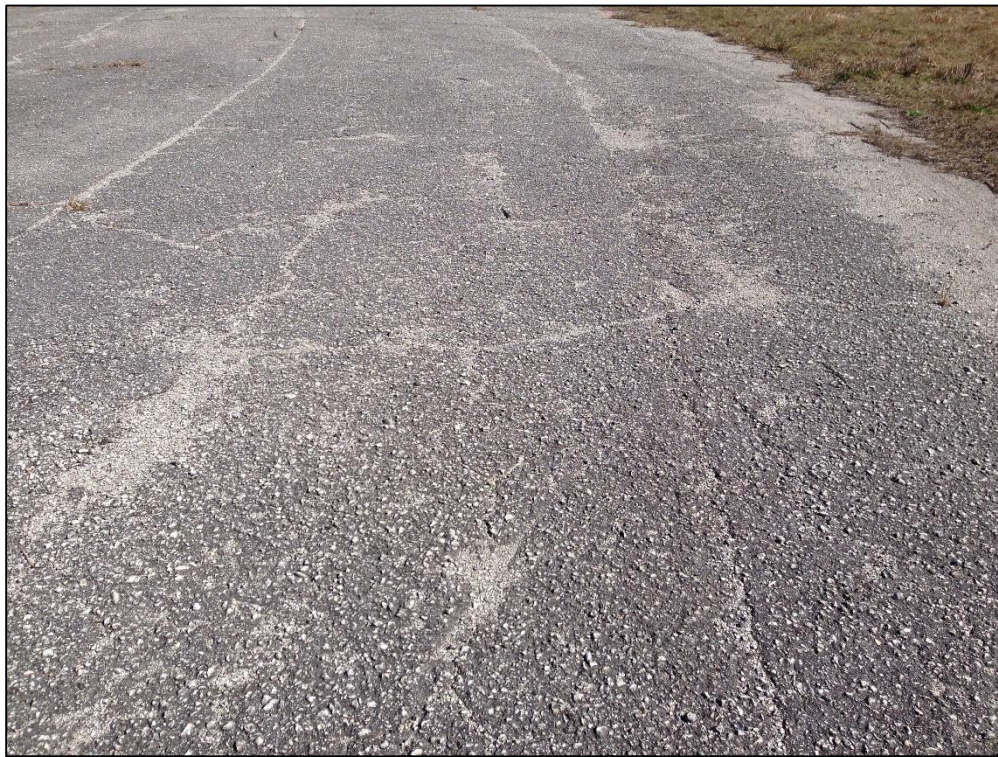
Taxiway Foxtrot, Section 550, Sample Unit 145 – Medium Severity (43) Block Cracking, High Severity (52) Raveling

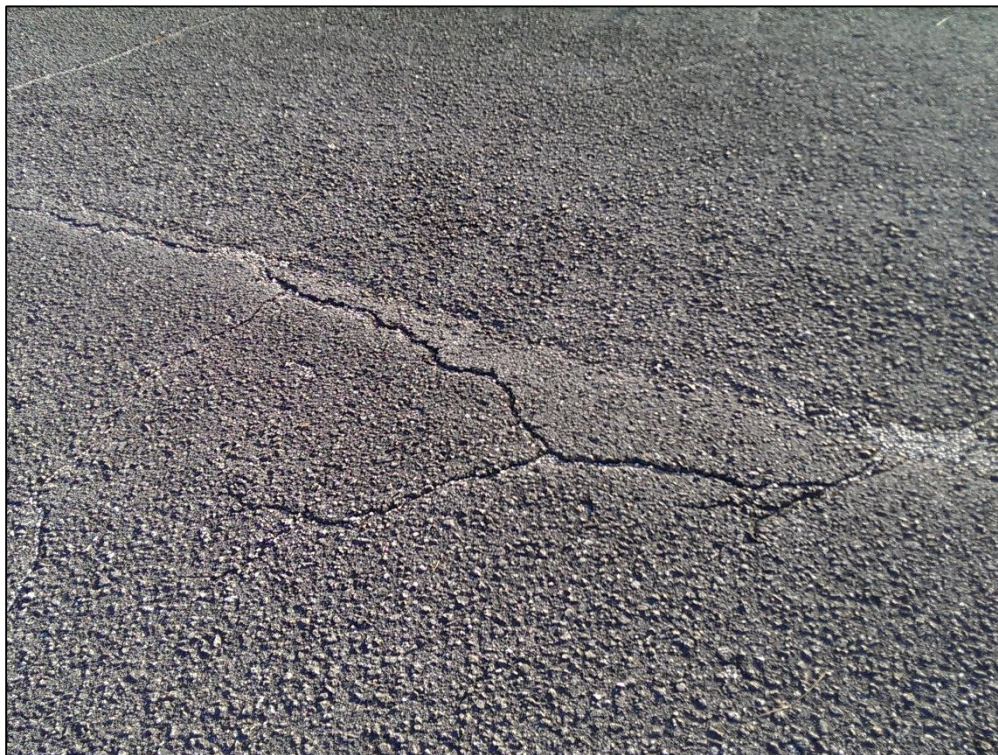
Taxiway Golf, Section 450, Sample Unit 105 – Medium Severity (43) Block Cracking, High Severity (52) Raveling

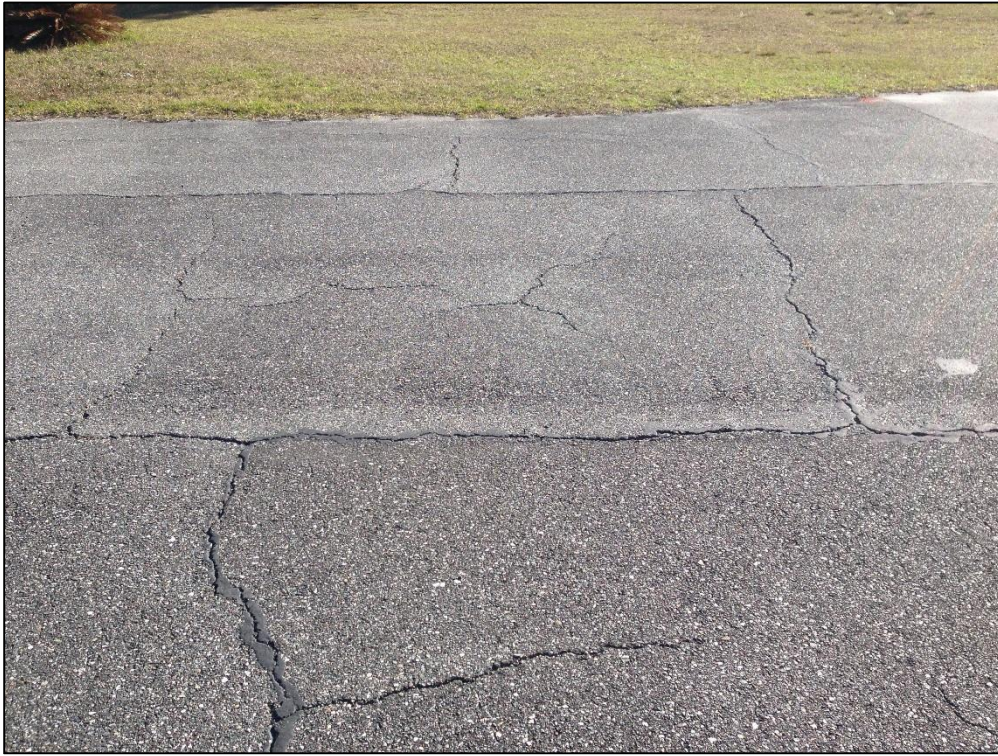
Apron T-Hangars, Section 4315, Sample Unit 100 – Low Severity (48) Longitudinal and Transverse Cracking, Low Severity (52) Raveling

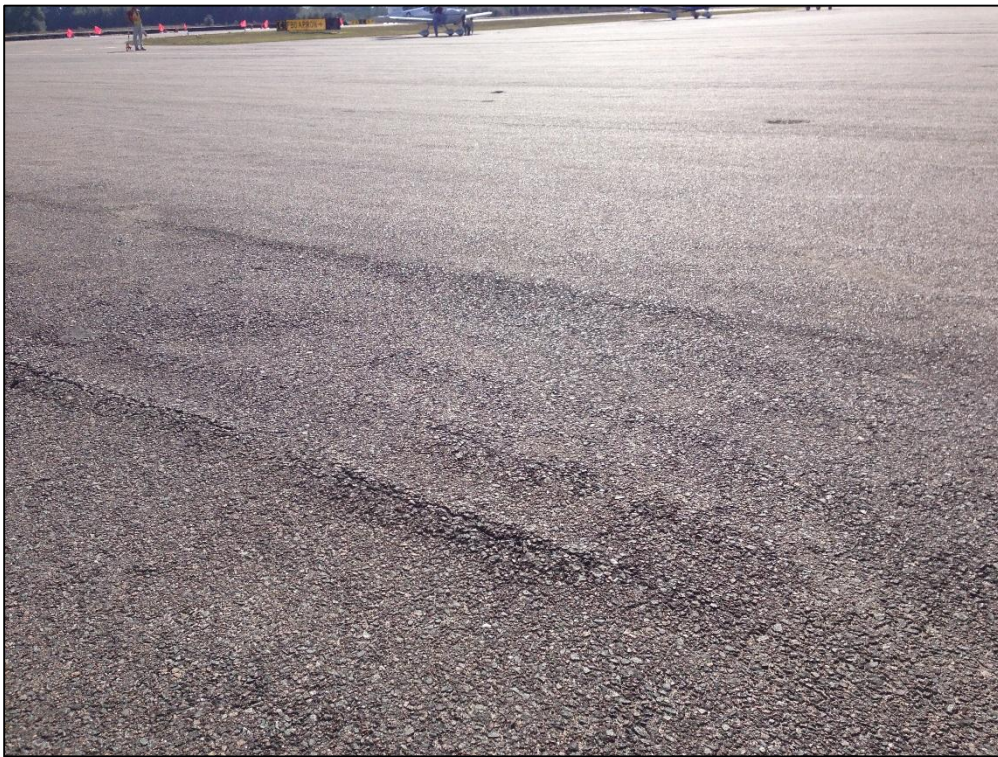
Apron, Section 4105, Sample Unit 300 – Low Severity (48) Longitudinal and Transverse Cracking, Low Severity (56) Swelling, Low Severity (57) Weathering
