Statewide Airfield Pavement Management Program

Airport Pavement Evaluation Report September 2017

Plant City Airport (PCM) General Aviation Airport District 7

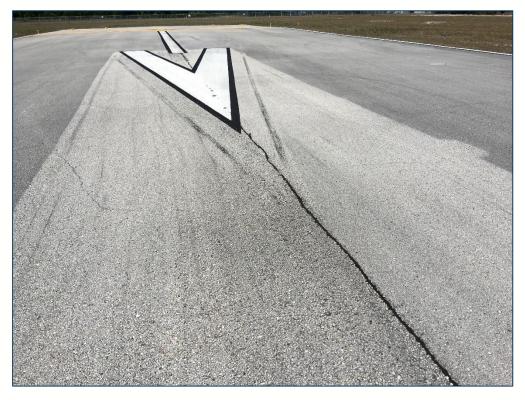
Runway 10-28, Section 6103, Sample Unit 296 – Low Severity (48) Longitudinal and Transverse Cracking, Low Severity (52) Raveling, Medium Severity (52) Raveling,Low Severity (56) Swelling

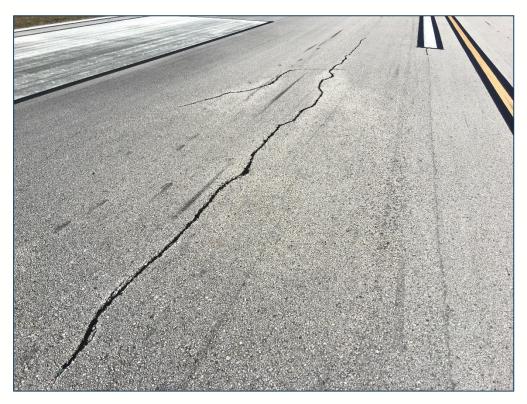
Runway 10-28, Section 6115, Sample Unit 321 – Low Severity (48) Longitudinal and Transverse Cracking, Low Severity (52) Raveling, Medium Severity (52) Raveling

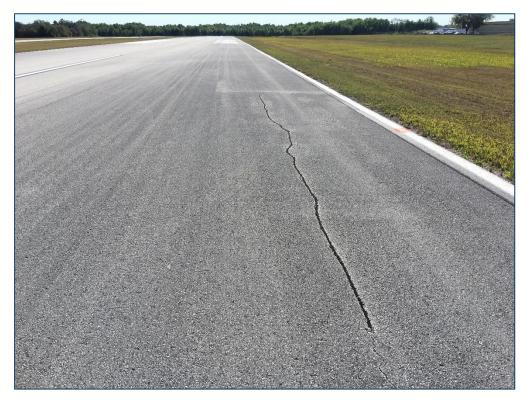
Runway 10-28, Section 6115, Sample Unit 346 – Low Severity (48) Longitudinal and Transverse Cracking, Low Severity (52) Raveling, Medium Severity (52) Raveling

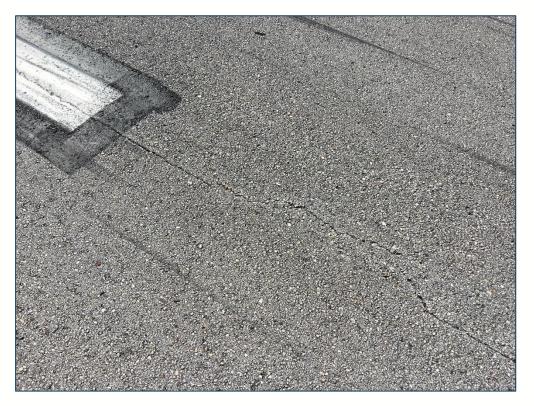
Runway 10-28, Section 6120, Sample Unit 366 – Low Severity (48) Longitudinal and Transverse Cracking, Low Severity (52) Raveling, Medium Severity (52) Raveling

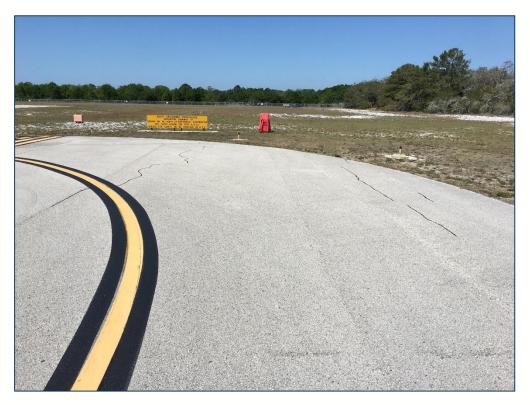
Taxiway A, Section 110, Sample Unit 101 – Low Severity (48) Longitudinal and Transverse Cracking, Low Severity (52) Raveling

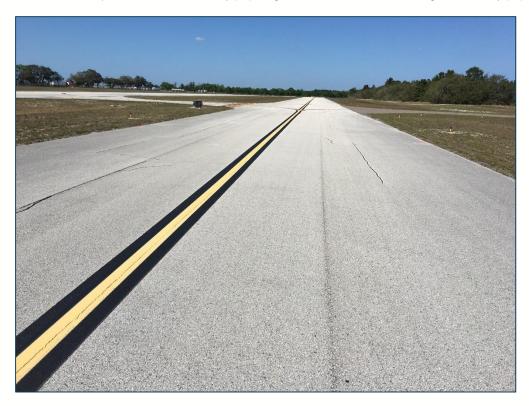
Taxiway A, Section 110, Sample Unit 115 - Low Severity (48) Longitudinal and Transverse Cracking, Low Severity (52) Raveling

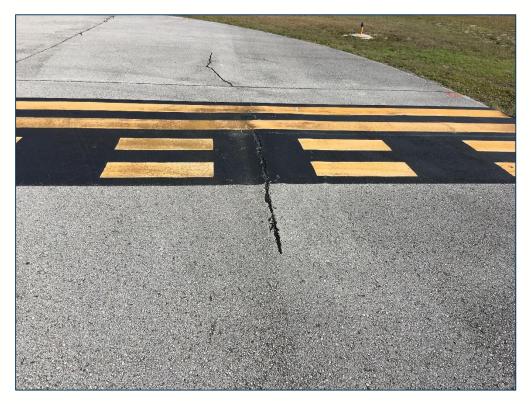
Taxiway A, Section 115, Sample Unit 600 – Medium Severity (48) Longitudinal and Transverse Cracking, Low Severity (52) Raveling, Medium Severity (52) Raveling

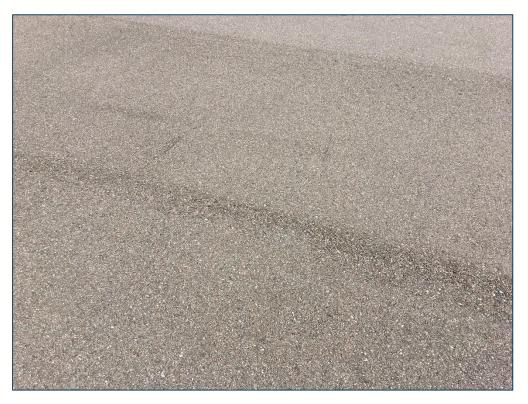
Apron, Section 4105, Sample Unit 502 - Low Severity (52) Raveling, Low Severity (57) Weathering

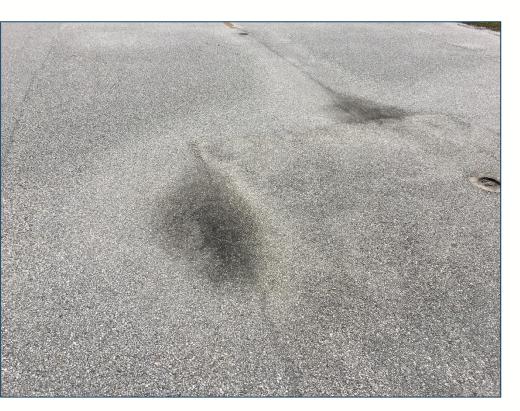
Apron, Section 4135, Sample Unit 111 - Low Severity (45) Depression, Low Severity (52) Raveling

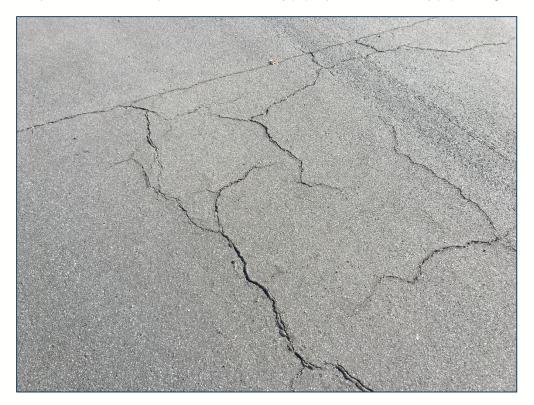
Apron, Section 4130, Sample Unit 610 – Low Severity (43) Block Cracking, Low Severity (48) Longitudinal and Transverse Cracking, Low Severity (57) Weathering

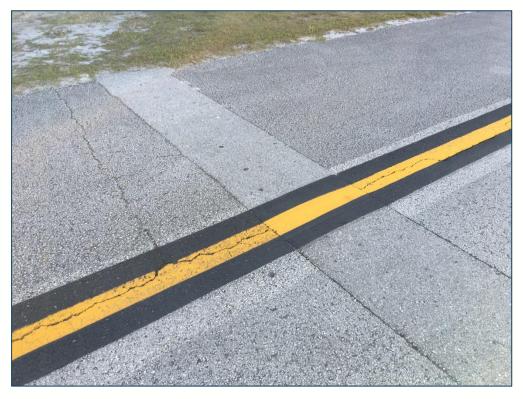
T-Hangars Taxiway, Section 710, Sample Unit 200 – Low Severity (48) Longitudinal and Transverse Cracking, Low Severity (50) Patching, Low Severity (52) Raveling, Medium Severity (52) Raveling
