# Statewide Airfield Pavement Management Program

Airport Pavement  
Evaluation Report  
September 2017

**Airglades Airport (2IS)**  
General Aviation Airport  
District 1

*Florida Department of Transportation*

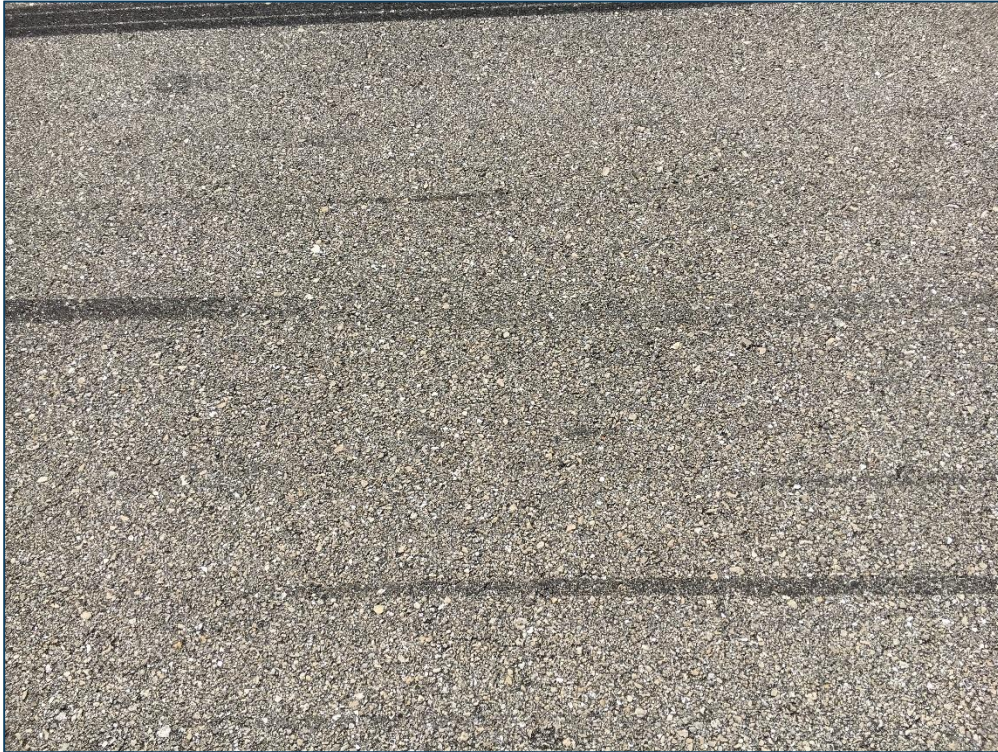
Runway 13-31, Section 6103, Sample Unit 80 – Low Severity (57) Weathering

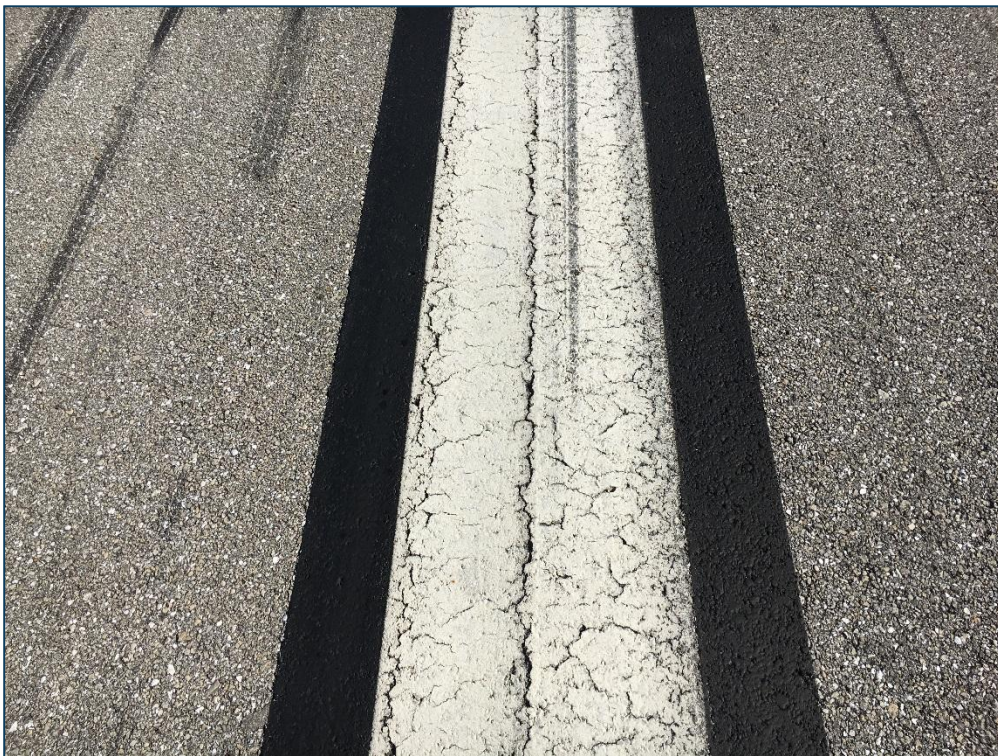
Runway 13-31, Section 6110, Sample Unit 176 – Low Severity (48) Longitudinal and Transverse Cracking, Low Severity (57) Weathering

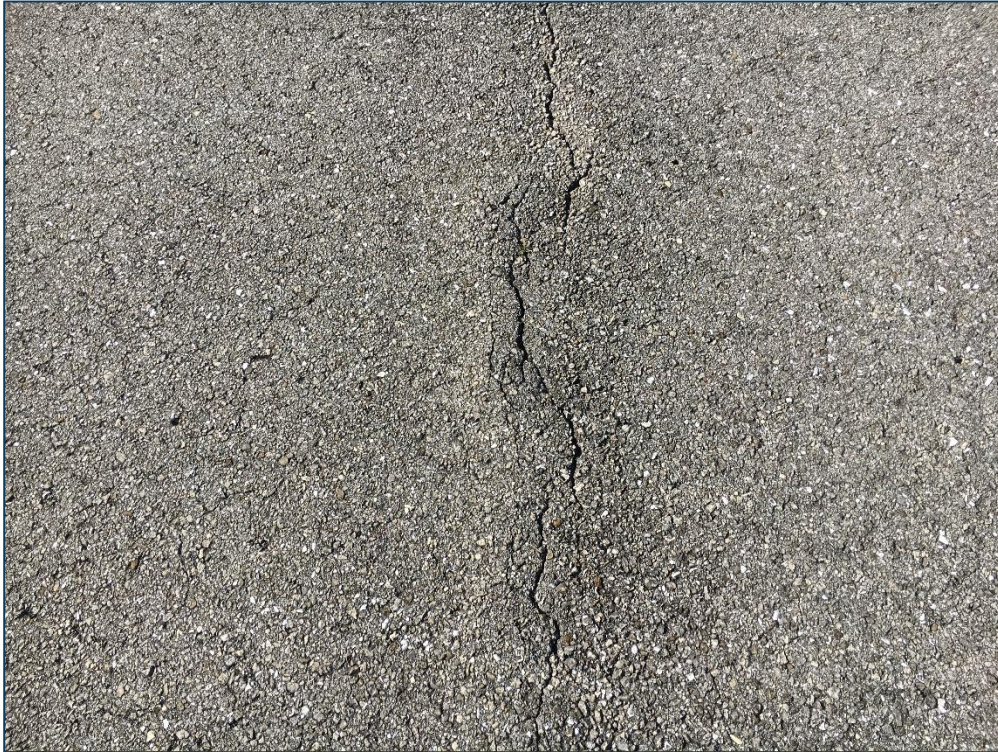
Taxiway A, Section 103, Sample Unit 112 – Low Severity (48) Longitudinal and Transverse Cracking, Low Severity (56) Swelling, Low Severity (57) Weathering

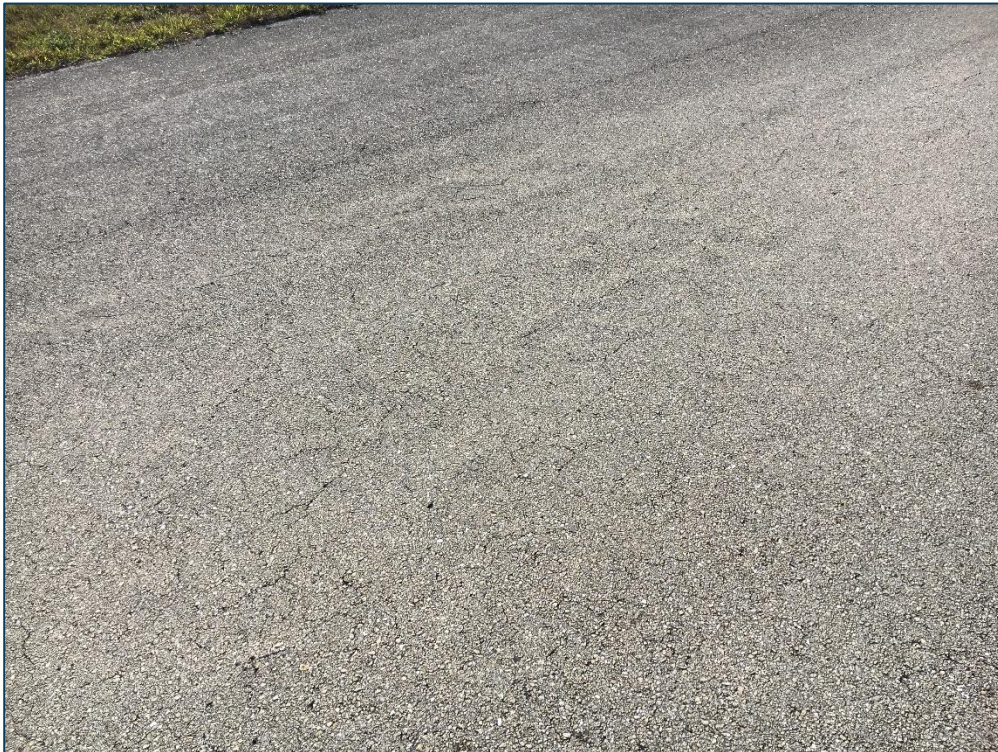
Taxiway A, Section 105, Sample Unit 108 – Low Severity (48) Longitudinal and Transverse Cracking, Low Severity (56) Swelling, Low Severity (57) Weathering

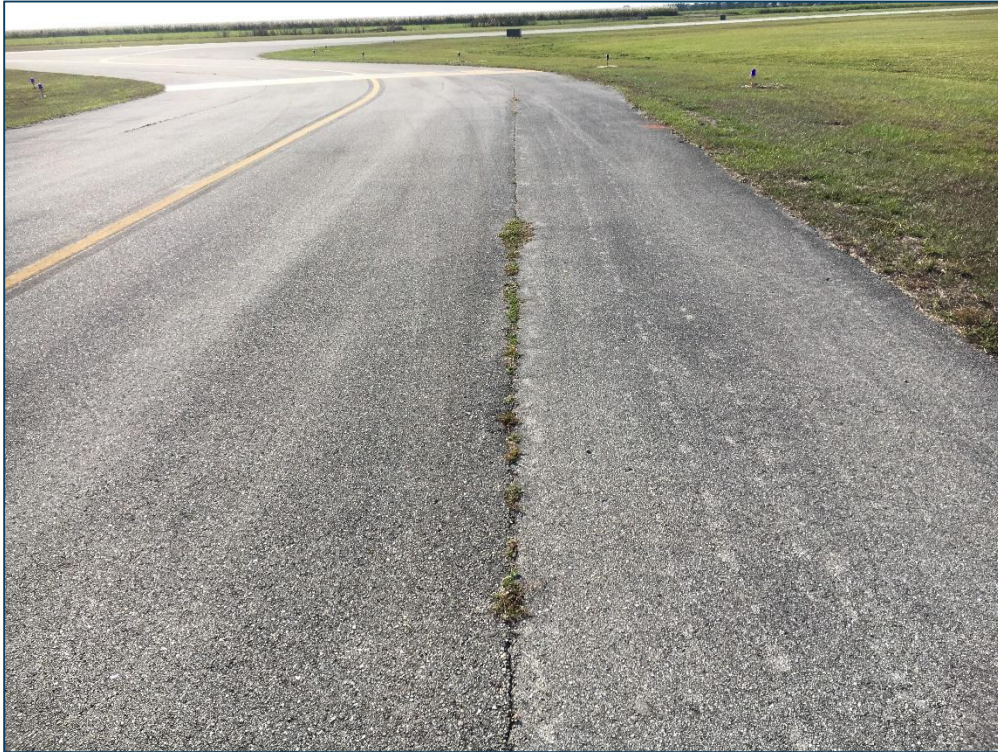
Taxiway A1, Section 104, Sample Unit 102 – Medium Severity (48) Longitudinal and Transverse Cracking, Low Severity (52) Raveling, Low Severity (57) Weathering

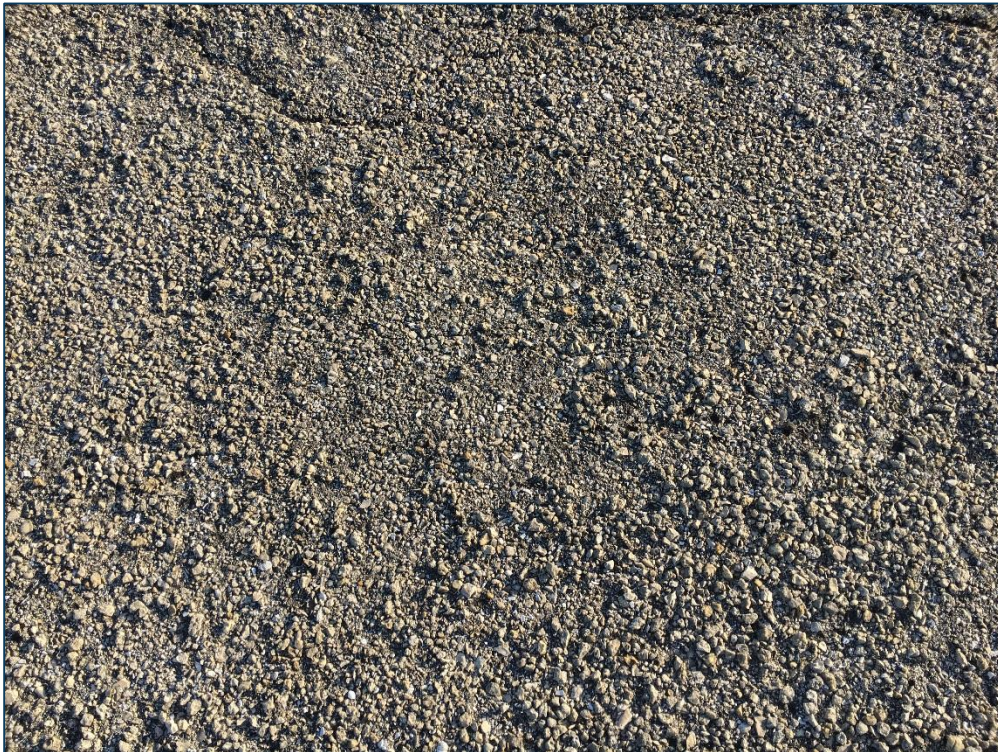
Taxiway A2, Section 210, Sample Unit 109 – Low Severity (48) Longitudinal and Transverse Cracking, Low Severity (52) Raveling, Medium Severity (52) Raveling

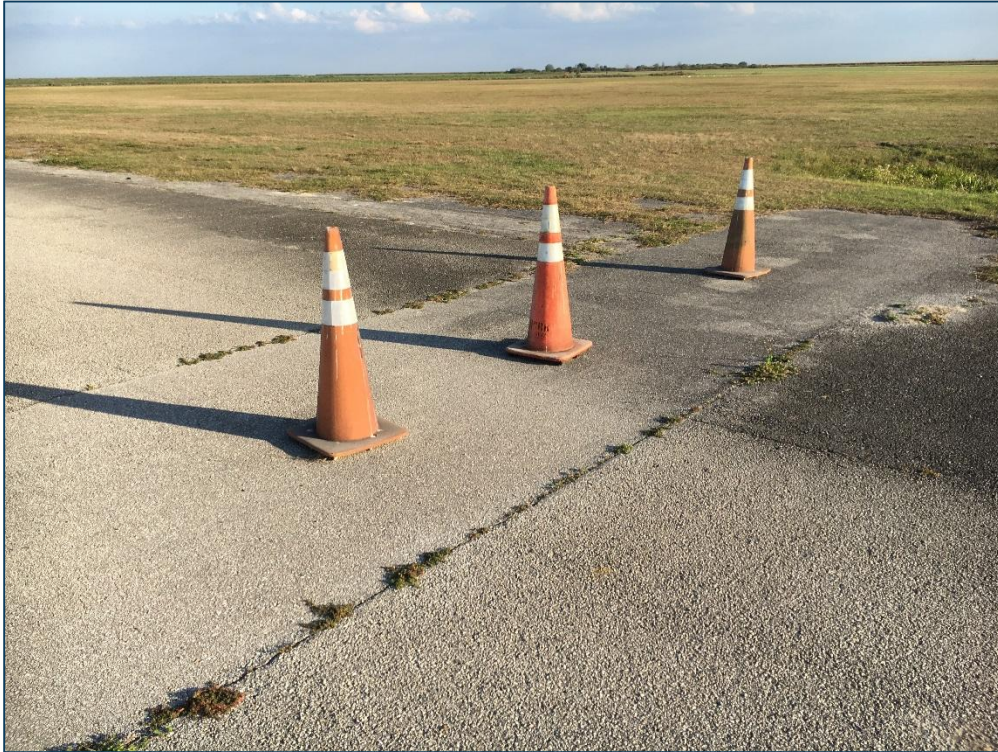
Taxiway A2, Section 215, Sample Unit 112 – Low Severity (48) Longitudinal and Transverse Cracking, Low Severity (50) Patching, Medium Severity (52) Raveling

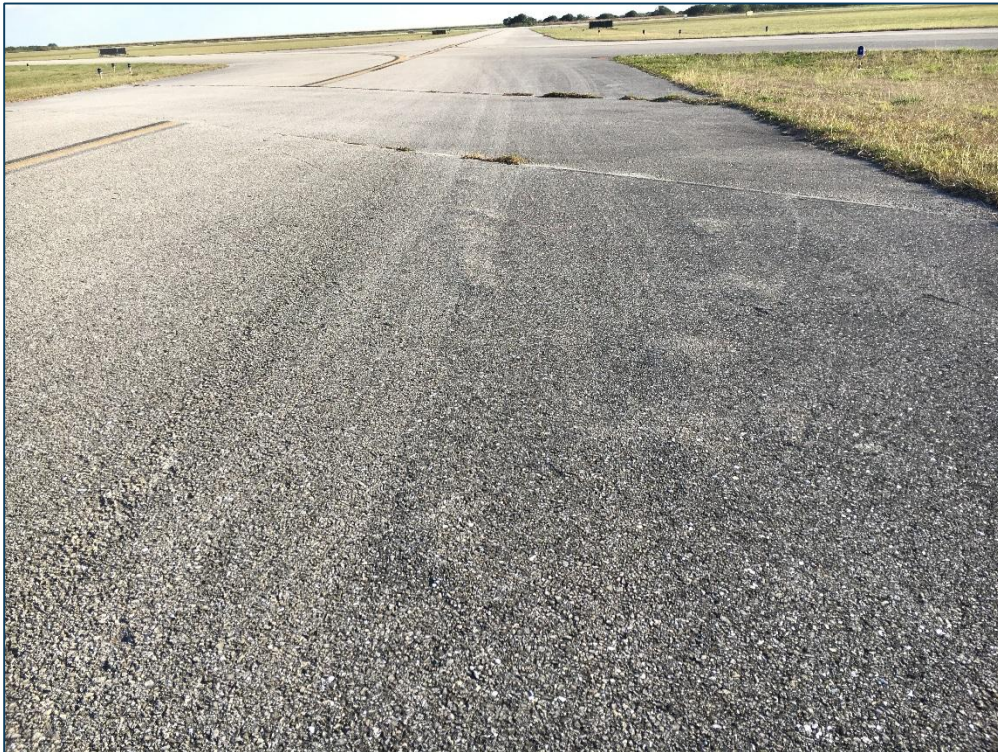
Taxiway A3, Section 410, Sample Unit 108 – Low Severity (50) Patching, Low Severity (52) Raveling, Medium Severity (52) Raveling, Low Severity (56) Swelling

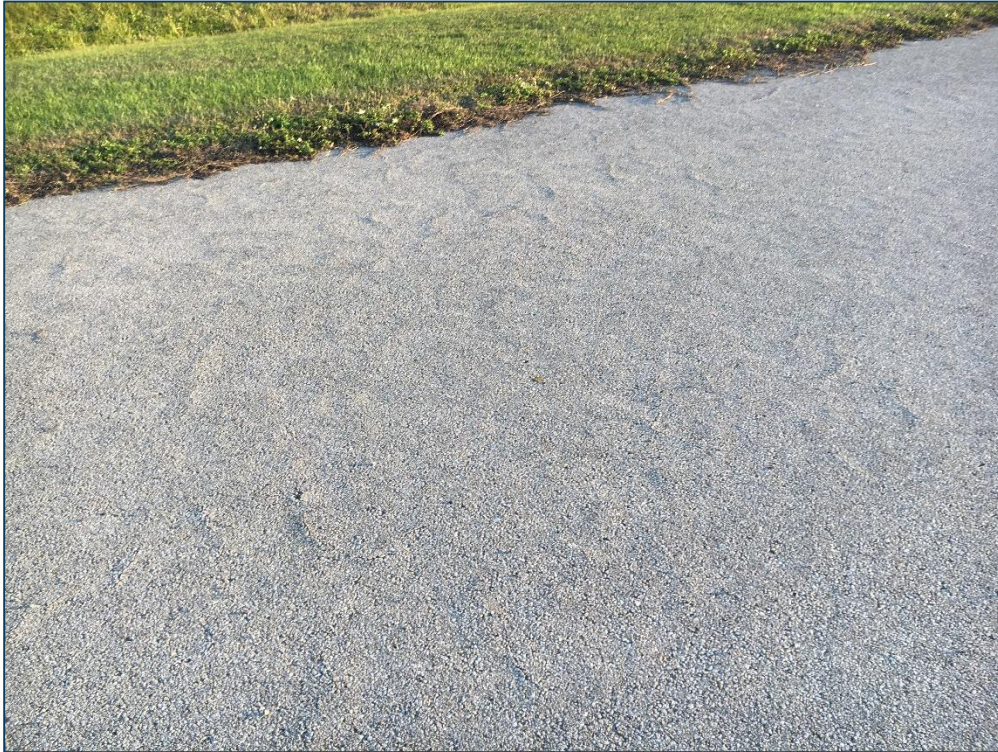
Taxiway to East Apron, Section 710, Sample Unit 101 – Low Severity (48) Longitudinal and Transverse Cracking, Low Severity (52) Raveling

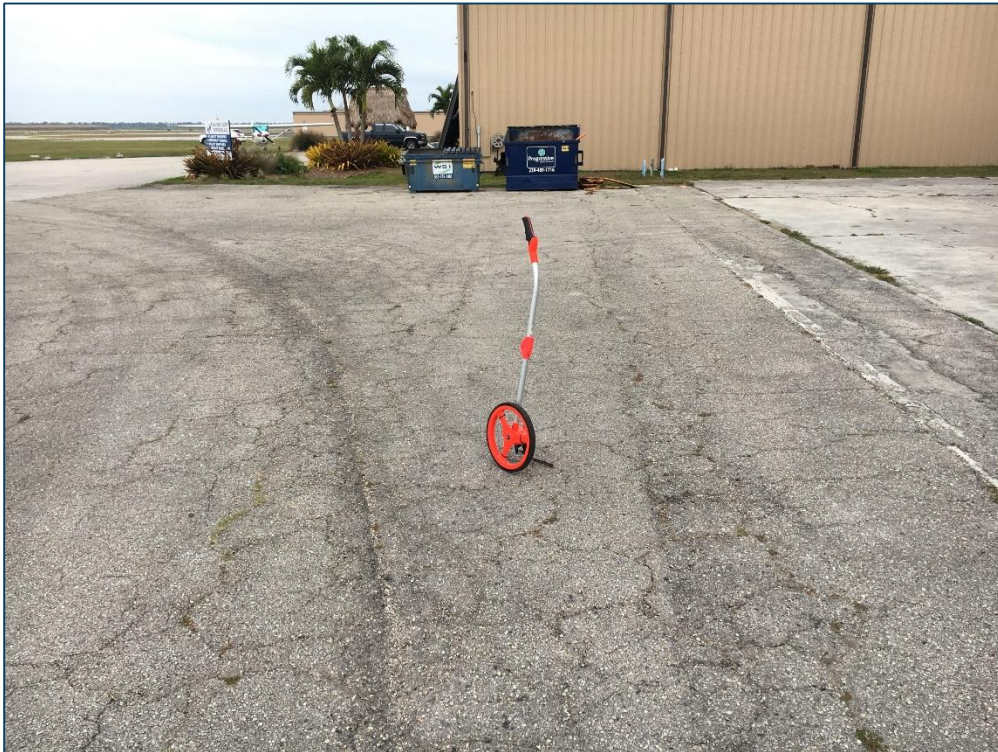
Taxiway to Hangar, Section 405, Sample Unit 104 – Low Severity (41) Alligator Cracking, Low Severity (43) Block Cracking, Low Severity (45) Depression, Low Severity (52) Raveling, Medium Severity (52) Raveling

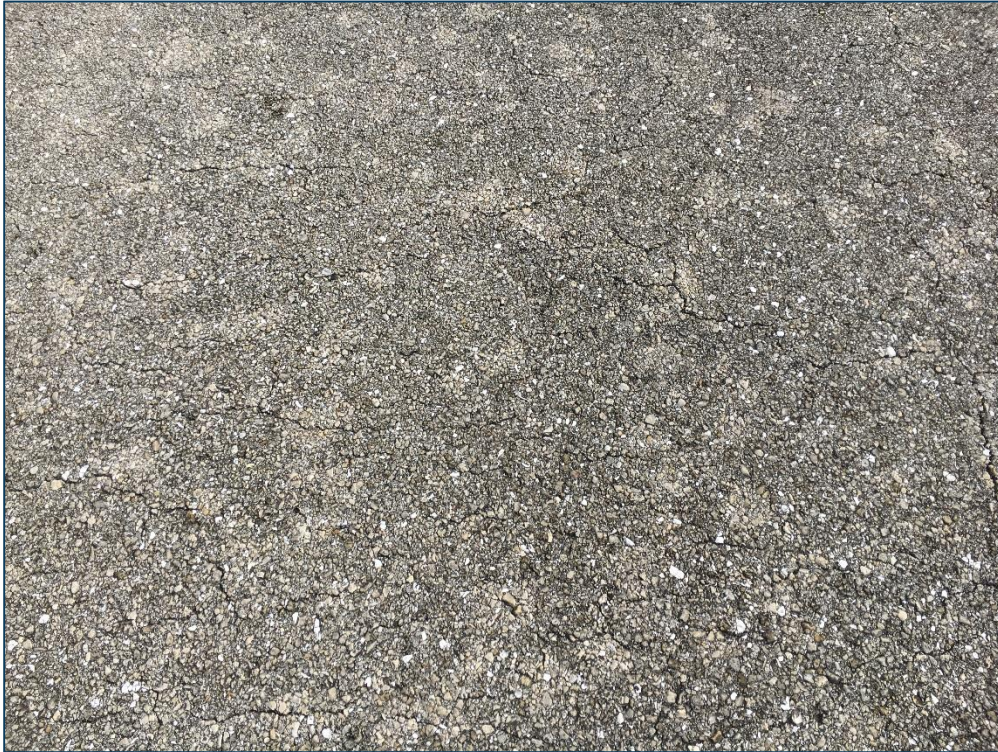
Taxiway S, Section 605, Sample Unit 101 – Low Severity (48) Longitudinal and Transverse Cracking, Low Severity (52) Raveling

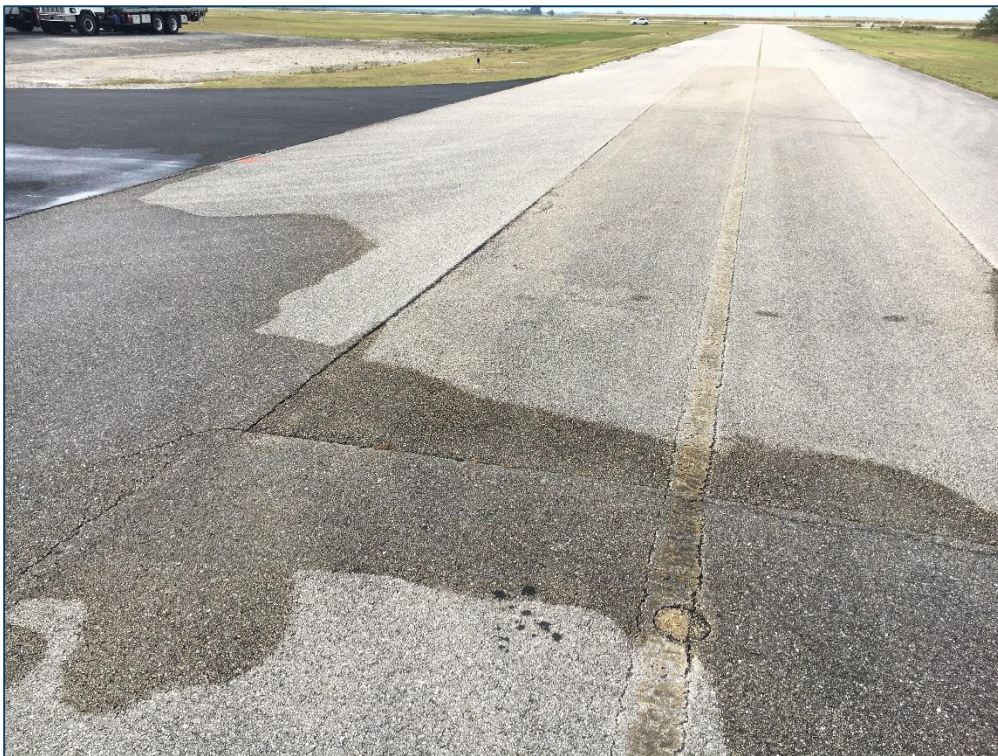
Taxiway S, Section 605, Sample Unit 109 – Low Severity (48) Longitudinal and Transverse Cracking, Low Severity (50) Patching,  
Low Severity (52) Raveling

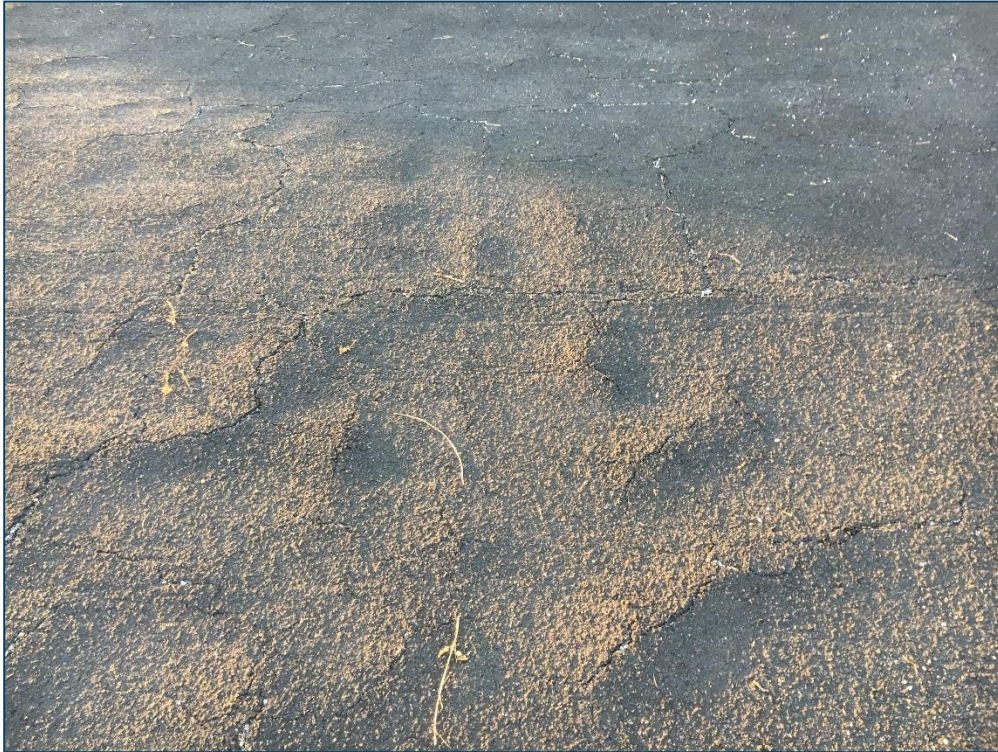
East Apron, Section 4505, Sample Unit 200 – Low Severity (43) Block Cracking, Low Severity (52) Raveling, Low Severity (56) Swelling

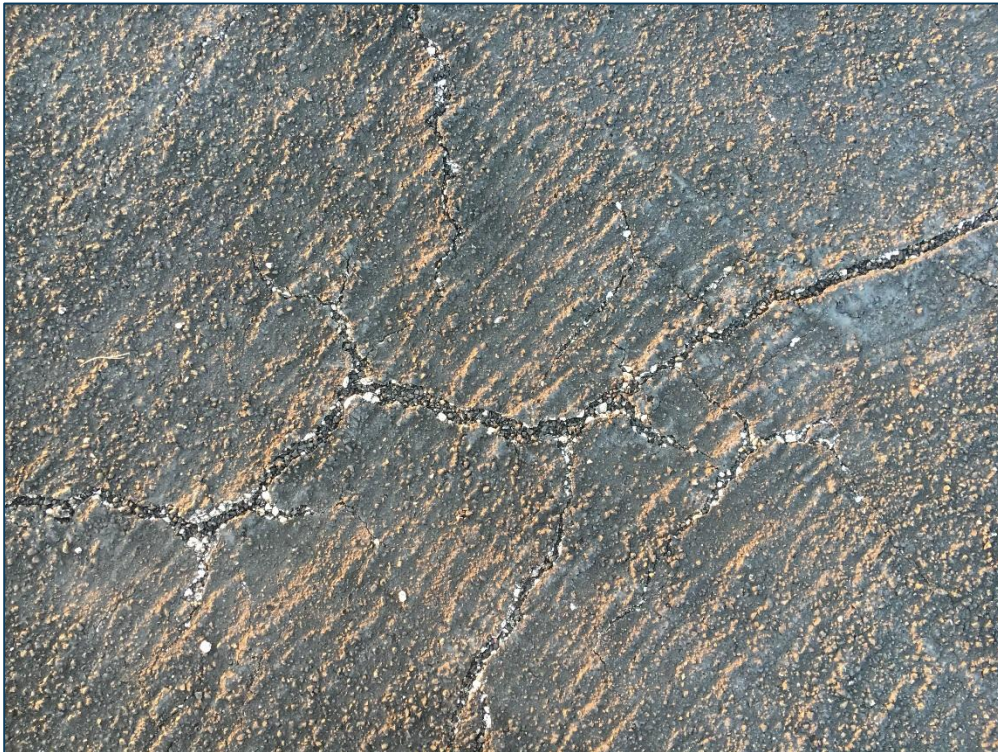
East Apron, Section 4505, Sample Unit 200 – Low Severity (43) Block Cracking, Low Severity (52) Raveling

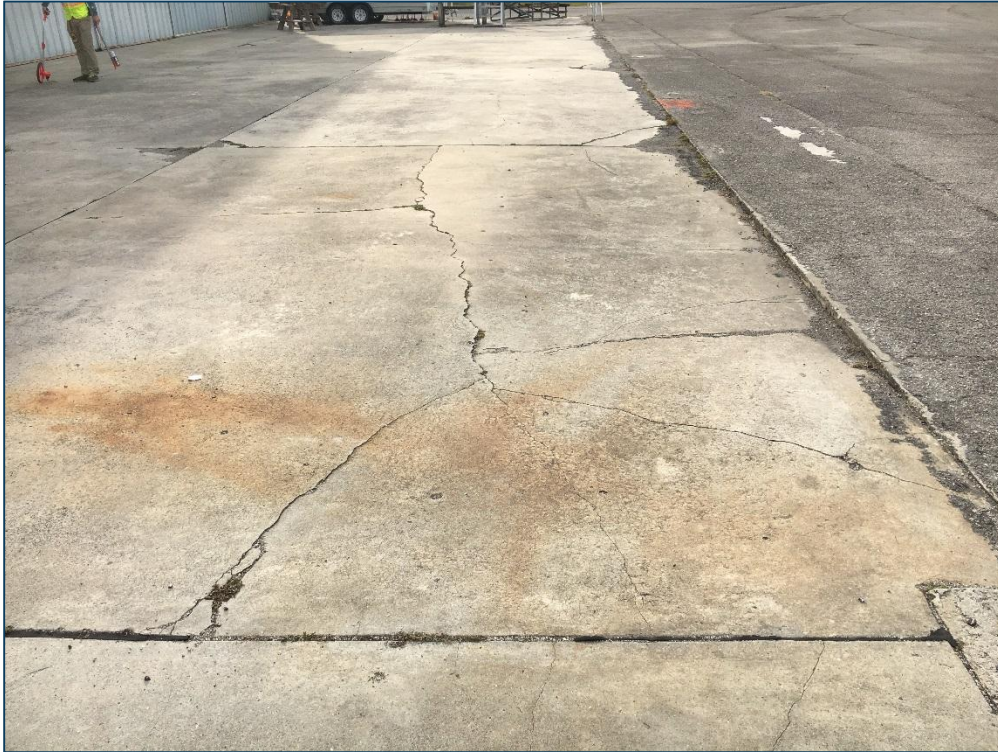
Apron Hangar, Section 4205, Sample Unit 100 – Medium Severity (72) Shattered Slab, High Severity (71) Faulting, Medium Severity (65) Joint Seal Damage

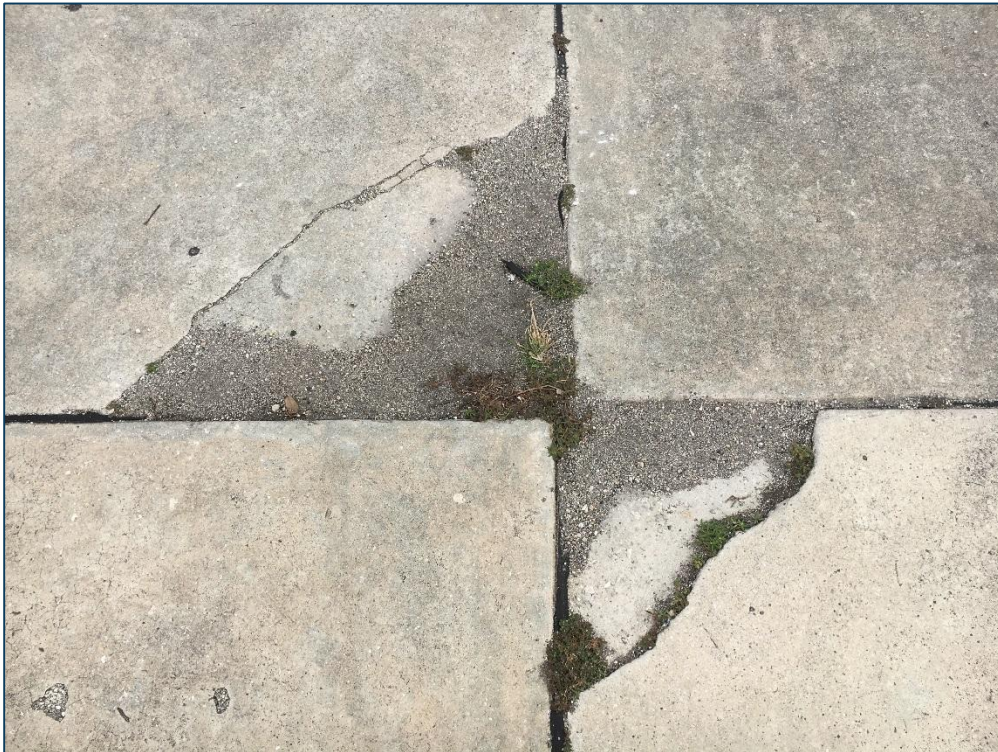
Apron Hangar, Section 4205, Sample Unit 100 – High Severity (62) Corner Break, Medium Severity (65) Joint Seal Damage

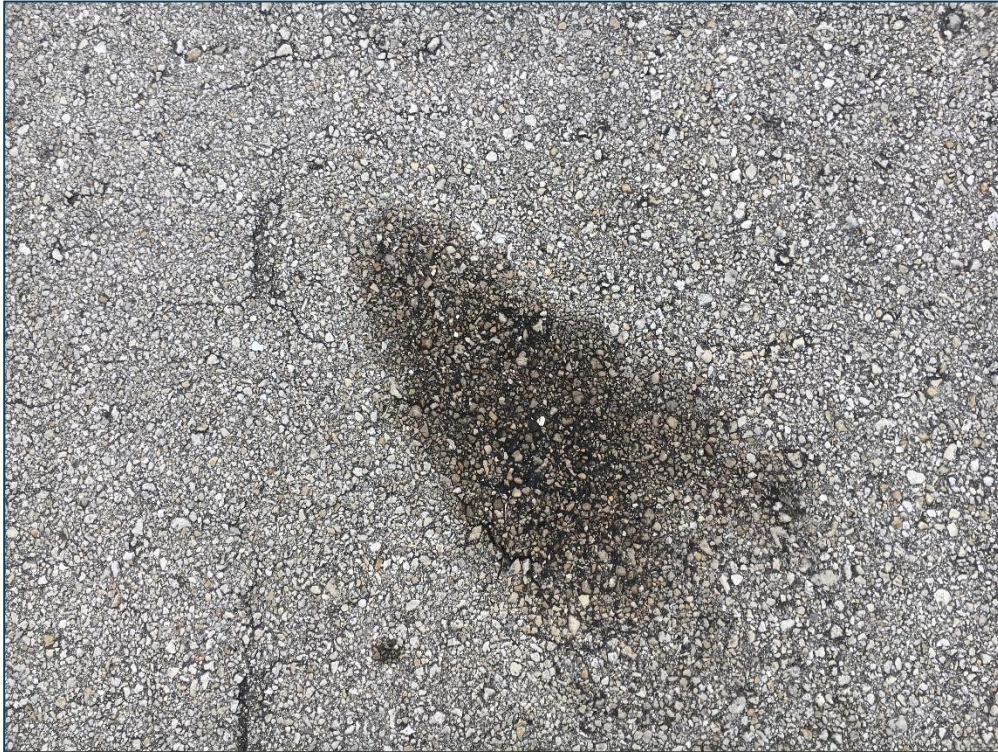
Apron Hangar, Section 4210, Sample Unit 201 – (49) Oil Spillage, Low Severity (57) Weathering

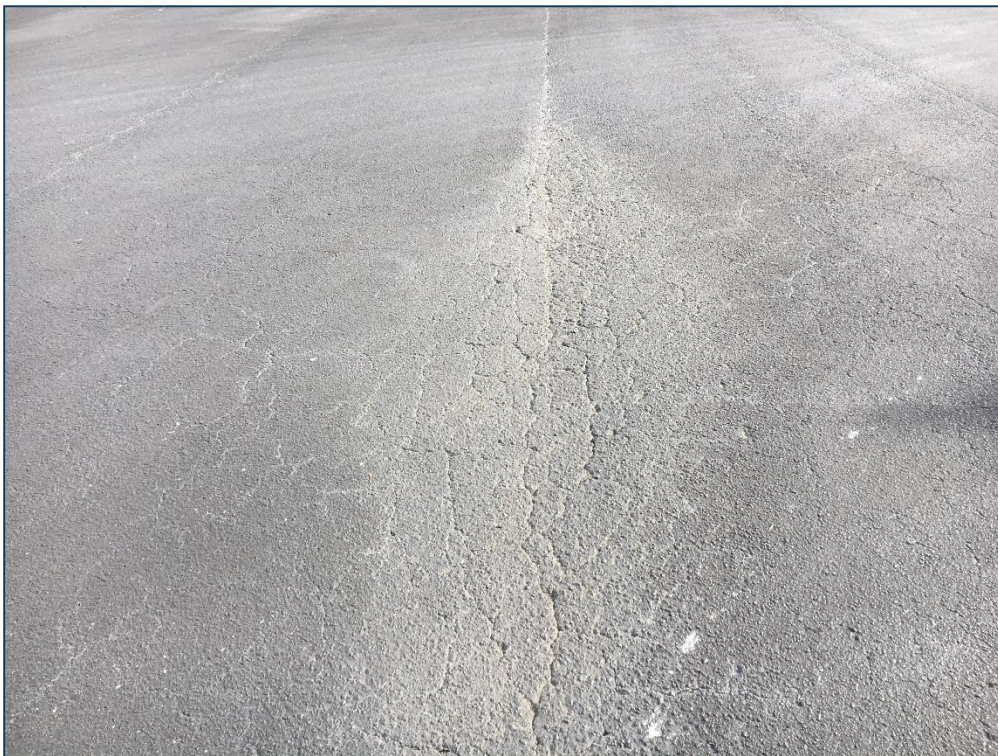
Apron NW, Section 4405, Sample Unit 304 – Medium Severity (41) Alligator Cracking, Low Severity (52) Raveling, Low Severity (53) Rutting

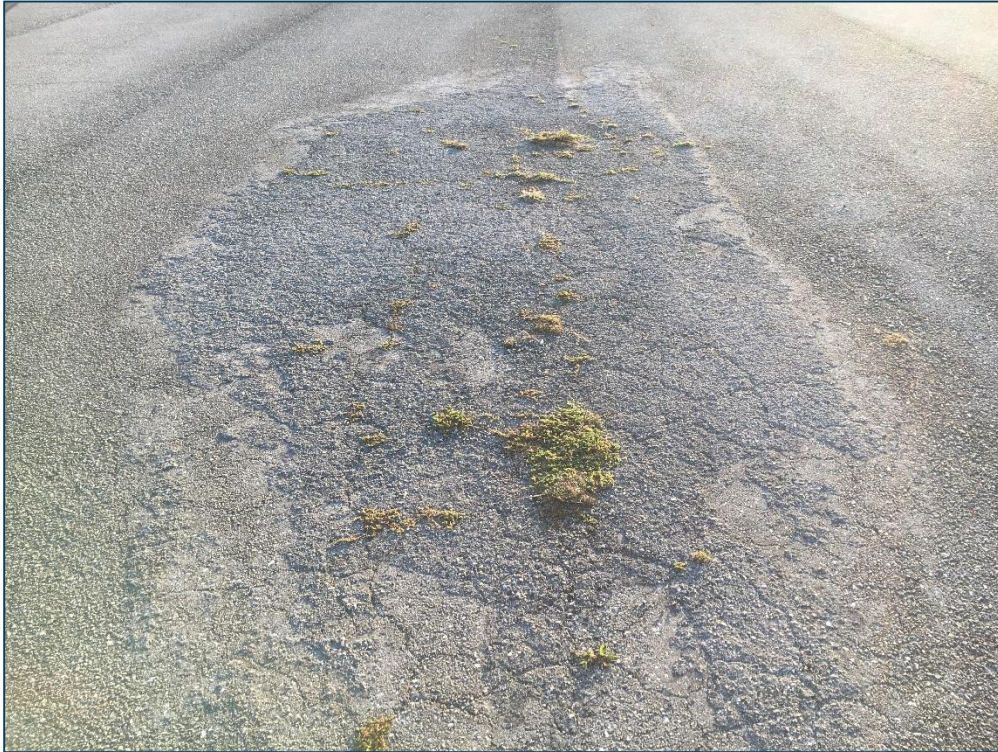
South Apron, Section 4305, Sample Unit 201 – High Severity (52) Raveling

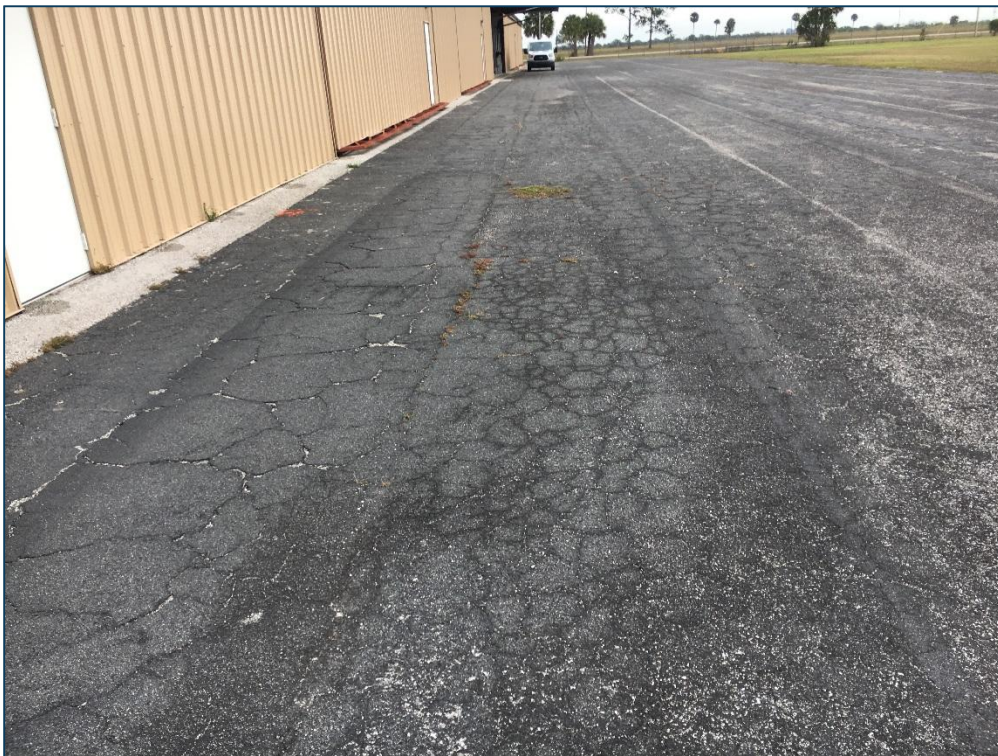
West Apron, Section 4105, Sample Unit 150 – Low Severity (41) Alligator Cracking, Low and Medium Severity (52) Raveling

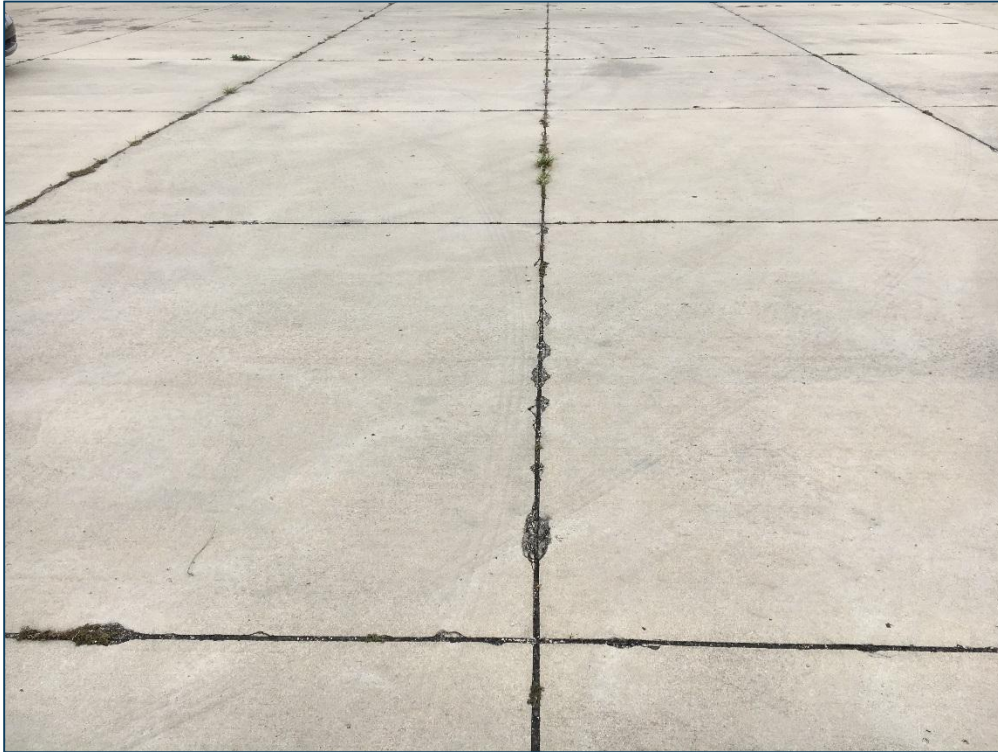
West Apron, Section 4110, Sample Unit 98 – Low Severity (74) Joint Spalling, High Severity (65) Joint Seal Damage

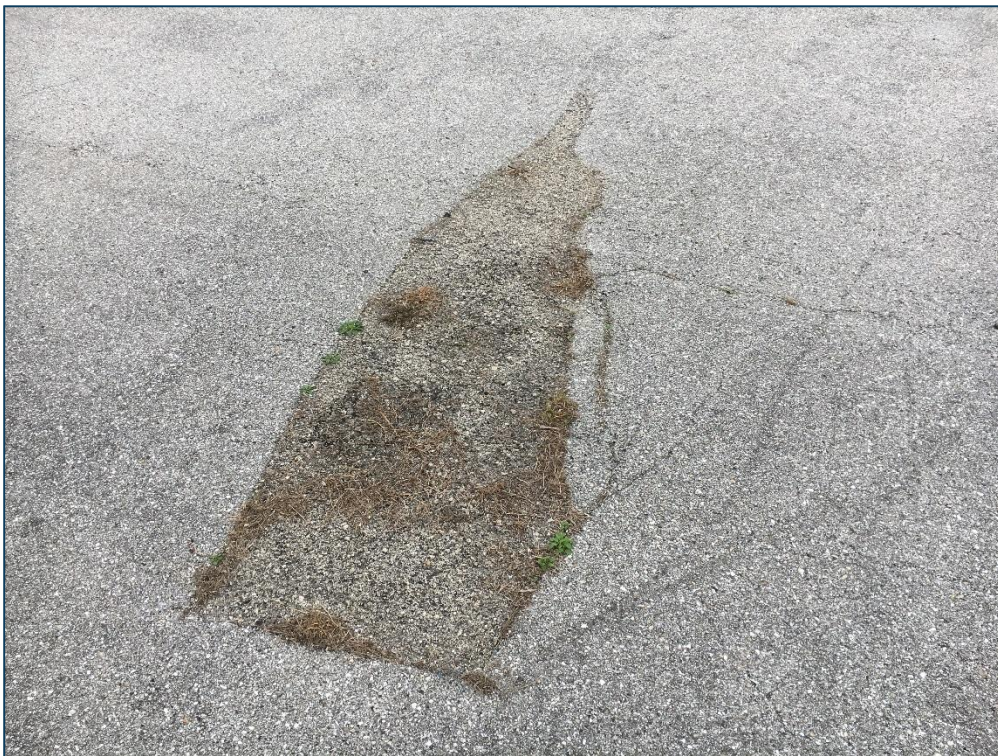
West Apron, Section 4115, Sample Unit 102 – High Severity (50) Patching, Low Severity (52) Raveling
