FLORIDA DEPARTMENT OF TRANSPORTATION AVIATION AND SPACEPORTS OFFICE

Statewide Airfield Pavement Management Program

Airport Pavement Evaluation Report September 2017

Quincy Municipal Airport (2J9) General Aviation Airport District 3

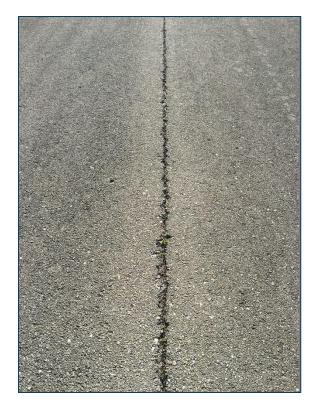
Runway 14-32, Section 6105, Sample Unit 154 – Medium Severity (48) Longitudinal and Transverse Cracking, Low Severity (52) Raveling, Low Severity (57) Weathering

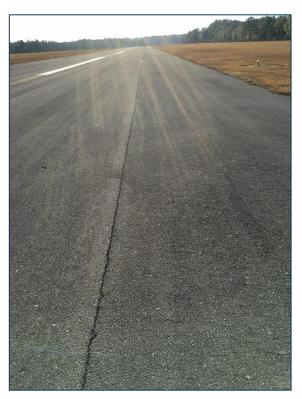
Runway 14-32, Section 6105, Sample Unit 114 – Low and Medium Severity (48) Longitudinal and Transverse Cracking, Low Severity (52) Raveling, Low Severity (57) Weathering

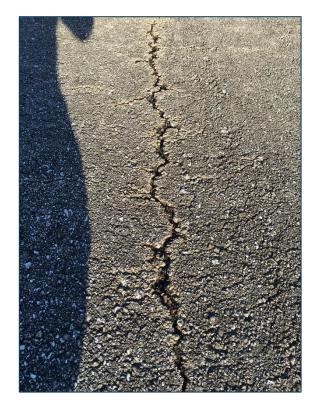
Runway 14-32, Section 6110, Sample Unit 105 – Medium Severity (48) Longitudinal and Transverse Cracking, Low Severity (52) Raveling, Low Severity (57) Weathering

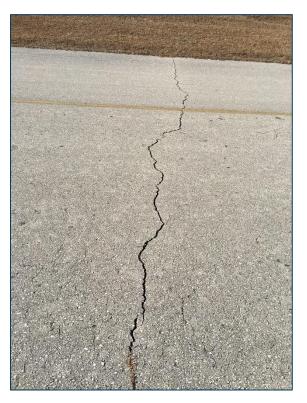
Taxiway Hangar, Section 115, Sample Unit 100 – Low and Medium Severity (48) Longitudinal and Transverse Cracking, Low Severity (52) Raveling, Low Severity (57) Weathering

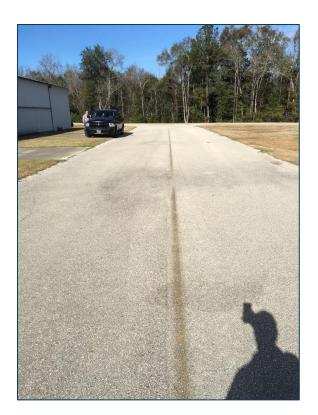
Taxiway Hangar, Section 125, Sample Unit 202 – Low Severity (45) Depression, Medium Severity (45) Depression, Low Severity (48) Longitudinal and Transverse Cracking, Low Severity (52) Raveling, Low Severity (57) Weathering

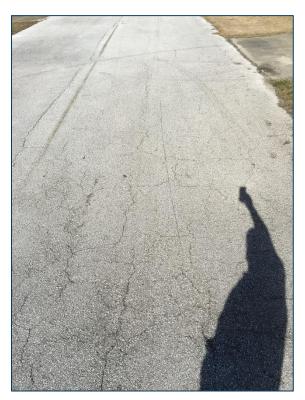
Taxiway Hangar, Section 130, Sample Unit 203 – Low Severity (43) Block Cracking, Low Severity (48) Longitudinal and Transverse Cracking, Low Severity (52) Raveling, Medium Severity (52) Raveling
