# Statewide Airfield Pavement Management Program

#### Summary of Peter Prince Field

Peter Prince Field was inspected in March 2017 - the overall weighted PCI value was 75, a condition rating of Satisfactory. The results of the maintenance, repair, and major rehabilitation analysis identified \$551.610 in localized M&R needs based on current conditions and a 10-Year major rehabilitation need of \$5,094,000 based on forecasted conditions. The current major rehabilitation needs based on the latest inspection consist of \$4,411,000 for pavements below critical condition.

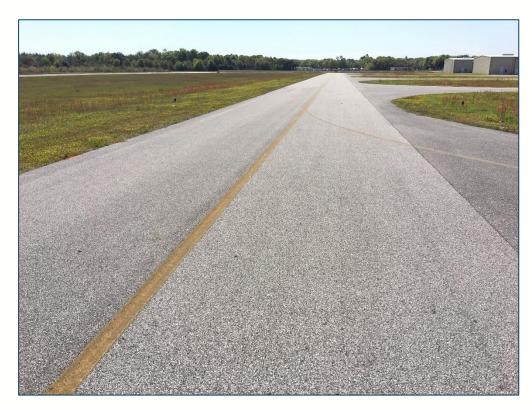
Taxiway A, Section 510, Sample Unit 103 - Low Severity (52) Raveling

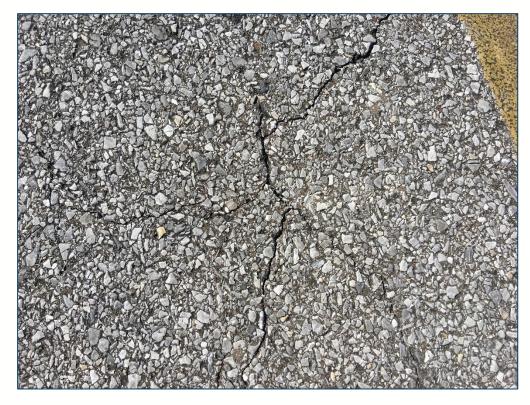
Taxiway A, Section 105, Sample Unit 101 - Low Severity (48) Longitudinal and Transverse Cracking, Low Severity (52) Raveling, Medium Severity (52) Raveling

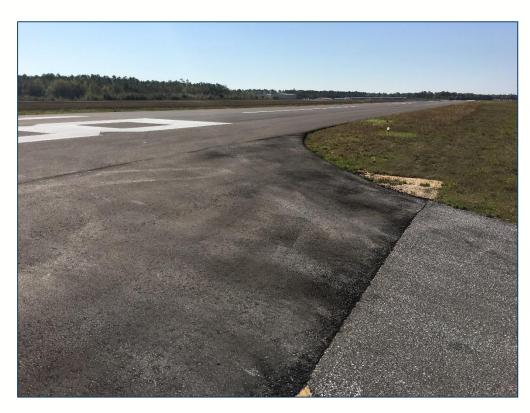
Taxiway A, Section 115, Sample Unit 110 - Low Severity (50) Patching, Low Severity (52) Raveling

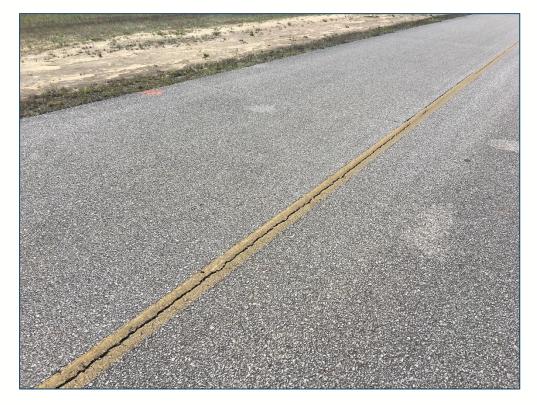
Taxiway B, Section 205, Sample Unit 103 - Low and Medium Severity (48) Longitudinal and Transverse Cracking, Low Severity (52) Raveling

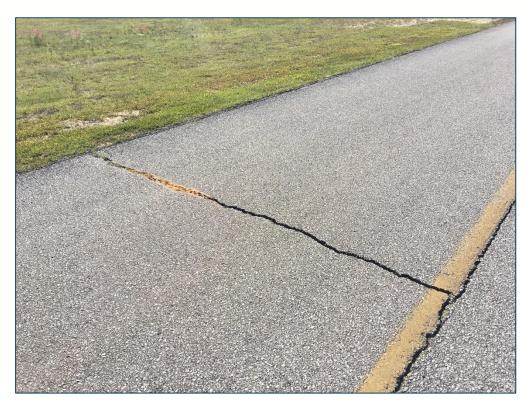
Taxiway B, Section 205, Sample Unit 111 - Low and Medium Severity (48) Longitudinal and Transverse Cracking, Low Severity (52) Raveling

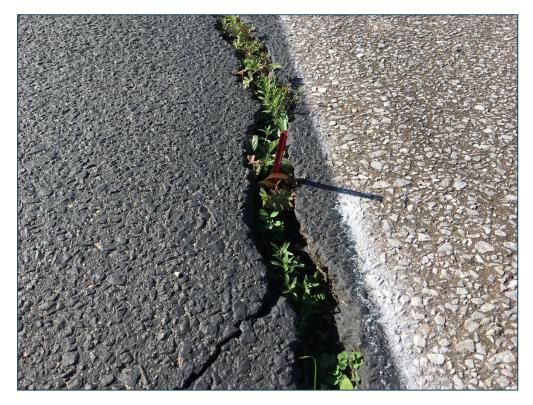
Taxiway B, Section 205, Sample Unit 120 - Low Severity (48) Longitudinal and Transverse Cracking, High Severity (48) Longitudinal and Transverse Cracking, Low Severity (52) Raveling

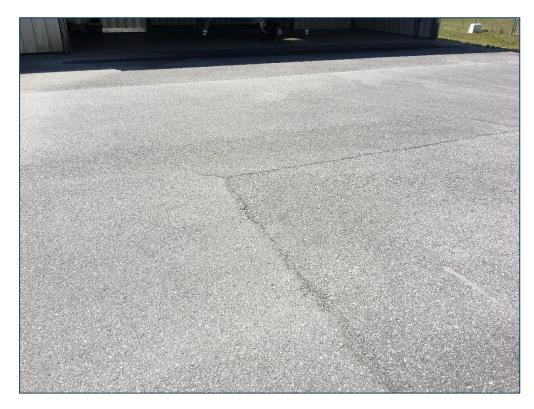
Apron West, Section 4130, Sample Unit 108 - Low Severity (48) Longitudinal and Transverse Cracking, Low Severity (50) Patching, Low Severity (52) Raveling, Low Severity (57) Weathering

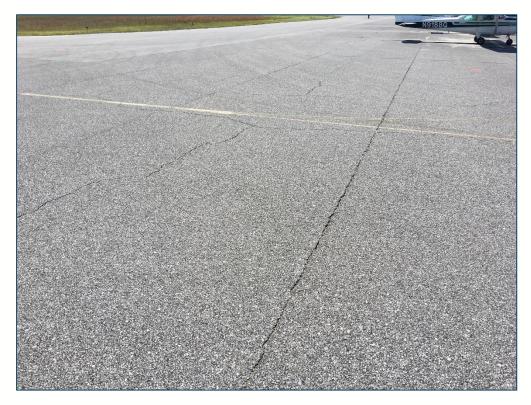
Apron West, Section 4110, Sample Unit 106 - Low and Medium Severity (48) Longitudinal and Transverse Cracking, Low Severity (52) Raveling, Medium Severity (52) Raveling

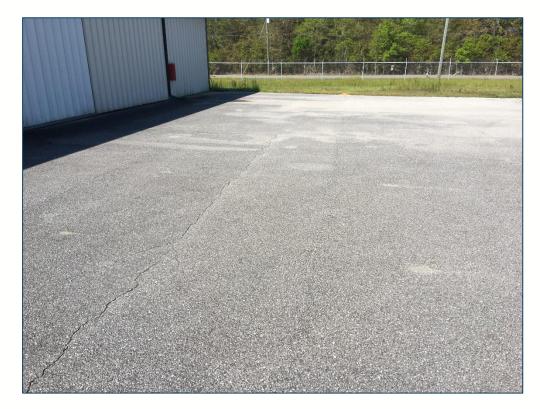
Apron West, Section 4125, Sample Unit 300 - Low Severity (48) Longitudinal and Transverse Cracking, Low Severity (52) Raveling

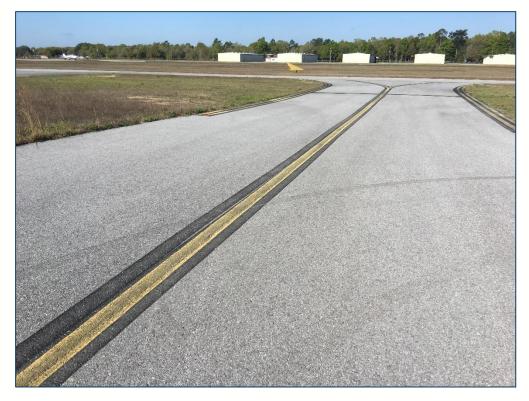
Taxiway To Hangar, Section 605, Sample Unit 301 - Low Severity (57) Weathering
