FLORIDA DEPARTMENT OF TRANSPORTATION
AVIATION AND SPACEPORTS OFFICE

Statewide Airfield Pavement Management Program

Airport Pavement Evaluation Report September 2017

**Palatka Municipal-
Lt. Kay Larkin Field (28J)**
General Aviation Airport
District 2

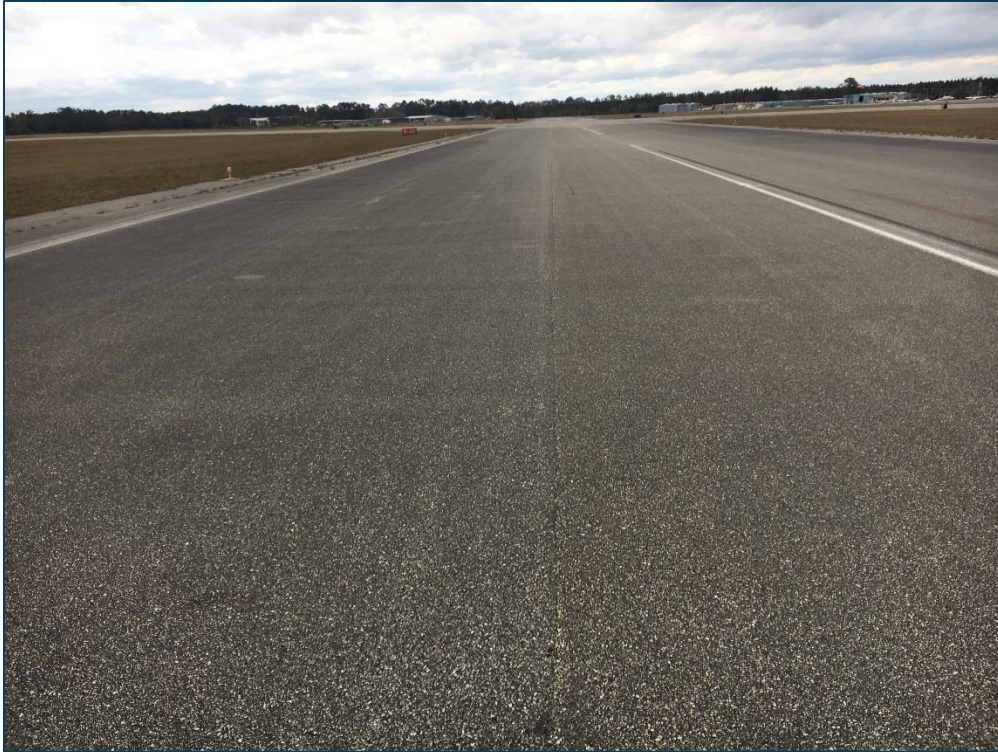
Runway 17-35, Section 6205, Sample Unit 130 – Low Severity (48) Longitudinal and Transverse Cracking, Low Severity (57) Weathering

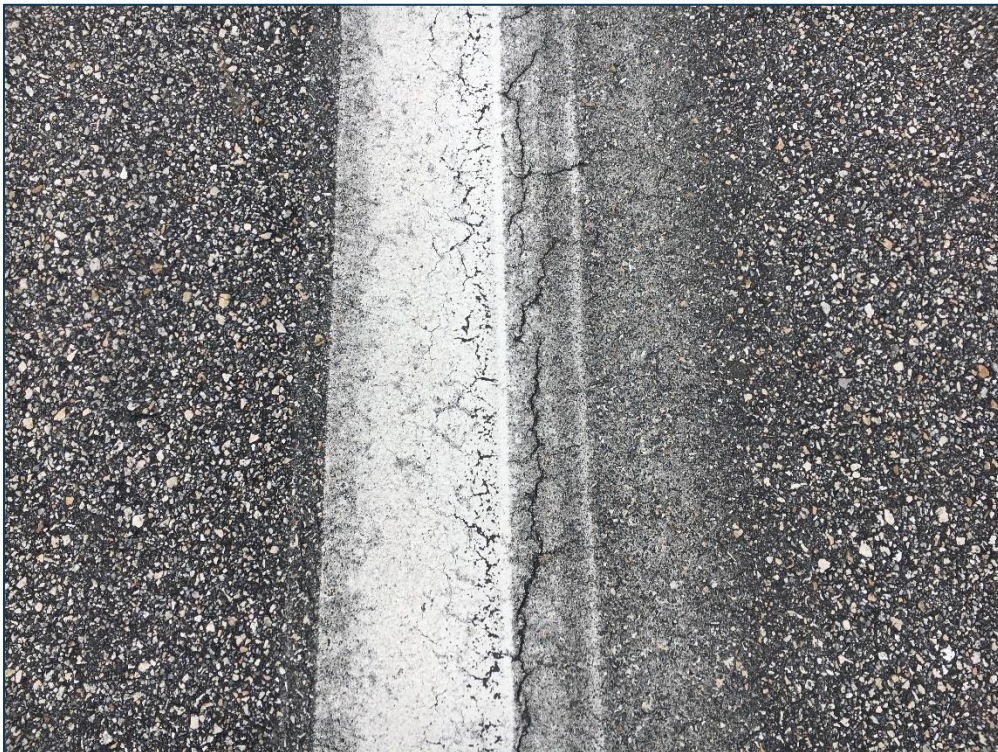
Runway 17-35, Section 6205, Sample Unit 154 – Low Severity (48) Longitudinal and Transverse Cracking, Low Severity (57) Weathering

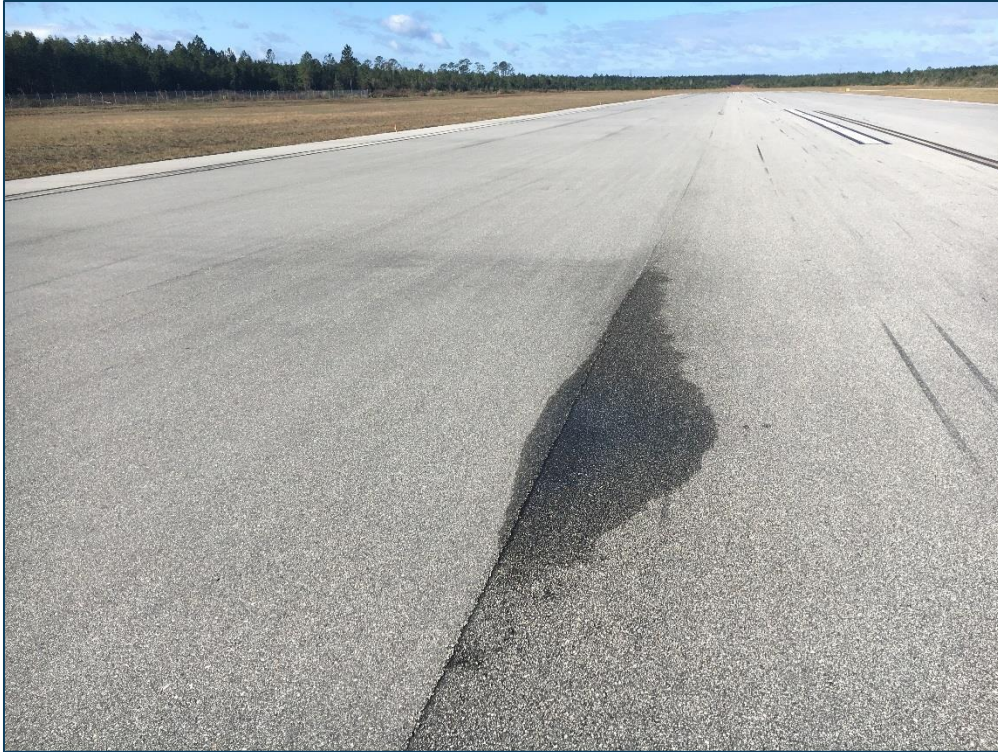
Runway 9-27, Section 6115, Sample Unit 98 – Low Severity (48) Longitudinal and Transverse Cracking, Low Severity (57) Weathering

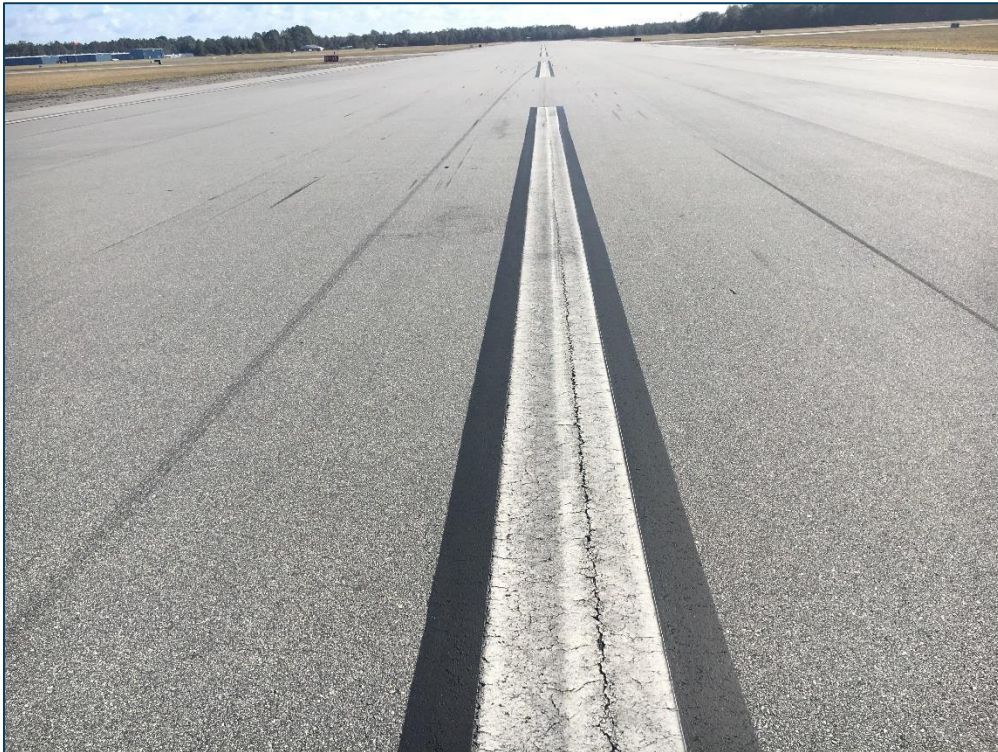
Runway 9-27, Section 6105, Sample Unit 134 – Low Severity (48) Longitudinal and Transverse Cracking, Low Severity (57) Weathering

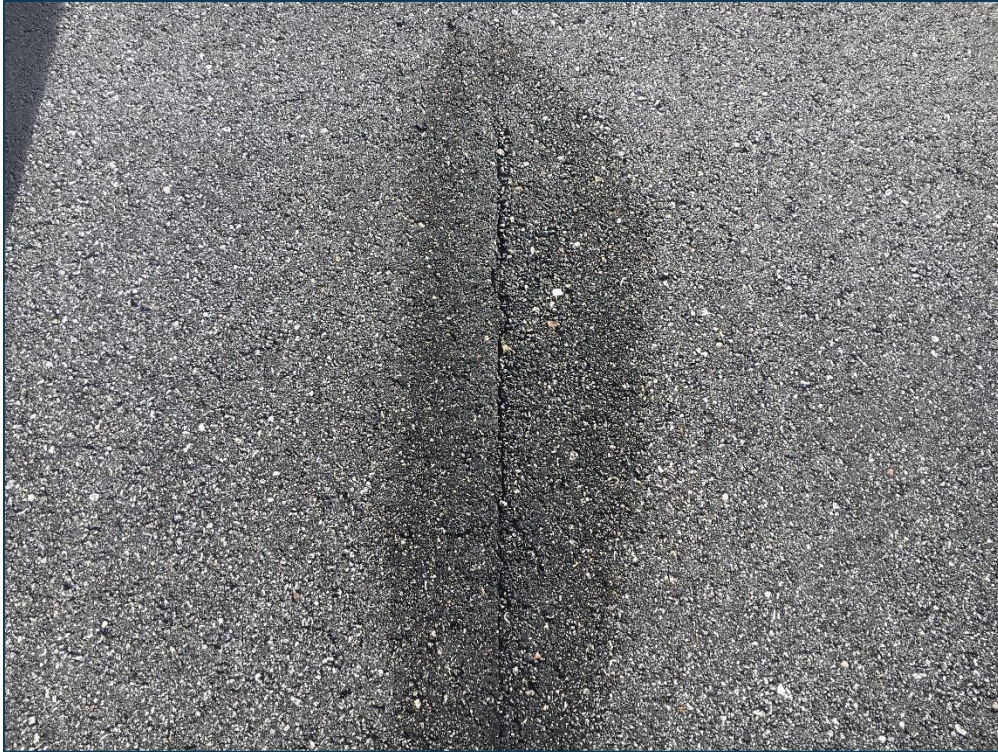
Runway 9-27, Section 6110, Sample Unit 190 – Low Severity (48) Longitudinal and Transverse Cracking, Low Severity (57) Weathering

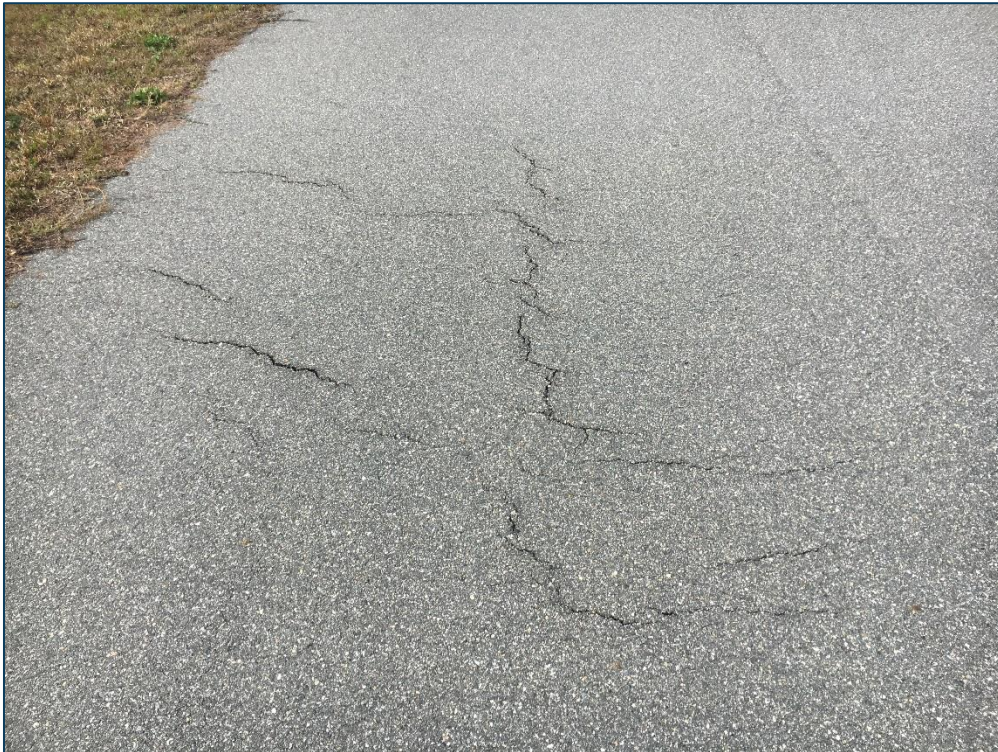
Taxiway A, Section 105, Sample Unit 103 – (55) Slippage Cracking, Low Severity (57) Weathering

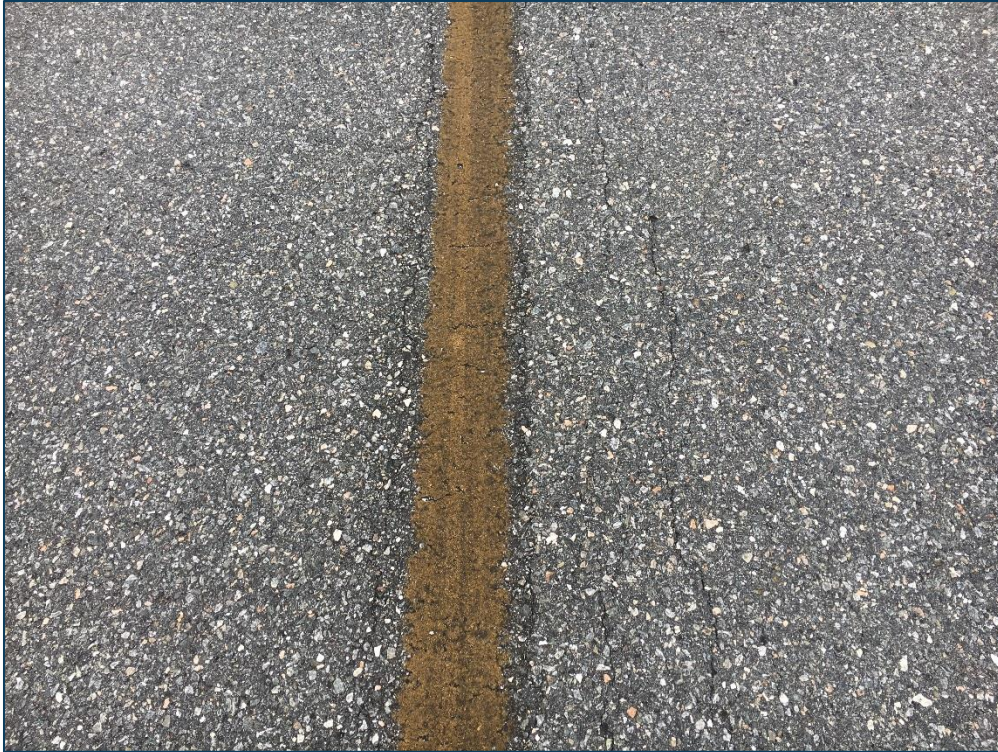
Taxiway A, Section 110, Sample Unit 141 – Low Severity (48) Longitudinal and Transverse Cracking, Low Severity (52) Raveling, Low Severity (57) Weathering

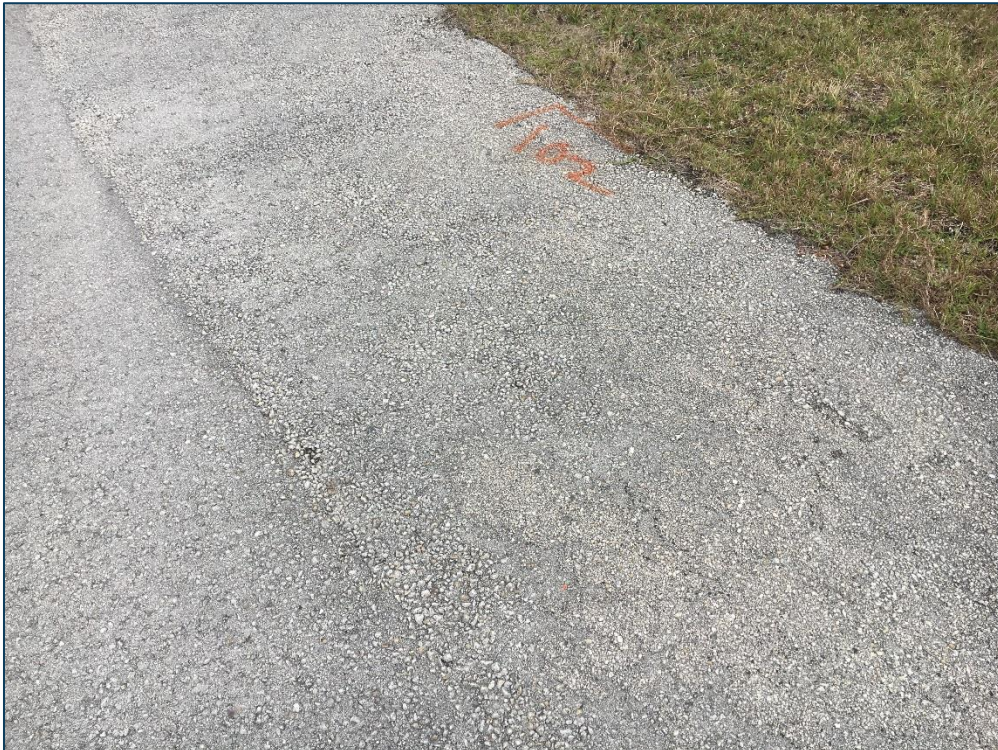
Taxiway A, Section 100, Sample Unit 102 – Low Severity (52) Raveling, Medium Severity (52) Raveling

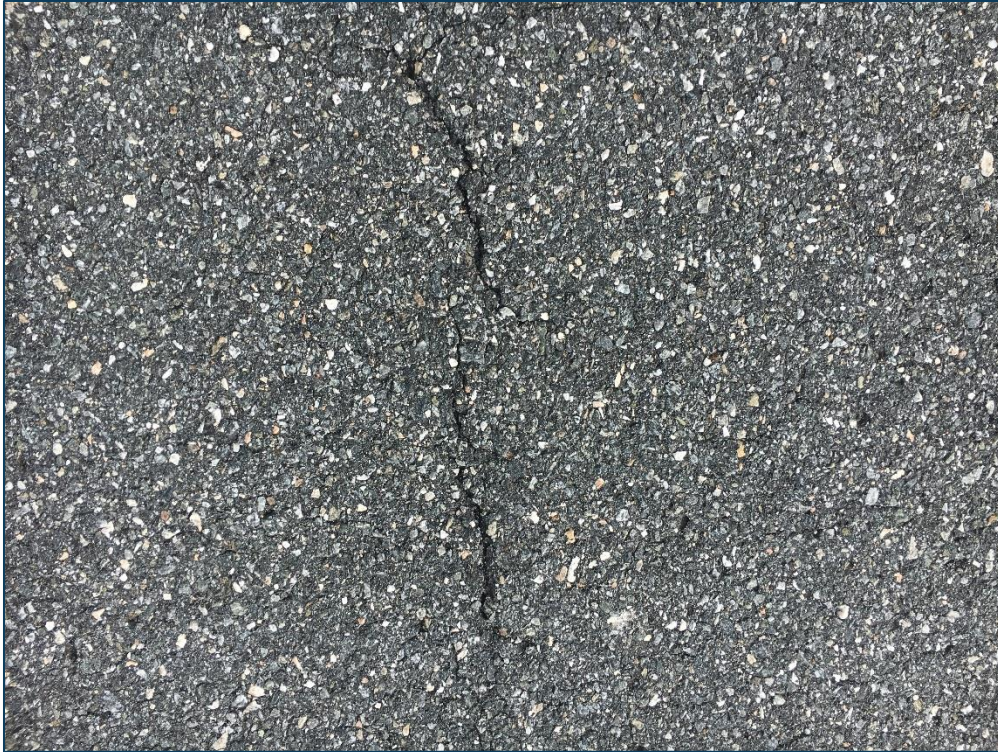
Taxiway A1, Section 117, Sample Unit 102 – Low Severity (48) Longitudinal and Transverse Cracking, Low Severity (52) Raveling, Low Severity (57) Weathering

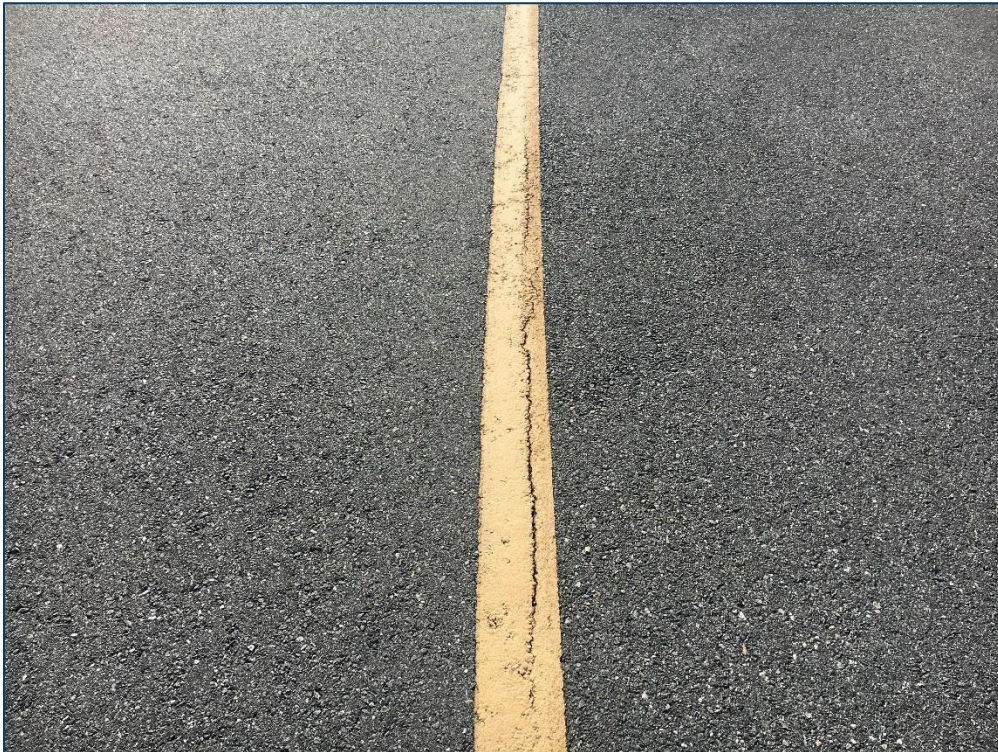
Taxiway B, Section 205, Sample Unit 124 – (42) Bleeding, Low Severity (48) Longitudinal and Transverse Cracking, Medium Severity (52) Raveling, Low Severity (57) Weathering

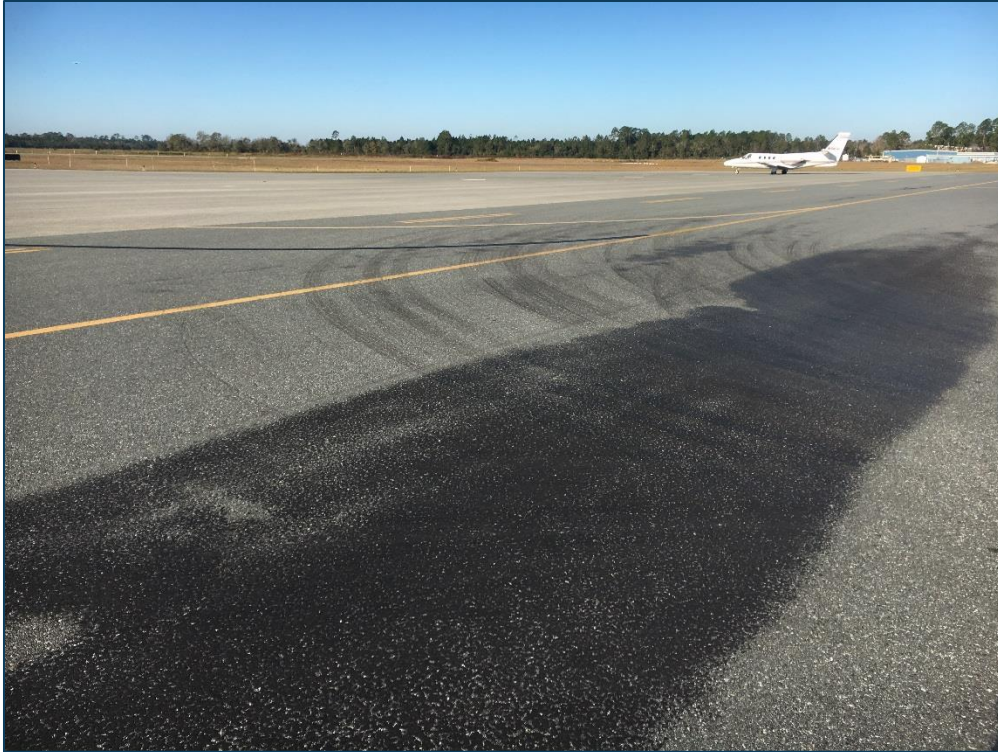
Taxiway B, Section 215, Sample Unit 108 – (42) Bleeding, Low Severity (52) Raveling, Low Severity (57) Weathering

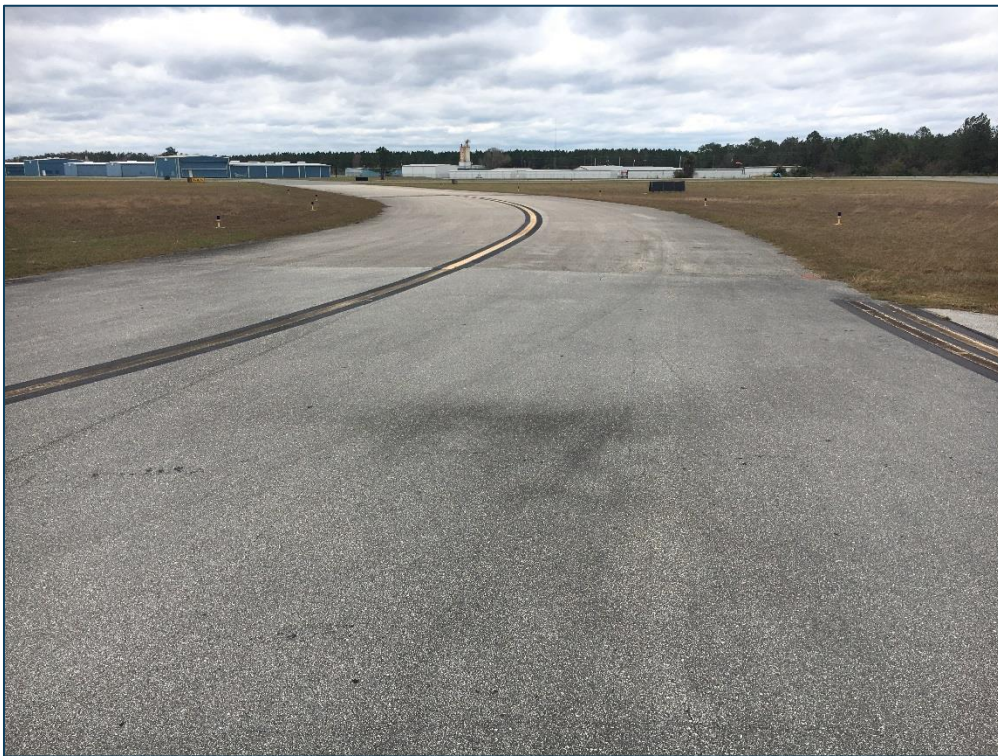
Taxiway B, Section 220, Sample Unit 100 – Low Severity (45) Depression, Low Severity (57) Weathering

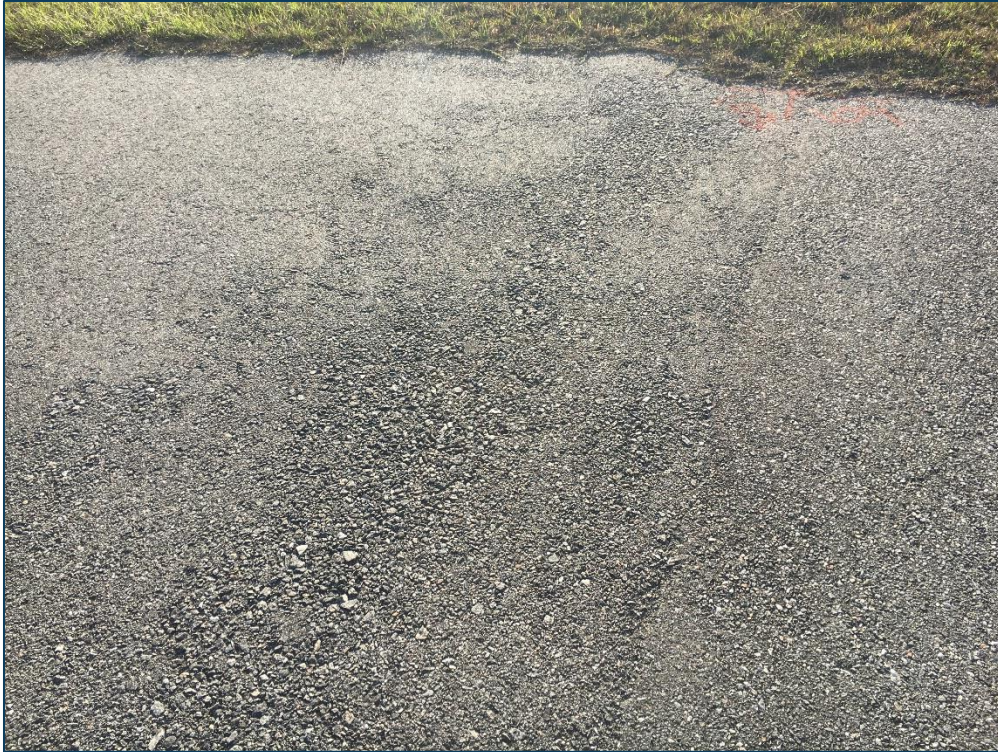
Taxiway C, Section 305, Sample Unit 103 – Low Severity (52) Raveling, Low Severity (57) Weathering

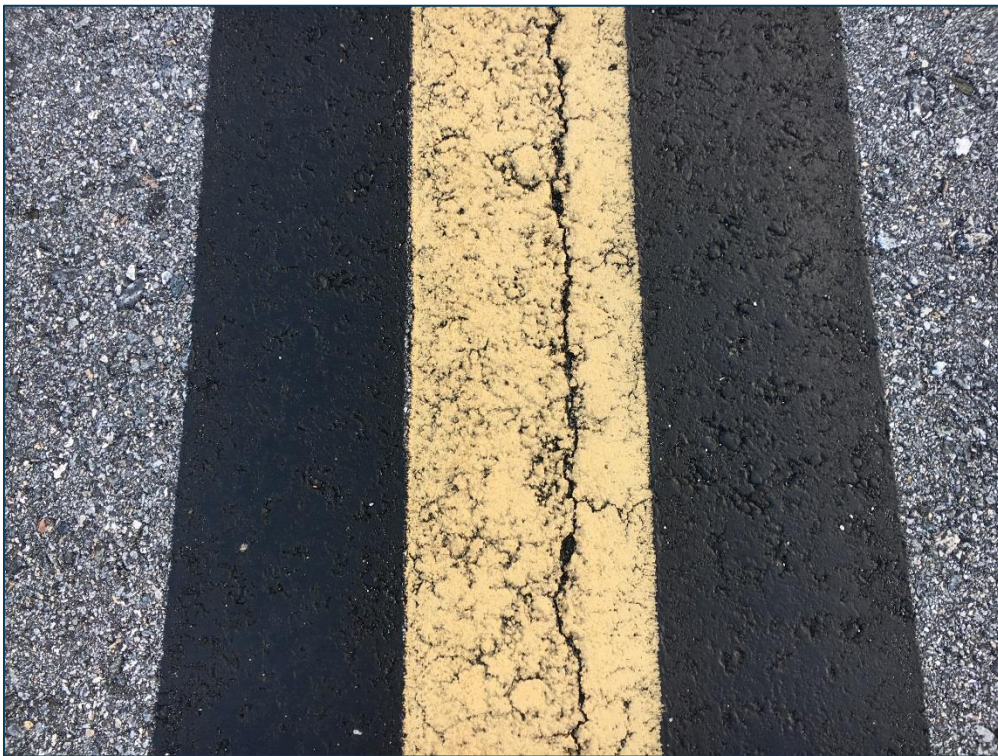
Taxiway C, Section 310, Sample Unit 120 – Low Severity (48) Longitudinal and Transverse Cracking, Low Severity (57) Weathering

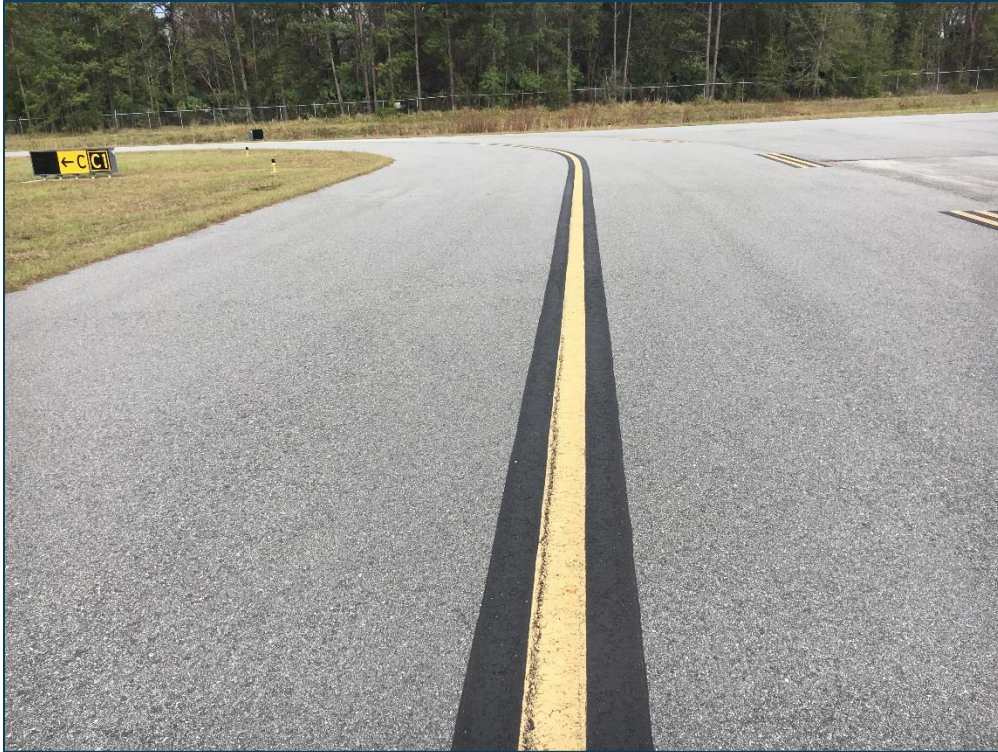
Taxiway C1, Section 330, Sample Unit 102 – Low Severity (48) Longitudinal and Transverse Cracking, Low Severity (57) Weathering

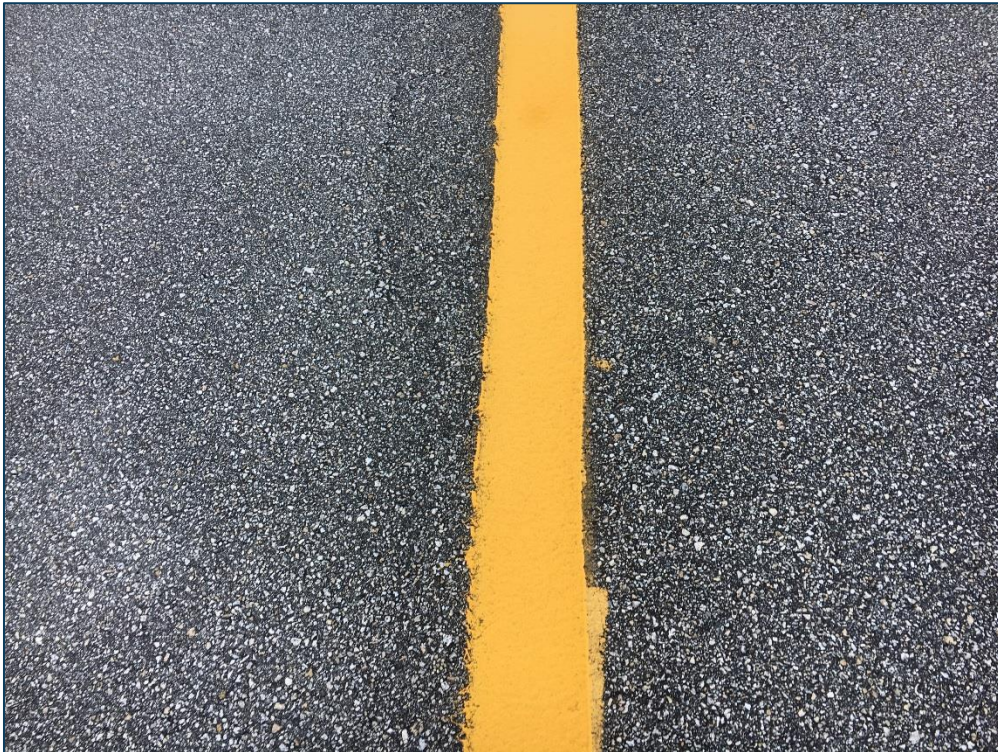
Taxiway C2, Section 320, Sample Unit 103 – Low Severity (57) Weathering

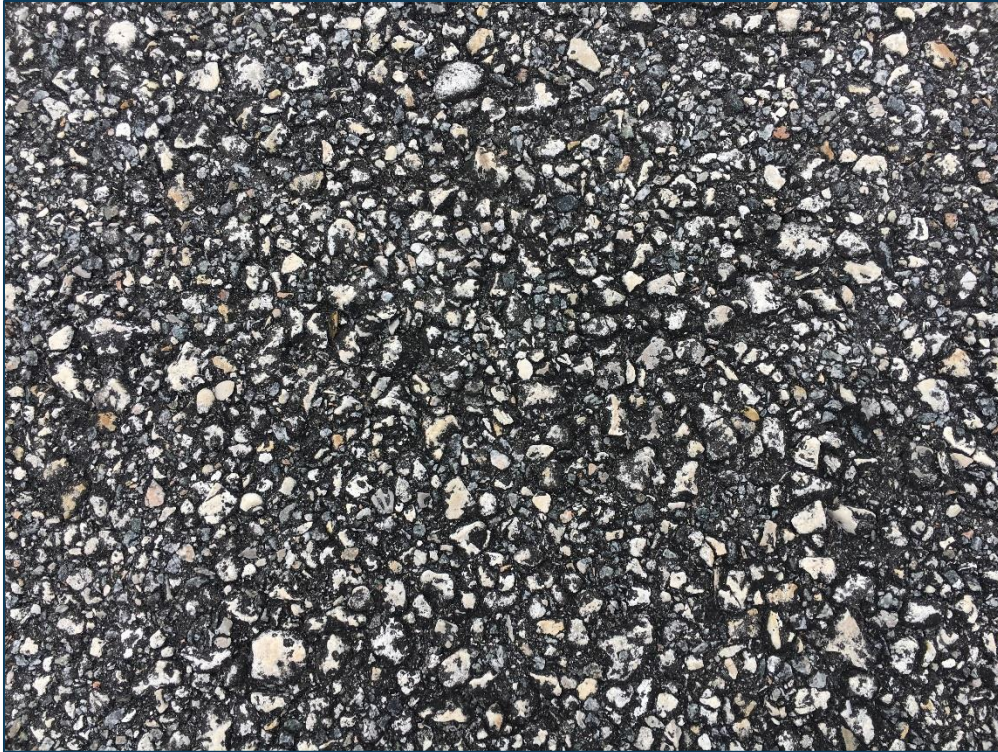
Taxiway C3, Section 410, Sample Unit 103 – Low Severity (52) Raveling

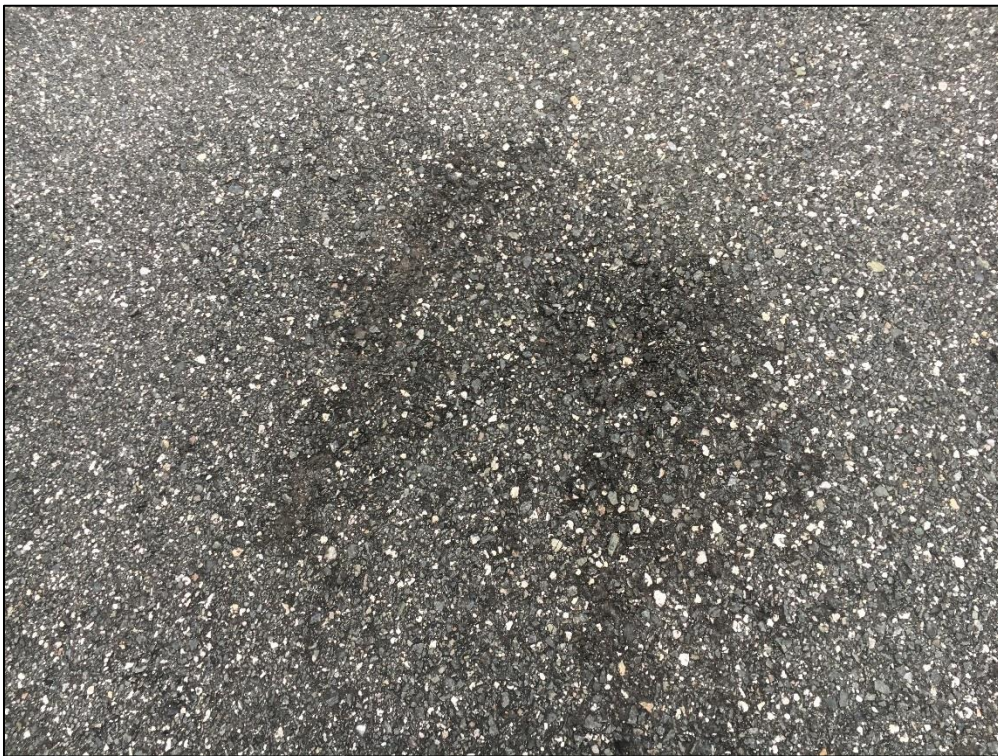
Apron, Section 4105, Sample Unit 201 – (49) Oil Spillage, Low Severity (57) Weathering

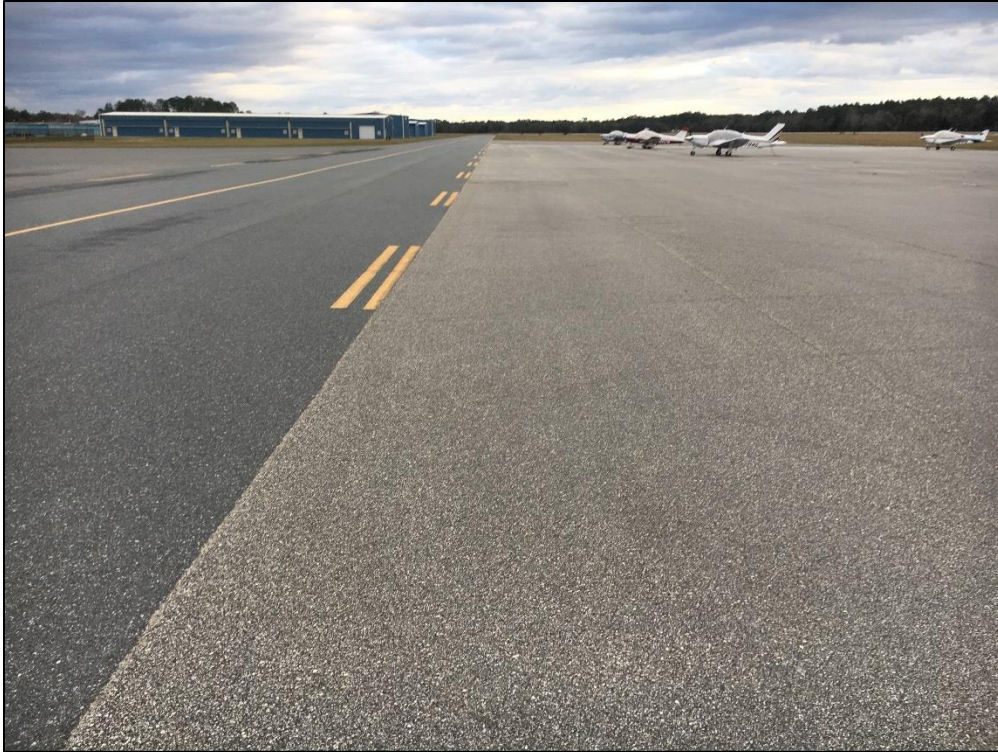
Apron, Section 4115, Sample Unit 403 – Low Severity (48) Longitudinal and Transverse Cracking, Low Severity (57) Weathering

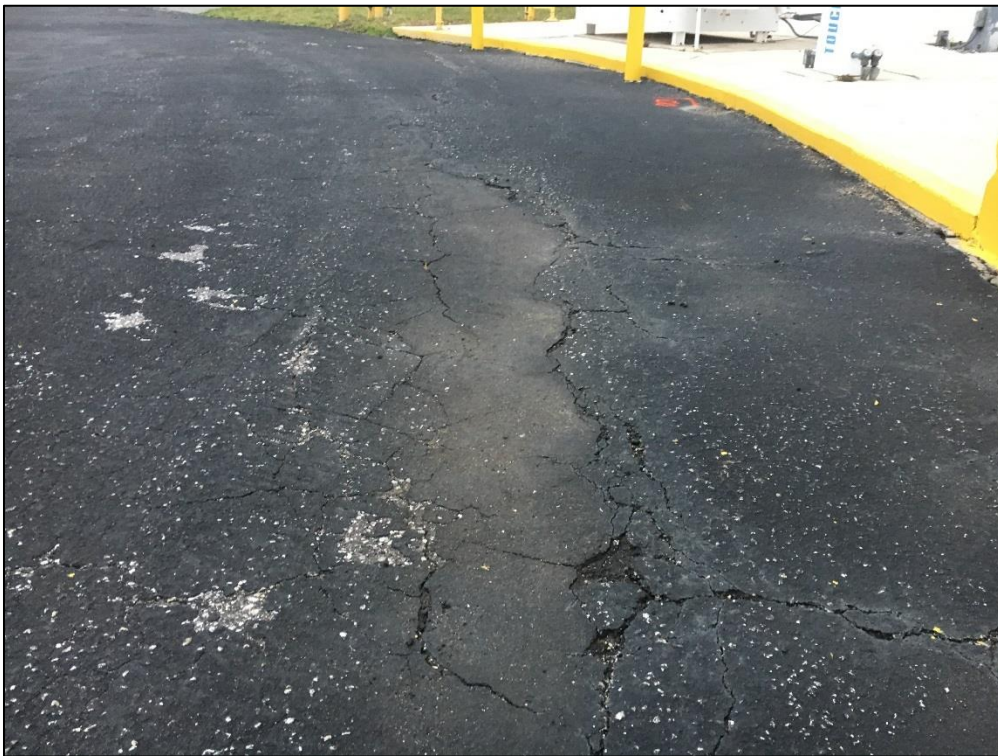
Apron, Section 4215, Sample Unit 100 – Low Severity (41) Alligator Cracking, Low Severity (52) Raveling

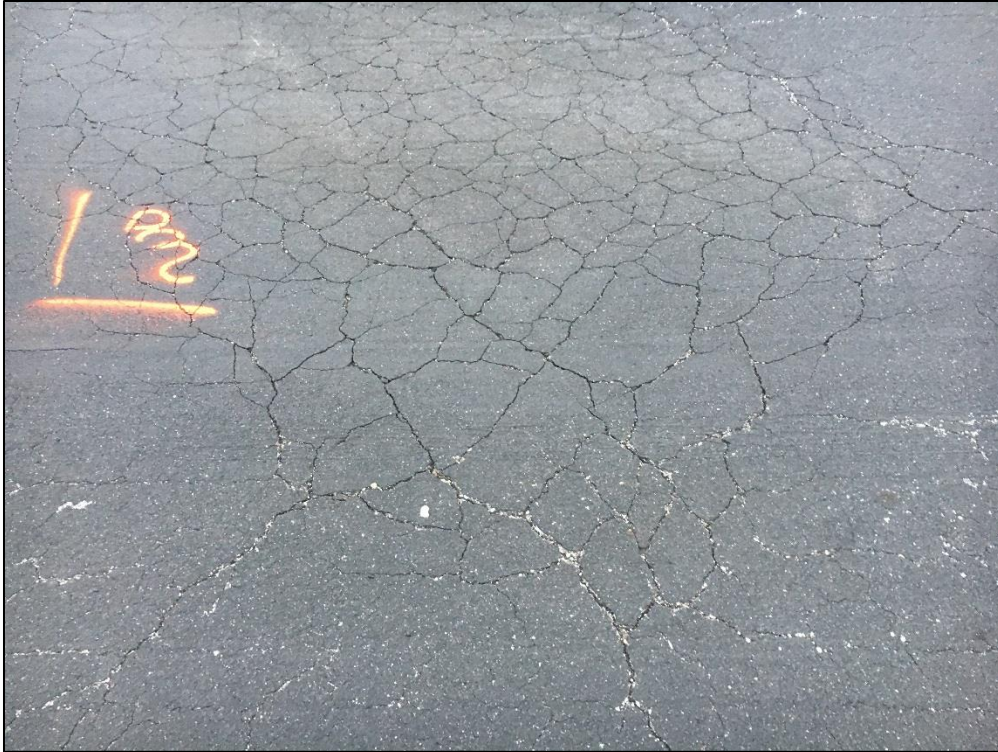
Apron, Section 4215, Sample Unit 200 – Medium Severity (41) Alligator Cracking, Low Severity (45) Depression, Low Severity (52) Raveling

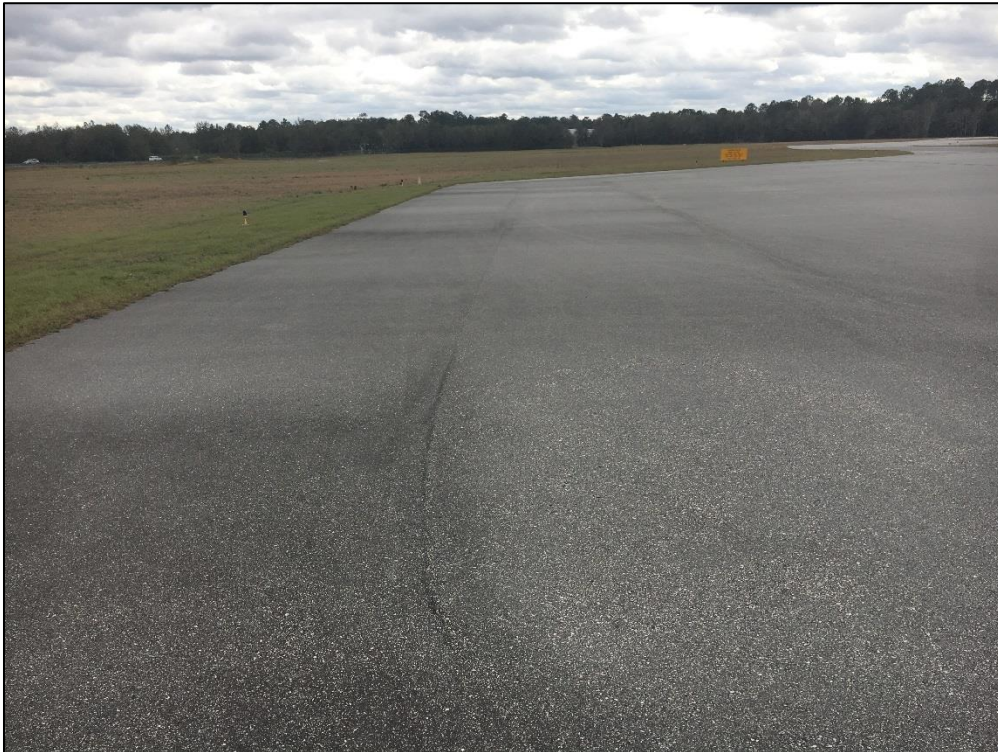
Run-Up Apron RW 27, Section 5105, Sample Unit 100 – Low Severity (57) Weathering

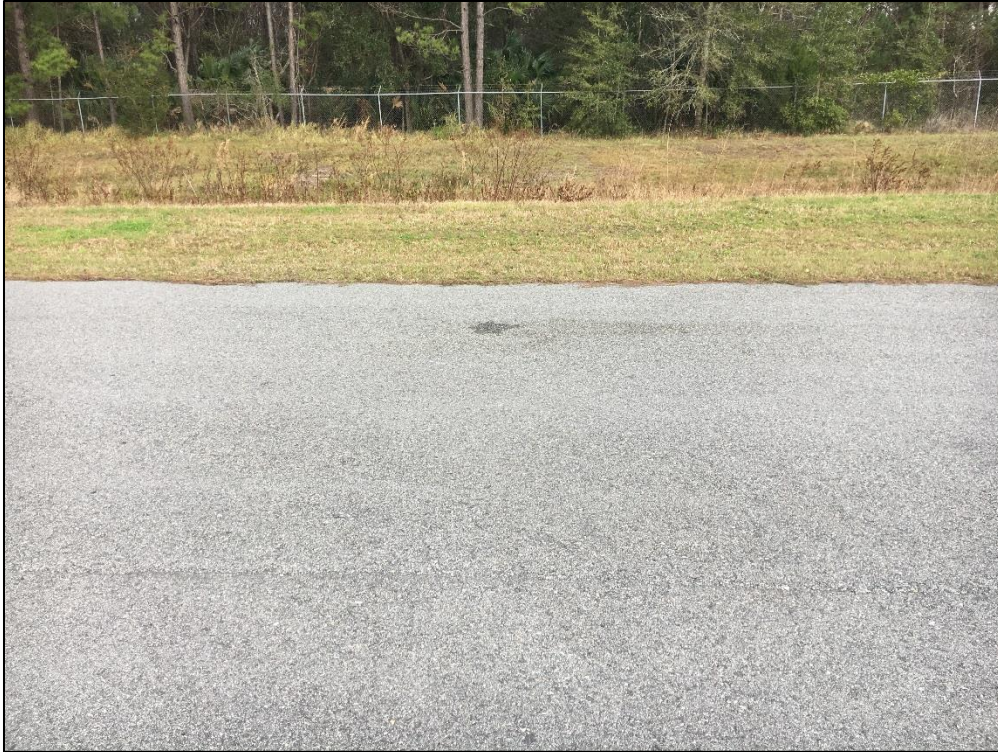
Run-Up Apron RW 35, Section 5210, Sample Unit 101 – Low Severity (57) Weathering, Low Severity (48) Longitudinal and Transverse Cracking

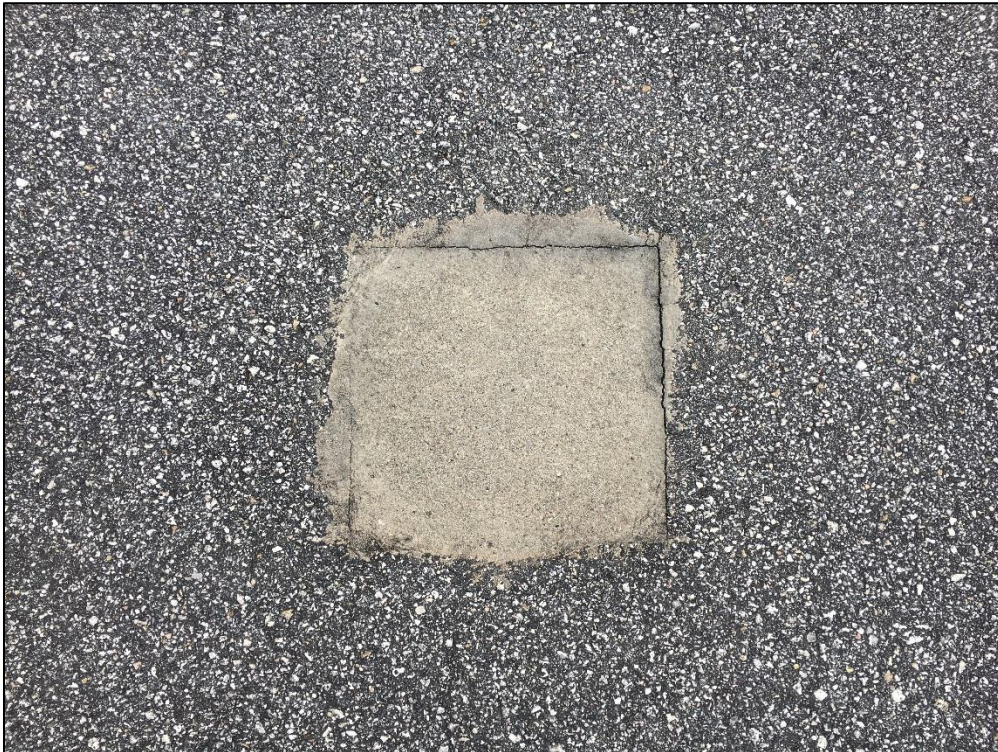
Run-Up Apron RW 35, Section 5205, Sample Unit 100 – Low Severity (50) Patching, Low Severity (57) Weathering

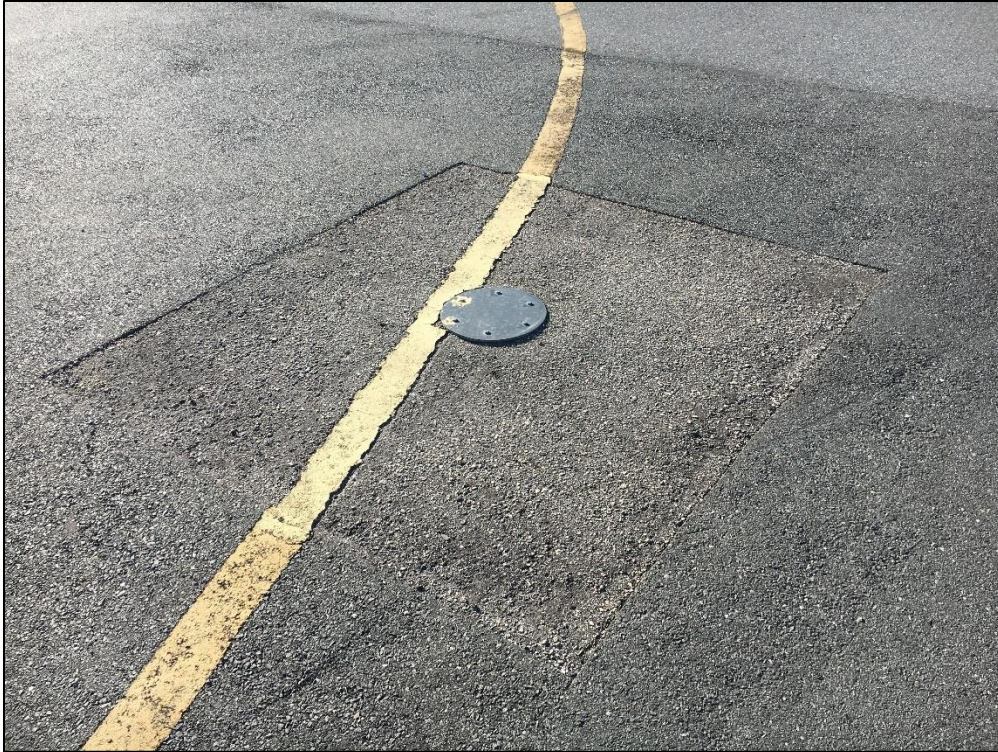
Apron E T-Hangar, Section 4310, Sample Unit 501 – Low Severity (50) Patching, Low Severity (57) Weathering

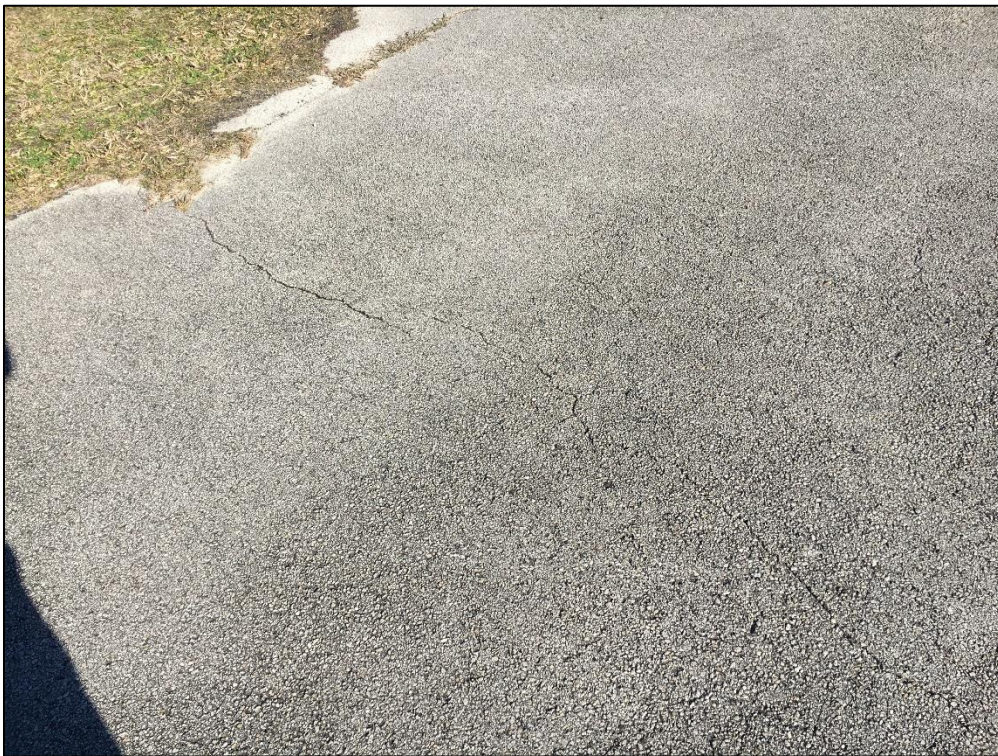
East T-Hangar Taxiways, Section 4305, Sample Unit 100 – Low Severity (48) Longitudinal and Transverse Cracking, Low Severity (57) Weathering

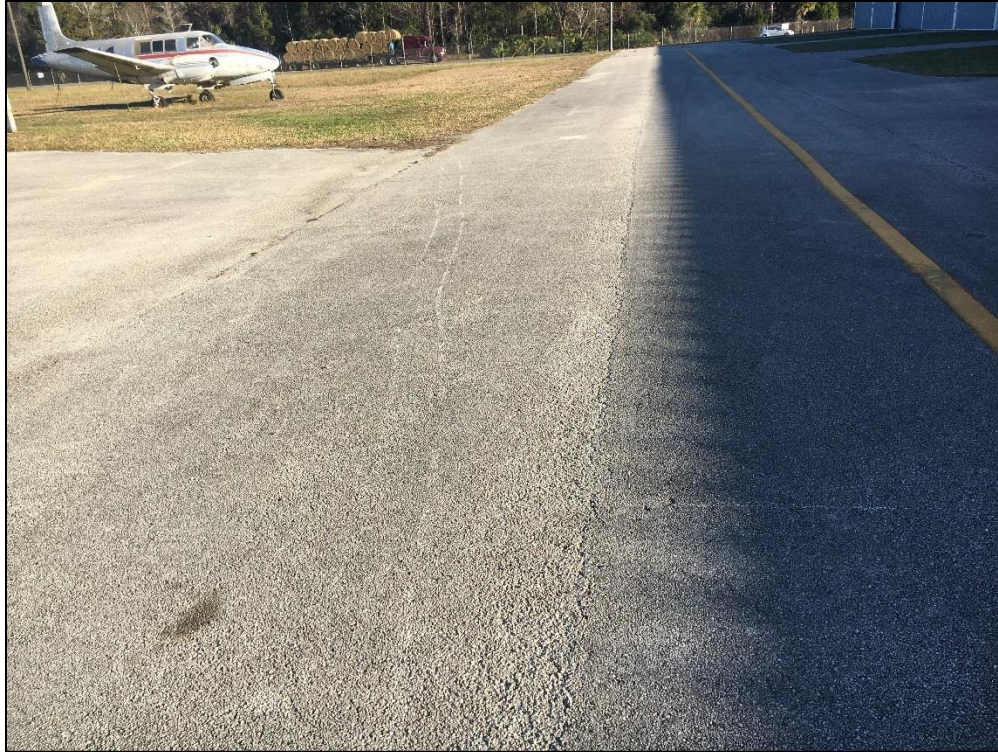
North T-Hangar Taxilane, Section 4220, Sample Unit 503 – Low and Medium Severity (48) Longitudinal and Transverse Cracking, Low Severity (52) Raveling, Medium Severity (52) Raveling

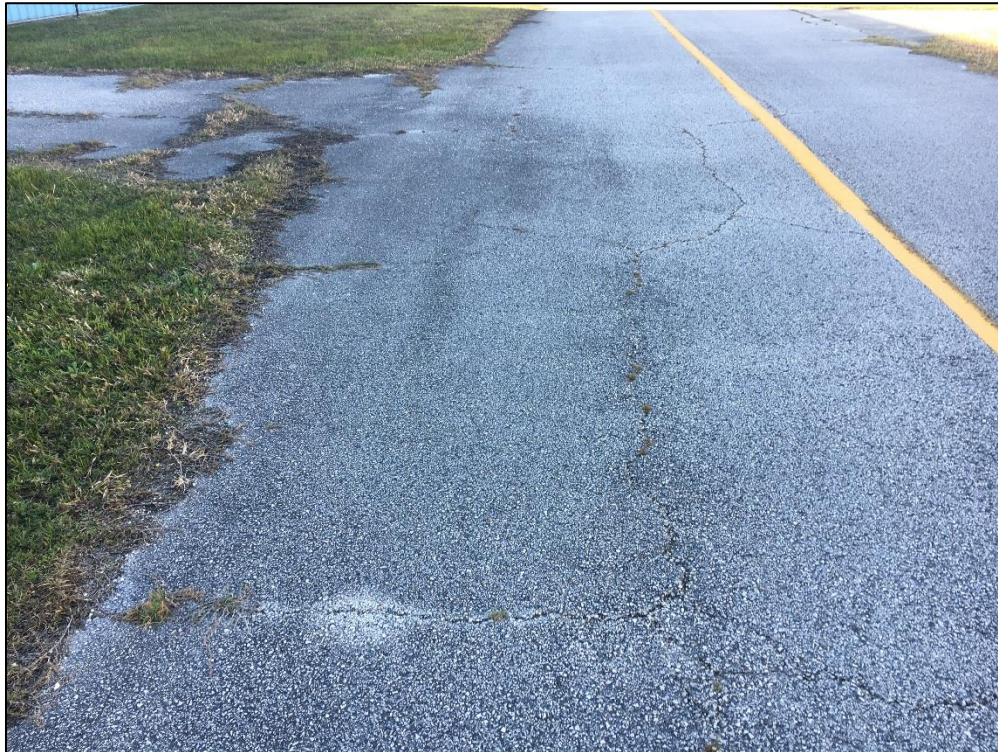
North T-Hangar Taxilane, Section 4205, Sample Unit 403 – Low Severity (43) Block Cracking, Low Severity (52) Raveling, Medium Severity (52) Raveling

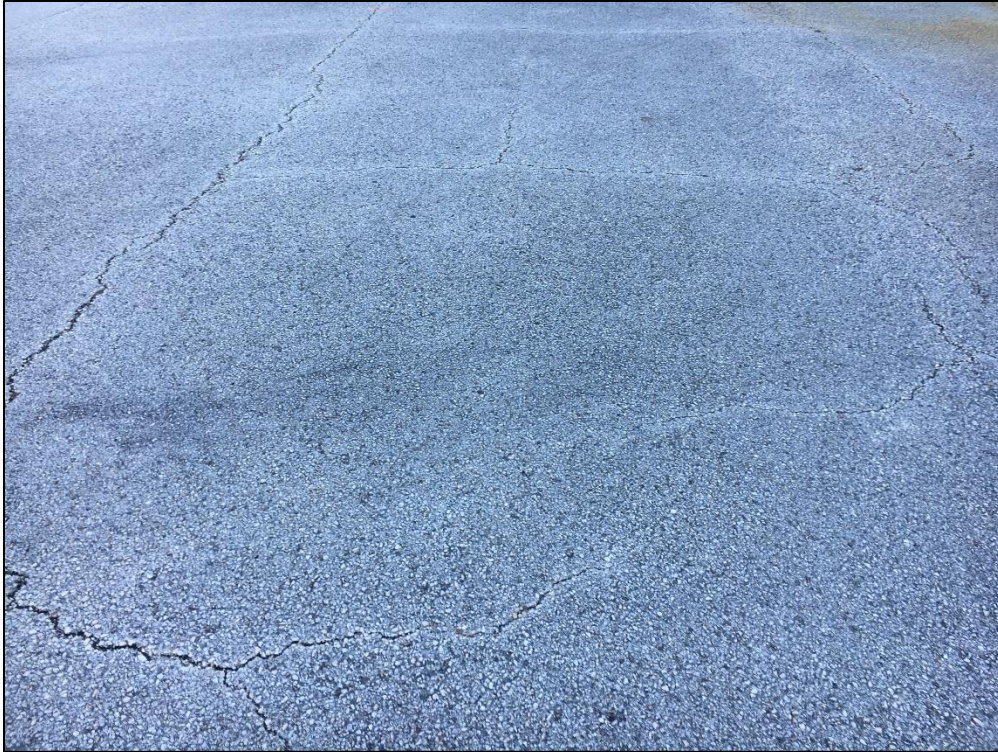
North T-Hangar Taxilane, Section 4210, Sample Unit 204 – Low Severity (43) Block Cracking, Low Severity (52) Raveling
