## FLORIDA DEPARTMENT OF TRANSPORTATION AVIATION AND SPACEPORTS OFFICE

## Statewide Airfield Pavement Management Program

Airport Pavement Evaluation Report September 2017

**Keystone Airpark (42J)** General Aviation Airport District 2

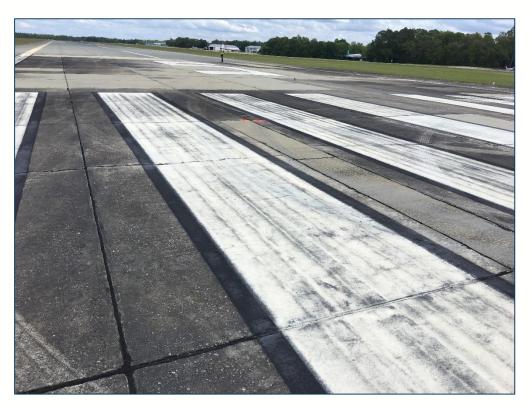
Runway 5-23, Section 6110, Sample Unit 96 – Medium Severity (65) Joint Seal Damage, Low Severity (67) Large Patching

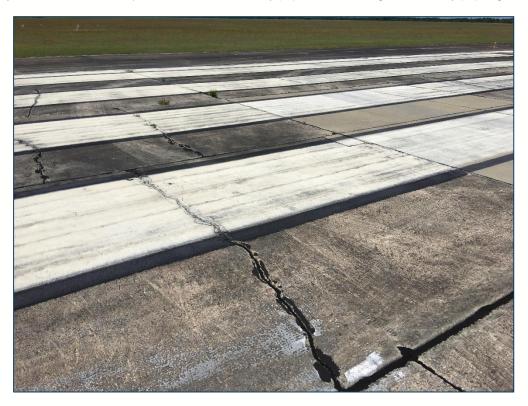
Runway 5-23, Section 6105, Sample Unit 297 – Low Severity (63) Longitudinal, Transverse, and Diagonal Cracking, Medium Severity (65) Joint Seal Damage, Low Severity (66) Small Patching

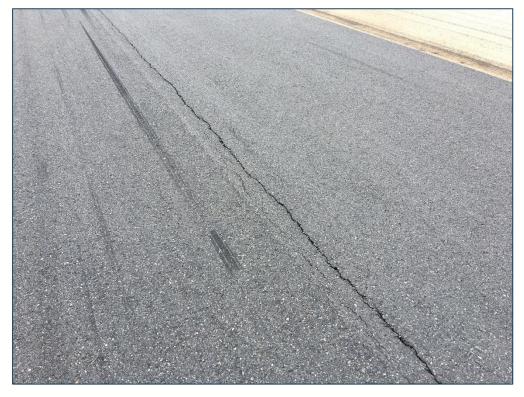
Runway 5-23, Section 6115, Sample Unit 307 – Low Severity (48) Longitudinal and Transverse Cracking, Low Severity (56) Swelling, Low Severity (57) Weathering

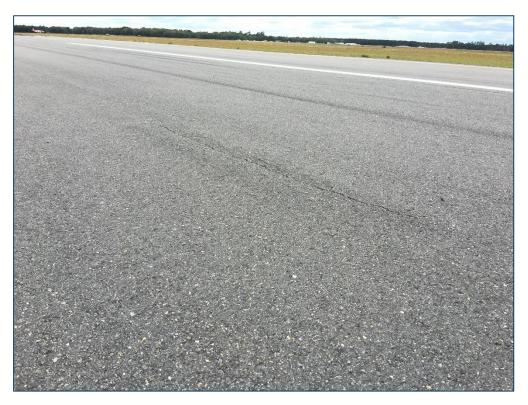
Runway 5-23, Section 6115, Sample Unit 332 – Low Severity (48) Longitudinal and Transverse Cracking, Low Severity (56) Swelling, Low Severity (57) Weathering

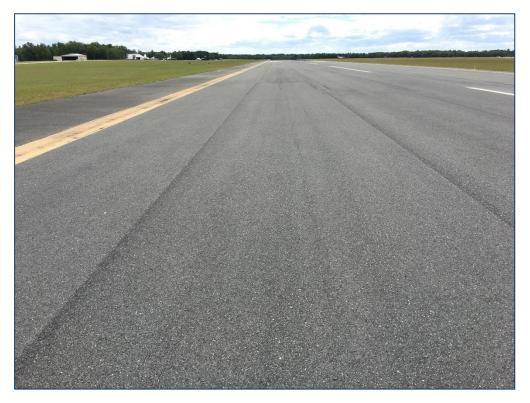
Runway 5-23, Section 6120, Sample Unit 542 – Low Severity (48) Longitudinal and Transverse Cracking, Low Severity (57) Weathering

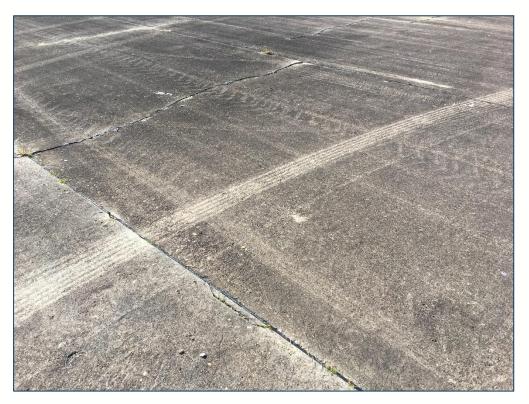
Runway 11-29, Section 6220, Sample Unit 103 – Low Severity (63) Longitudinal, Transverse, and Diagonal Cracking, Medium Severity (65) Joint Seal Damage, Low Severity (74) Joint Spalling

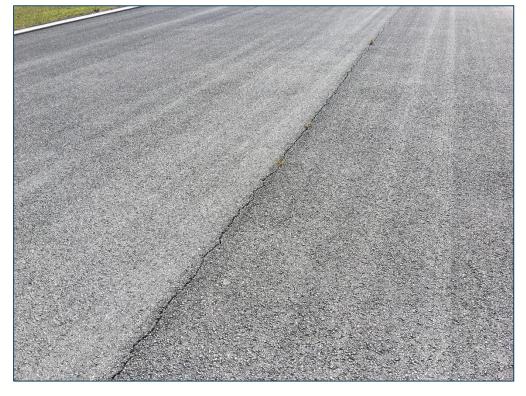
Runway 11-29, Section 6215, Sample Unit 156 – Low and Medium Severity (48) Longitudinal and Transverse Cracking, Low Severity (52) Raveling

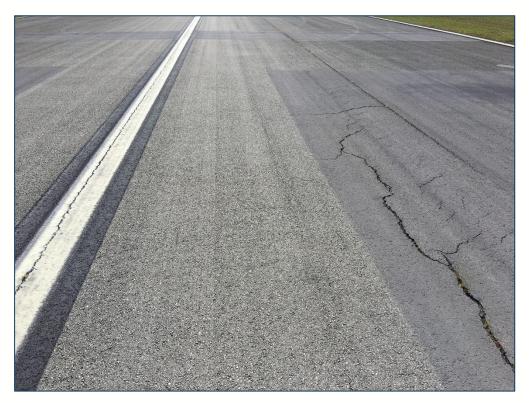
Runway 11-29, Section 6215, Sample Unit 170 – Low and Medium Severity (48) Longitudinal and Transverse Cracking, Low Severity (52) Raveling

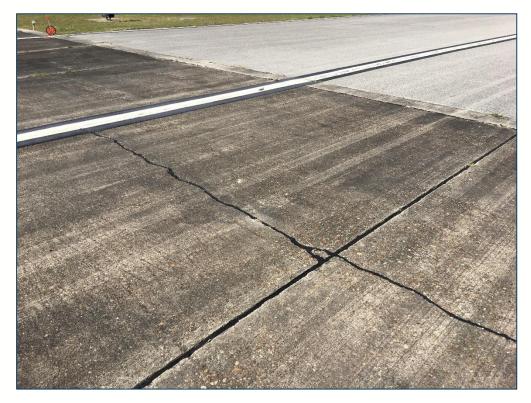
Runway 11-29, Section 6205, Sample Unit 195 – Low Severity (63) Longitudinal, Transverse, and Diagonal Cracking, Medium Severity (65) Joint Seal Damage

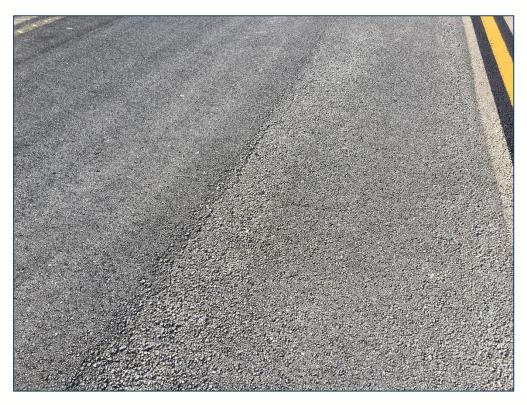
Taxiway B, Section 210, Sample Unit 111 – Low Severity (48) Longitudinal and Transverse Cracking, Low Severity (52) Raveling, Medium Severity (52) Raveling

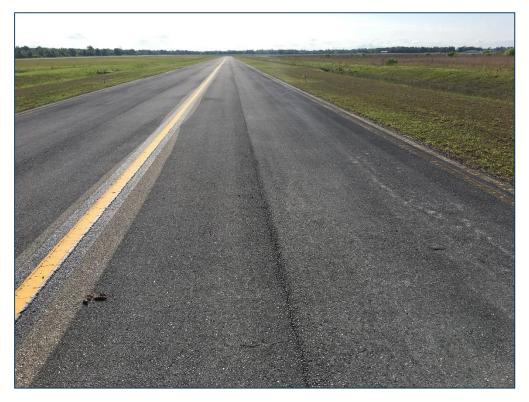
Taxiway C, Section 305, Sample Unit 139 - Low Severity (48) Longitudinal and Transverse Cracking, Low Severity (52) Raveling

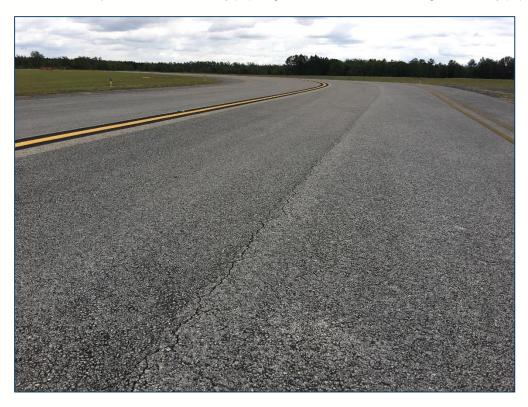
Taxiway A, Section 105, Sample Unit 147 – Low Severity (48) Longitudinal and Transverse Cracking, Medium Severity (52) Raveling

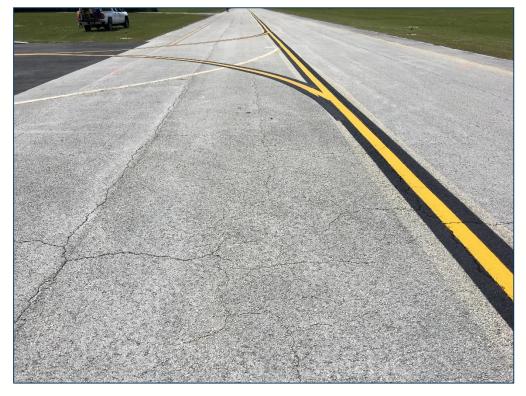
Taxiway A, Section 105, Sample Unit 122 – Low Severity (43) Block Cracking, Low Severity (48) Longitudinal and Transverse Cracking, Medium Severity (52) Raveling

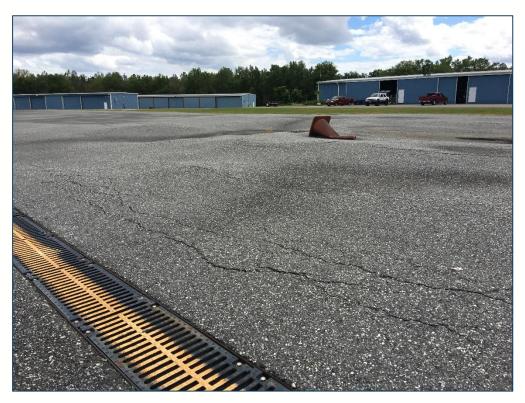
Apron T-Hangars, Section 4520, Sample Unit 402 – Low Severity (48) Longitudinal and Transverse Cracking, High Severity (56) Swelling

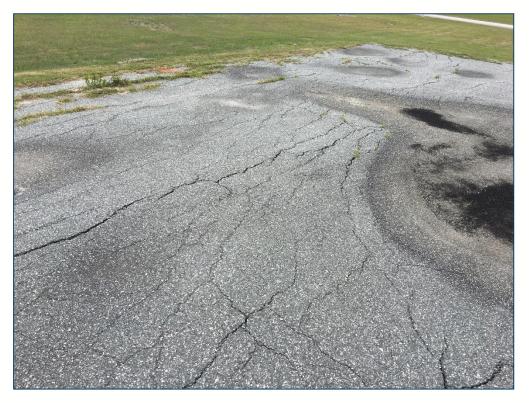
Apron T-Hangars, Section 4520, Sample Unit 402 – Low and Medium Severity (48) Longitudinal and Transverse Cracking, High Severity (56) Swelling

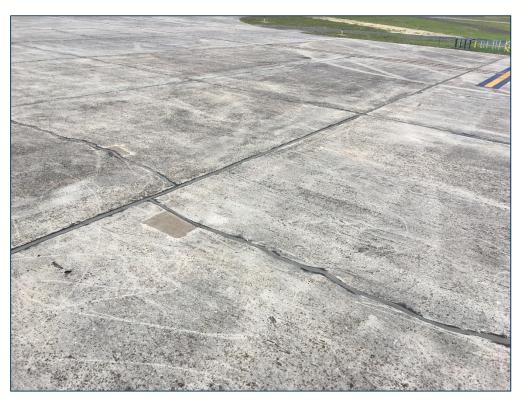
Apron, Section 4105, Sample Unit 205 – Low Severity (63) Longitudinal, Transverse, and Diagonal Cracking, Low Severity (66) Small Patching

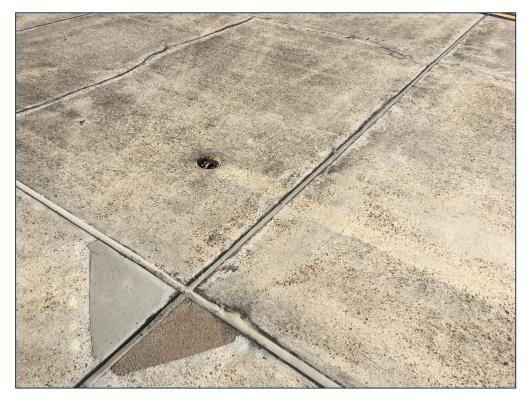
Apron, Section 4105, Sample Unit 500 – Low Severity (63) Longitudinal, Transverse, and Diagonal Cracking, Low Severity (66) Small Patching
