Statewide Airfield Pavement Management Program

**Airport Pavement
Evaluation Report
September 2017**

**Avon Park Executive
Airport (AVO)**
General Aviation Airport
District 1

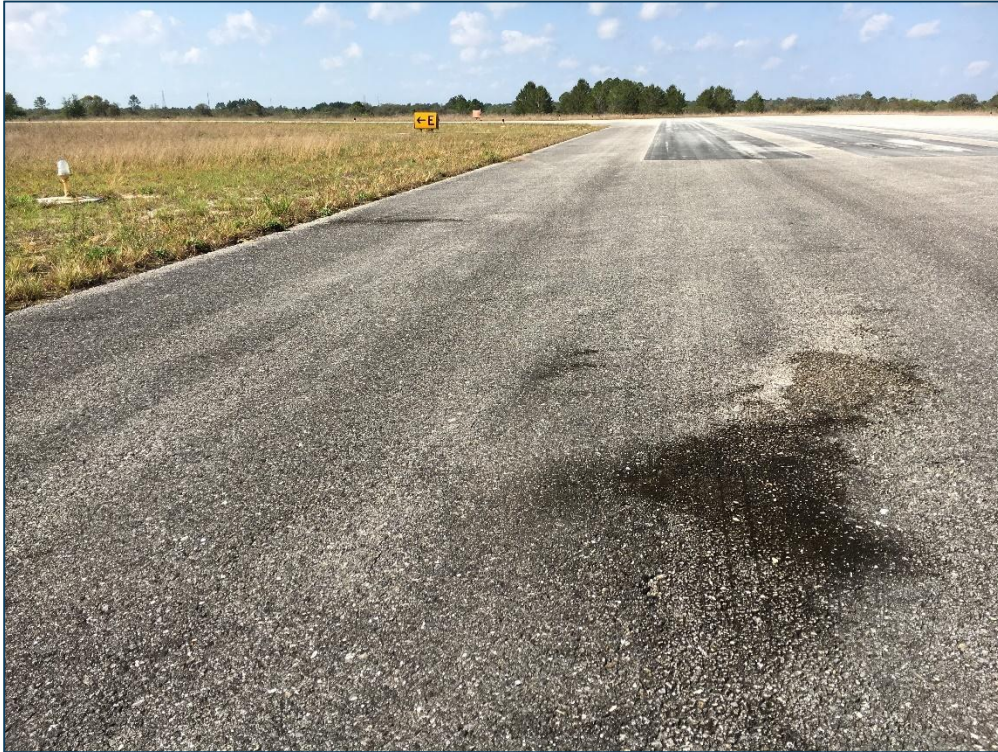
Runway 5-23, Section 6102, Sample Unit 074 – Low Severity (52) Raveling, Medium Severity (52) Raveling

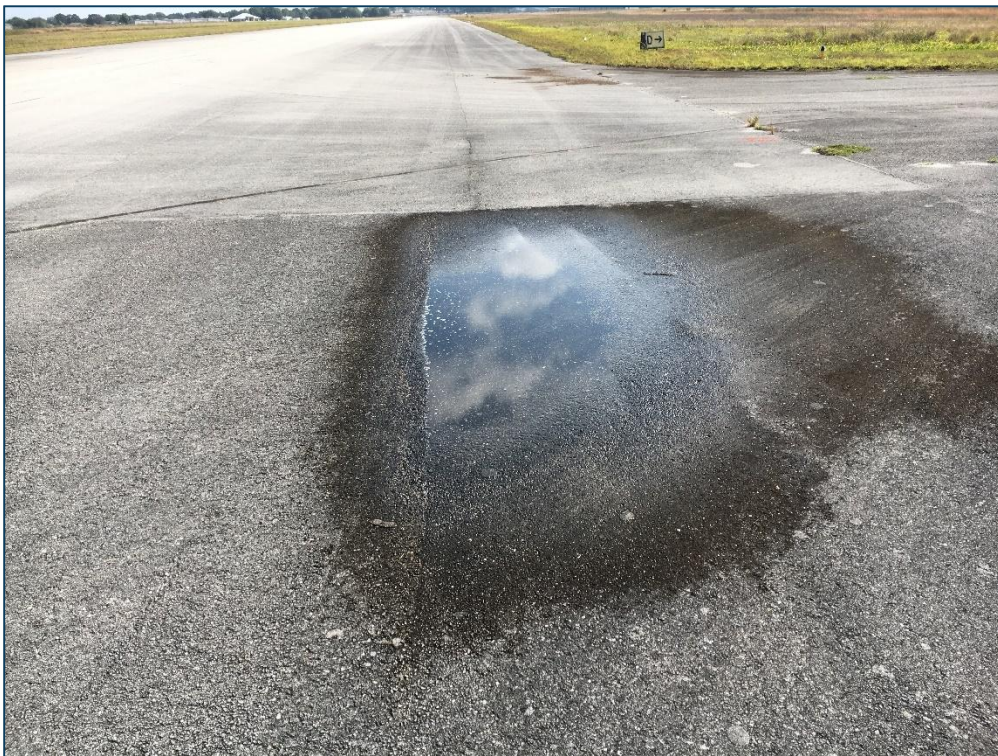
Runway 5-23, Section 6102, Sample Unit 099 – Medium Severity (48) Longitudinal and Transverse Cracking, Low Severity (45) Depression, Low Severity (52) Raveling

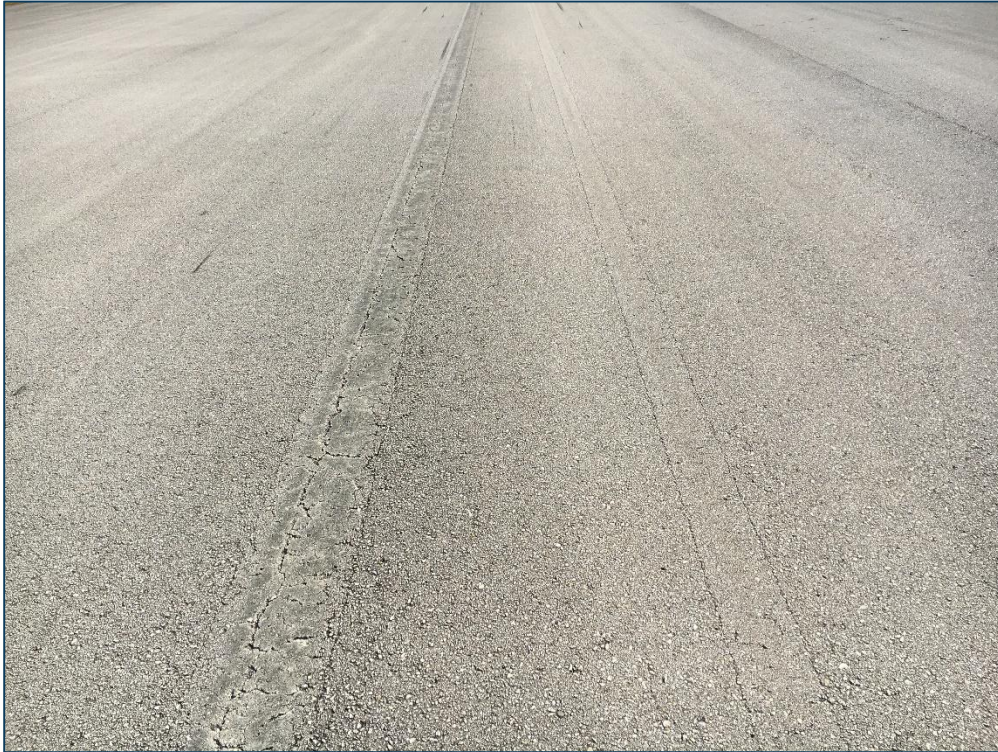
Runway 5-23, Section 6105, Sample Unit 121 – Low Severity (52) Raveling, Low Severity (57) Weathering

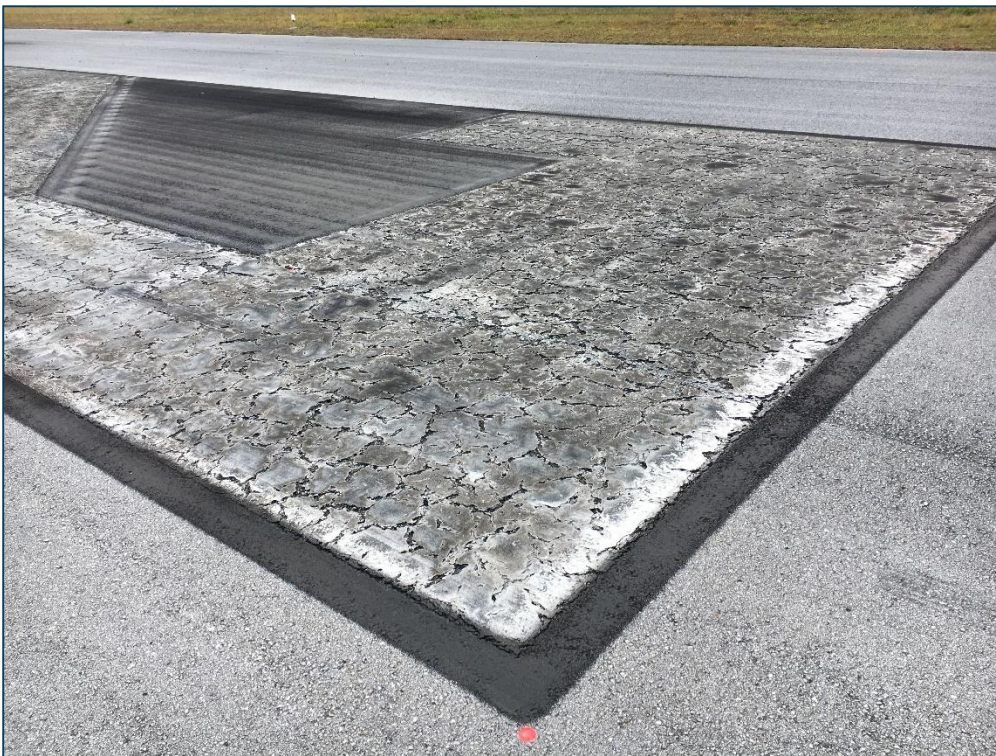
Runway 5-23, Section 6105, Sample Unit 151 – Low Severity (52) Raveling, Medium Severity (52) Raveling

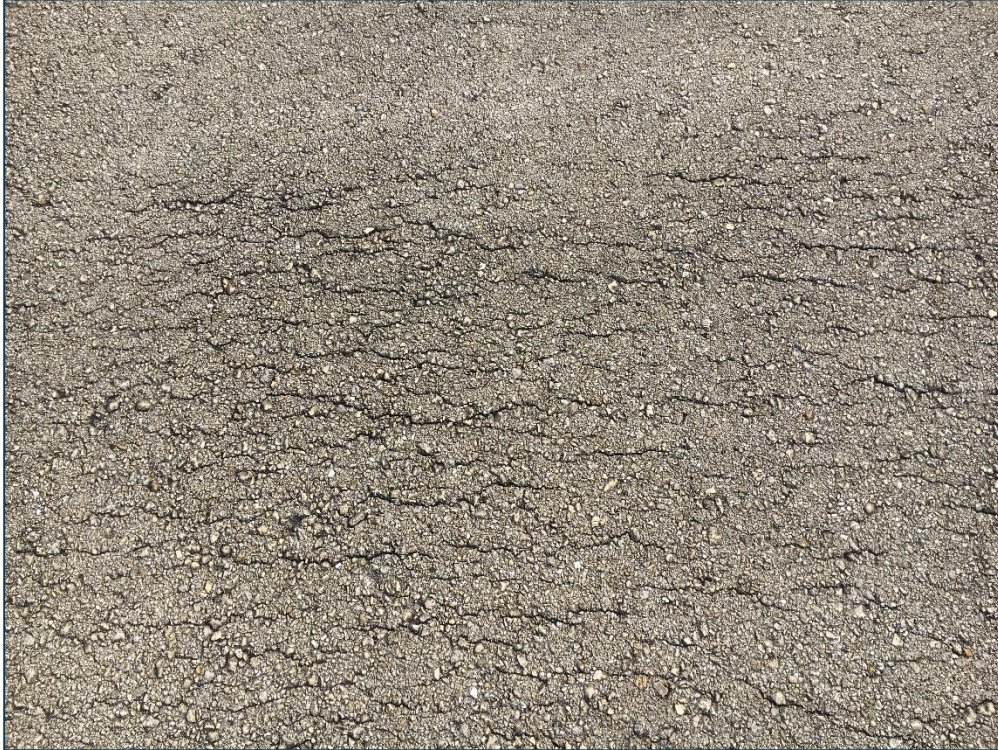
Runway 5-23, Section 6105, Sample Unit 177 – Low Severity (48) Longitudinal and Transverse Cracking, Low Severity (52) Raveling, Low Severity (57) Weathering

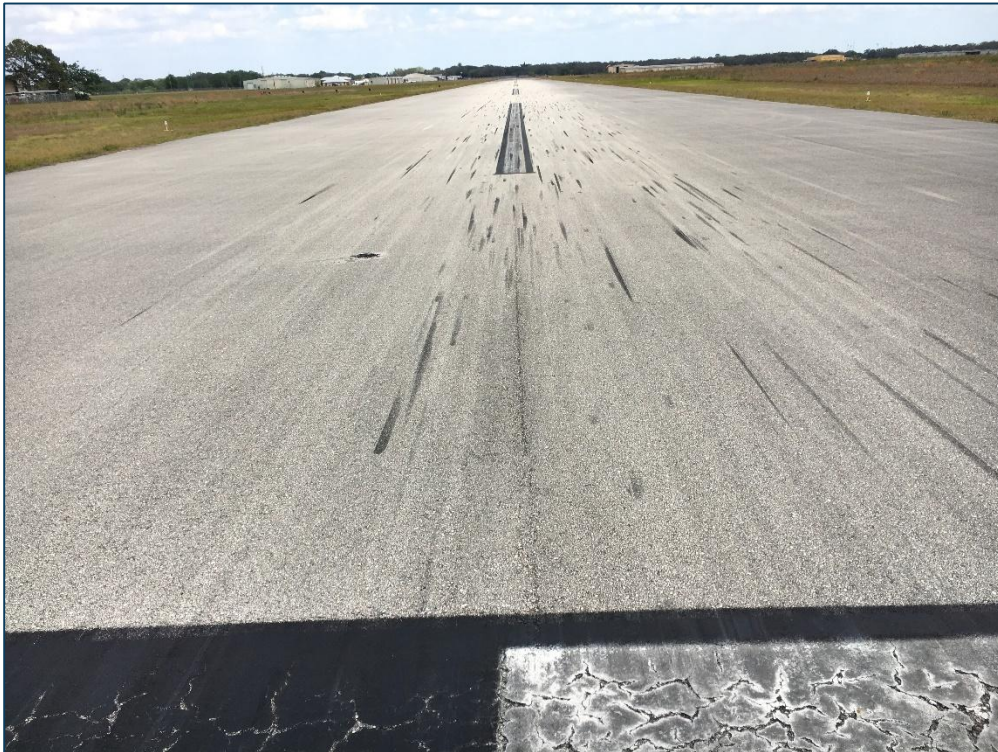
Runway 10-28, Section 6205, Sample Unit 105 – Low Severity (48) Longitudinal and Transverse Cracking, Low Severity (52) Raveling, Low Severity (57) Weathering

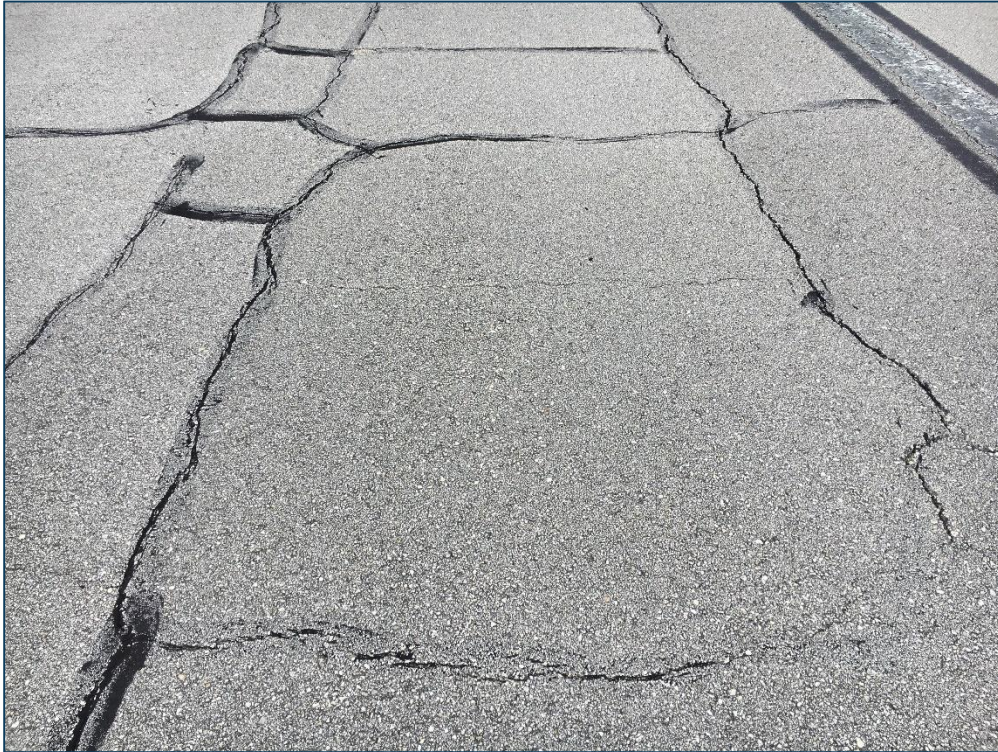
Runway 10-28, Section 6205, Sample Unit 130 – Low Severity (43) Block Cracking, Low Severity (48) Longitudinal and Transverse Cracking, Low Severity (57) Weathering

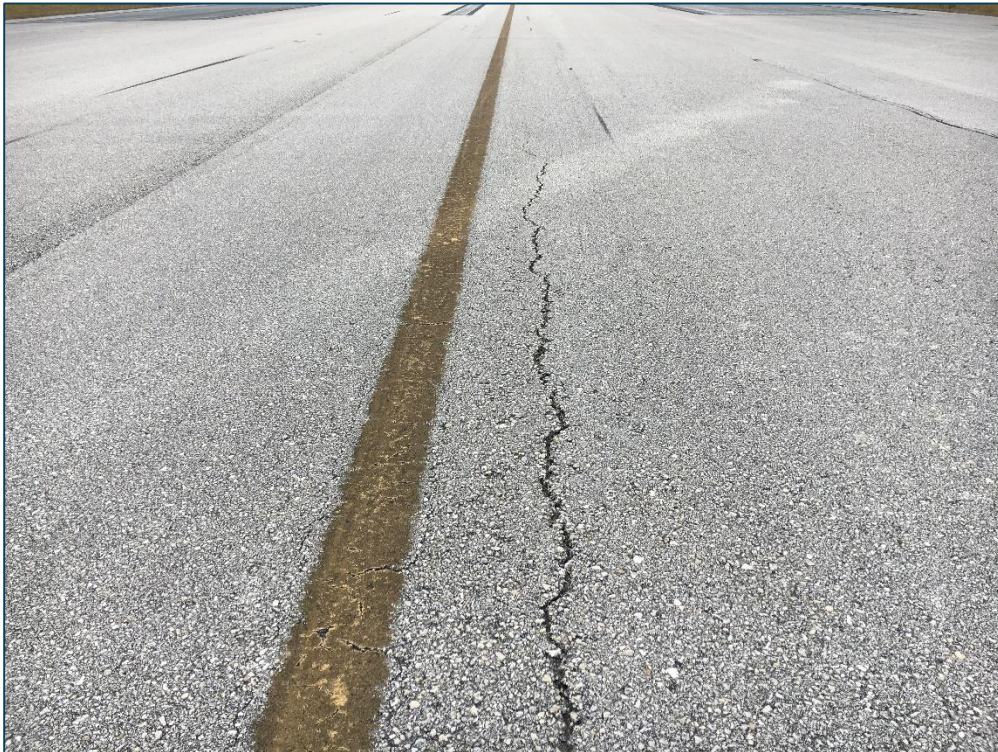
Runway 10-28, Section 6205, Sample Unit 157 – Low Severity (48) Longitudinal and Transverse Cracking, Low Severity (57) Weathering

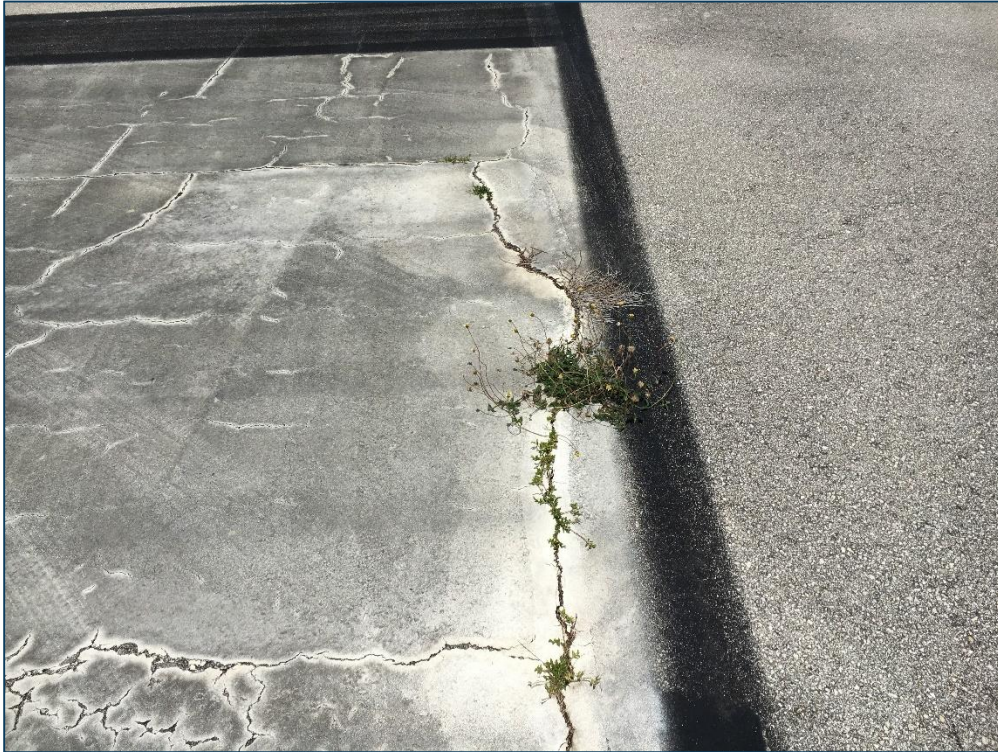
Runway 10-28, Section 6220, Sample Unit 176 – Medium Severity (48) Longitudinal and Transverse Cracking, Low Severity (52) Raveling, Low Severity (57) Weathering

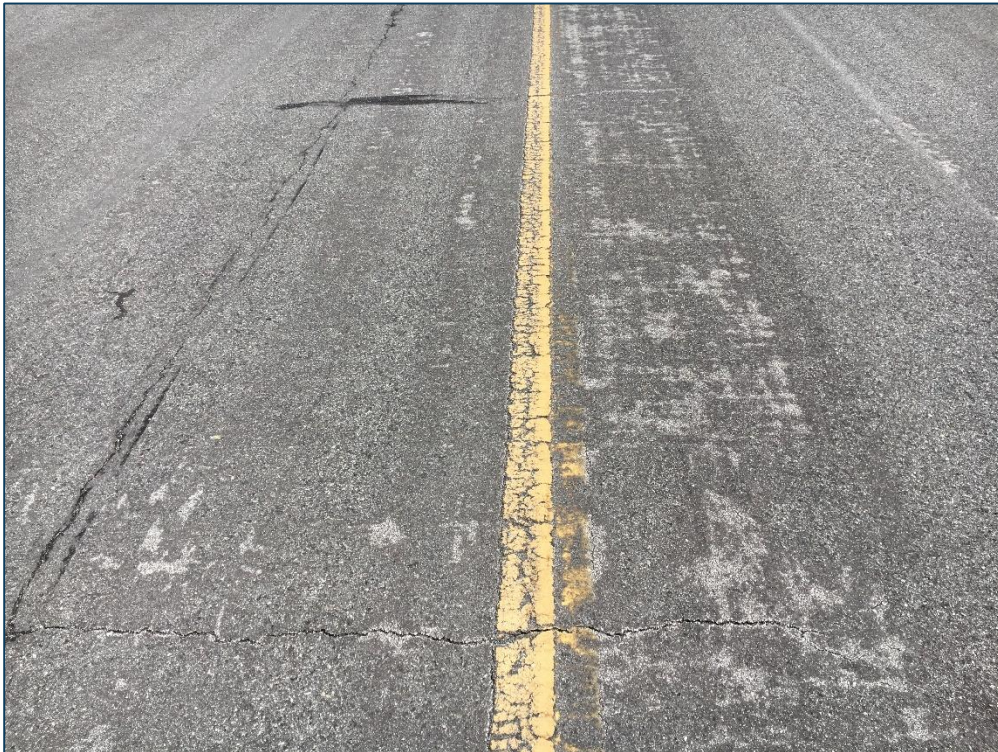
Taxiway A, Section 135, Sample Unit 110 – Low Severity (48) Longitudinal and Transverse Cracking, Low Severity (52) Raveling

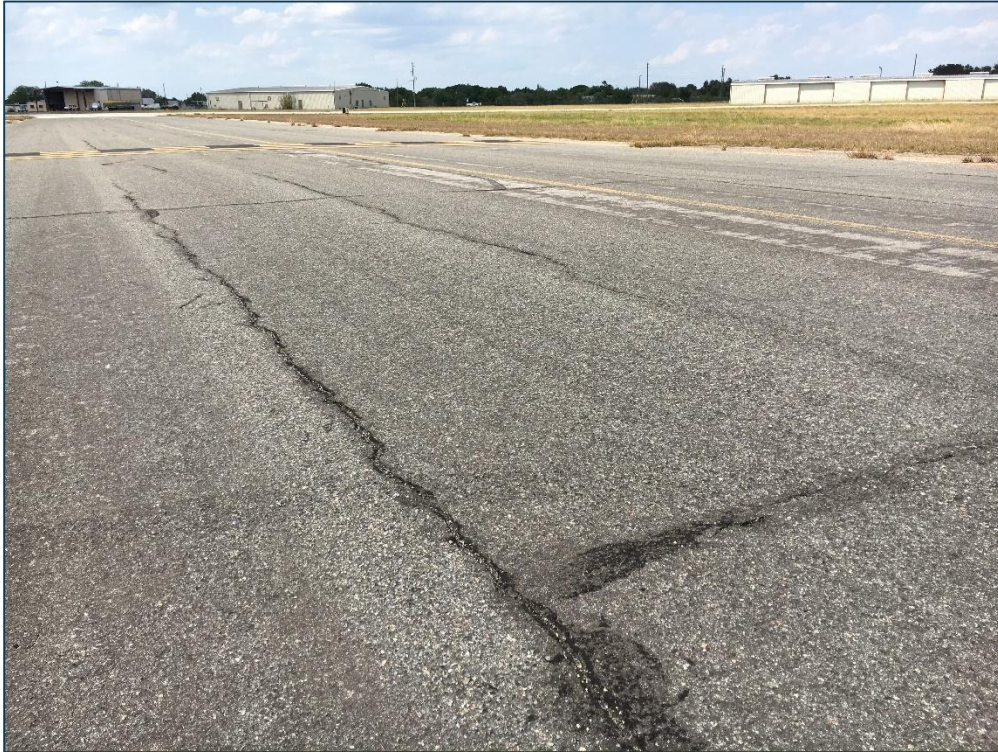
Taxiway A, Section 105, Sample Unit 103 – Medium Severity (43) Block Cracking, Low Severity (52) Raveling

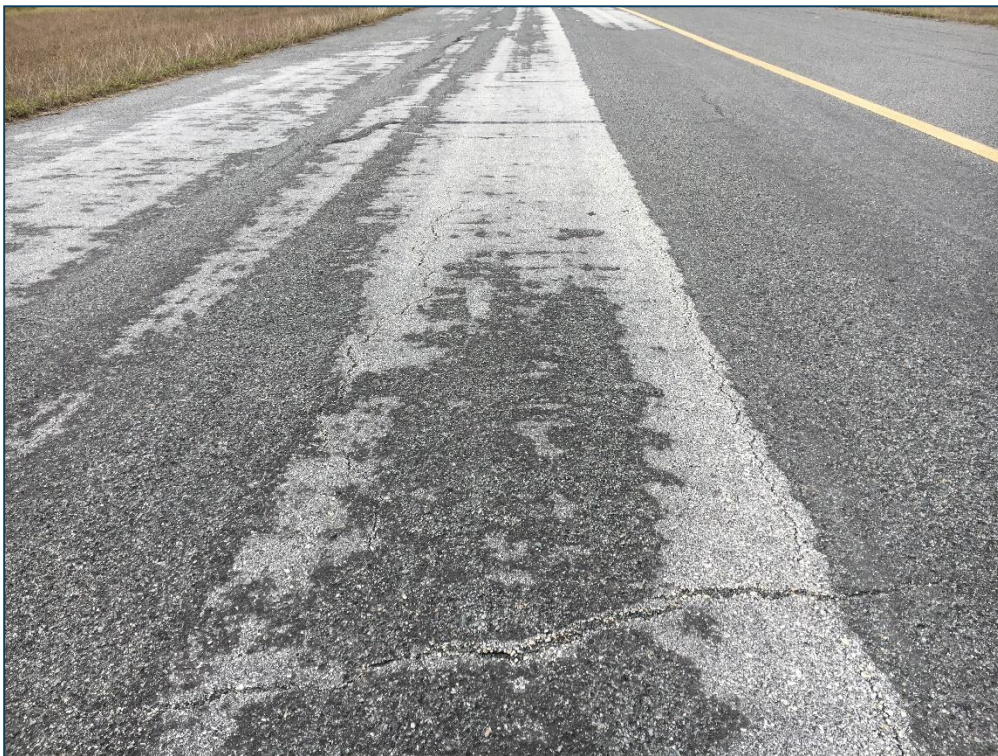
Taxiway A, Section 120, Sample Unit 108 – Low Severity (48) Longitudinal and Transverse Cracking, Low Severity (52) Raveling

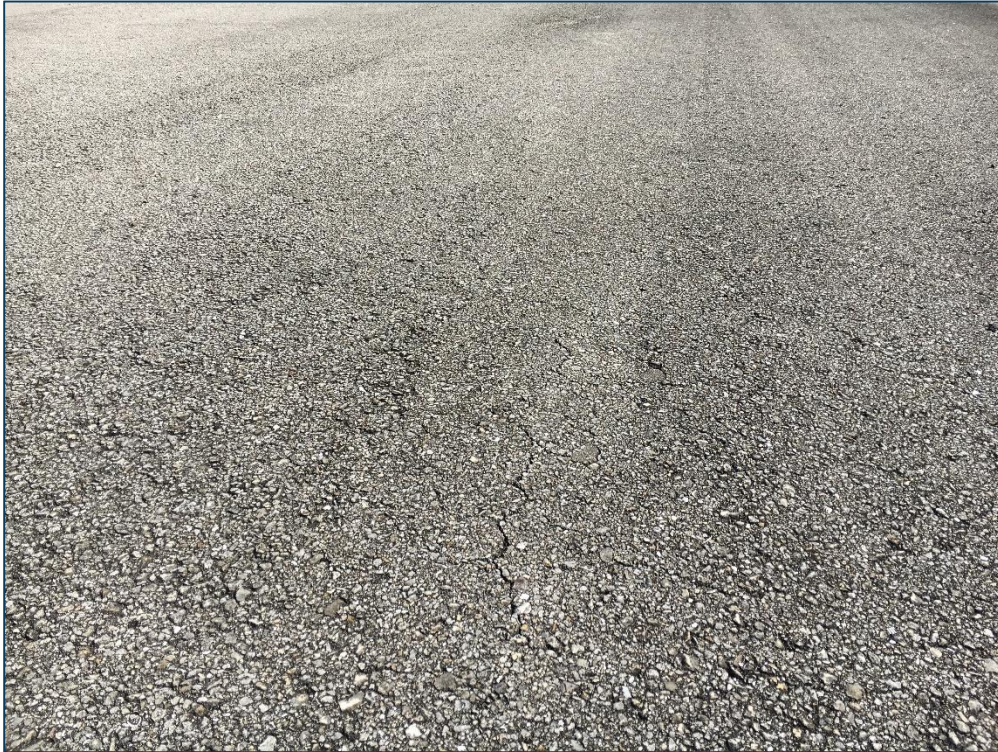
Taxiway E, Section 502, Sample Unit 104 – Low Severity (48) Longitudinal and Transverse Cracking, Low Severity (52) Raveling,
Low Severity (57) Weathering

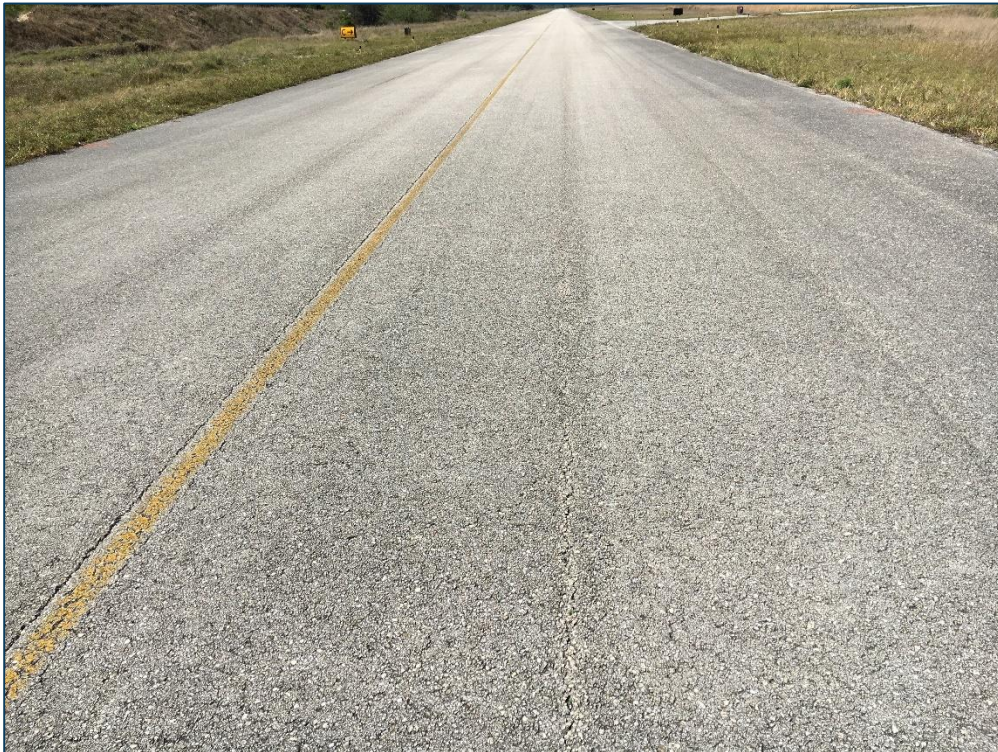
Taxiway E, Section 505, Sample Unit 113 – Low Severity (48) Longitudinal and Transverse Cracking, Low Severity (52) Raveling,
Low Severity (57) Weathering

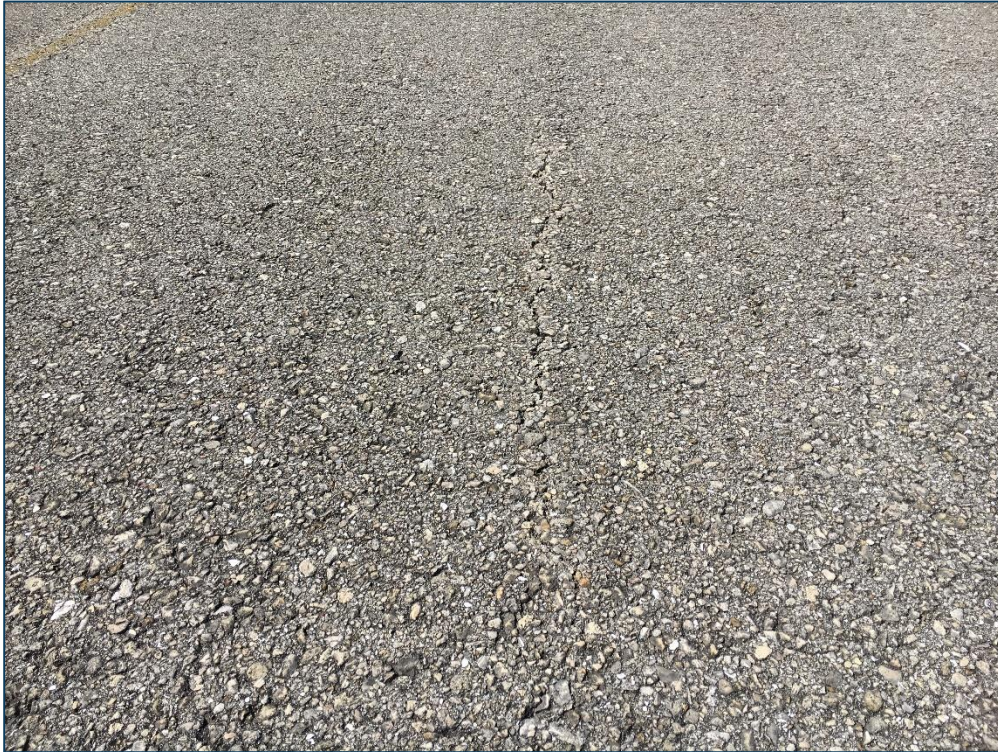
Taxiway E, Section 505, Sample Unit 129 – Low Severity (48) Longitudinal and Transverse Cracking, Low Severity (52) Raveling, Low Severity (57) Weathering

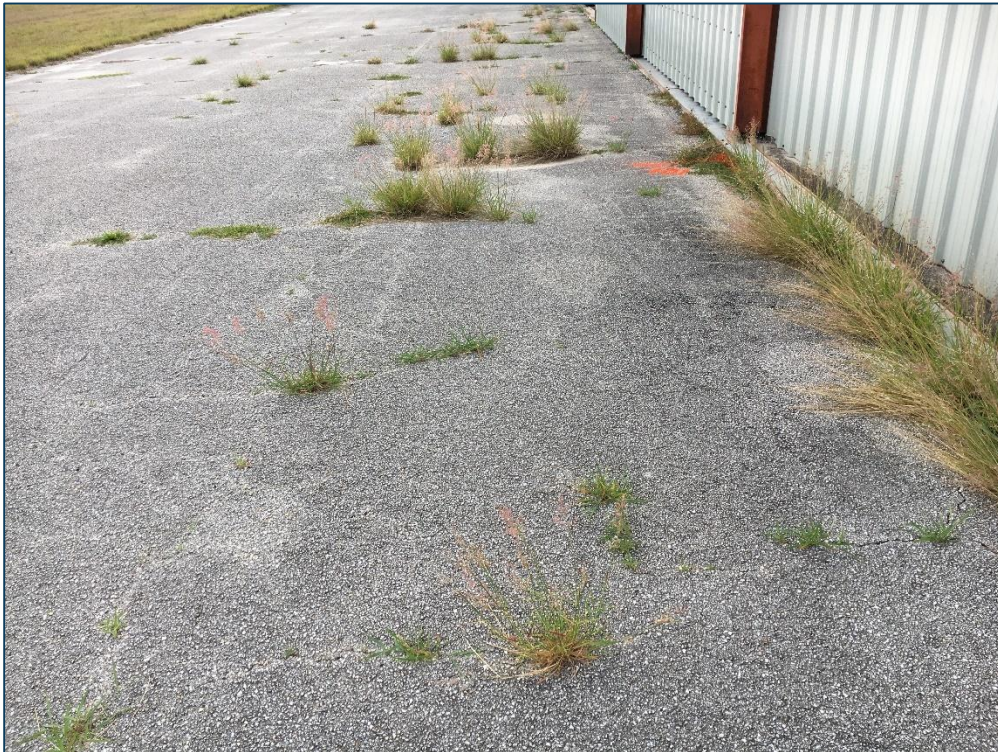
Apron NW, Section 4105, Sample Unit 101 – Low Severity (43) Block Cracking, Medium Severity (43) Block Cracking, Low Severity (52) Raveling

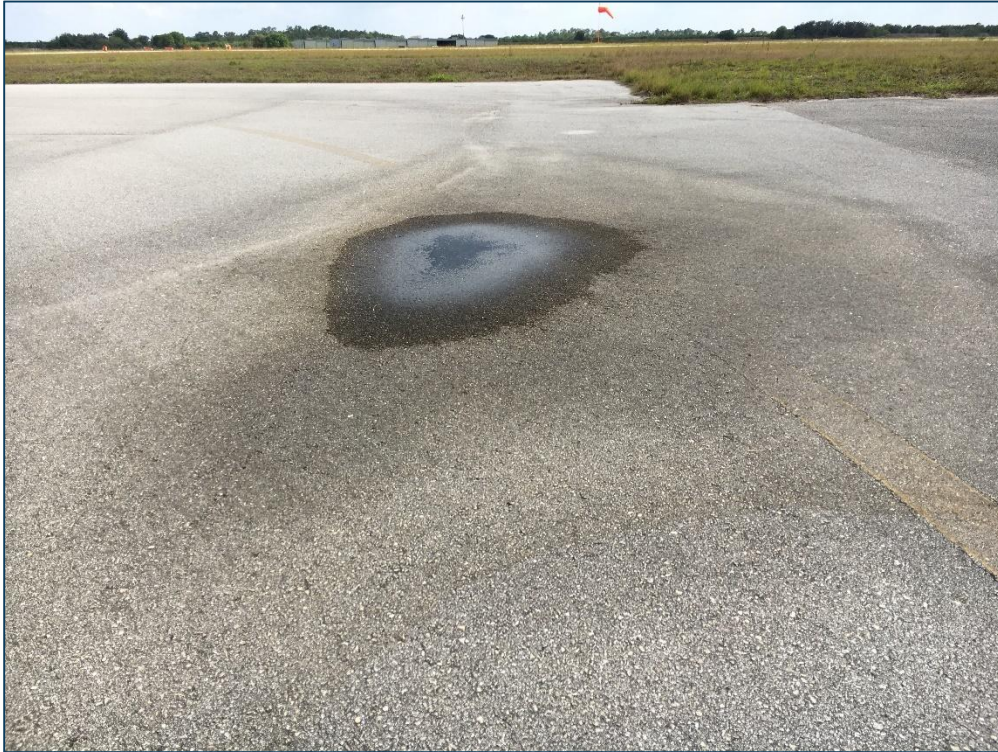
Apron NE, Section 4215, Sample Unit 200 – Low Severity (45) Depression, Low Severity (57) Weathering

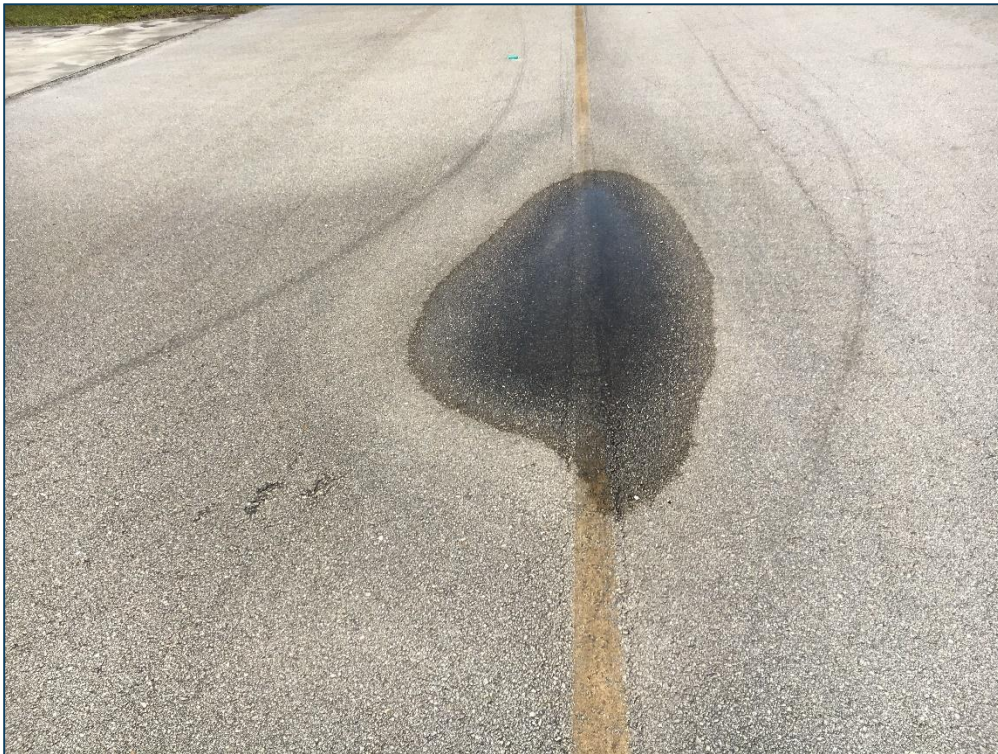
Apron T-Hangar, Section 4605, Sample Unit 402 – Low Severity (45) Depression, Low Severity (52) Raveling, Medium Severity (52) Raveling

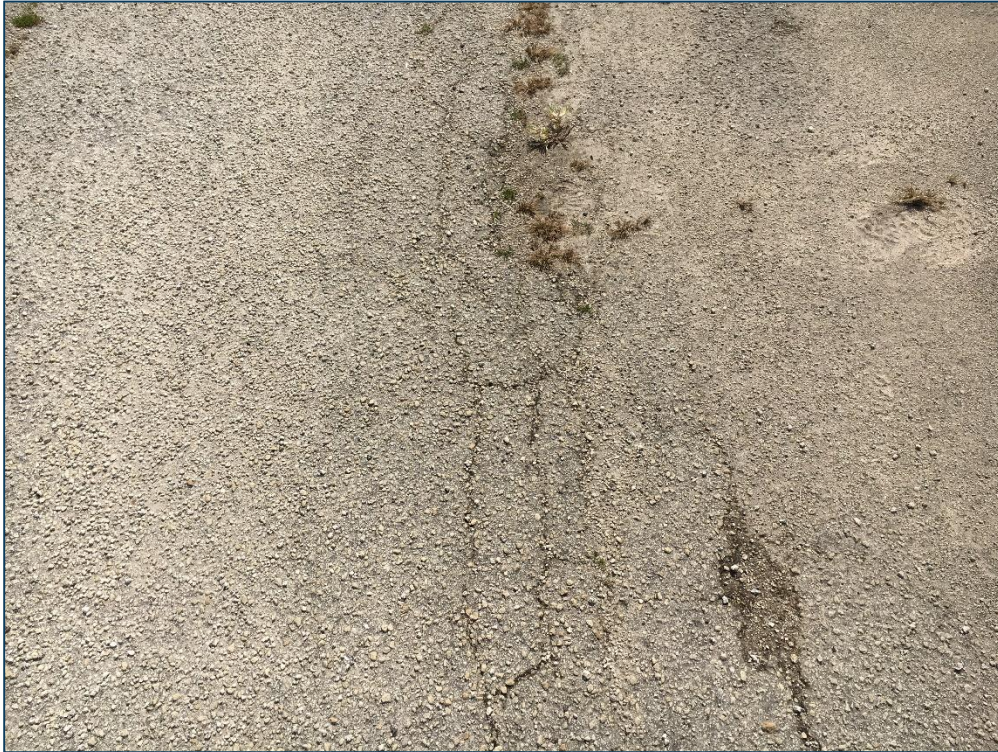
South Apron, Section 4305, Sample Unit 302 – Low Severity (41) Alligator Cracking, Medium Severity (52) Raveling

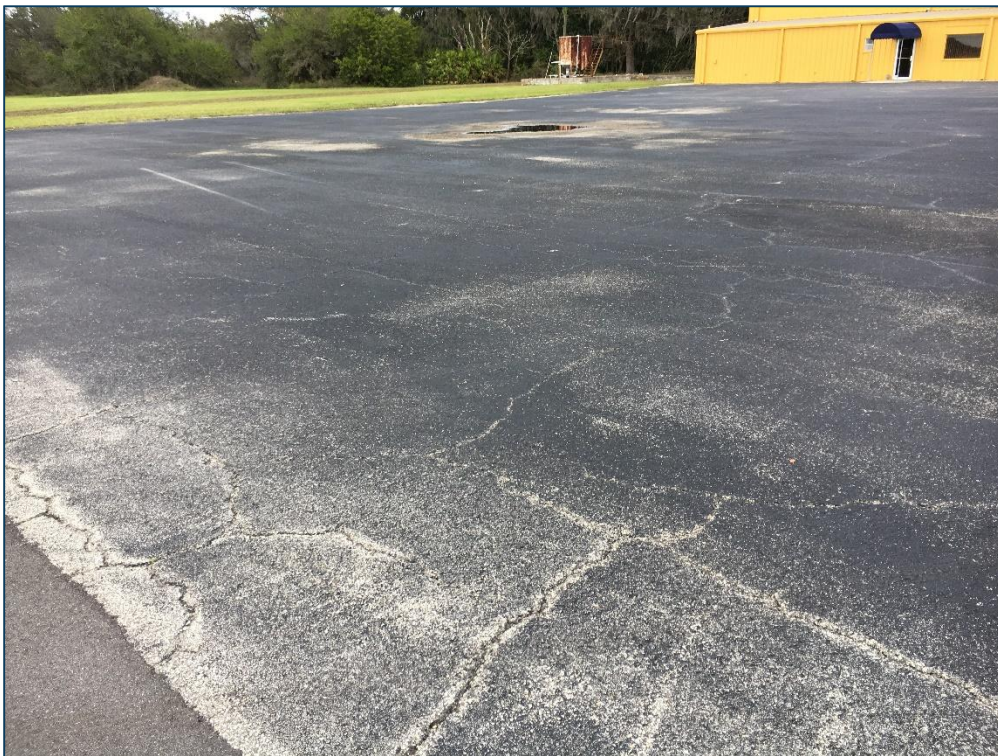
Apron SE, Section 4405, Sample Unit 300 – Low Severity (43) Block Cracking, Low Severity (45) Depression, Low Severity (52) Raveling
