# **Statewide Airfield Pavement Management Program**

**Airport Pavement  
Evaluation Report  
September 2017**

**Brooksville -  
Tampa Bay Regional  
Airport (BKV)**  
General Aviation Airport  
District 7

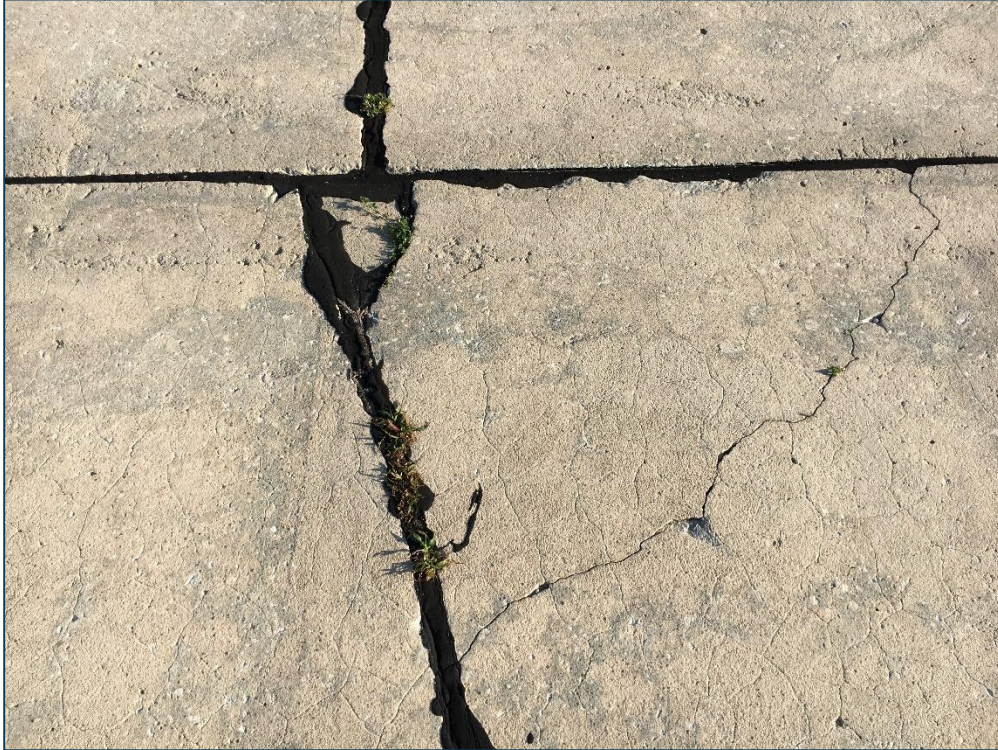
Runway 9-27, Section 6110, Sample Unit 300 – Medium Severity (63) Longitudinal, Transverse, and Diagonal Cracking, Low Severity (65) Joint Seal Damage, (73) Shrinkage Cracks

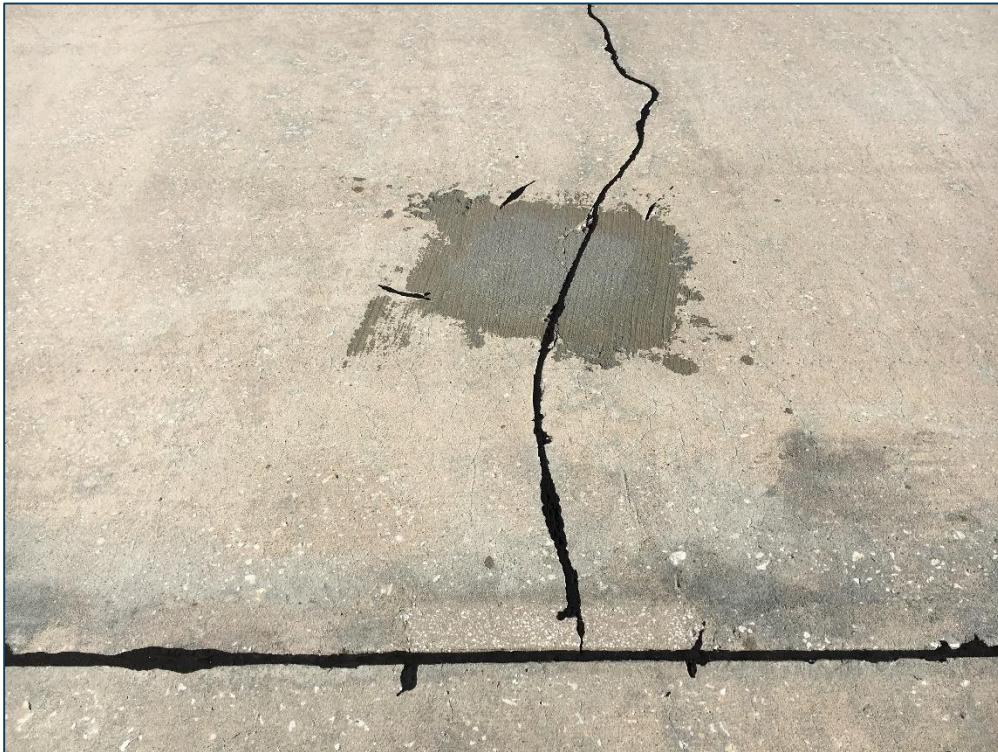
Runway 9-27, Section 6110, Sample Unit 349 – Medium Severity (63) Longitudinal, Transverse, and Diagonal Cracking, Low Severity (65) Joint Seal Damage, Low Severity (66) Small Patching, (73) Shrinkage Cracks

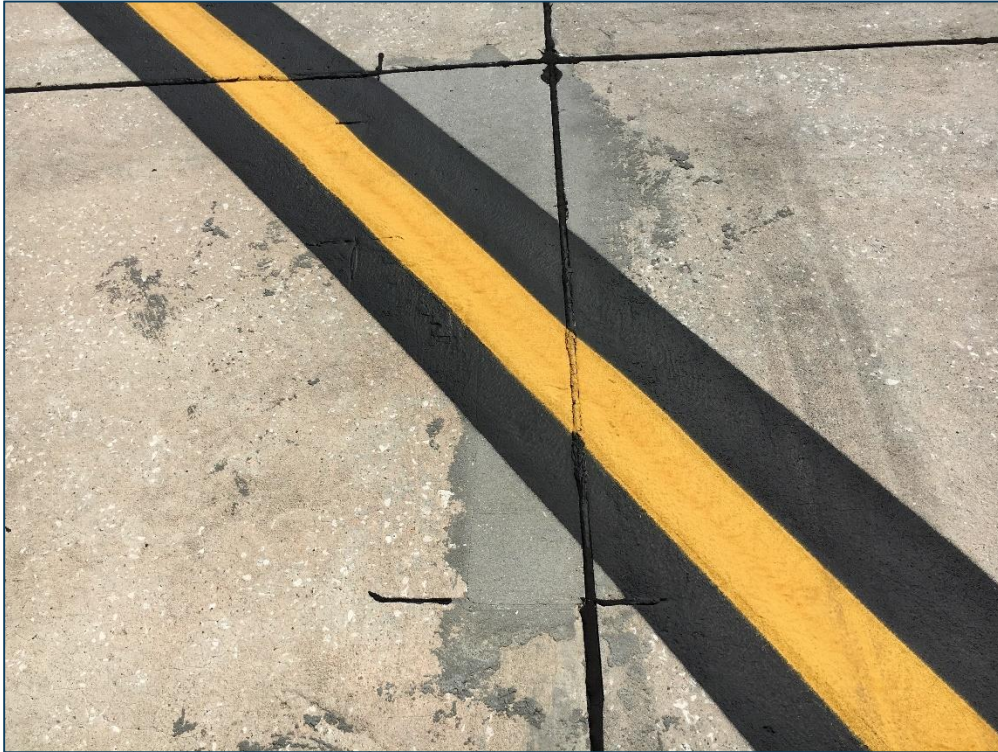
Runway 9-27, Section 6110, Sample Unit 398 – Low Severity (65) Joint Seal Damage, Low Severity (66) Small Patching, (73) Shrinkage Cracks

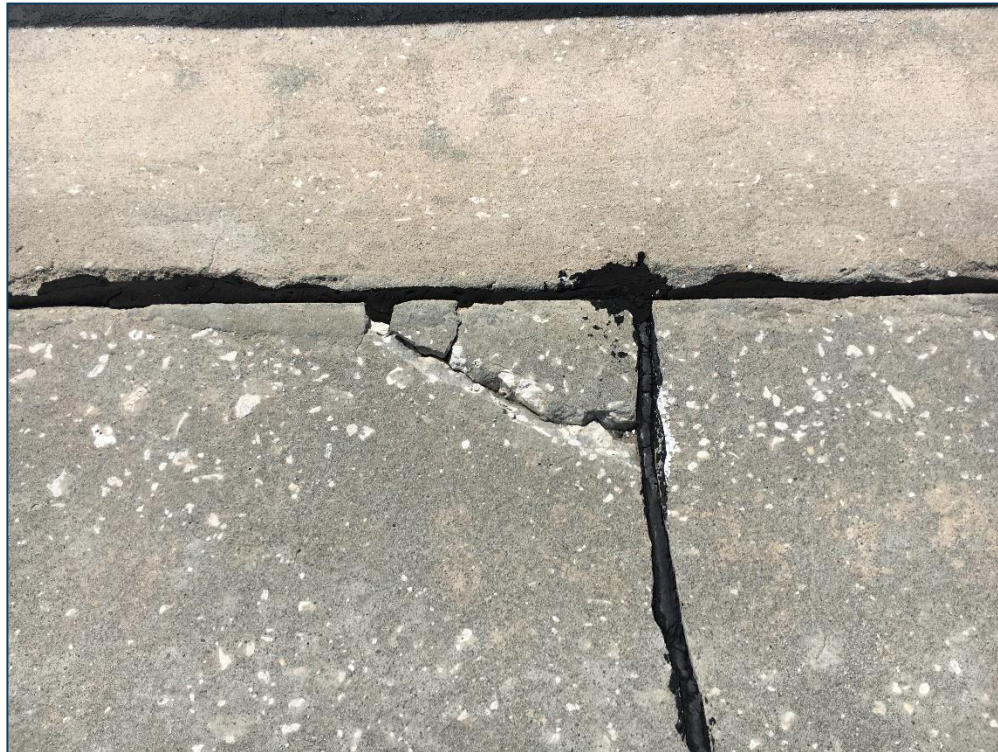
Runway 9-27, Section 6110, Sample Unit 439 – Low Severity (63) Longitudinal, Transverse, and Diagonal Cracking, Low Severity (65) Joint Seal Damage, Low Severity (74) Joint Spalling

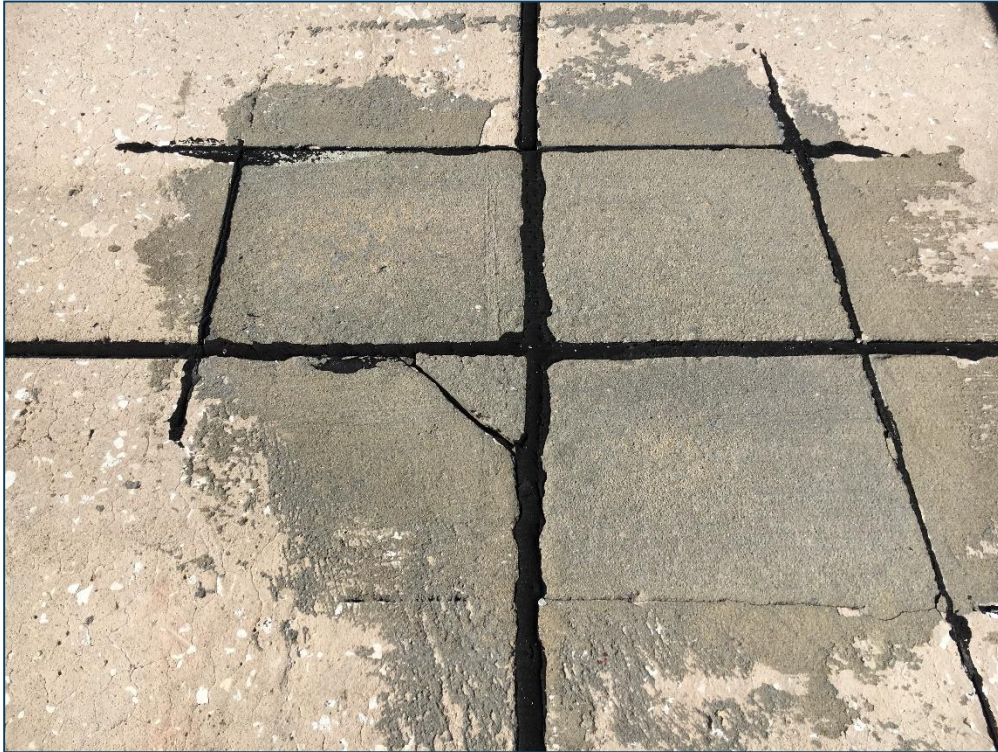
Runway 3-21, Section 6210, Sample Unit 301 – Low Severity (65) Joint Seal Damage, Medium Severity (66) Small Patching, Low Severity (74) Joint Spalling, Low Severity (75) Corner Spalling

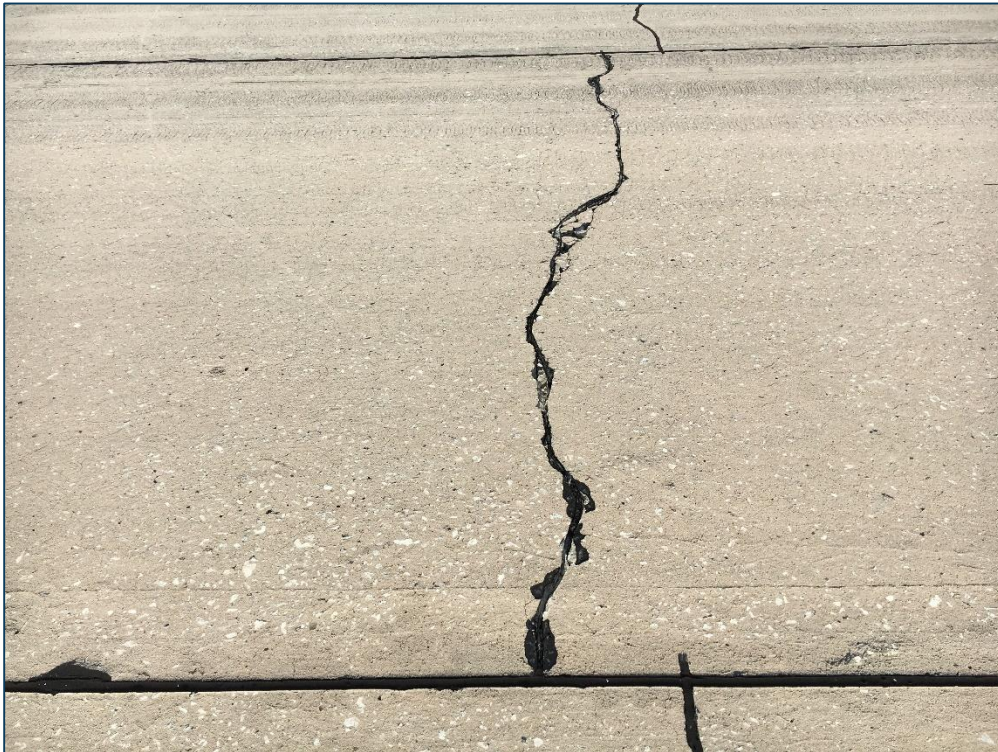
Runway 3-21, Section 6210, Sample Unit 337 – Medium Severity (63) Longitudinal, Transverse, and Diagonal Cracking, Low Severity (65) Joint Seal Damage

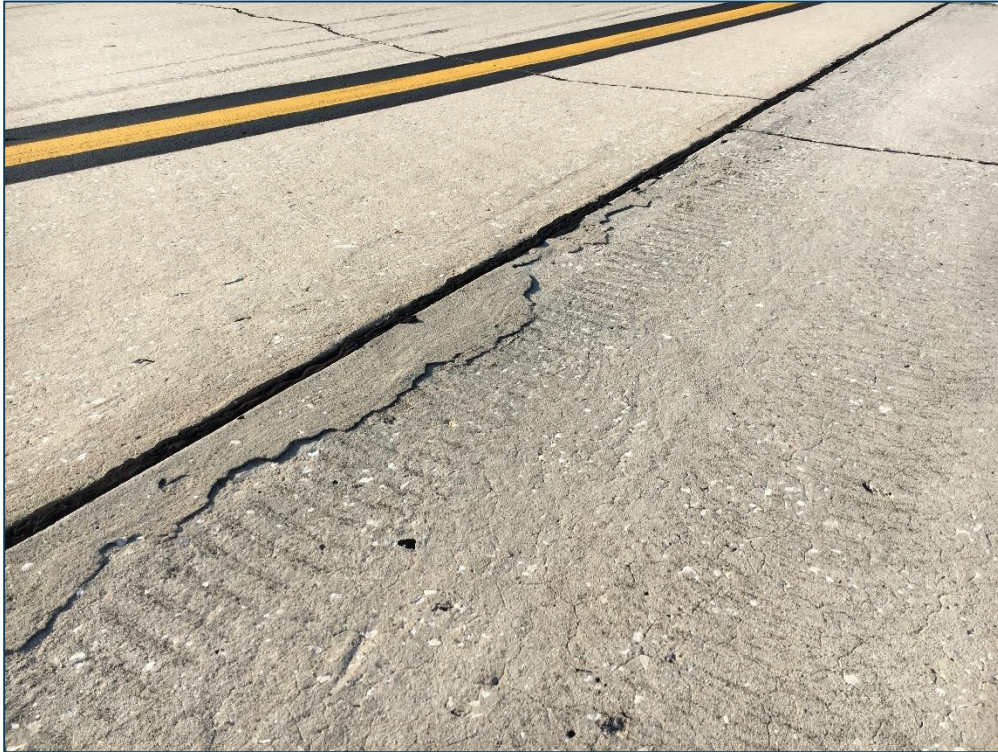
Runway 3-21, Section 6210, Sample Unit 367 – Low Severity (63) Longitudinal, Transverse, and Diagonal Cracking, Low Severity (65) Joint Seal Damage, Low Severity (70) Scaling, Map Cracking, Cracking, (73) Shrinkage Cracks

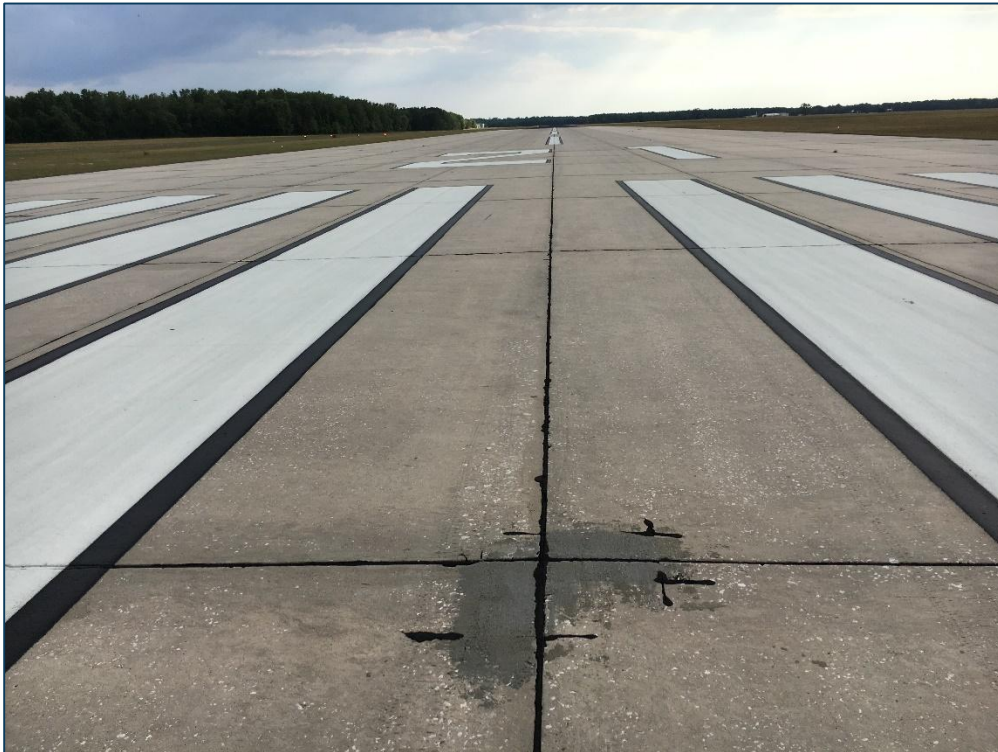
Runway 3-21, Section 6210, Sample Unit 398 – Low Severity (65) Joint Seal Damage, Low Severity (66) Small Patching

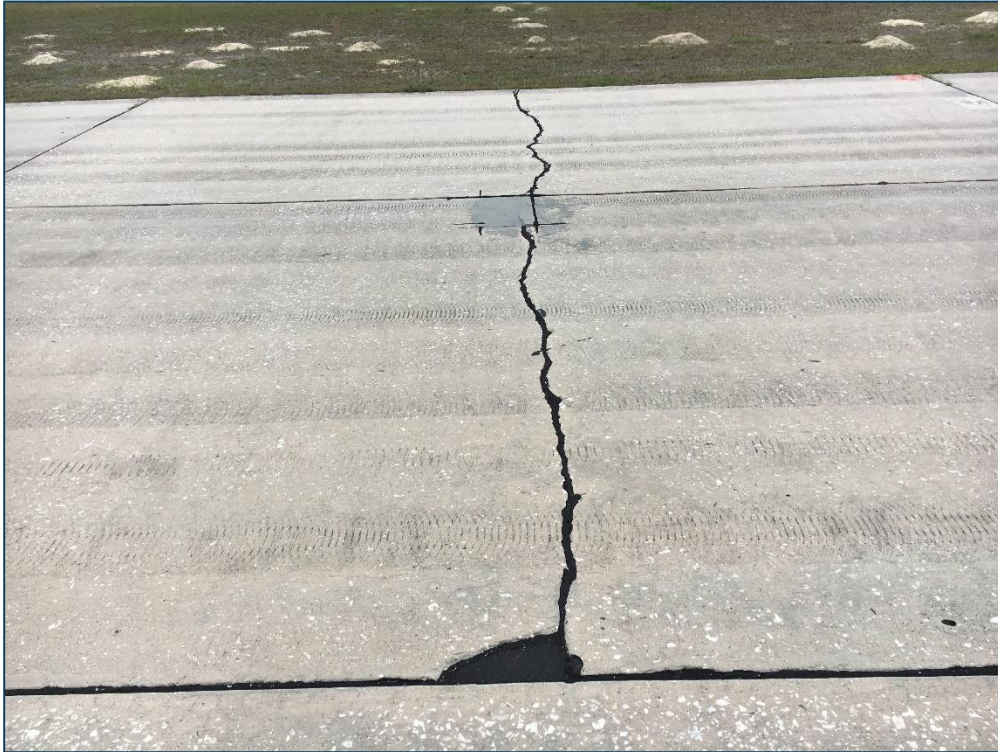
Taxiway A, Section 105, Sample Unit 107 – Low Severity (63) Longitudinal, Transverse, and Diagonal Cracking, Low Severity (65) Joint Seal Damage, Low Severity (66) Small Patching, (73) Shrinkage Cracks

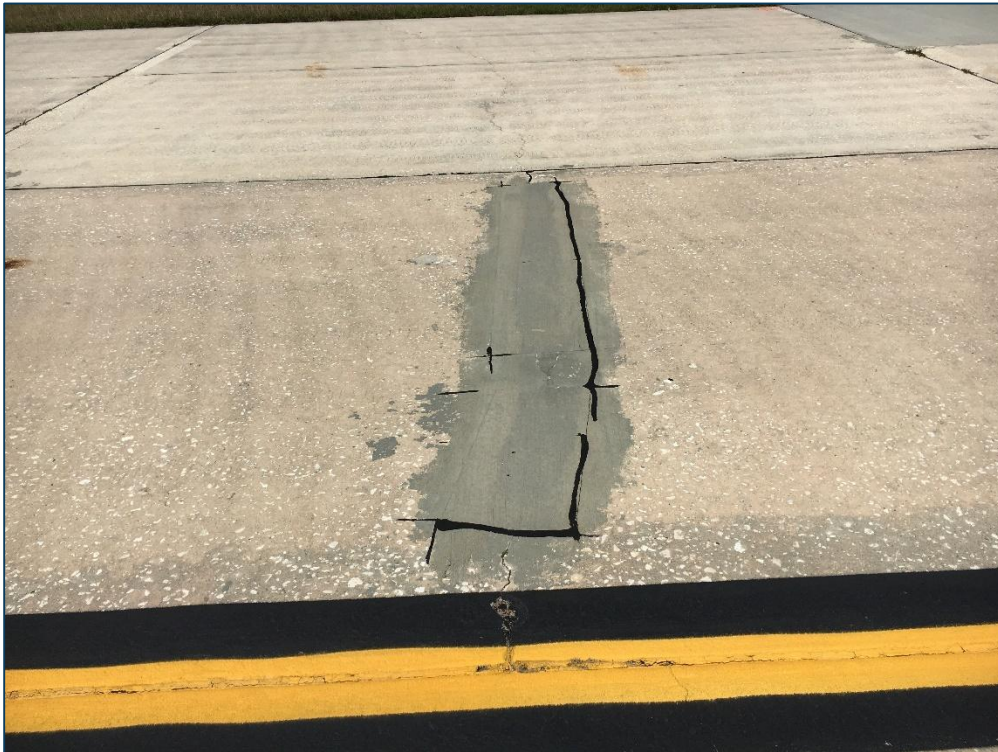
Taxiway A, Section 105, Sample Unit 191 – Low Severity (63) Longitudinal, Transverse, and Diagonal Cracking, Low Severity (65) Joint Seal Damage, Low Severity (67) Large Patching

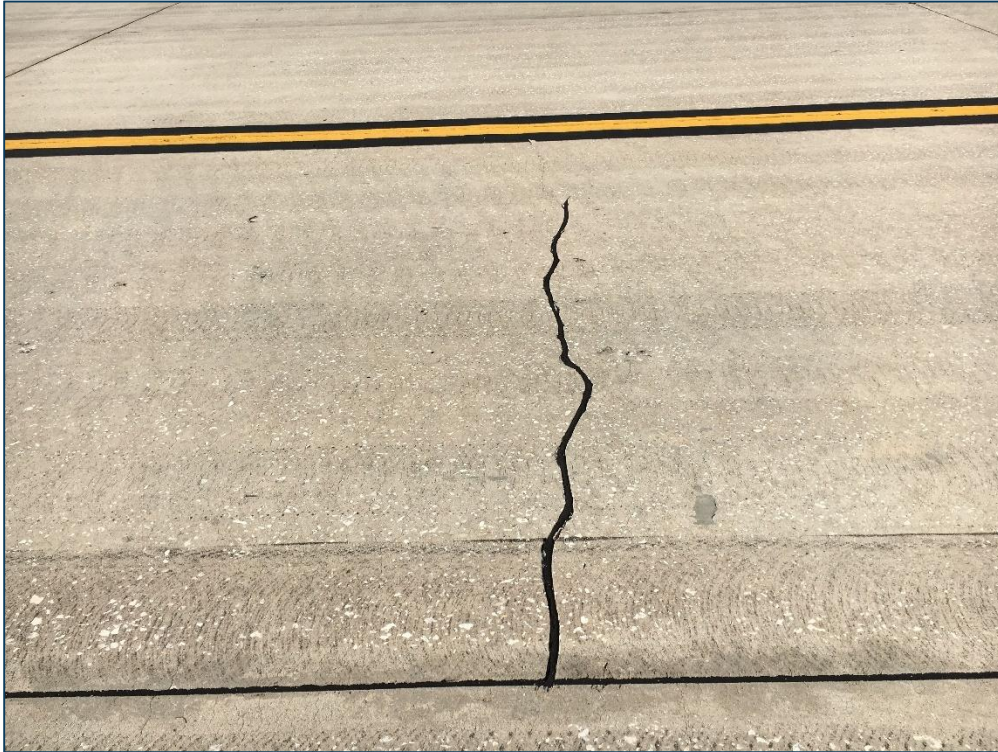
Taxiway A, Section 105, Sample Unit 268 – Low Severity (63) Longitudinal, Transverse, and Diagonal Cracking, Low Severity (65) Joint Seal Damage

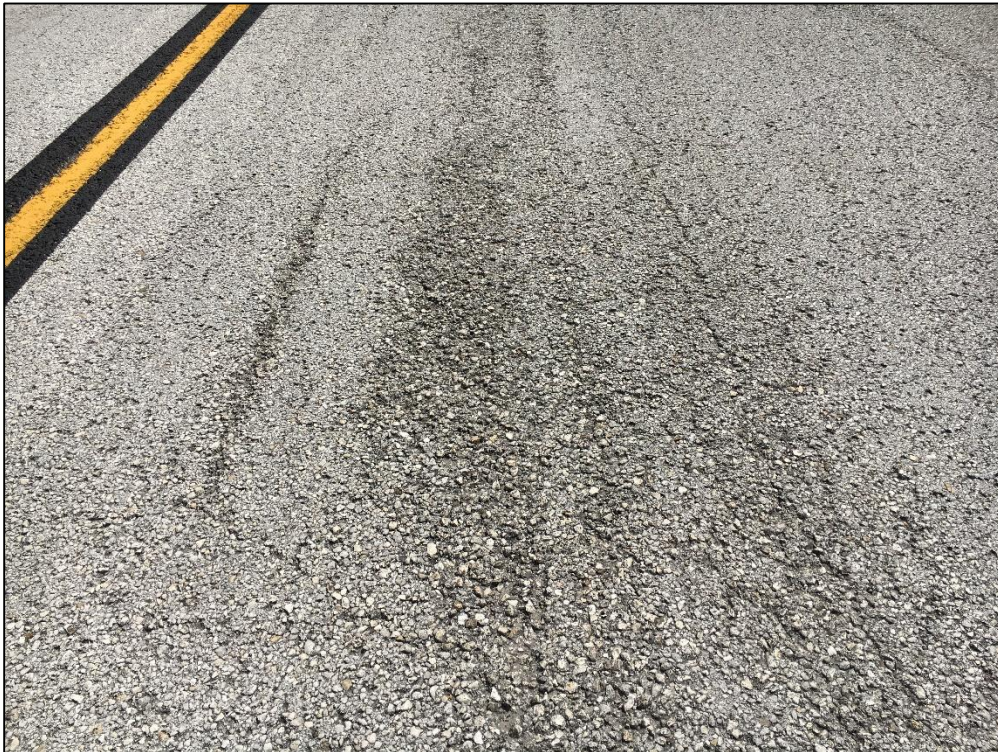
Taxiway A3, Section 125, Sample Unit 301 – Low Severity (48) Longitudinal and Transverse Cracking, Medium Severity (52) Raveling, High Severity (52) Raveling

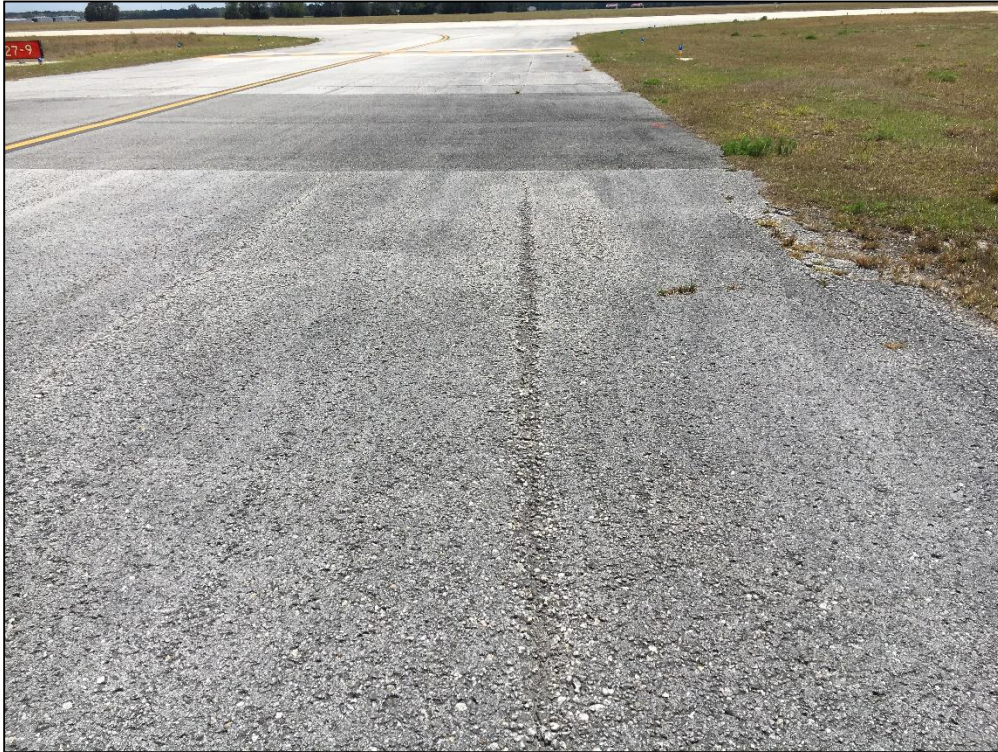
Taxiway A6, Section 135, Sample Unit 605 – Low Severity (48) Longitudinal and Transverse Cracking, Low Severity (50) Patching, Medium Severity (52) Raveling, High Severity (52) Raveling

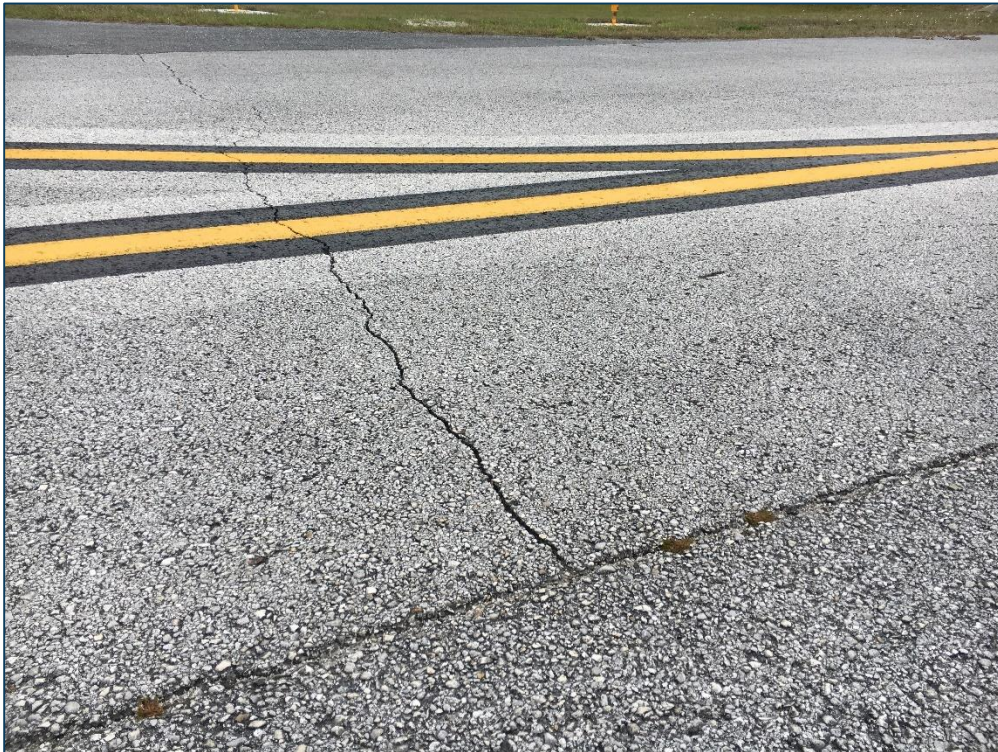
Taxiway B, Section 210, Sample Unit 104 – Low and Medium Severity (48) Longitudinal and Transverse Cracking, Low Severity (52) Raveling

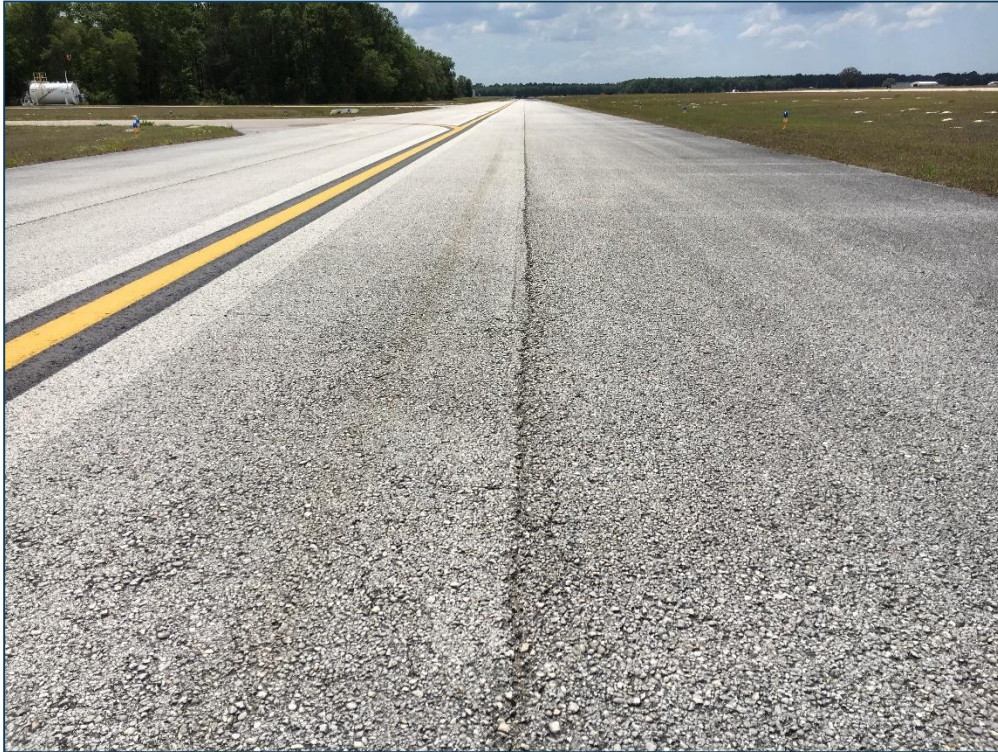
Taxiway B, Section 210, Sample Unit 128 – Low Severity (48) Longitudinal and Transverse Cracking, Low Severity (52) Raveling

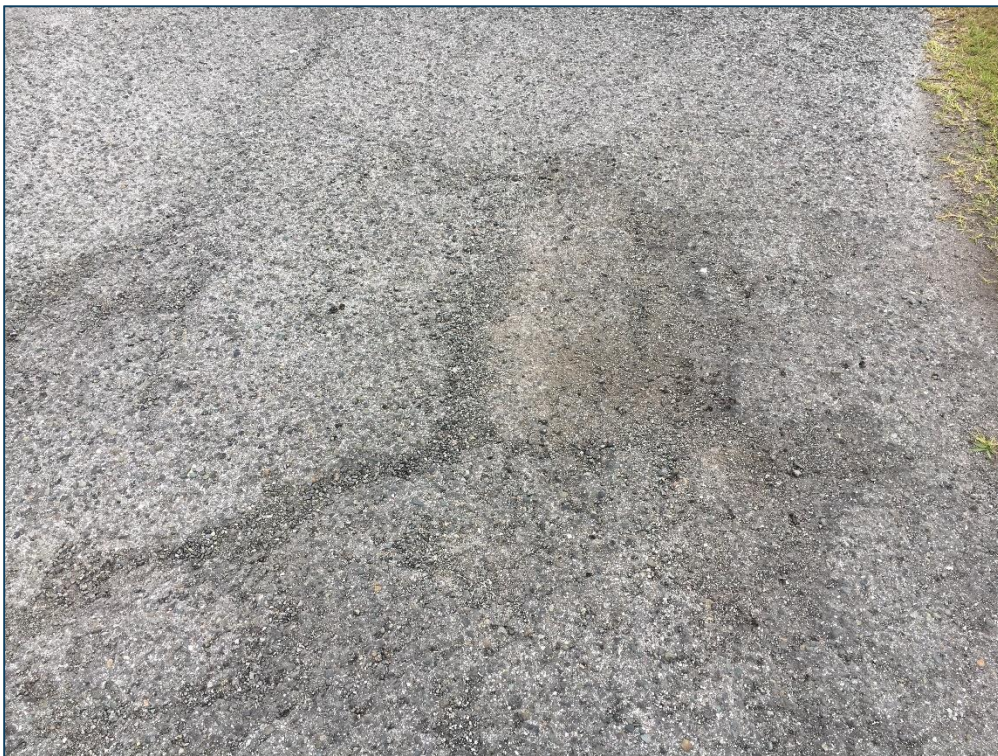
Taxiway B, Section 205, Sample Unit 148 – Medium Severity (52) Raveling, High Severity (52) Raveling

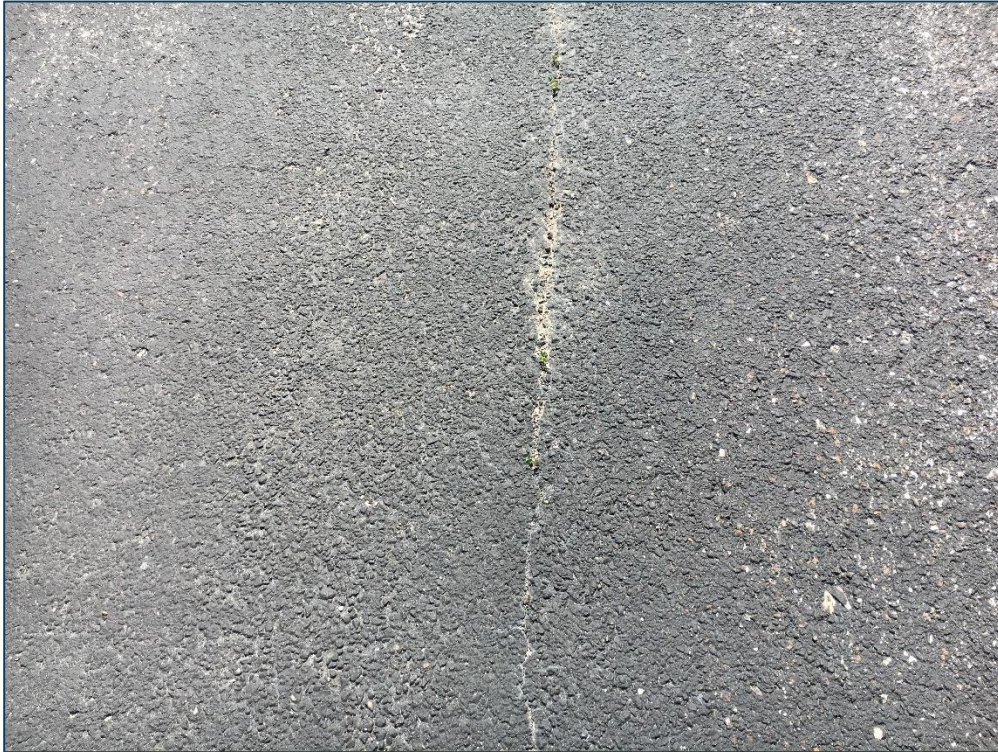
South Apron, Section 4210, Sample Unit 504 – Low Severity (48) Longitudinal and Transverse Cracking, Low Severity (52) Raveling

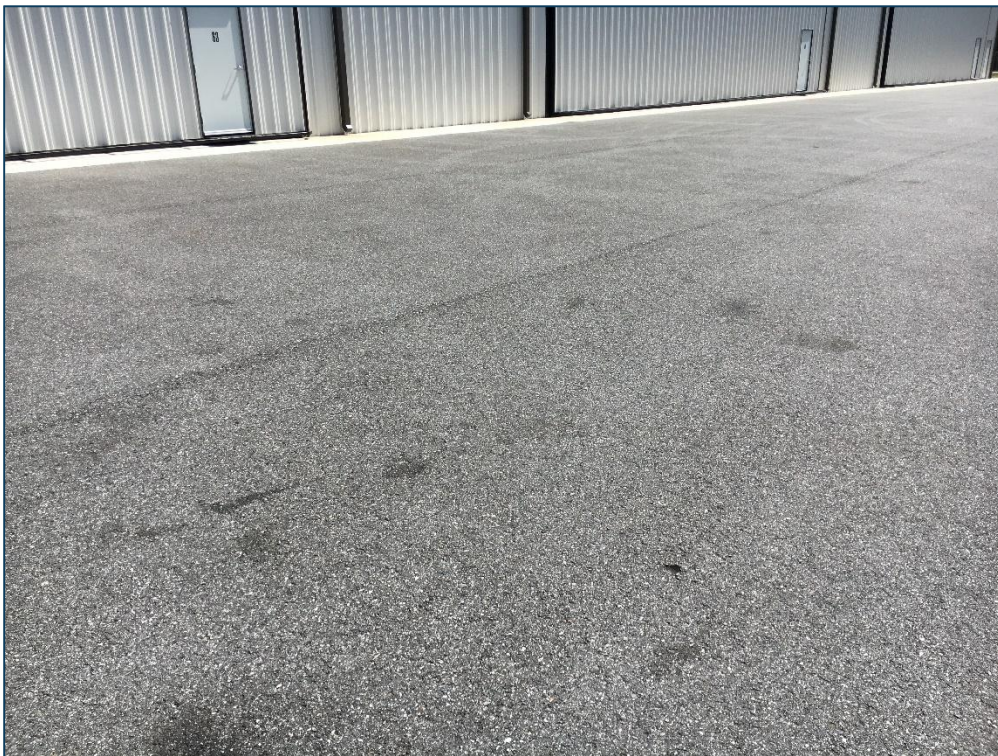
South Apron, Section 4225, Sample Unit 302 – Low Severity (57) Weathering

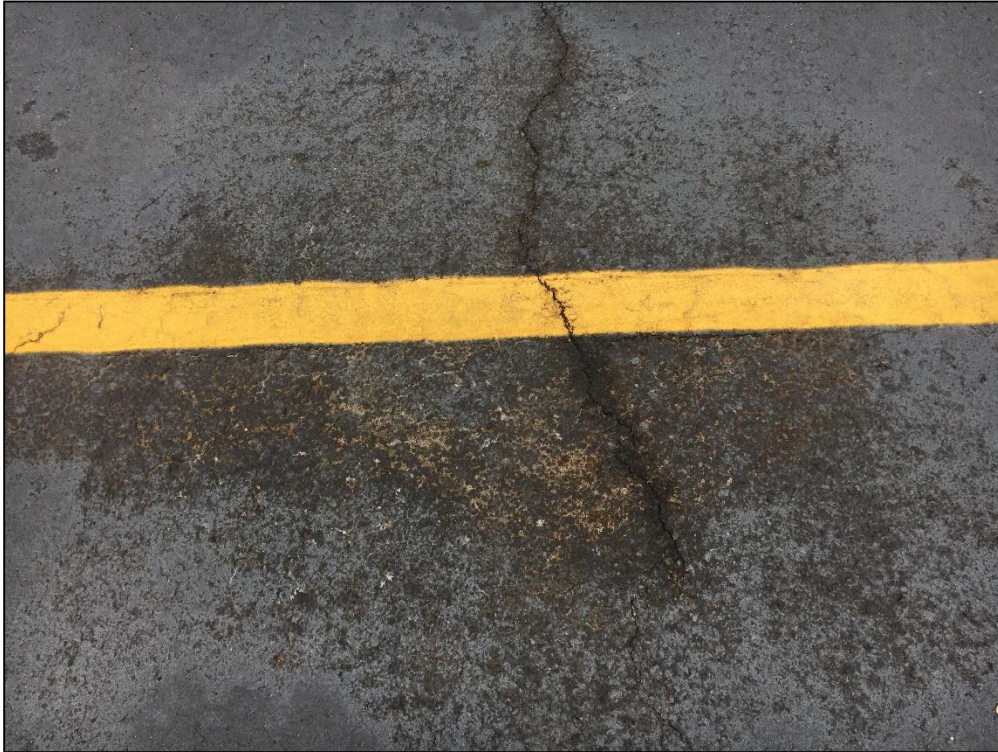
Apron NE, Section 4140, Sample Unit 207 – Low Severity (48) Longitudinal and Transverse Cracking, (49) Oil Spillage, Low Severity (57) Weathering
