FLORIDA DEPARTMENT OF TRANSPORTATION
AVIATION AND SPACEPORTS OFFICE

Statewide Airfield Pavement Management Program

Airport Pavement Evaluation Report September 2017

**Bob Sikes Airport
(CEW)**
General Aviation Airport
District 3

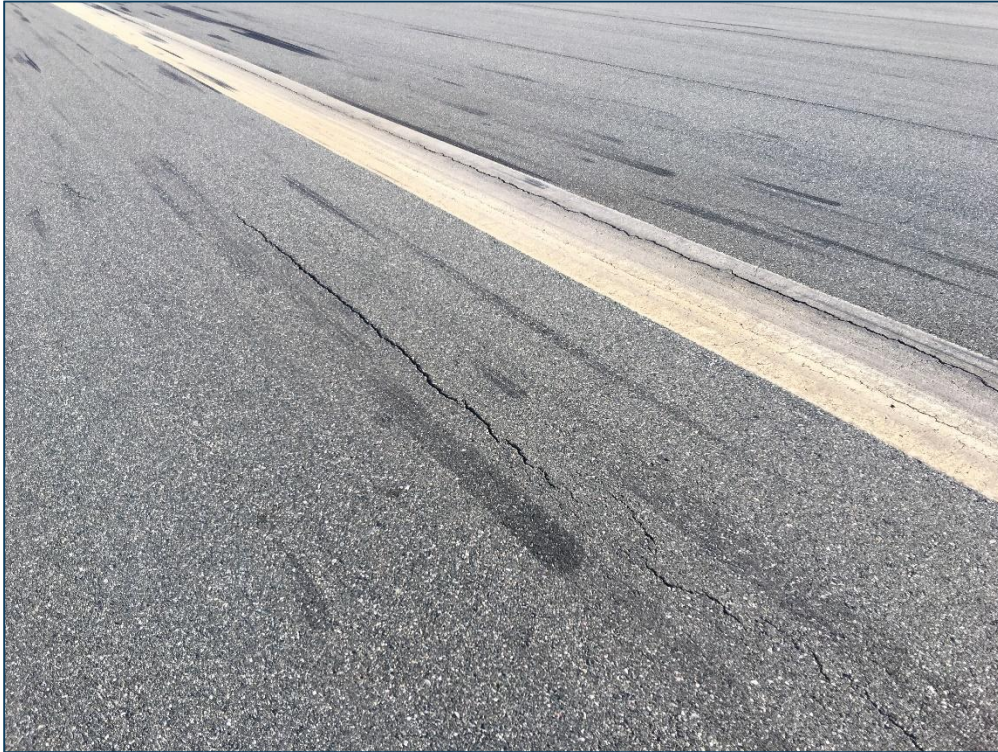
Runway 17-35, Section 6105, Sample Unit 306 – Low and Medium Severity (48) Longitudinal and Transverse Cracking, Low Severity (57) Weathering

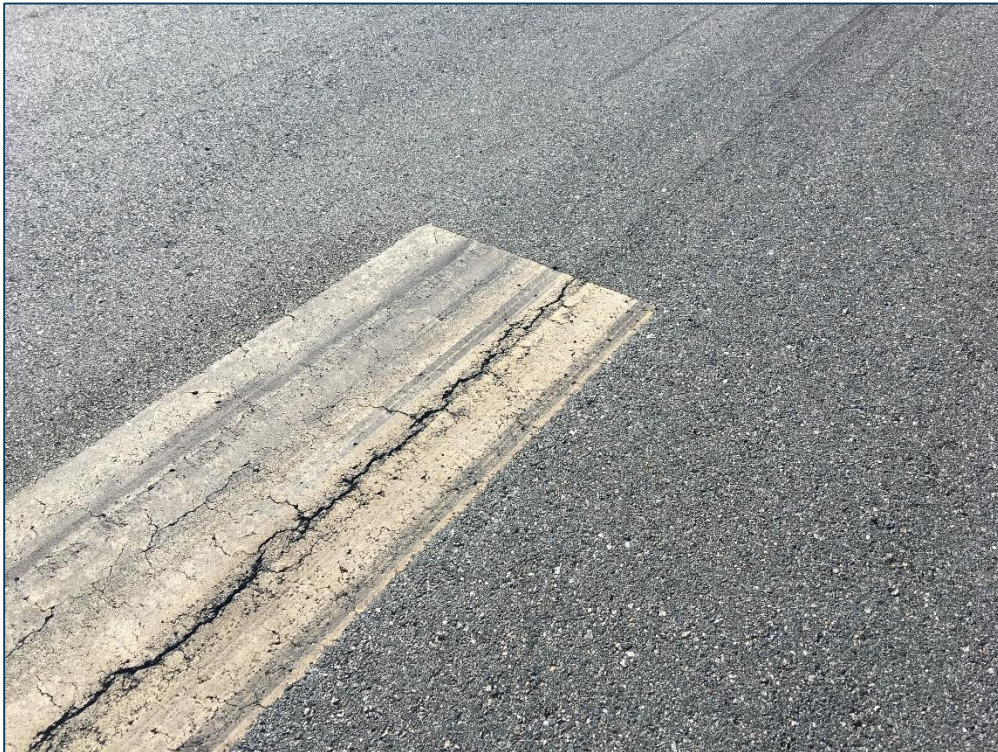
Runway 17-35, Section 6115, Sample Unit 346 – Low Severity (48) Longitudinal and Transverse Cracking, Low Severity (57) Weathering, Medium Severity (57) Weathering

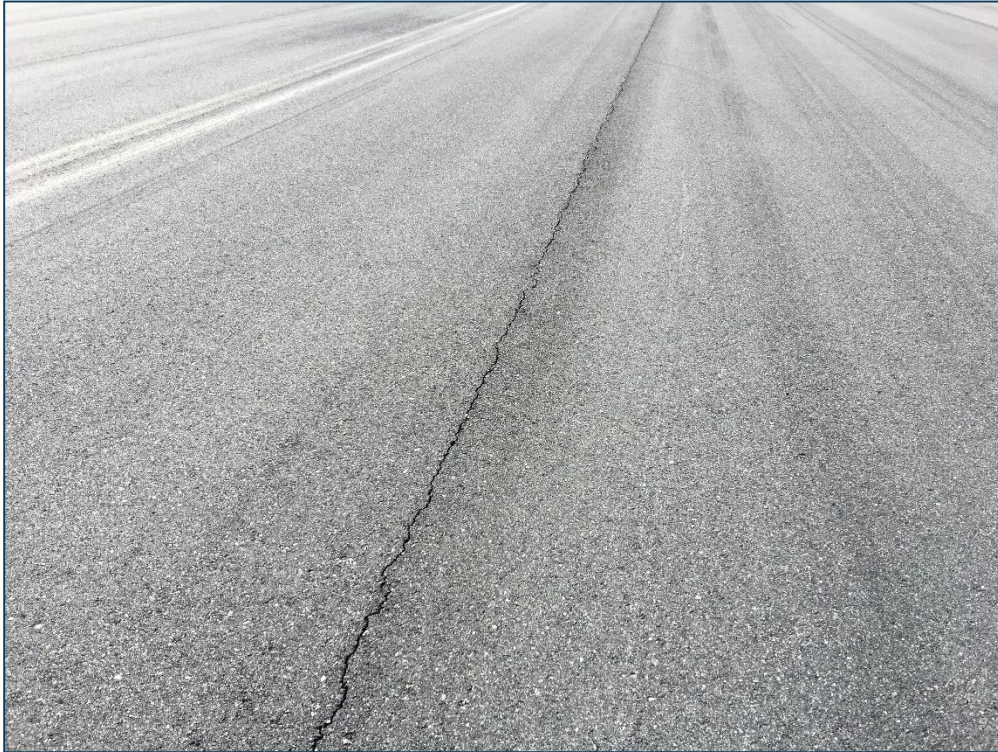
Runway 17-35, Section 6115, Sample Unit 394 – Low Severity (48) Longitudinal and Transverse Cracking, Low Severity (57) Weathering

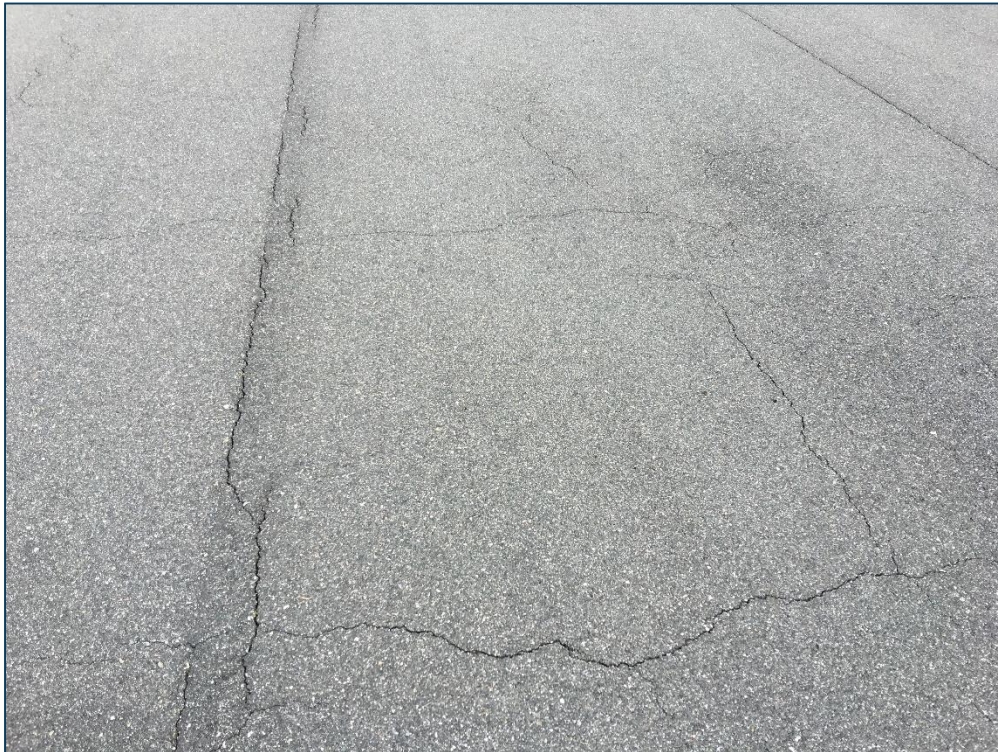
Runway 17-35, Section 6125, Sample Unit 452 – Low Severity (43) Block Cracking, Low Severity (48) Longitudinal and Transverse Cracking, Low Severity (57) Weathering

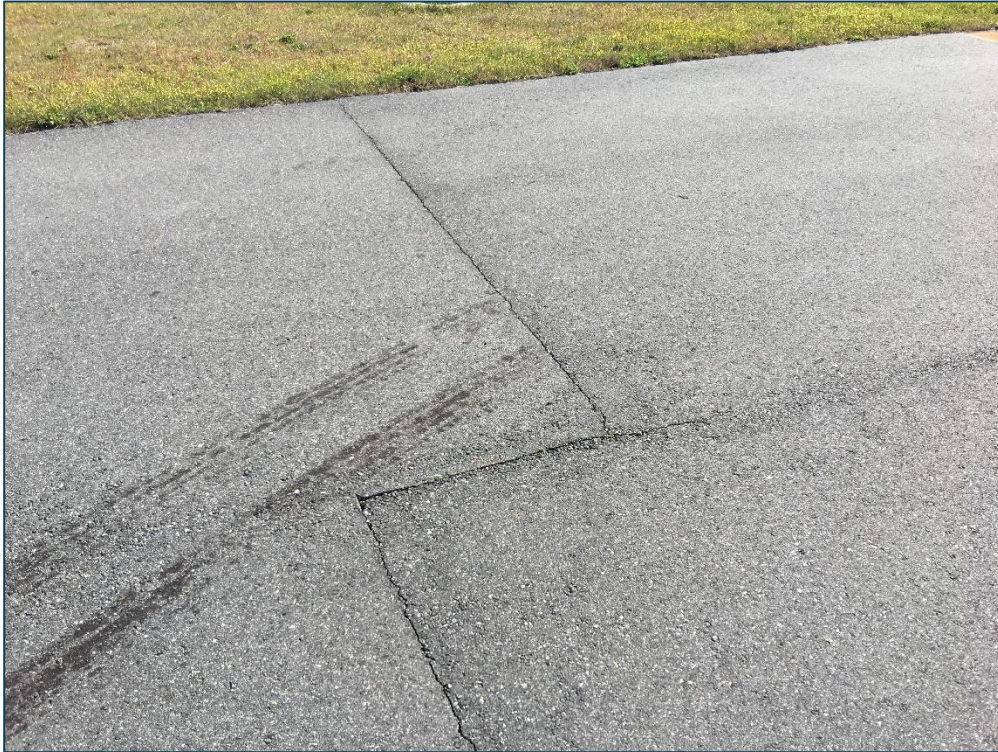
Taxiway A, Section 105, Sample Unit 103 – Low Severity (48) Longitudinal and Transverse Cracking, Low Severity (57) Weathering

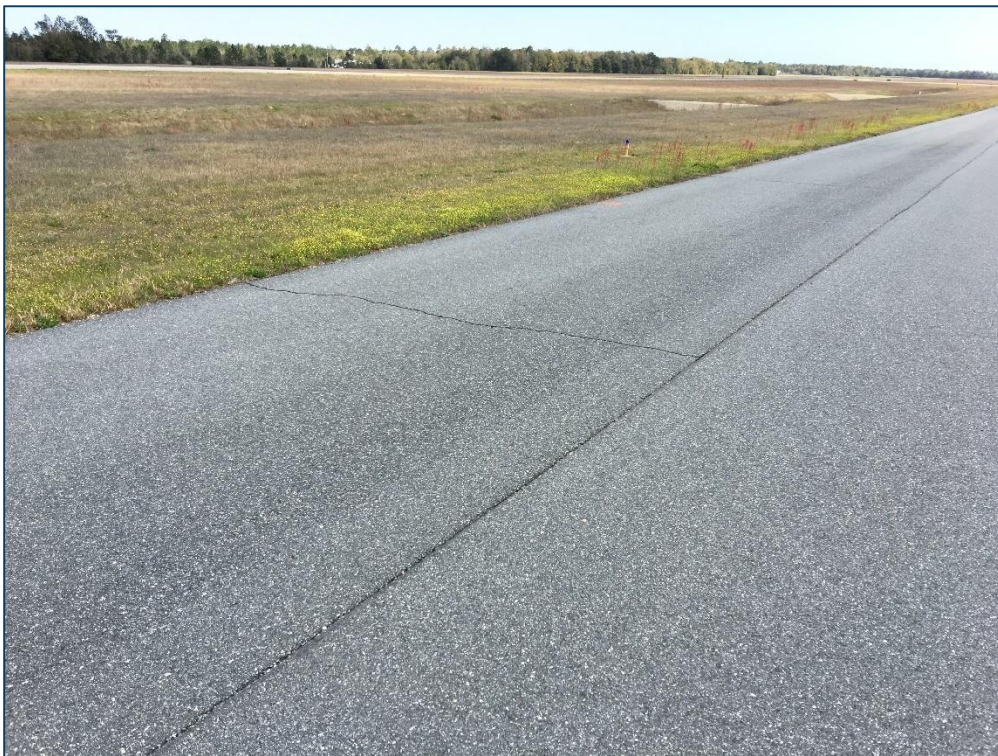
Taxiway A, Section 110, Sample Unit 193 – Low Severity (48) Longitudinal and Transverse Cracking, Low Severity (57) Weathering

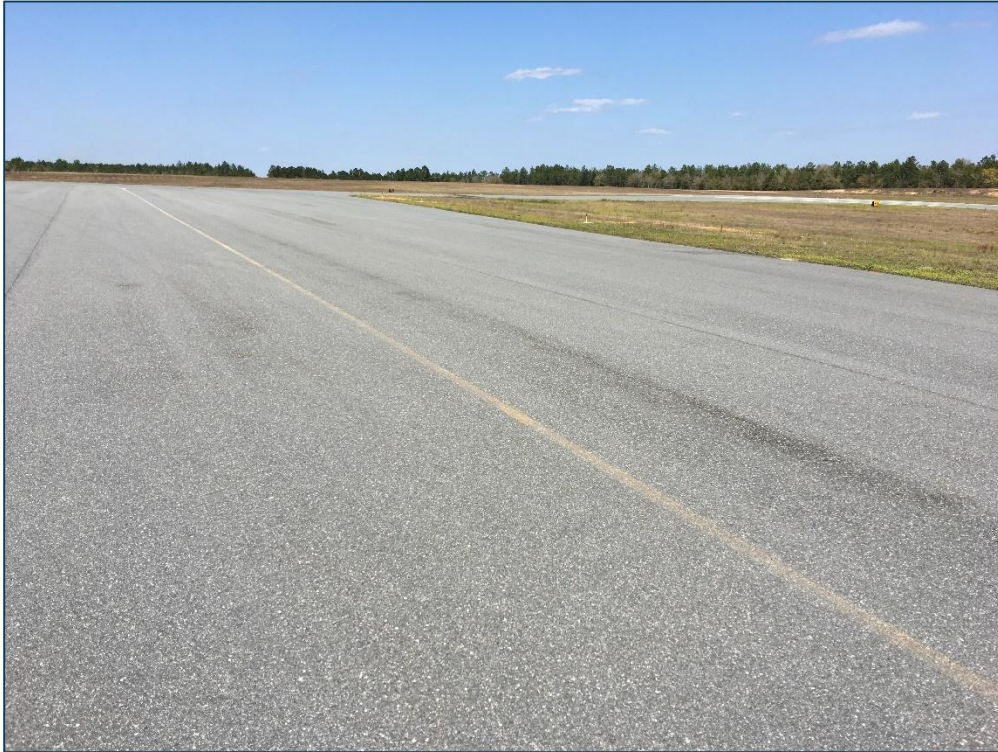
Taxiway A, Section 125, Sample Unit 255 – Low Severity (48) Longitudinal and Transverse Cracking, Low Severity (52) Raveling
Low Severity (57) Weathering

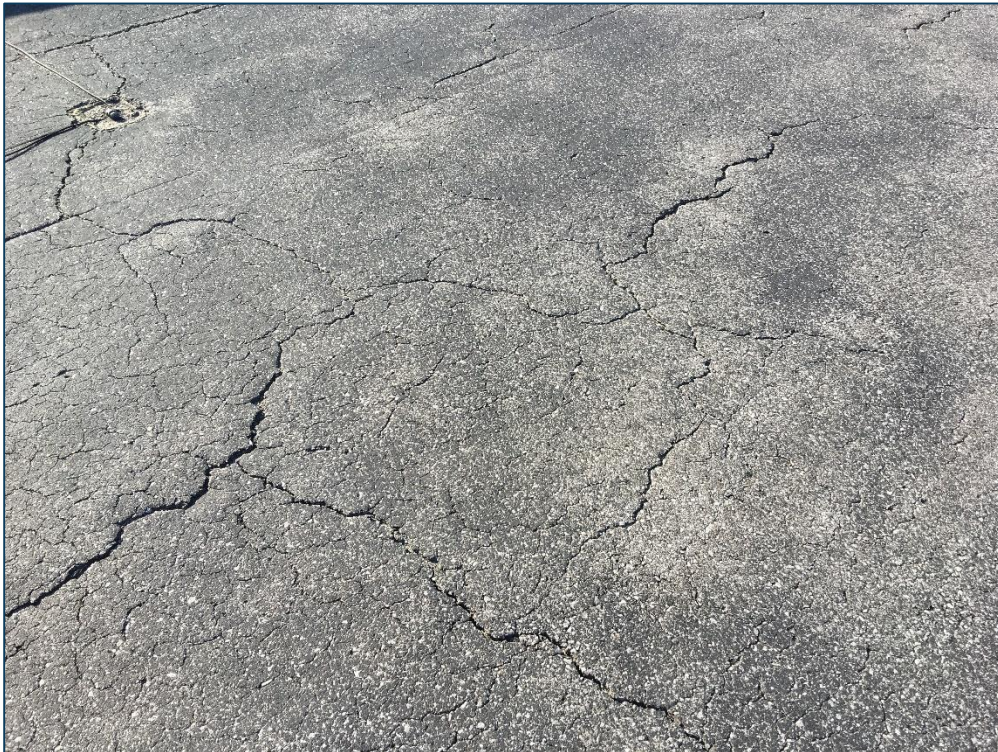
Apron, Section 4110, Sample Unit 306 – Low Severity (43) Block Cracking, Medium Severity (43) Block Cracking, Low Severity (52)
Raveling

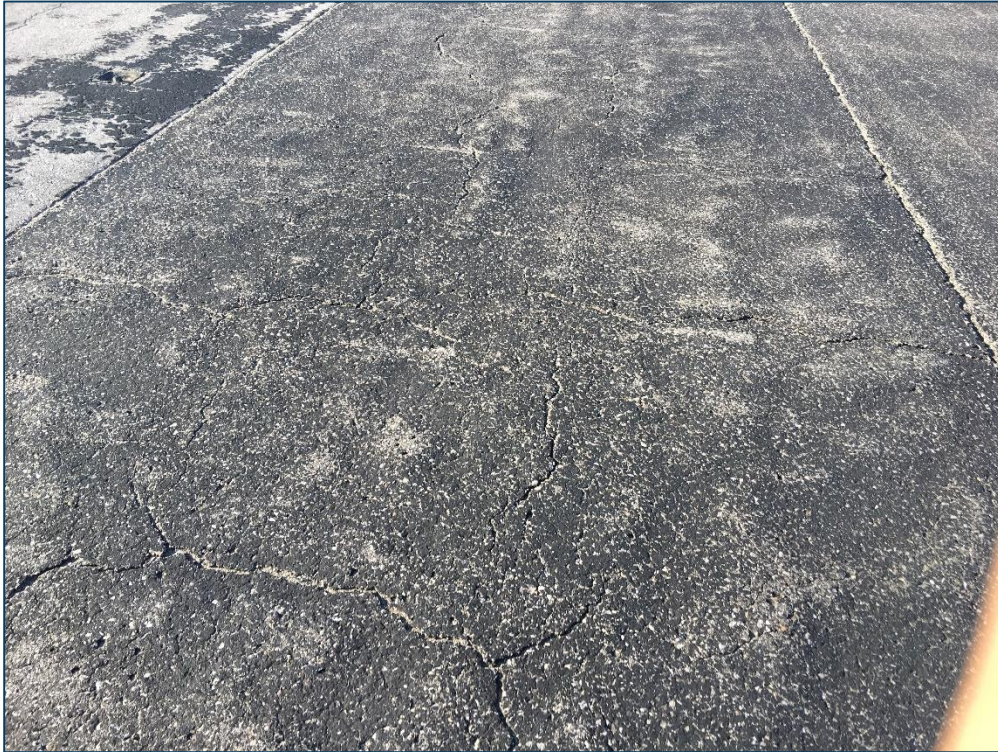
Apron, Section 4115, Sample Unit 210 – Low Severity (43) Block Cracking, Low and Medium Severity (48) Longitudinal and Transverse Cracking, Low Severity (52) Raveling Medium Severity (52) Raveling

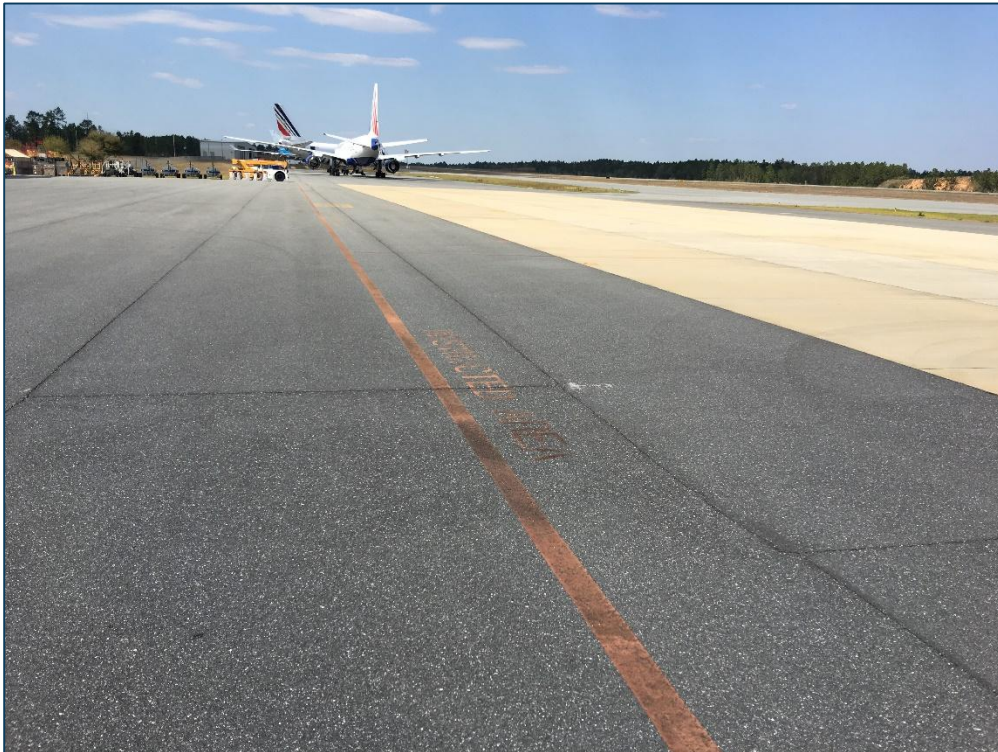
Apron, Section 4120, Sample Unit 317 – Low Severity (48) Longitudinal and Transverse Cracking, Low Severity (57) Weathering

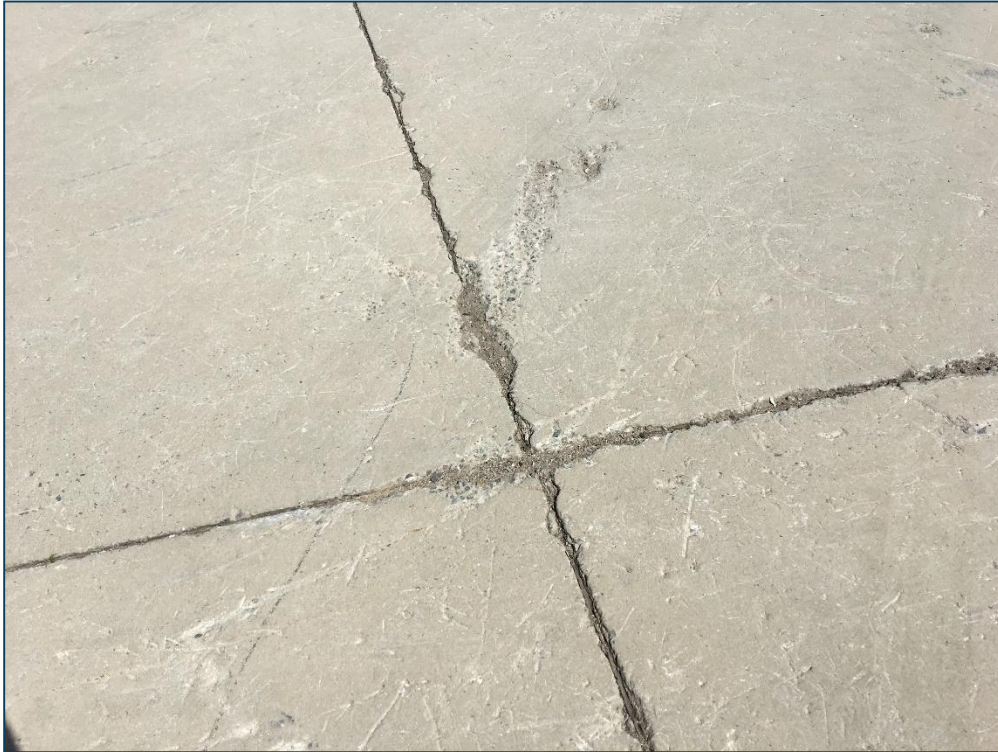
North Apron, Section 4350, Sample Unit 260 – High Severity (65) Joint Seal Damage, Low Severity (74) Joint Spalling

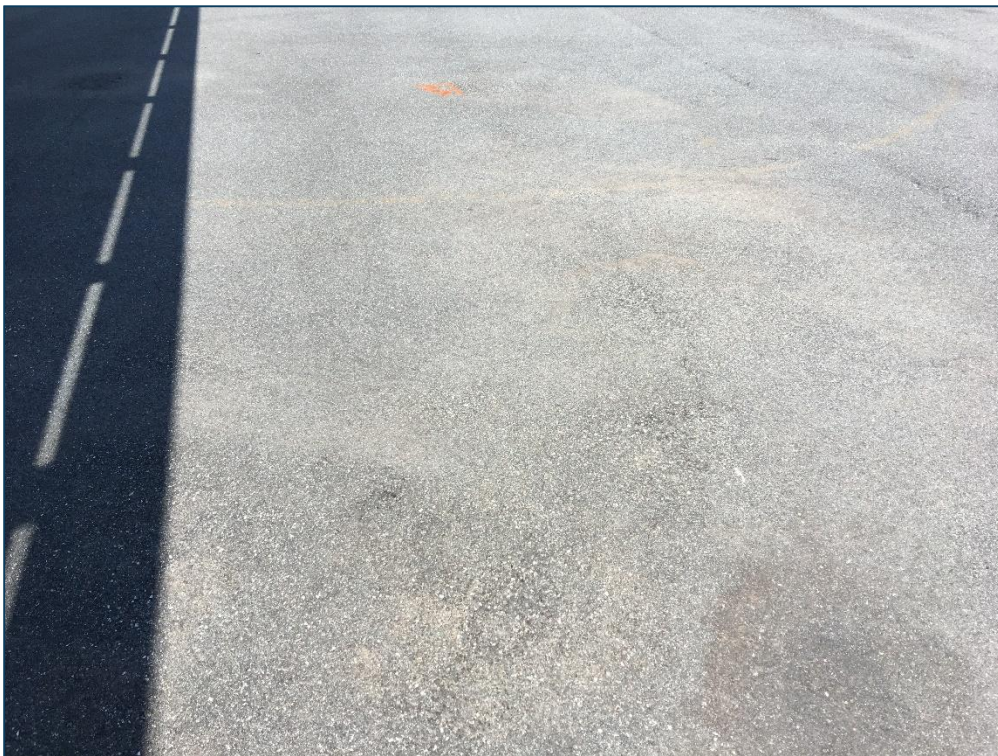
North Apron, Section 4355, Sample Unit 263 – Low Severity (48) Longitudinal and Transverse Cracking, Low Severity (52) Raveling
Low Severity (57) Weathering

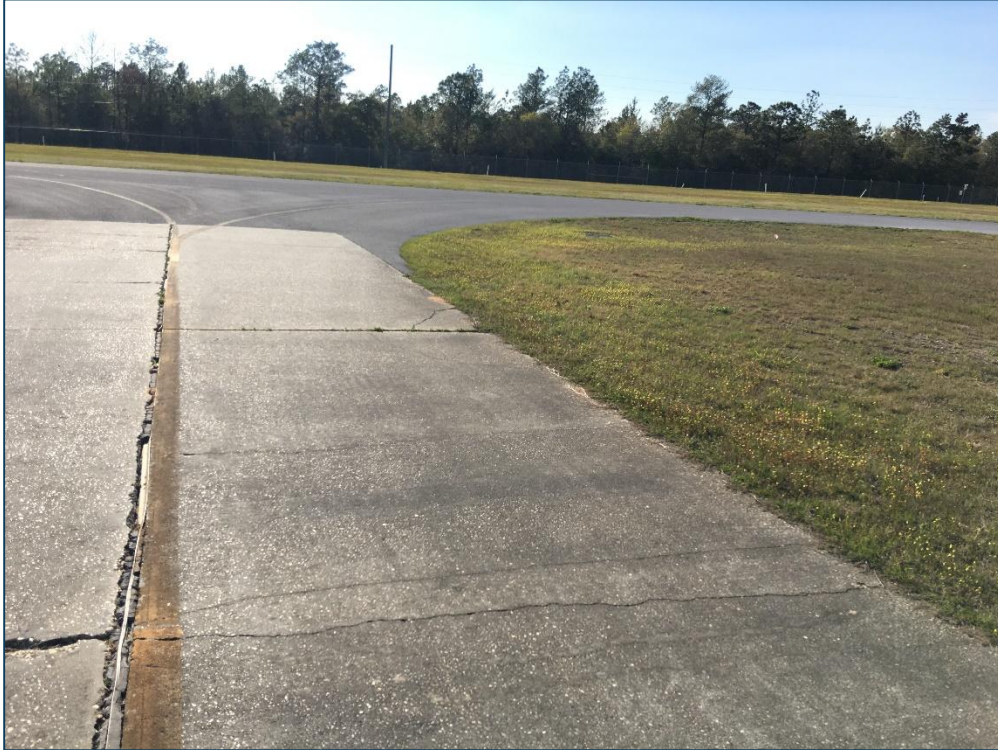
Hangar Apron, Section 4215, Sample Unit 302 – Medium Severity (62) Corner Break, Low Severity (63) Longitudinal, Transverse, and Diagonal Cracking, High Severity (65) Joint Seal Damage,
