Statewide Airfield Pavement Management Program

**Airport Pavement
Evaluation Report
September 2017**

**Crystal River-
Captain Tom Davis
Field (CGC)**

General Aviation Airport
District 7

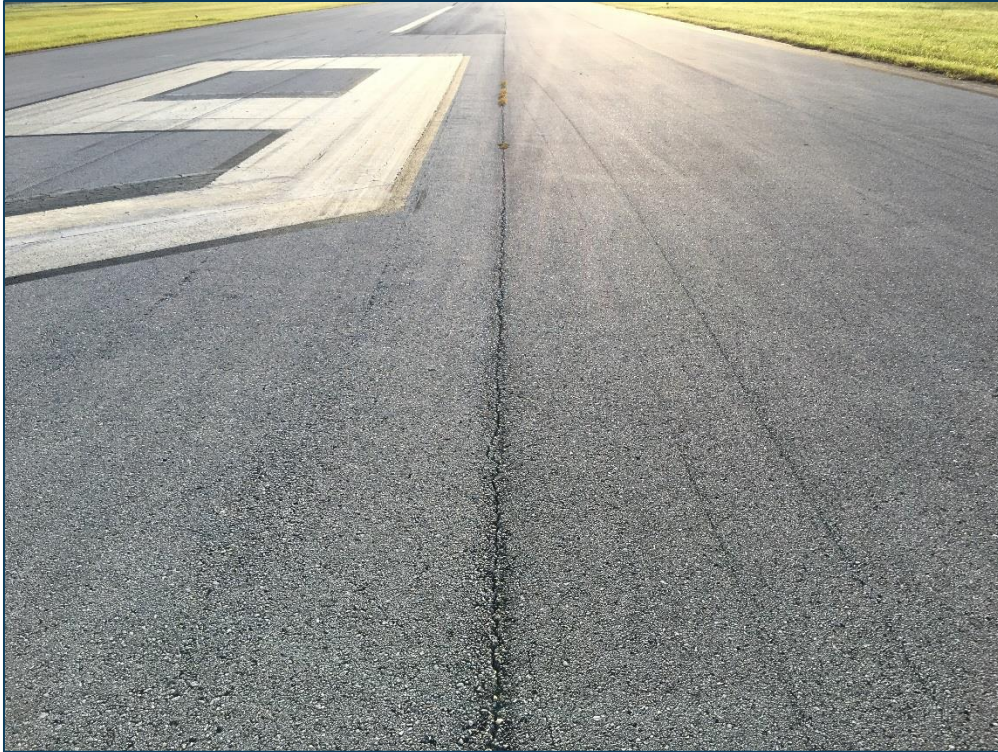
Runway 9-27, Section 6105, Sample Unit 101 – Low Severity (48) Longitudinal and Transverse Cracking, Low Severity (52) Raveling, Low Severity (57) Weathering

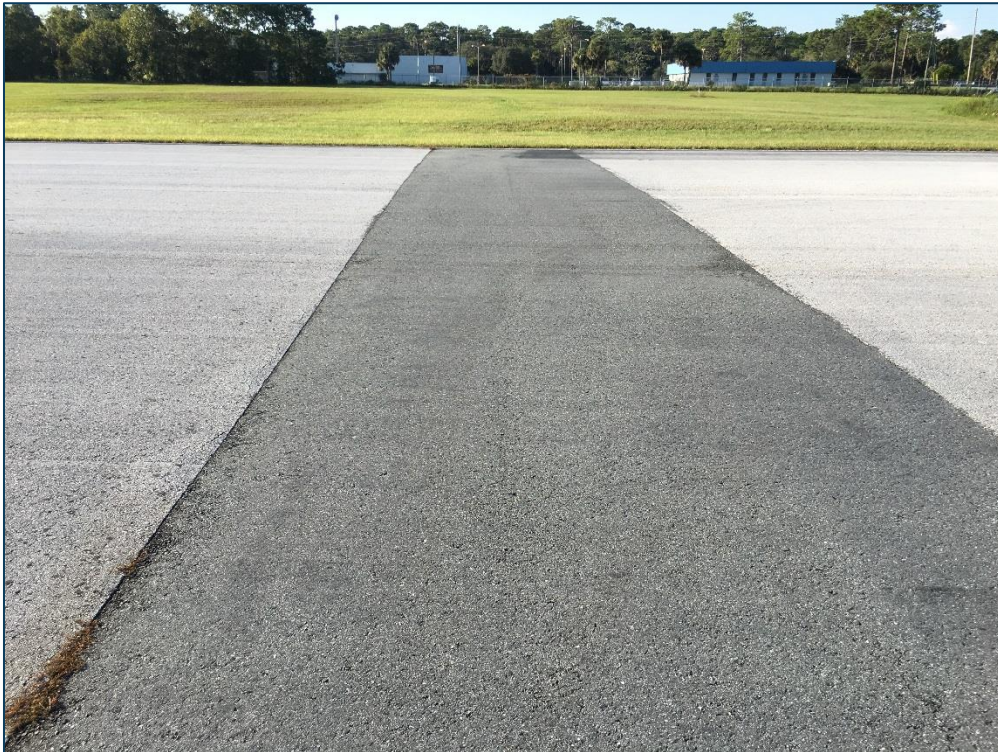
Runway 9-27, Section 6105, Sample Unit 146 – Low Severity (50) Patching, Low Severity (52) Raveling, Low Severity (57) Weathering

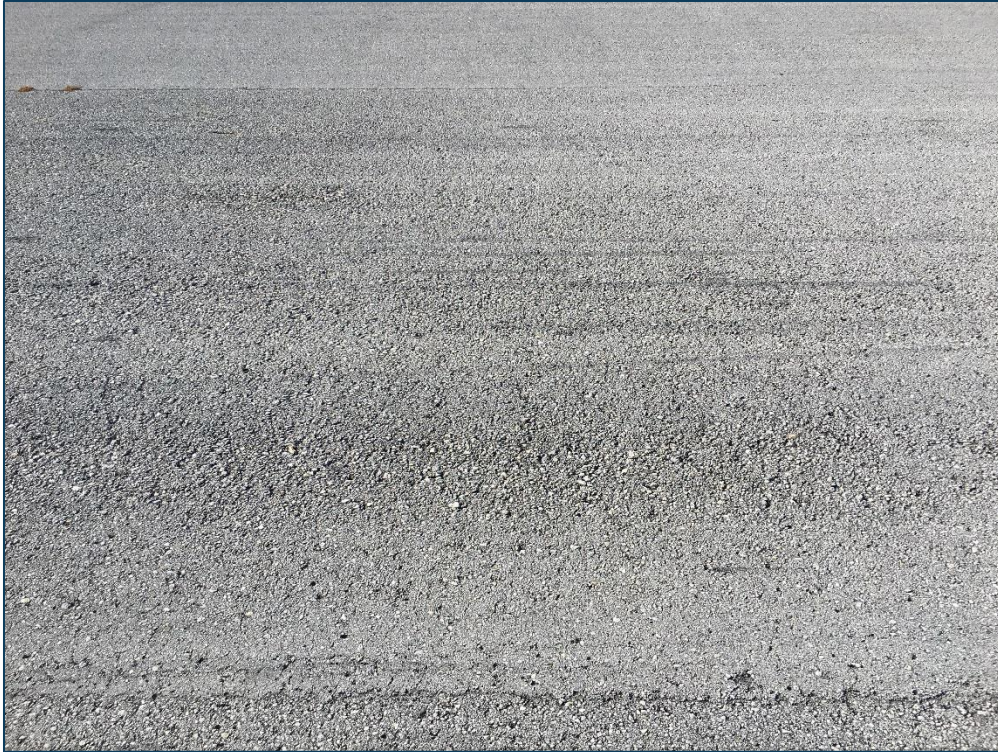
Runway 9-27, Section 6110, Sample Unit 171 – Low Severity (48) Longitudinal and Transverse Cracking, Low Severity (52) Raveling, Medium Severity (52) Raveling

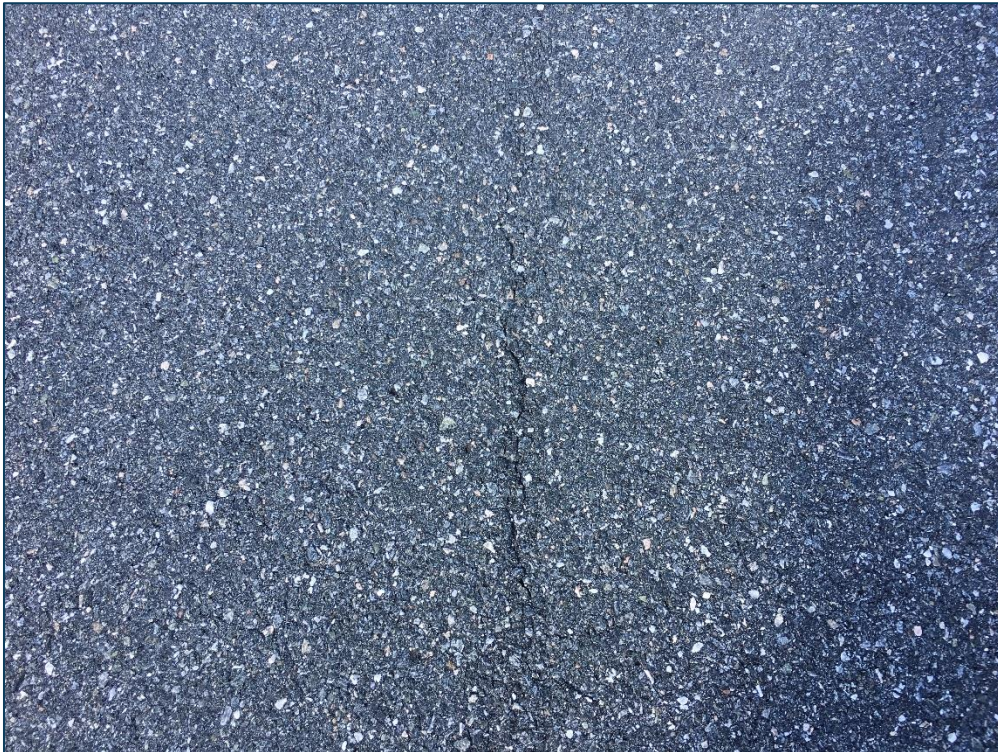
Taxiway A, Section 105, Sample Unit 107 – Low Severity (48) Longitudinal and Transverse Cracking, Low Severity (57) Weathering

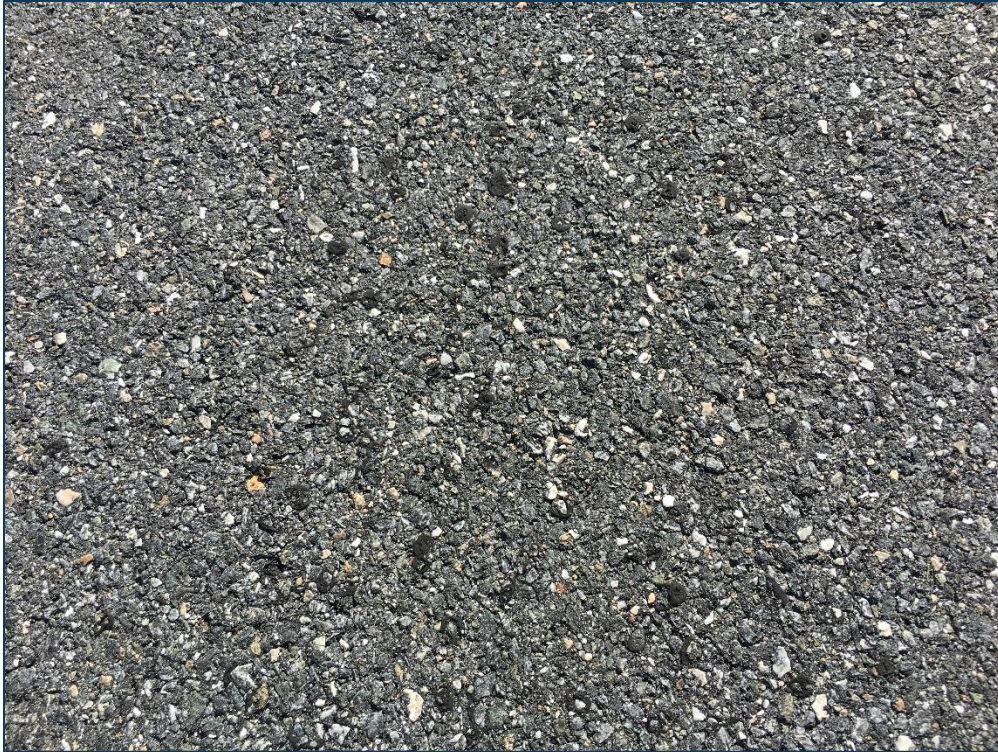
Taxiway A, Section 105, Sample Unit 127 – (42) Bleeding, Low Severity (57) Weathering

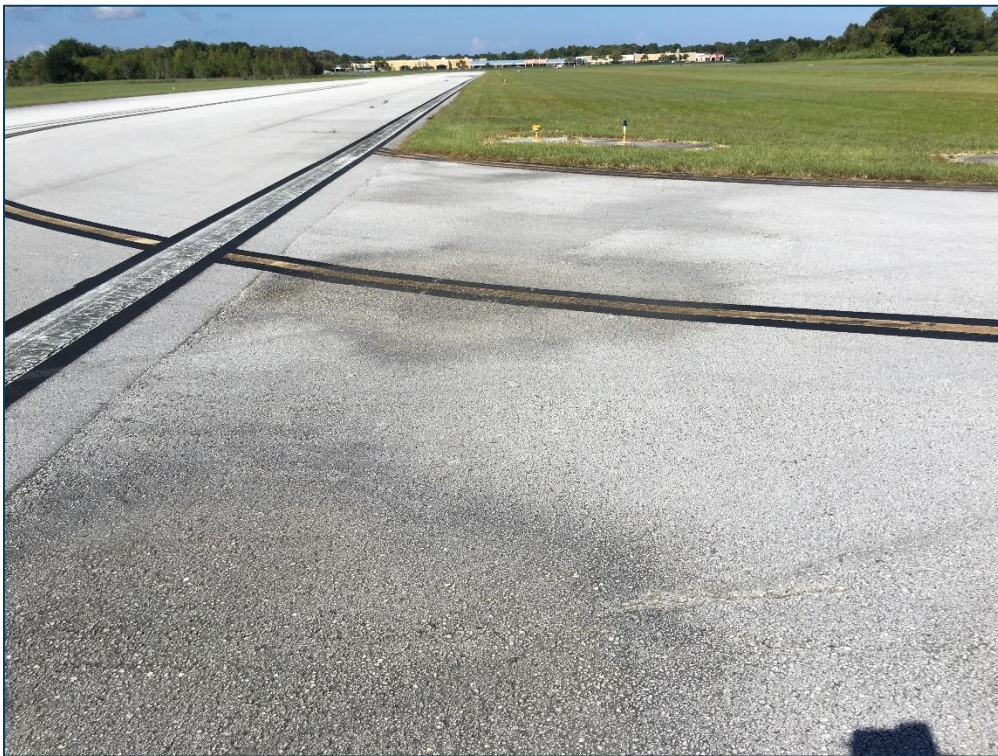
Taxiway A1, Section 115, Sample Unit 100 – Low Severity (45) Depression , Medium Severity (45) Depression, Low Severity (48)
Longitudinal and Transverse Cracking, Low Severity (52) Raveling, Medium Severity (52) Raveling

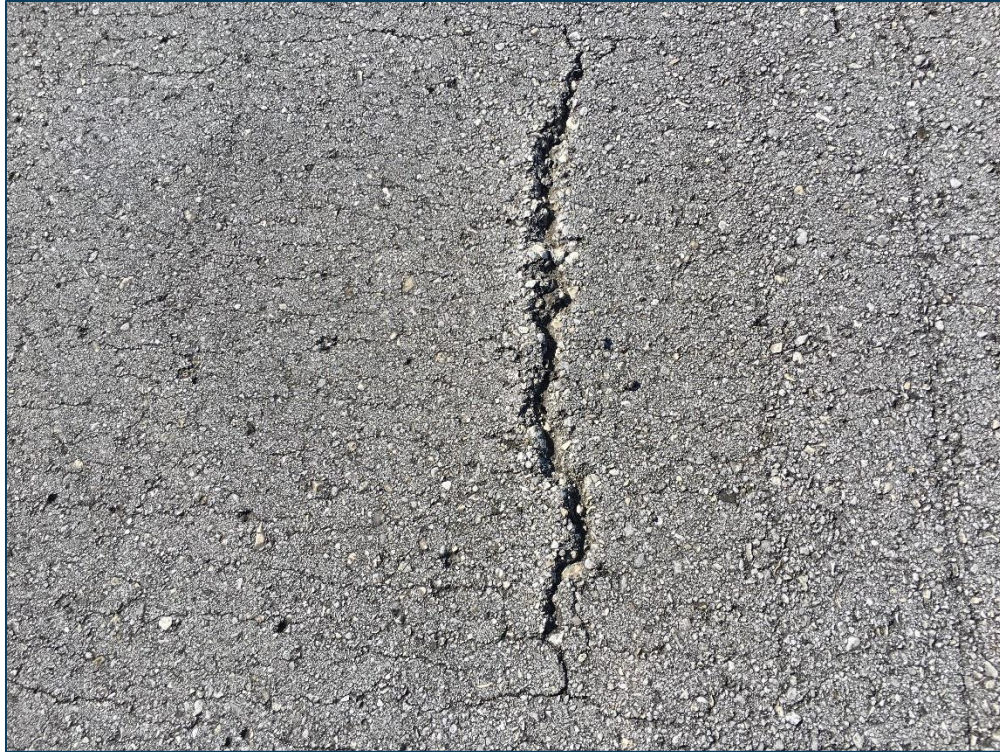
Taxiway A2, Section 118, Sample Unit 100 – Medium Severity (48) Longitudinal and Transverse Cracking, Low Severity (52) Raveling, Medium Severity (52) Raveling

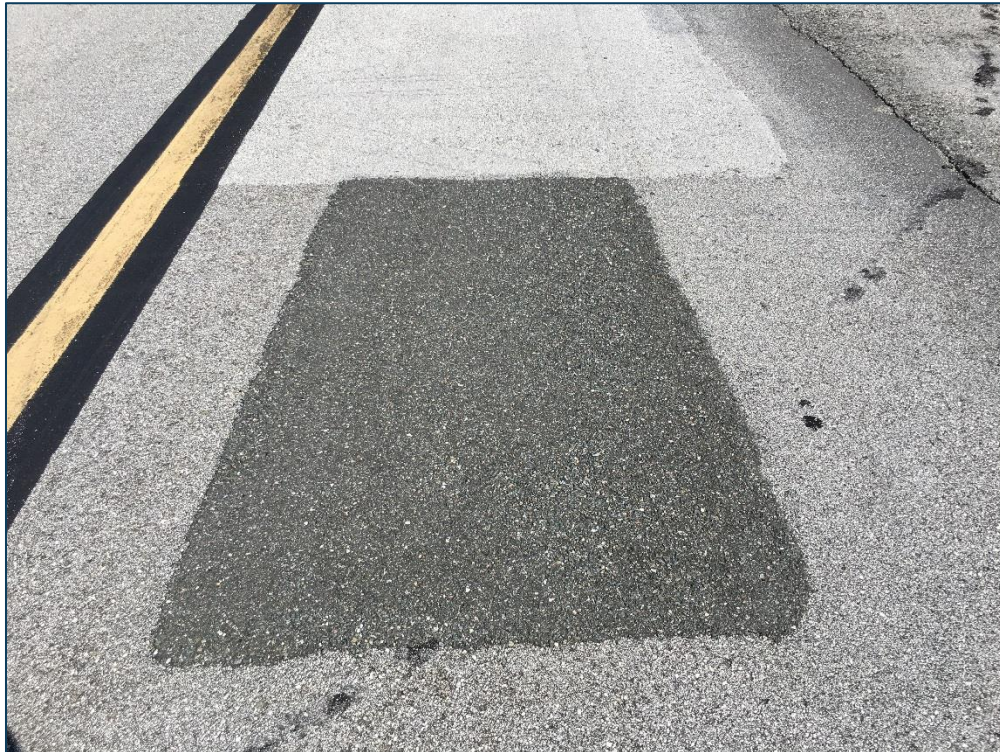
Connector Taxiway, Section 205, Sample Unit 101 – Low Severity (48) Longitudinal and Transverse Cracking, Low Severity (50) Patching, Low Severity (57) Weathering

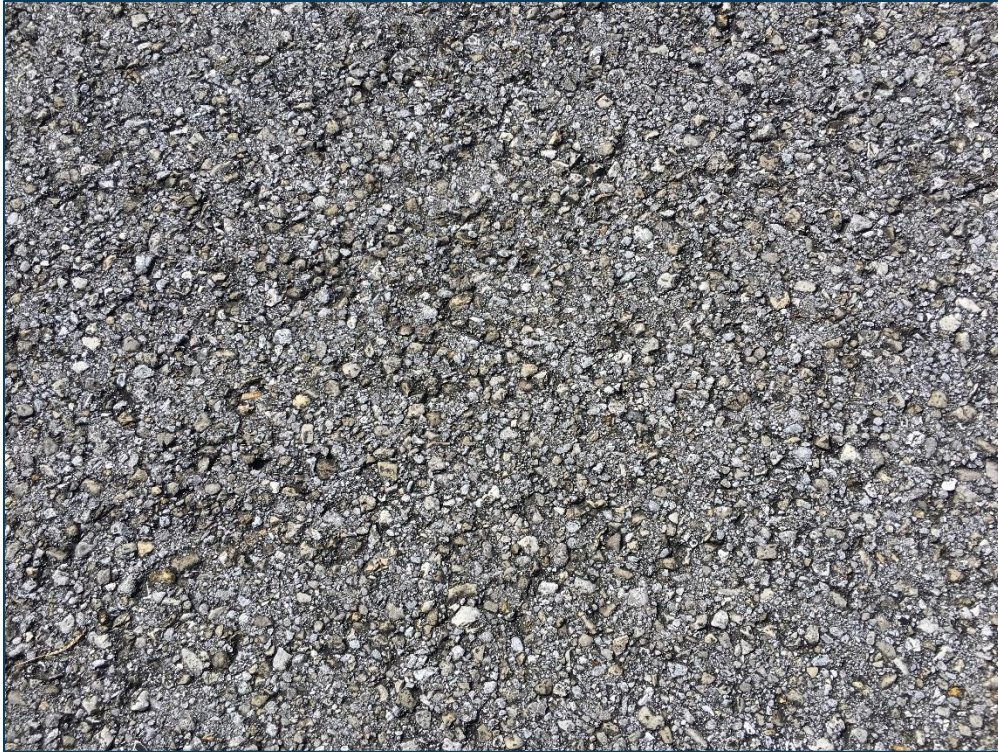
Connector Taxiway, Section 210, Sample Unit 101 – Low Severity (52) Raveling, Medium Severity (52) Raveling

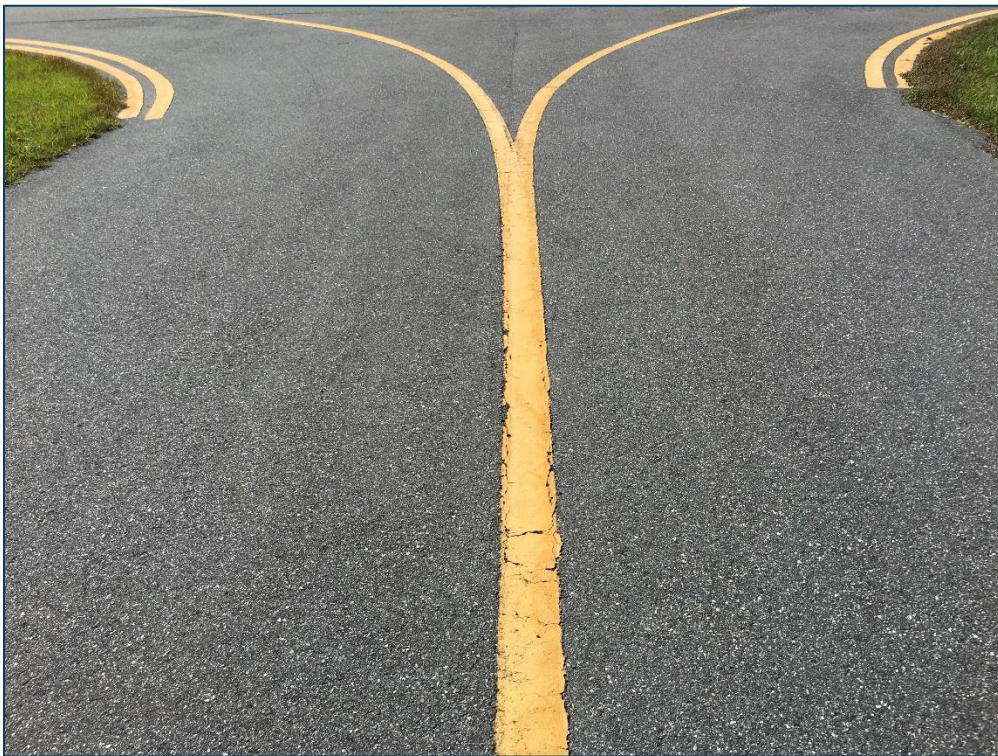
Taxiway to Hangar, Section 215, Sample Unit 100 – Low Severity (48) Longitudinal and Transverse Cracking, Low Severity (57) Weathering

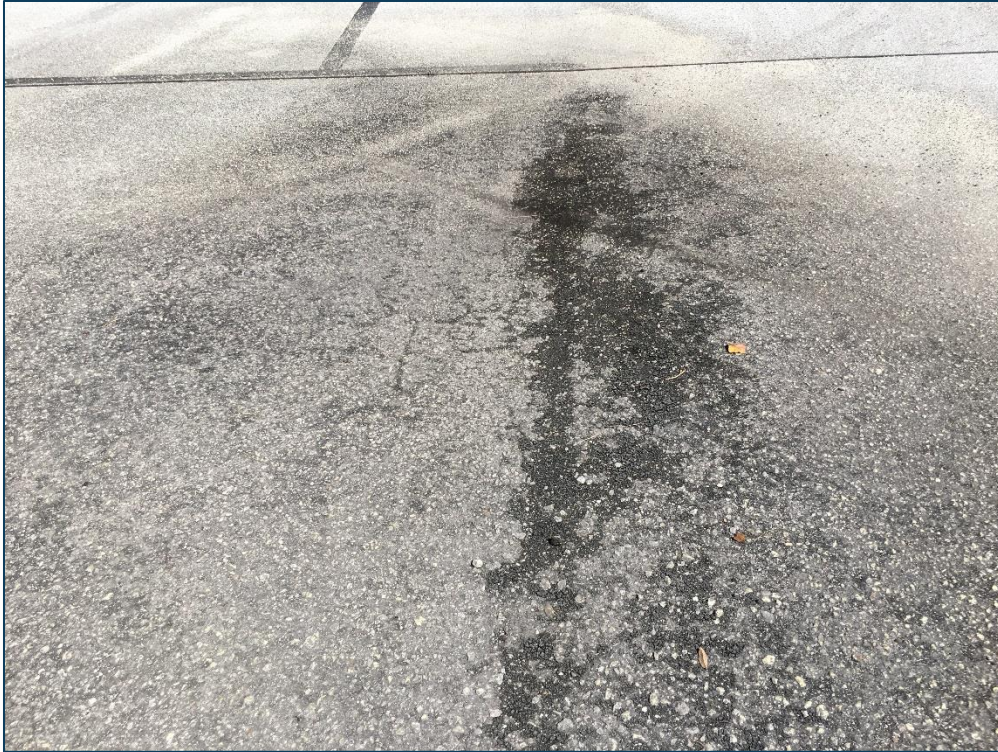
Main Apron, Section 4105, Sample Unit 198 – Low Severity (45) Depression, (49) Oil Spillage, Low Severity (52) Raveling, Medium Severity (52) Raveling

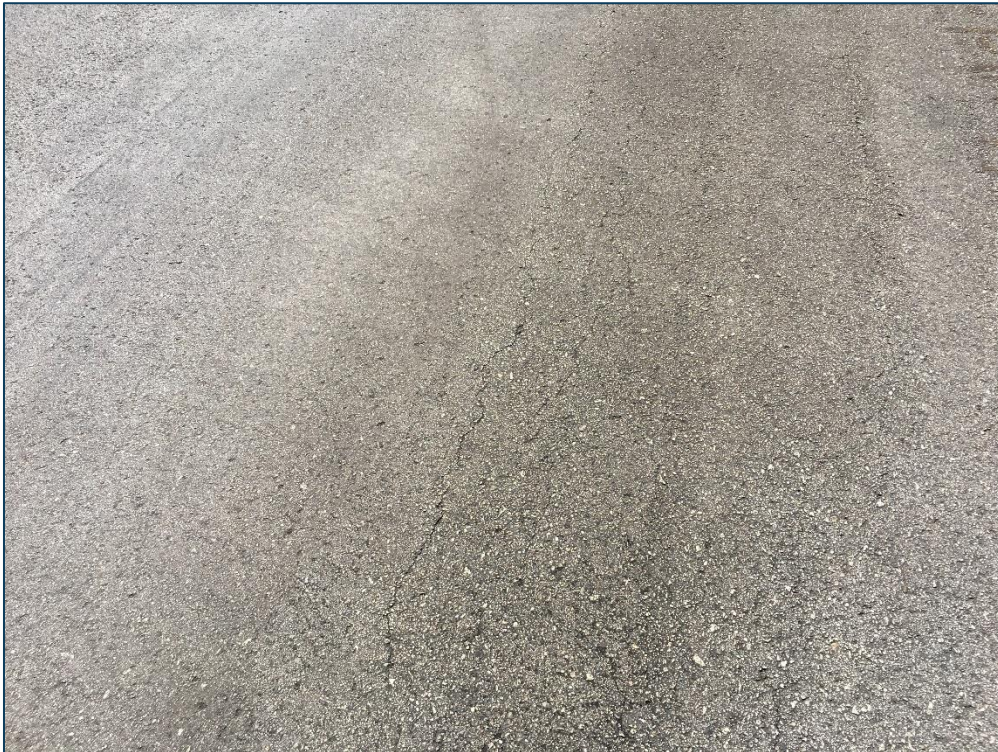
Main Apron, Section 4120, Sample Unit 221 – Low Severity (48) Longitudinal and Transverse Cracking, Low Severity (52) Raveling, Low Severity (57) Weathering

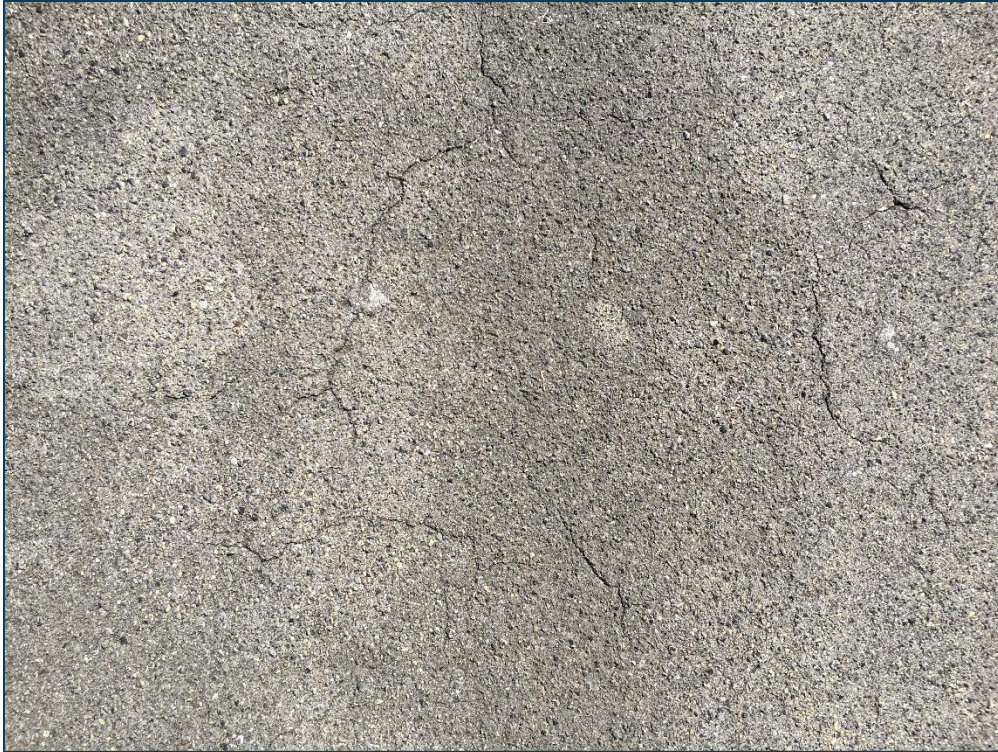
Main Apron, Section 4120, Sample Unit 202 – Low Severity (48) Longitudinal and Transverse Cracking, Low Severity (52) Raveling

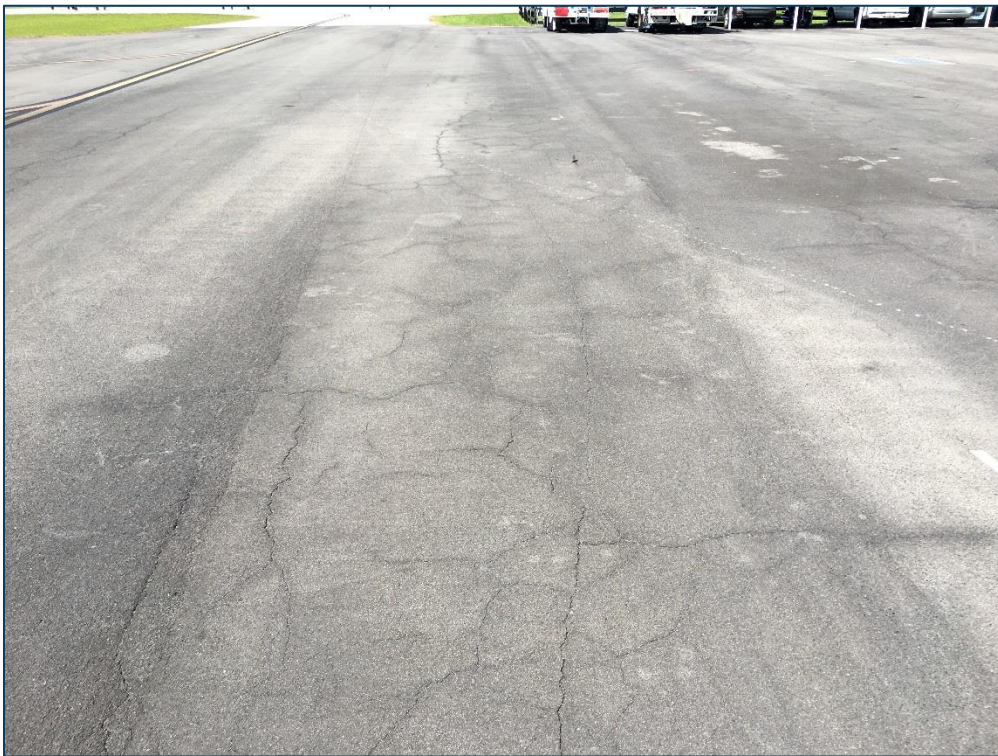
T-Hangar Apron, Section 4205, Sample Unit 412 – Low Severity (43) Block Cracking, Low Severity (52) Raveling
