Statewide Airfield Pavement Management Program

Airport Pavement
Evaluation Report
September 2017

**Merritt Island
Airport (COI)**
General Aviation Airport
District 5

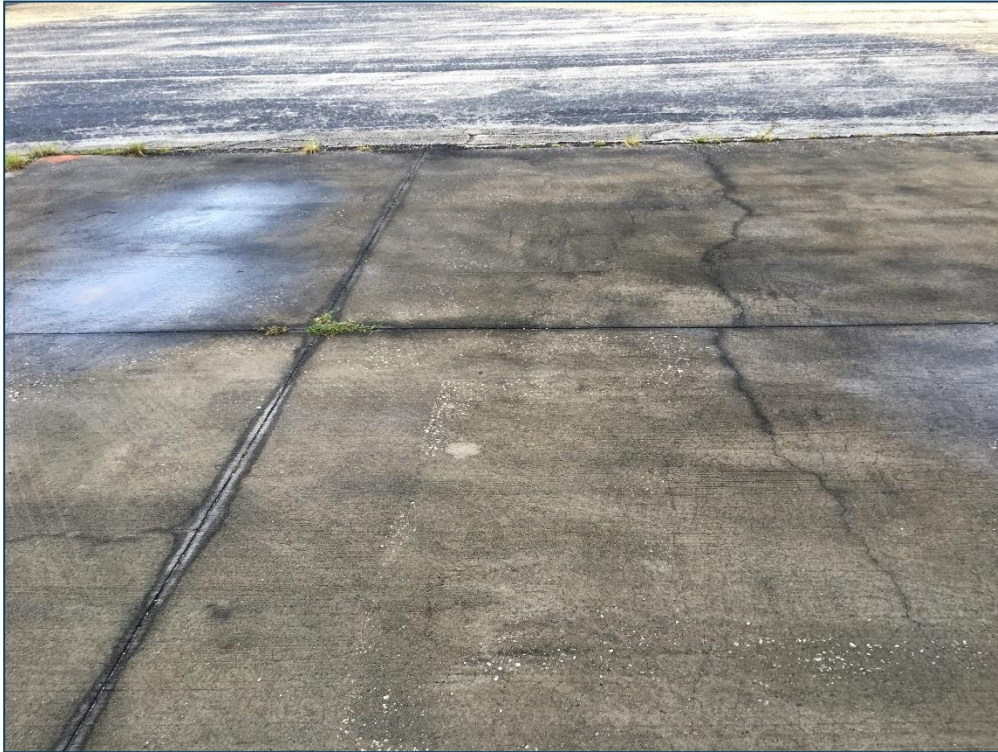
Apron N, Section 4203, Sample Unit 100 – Low Severity (63) Longitudinal, Transverse, and Diagonal Cracking, (73) Shrinkage Cracks, High Severity (65) Joint Seal Damage

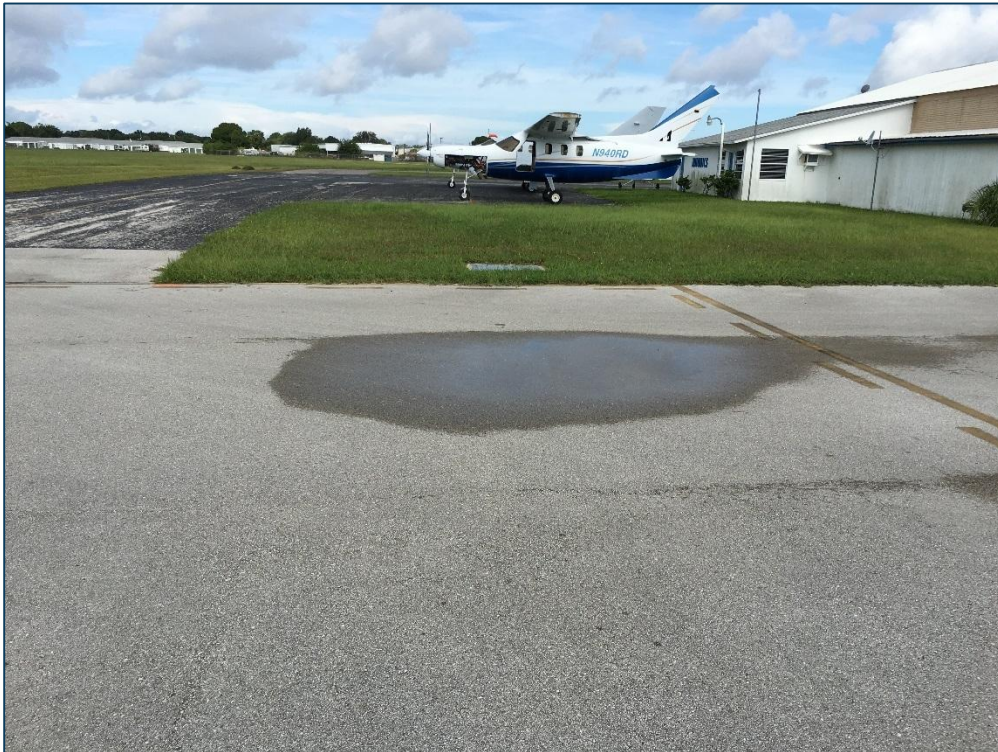
Apron N, Section 4215, Sample Unit 221 – Low Severity (45) Depression, Low Severity (48) Longitudinal and Transverse Cracking, Low Severity (52) Raveling

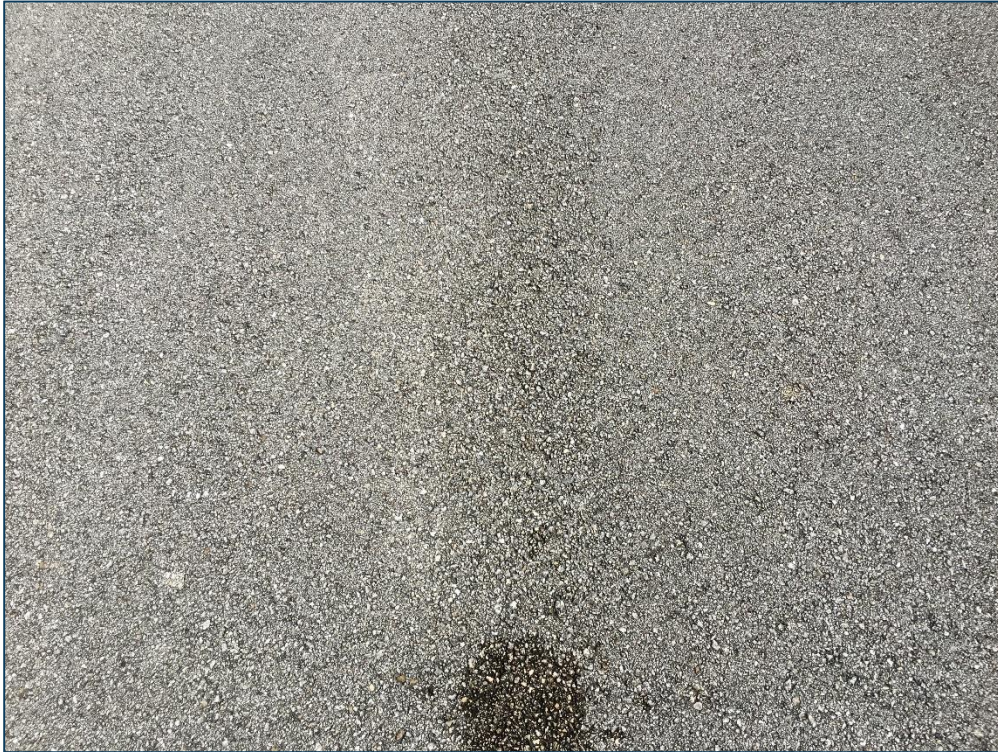
Apron N, Section 4220, Sample Unit 501 – (49) Oil Spillage, (73) Shrinkage Cracks, Low Severity (52) Raveling, Low Severity (57) Weathering

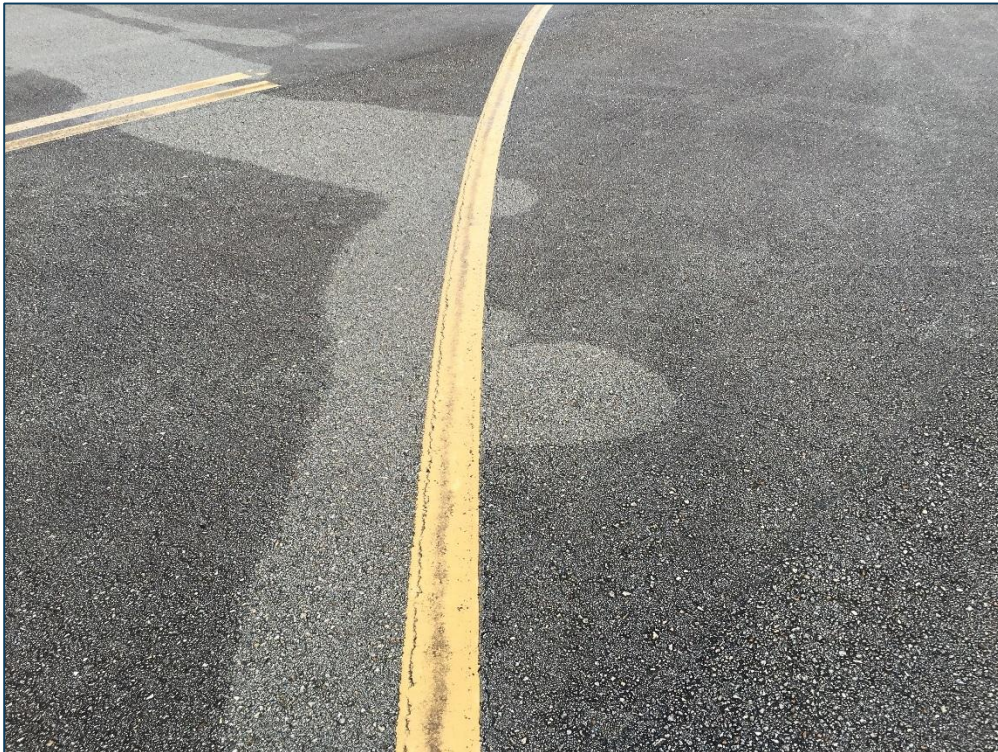
Apron RU RW29, Section 5105, Sample Unit 102 – Low Severity (48) Longitudinal and Transverse Cracking, Low Severity (57) Weathering

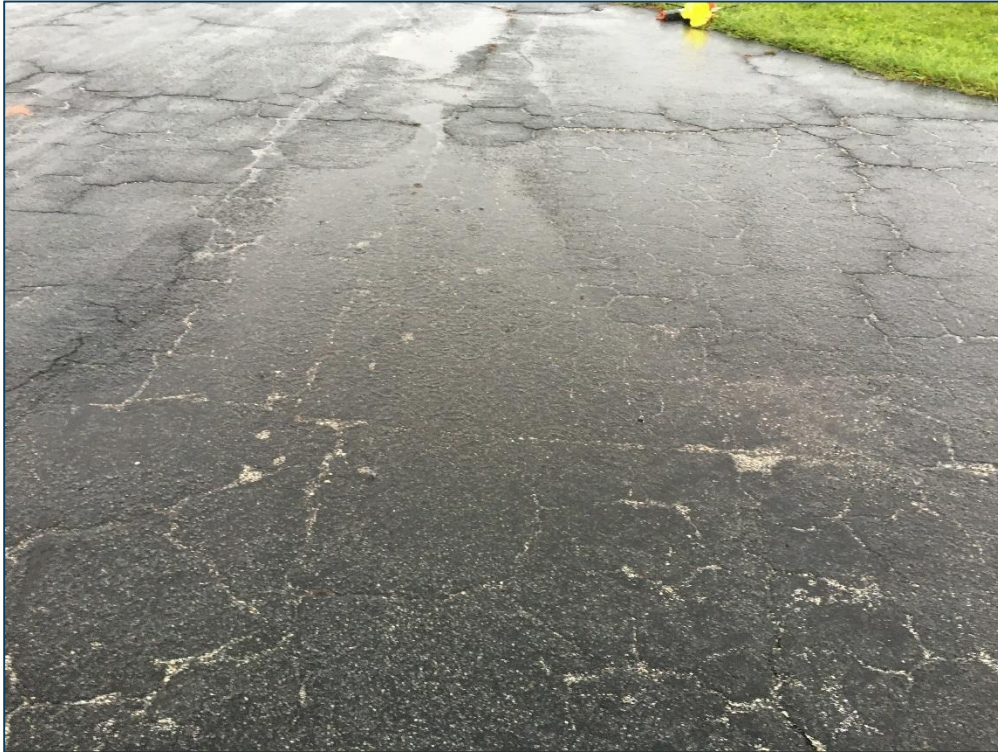
Apron S, Section 4105, Sample Unit 599 – Medium Severity (43) Block Cracking, Low Severity (45) Depression, Low Severity (52) Raveling

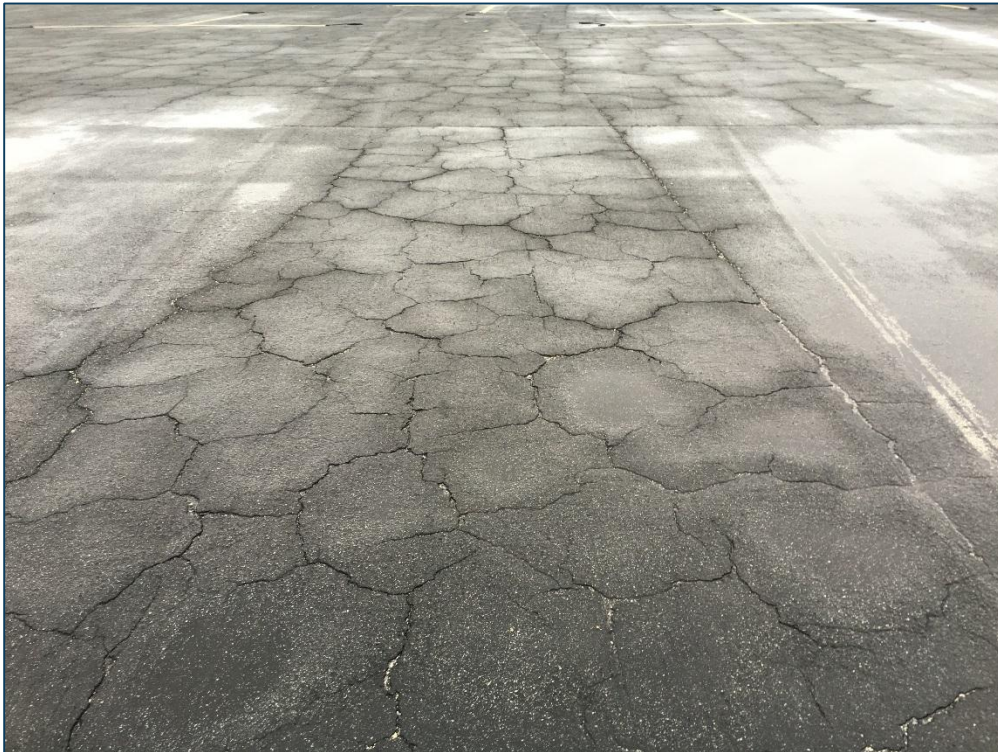
Apron S, Section 4111, Sample Unit 205 – Medium Severity (43) Block Cracking, Low Severity (45) Depression

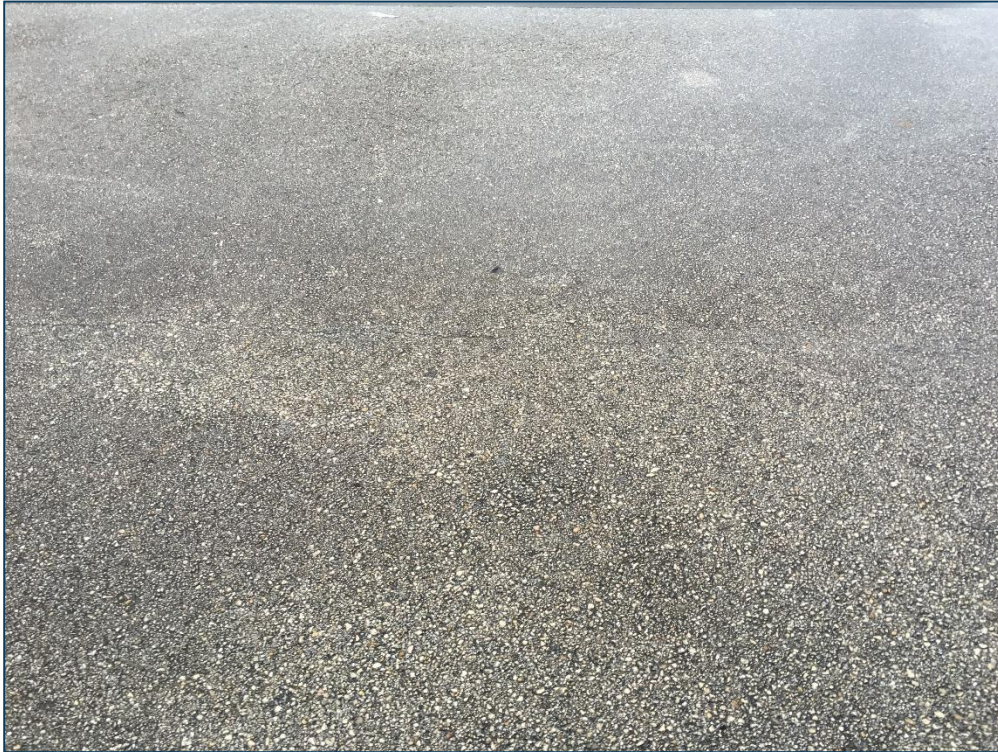
Apron SW, Section 4310, Sample Unit 101 – Low Severity (48) Longitudinal and Transverse Cracking, Low Severity (52) Raveling, Low Severity (57) Weathering

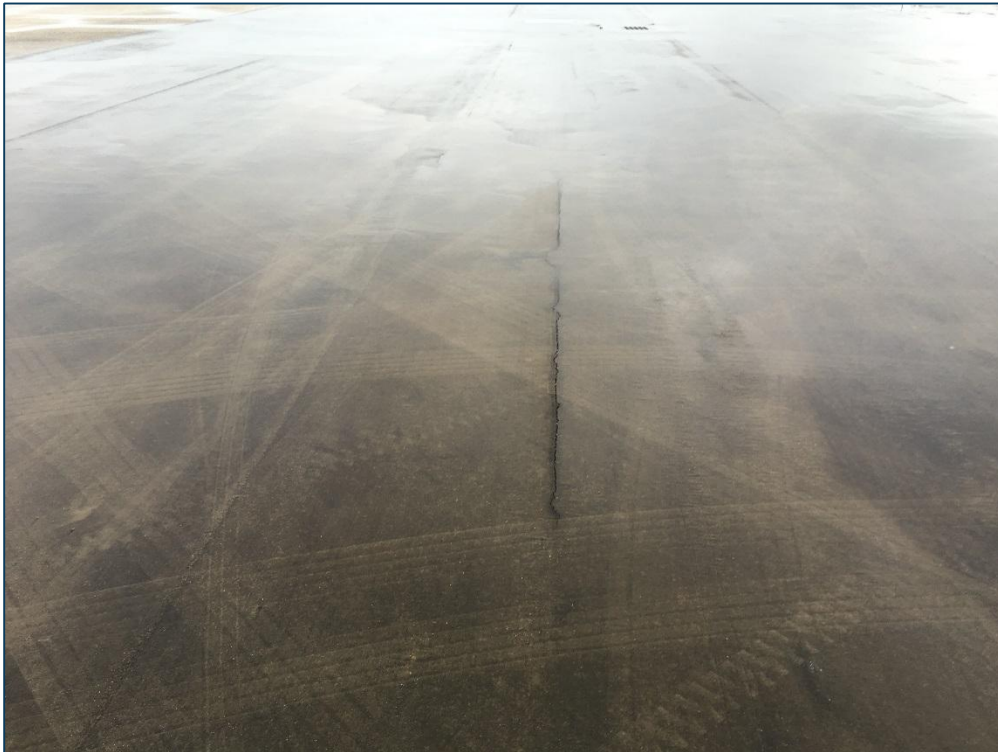
Apron SW, Section 4305, Sample Unit 200 – Low Severity (48) Longitudinal and Transverse Cracking, Low Severity (57) Weathering

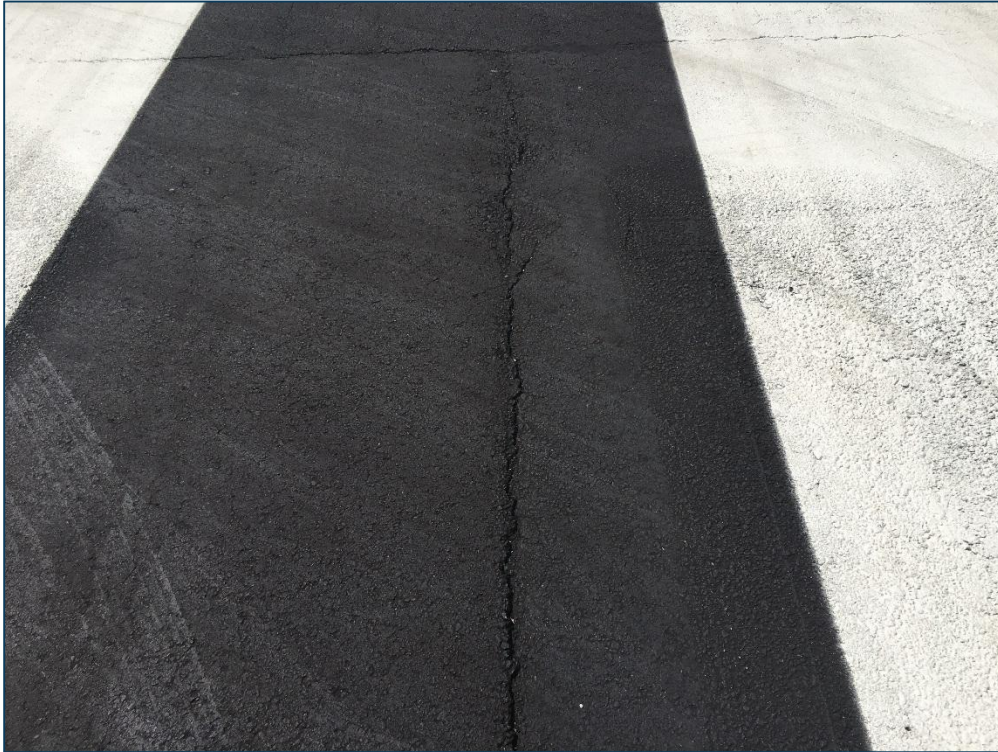
Runway 11-29, Section 6105, Sample Unit 100 – Low Severity (48) Longitudinal and Transverse Cracking, Low Severity (57) Weathering

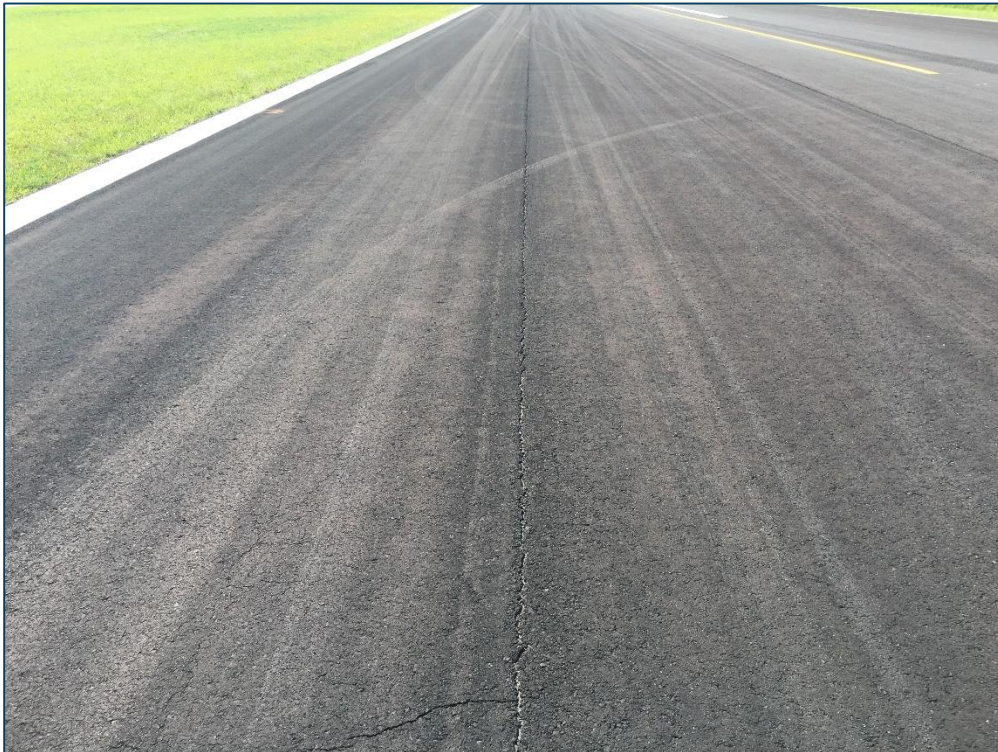
Runway 11-29, Section 6105, Sample Unit 137 – Low Severity (48) Longitudinal and Transverse Cracking, Low Severity (57) Weathering

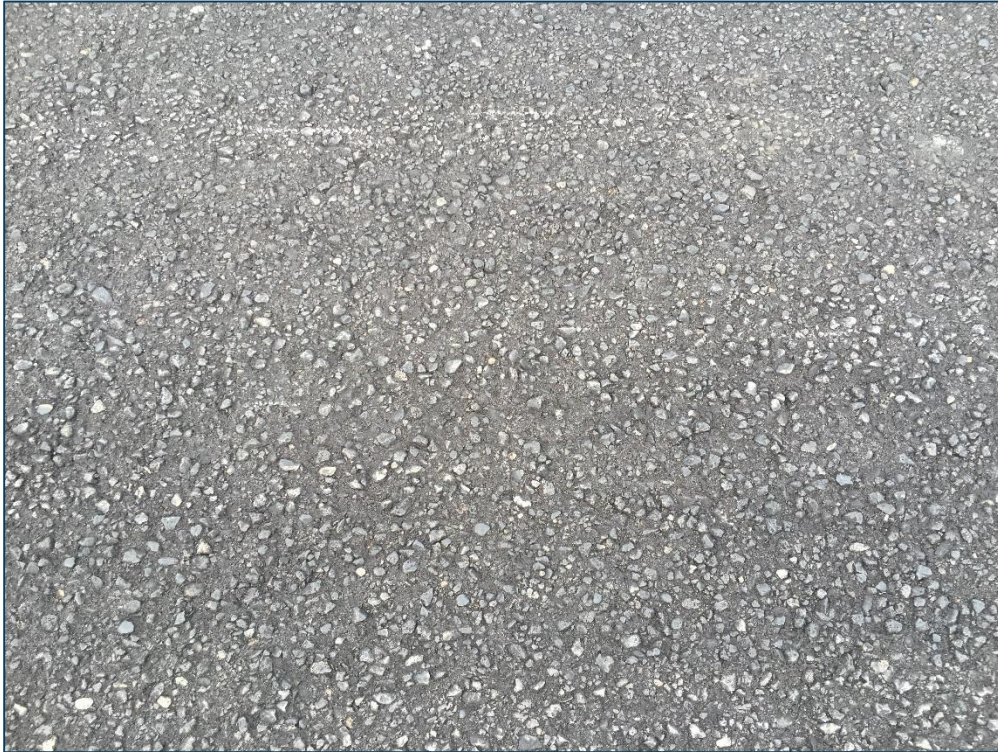
Runway 11-29, Section 6105, Sample Unit 149 – Low Severity (52) Raveling

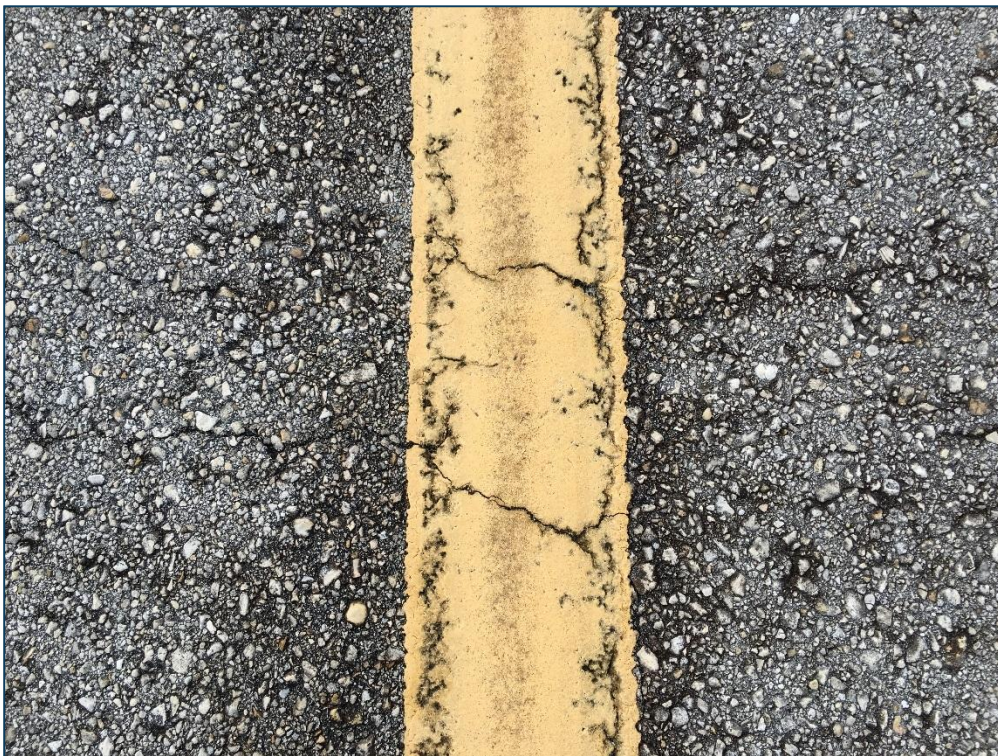
Taxiway A, Section 105, Sample Unit 131 – Low Severity (48) Longitudinal and Transverse Cracking, Low Severity (57) Weathering

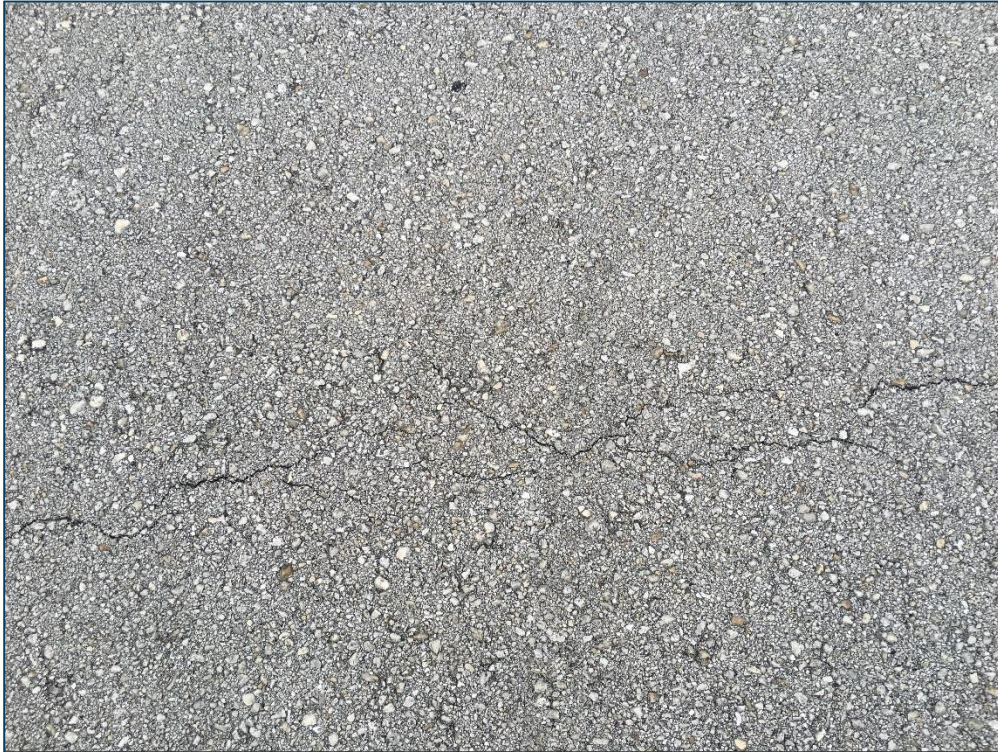
Taxiway A, Section 105, Sample Unit 103 – Low Severity (48) Longitudinal and Transverse Cracking, Low Severity (57) Weathering

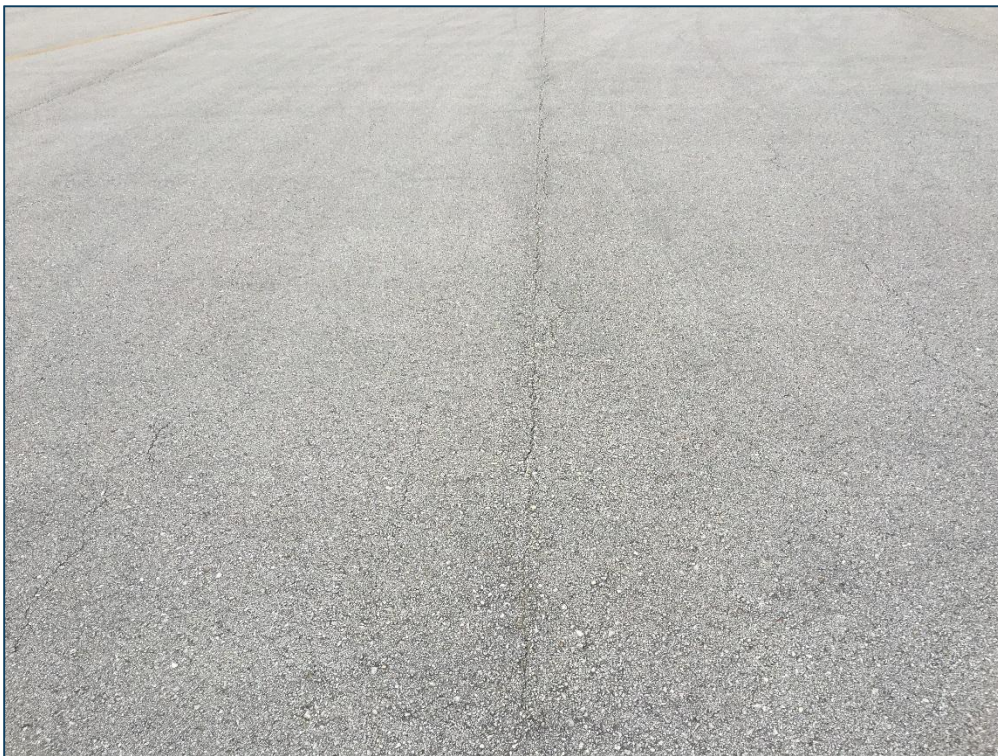
Taxiway A1, Section 305, Sample Unit 101 – Low Severity (48) Longitudinal and Transverse Cracking, Low Severity (57) Weathering

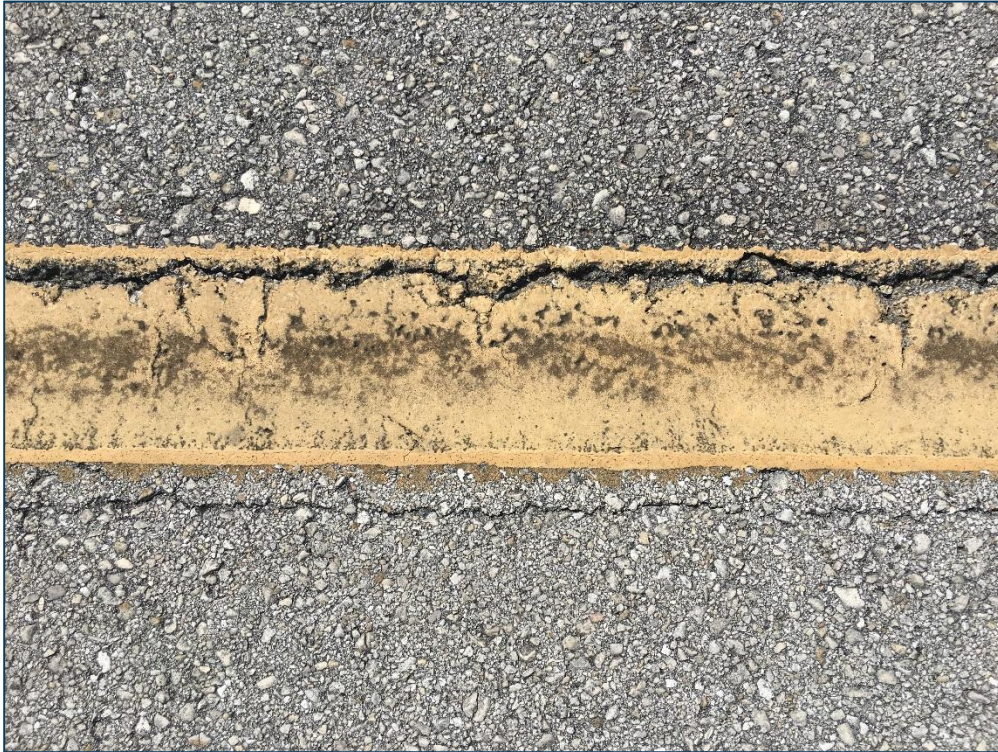
Taxiway A2, Section 405, Sample Unit 400 – Low Severity (48) Longitudinal and Transverse Cracking, Low Severity (57) Weathering

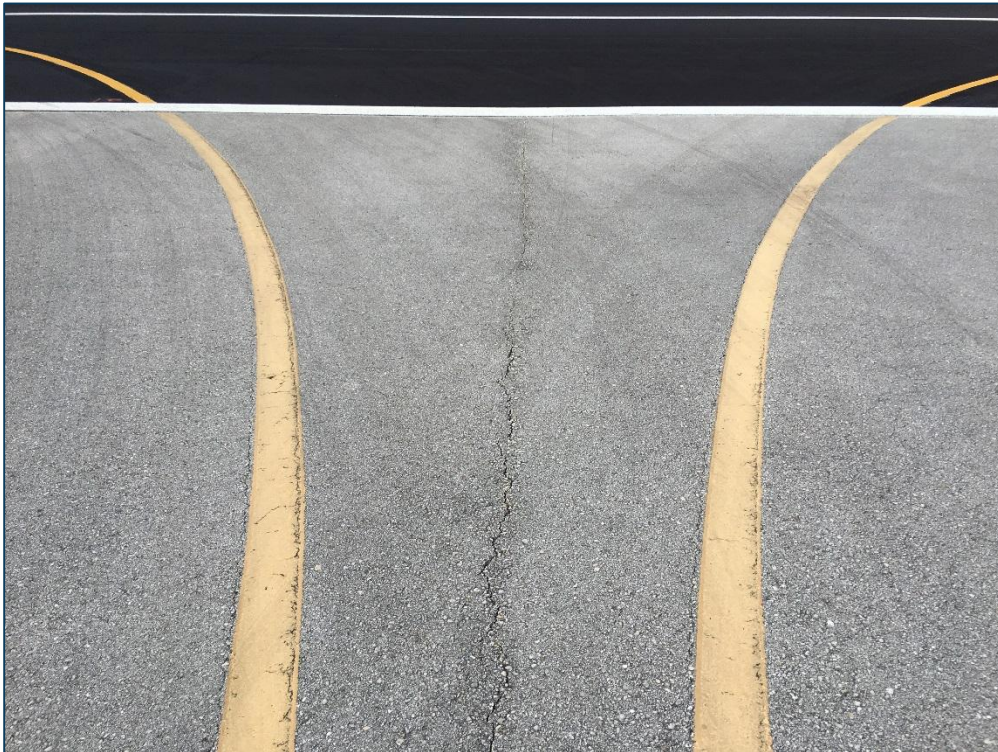
Taxiway A3, Section 505, Sample Unit 100 – Low Severity (48) Longitudinal and Transverse Cracking, Low Severity (57) Weathering, and Low Severity (52) Raveling

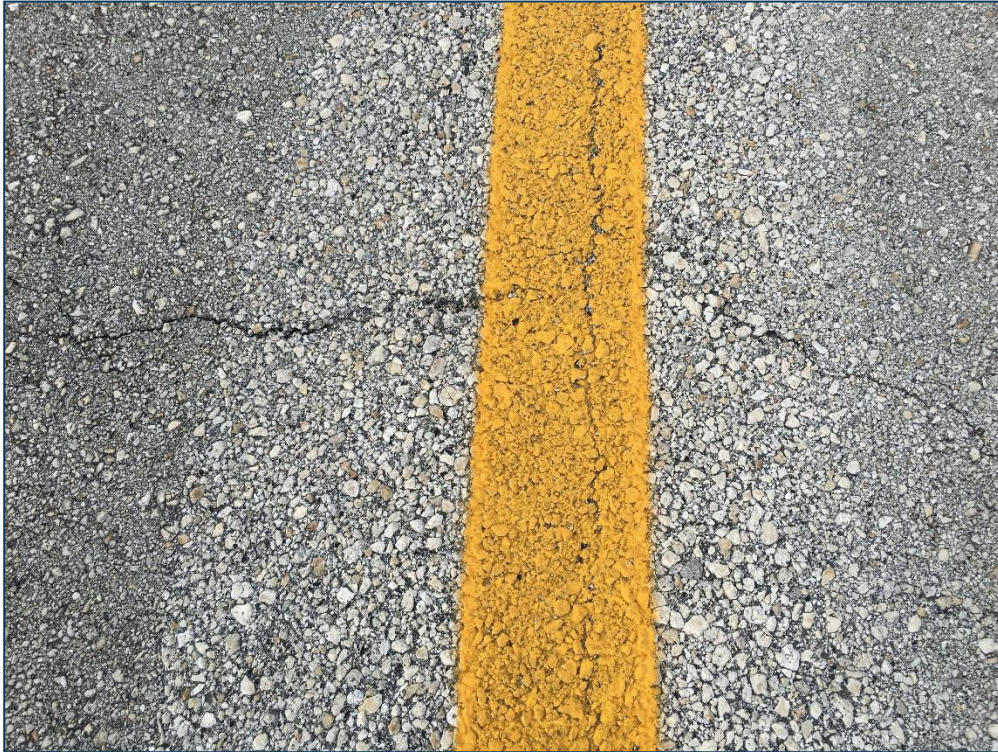
Taxiway A4, Section 605, Sample Unit 600 – Low Severity (48) Longitudinal and Transverse Cracking, Low Severity (57) Weathering

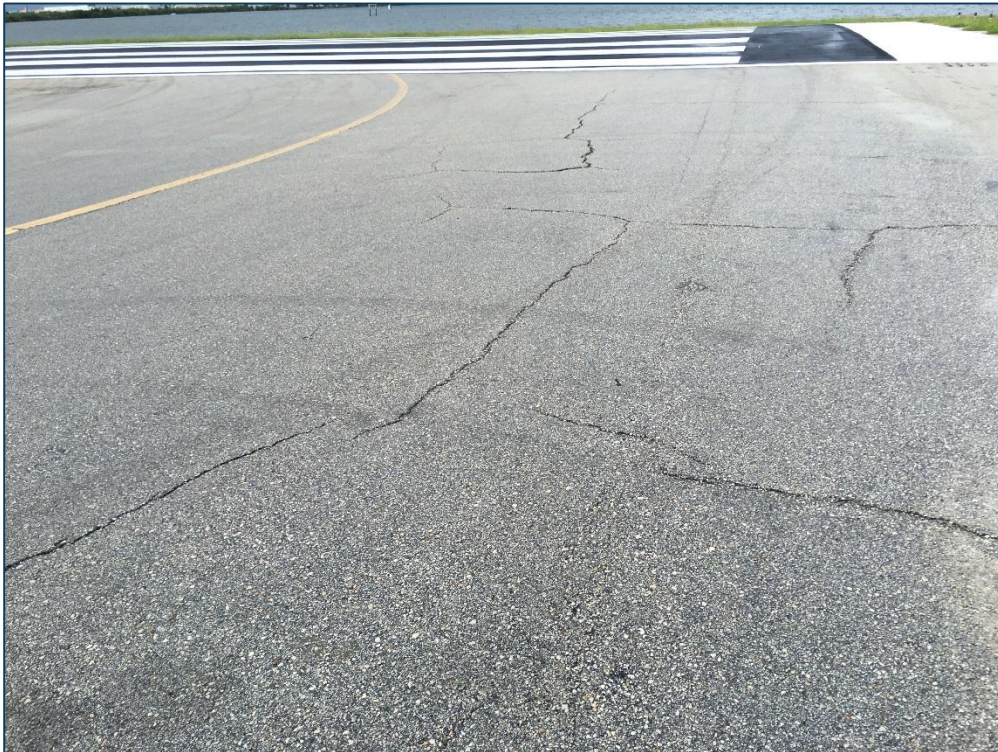
Taxiway A5, Section 110, Sample Unit 101 – Low Severity (48) Longitudinal and Transverse Cracking, Low Severity (57) Weathering, and Low Severity (52) Raveling

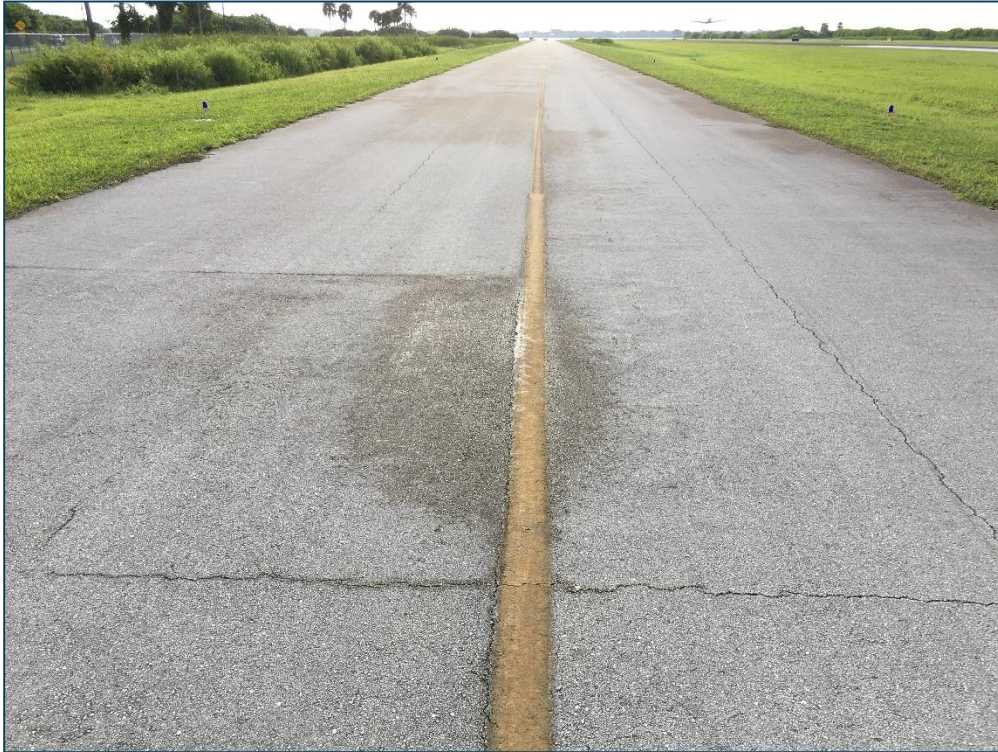
Taxiway B, Section 210, Sample Unit 109 – Low Severity (48) Longitudinal and Transverse Cracking, Low Severity (52) Raveling

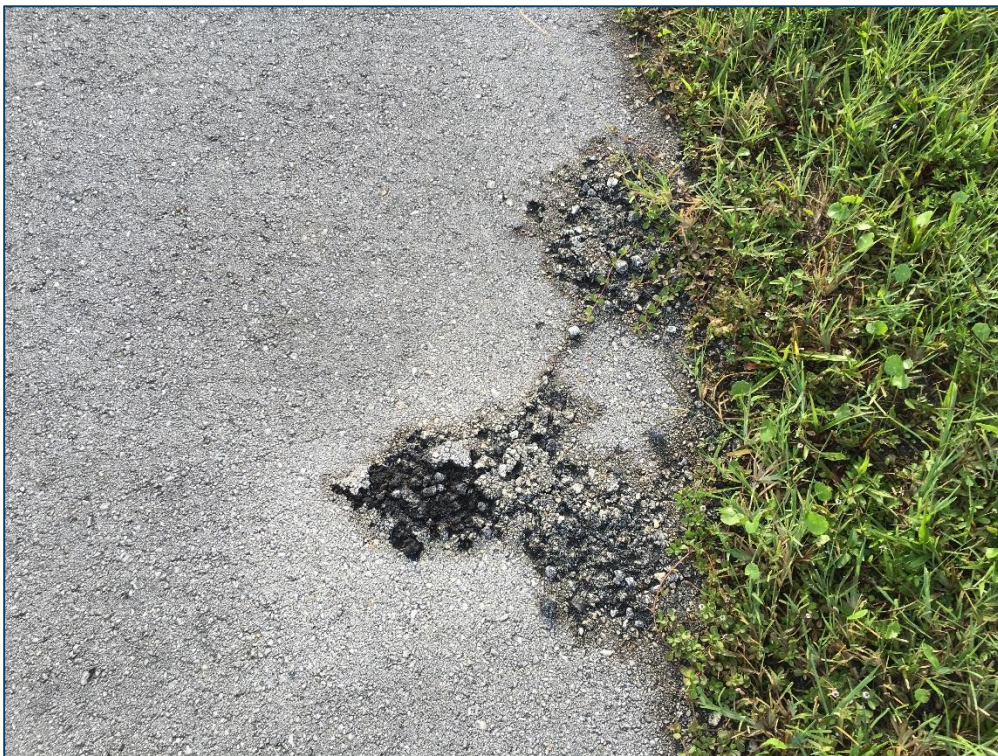
Taxiway B, Section 210, Sample Unit 116 – Low Severity (56) Swelling, Medium Severity (52) Raveling.

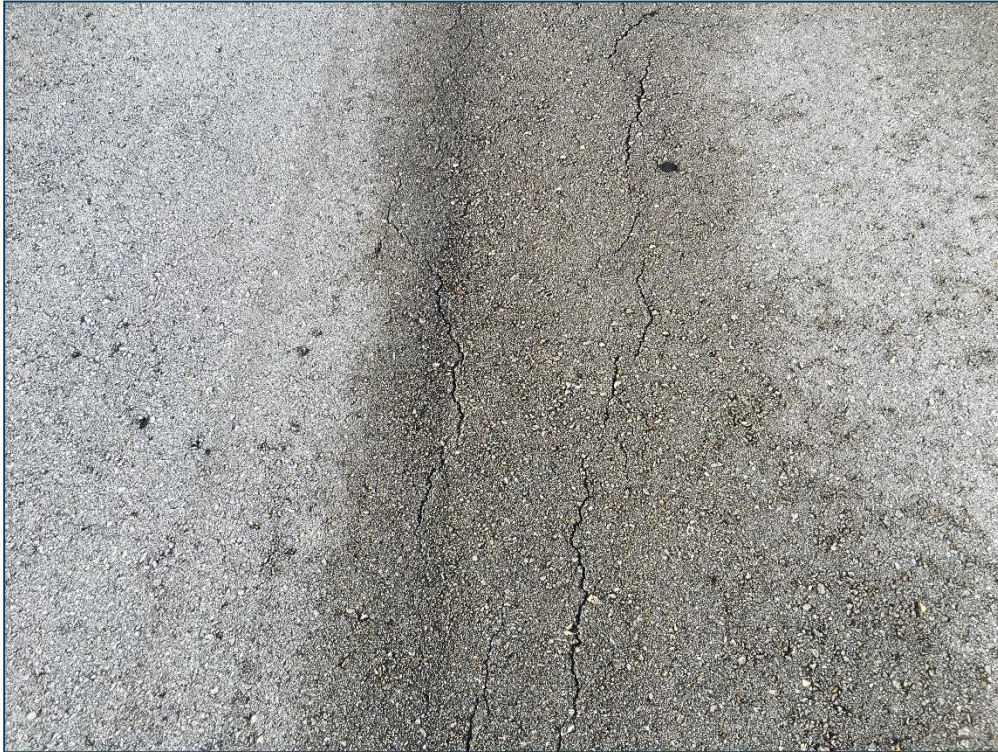
Taxiway B1, Section 315, Sample Unit 300 – Low Severity (48) Longitudinal and Transverse Cracking, Low Severity (52) Raveling

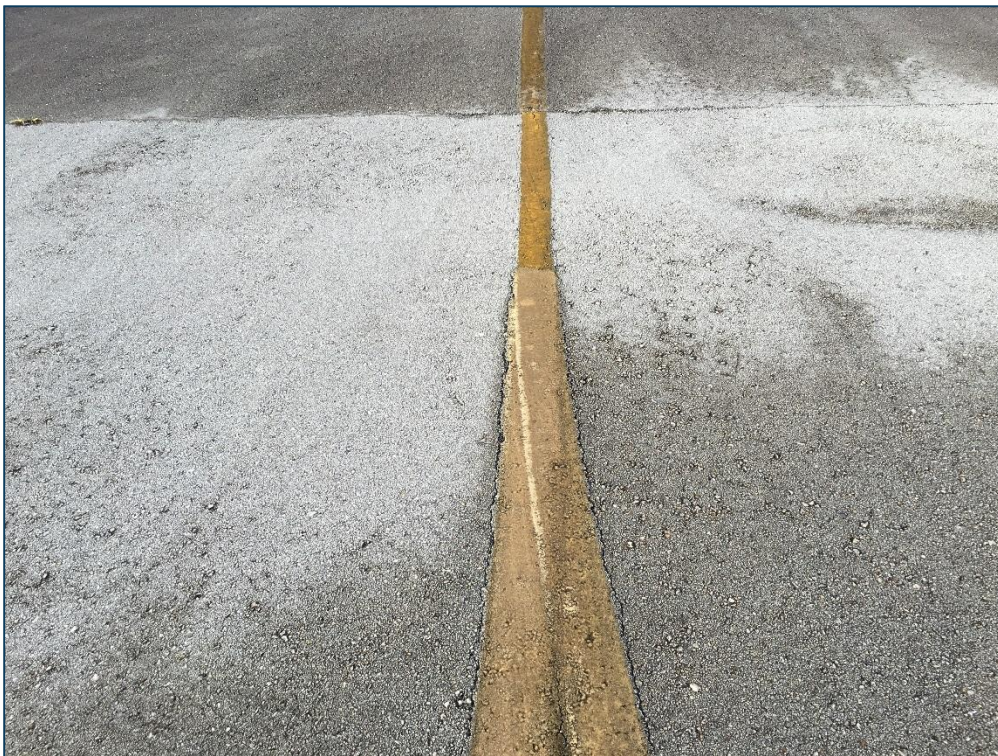
Taxiway B2, Section 410, Sample Unit 400 – Low Severity (48) Longitudinal and Transverse Cracking, Low Severity (52) Raveling

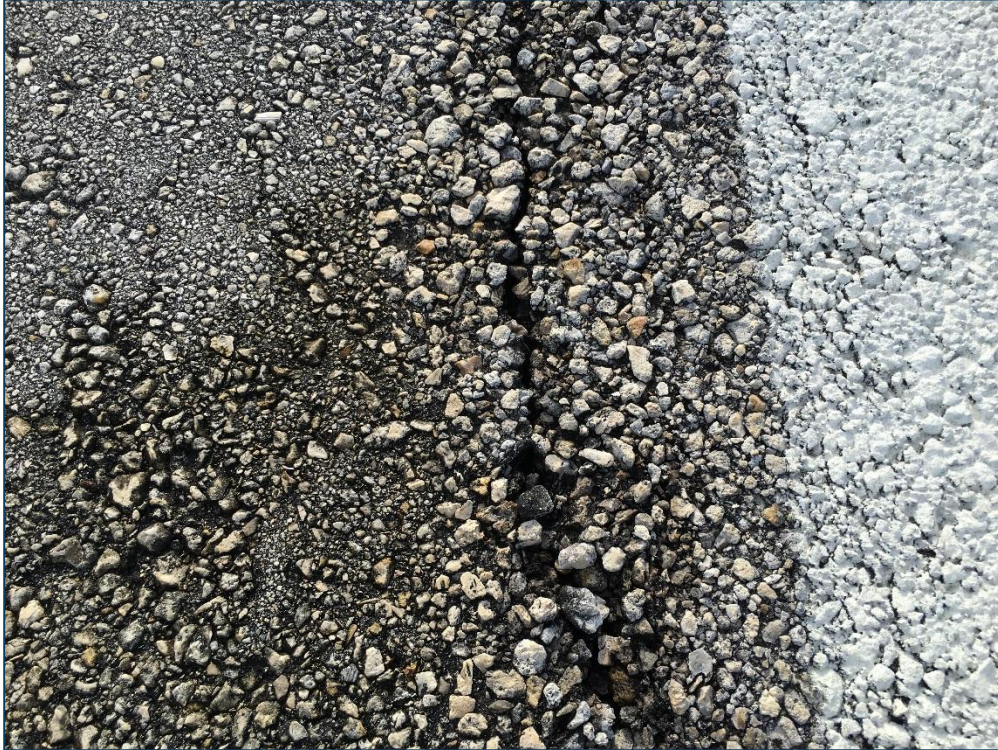
Taxiway B4, Section 216, Sample Unit 124 – Medium Severity (48) Longitudinal and Transverse Cracking, Low Severity (52) Raveling
