Statewide Airfield Pavement Management Program

**Airport Pavement
Evaluation Report
September 2017**

**Cross City
Airport (CTY)**
General Aviation Airport
District 2

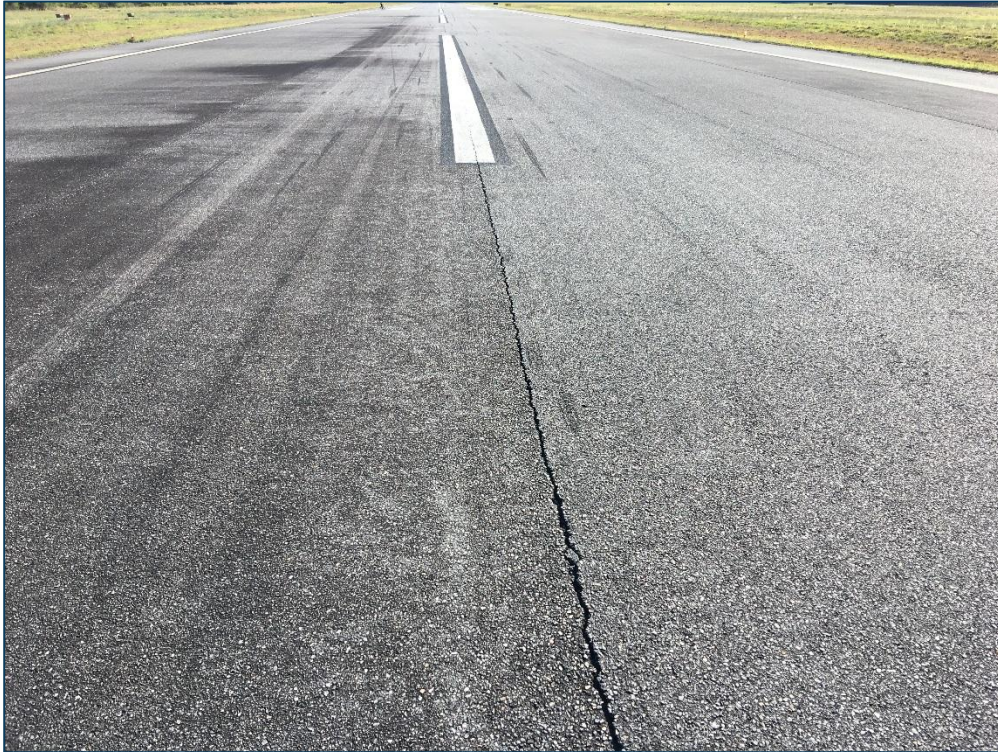
Runway 4-22, Section 6210, Sample Unit 115 – Low and Medium Severity (48) Longitudinal and Transverse Cracking, Low Severity (52) Raveling, Low Severity (57) Weathering

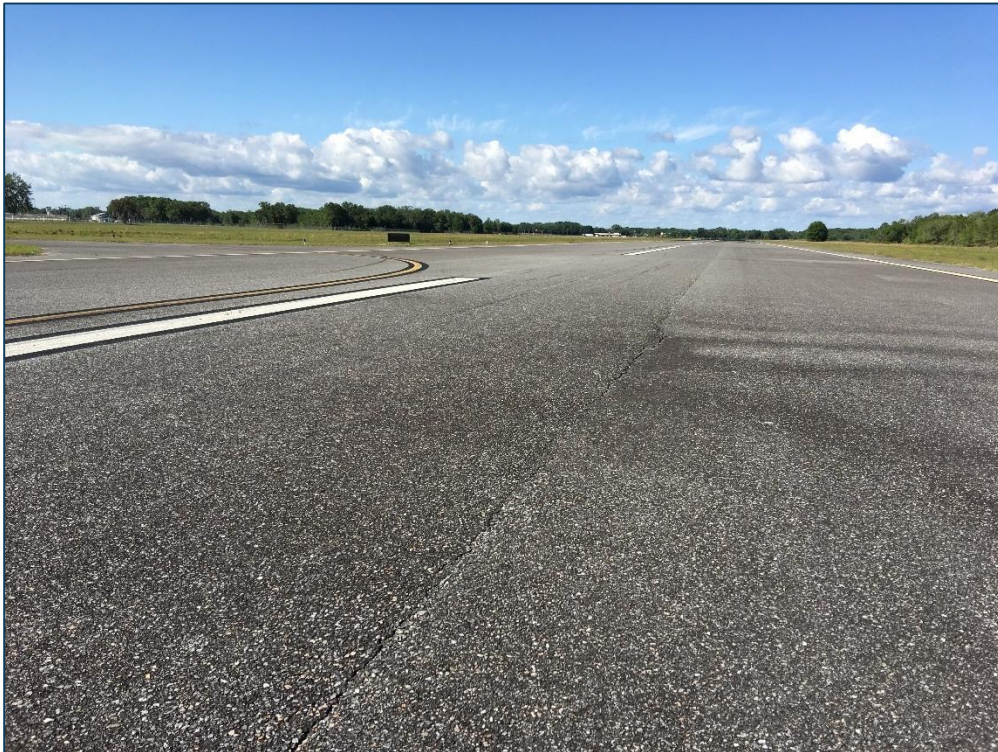
Runway 4-22, Section 6210, Sample Unit 174 – Low Severity (48) Longitudinal and Transverse Cracking, Low Severity (52) Raveling, Low Severity (57) Weathering

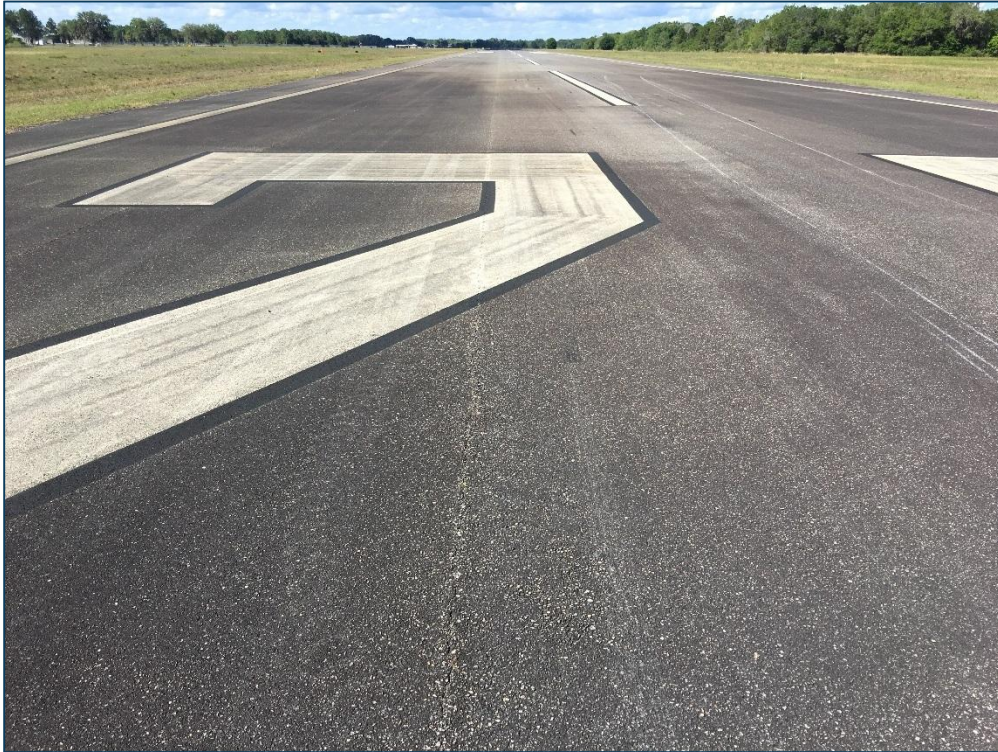
Runway 4-22, Section 6210, Sample Unit 201 – Low Severity (48) Longitudinal and Transverse Cracking, Low Severity (52) Raveling, Low Severity (57) Weathering

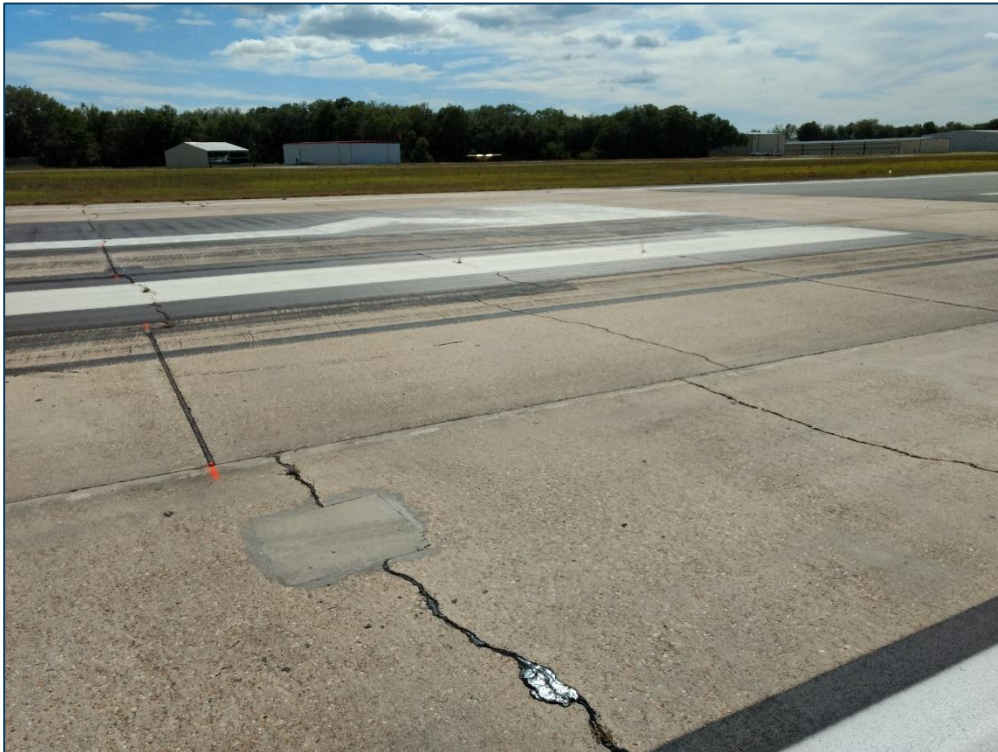
Runway 13-31, Section 6110, Sample Unit 194 – Low Severity (63) Longitudinal, Transverse, and Diagonal Cracking, Low Severity (66) Small Patching, Low Severity (65) Joint Seal Damage

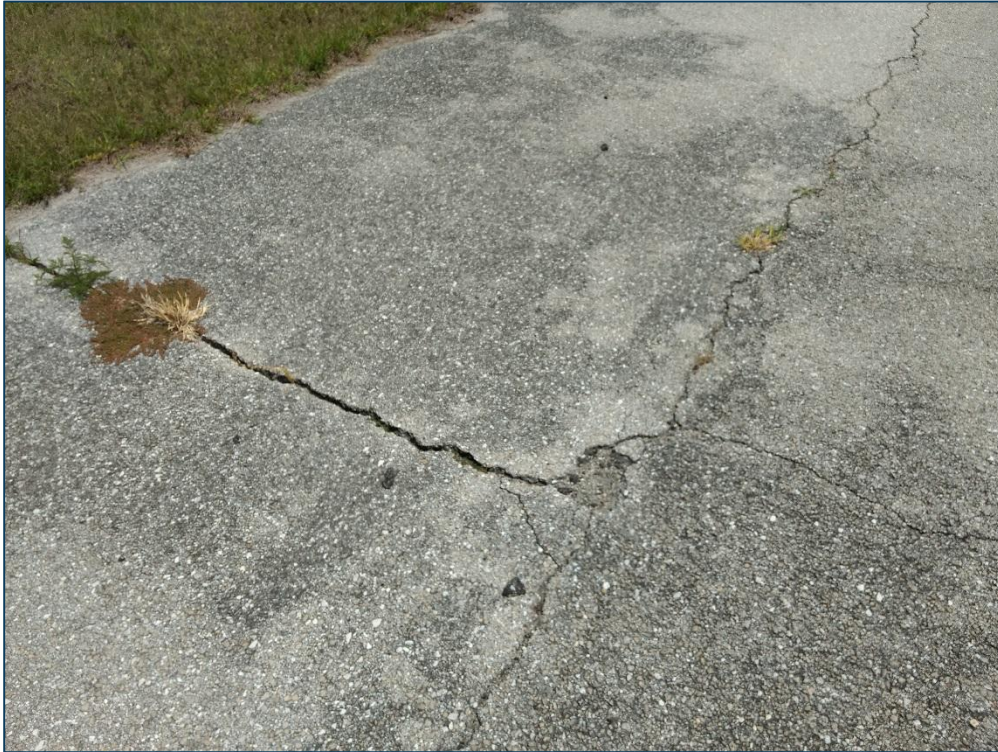
Taxiway A, Section 110, Sample Unit 114 – Low and Medium Severity (48) Longitudinal and Transverse Cracking, Low Severity (52) Raveling, Medium Severity (52) Raveling

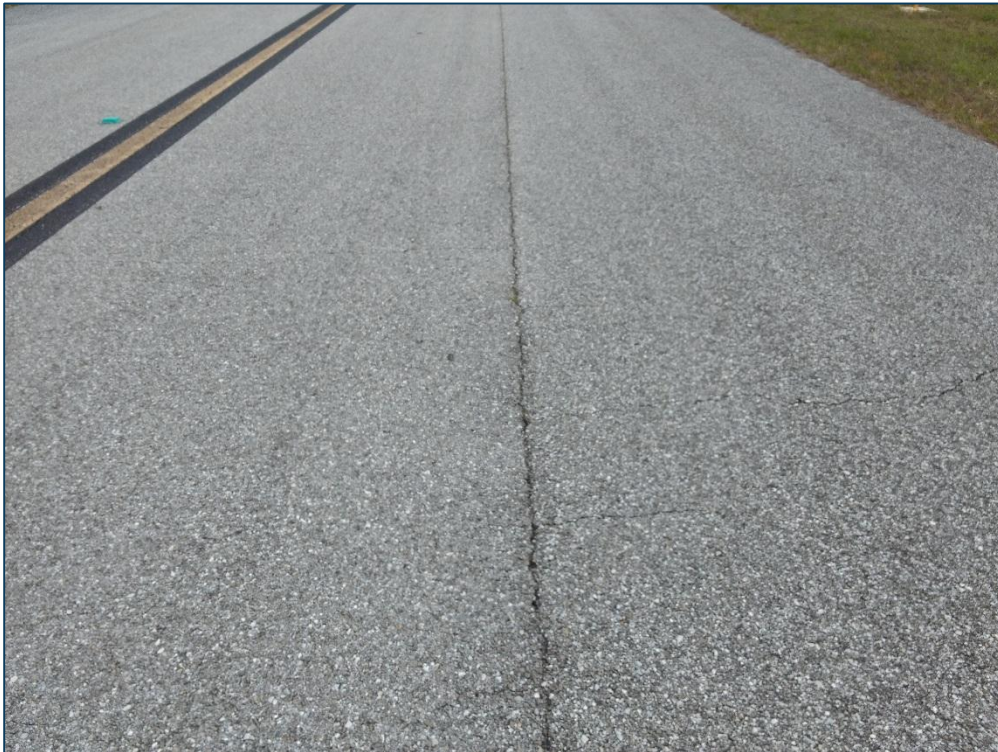
Taxiway A, Section 110, Sample Unit 130 – Low Severity (48) Longitudinal and Transverse Cracking, Low Severity (52) Raveling

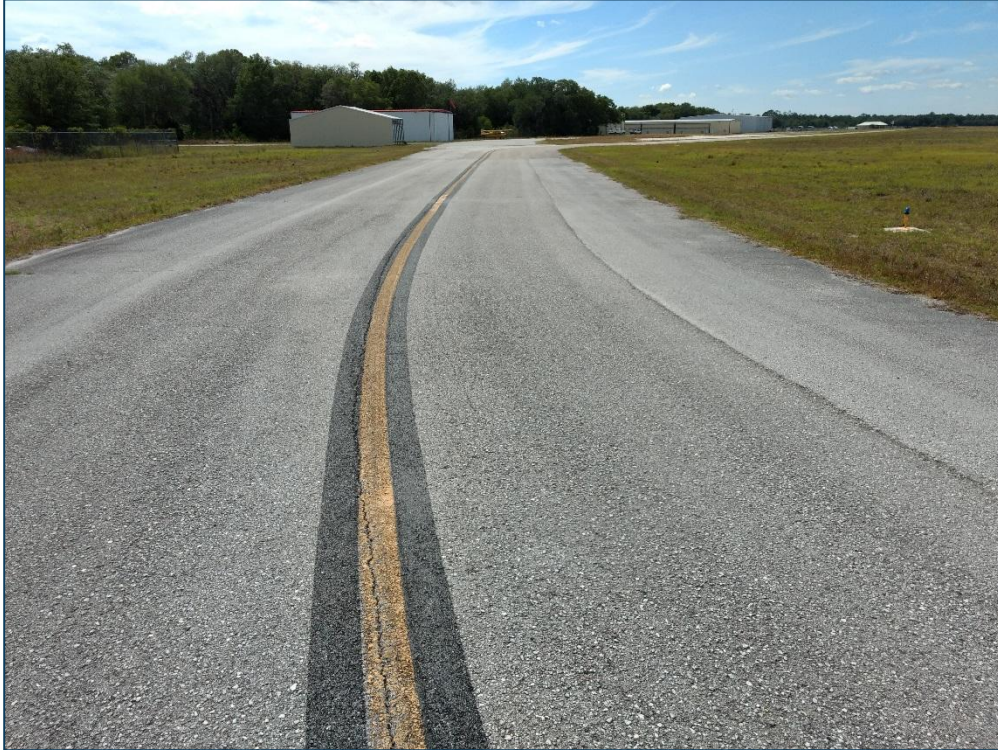
Taxiway A, Section 115, Sample Unit 151 – Low and Medium Severity (48) Longitudinal and Transverse Cracking, Low Severity (52) Raveling, Medium Severity (52) Raveling

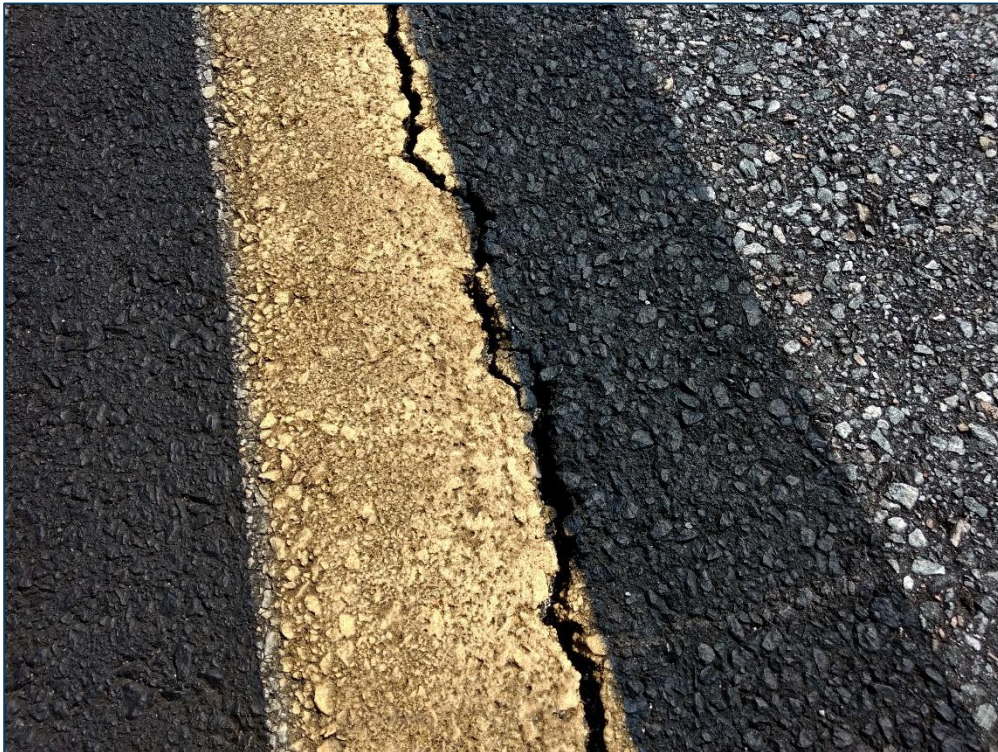
Taxiway B, Section 210, Sample Unit 123 – Medium Severity (48) Longitudinal and Transverse Cracking, Low Severity (52) Raveling

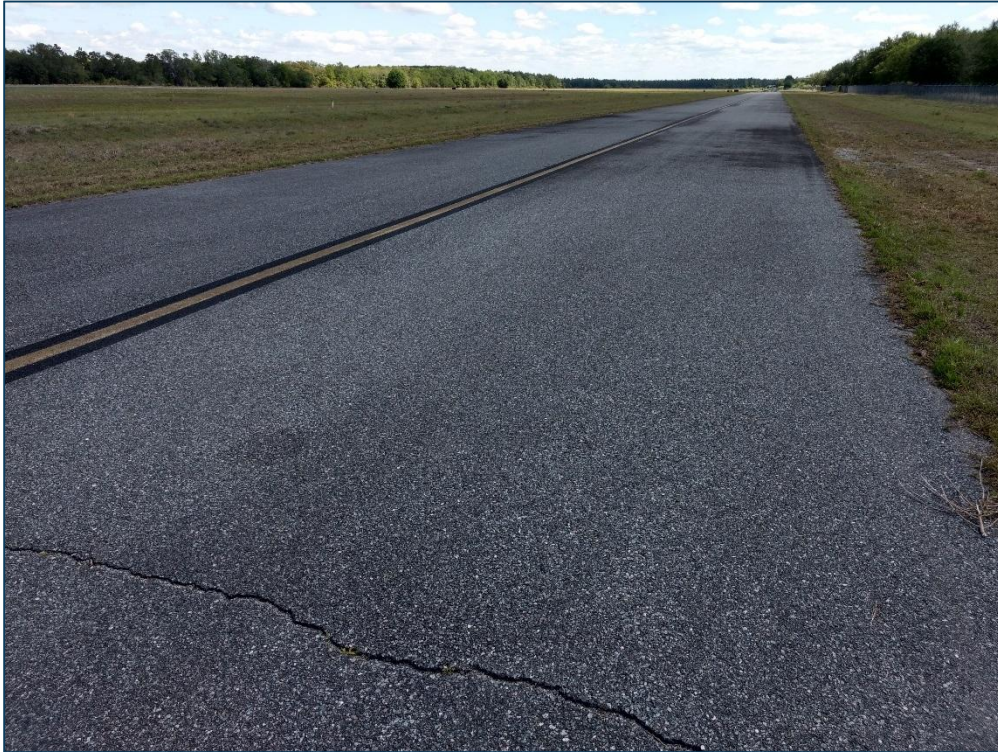
Taxiway B, Section 210, Sample Unit 107 – Low and Medium Severity (48) Longitudinal and Transverse Cracking, Low Severity (52) Raveling, Medium Severity (52) Raveling

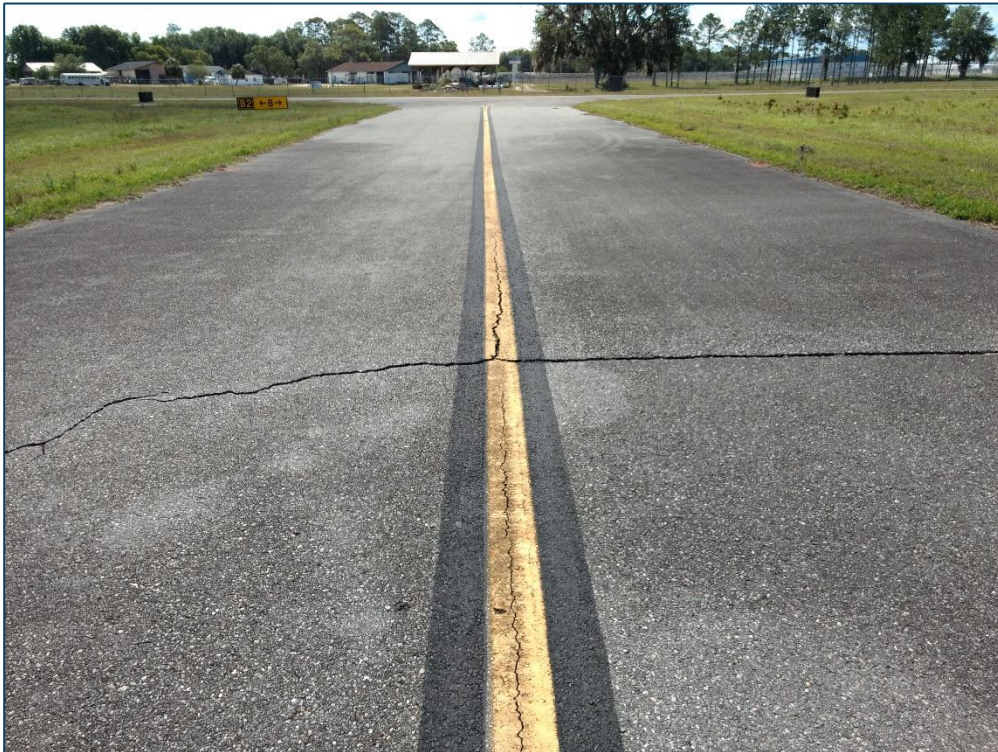
Taxiway B2, Section 220, Sample Unit 102 – Low and Medium Severity (48) Longitudinal and Transverse Cracking, Low Severity (52) Raveling

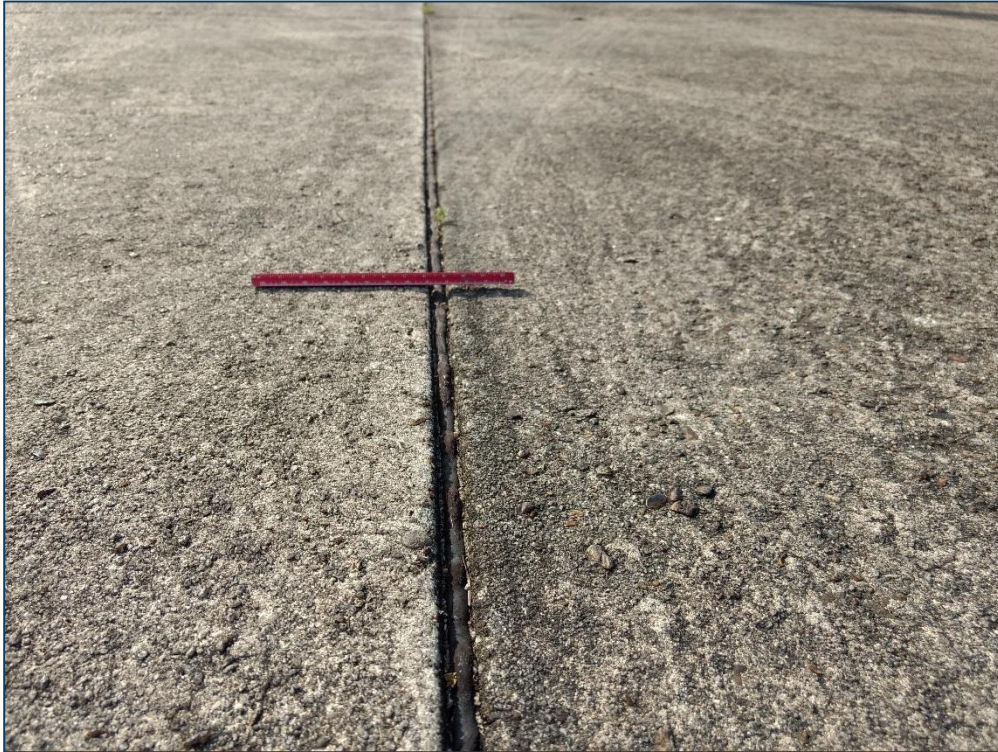
Apron, Section 4105, Sample Unit 101 – Low Severity (65) Joint Seal Damage, Low Severity (71) Faulting

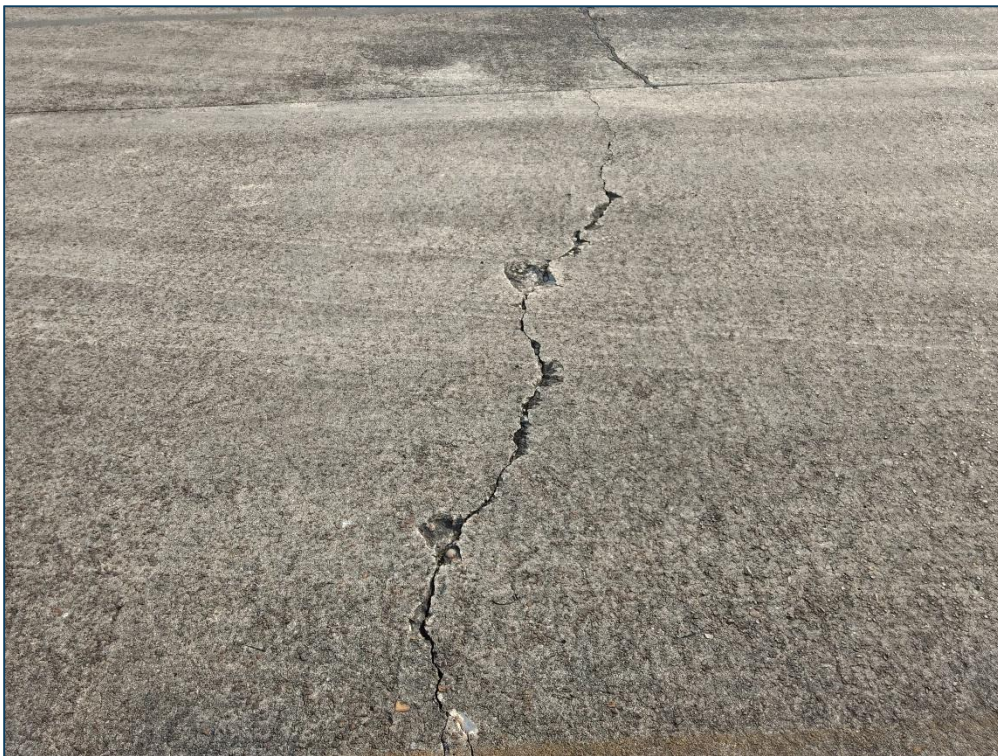
Apron, Section 4105, Sample Unit 401 –Medium Severity (63) Longitudinal, Transverse, and Diagonal Cracking
