FLORIDA DEPARTMENT OF TRANSPORTATION
AVIATION AND SPACEPORTS OFFICE

Statewide Airfield Pavement Management Program

Airport Pavement Evaluation Report September 2017

**Flagler Executive
Airport (FIN)**
General Aviation Airport
District 5

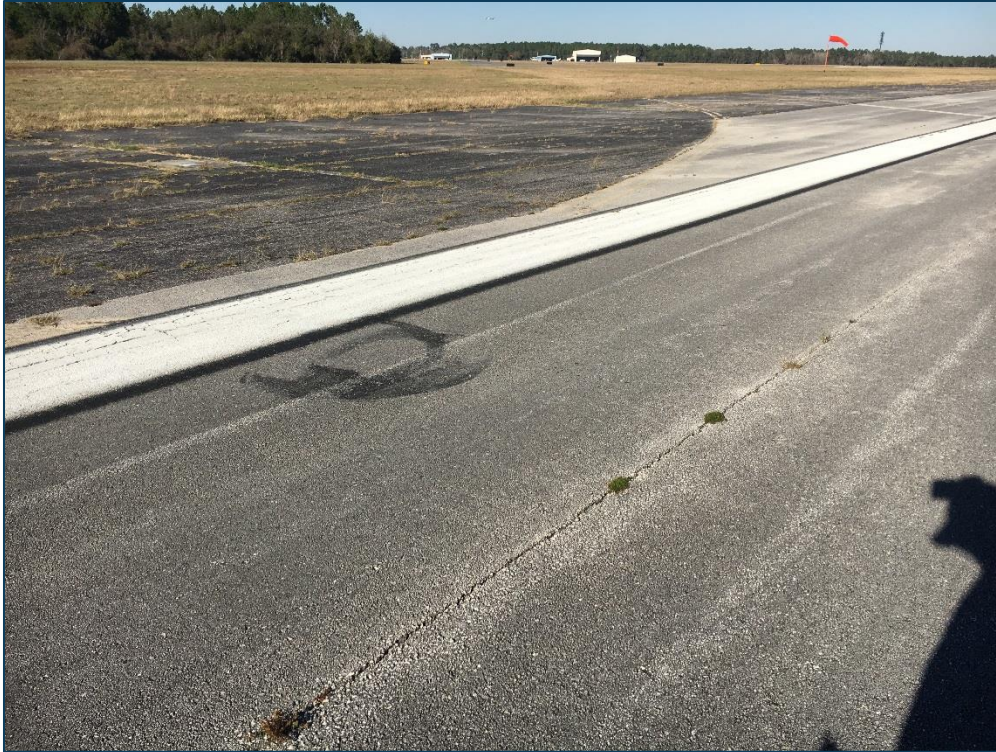
Runway 6-24, Section 6205, Sample Unit 117 – Low Severity (48) Longitudinal and Transverse Cracking, Low Severity (56) Swelling, Low Severity (52) Raveling

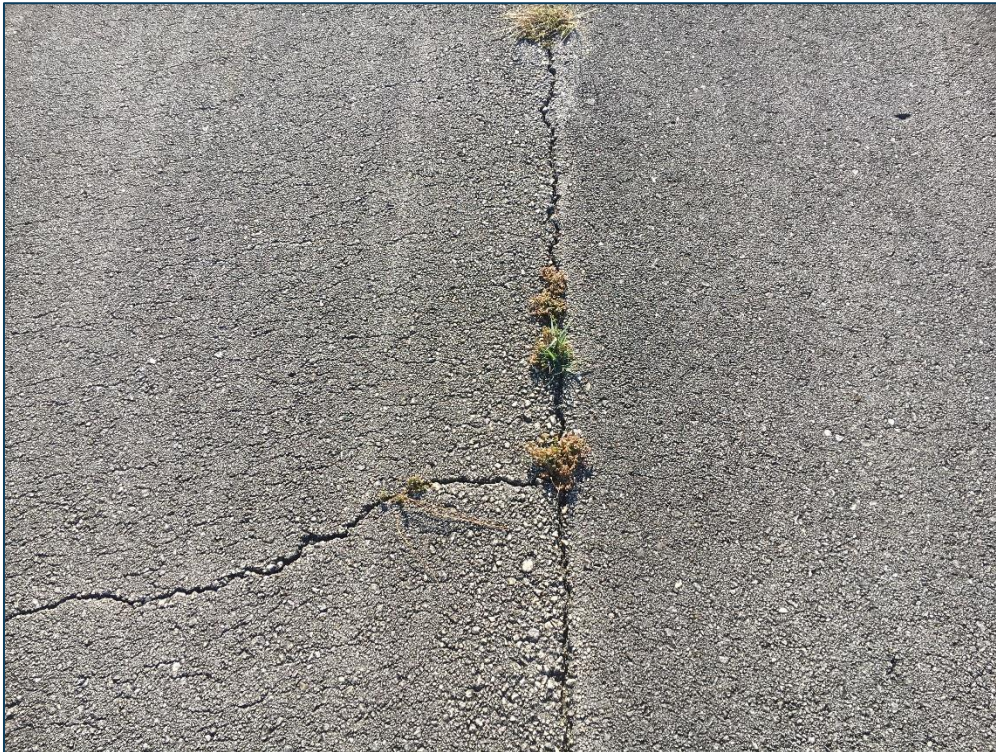
Runway 6-24, Section 6205, Sample Unit 107 - Low Severity (48) Longitudinal and Transverse Cracking, Medium Severity (48) Longitudinal and Transverse Cracking, Low Severity (52) Raveling, Medium Severity (52) Raveling

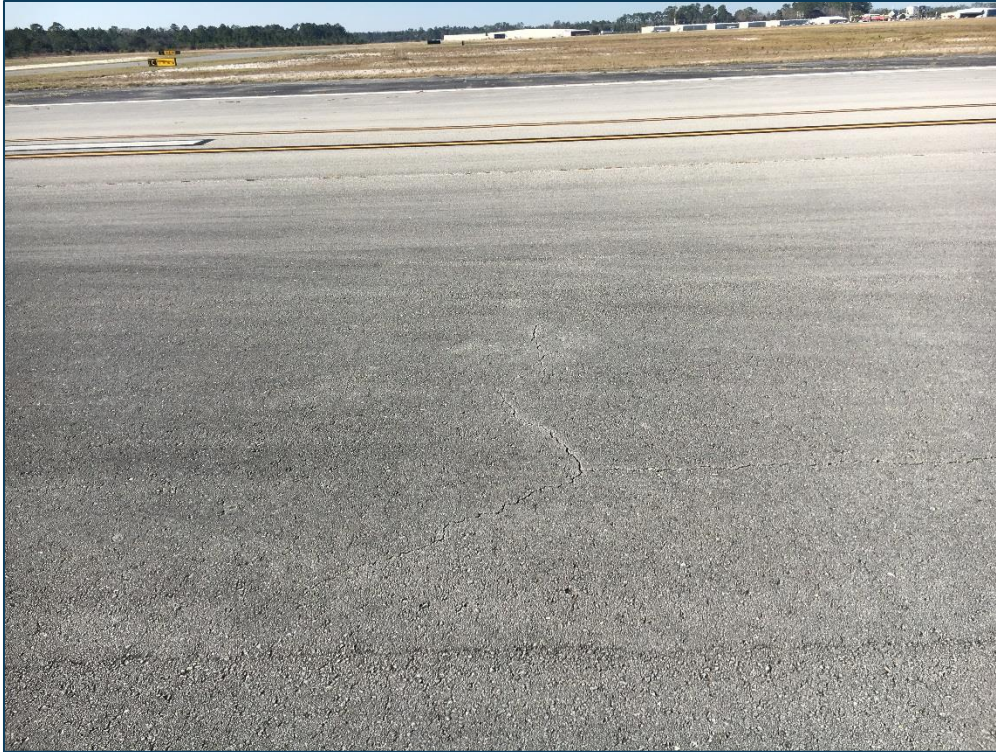
Runway 6-24, Section 6205, Sample Unit 149 - Low Severity (48) Longitudinal and Transverse Cracking, Medium Severity (48) Longitudinal and Transverse Cracking, Low Severity (52) Raveling, Medium Severity (52) Raveling

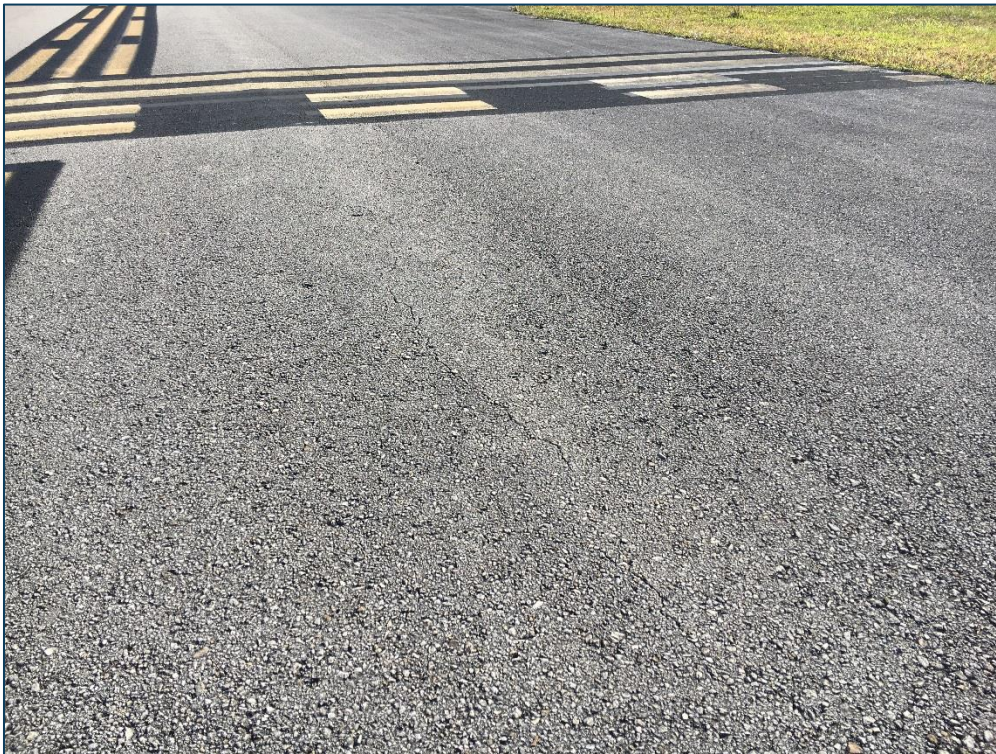
Taxiway A, Section 102, Sample Unit 101 - Low Severity (48) Longitudinal and Transverse Cracking, Low Severity (52) Raveling, Medium Severity (52) Raveling, Low Severity (56) Swelling

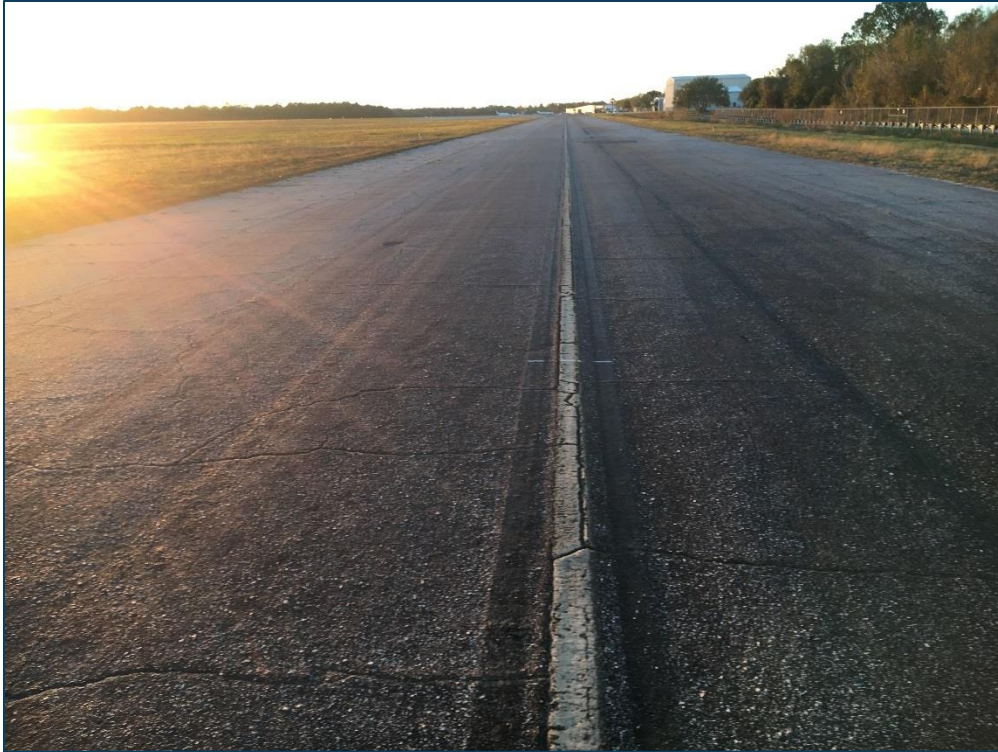
Taxiway A, Section 105, Sample Unit 141 - Low Severity (43) Block Cracking, Medium Severity (43) Block Cracking, Low Severity (52) Raveling, Low Severity (53) Rutting

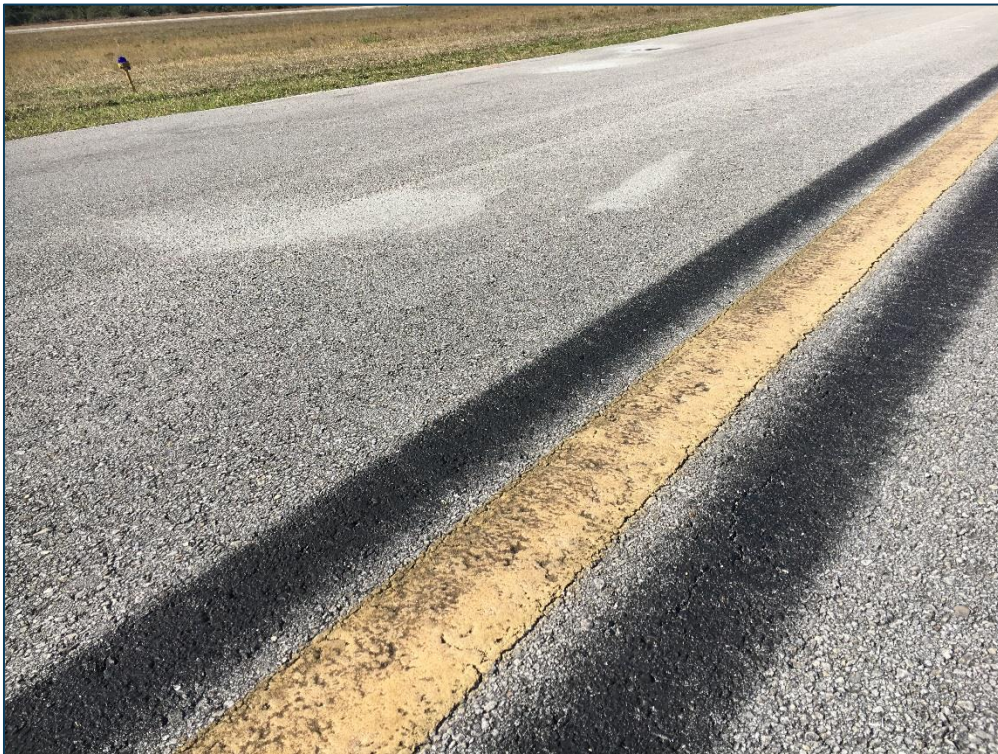
Taxiway B, Section 205, Sample Unit 113 - Low Severity (48) Longitudinal and Transverse Cracking, Low Severity (52) Raveling, Medium Severity (52) Raveling, Low Severity (56) Swelling

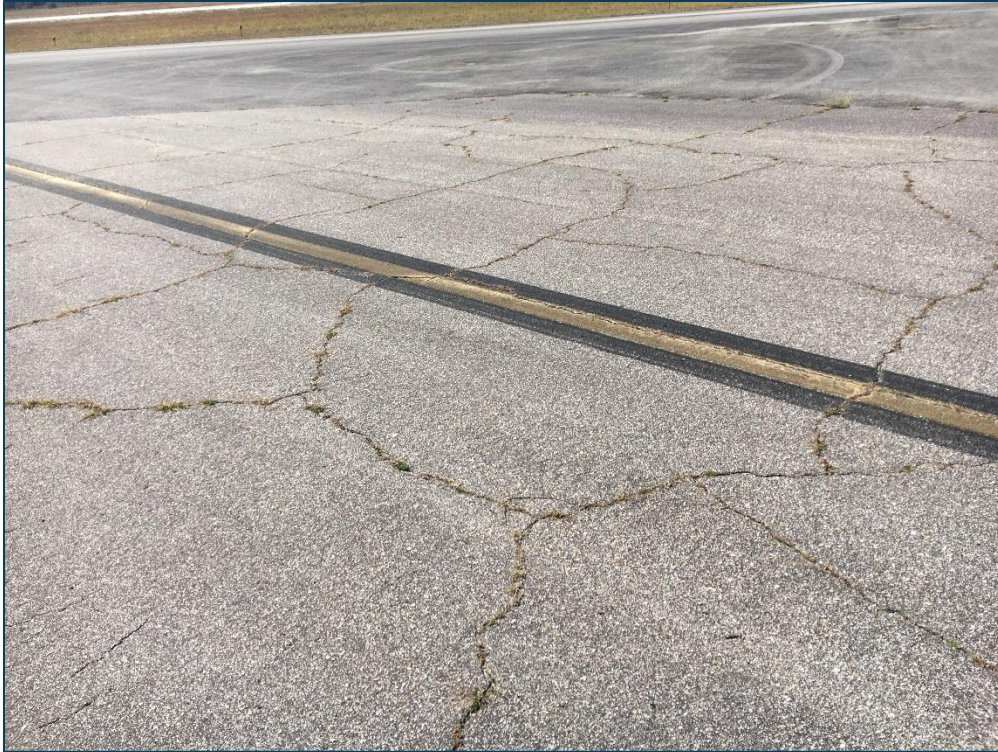
Taxiway C, Section 307, Sample Unit 104 - Medium Severity (43) Block Cracking, Low Severity (52) Raveling

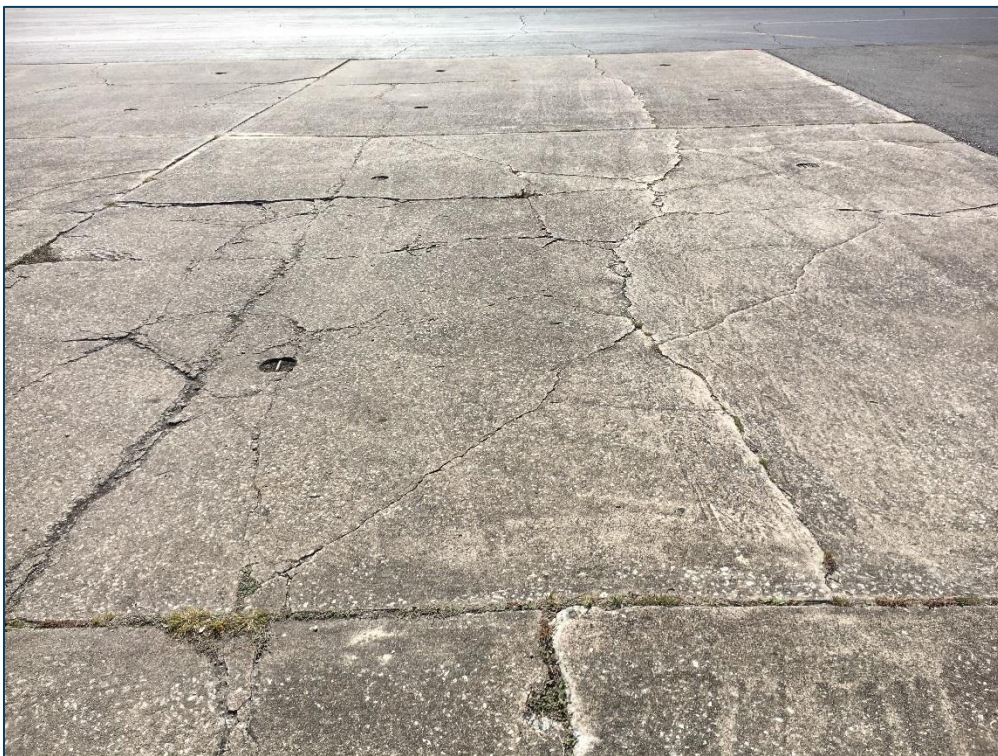
Apron, Section 4105, Sample Unit 101 – High Severity (72) Shattered Slab, High Severity (65) Joint Seal Damage

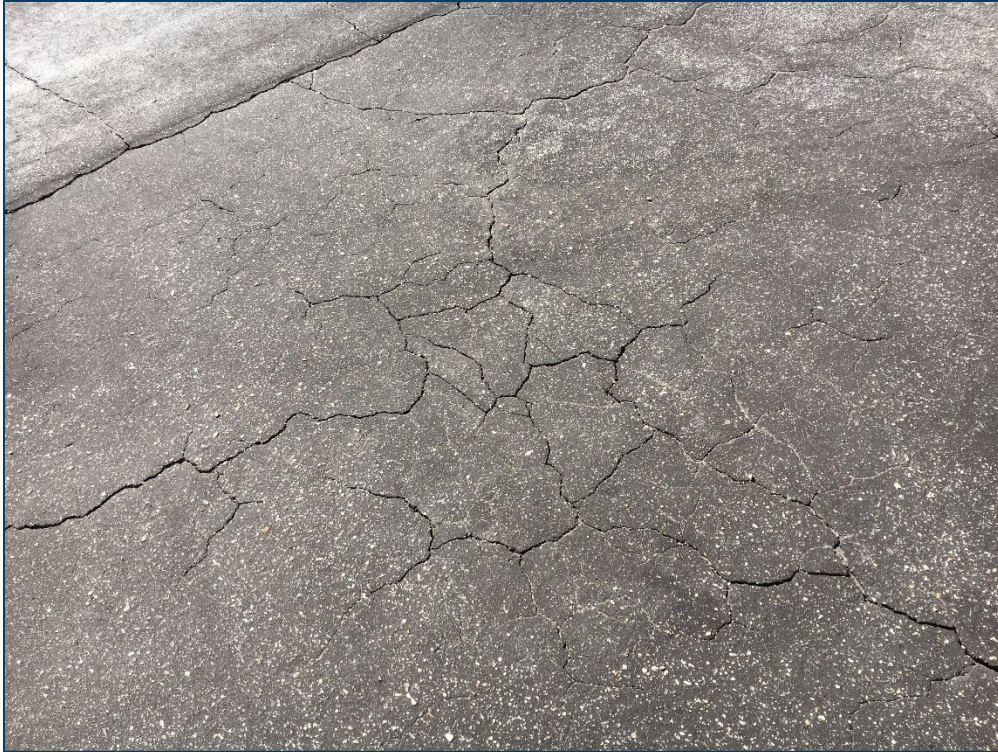
Apron, Section 4115, Sample Unit 401 – Medium Severity (41) Alligator Cracking, Medium Severity (48) Longitudinal and Transverse Cracking, Low Severity (52) Raveling

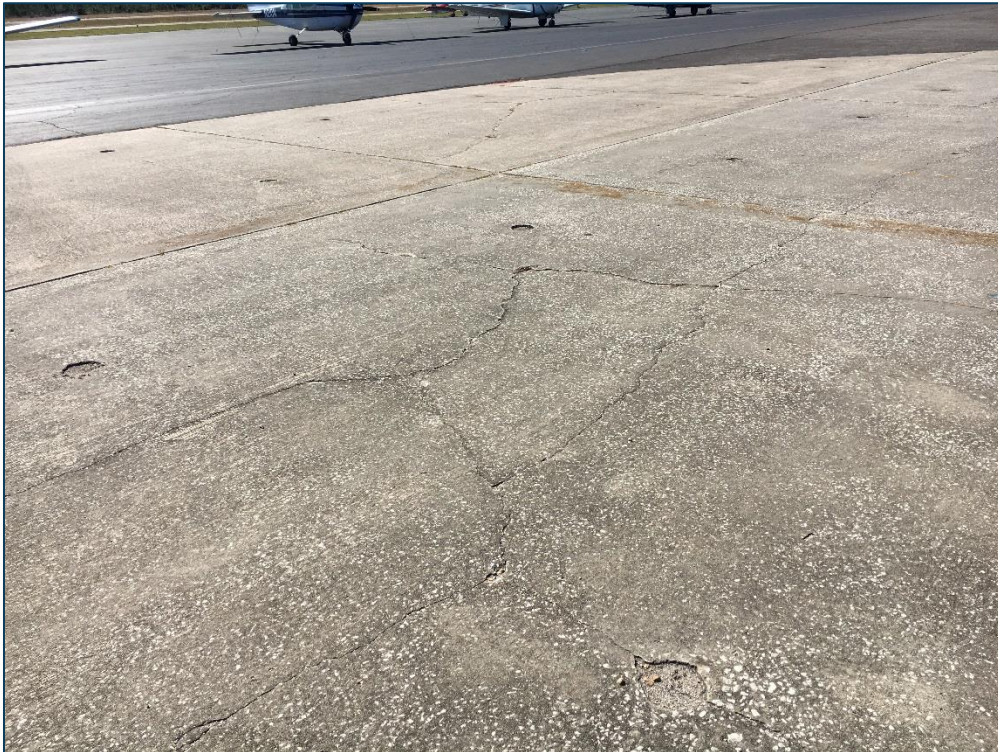
Apron, Section 4120, Sample Unit 402 – High Severity (65) Joint Seal Damage, Medium Severity (72) Shattered Slab

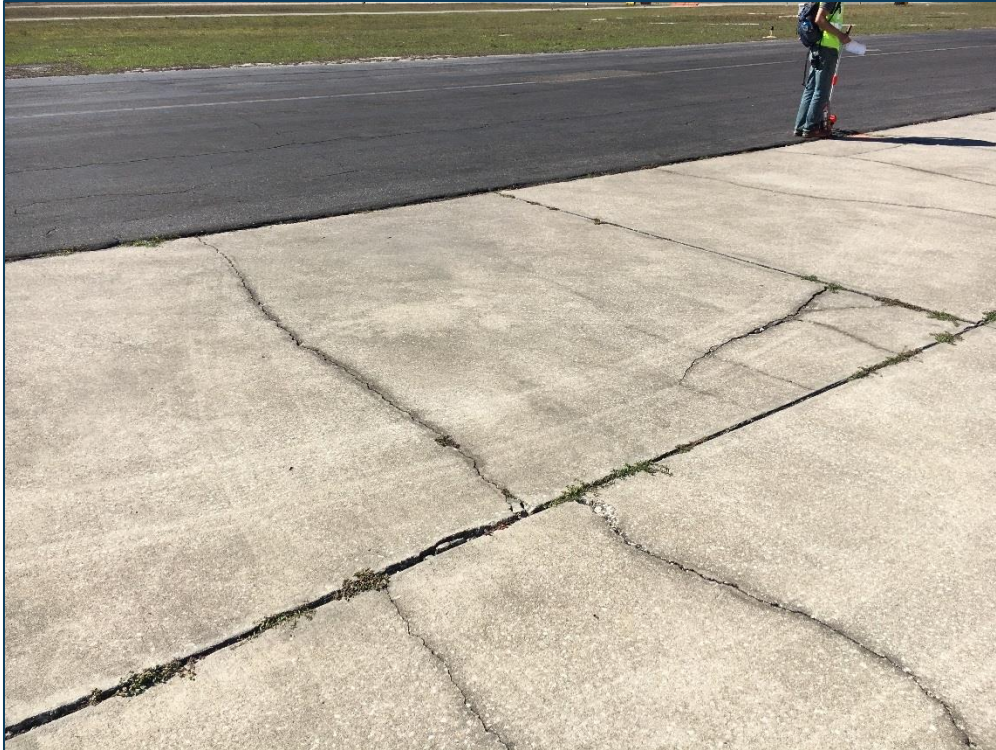
Apron, Section 4130, Sample Unit 101 – Medium Severity (63) Longitudinal, Transverse, and Diagonal Cracking, Medium Severity (62) Corner Break, High Severity (65) Joint Seal Damage

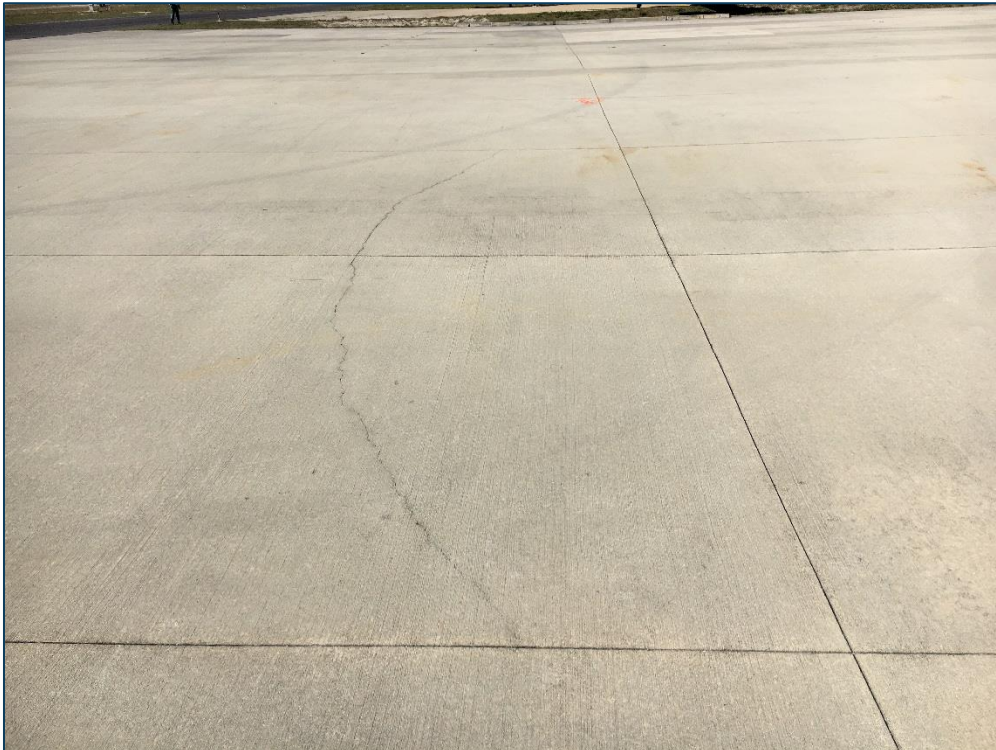
GA Apron, Section 4510, Sample Unit 100 – Low Severity (63) Longitudinal, Transverse, and Diagonal Cracking, High Severity (65) Joint Seal Damage

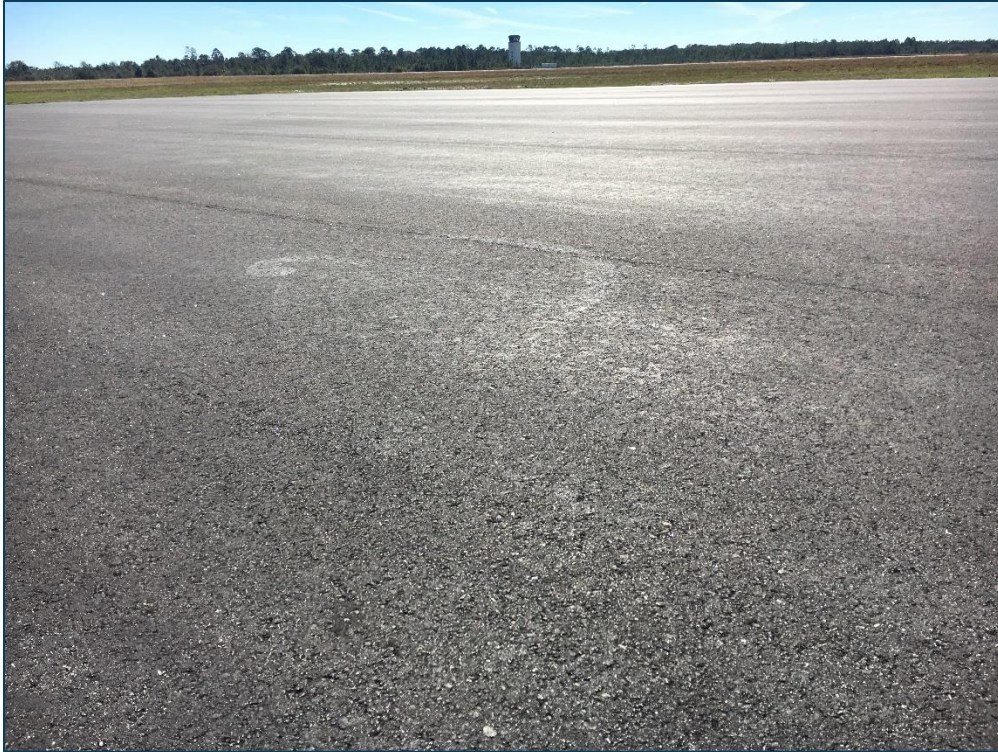
Apron Mid, Section 4610, Sample Unit 102 – Low Severity (57) Weathering

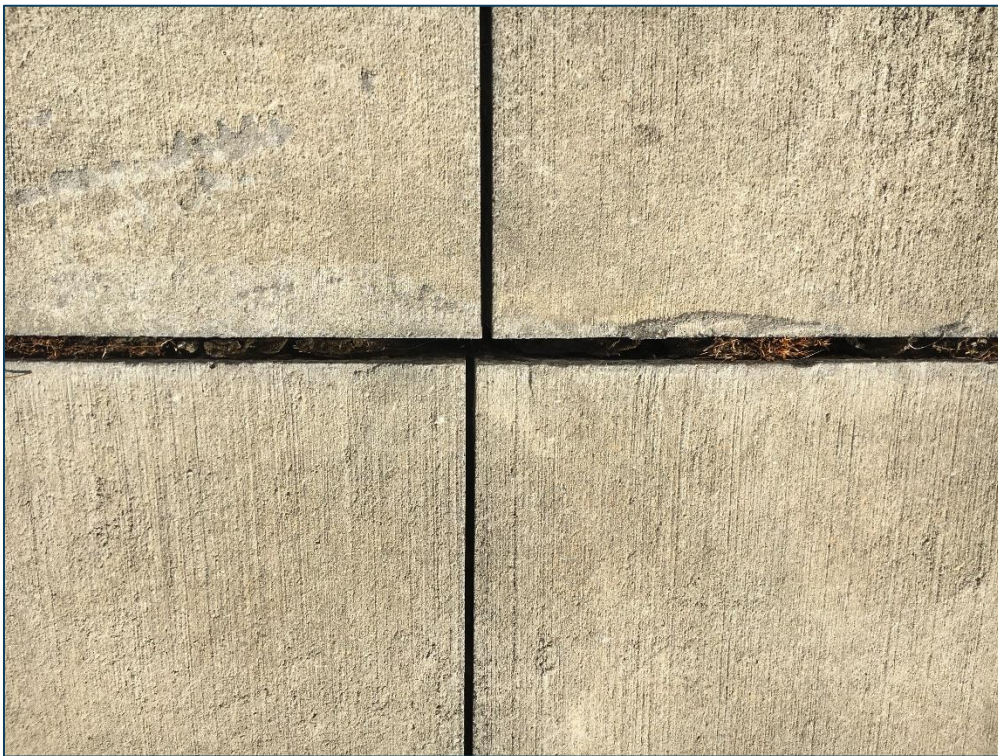
North Apron, Section 4405, Sample Unit 101 – High Severity (65) Joint Seal Damage

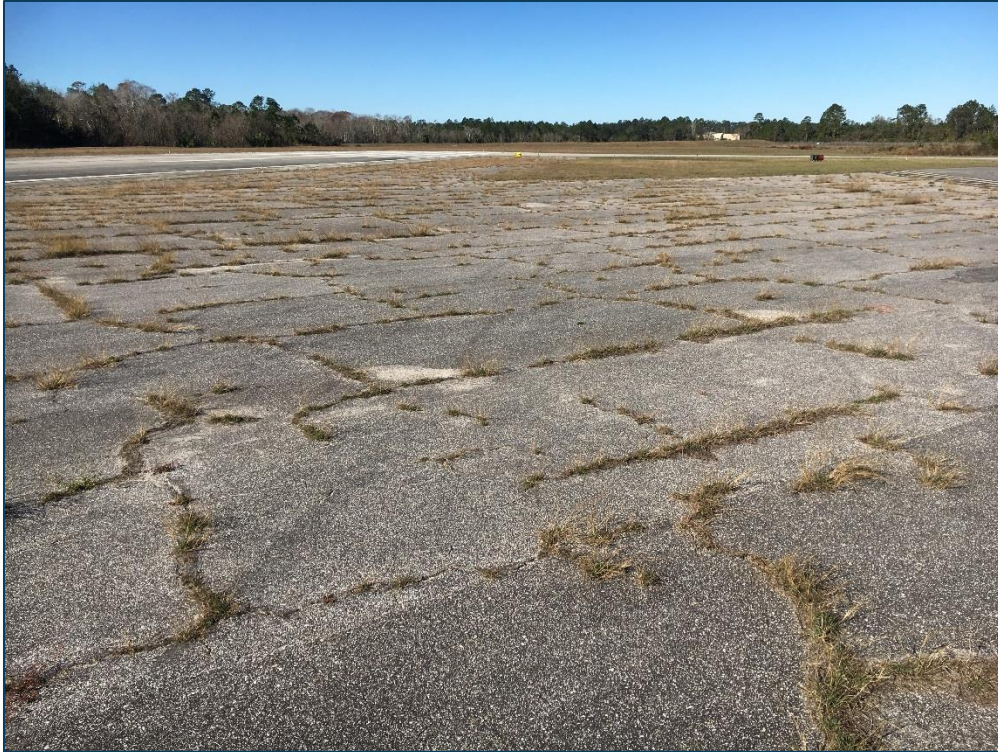
Run-Up Apron RW 11, Section 5103, Sample Unit 602 – Medium Severity (43) Block Cracking, Low Severity (52) Raveling
