Statewide Airfield Pavement Management Program

**Airport Pavement
Evaluation Report
September 2017**

**Winter Haven's
Gilbert Airport (GIF)**
General Aviation Airport
District 1

Florida Department of Transportation

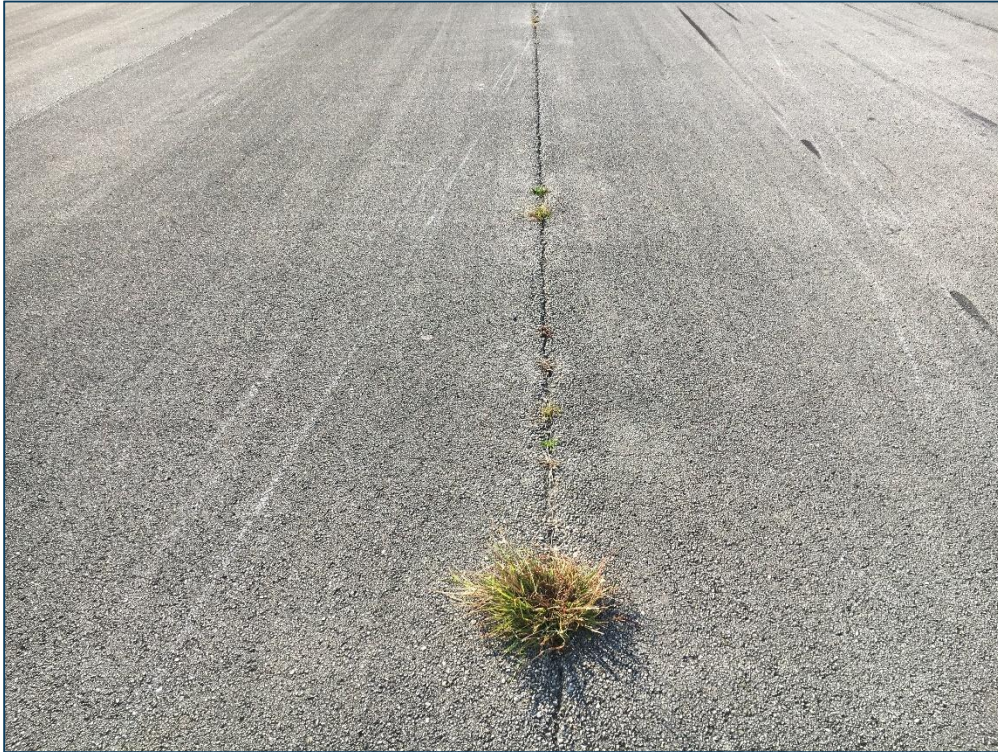
Runway 11-29, Section 6205, Sample Unit 163 – Medium Severity (48) Longitudinal and Transverse Cracking, Low Severity (52) Raveling, Low Severity (57) Weathering

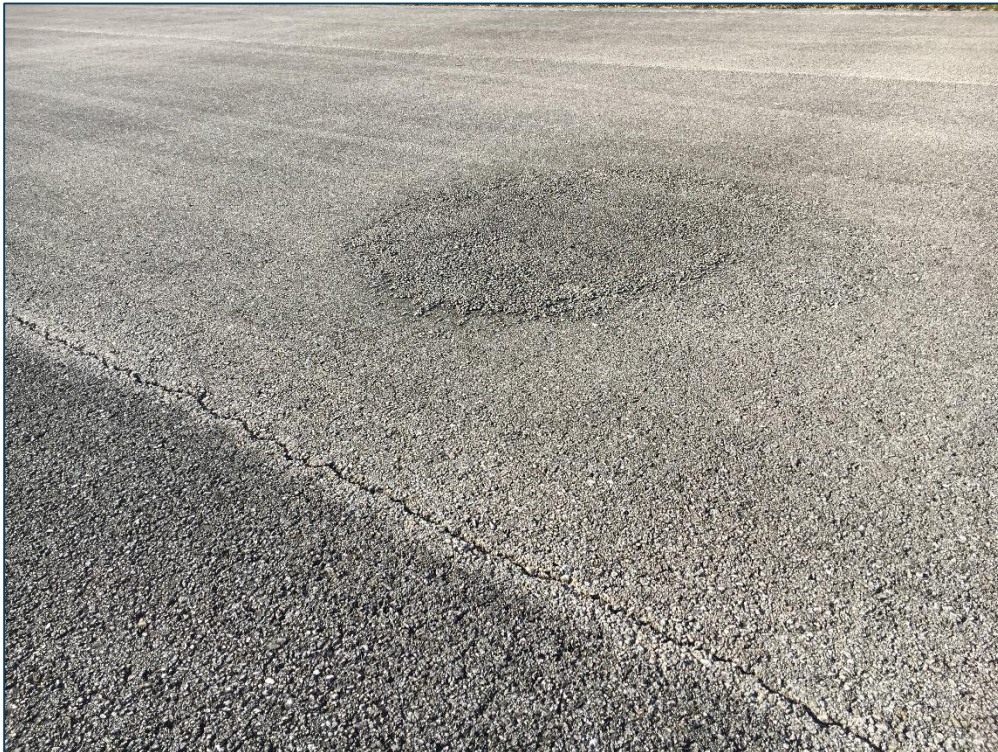
Runway 11-29, Section 6205, Sample Unit 151 – Low Severity (45) Depression, Low Severity (48) Longitudinal and Transverse Cracking, Low Severity (52) Raveling, Low Severity (57) Weathering

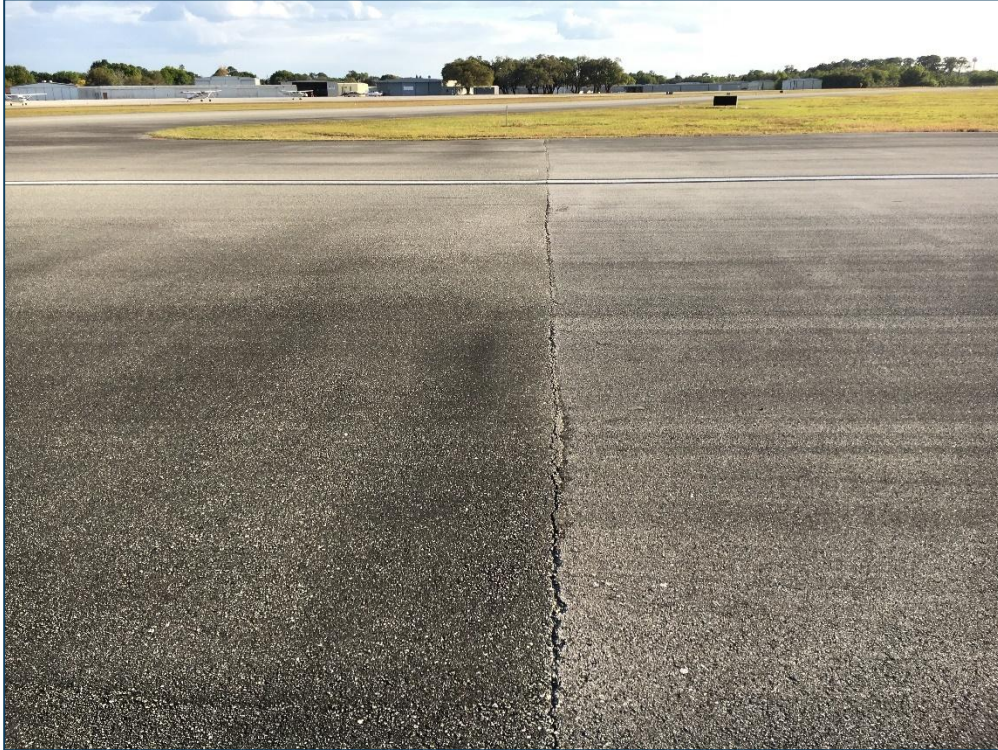
Runway 11-29, Section 6210, Sample Unit 136 – Low Severity (48) Longitudinal and Transverse Cracking, Low Severity (57) Weathering

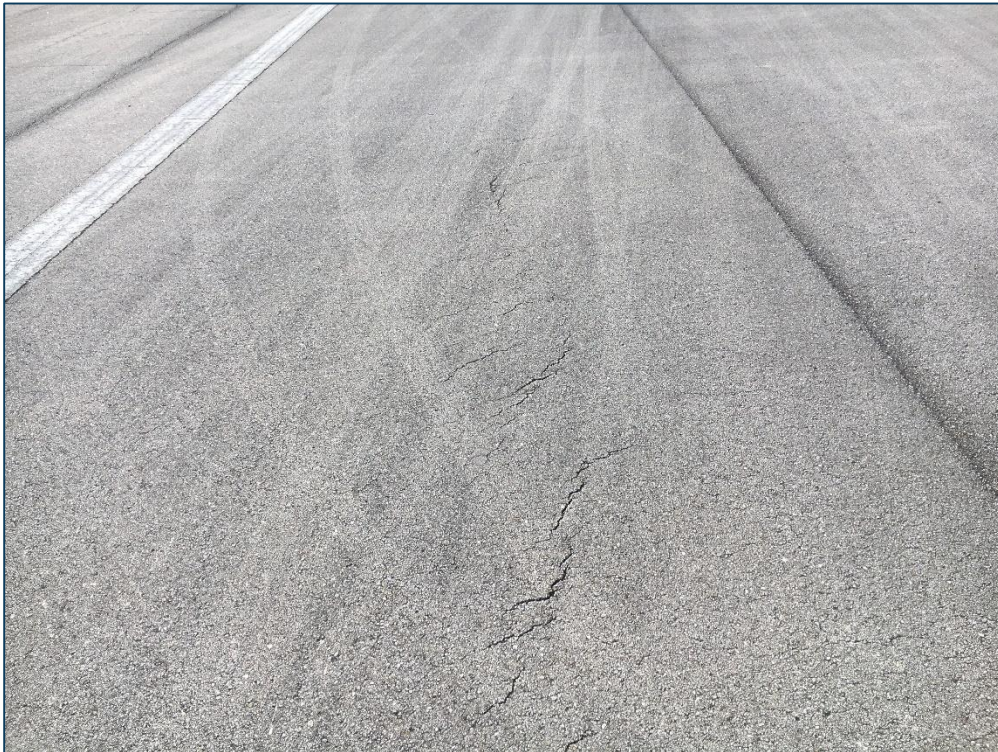
Runway 11-29, Section 6205, Sample Unit 103 – Low Severity (48) Longitudinal and Transverse Cracking, Low Severity (52) Raveling, Low Severity (57) Weathering

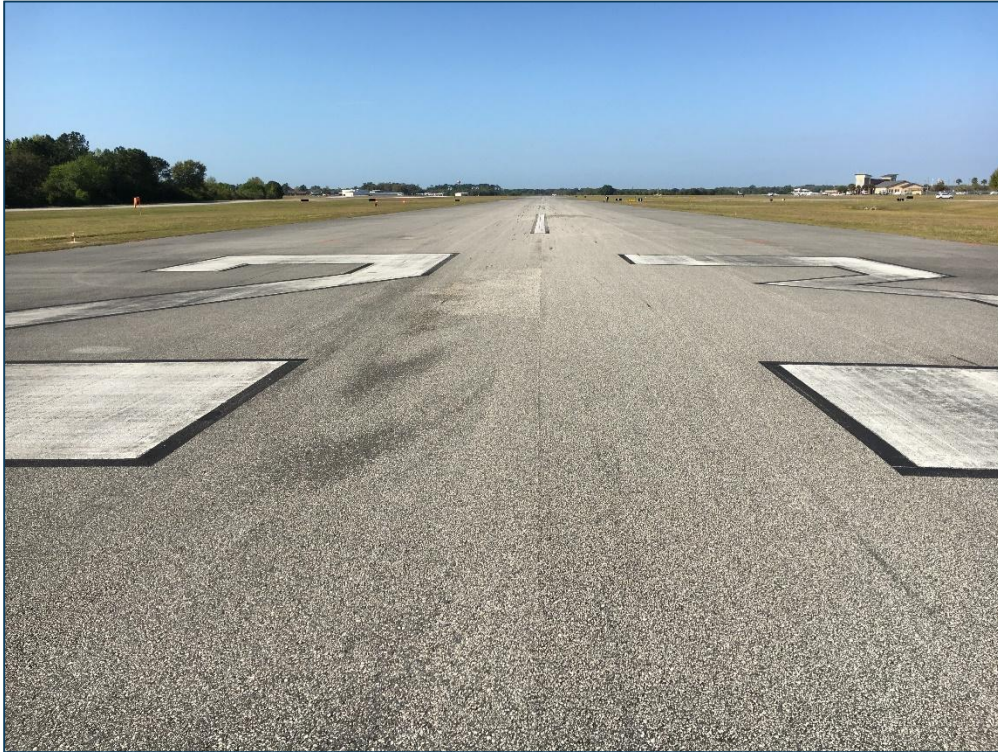
Runway 5-23, Section 6115, Sample Unit 147 – Low Severity (48) Longitudinal and Transverse Cracking, Low Severity (52) Raveling, Low Severity (57) Weathering

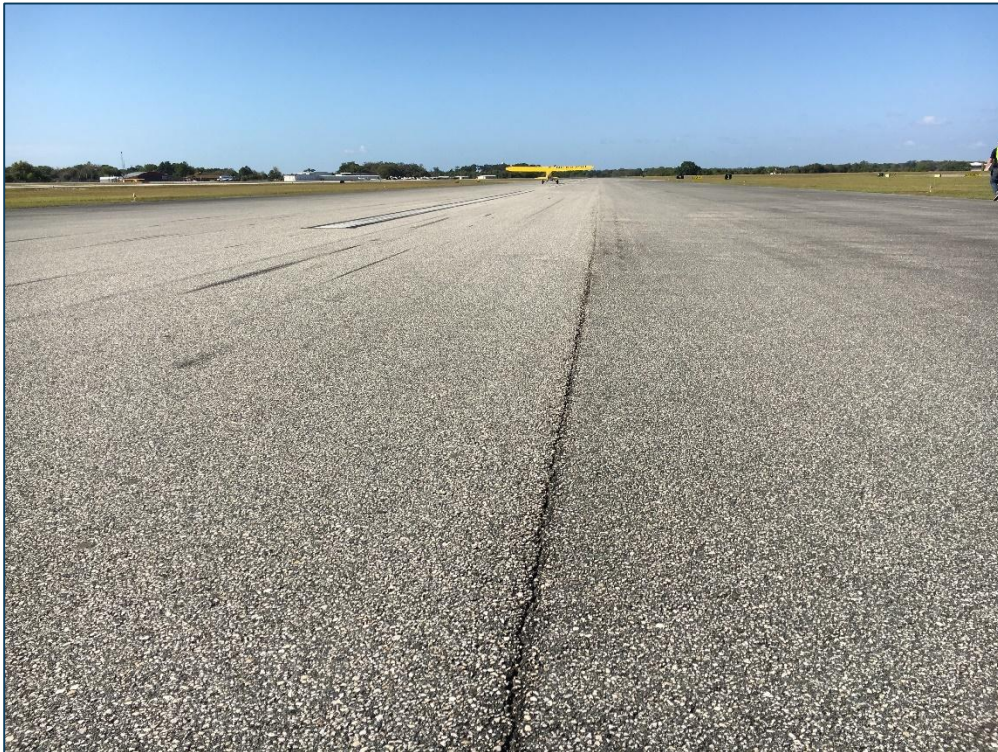
Runway 5-23, Section 6105, Sample Unit 135 – Low Severity (48) Longitudinal and Transverse Cracking, Low Severity (52) Raveling, Low Severity (57) Weathering

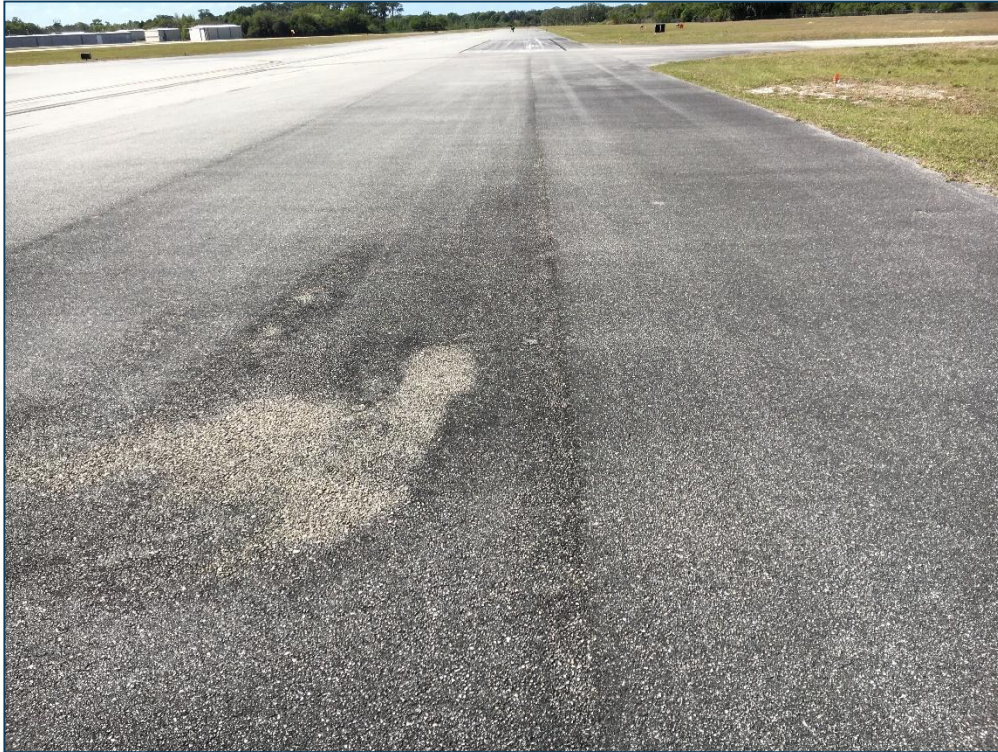
Runway 5-23, Section 6105, Sample Unit 114 – Low Severity (48) Longitudinal and Transverse Cracking, Low Severity (52) Raveling, Low Severity (57) Weathering

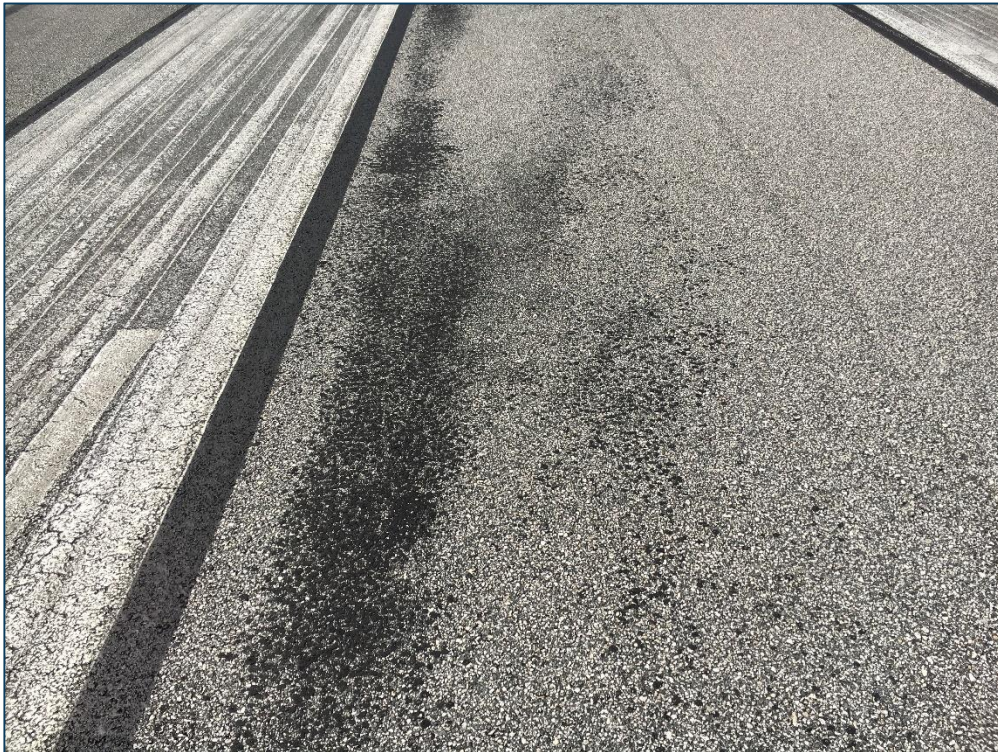
Runway 5-23, Section 6105, Sample Unit 101 – (42) Bleeding, Low Severity (48) Longitudinal and Transverse Cracking, Low Severity (52) Raveling, Low Severity (57) Weathering

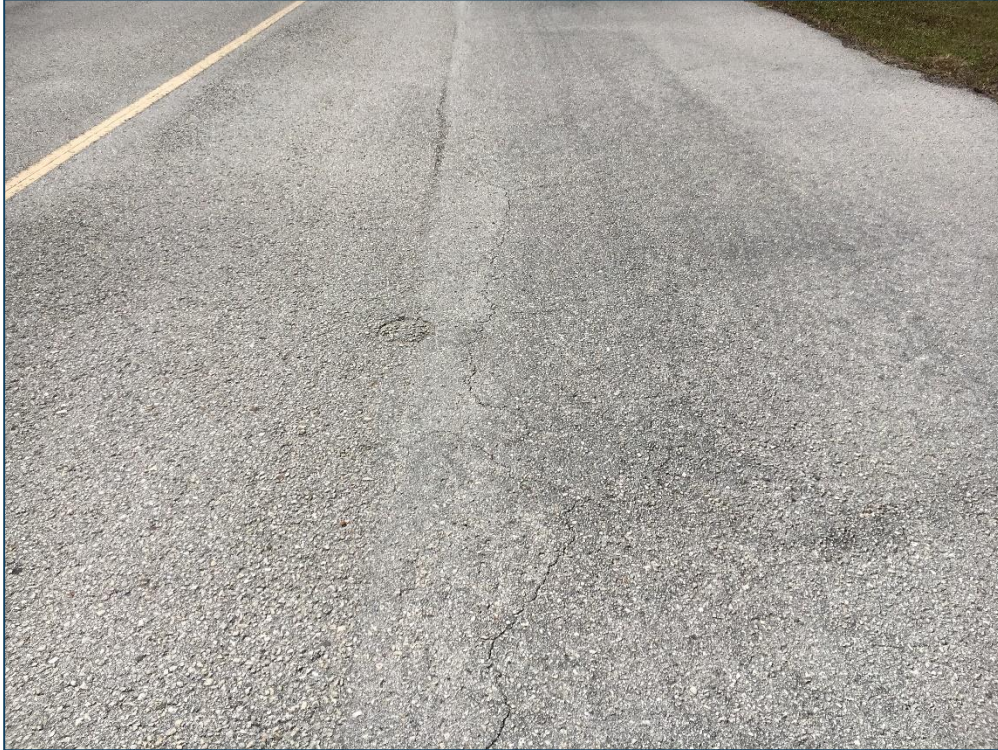
Taxiway B, Section 215, Sample Unit 111 – Low Severity (48) Longitudinal and Transverse Cracking, Medium Severity (52) Raveling, High Severity (52) Raveling

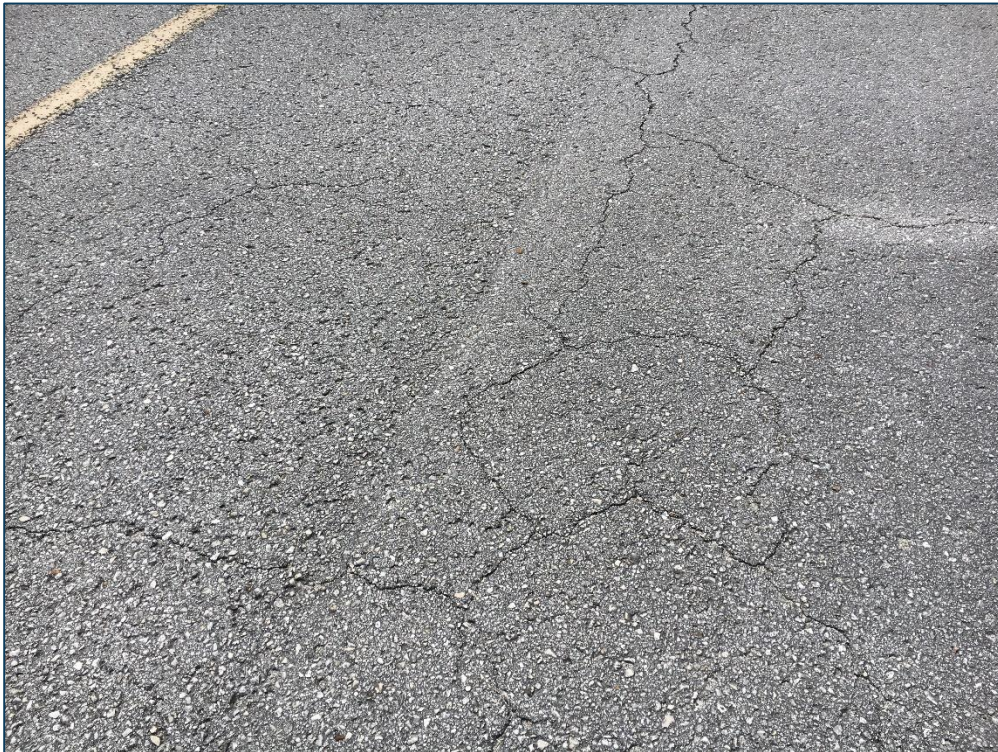
Taxiway B, Section 205, Sample Unit 204 – Low Severity (43) Block Cracking, Low Severity (48) Longitudinal and Transverse Cracking, Low Severity (52) Raveling, Medium Severity (52) Raveling

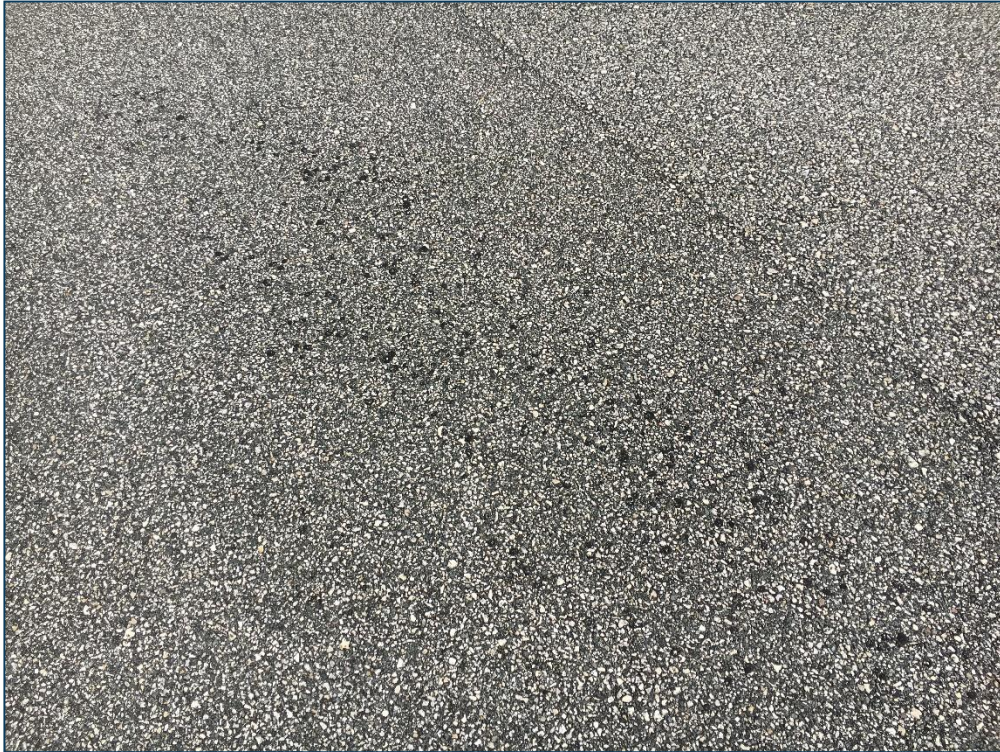
Taxiway B, Section 230, Sample Unit 105 – (42) Bleeding, Low Severity (48) Longitudinal and Transverse Cracking, Low Severity (52) Raveling, Low Severity (57) Weathering

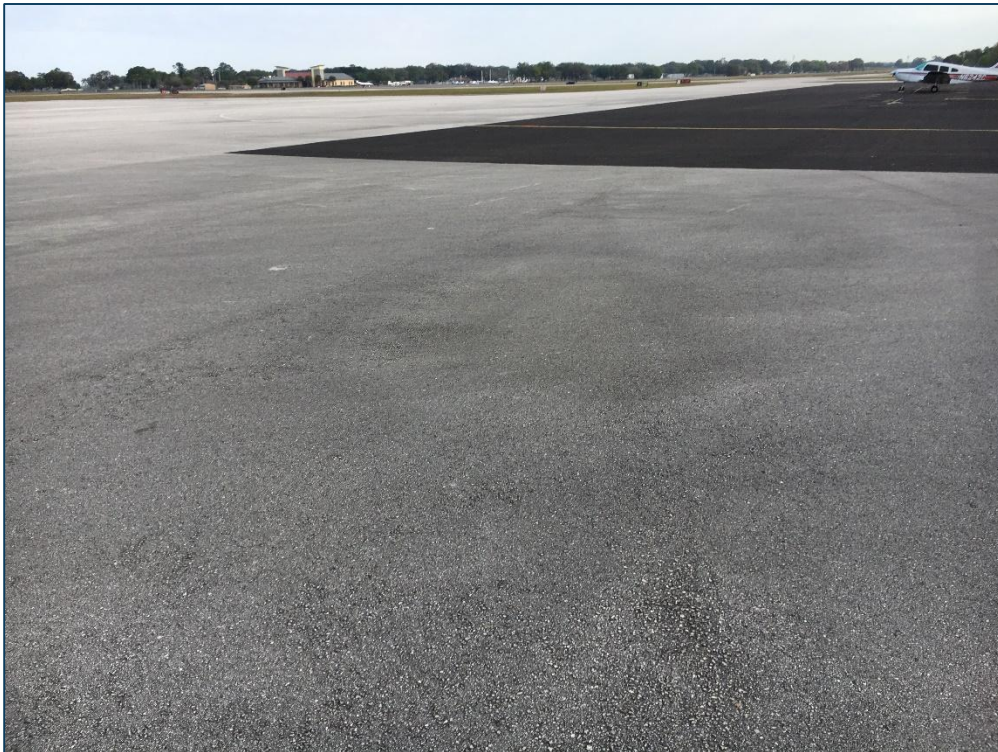
Apron, Section 4110, Sample Unit 255 – (42) Bleeding, Low Severity (45) Depression, Low Severity (48) Longitudinal and Transverse Cracking, Low Severity (52) Raveling, Low Severity (56) Swelling, Low Severity (57) Weathering

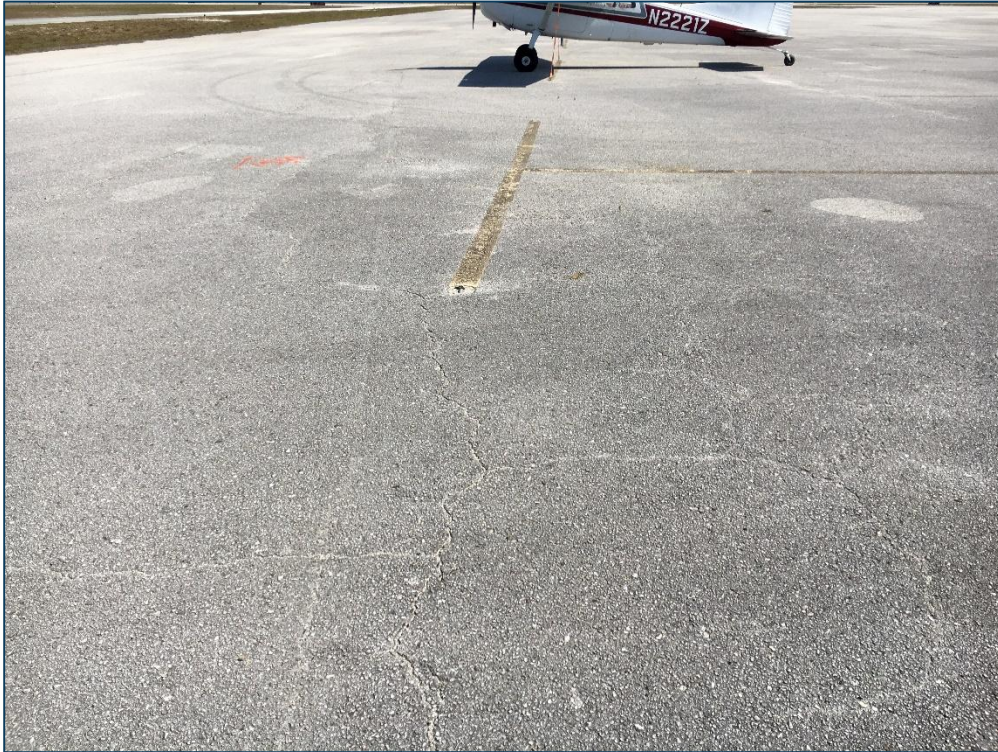
Apron, Section 4105, Sample Unit 154 – Low Severity (43) Block Cracking, Low Severity (48) Longitudinal and Transverse Cracking, Low Severity (52) Raveling, Medium Severity (52) Raveling

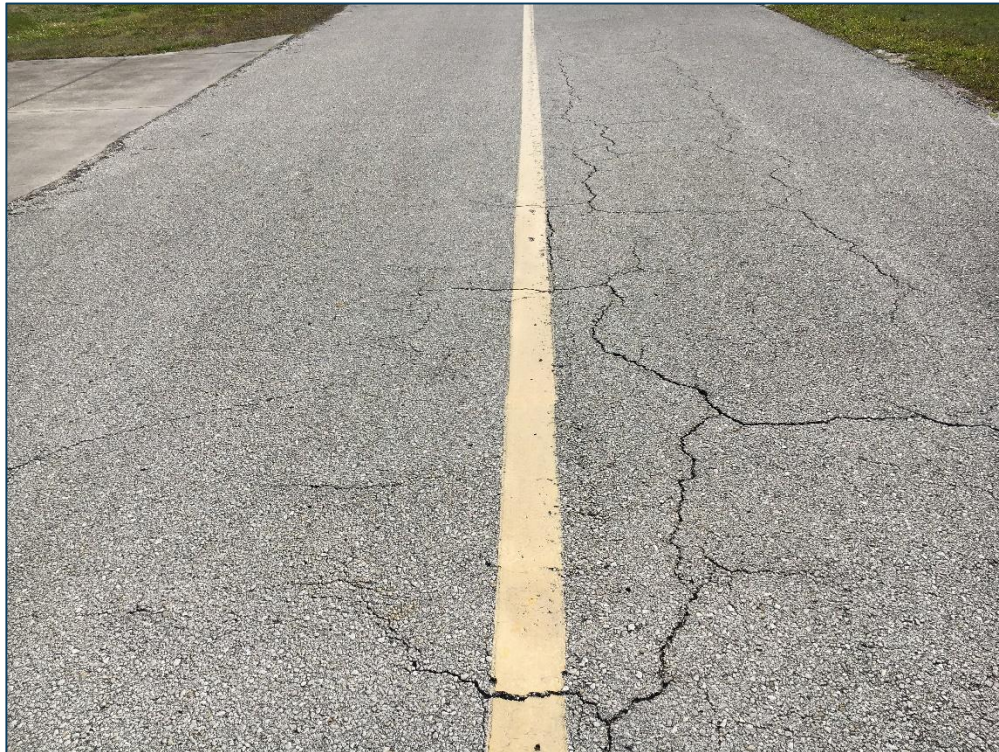
Apron T-Hangars, Section 4205, Sample Unit 454 – Low Severity (43) Block Cracking, Low Severity (48) Longitudinal and Transverse Cracking, Low Severity (52) Raveling, Medium Severity (52) Raveling, Low Severity (54) Shoving, Low Severity (56) Swelling

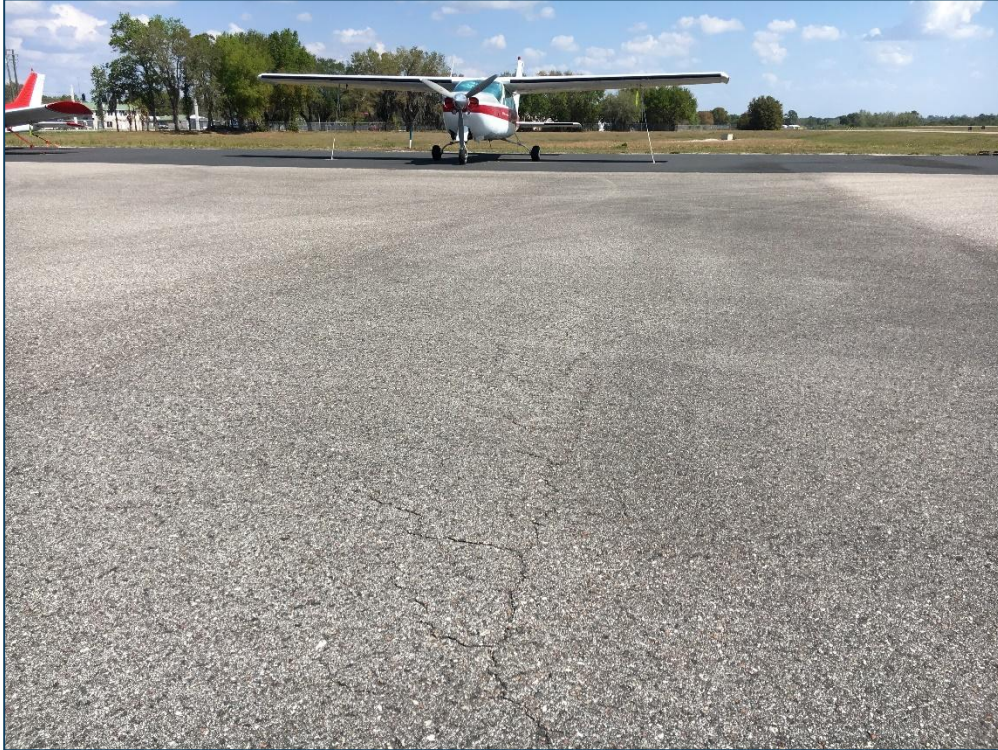
Apron North, Section 4505, Sample Unit 305 – Low Severity (48) Longitudinal and Transverse Cracking, Low Severity (52) Raveling, Low Severity (57) Weathering

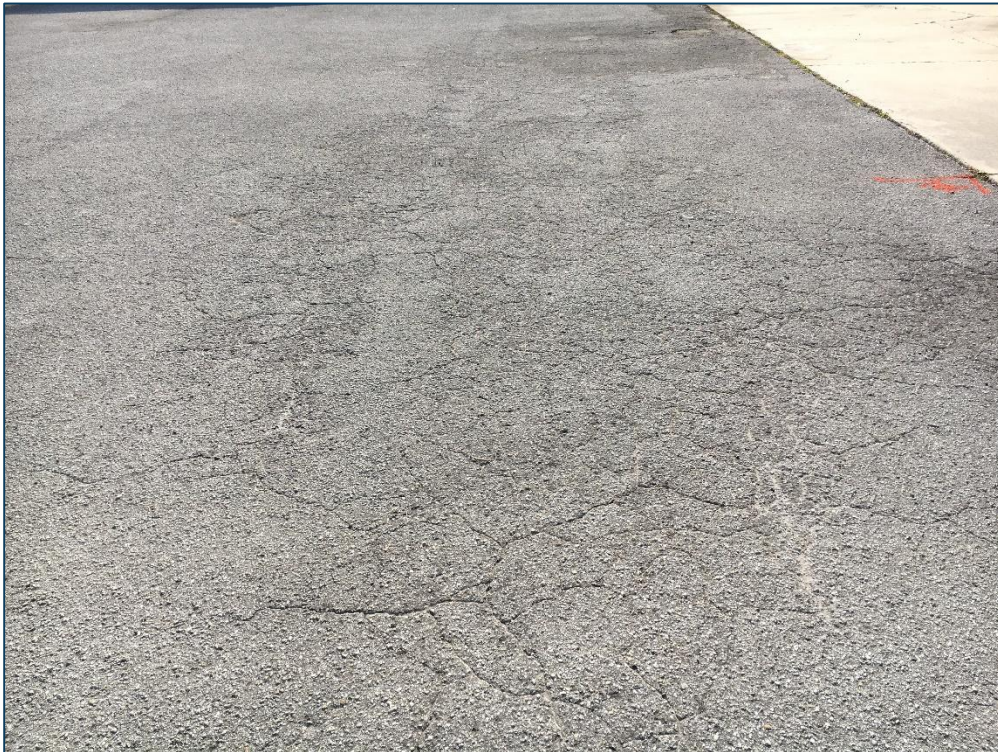
Apron, Section 4125, Sample Unit 101 – Low Severity (41) Alligator Cracking, Medium Severity (41) Alligator Cracking, Medium Severity (52) Raveling, High Severity (52) Raveling

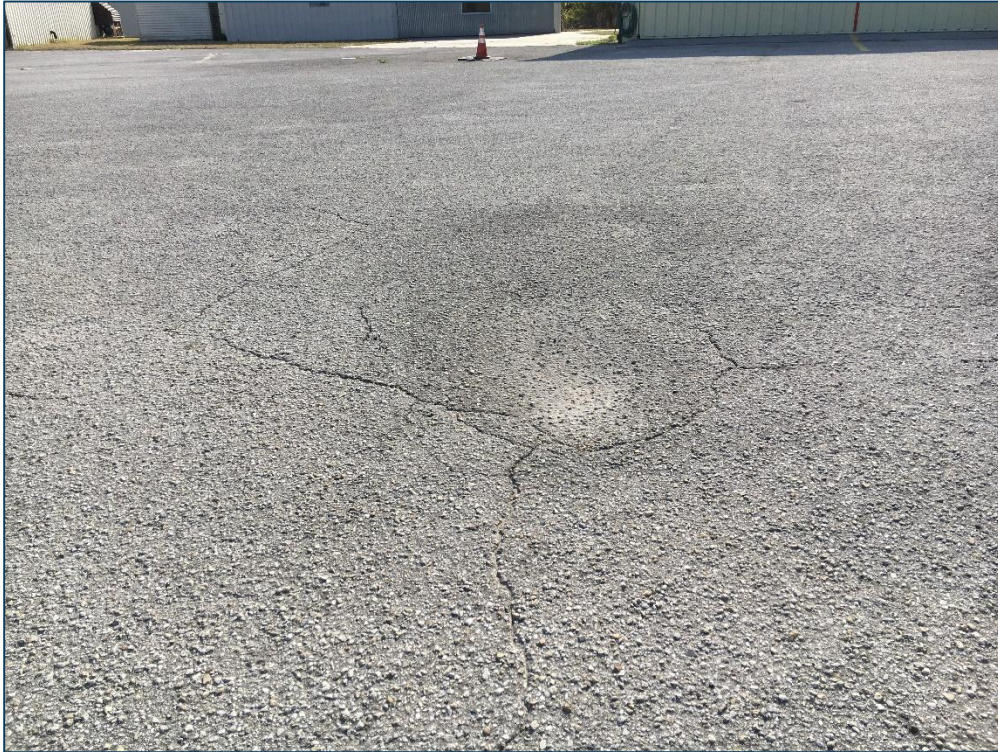
Apron, Section 4125, Sample Unit 101 – Low Severity (45) Depression, Medium Severity (45) Depression, Low Severity (48)
Longitudinal and Transverse Cracking
