FLORIDA DEPARTMENT OF TRANSPORTATION AVIATION AND SPACEPORTS OFFICE

Statewide Airfield Pavement Management Program

Airport Pavement Evaluation Report September 2017

Immokalee Regional Airport (IMM) General Aviation Airport District 1

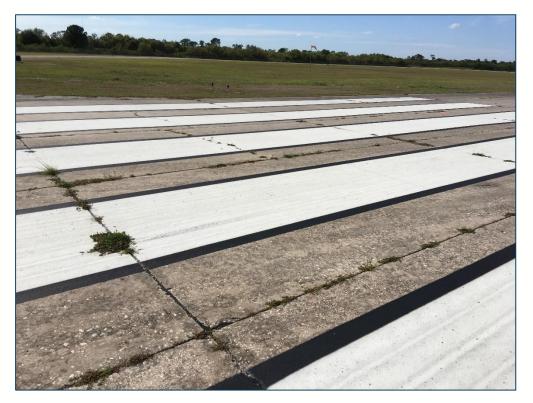
Runway 18-36, Section 6105, Sample Unit 301 – Medium Severity (63) Longitudinal, Transverse, and Diagonal Cracking, Medium Severity (65) Joint Seal Damage, Low Severity (74) Joint Spalling

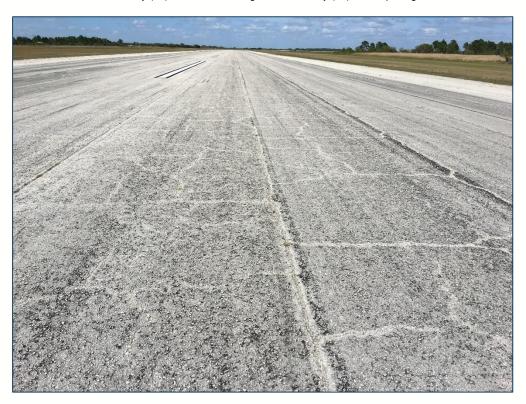
Runway 18-36, Section 6115, Sample Unit 324 – Medium Severity (43) Block Cracking, Low and Medium Severity (48) Longitudinal and Transverse Cracking, Medium Severity (52) Raveling

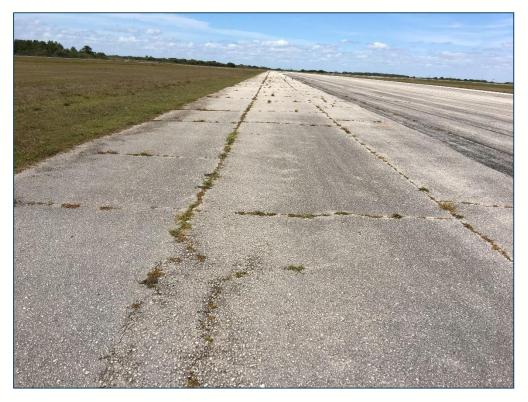
Runway 18-36, Section 6120, Sample Unit 150 – Low Severity (43) Block Cracking, Medium Severity (43) Block Cracking, Medium Severity (52) Raveling

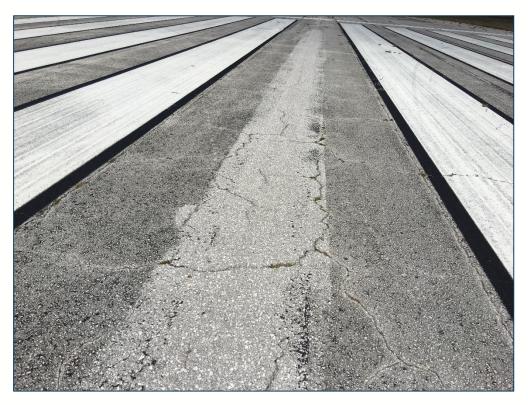
Runway 18-36, Section 6115, Sample Unit 383 – Medium Severity (43) Block Cracking, Low Severity (48) Longitudinal and Transverse Cracking, Medium Severity (52) Raveling

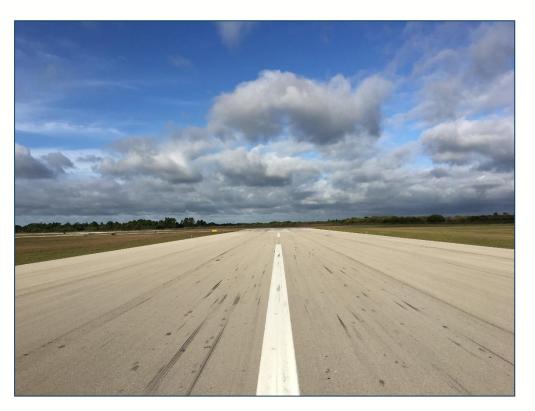
Runway 9-27, Section 6235, Sample Unit 312 - Low Severity (57) Weathering

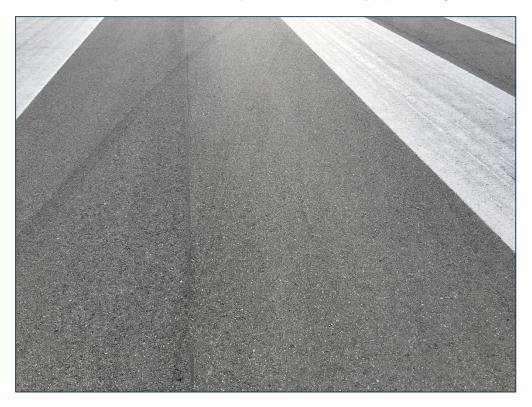
Runway 9-27, Section 6235, Sample Unit 397 - Low Severity (57) Weathering

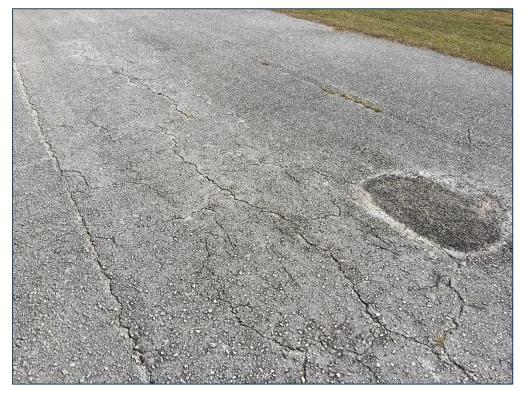
Taxiway A, Section 205, Sample Unit 103 – Low Severity (43) Block Cracking, Medium Severity (43) Block Cracking, High Severity (50) Patching, Medium Severity (52) Raveling

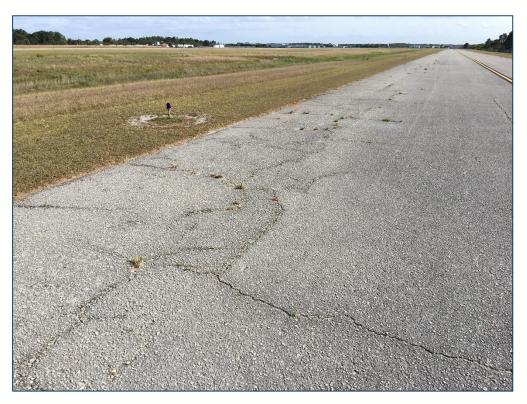
Taxiway A, Section 205, Sample Unit 133 – Low Severity (43) Block Cracking, Medium Severity (43) Block Cracking, Medium Severity (48) Longitudinal and Transverse Cracking, Medium Severity (52) Raveling

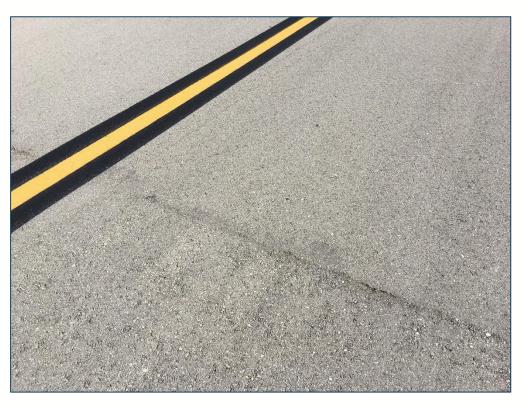
Taxiway A, Section 207, Sample Unit 145 - Low Severity (57) Weathering

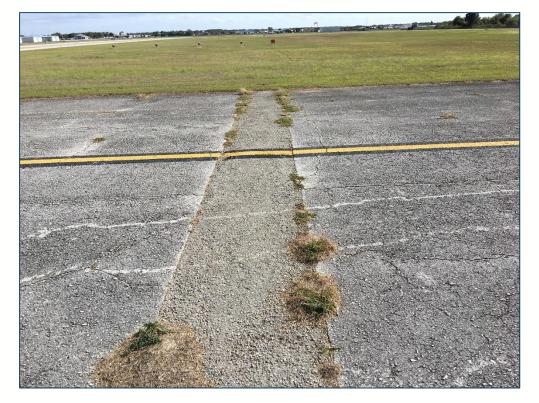
Taxiway A1, Section 210, Sample Unit 201– Low Severity (43) Block Cracking, High Severity (50) Patching, Medium Severity (52) Raveling

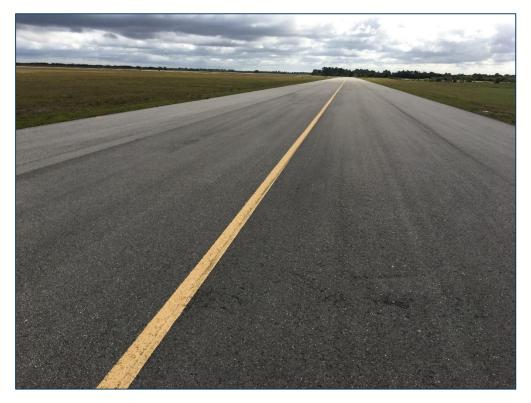
Taxiway B, Section 105, Sample Unit 105 - Low Severity (57) Weathering

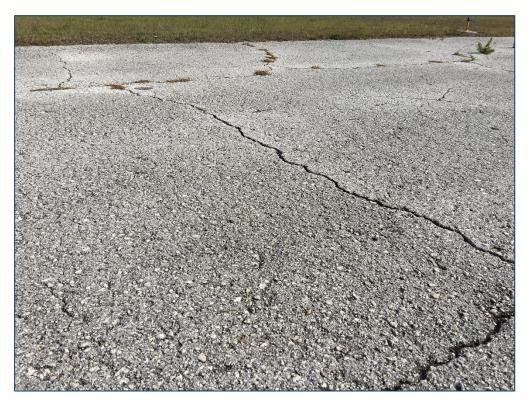
Taxiway B, Section 110, Sample Unit 117 – Low Severity (43) Block Cracking, Medium Severity (43) Block Cracking, Low Severity (48) Longitudinal and Transverse Cracking, Medium Severity (52) Raveling

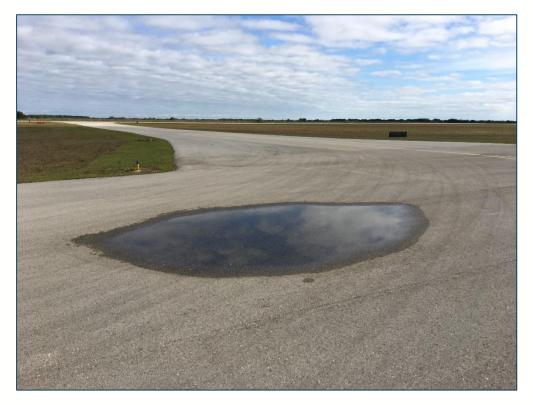
Taxiway B, Section 110, Sample Unit 119 – Depression. Sample Unit not inspected.

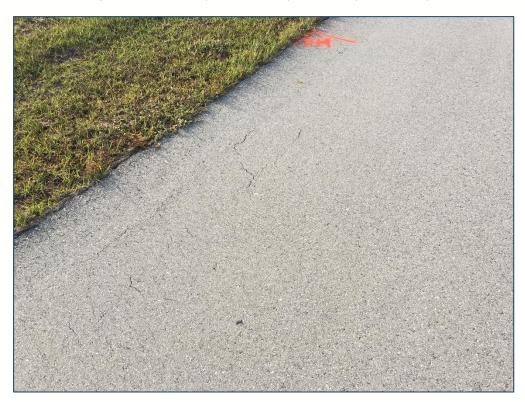
Taxiway B, Section 125, Sample Unit 149 - Low Severity (48) Longitudinal and Transverse Cracking, Low Severity (57) Weathering

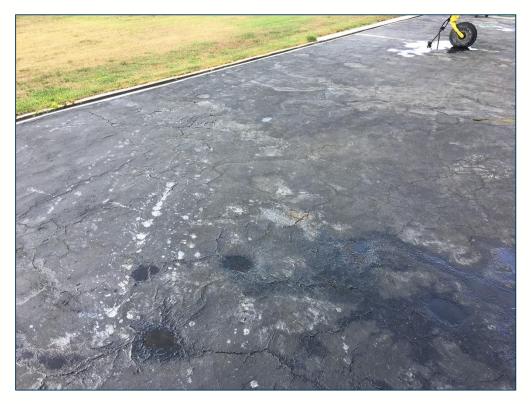
Crop Apron, Section 4105, Sample Unit 201 – Low Severity (43) Block Cracking, Low Severity (45) Depression, Low Severity (56) Swelling

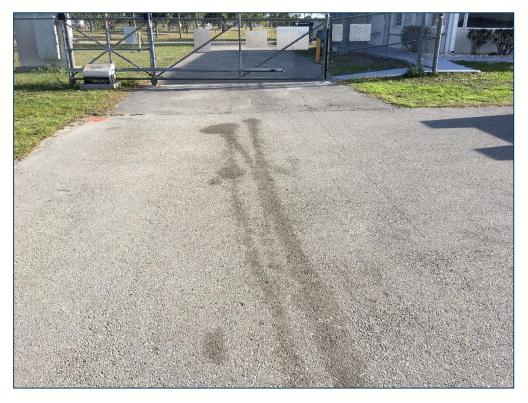
South Apron, Section 4205, Sample Unit 300 – Low Severity (48) Longitudinal and Transverse Cracking, (49) Oil Spillage, Low Severity (52) Raveling, Low Severity (57) Weathering

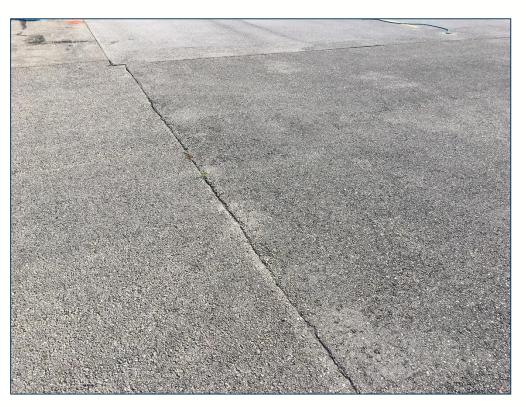
South Apron, Section 4210, Sample Unit 104 – Low Severity (48) Longitudinal and Transverse Cracking, Low Severity (50) Patching, Low Severity (52) Raveling, Low Severity (57) Weathering

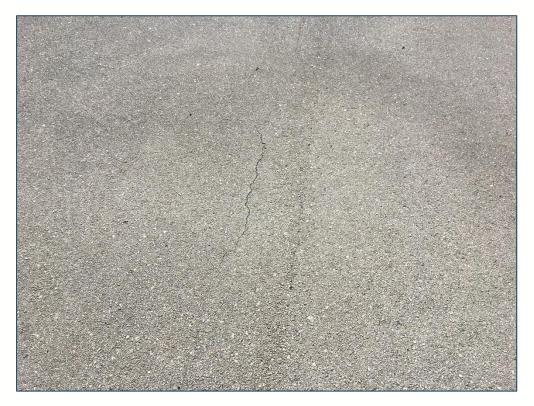
Apron to Hangars, Section 4405, Sample Unit 200 – Low Severity (48) Longitudinal and Transverse Cracking, Low Severity (52) Raveling, Low Severity (57) Weathering
