Statewide Airfield Pavement Management Program

Airport Pavement Evaluation Report September 2017

Inverness Airport (INF) General Aviation Airport District 7

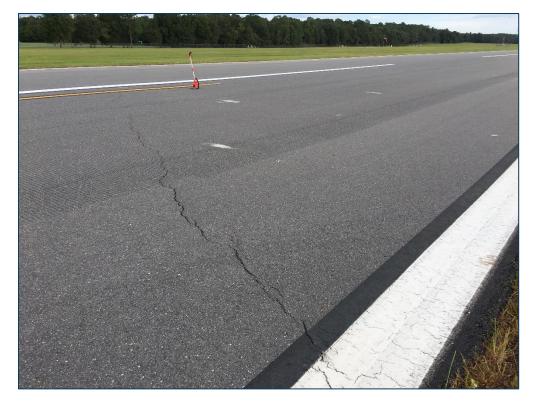
Runway 1-19, Section 6105, Sample Unit 131 – Low Severity (48) Longitudinal and Transverse Cracking, Low Severity (57) Weathering

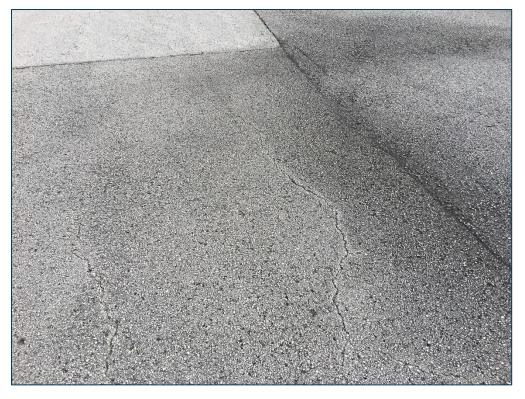
Taxilane to GA Apron, Section 205, Sample Unit 401 – Low Severity (48) Longitudinal and Transverse Cracking, Low Severity (52) Raveling

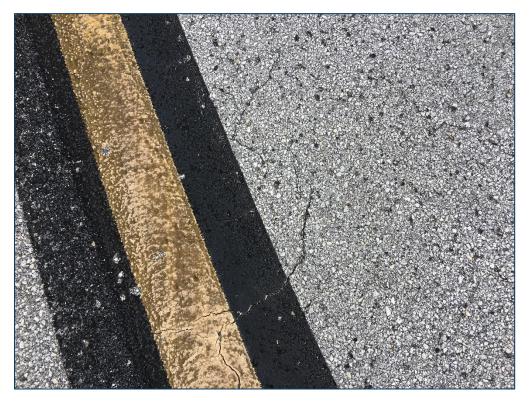
Taxilane to GA Apron, Section 205, Sample Unit 407 – Low Severity (48) Longitudinal and Transverse Cracking, Low Severity (52) Raveling

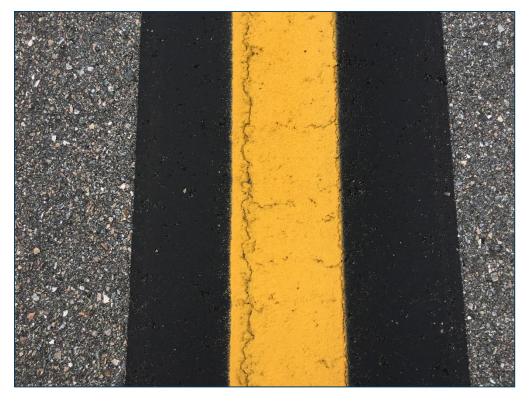
Taxiway A, Section 105, Sample Unit 127 – Low Severity (48) Longitudinal and Transverse Cracking, Low Severity (57) Weathering

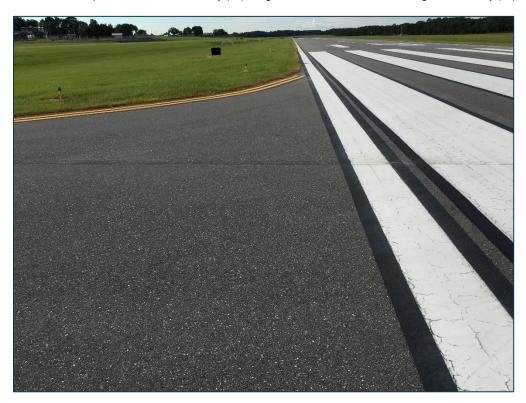
Taxiway A, Section 130, Sample Unit 500 - Low Severity (48) Longitudinal and Transverse Cracking, Low Severity (57) Weathering

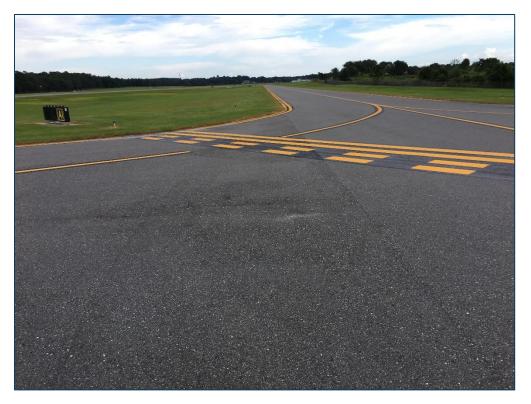
Taxiway A1, Section 115, Sample Unit 201 - Low Severity (45) Depression, Low Severity (57) Weathering

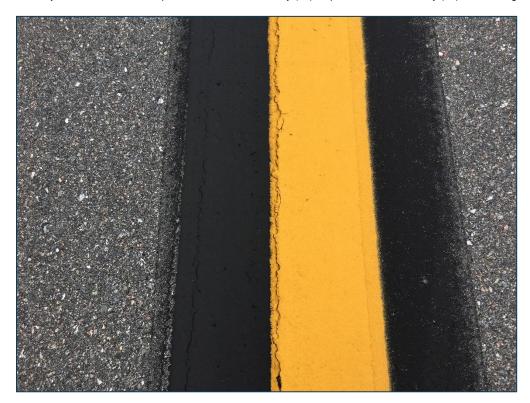
Taxiway A2, Section 120, Sample Unit 300 - Low Severity (48) Longitudinal and Transverse Cracking, Low Severity (57) Weathering

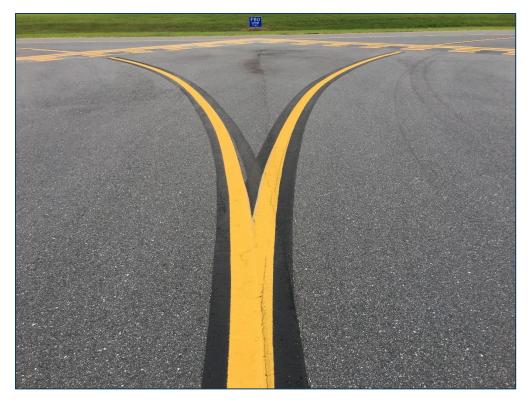
Taxiway A3, Section 125, Sample Unit 401 - Low Severity (57) Weathering

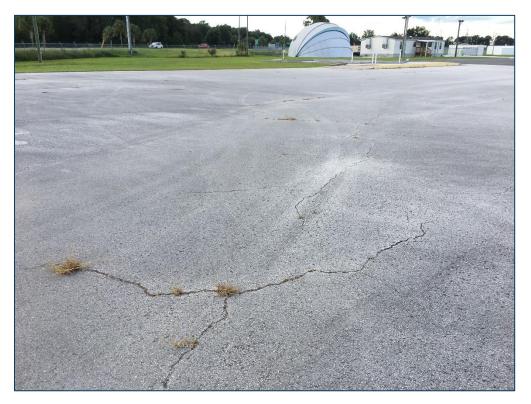
Apron GA, Section 4005, Sample Unit 604 – Low and Medium Severity (48) Longitudinal and Transverse Cracking, Low Severity (52) Raveling, Medium Severity (52) Raveling

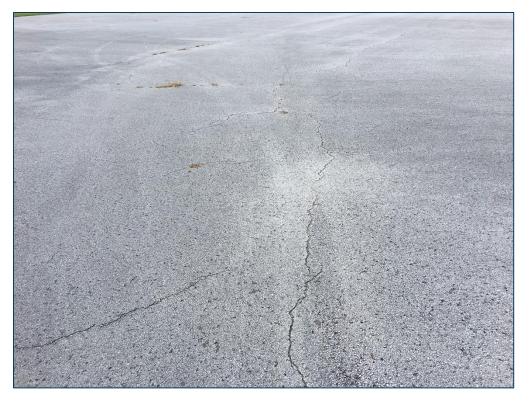
Apron GA, Section 4005, Sample Unit 604 – Low and Medium Severity (48) Longitudinal and Transverse Cracking, Low Severity (52) Raveling, Medium Severity (52) Raveling

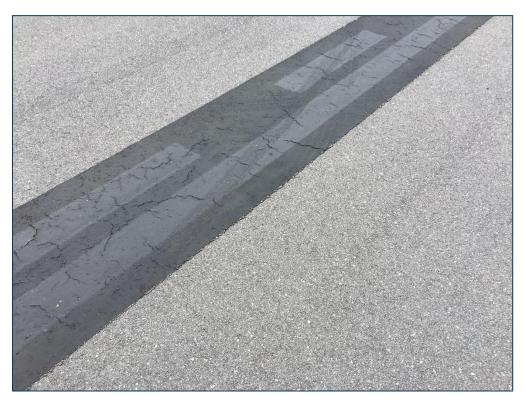
Apron FBO, Section 4210, Sample Unit 403 – Low Severity (48) Longitudinal and Transverse Cracking, Low Severity (57) Weathering
