Florida Department of Transportation

Statewide Airfield Pavement Management Program

Summary of Lake City Gateway Airport

Lake City Gateway Airport was inspected in February 2017 – the overall weighted PCI value was 67, a condition rating of Fair. The results of the maintenance, repair, and major rehabilitation analysis identified \$1,445,970 in localized M&R needs based on current conditions and a 10-Year major rehabilitation need of \$20,389,000 based on forecasted conditions. The current major rehabilitation needs based on the latest inspection consist of \$17,527,000 for pavements below critical condition.

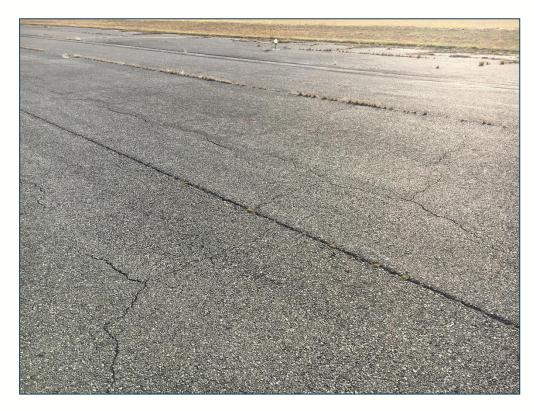
Runway 5-23, Section 6205, Sample Unit 122 - Low Severity (43) Block Cracking, Low and Medium Severity (48) Longitudinal and Transverse Cracking, Low Severity (52) Raveling, Low Severity (53) Rutting

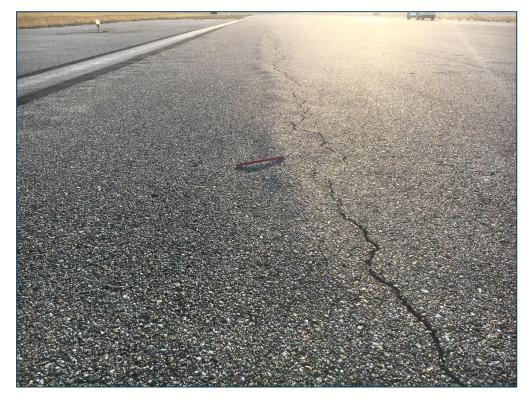
Runway 5-23, Section 6207, Sample Unit 155 - Low and Medium Severity (48) Longitudinal and Transverse Cracking, Low Severity (56) Swelling, Low Severity (57) Weathering

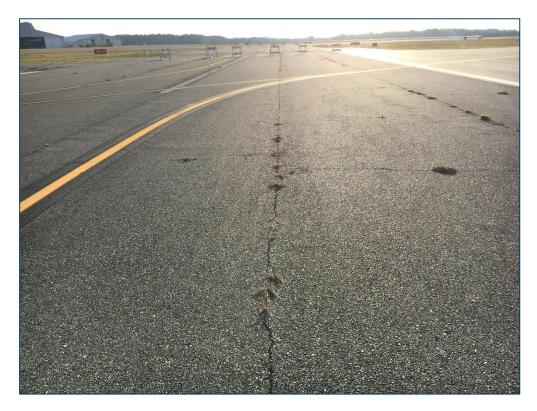
Runway 5-23, Section 6209, Sample Unit 160 - Low and Medium Severity (48) Longitudinal and Transverse Cracking, Low Severity (56) Swelling, Low Severity (57) Weathering

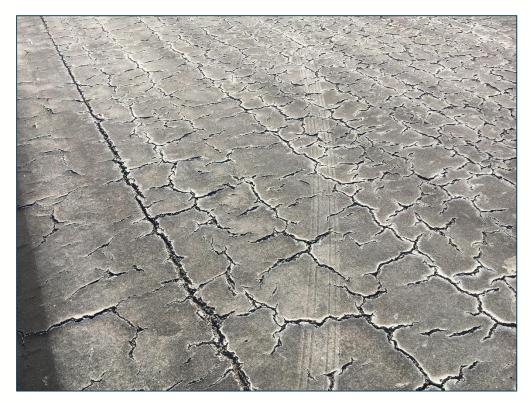
Runway 10-28, Section 6105, Sample Unit 321 - Low and Medium Severity (48) Longitudinal and Transverse Cracking, High Severity (52) Raveling

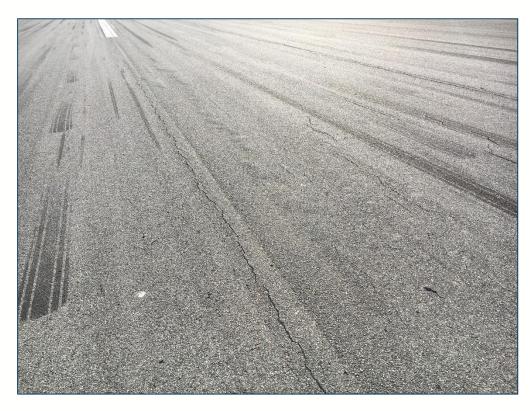
Runway 10-28, Section 6105, Sample Unit 321 - Low and Medium Severity (48) Longitudinal and Transverse Cracking, Low Severity (56) Swelling

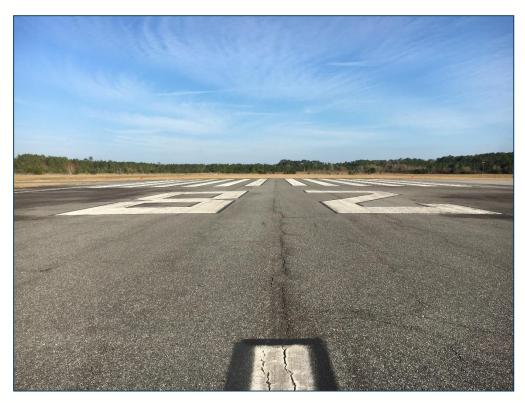
Runway 10-28, Section 6115, Sample Unit 453 – Low and Medium Severity (48) Longitudinal and Transverse Cracking, Low Severity (52) Raveling

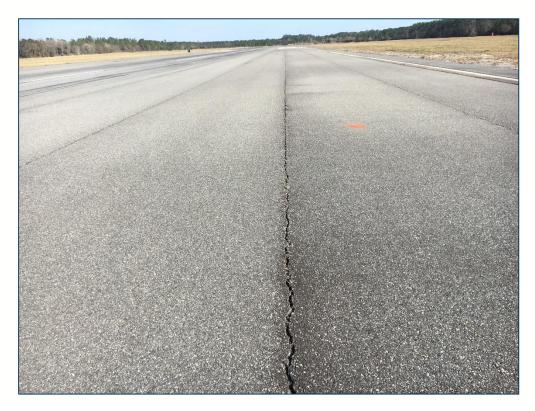
Runway 10-28, Section 6114, Sample Unit 423 - Low and Medium Severity (48) Longitudinal and Transverse Cracking, Low Severity (52) Raveling

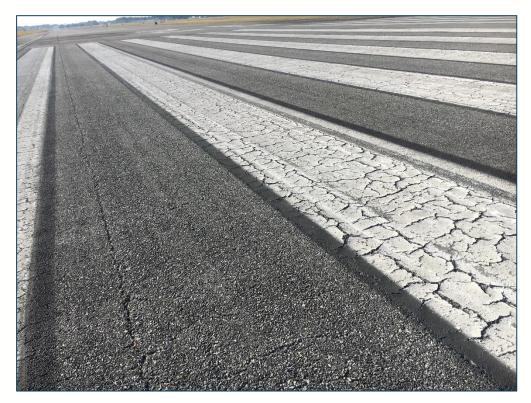
Runway 10-28, Section 6120, Sample Unit 656 – Low and Medium Severity (48) Longitudinal and Transverse Cracking, Low Severity (52) Raveling

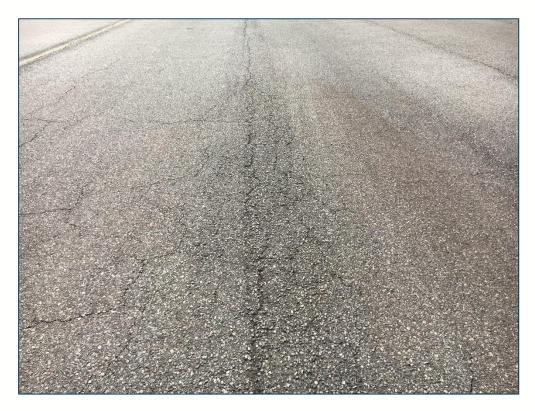
Taxiway D, Section 405, Sample Unit 100 – Low Severity (41) Alligator Cracking, Low Severity (43) Block Cracking, Low and Medium Severity (48) Longitudinal and Transverse Cracking, Low Severity (52) Raveling, Low Severity (53) Rutting

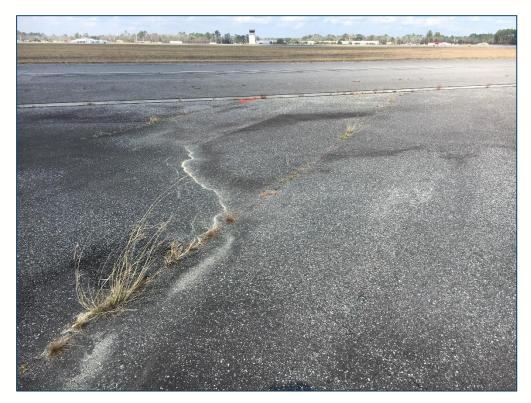
Taxiway D, Section 410, Sample Unit 201 - Low and Medium Severity (48) Longitudinal and Transverse Cracking, Low Severity (52) Raveling

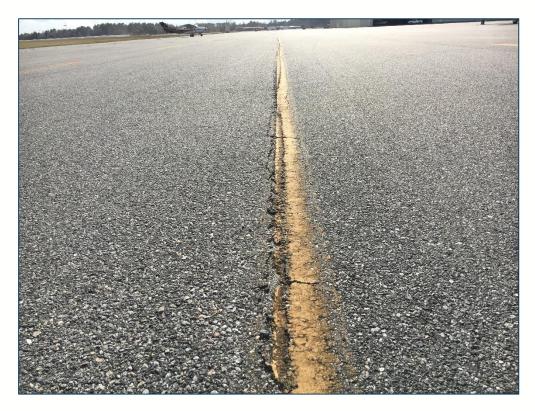
Taxiway C, Section 310, Sample Unit 116 - Low and Medium Severity (48) Longitudinal and Transverse Cracking, Low Severity (52) Raveling, Low Severity (57) Weathering

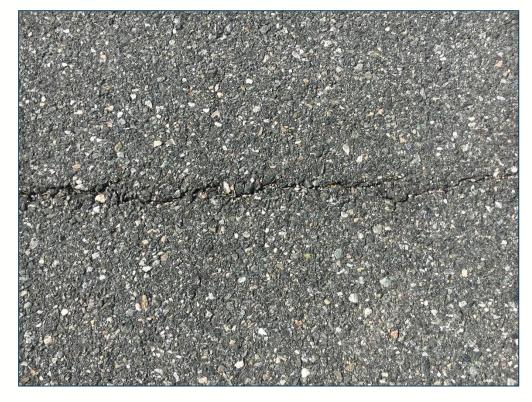
Taxiway A1, Section 140, Sample Unit 708 - Low Severity (48) Longitudinal and Transverse Cracking, Low Severity (52) Raveling, Low Severity (57) Weathering

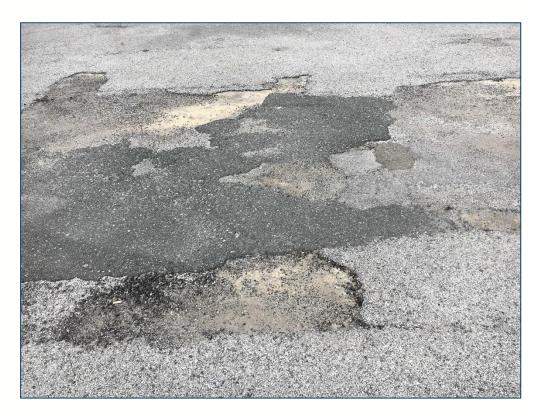
East Apron, Section 4228, Sample Unit 101 - Medium Severity (45) Depression, High Severity (50) Patching, High Severity (52) Raveling

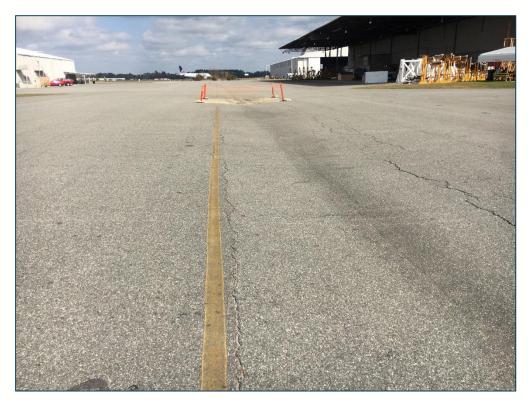
East Apron, Section 4205, Sample Unit 111 - High Severity (45) Depression, Low and Medium Severity (48) Longitudinal and Transverse Cracking, Low Severity (52) Raveling

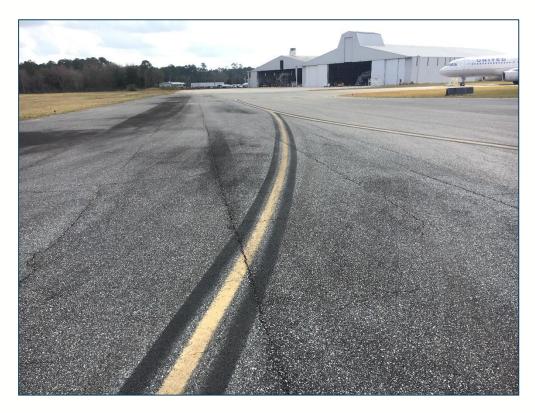
East Apron, Section 4215, Sample Unit 401 – Low and Medium Severity (48) Longitudinal and Transverse Cracking, Low Severity (52) Raveling, Medium Severity (52) Raveling

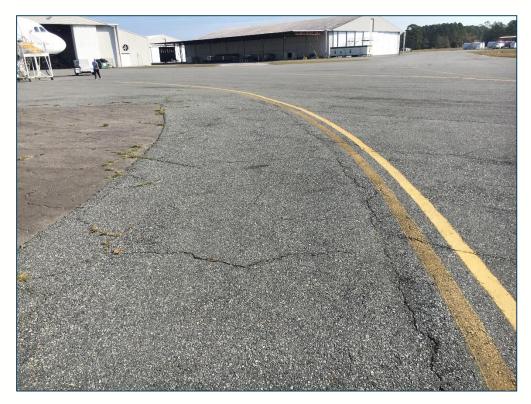
East Apron, Section 4230, Sample Unit 204 - Medium Severity (43) Block Cracking, Low and Medium Severity (48) Longitudinal and Transverse Cracking, Low Severity (52) Raveling

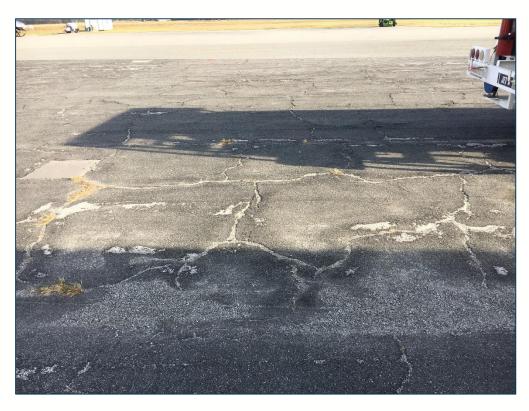
Apron NW, Section 4110, Sample Unit 100 - Medium Severity (43) Block Cracking and Low and Medium Severity (48) Longitudinal and Transverse Cracking, Low Severity (45) Depression, Low Severity (52) Raveling

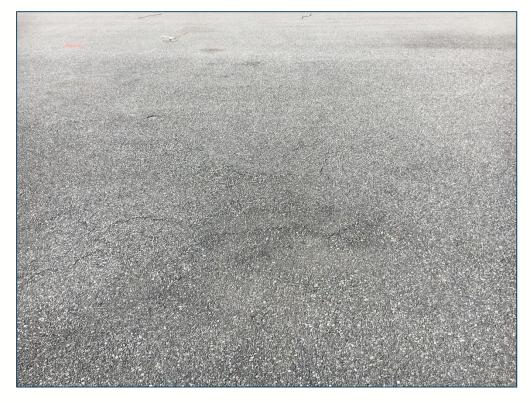
Apron NW, Section 4105, Sample Unit 813 - Low and Medium Severity (48) Longitudinal and Transverse Cracking, Low Severity (52) Raveling, Low Severity (56) Swelling, Low Severity (57) Weathering.

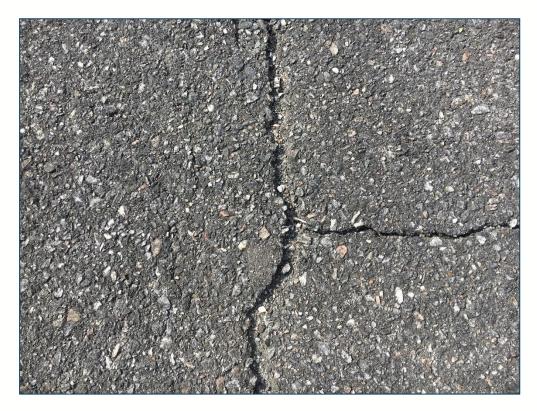
Apron RW 10-28, Section 5125, Sample Unit 202 - Low and Medium Severity (48) Longitudinal and Transverse Cracking, Low Severity (57) Weathering.

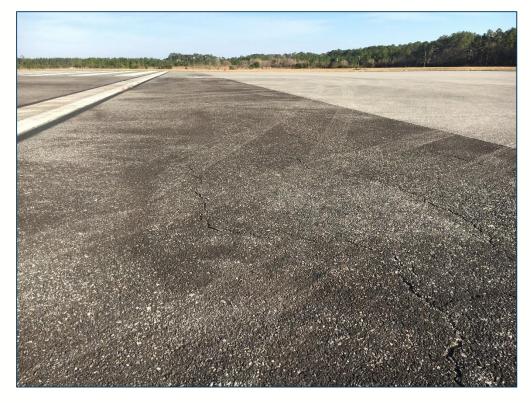
Apron RW 10-28, Section 5115, Sample Unit 105 - Low Severity (48) Longitudinal and Transverse Cracking, Low Severity (56) Swelling, Low Severity (57) Weathering.

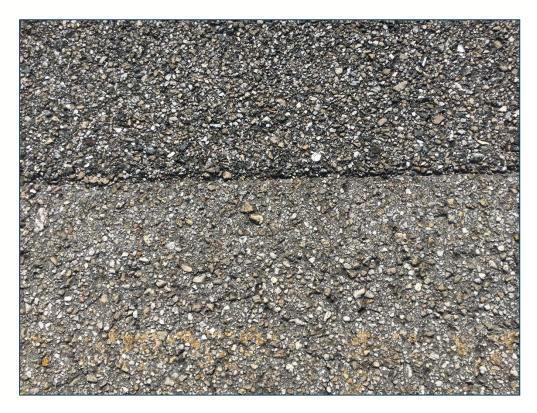
Taxilane T-Hang NW, Section 4125, Sample Unit 102 - Low Severity (48) Longitudinal and Transverse Cracking, Low Severity (52) Raveling, Medium Severity (52) Raveling

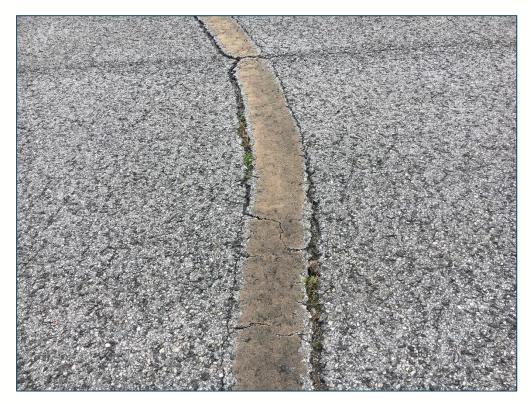
Taxilane to T-Hang NW, Section 4115, Sample Unit 101 - Low and Medium Severity (48) Longitudinal and Transverse Cracking, Low Severity (52) Raveling, Medium Severity (52) Raveling.

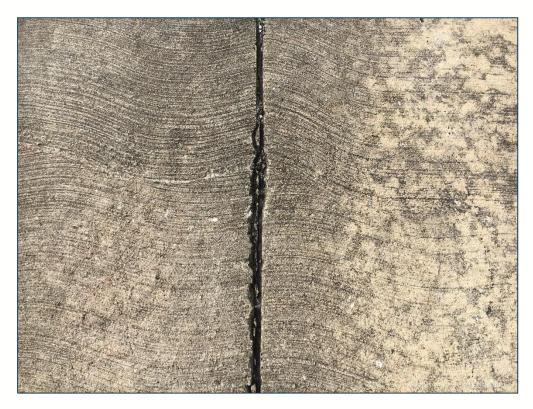
Apron SW, Section 5135, Sample Unit 101 – Medium Severity (65) Joint Seal Damage, (73) Shrinkage Cracks.
