Statewide Airfield Pavement Management Program

**Airport Pavement
Evaluation Report
September 2017**

Marianna
Municipal Airport (MAI)
General Aviation Airport
District 3

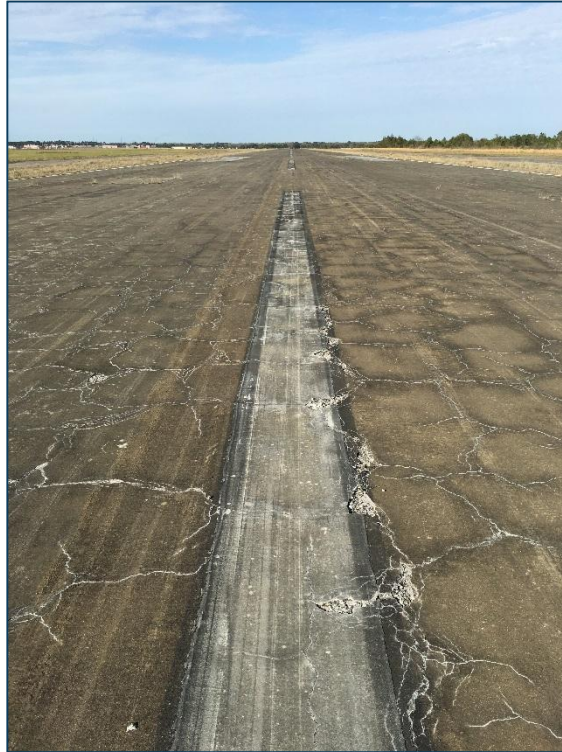
Runway 8-26, Section 6105, Sample Unit 315 – Low Severity (43) Block Cracking, Medium Severity (43) Block Cracking, Low Severity (52) Raveling, High Severity (52) Raveling

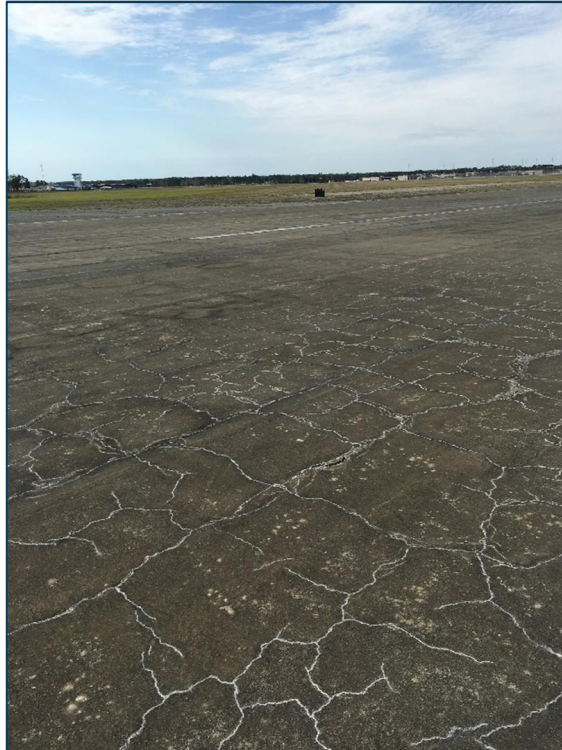
Runway 8-26, Section 6105, Sample Unit 359 – Low Severity (43) Block Cracking, Medium Severity (43) Block Cracking, Low Severity (52) Raveling, High Severity (52) Raveling

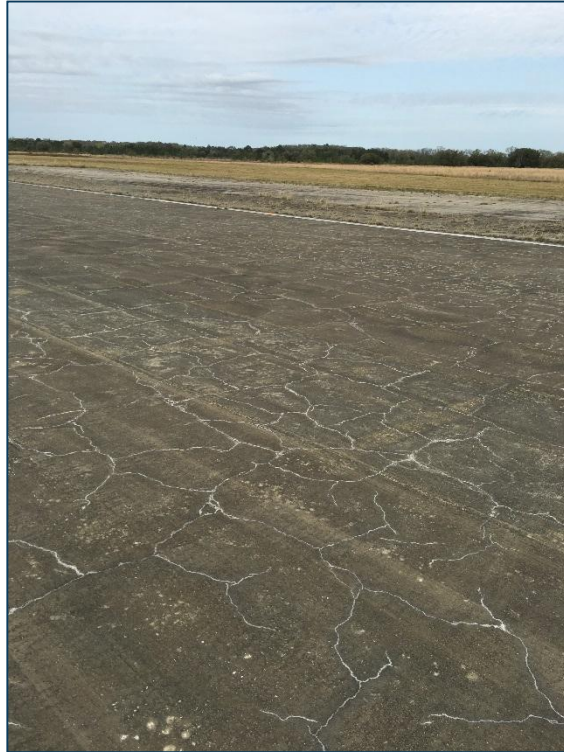
Runway 8-26, Section 6105, Sample Unit 388 – Low Severity (43) Block Cracking, Medium Severity (43) Block Cracking, Low Severity (52) Raveling

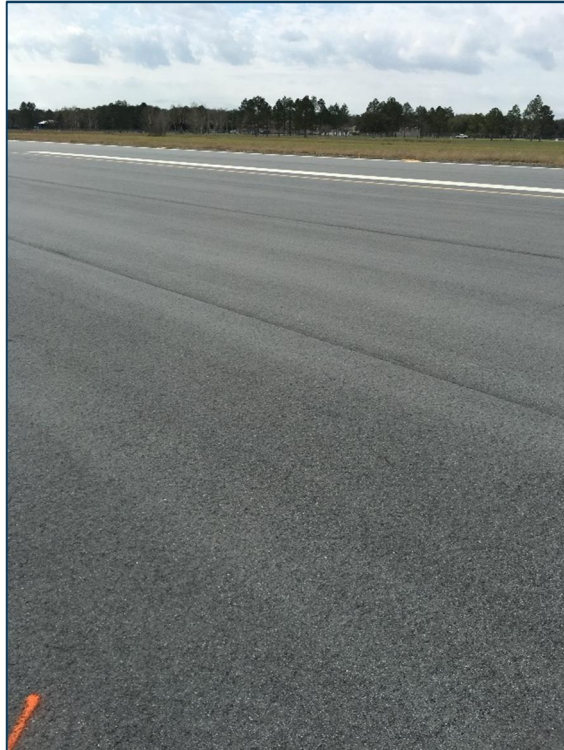
Runway 18-36, Section 6205, Sample Unit 135 – No Distress

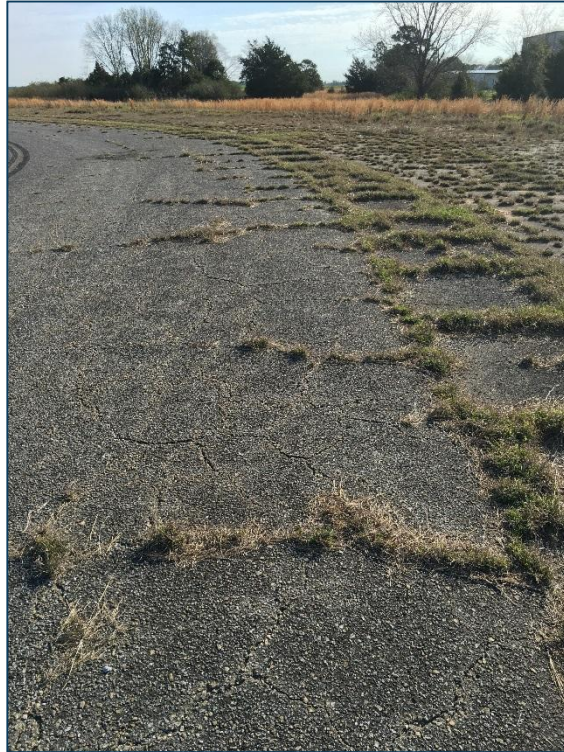
Taxiway G, Section 105, Sample Unit 105 – Medium Severity (43) Block Cracking, Medium Severity (52) Raveling, High Severity (52) Raveling

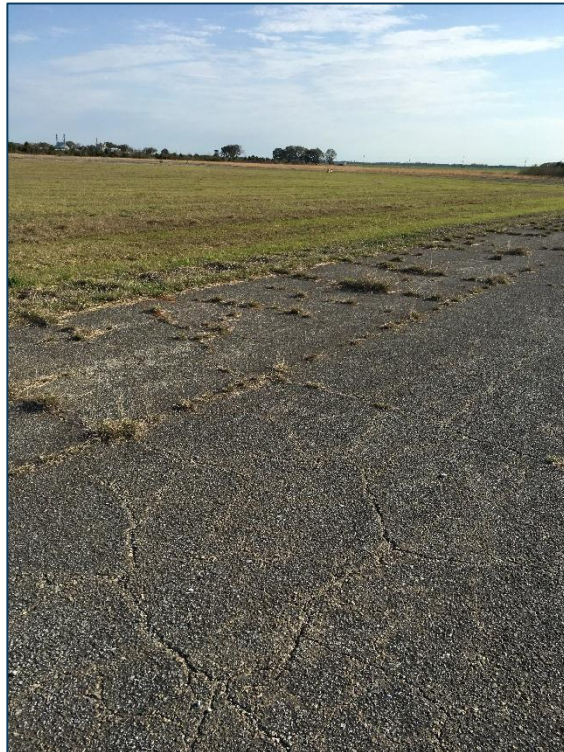
Taxiway G, Section 105, Sample Unit 107 – Medium Severity (43) Block Cracking, Medium Severity (52) Raveling, High Severity (52) Raveling

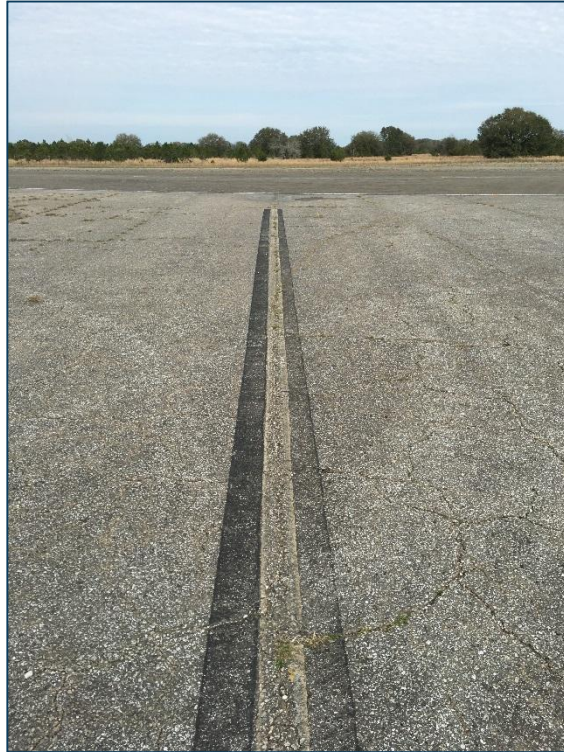
Taxiway F, Section 305, Sample Unit 100 – Medium Severity (43) Block Cracking, Medium Severity (52) Raveling, High Severity (52) Raveling

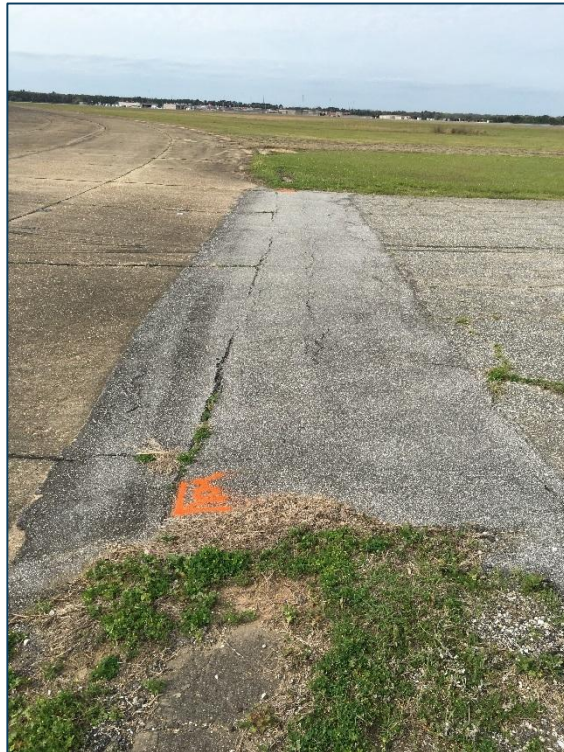
Taxiway F, Section 305, Sample Unit 104 – Medium Severity (43) Block Cracking, Medium Severity (50) Patching, Medium Severity (52) Raveling

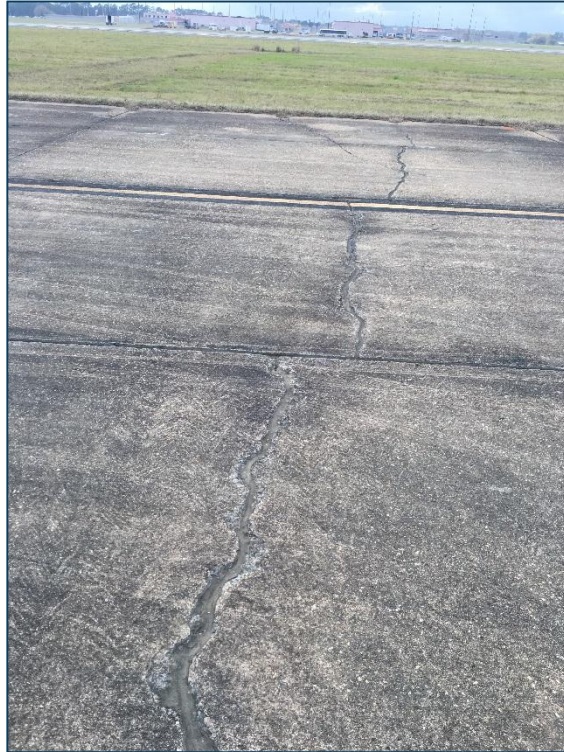
Taxiway Parallel, Section 150, Sample Unit 154 – Low Severity (63) Longitudinal, Transverse, and Diagonal Cracking, Medium Severity (65) Joint Seal Damage

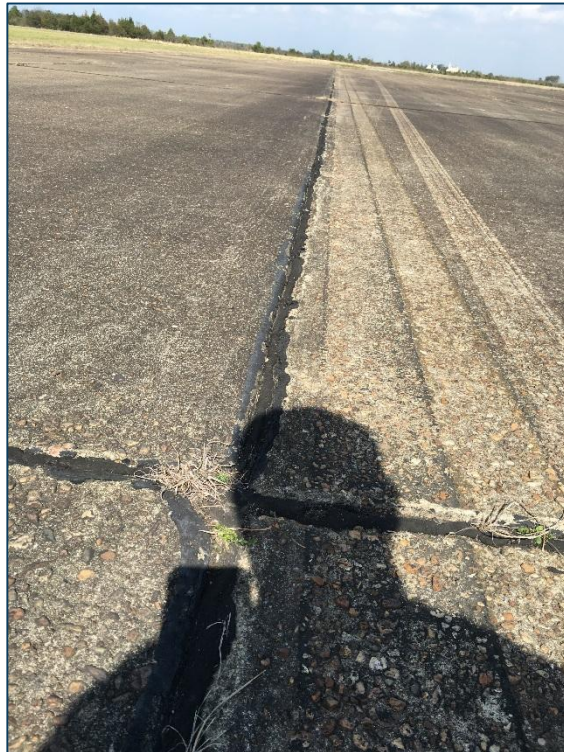
Taxiway Parallel, Section 150, Sample Unit 133 – Medium Severity (65) Joint Seal Damage, Low Severity (71) Faulting

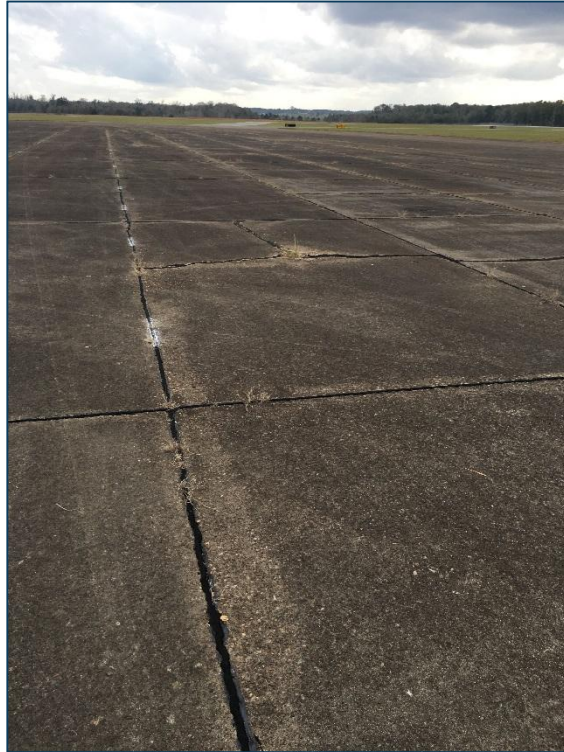
Apron, Section 4105, Sample Unit 246 – Low Severity (63) Longitudinal, Transverse, and Diagonal Cracking, Medium Severity (65) Joint Seal Damage

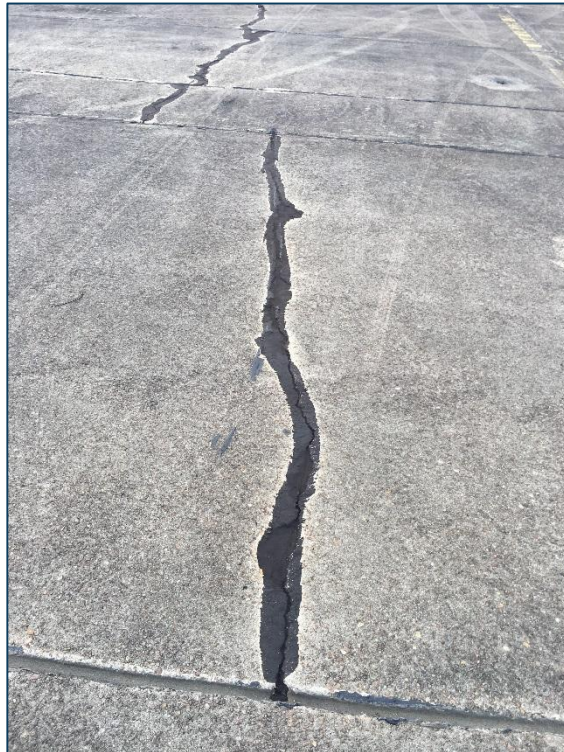
Apron, Section 4105, Sample Unit 326 – Low Severity (63) Longitudinal, Transverse, and Diagonal Cracking, Medium Severity (65) Joint Seal Damage

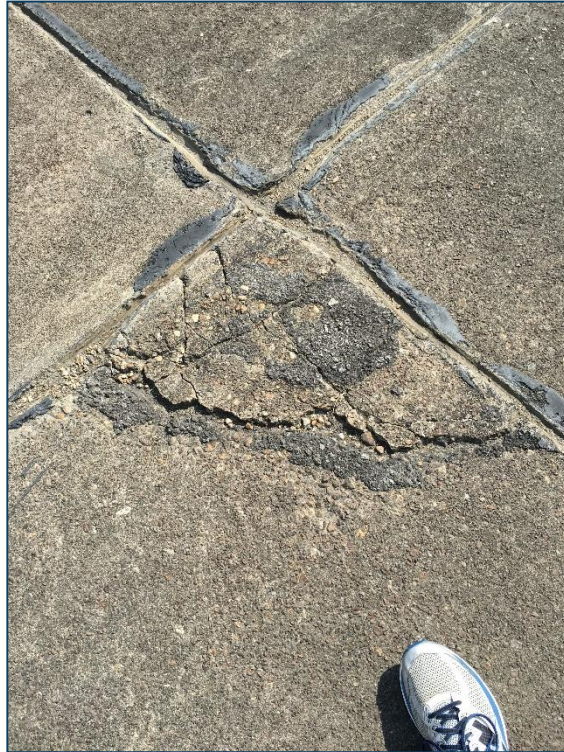
Apron, Section 4105, Sample Unit 711 – Medium Severity (65) Joint Seal Damage, Medium Severity (75) Corner Spalling
