# **Statewide Airfield Pavement Management Program**

## **Airport Pavement Evaluation Report September 2017**

**Marco Island  
Airport (MKY)**  
General Aviation Airport  
District 1

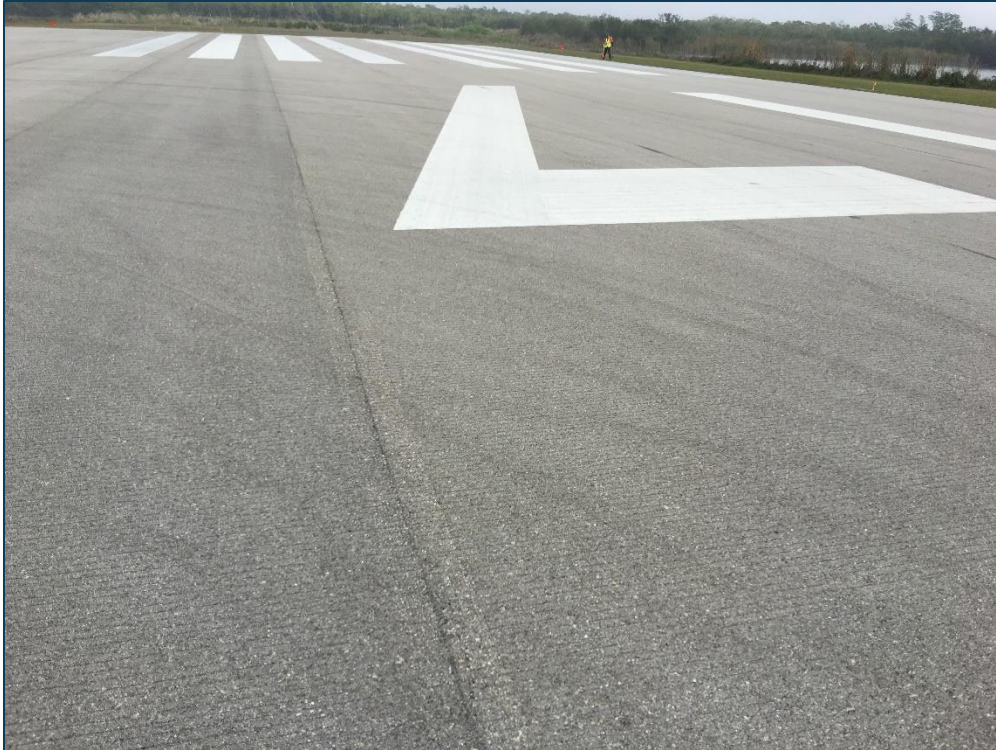
Runway 17-35, Section 6105, Sample Unit 194 – Low Severity (57) Weathering

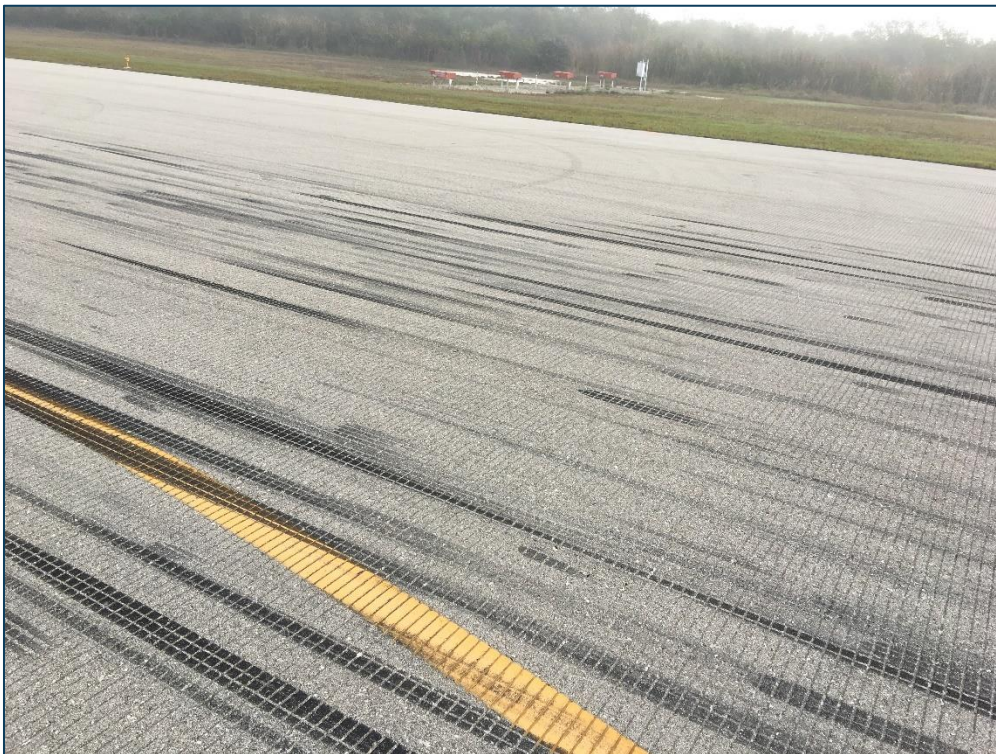
Runway 17-35, Section 6105, Sample Unit 186 – Low Severity (57) Weathering

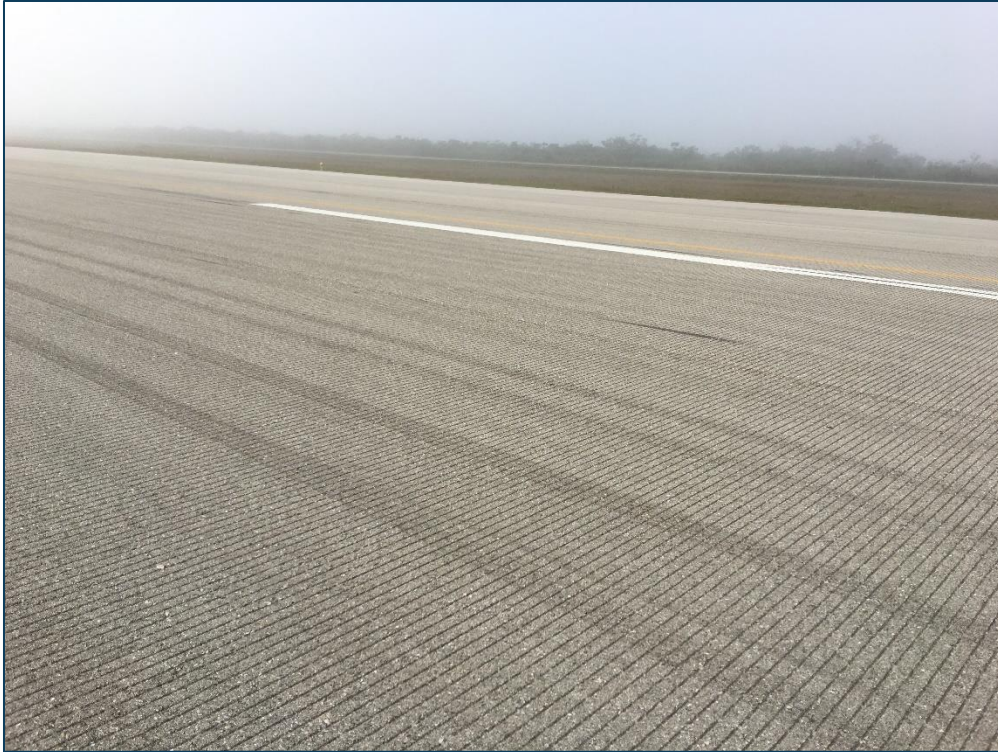
Runway 17-35, Section 6105, Sample Unit 146 – Low Severity (57) Weathering

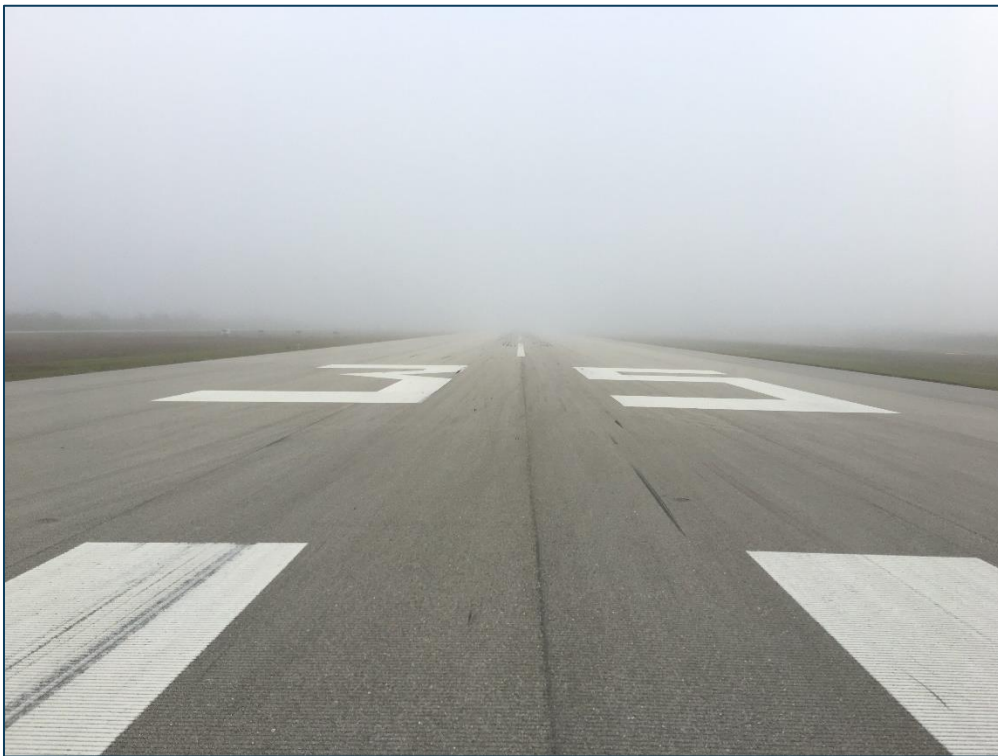
Runway 17-35, Section 6105, Sample Unit 103 – Low Severity (57) Weathering

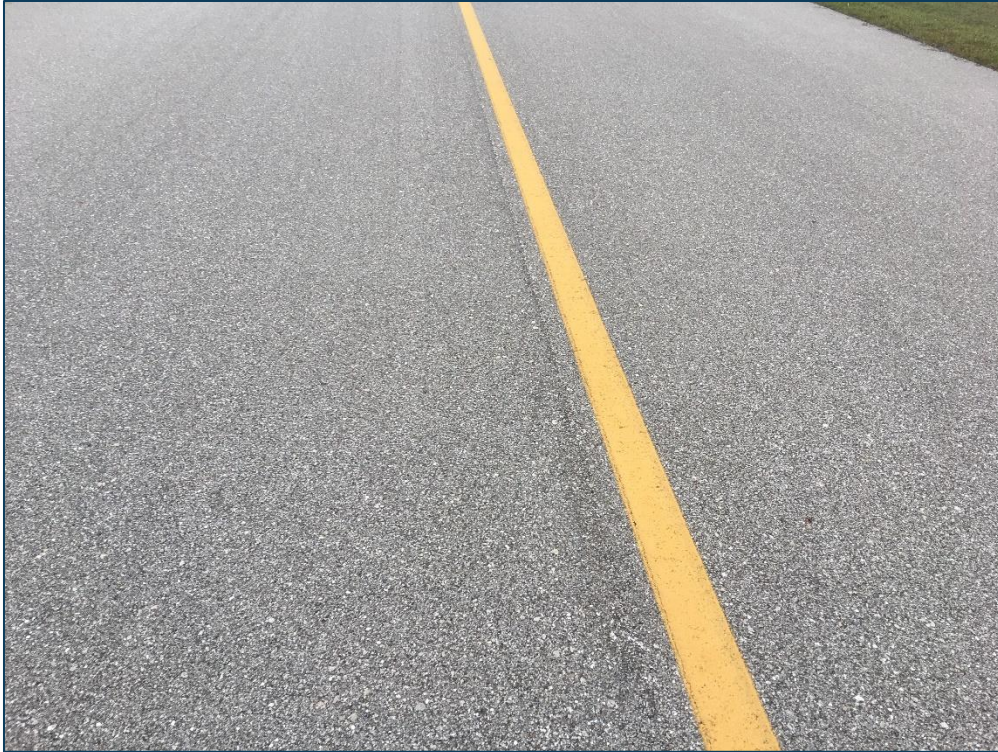
Taxiway A, Section 110, Sample Unit 107 – Low Severity (57) Weathering

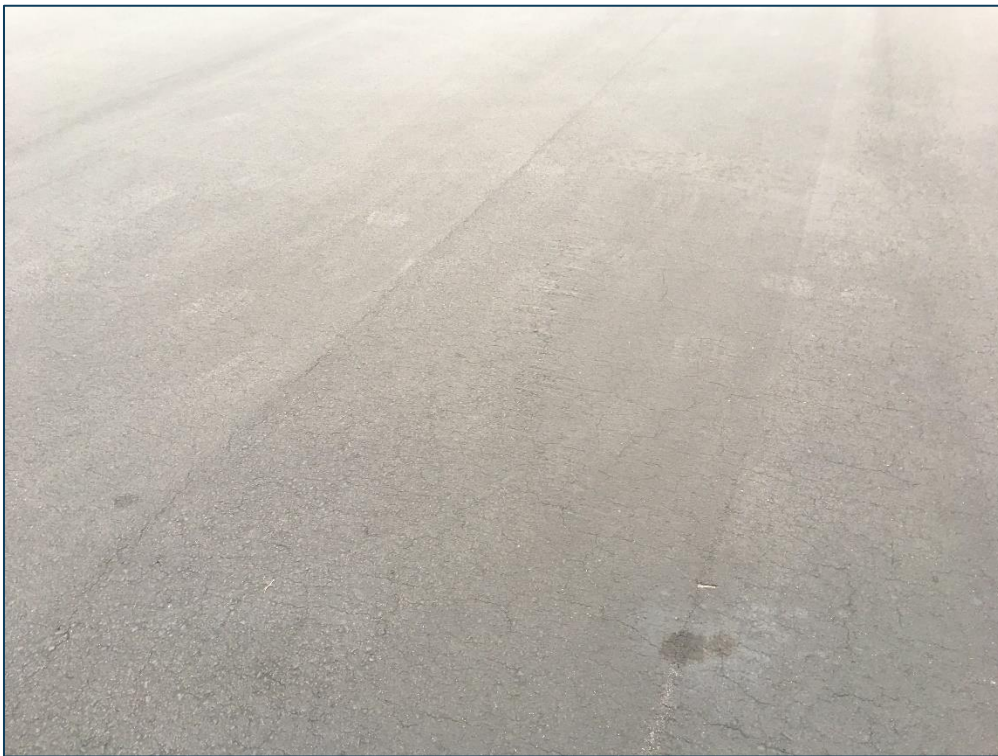
Apron NW, Section 4120, Sample Unit 104 – Low Severity (48) Longitudinal and Transverse Cracking, Low Severity (57) Weathering

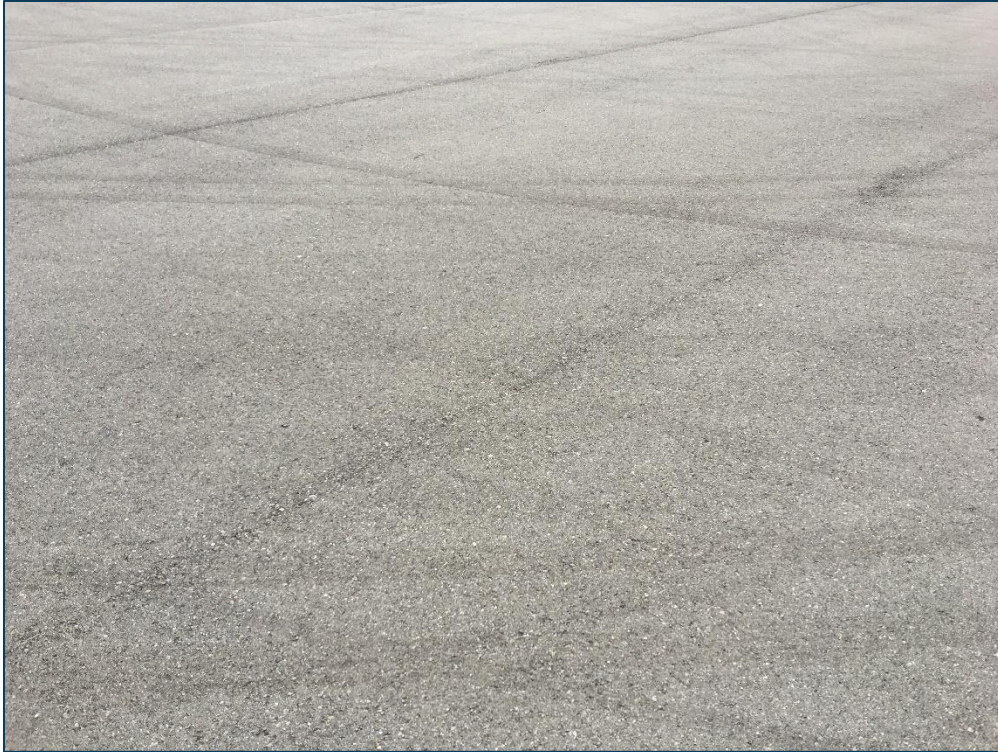
Apron N, Section 4205, Sample Unit 100 – Low Severity (57) Weathering

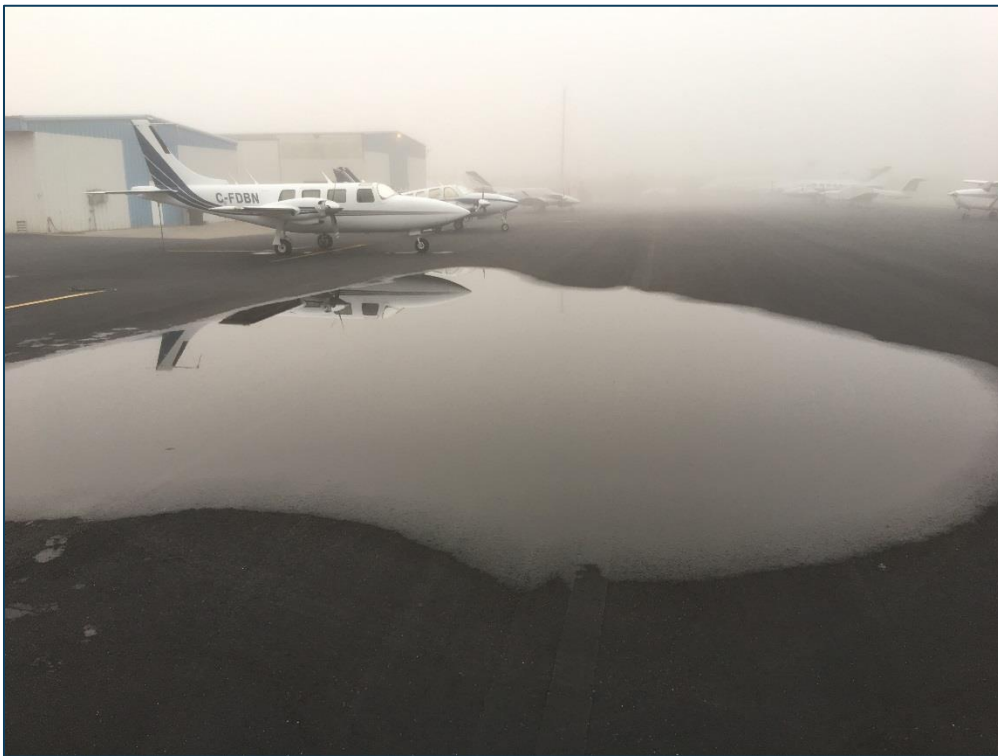
Apron NW, Section 4120, Sample Unit 155 (Not Inspected) – Medium Severity (45) Depression
