Statewide Airfield Pavement Management Program

Airport Pavement Evaluation Report September 2017

Palm Beach County Glades Airport (PHK) General Aviation Airport District 4

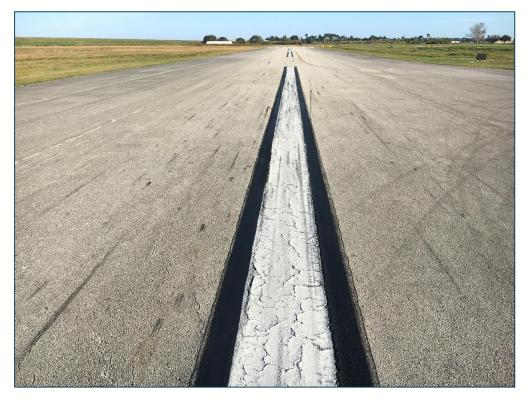
Runway 17-35, Section 6110, Sample Unit 164 – Low and Medium Severity (48) Longitudinal and Transverse Cracking, Low Severity (52) Raveling, Low Severity (57) Weathering

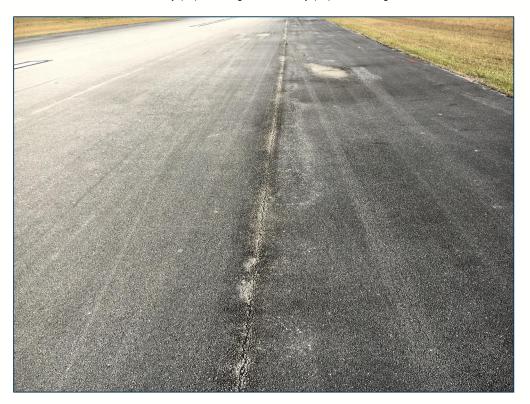
Runway 17-35, Section 6110, Sample Unit 145 – Low and Medium Severity (48) Longitudinal and Transverse Cracking, Low Severity (52) Raveling, Low Severity (56) Swelling, Low Severity (57) Weathering

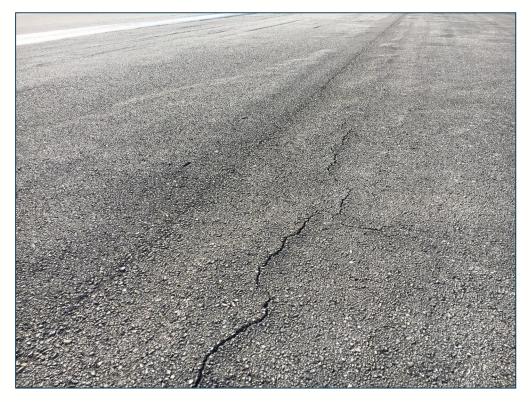
Runway 17-35, Section 6105, Sample Unit 109 – Low and Medium Severity (48) Longitudinal and Transverse Cracking, Low Severity (52) Raveling, Low Severity (56) Swelling, Low Severity (57) Weathering

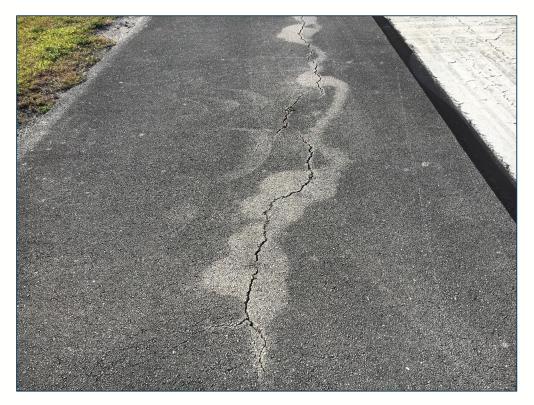
Runway 17-35, Section 6105, Sample Unit 105 – Low and Medium Severity (48) Longitudinal and Transverse Cracking, Low Severity (52) Raveling, Low Severity (56) Swelling, Low Severity (57) Weathering

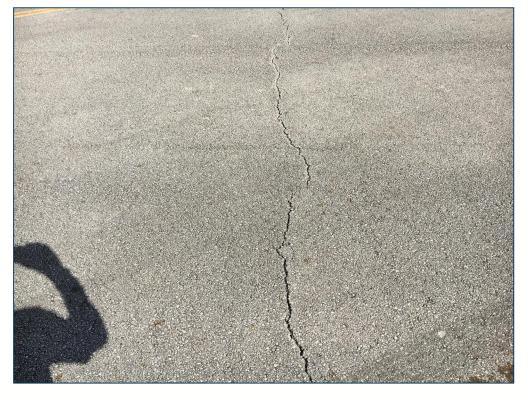
Taxiway D, Section 110, Sample Unit 100 – Low and Medium Severity (48) Longitudinal and Transverse Cracking, Low Severity (52) Raveling, Low Severity (57) Weathering

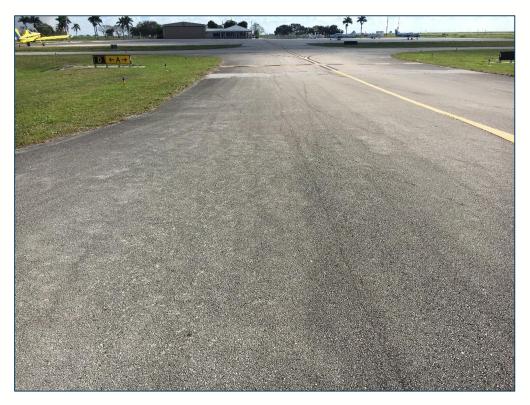
Taxiway D, Section 110, Sample Unit 100 – Low Severity (48) Longitudinal and Transverse Cracking, Low Severity (52) Raveling, Low Severity (57) Weathering

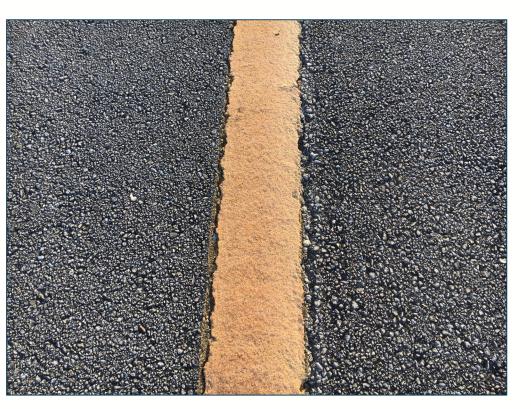
Taxiway A2, Section 125, Sample Unit 100 – Low Severity (48) Longitudinal and Transverse Cracking, Low Severity (52) Raveling, Low Severity (57) Weathering

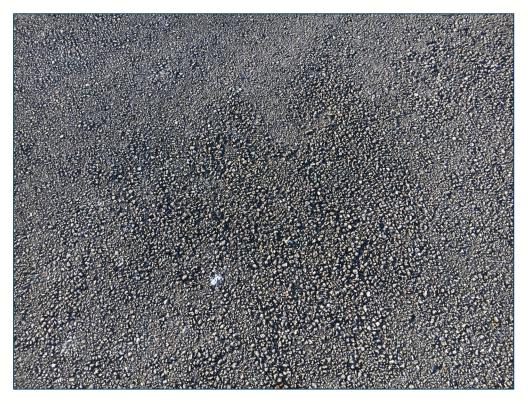
Taxiway A2, Section 125, Sample Unit 100 - Low Severity (52) Raveling, Low Severity (57) Weathering

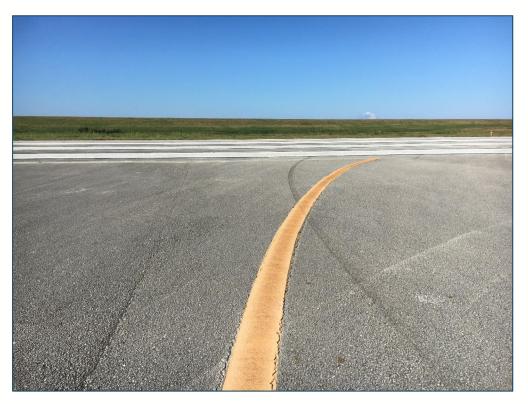
Taxiway A5, Section 115, Sample Unit 100 – Low and Medium Severity (48) Longitudinal and Transverse Cracking, Low Severity (52) Raveling, Low Severity (57) Weathering

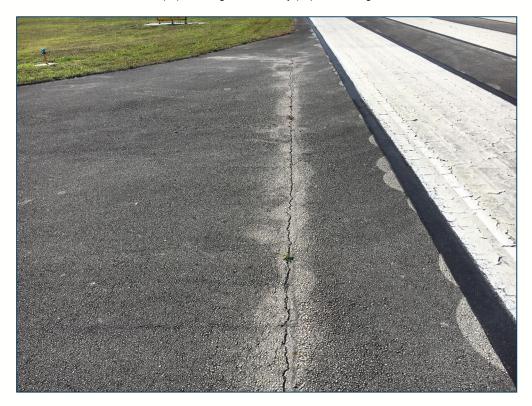
Taxiway A5, Section 115, Sample Unit 100 – Low and Medium Severity (48) Longitudinal and Transverse Cracking, Low Severity (52) Raveling, Low Severity (57) Weathering

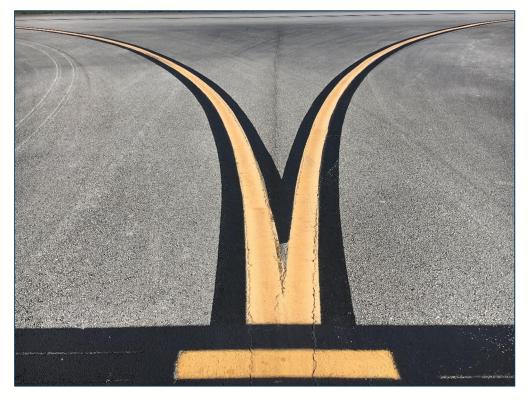
Taxiway A3, Section 130, Sample Unit 104 – Low Severity (48) Longitudinal and Transverse Cracking, Low Severity (57) Weathering

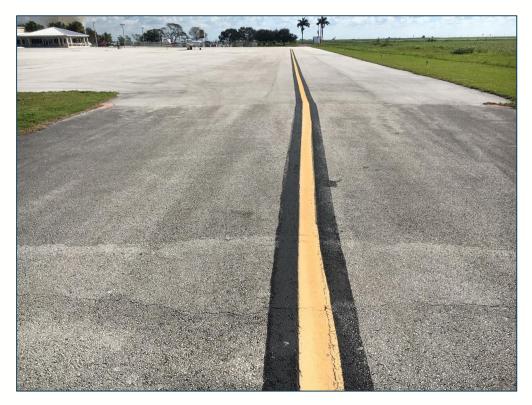
Taxiway A3, Section 130, Sample Unit 104 – Low Severity (48) Longitudinal and Transverse Cracking, Low Severity (57) Weathering

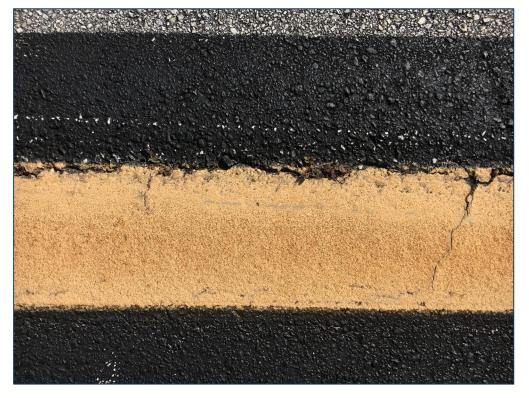
Taxiway A, Section 105, Sample Unit 121 – Low Severity (48) Longitudinal and Transverse Cracking, Low Severity (52) Raveling, Low Severity (57) Weathering

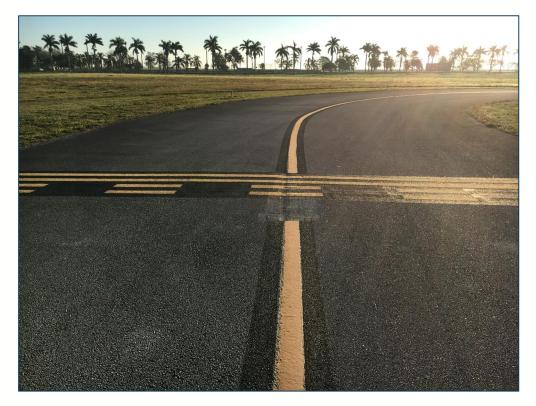
Taxiway A, Section 105, Sample Unit 100 – Low Severity (48) Longitudinal and Transverse Cracking, Low Severity (52) Raveling, Low Severity (57) Weathering

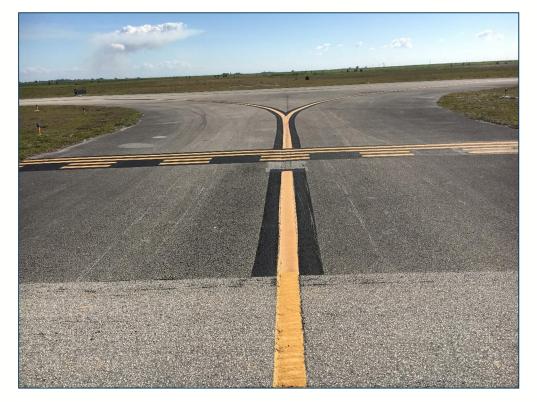
Taxiway A4, Section 120, Sample Unit 101 – Low Severity (48) Longitudinal and Transverse Cracking, Low Severity (52) Raveling, Low Severity (57) Weathering

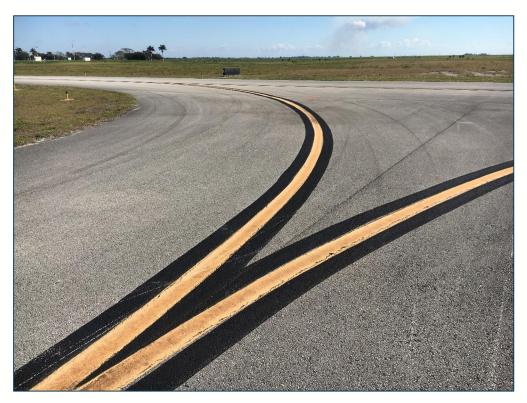
Taxiway A4, Section 120, Sample Unit 101 – Low Severity (48) Longitudinal and Transverse Cracking, Low Severity (52) Raveling, Low Severity (57) Weathering

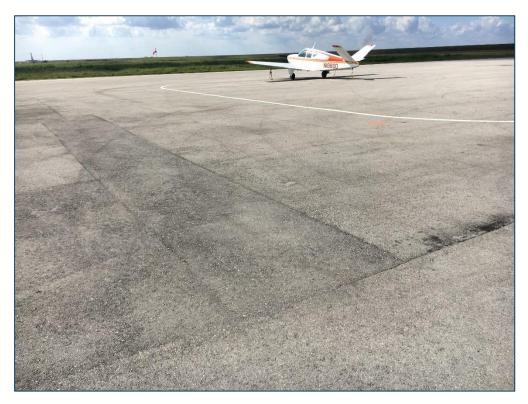
Apron, Section 4105, Sample Unit 400 - Low Severity (48) Longitudinal and Transverse Cracking, Low Severity (50) Patching, Low Severity (57) Weathering

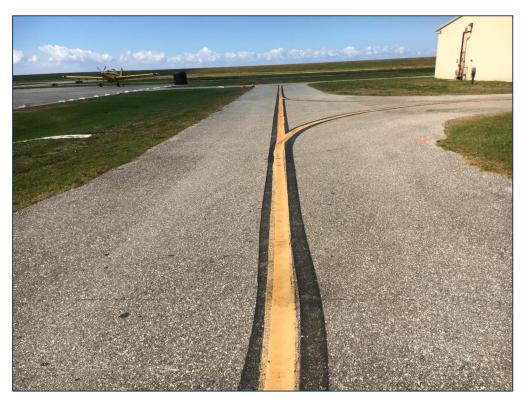
T-Hanger Taxilane, Section 4205, Sample Unit 100 – Low Severity (48) Longitudinal and Transverse Cracking, Low Severity (52) Raveling, Low Severity (57) Weathering
