Florida Department of Transportation

# Statewide Airfield Pavement Management Program

#### Summary of Pompano Beach Airpark

Pompano Beach Airpark was inspected in May 2017 - the overall weighted PCI value was 75, a condition rating of Satisfactory. The results of the maintenance, repair, and major rehabilitation analysis identified \$756.570 in localized M&R needs based on current conditions and a 10-Year major rehabilitation need of \$15,873,000 based on forecasted conditions. The current major rehabilitation needs based on the latest inspection consist of \$15,160,000 for pavements below critical condition.

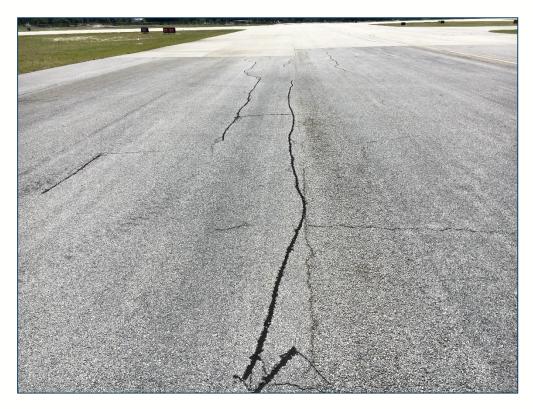
Runway 10-28, Section 6105, Sample Unit 152 - Low Severity (48) Longitudinal and Transverse Cracking, Low Severity (52) Raveling, Medium Severity (52) Raveling, Low Severity (56) Swelling

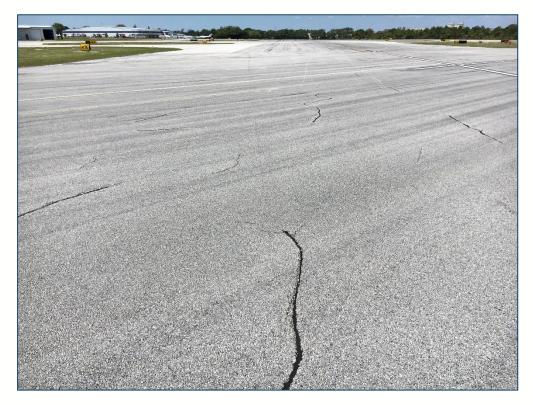
Runway 10-28, Section 6105, Sample Unit 117 - Low Severity (48) Longitudinal and Transverse Cracking, Low Severity (52) Raveling

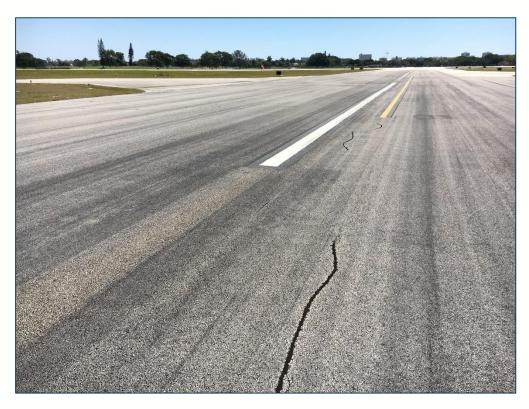
Runway 10-28, Section 6105, Sample Unit 141 - Low Severity (48) Longitudinal and Transverse Cracking, Low Severity (52) Raveling, Low Severity (56) Swelling

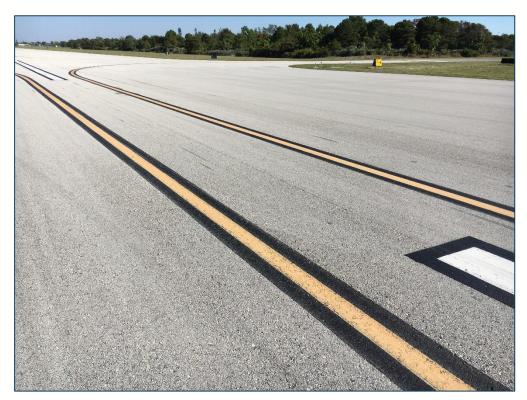
Runway 15-33, Section 6305, Sample Unit 325 - Low Severity (57) Weathering

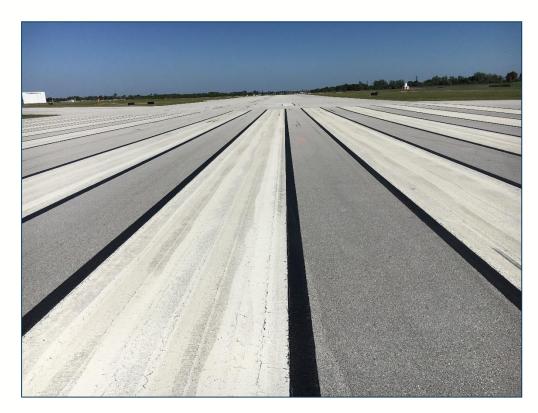
Runway 15-33, Section 6305, Sample Unit 303 - Low Severity (57) Weathering

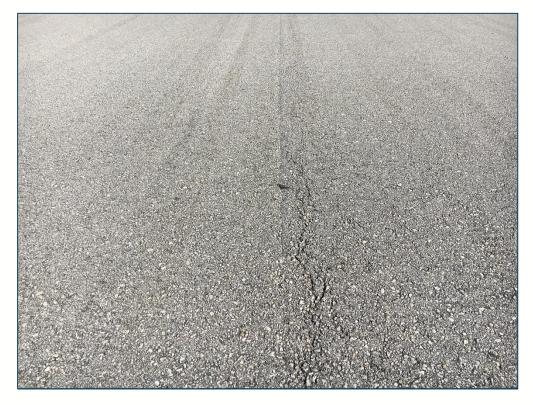
Runway 15-33, Section 6310, Sample Unit 112 - Low Severity (48) Longitudinal and Transverse Cracking, Low Severity (57) Weathering

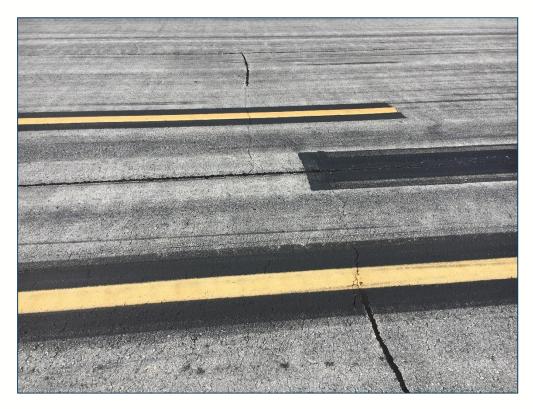
Runway 6-24, Section 6205, Sample Unit 306 - Low Severity (48) Longitudinal and Transverse Cracking, Low Severity (52) Raveling, Low Severity (57) Weathering

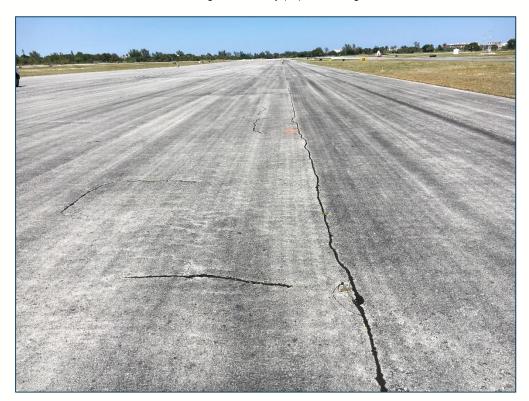
Runway 6-24, Section 6205, Sample Unit 323 - Low Severity (48) Longitudinal and Transverse Cracking, Low Severity (52) Raveling, Low Severity (57) Weathering

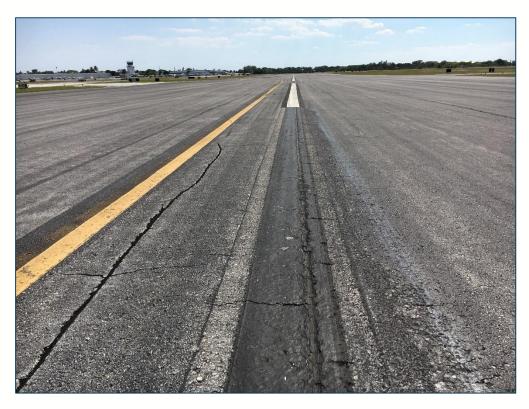
Runway 6-24, Section 6205, Sample Unit 346 - Low Severity (48) Longitudinal and Transverse Cracking, Low Severity (50) Patching, Low Severity (52) Raveling, Low Severity (57) Weathering

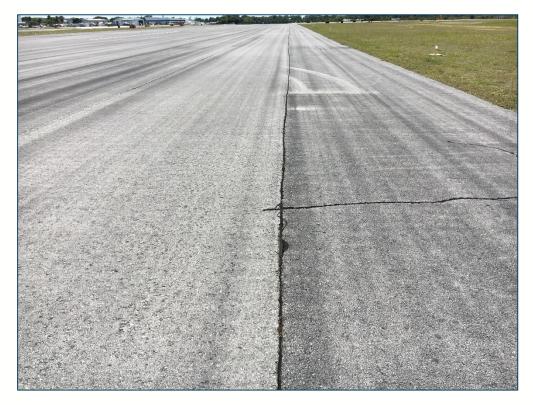
Runway 6-24, Section 6210, Sample Unit 132 - Low Severity (48) Longitudinal and Transverse Cracking, Low Severity (52) Raveling, Low Severity (57) Weathering

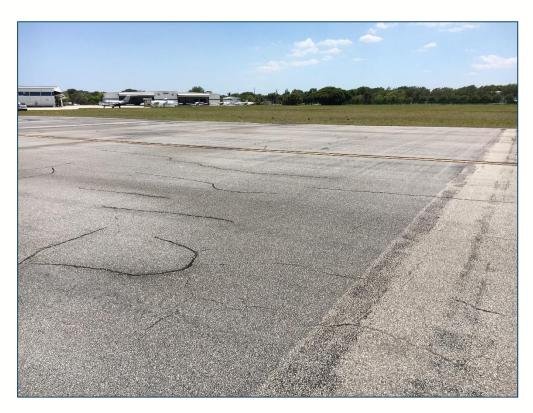
Taxiway A, Section 115, Sample Unit 106 - Low Severity (43) Block Cracking, Low Severity (48) Longitudinal and Transverse Cracking, Low Severity (52) Raveling, Low Severity (57) Weathering

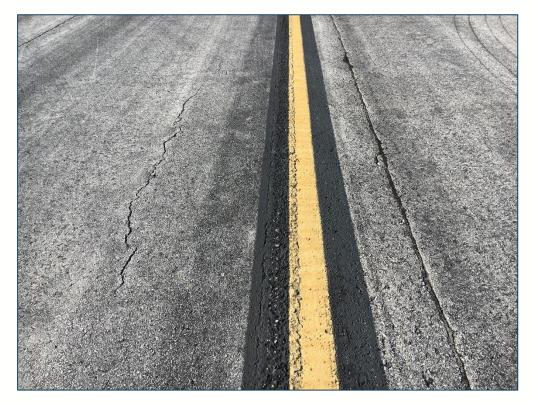
Taxiway B, Section 210, Sample Unit 706 - Low Severity (48) Longitudinal and Transverse Cracking, Low Severity (52) Raveling, Low Severity (57) Weathering

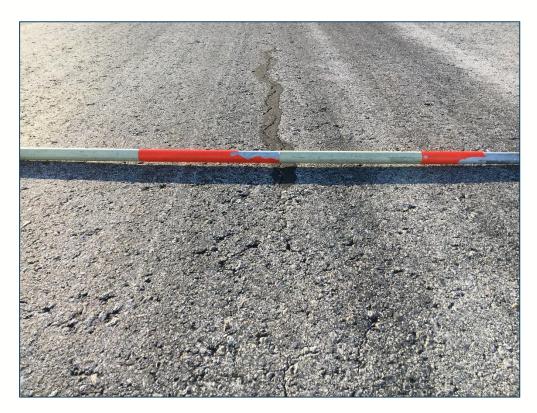
Taxiway D, Section 405, Sample Unit 413 - Low Severity (48) Longitudinal and Transverse Cracking, Low Severity (52) Raveling, Low Severity (53) Rutting, Low Severity (57) Weathering

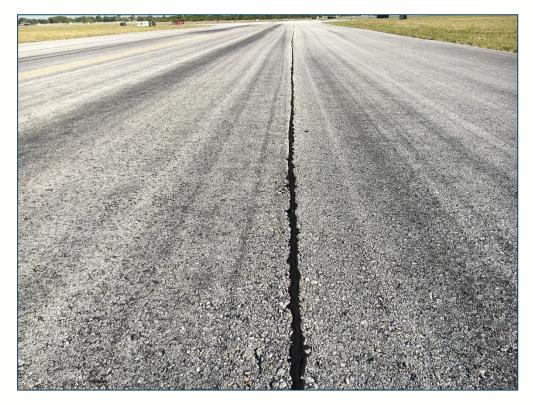
Taxiway D, Section 405, Sample Unit 420 - Low Severity (48) Longitudinal and Transverse Cracking, Low Severity (52) Raveling, Low Severity (57) Weathering

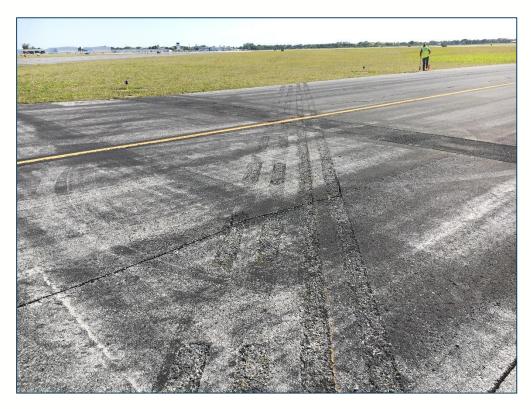
Taxiway F, Section 610, Sample Unit 601 - Medium Severity (48) Longitudinal and Transverse Cracking, Low Severity (50) Patching, Low Severity (52) Raveling, Low Severity (57) Weathering

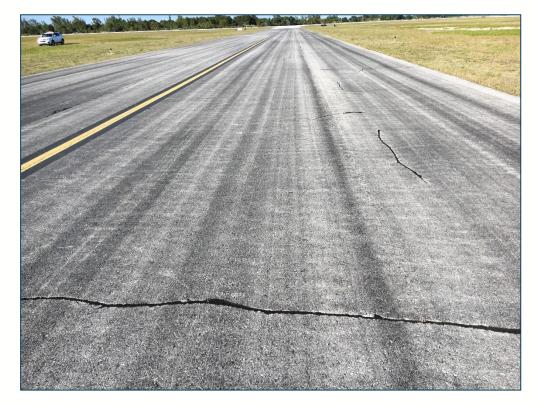
Taxiway F, Section 610, Sample Unit 625 - Low Severity (48) Longitudinal and Transverse Cracking, Low Severity (52) Raveling, Low Severity (57) Weathering

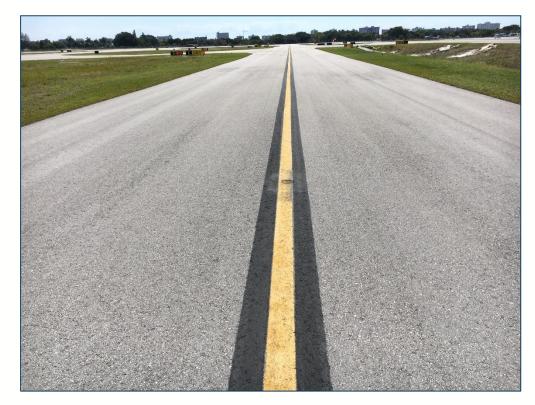
Taxiway K, Section 1110, Sample Unit 121 - Low Severity (57) Weathering

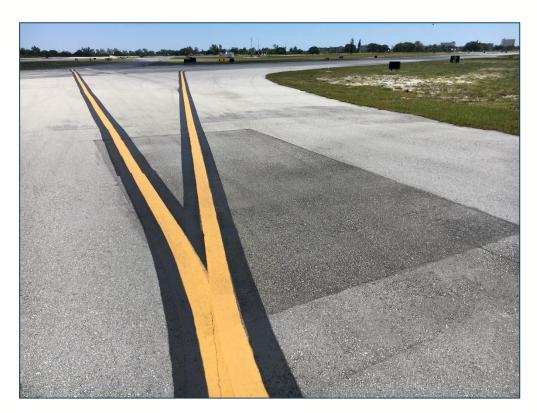
Taxiway M, Section 1306, Sample Unit 211 - Low Severity (48) Longitudinal and Transverse Cracking, Low Severity (50) Patching, Low Severity (52) Raveling, Low Severity (57) Weathering

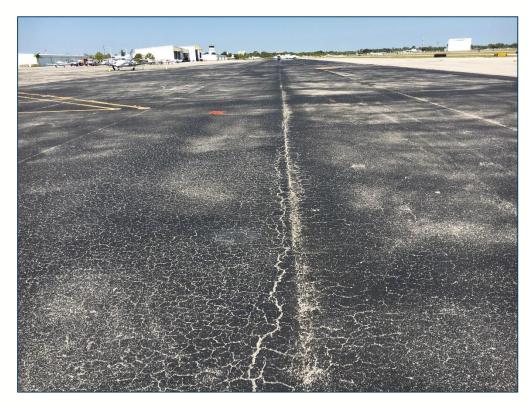
South Apron, Section 4105, Sample Unit 329 - Low Severity (43) Block Cracking, Low Severity (48) Longitudinal and Transverse Cracking, Low Severity (52) Raveling

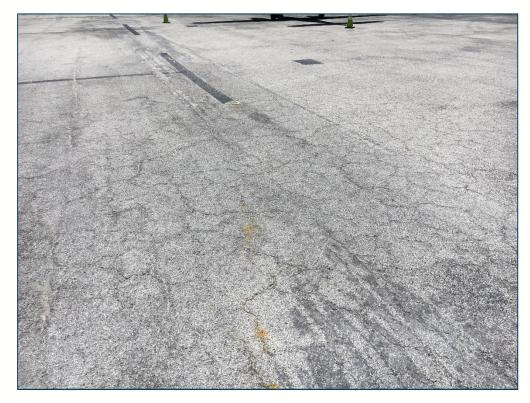
South Apron, Section 4125, Sample Unit 201 - Low Severity (43) Block Cracking, Low Severity (52) Raveling, Medium Severity (52) Raveling

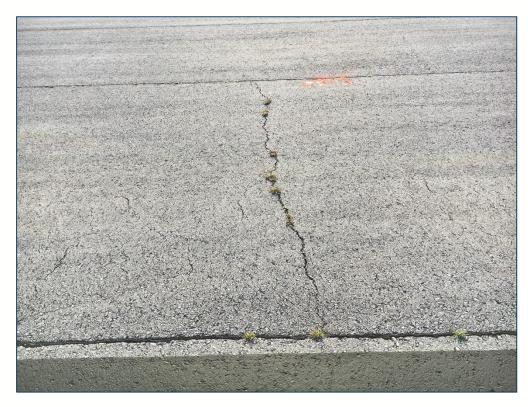
North Apron - Old RW, Section 4205, Sample Unit 321 - Low and Medium Severity (48) Longitudinal and Transverse Cracking, Low Severity (52) Raveling, Low Severity (57) Weathering

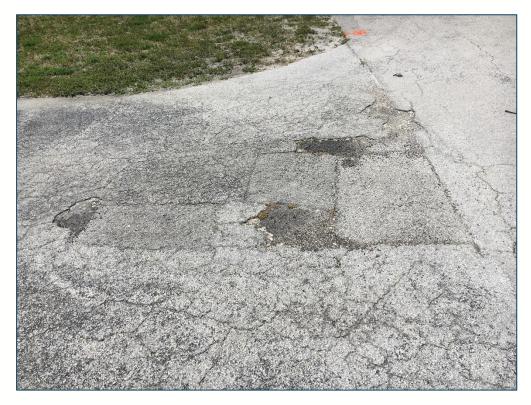
Taxilane To Hangars, Section 4305, Sample Unit 601 - Low Severity (43) Block Cracking, Low Severity (50) Patching, High Severity (50) Patching, Medium Severity (52) Raveling, High Severity (52) Raveling

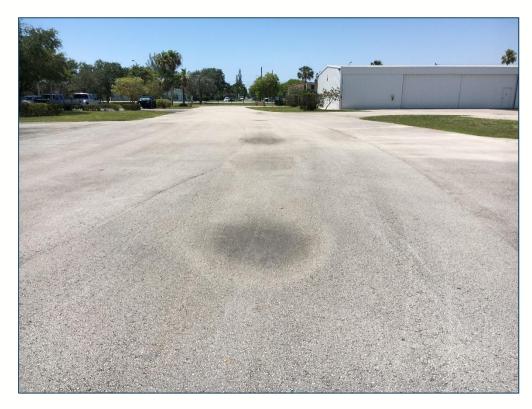
Taxilane To Hangars, Section 4315, Sample Unit 602 - Medium Severity (45) Depression, Low Severity (48) Longitudinal and Transverse Cracking, Low Severity (52) Raveling, Low Severity (57) Weathering

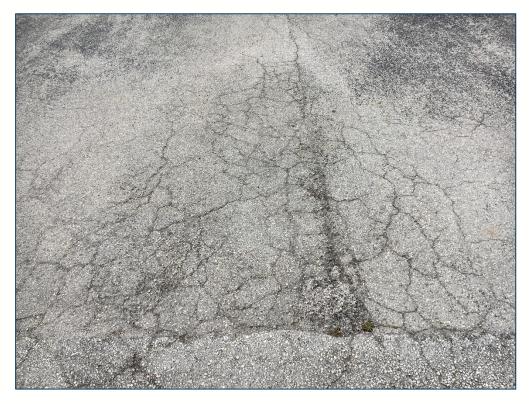
Taxilane To Hangars, Section 4315, Sample Unit 700 - Low Severity (41) Alligator Cracking, Low Severity (45) Depression, Low Severity (52) Raveling
