Statewide Airfield Pavement Management Program

Airport Pavement Evaluation Report September 2017

**Witham Field
(SUA)**

General Aviation Airport
District 4

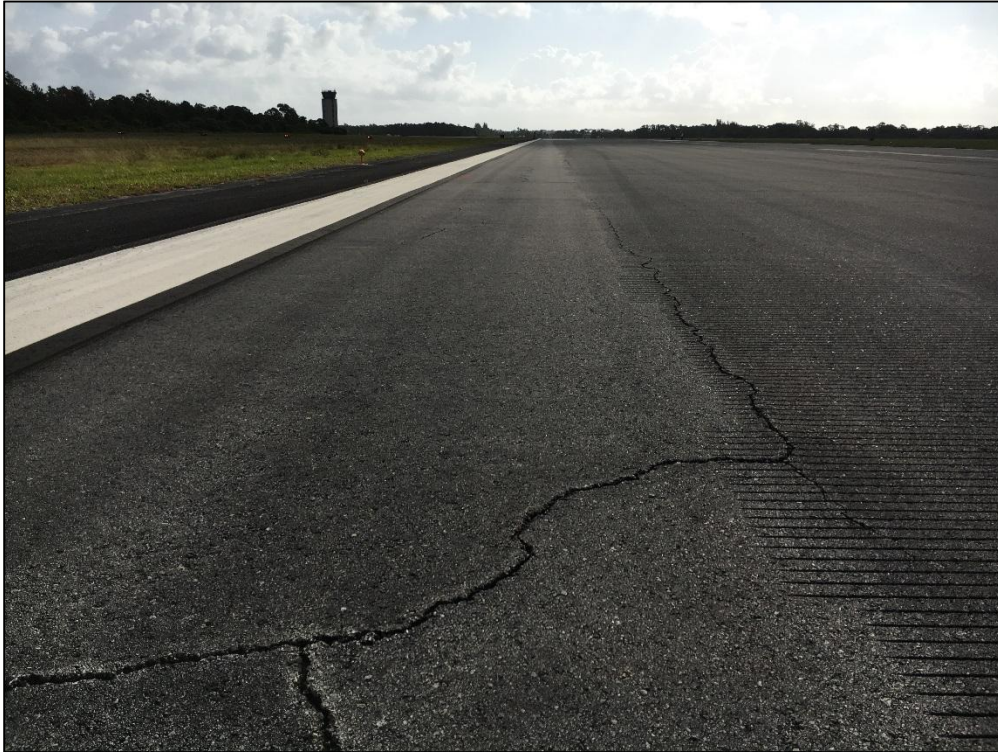
Runway 7-25, Section 6205, Sample Unit 315 - Low Severity (48) Longitudinal and Transverse Cracking, Low Severity (56) Swelling, Low Severity (57) Weathering

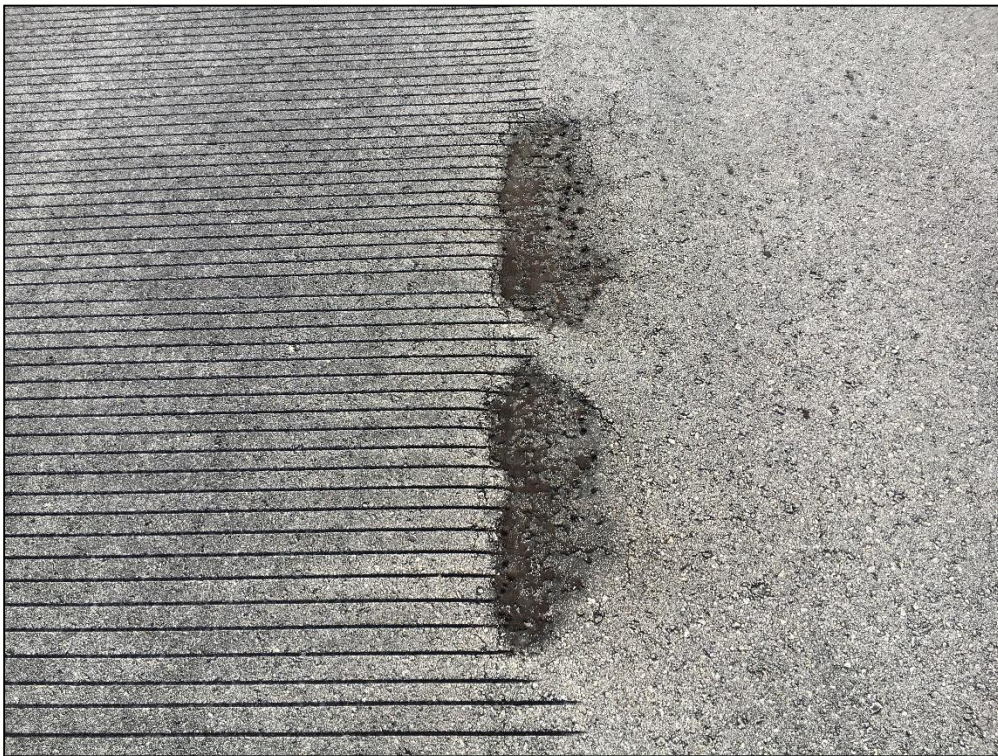
Runway 7-25, Section 6205, Sample Unit 319 - (42) Bleeding, Low Severity (48) Longitudinal and Transverse Cracking, Low Severity (57) Weathering

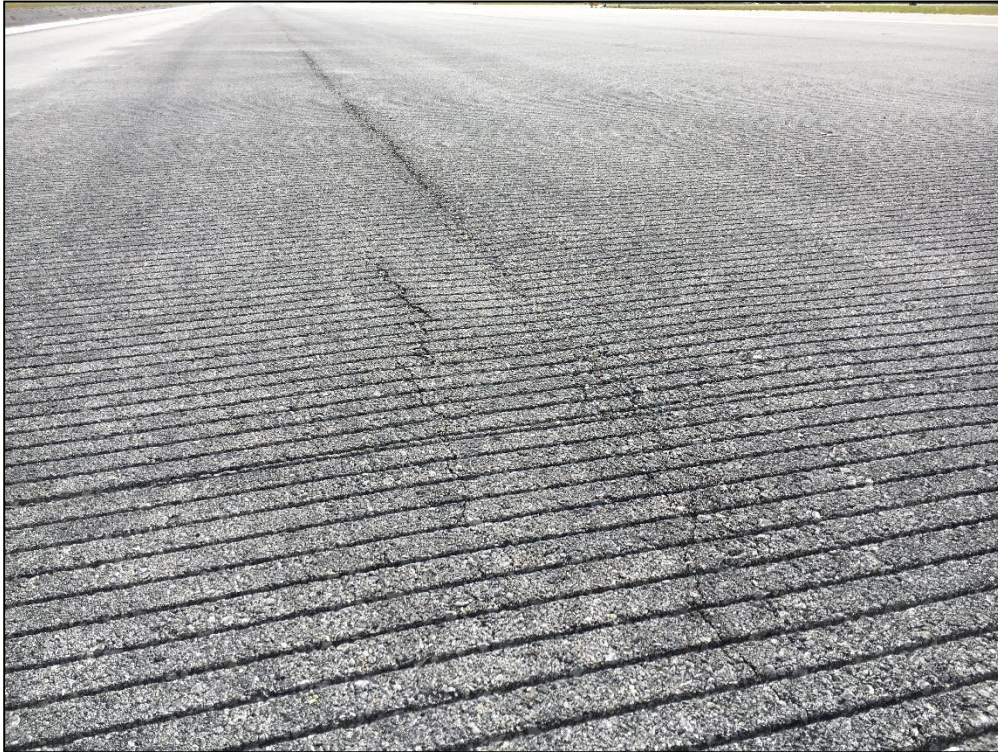
Runway 7-25, Section 6205, Sample Unit 389 - Low Severity (48) Longitudinal and Transverse Cracking, Low Severity (56) Swelling, Low Severity (57) Weathering

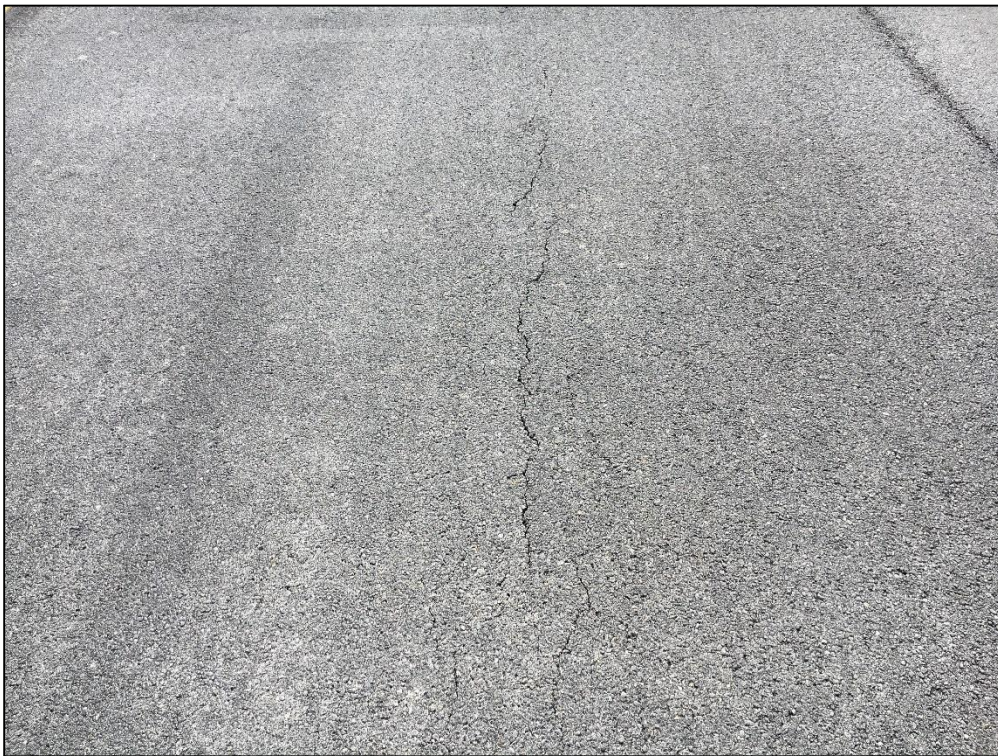
Taxiway A, Section 110, Sample Unit 204 - Low Severity (48) Longitudinal and Transverse Cracking, Low Severity (57) Weathering

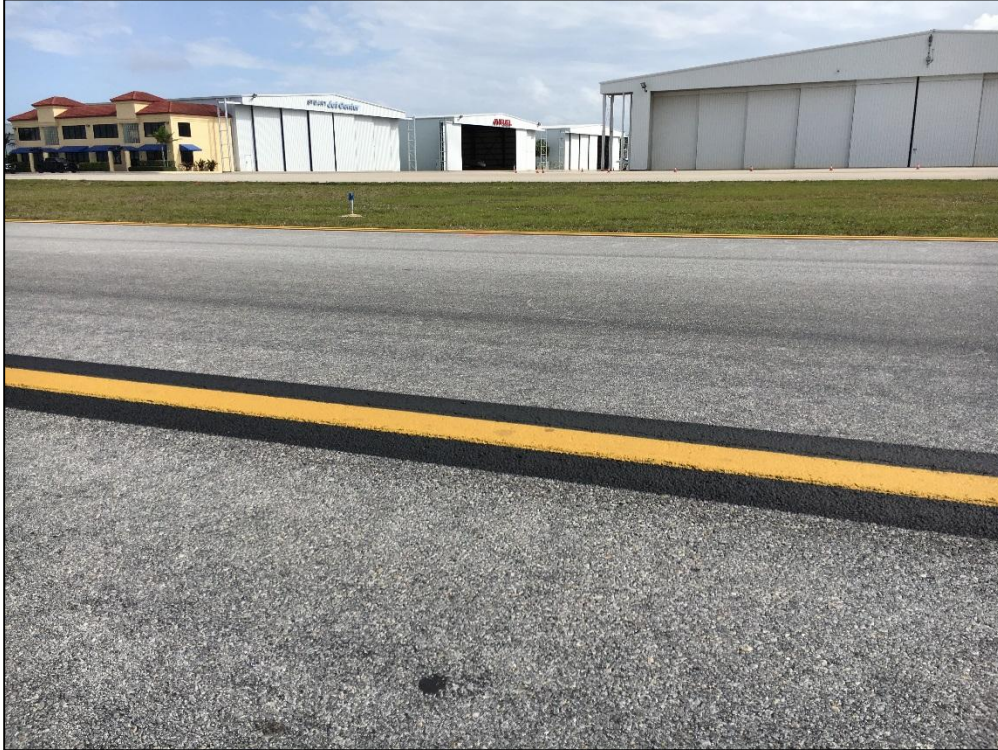
Taxiway A, Section 110, Sample Unit 225 - Low Severity (48) Longitudinal and Transverse Cracking, Low Severity (53) Rutting, Low Severity (57) Weathering

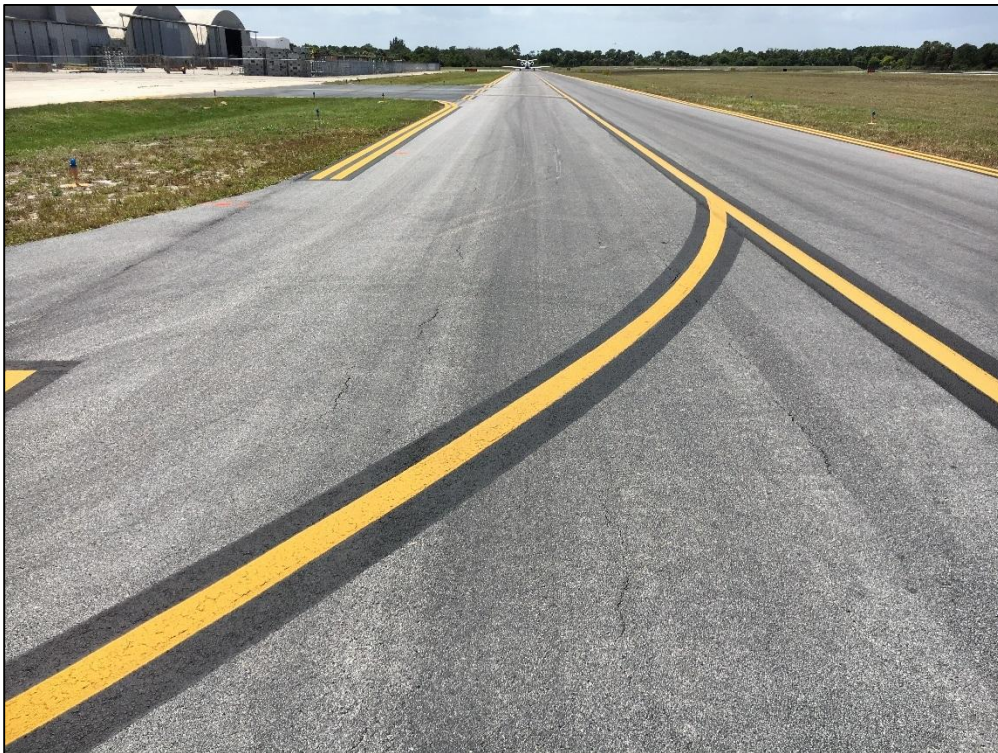
Taxiway A, Section 105, Sample Unit 112 - Low Severity (48) Longitudinal and Transverse Cracking, Low Severity (52) Raveling, Low Severity (56) Swelling, Low Severity (57) Weathering

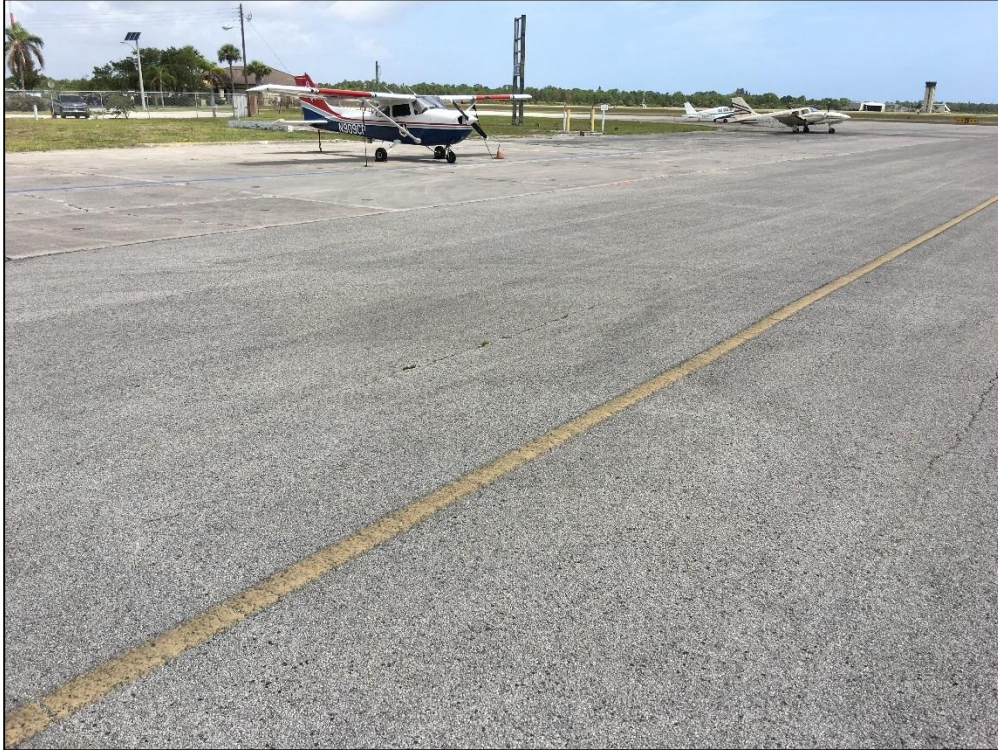
Taxiway B, Section 205, Sample Unit 207 - Medium Severity (52) Raveling, Low Severity (53) Rutting

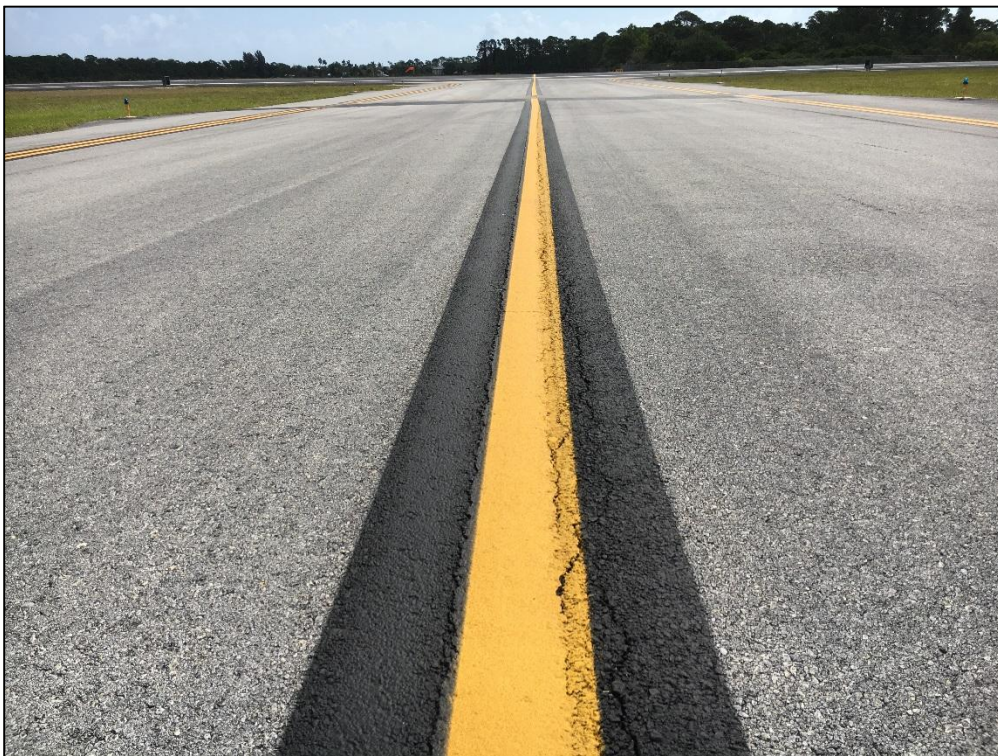
Taxiway C, Section 305, Sample Unit 420 - Low Severity (48) Longitudinal and Transverse Cracking, Low Severity (57) Weathering

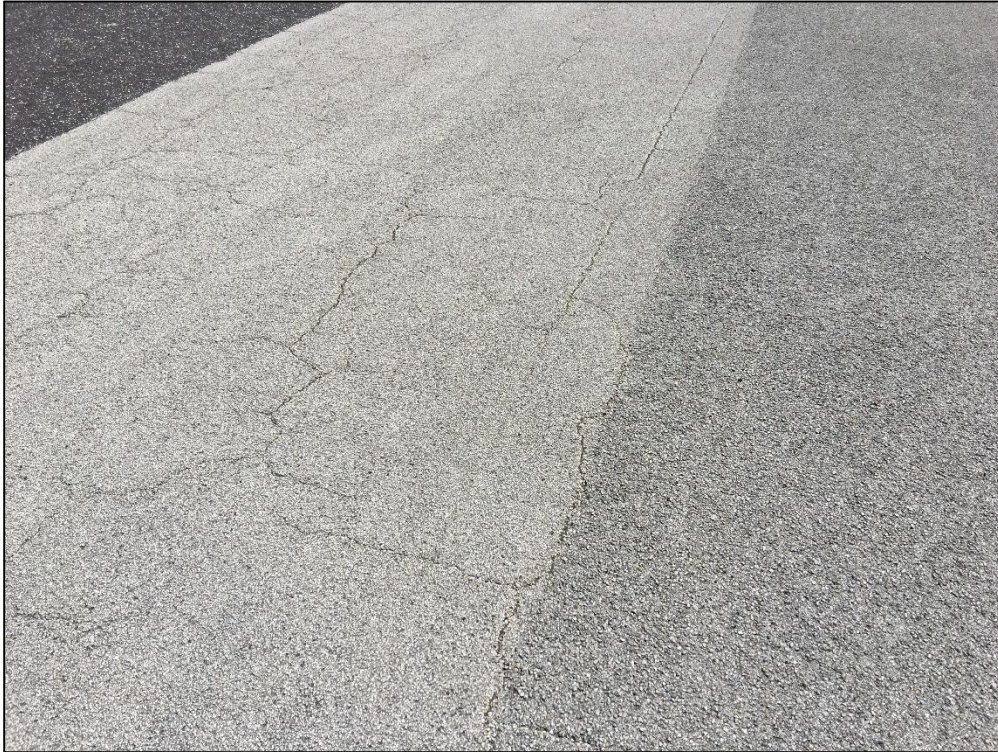
Taxiway C, Section 330, Sample Unit 902 - Low Severity (43) Block Cracking, Medium Severity (52) Raveling

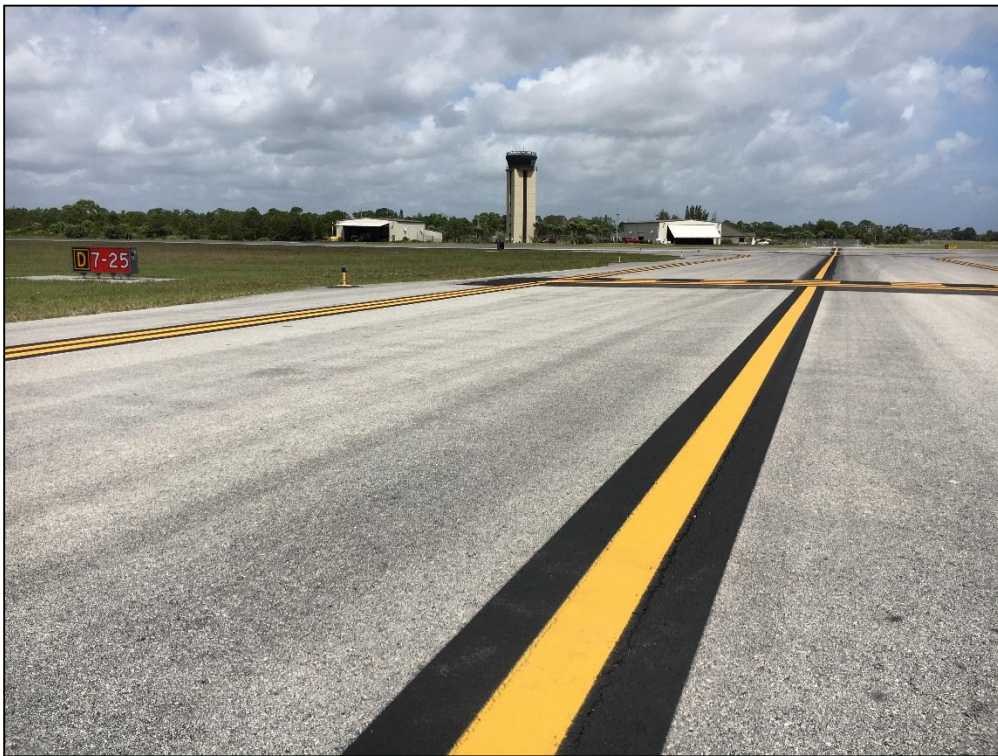
Taxiway D, Section 405, Sample Unit 320 - Low Severity (48) Longitudinal and Transverse Cracking, Low Severity (57) Weathering

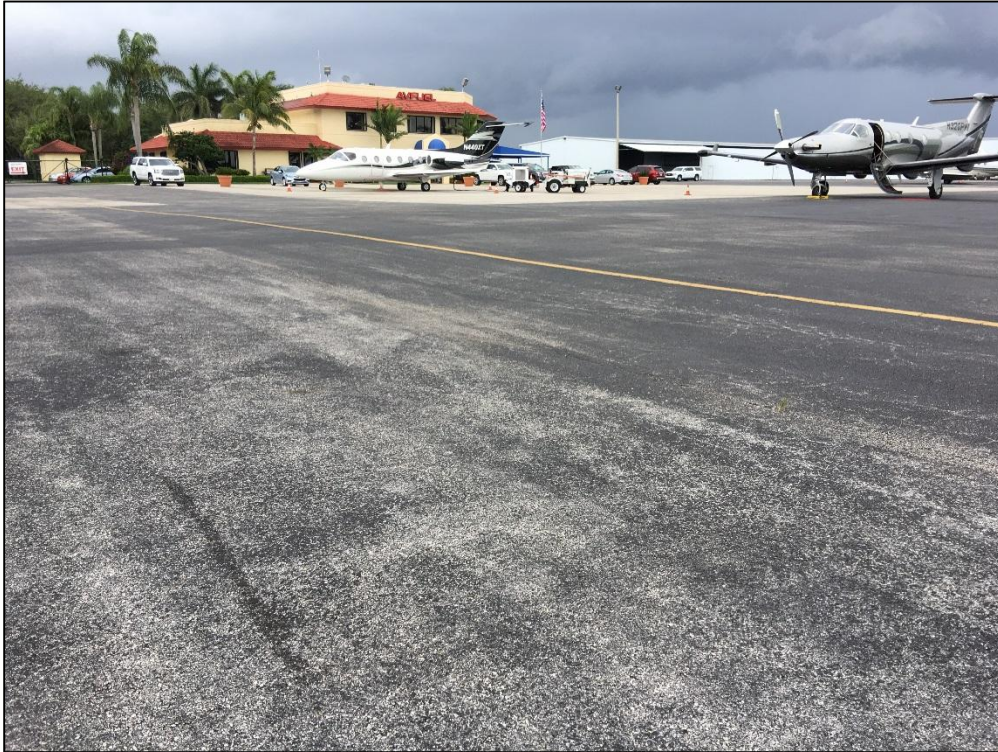
East Apron, Section 4205, Sample Unit 208 - Low Severity (52) Raveling, Low Severity (57) Weathering

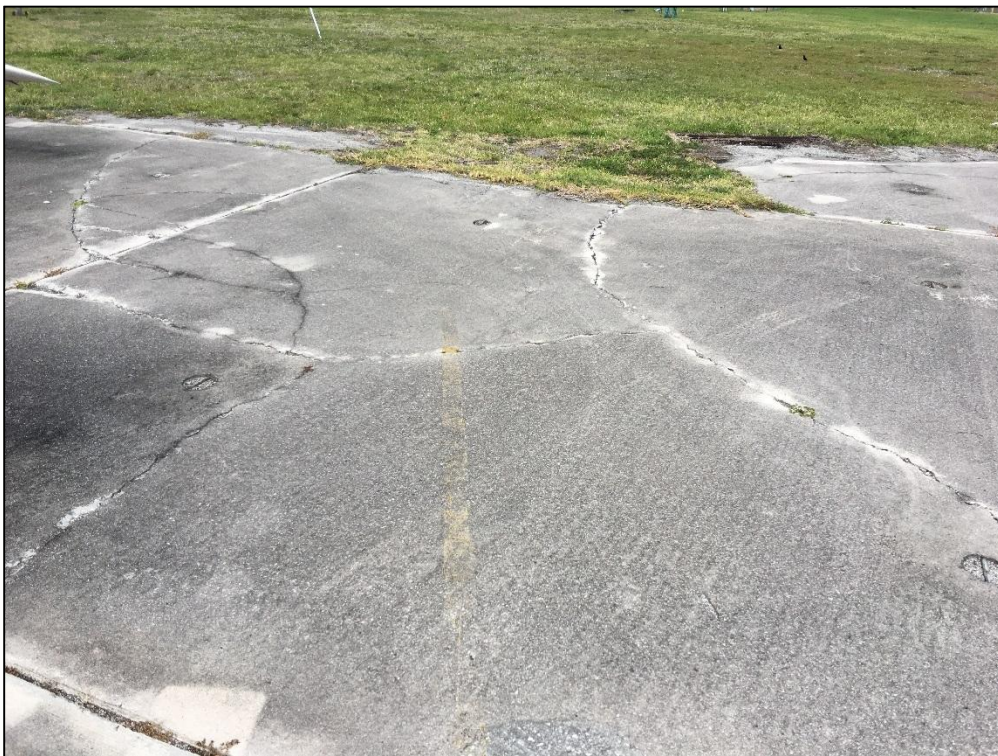
West Apron, Section 4110, Sample Unit 404 – Medium Severity (72) Shattered Slab

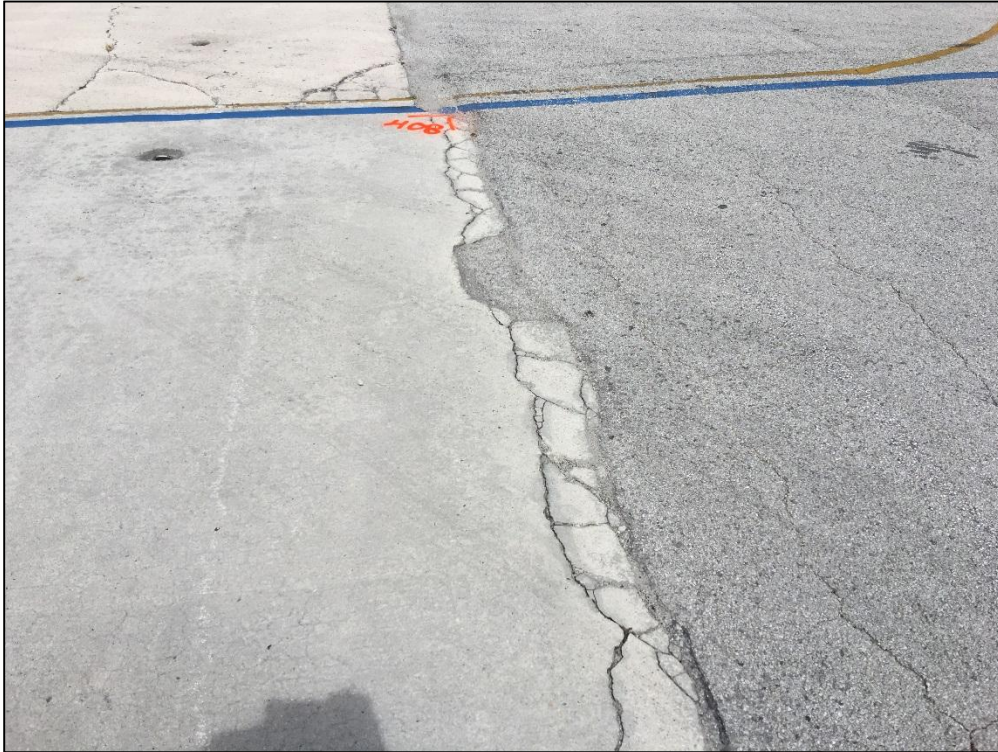
West Apron, Section 4110, Sample Unit 408 - High Severity (65) Joint Seal Damage, High Severity (74) Joint Spall, Medium Severity (75) Corner Spall

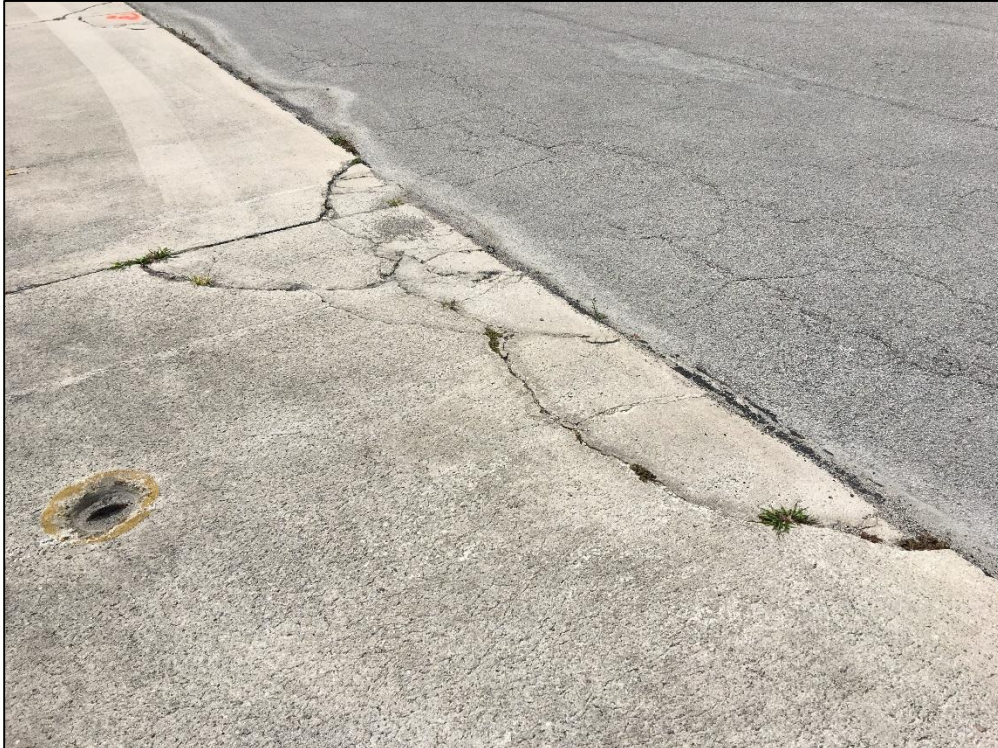
West Apron, Section 4107, Sample Unit 202 - High Severity (62) Corner Break, High Severity (65) Joint Seal Damage, (73) Shrinkage Cracking

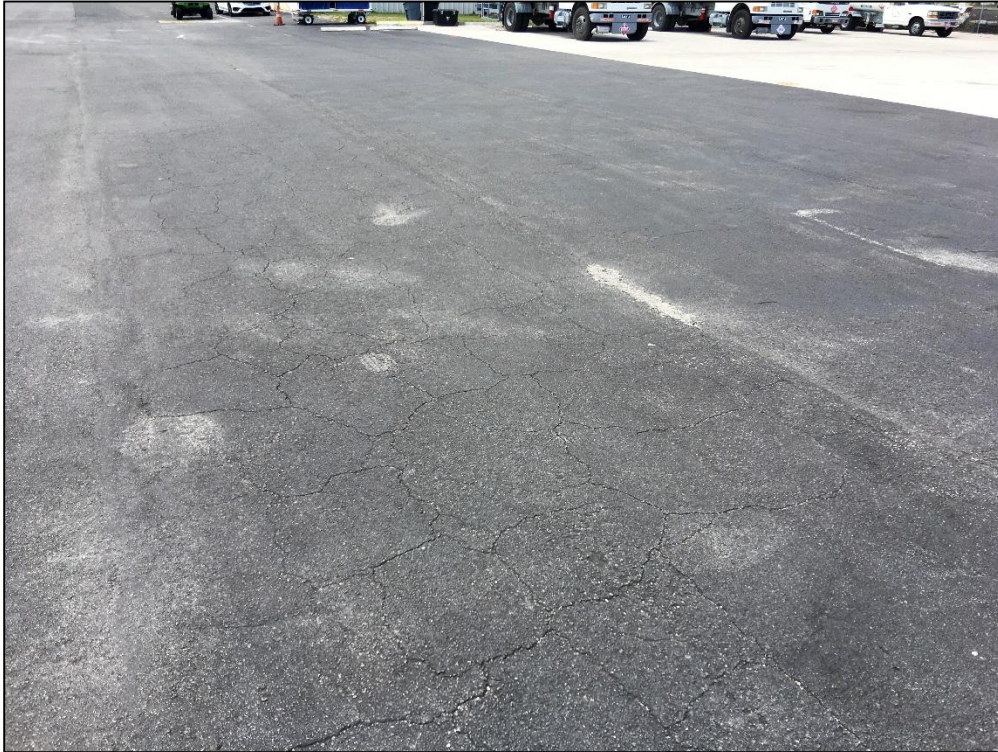
West Apron, Section 4120, Sample Unit 810 - Low Severity (43) Block Cracking, Low Severity (48) Longitudinal and Transverse Cracking, Low Severity (52) Raveling, Low Severity (57) Weathering

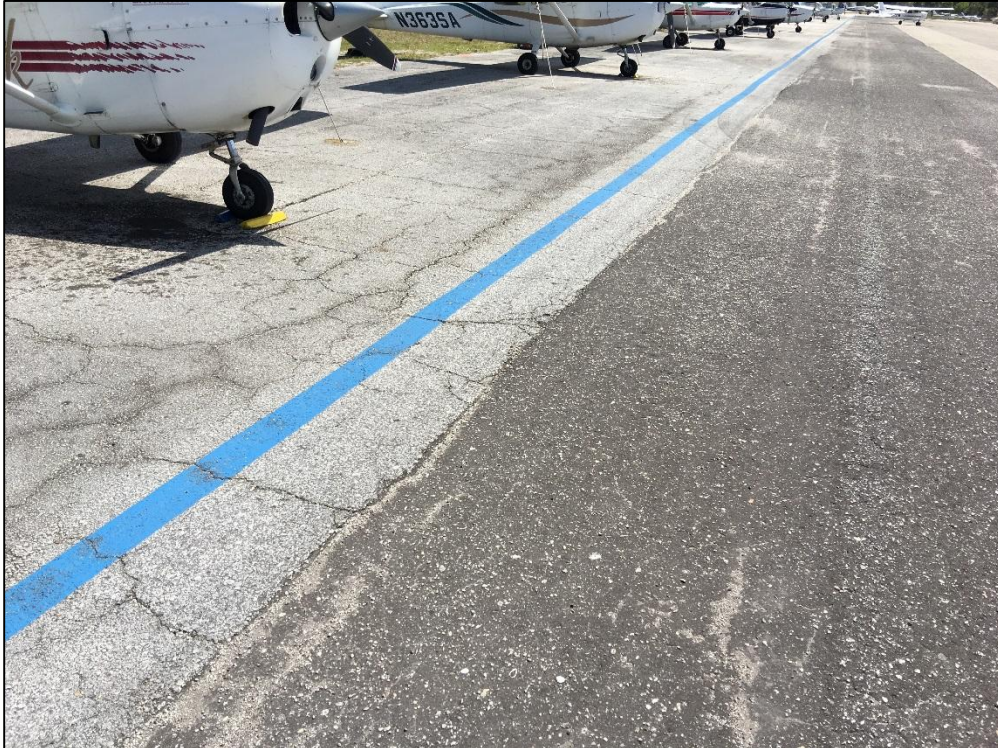
East Apron, Section 4235, Sample Unit 54 - Low Severity (43) Block Cracking, Medium Severity (52) Raveling
