Statewide Airfield Pavement Management Program

Airport Pavement
Evaluation Report
September 2017

**Dade-Collier
Training and Transition
Airport (TNT)**
General Aviation Airport
District 6

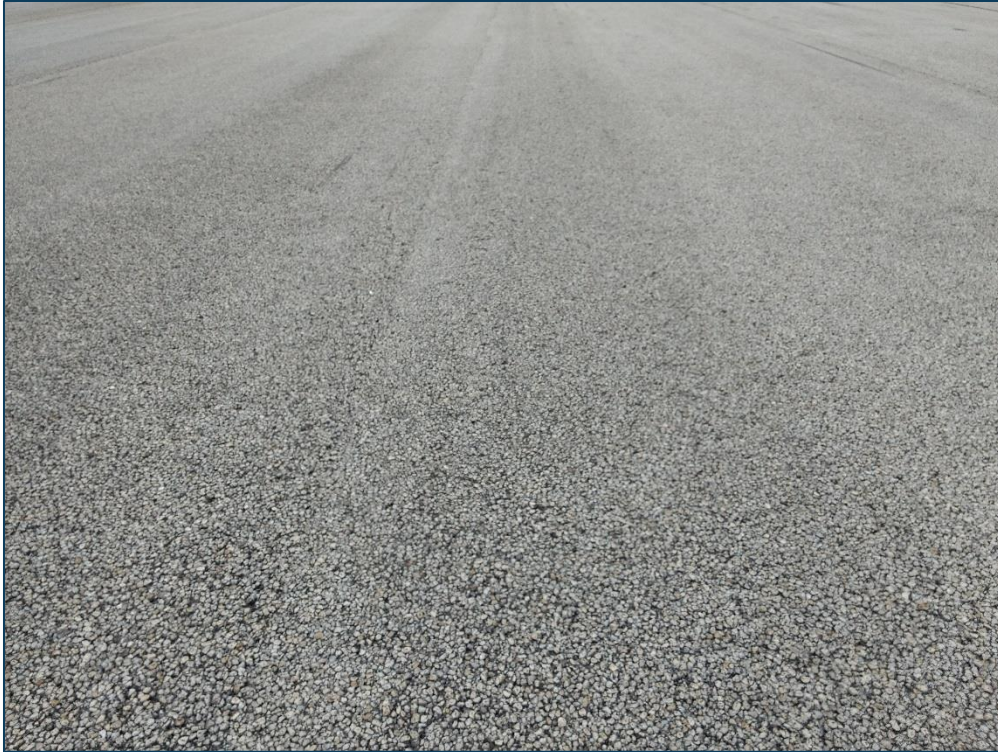
Runway 9-27, Section 6105, Sample Unit 344 – Low Severity (48) Longitudinal and Transverse Cracking, Low Severity (52) Raveling, Medium Severity (52) Raveling

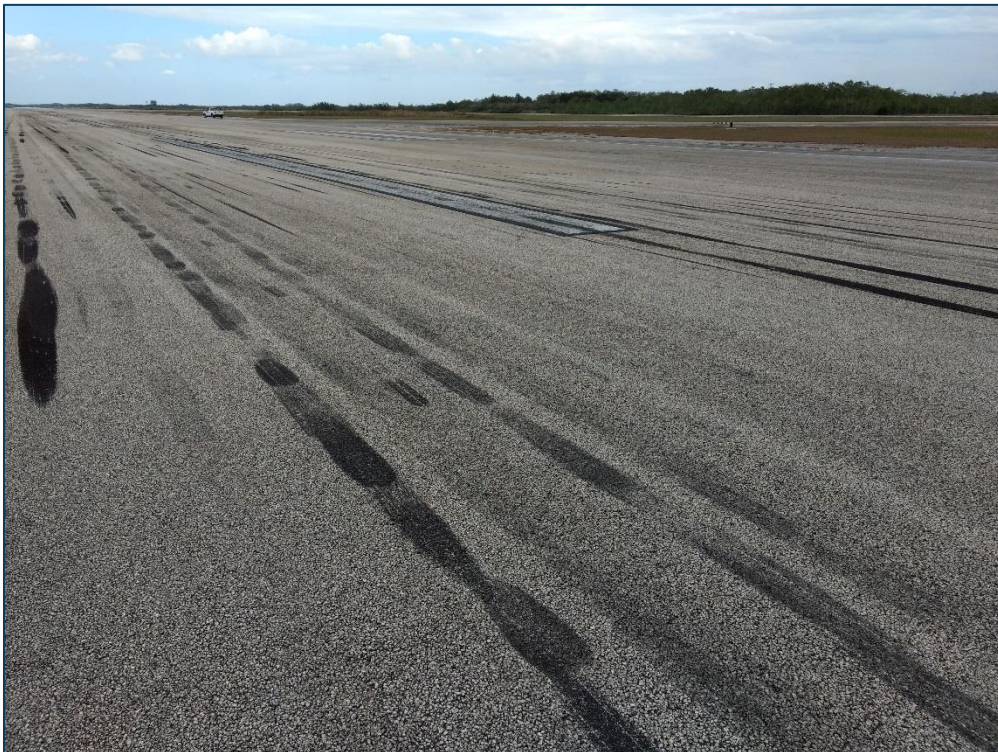
Runway 9-27, Section 6105, Sample Unit 385 – Low Severity (48) Longitudinal and Transverse Cracking, Low Severity (52) Raveling, Medium Severity (52) Raveling

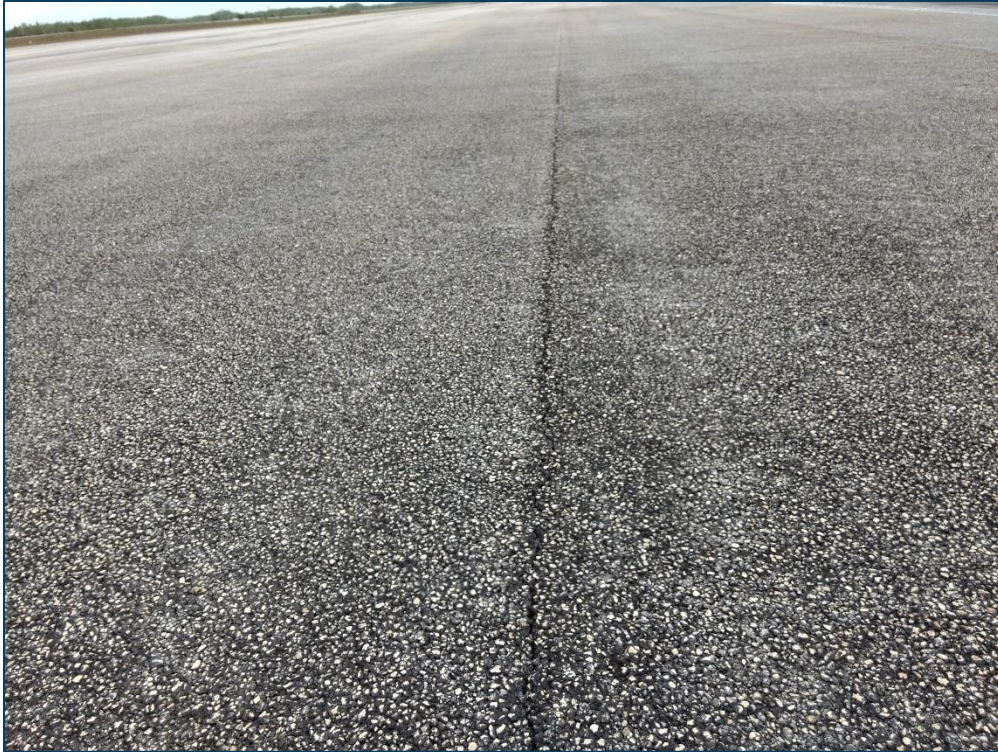
Runway 9-27, Section 6110, Sample Unit 580 – Low Severity (48) Longitudinal and Transverse Cracking, Low Severity (52) Raveling, Medium Severity (52) Raveling, Low Severity (56) Swelling

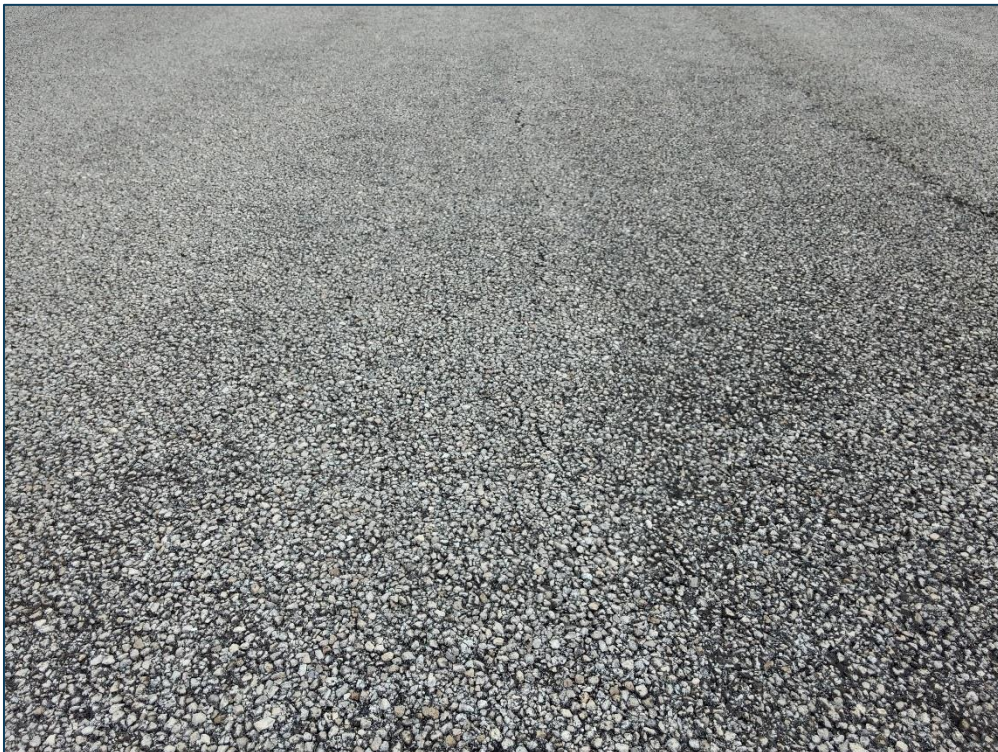
Runway 9-27, Section 6110, Sample Unit 126 – Low Severity (48) Longitudinal and Transverse Cracking, Low Severity (52) Raveling, Medium Severity (52) Raveling, Low Severity (56) Swelling

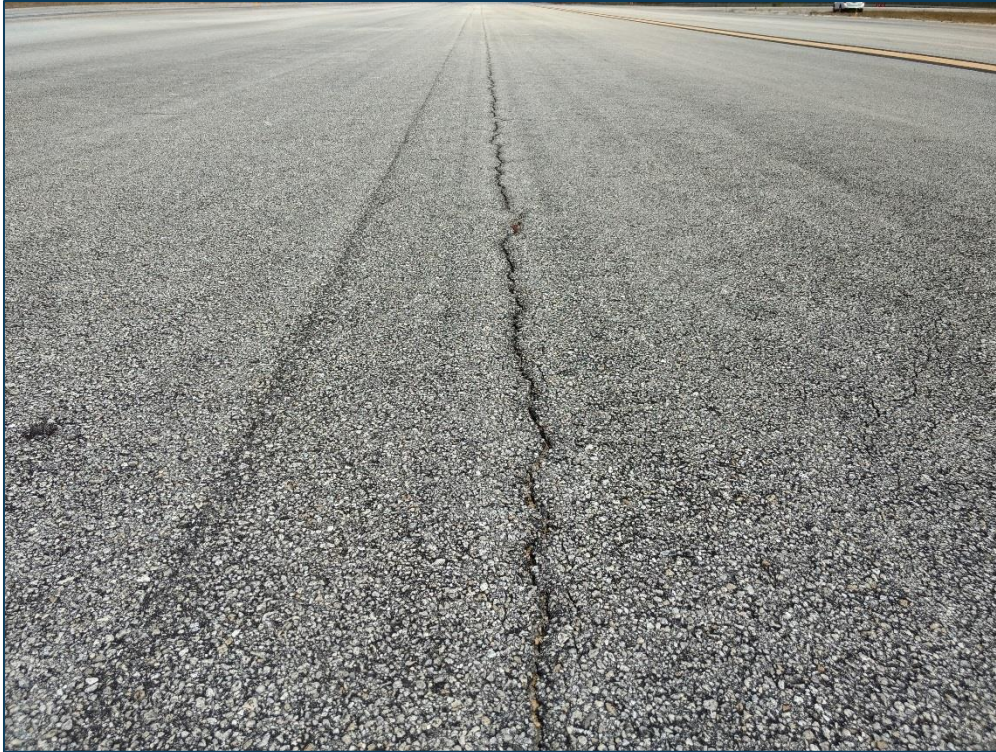
Taxiway A, Section 105, Sample Unit 123 – Low Severity (48) Longitudinal and Transverse Cracking, Low Severity (52) Raveling, Low Severity (56) Swelling

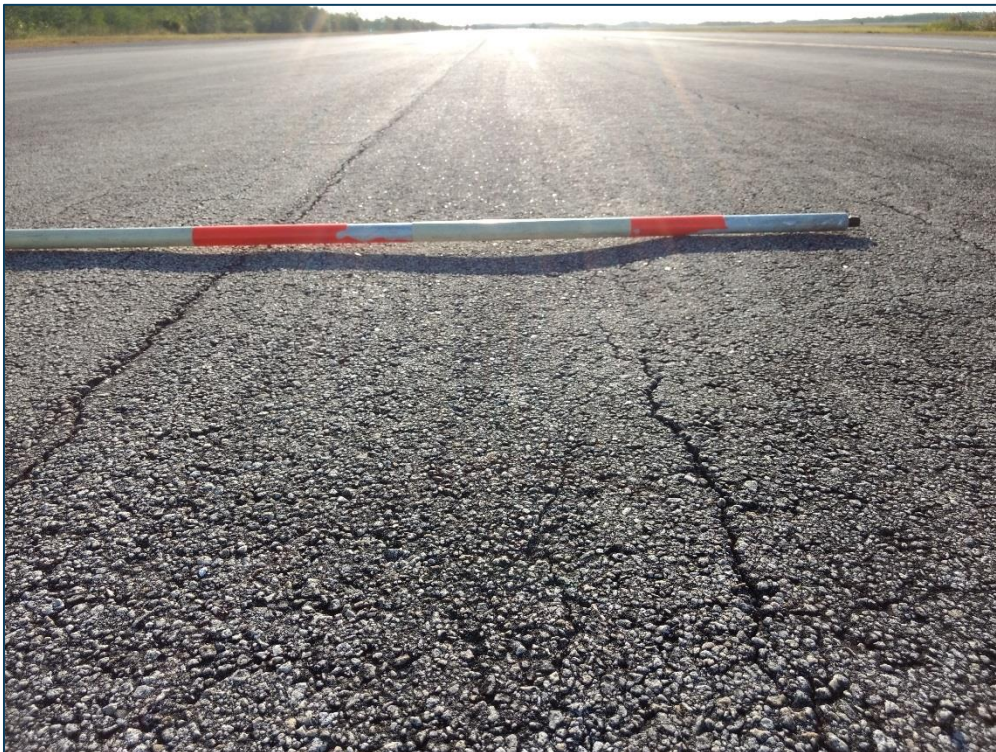
Taxiway A, Section 105, Sample Unit 237 – Low Severity (48) Longitudinal and Transverse Cracking, Low Severity (52) Raveling, Medium Severity (53) Rutting, Low Severity (56) Swelling, Low Severity (57) Weathering

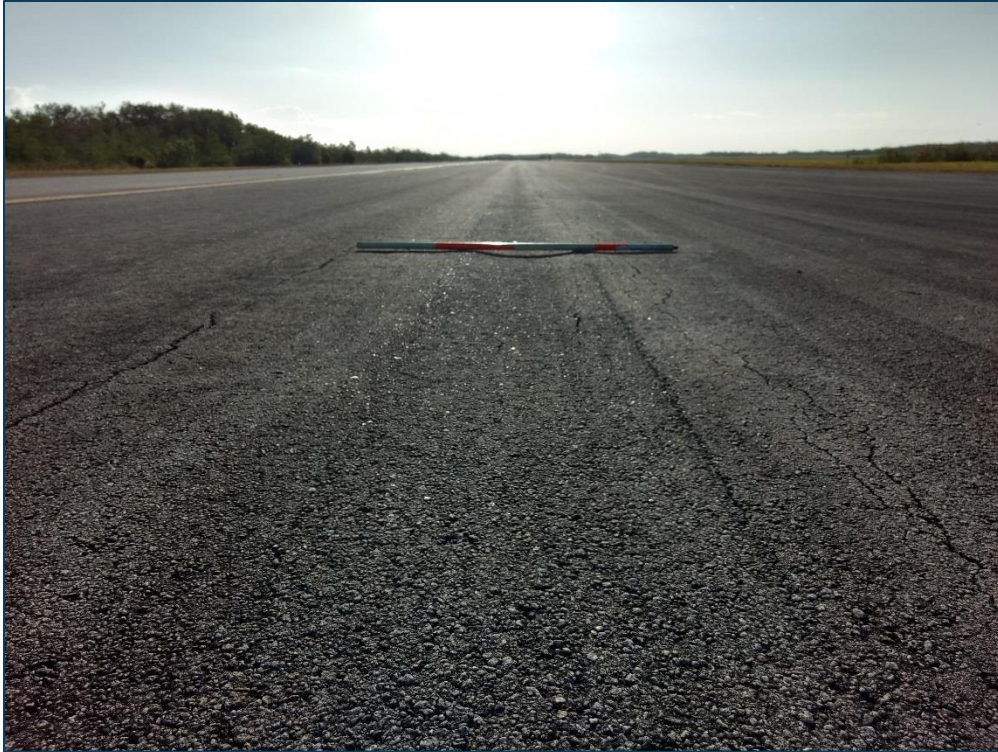
Taxiway A, Section 105, Sample Unit 237 – Low Severity (48) Longitudinal and Transverse Cracking, Low Severity (52) Raveling, Medium Severity (53) Rutting, Low Severity (56) Swelling, Low Severity (57) Weathering

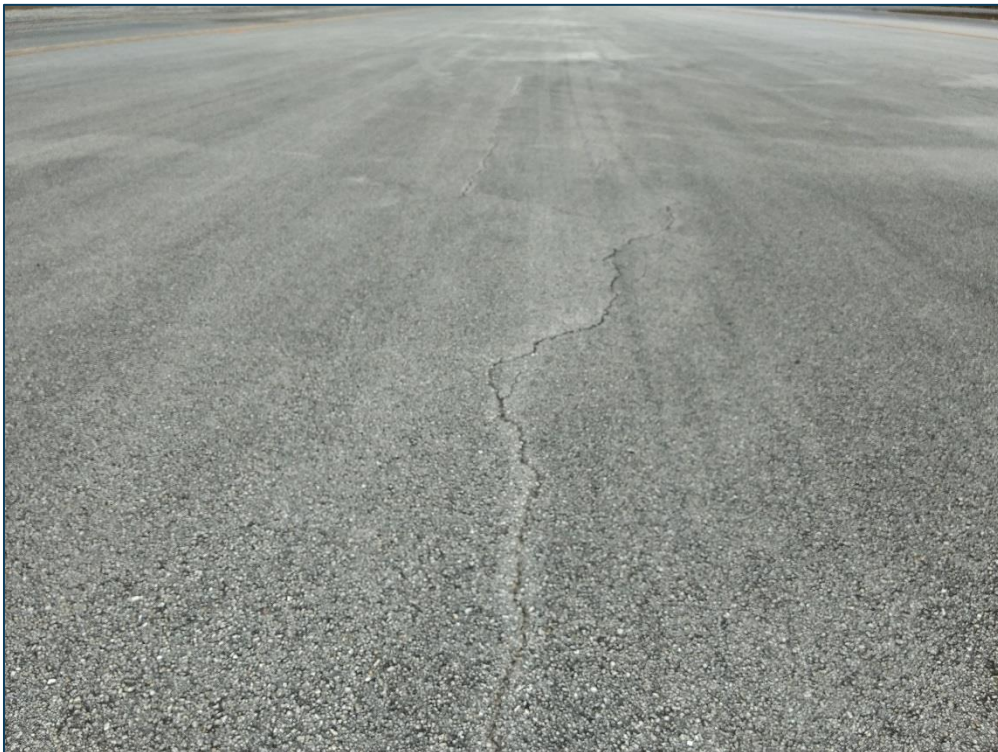
Taxiway A, Section 110, Sample Unit 106 – Low Severity (48) Longitudinal and Transverse Cracking, Low Severity (52) Raveling, Low Severity (56) Swelling

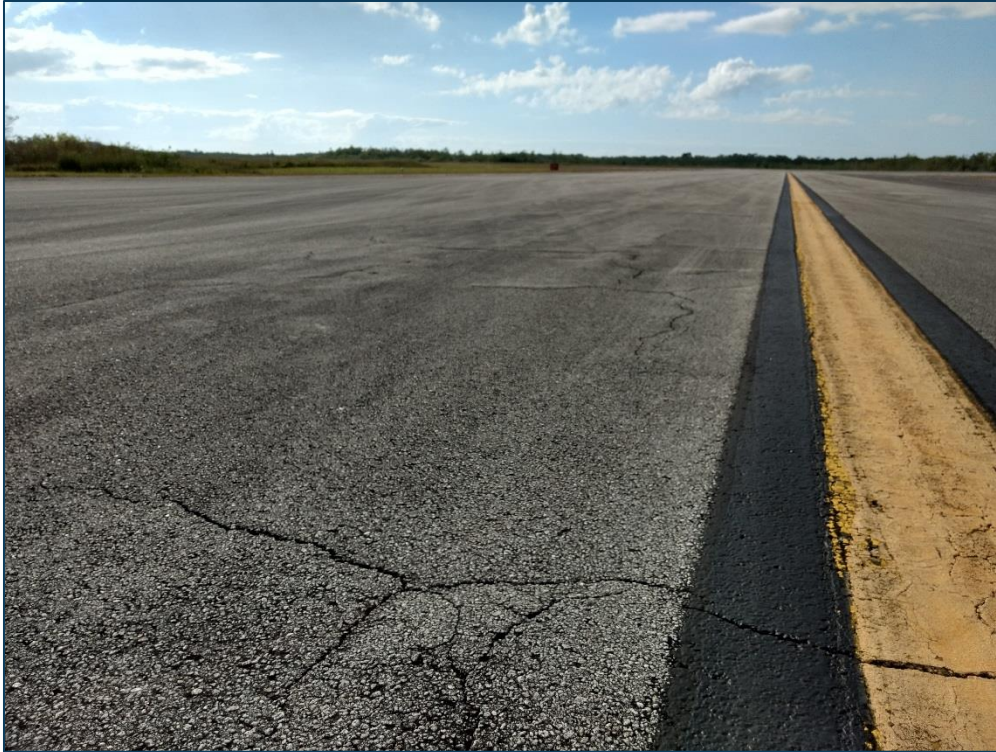
Taxiway A, Section 180, Sample Unit 111 – Low Severity (48) Longitudinal and Transverse Cracking, Low Severity (43) Block Cracking, Low Severity (52) Raveling, Low Severity (56) Swelling, Low Severity (57) Weathering

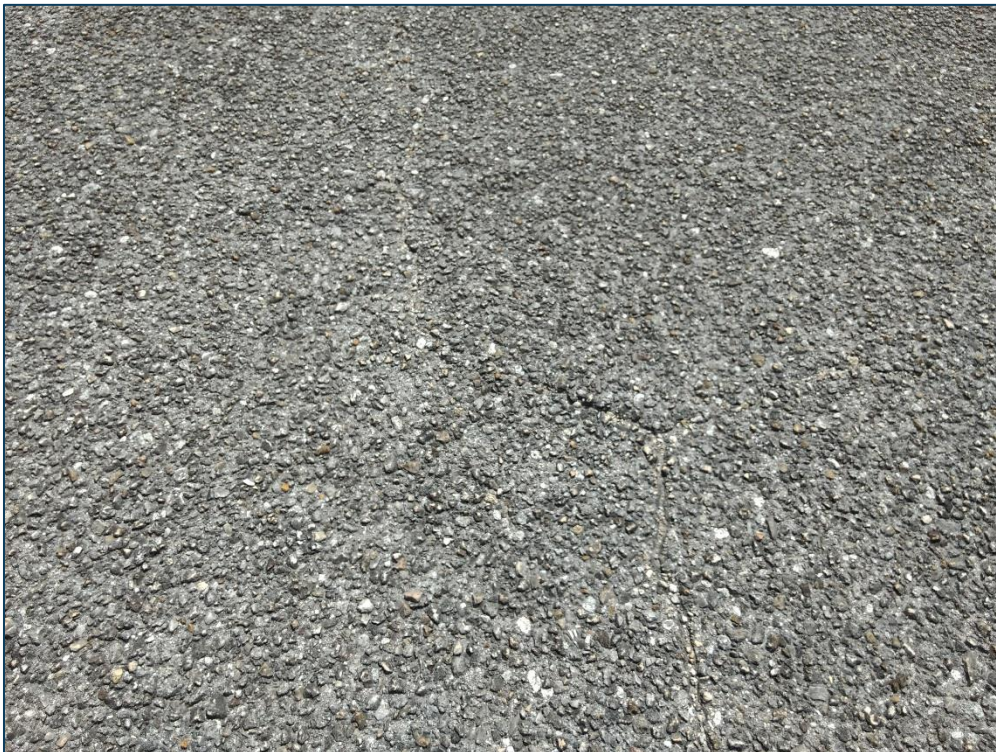
Taxiway A1, Section 120, Sample Unit 106 – Low Severity (48) Longitudinal and Transverse Cracking, Medium Severity (52) Raveling

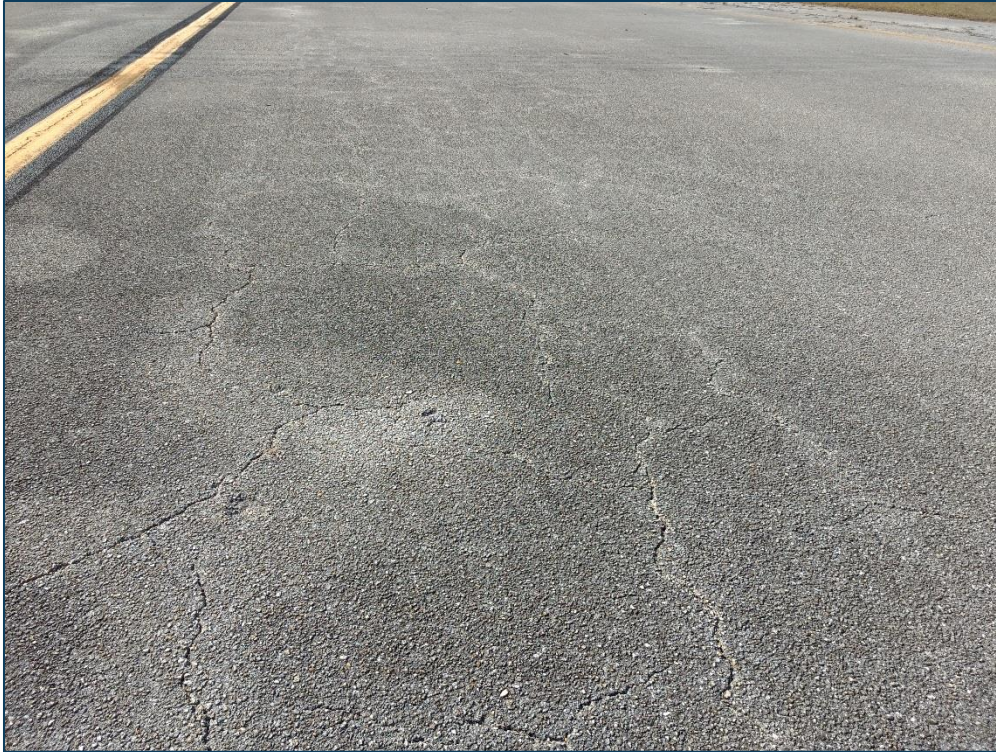
Taxiway A6, Section 170, Sample Unit 608 – Low Severity (43) Block Cracking, Low Severity (52) Raveling, Medium Severity (52) Raveling, Low Severity (56) Swelling

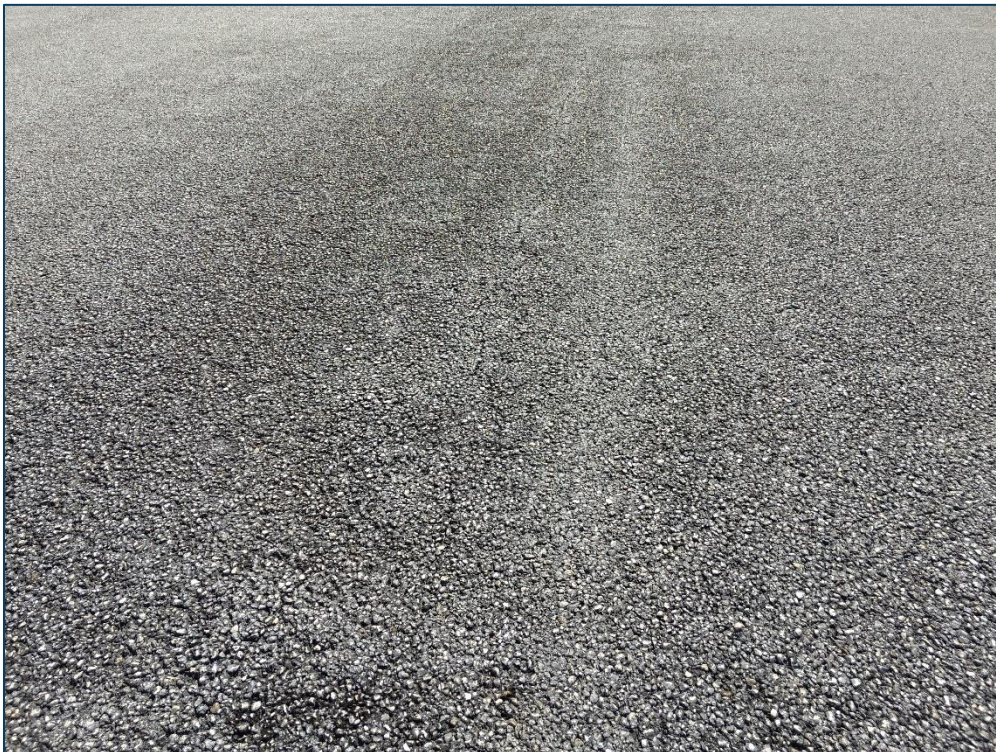
Taxiway B, Section 215, Sample Unit 105 – Low Severity (48) Longitudinal and Transverse Cracking, Low Severity (52) Raveling, Medium Severity (52) Raveling, Low Severity (56) Swelling

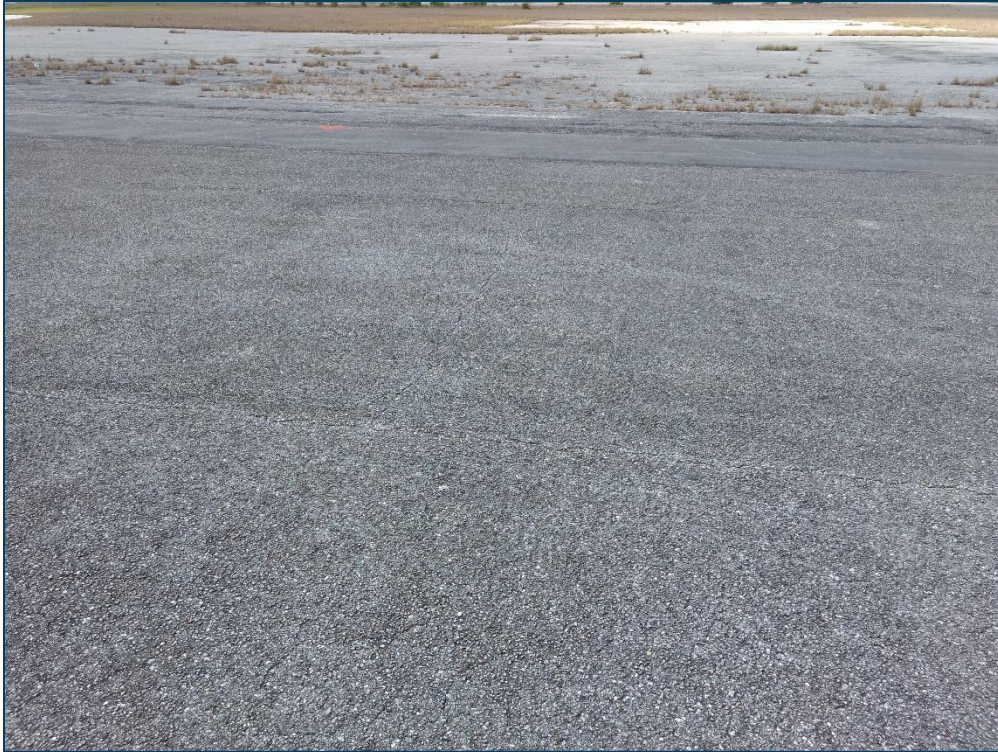
Apron North, Section 4105, Sample Unit 114 – Low Severity (48) Longitudinal and Transverse Cracking, Low Severity (52) Raveling, Medium Severity (52) Raveling

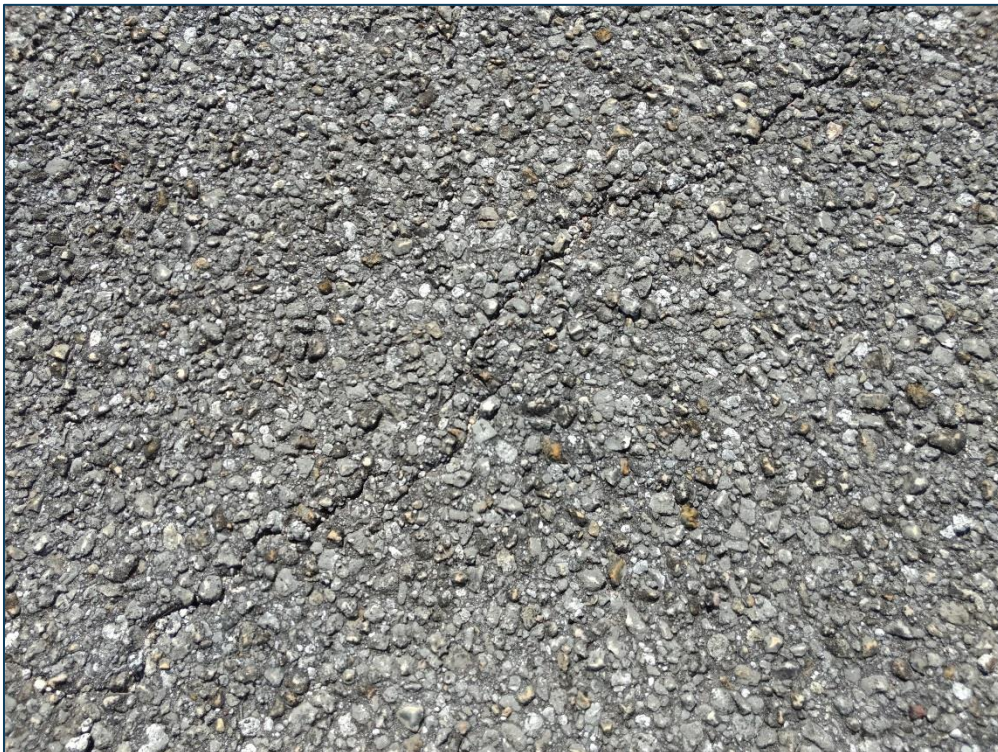
Apron North, Section 4105, Sample Unit 121 – Low Severity (48) Longitudinal and Transverse Cracking, Low Severity (52) Raveling, Medium Severity (52) Raveling
