# **Statewide Airfield Pavement Management Program**

**Airport Pavement  
Evaluation Report  
September 2017**

**Cecil Airport (VQQ)**  
General Aviation Airport  
District 2

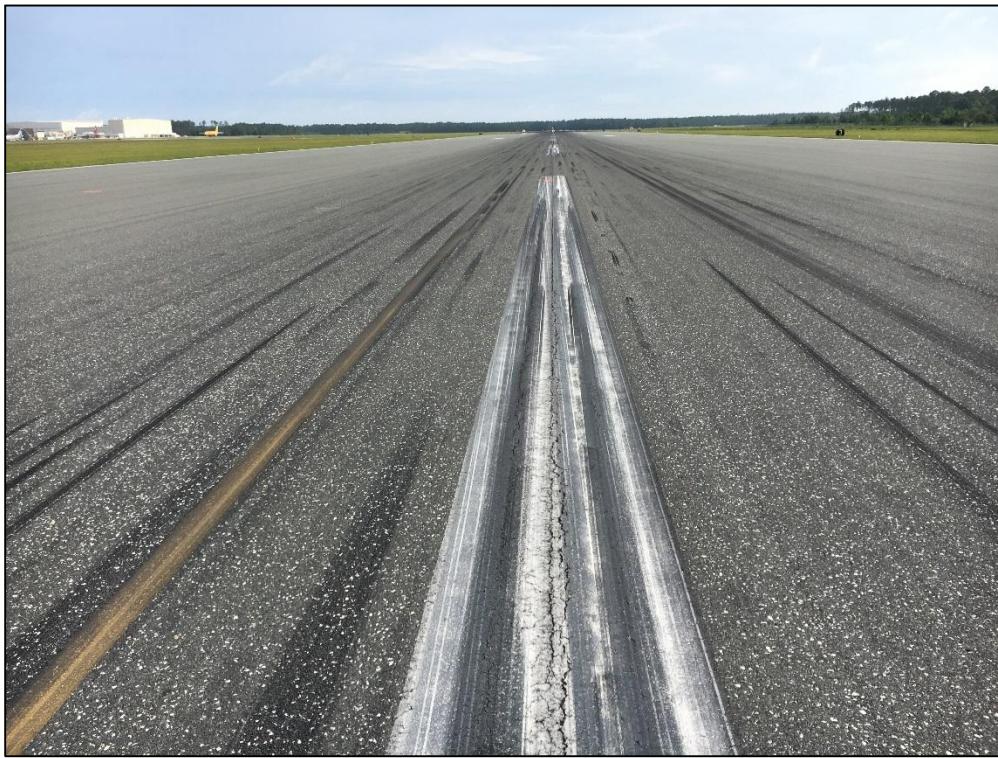
Runway 18L-36R, Section 6215, Sample Unit 538 - Low Severity (48) Longitudinal and Transverse Cracking, Low Severity (57) Weathering

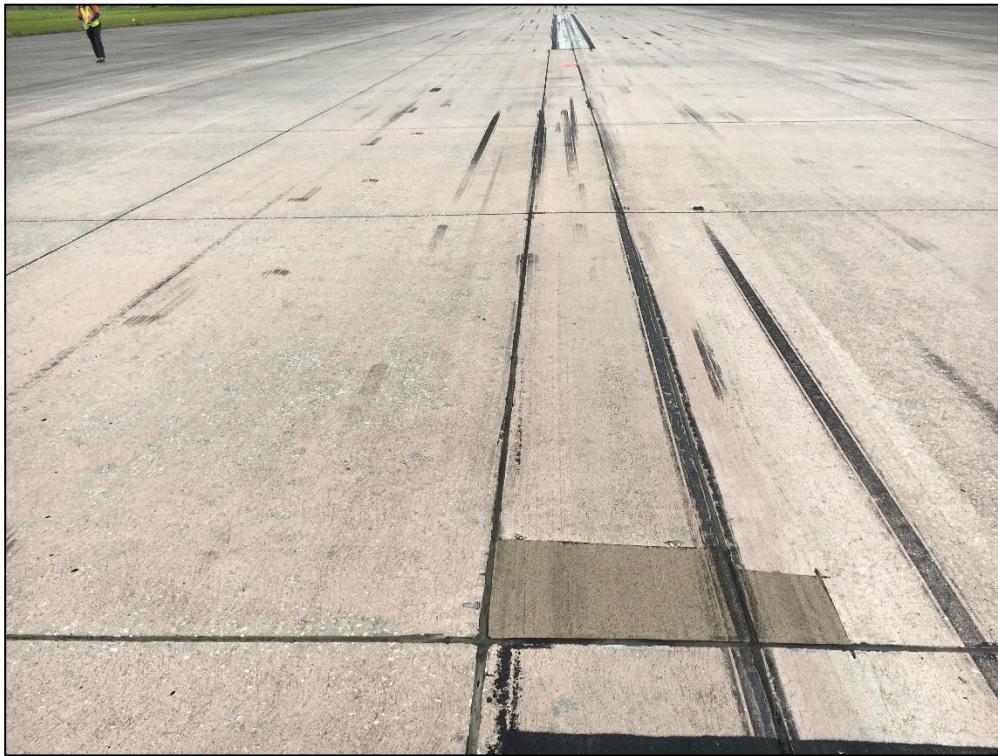
Runway 18L-36R, Section 6235, Sample Unit 388 - Low Severity (66) Small Patch

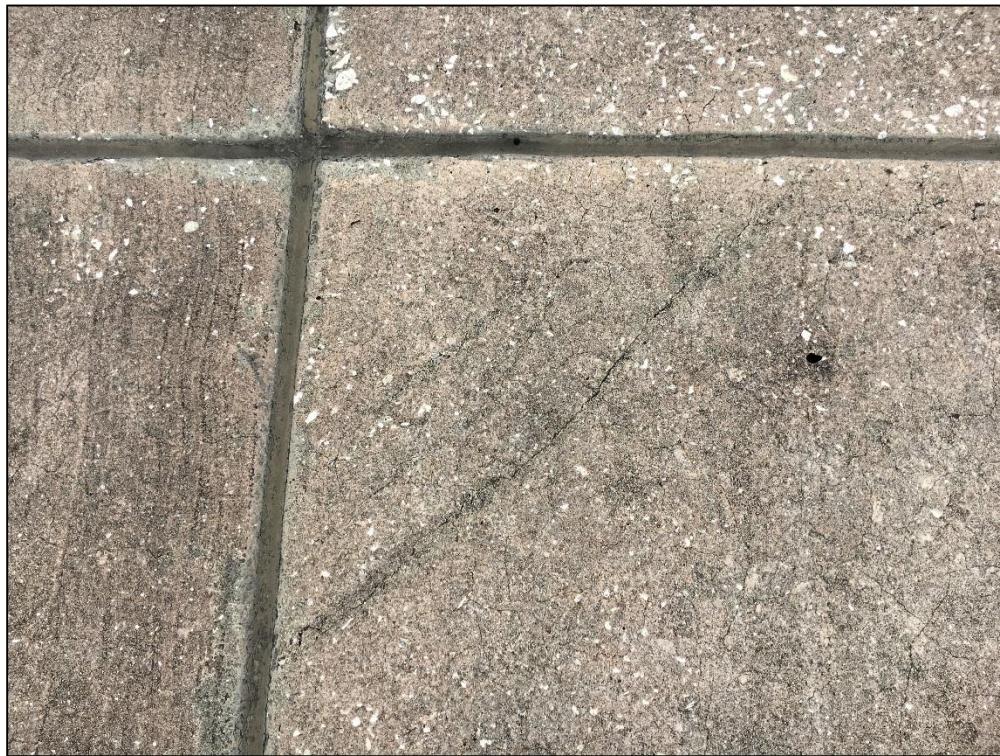
Runway 18L-36R, Section 6235, Sample Unit 425 - Low Severity (62) Corner Break, (73) Shrinkage Cracking

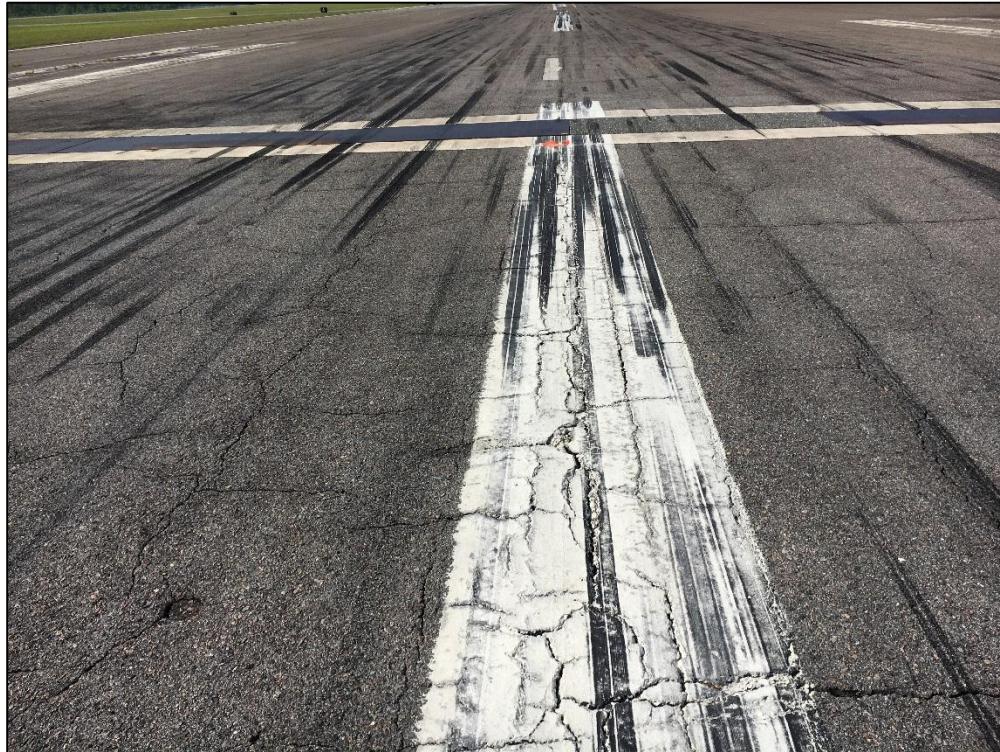
Runway 18R-36L, Section 6115, Sample Unit 216 - Low Severity (41) Alligator Cracking, Medium Severity (43) Block Cracking,  
Medium Severity (52) Raveling, Low Severity (56) Swelling

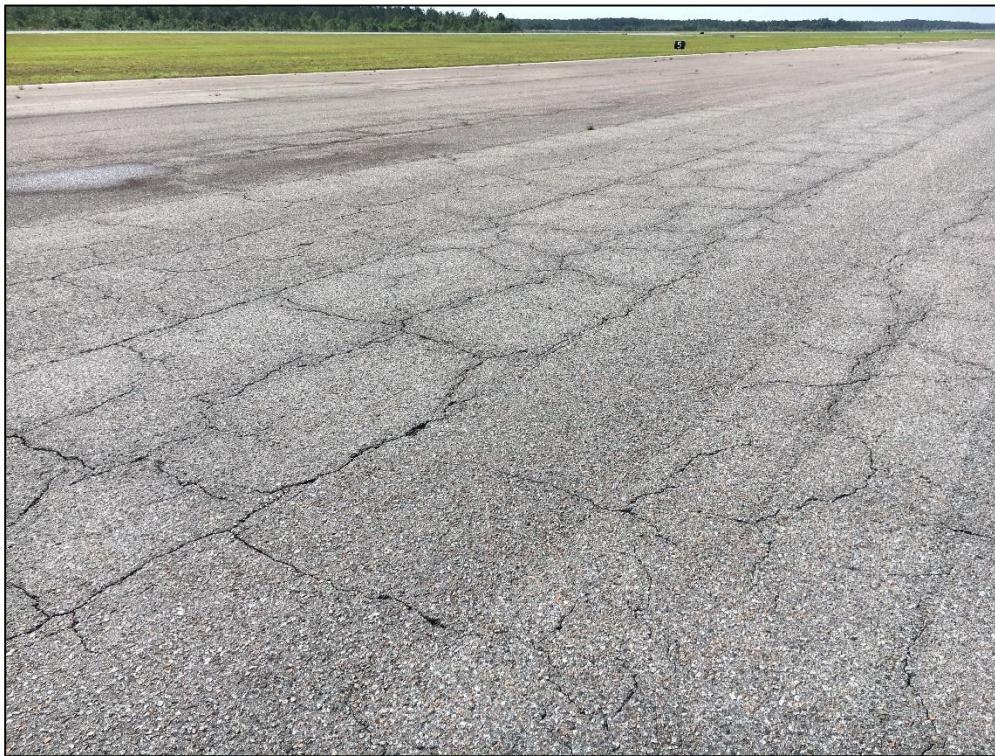
Runway 18R-36L, Section 6115, Sample Unit 229 - Medium Severity (43) Block Cracking, Low Severity (45) Depression, Medium Severity (52) Raveling, Low Severity (53) Rutting, Low Severity (56) Swelling

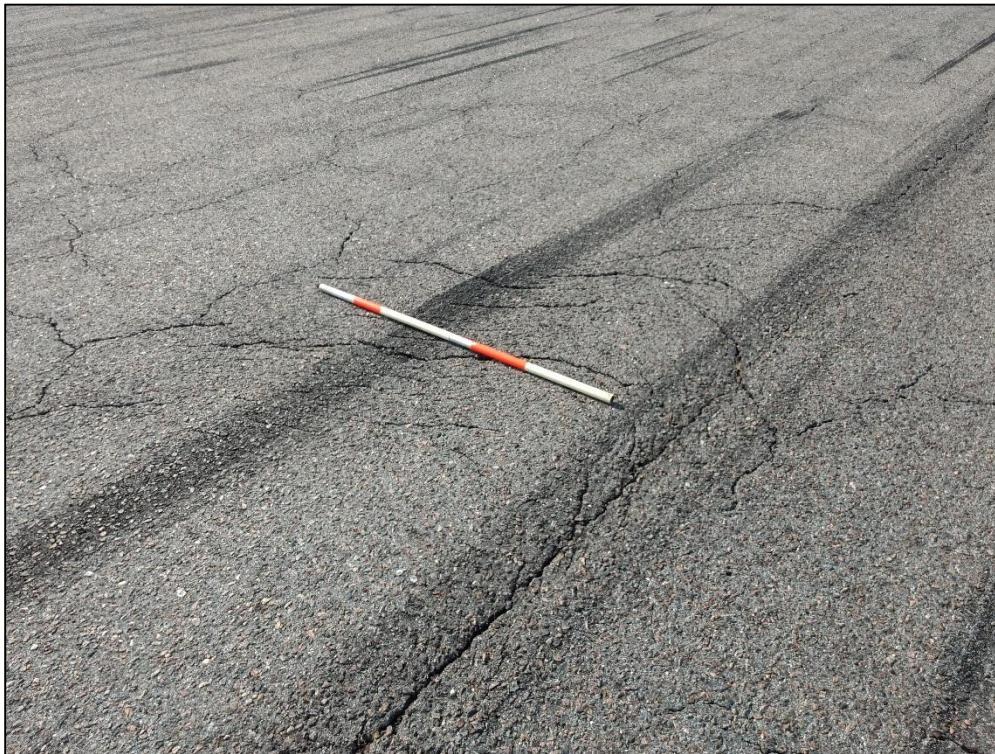
Runway 18R-36L, Section 6115, Sample Unit 313 - Medium Severity (43) Block Cracking, Medium Severity (52) Raveling, (55) Slippage Cracking

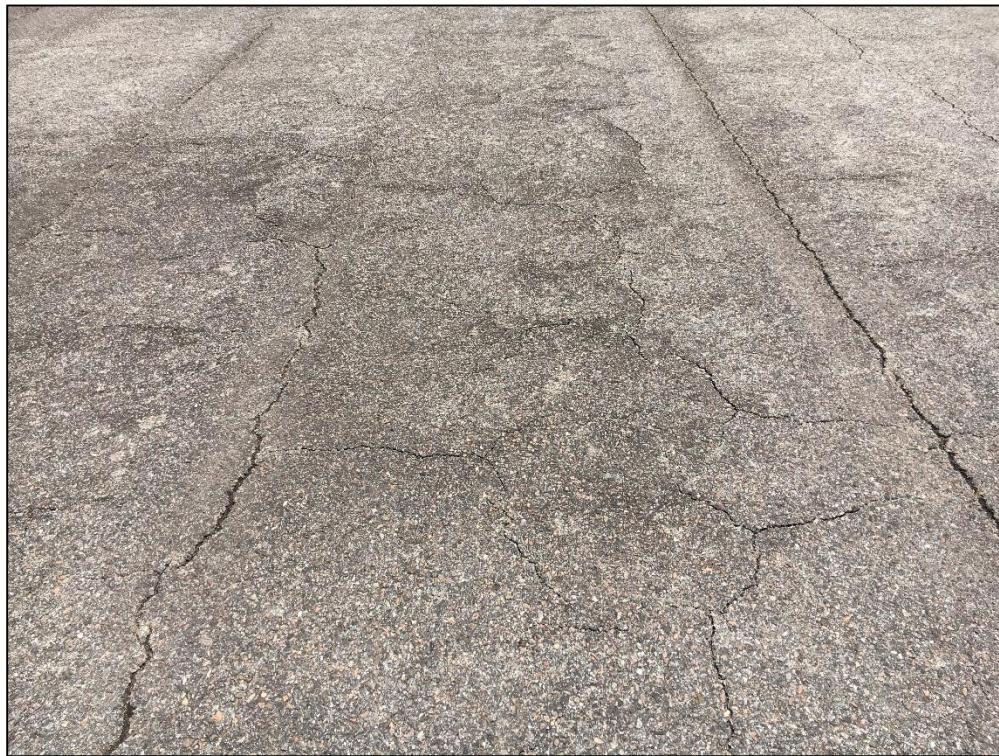
Runway 18R-36L, Section 6120, Sample Unit 169 - Medium Severity (43) Block Cracking, Medium Severity (52) Raveling, Low Severity (56) Swelling

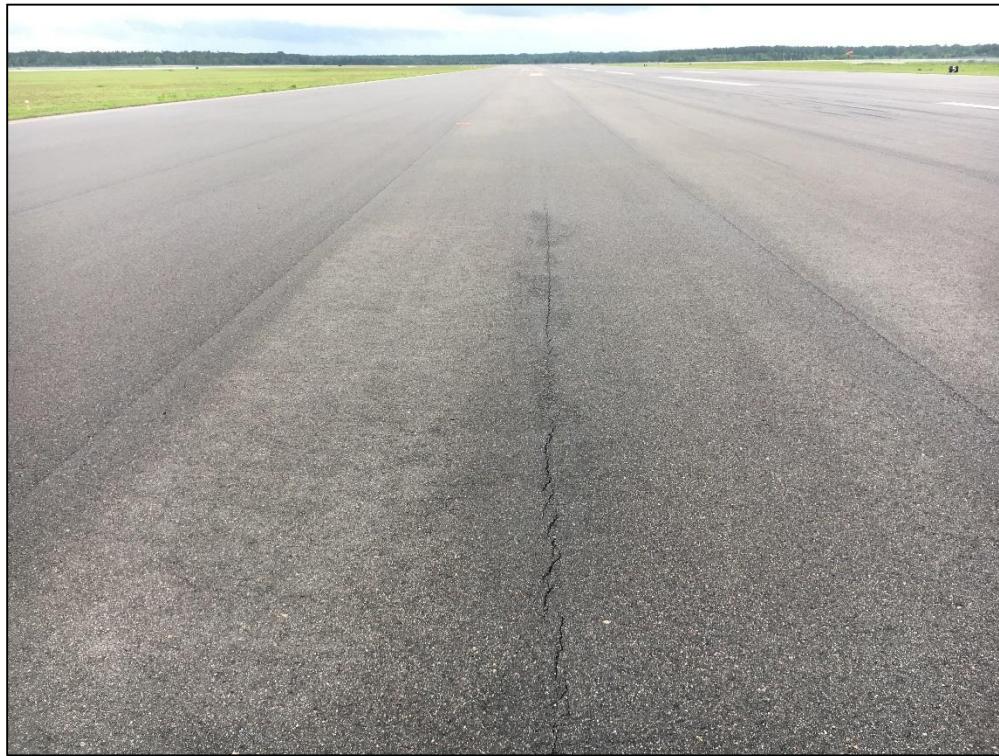
Runway 9R-27L, Section 6315, Sample Unit 328 - Low Severity (48) Longitudinal and Transverse Cracking, Low Severity (57) Weathering

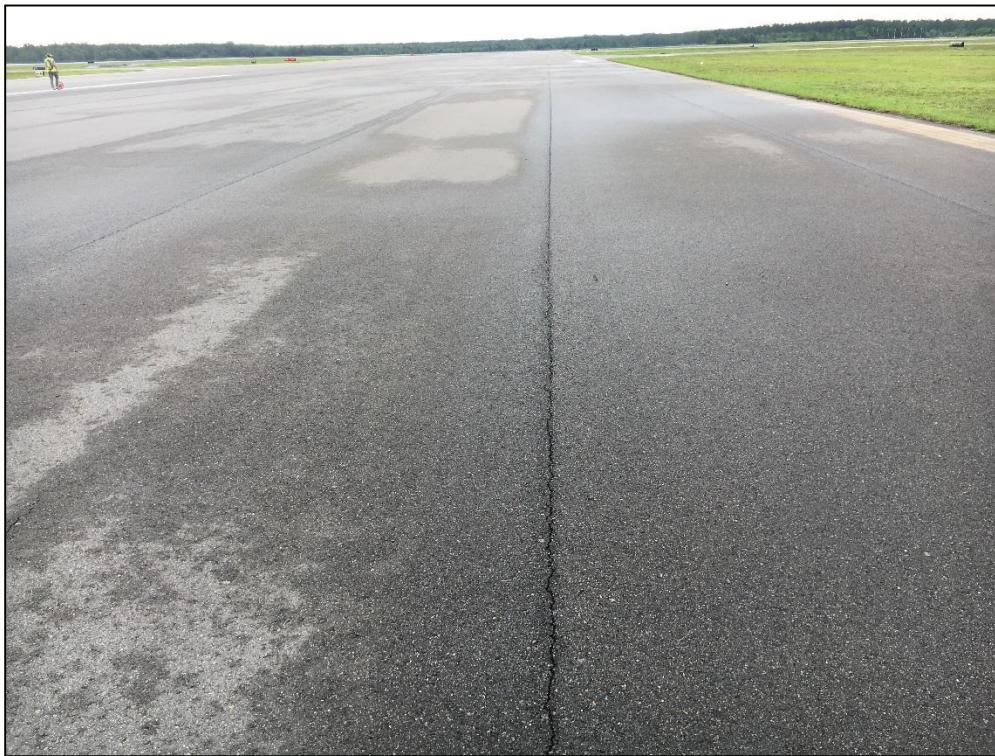
Runway 9R-27L, Section 6320, Sample Unit 741 - Low Severity (48) Longitudinal and Transverse Cracking, Low Severity (57) Weathering

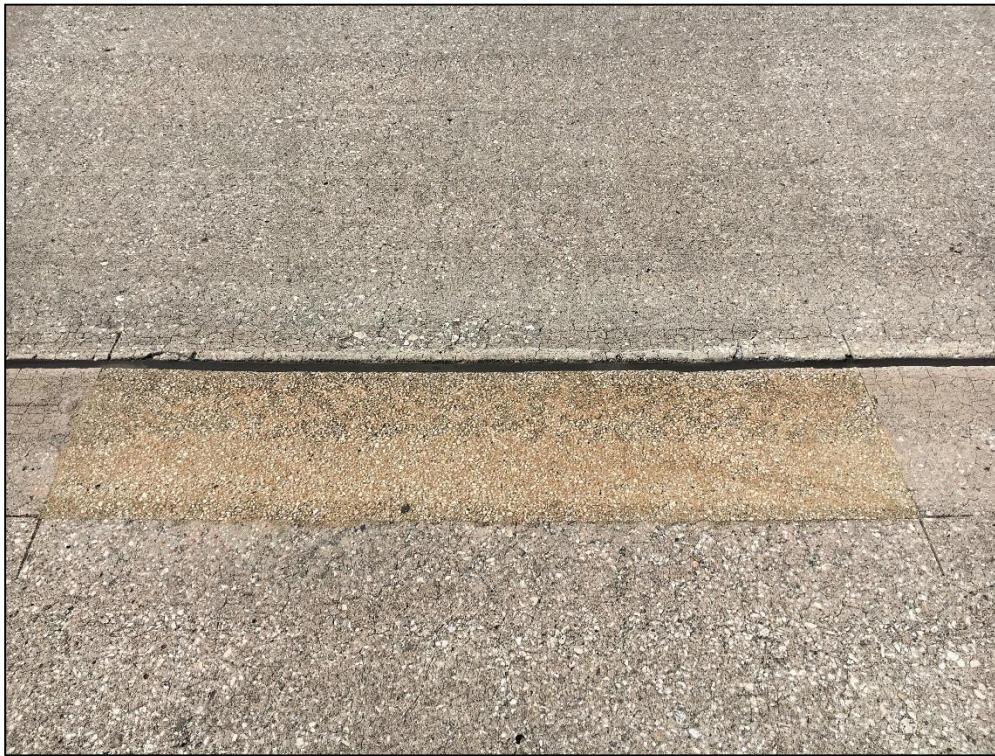
Runway 9R-27L, Section 6335, Sample Unit 382 - Low Severity (66) Small Patch, (73) Shrinkage Cracking

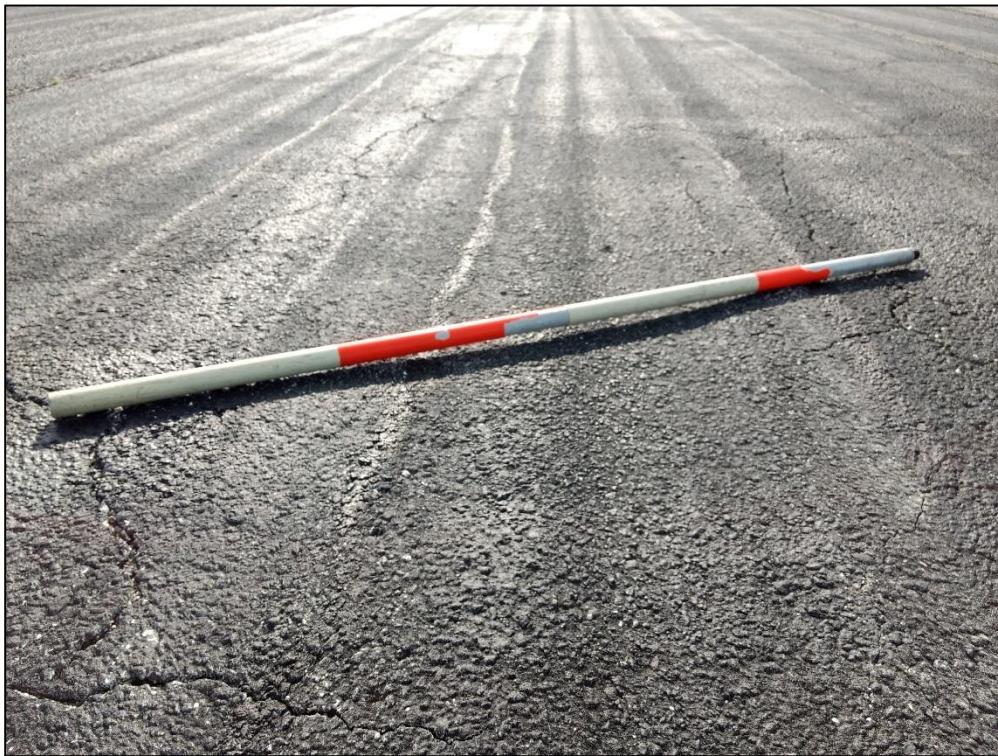
Runway 9L-27R, Section 6420, Sample Unit 709 – Low Severity (43) Block Cracking, Medium Severity (52) Raveling, Low Severity (56) Swelling

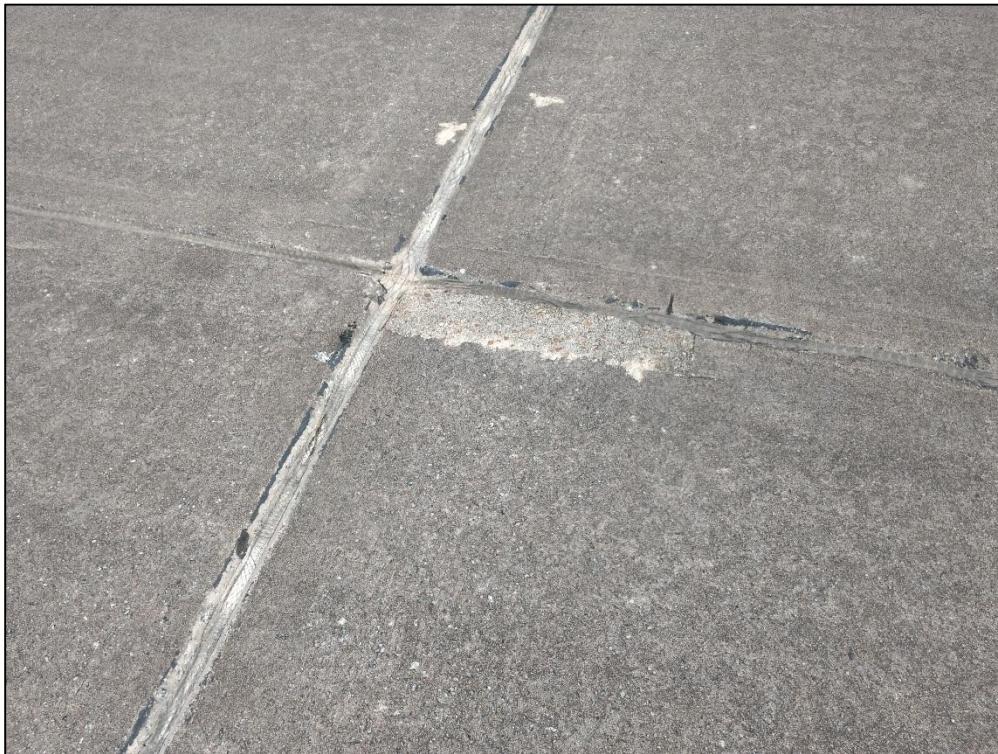
Runway 9L-27R, Section 6410, Sample Unit 105 - Medium Severity (65) Joint Seal Damage, Medium Severity (66) Small Patch,  
Low Severity (71) Faulting

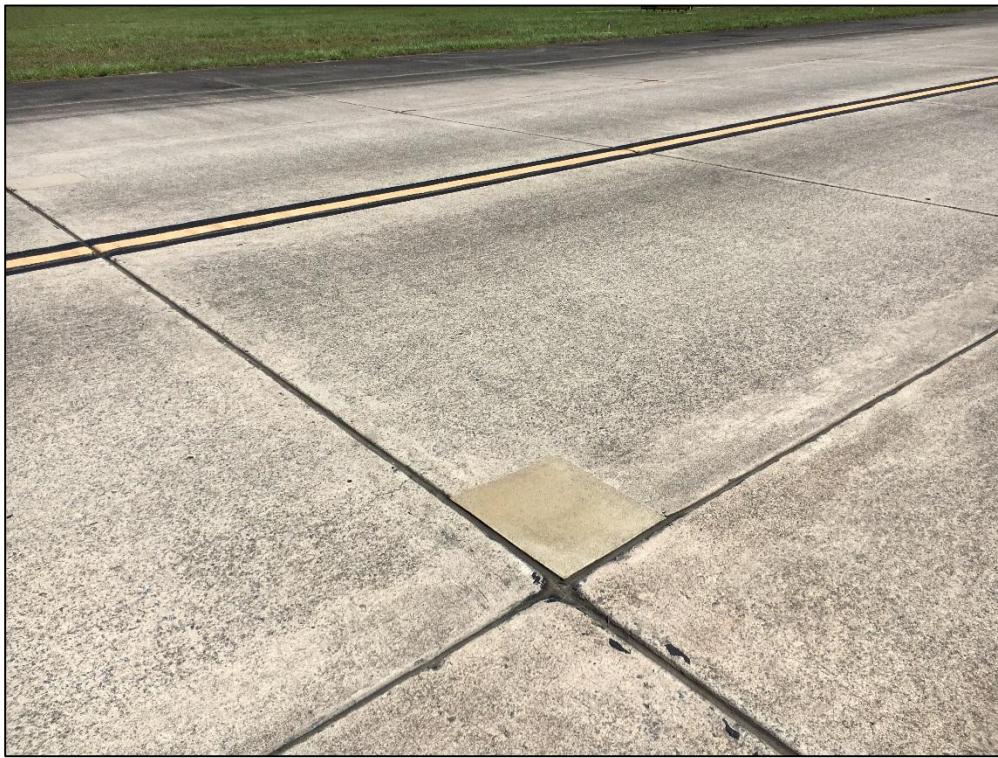
Taxiway A, Section 130, Sample Unit 131 - Low Severity (66) Small Patch, (73) Shrinkage Cracking

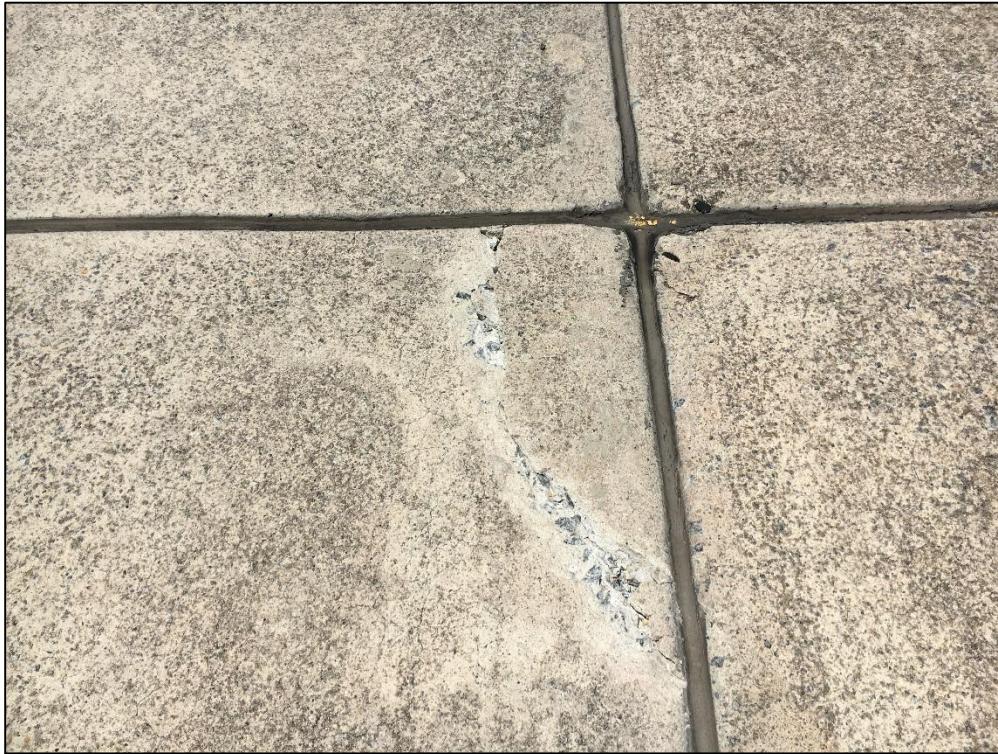
Taxiway A, Section 130, Sample Unit 158 - (73) Shrinkage Cracking, Medium Severity (75) Corner Spall

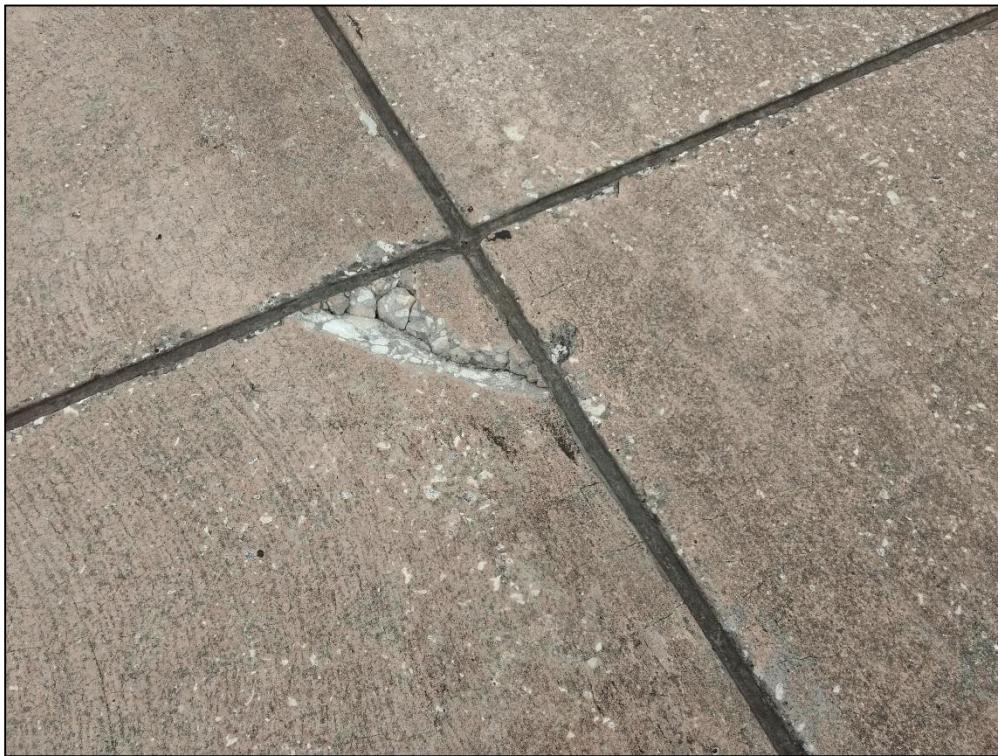
Taxiway A, Section 110, Sample Unit 266 - (73) Shrinkage Cracking, High Severity (75) Corner Spall

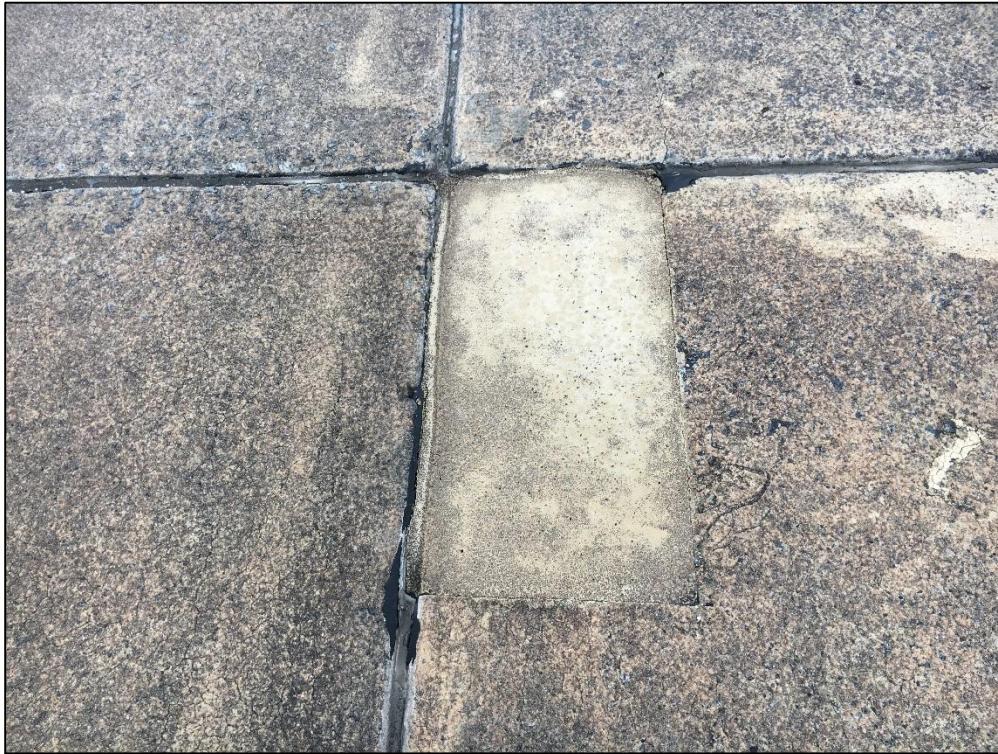
Taxiway B, Section 205, Sample Unit 148 - Low Severity (66) Small Patch, (73) Shrinkage Cracking

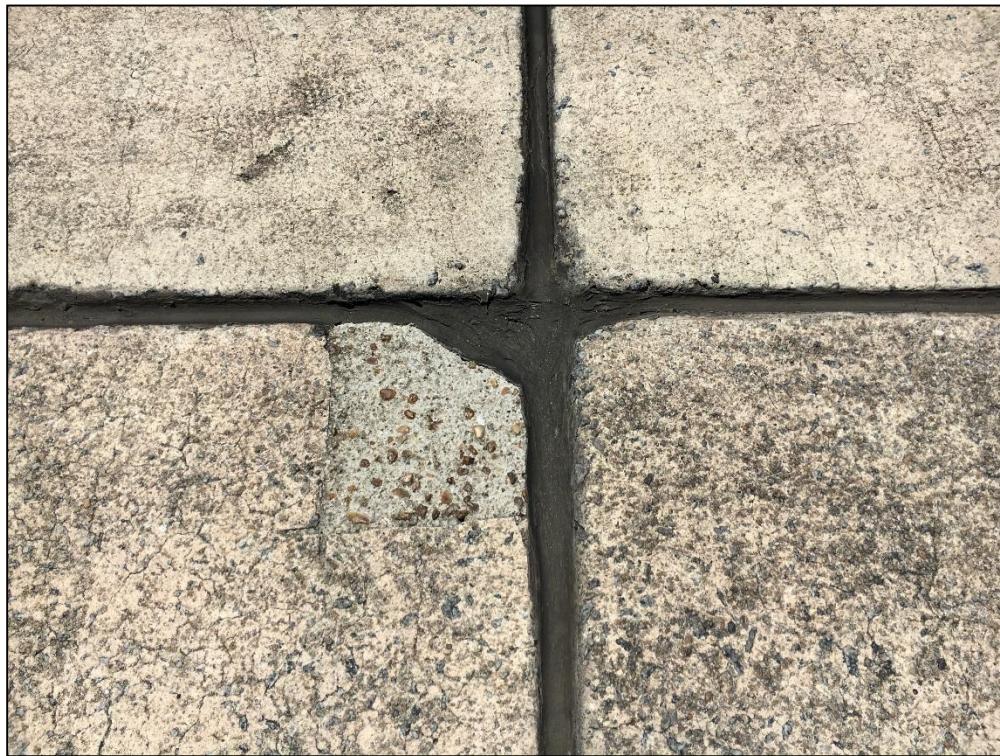
Taxiway B, Section 205, Sample Unit 177 - Medium Severity (66) Small Patch, (73) Shrinkage Cracking

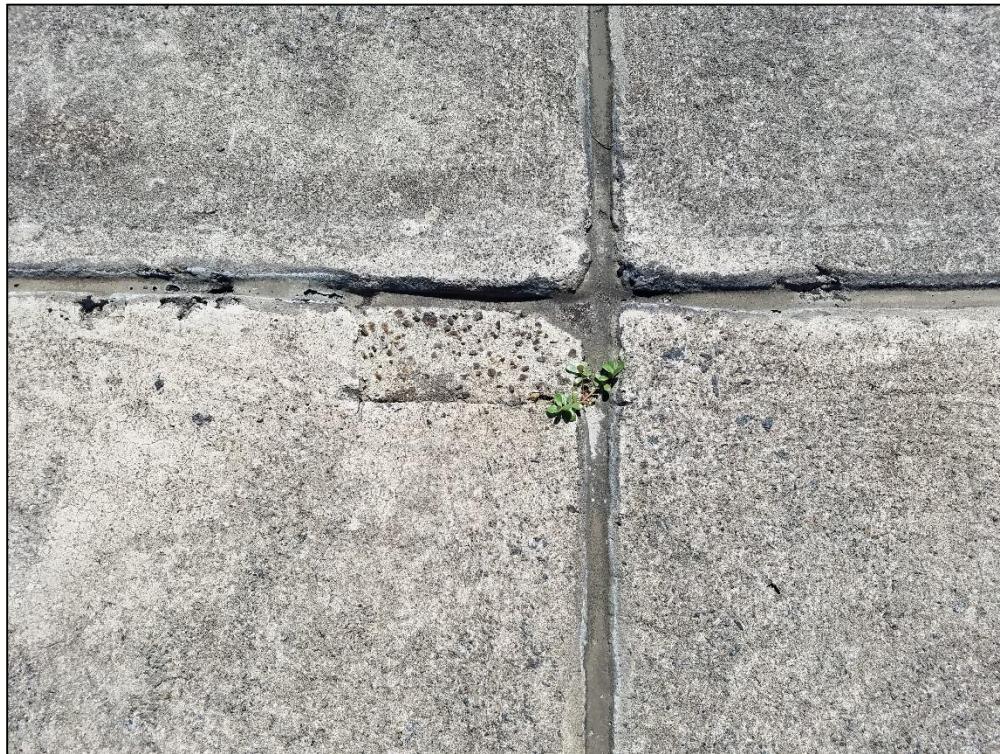
Taxiway C, Section 305, Sample Unit 117 - Low Severity (65) Joint Seal Damage, Medium Severity (66) Small Patch, (73) Shrinkage Cracking

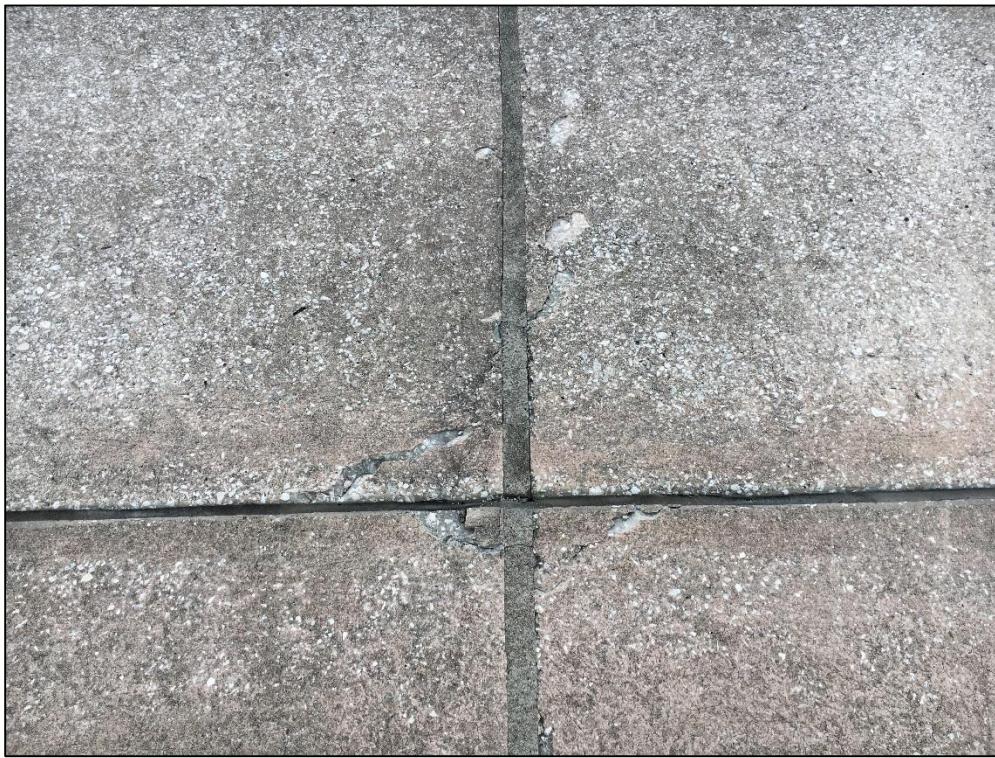
Taxiway D, Section 405, Sample Unit 468 - Low Severity (65) Joint Seal Damage, (73) Shrinkage Cracking, Low Severity (75) Corner Spall

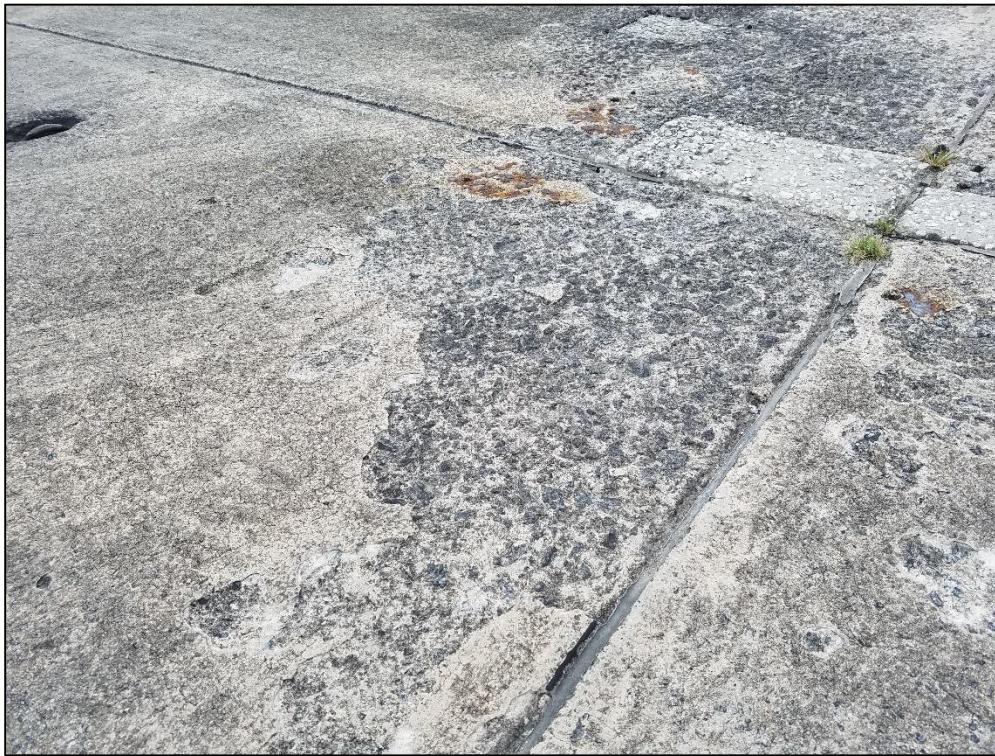
Apron N, Section 4125, Sample Unit 473 - Low Severity (65) Joint Seal Damage, Low Severity (66) Small Patch, Medium Severity (66) Small Patch, Medium Severity (70) Scaling

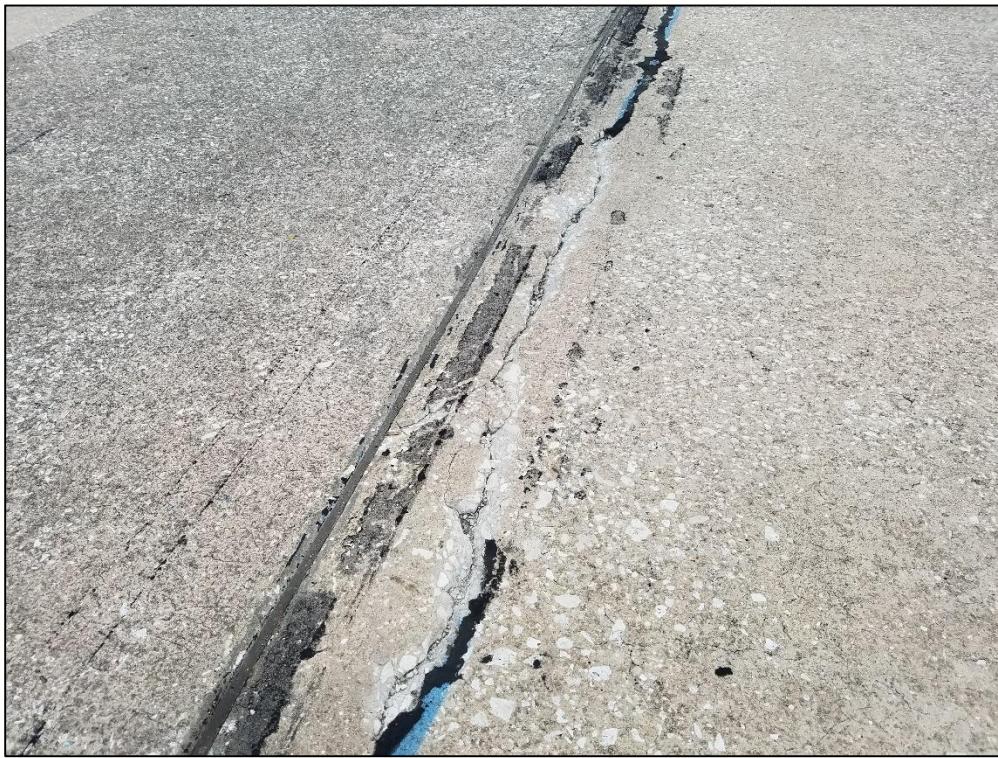
Apron N, Section 4120, Sample Unit 288 - Low Severity (65) Joint Seal Damage, Medium Severity (73) Joint Spall

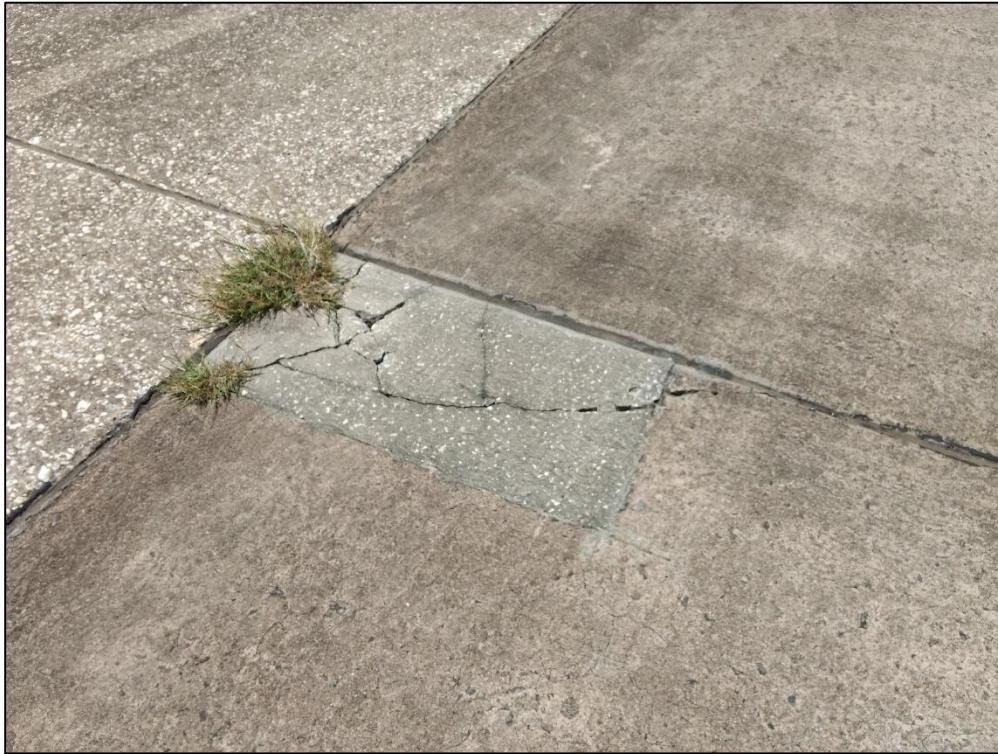
Apron W, Section 4270, Sample Unit 178 – Medium Severity (66) Small Patch, (73) Shrinkage Cracking

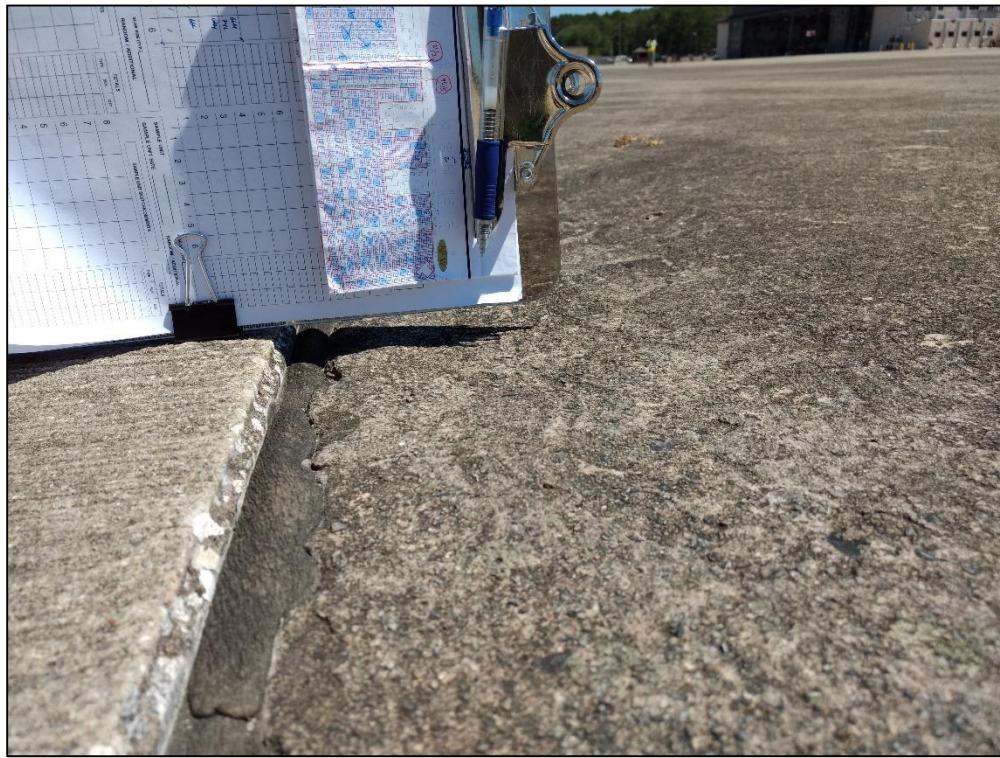
Apron W, Section 4270, Sample Unit 178 – Medium Severity (71) Faulting
