Florida Department of Transportation

Statewide Airfield Pavement Management Program

Summary of Everglades Airpark

Everglades Airpark was inspected in March 2017 - the overall weighted PCI value was 57, a condition rating of Fair. The results of the maintenance, repair, and major rehabilitation analysis identified \$201,250 in localized M&R needs based on current conditions and a 10-Year major rehabilitation need of \$1,634,000 based on forecasted conditions. The current major rehabilitation needs based on the latest inspection consist of \$1,017,000 for pavements below critical condition.

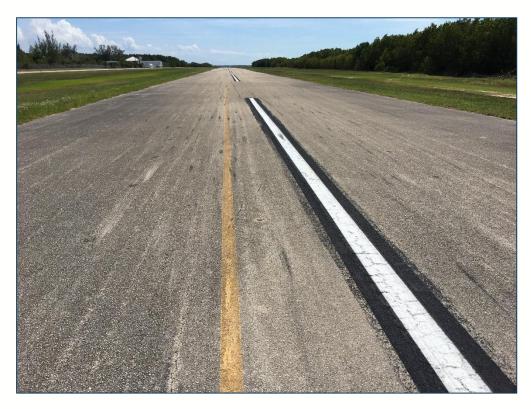
Runway 15-33, Section 6105, Sample Unit 101 - Low Severity (43) Block Cracking, Low Severity (48) Longitudinal and Transverse Cracking, Low Severity (52) Raveling, Medium Severity (52) Raveling

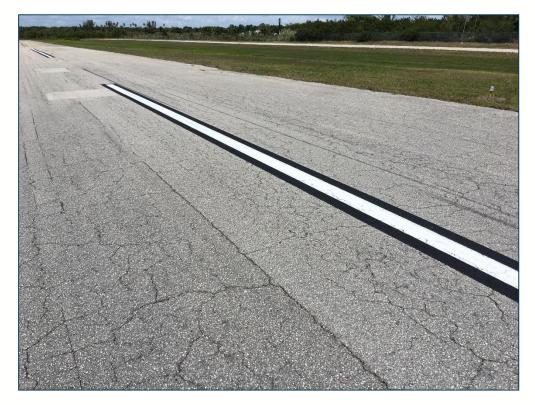
Runway 15-33, Section 6110, Sample Unit 109 - Low Severity (43) Block Cracking, Medium Severity (43) Block Cracking, Low Severity (50) Patching, Low Severity (52) Raveling, Medium Severity (52) Raveling

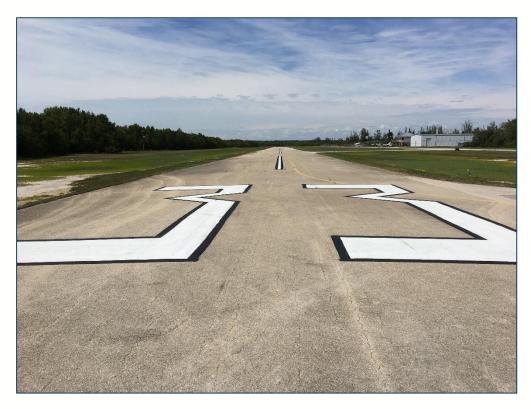
Runway 15-33, Section 6115, Sample Unit 122 – Low Severity (43) Block Cracking, Low Severity (48) Longitudinal and Transverse Cracking, Low Severity (52) Raveling, Medium Severity (52) Raveling

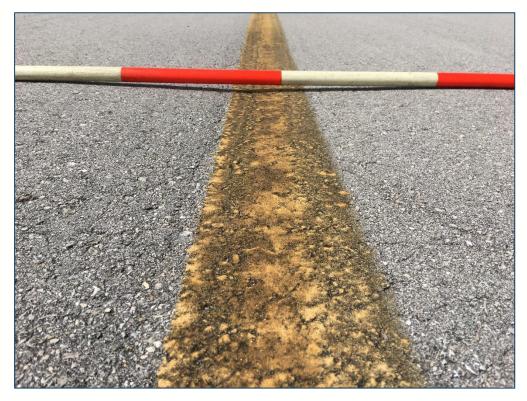
Taxiway A, Section 130, Sample Unit 103 - Low Severity (45) Depression, Low Severity (57) Weathering

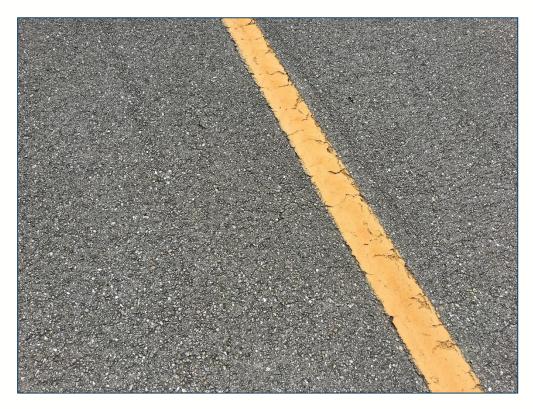
Taxiway A, Section 110, Sample Unit 204 – Low Severity (48) Longitudinal and Transverse Cracking, Low Severity (52) Raveling, Medium Severity (52) Raveling

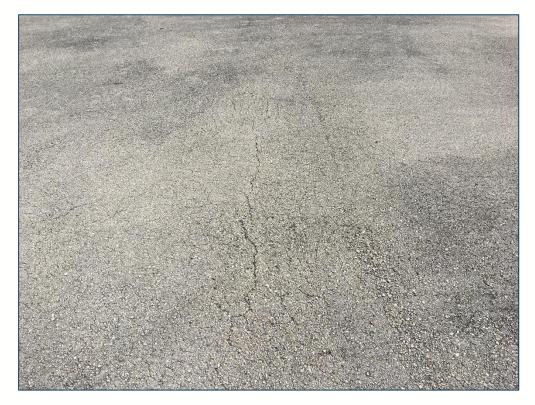
Run Up Apron RW33, Section 4120, Sample Unit 100 – Low Severity (48) Longitudinal and Transverse Cracking, Low Severity (52) Raveling, Low Severity (57) Weathering

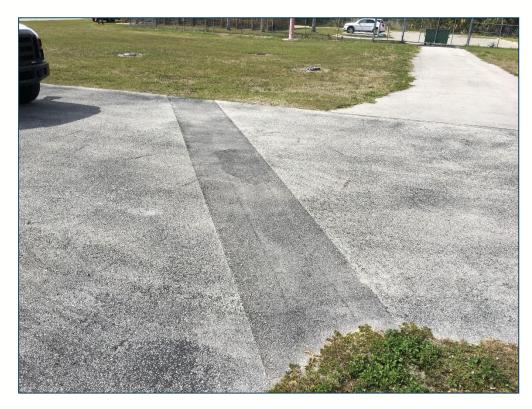
Apron, Section 4110, Sample Unit 100 - Low Severity (48) Longitudinal and Transverse Cracking, Low Severity (50) Patching, Low Severity (52) Raveling, Low Severity (57) Weathering

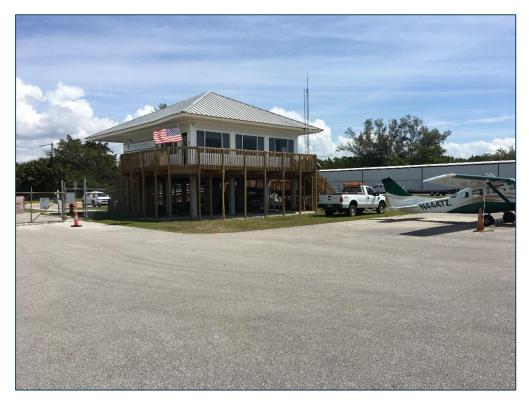
Apron, Section 4105, Sample Unit 101 – Low Severity (48) Longitudinal and Transverse Cracking, Low Severity (52) Raveling, Low Severity (57) Weathering
