AVIATION AND SPACEPORTS OFFICE

## Statewide Airfield Pavement Management Program

Arcadia Municipal Airport was inspected in November 2016 – the overall weighted PCI value was 60, a condition rating of Fair. The results of the maintenance, repair, and major rehabilitation analysis identified \$105.270 in localized M&R needs based on current conditions and a 10-Year major rehabilitation need of \$4,091,000 based on forecasted conditions. The current major rehabilitation needs based on the latest inspection consist of \$4,091,000 for pavements below critical condition.

Arcadia Municipal Airport (X06)

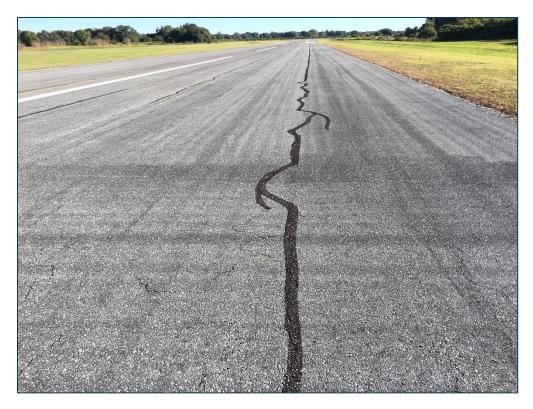
Runway 6-24, Section 6105, Sample Unit 137 – Low Severity (48) Longitudinal and Transverse Cracking, Low Severity (52) Raveling, Low Severity (57) Weathering

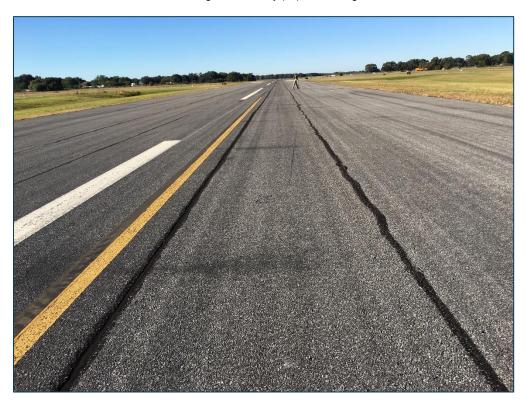
Runway 6-24, Section 6105, Sample Unit 134 – Low Severity (48) Longitudinal and Transverse Cracking, Low Severity (52) Raveling, Low Severity (57) Weathering

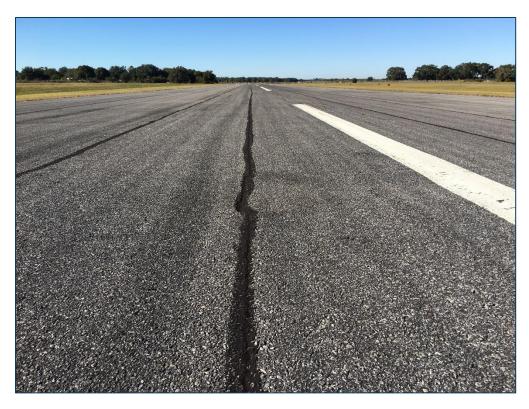
Runway 6-24, Section 6105, Sample Unit 118 – Low Severity (45) Depression, Low Severity (48) Longitudinal and Transverse Cracking, Low Severity (52) Raveling, Low Severity (57) Weathering

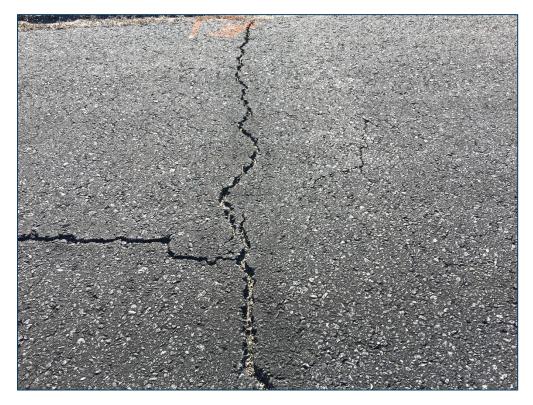
Runway 6-24, Section 6105, Sample Unit 106 – Low and Medium Severity (48) Longitudinal and Transverse Cracking, Low Severity (57) Weathering, Low Severity (52) Raveling

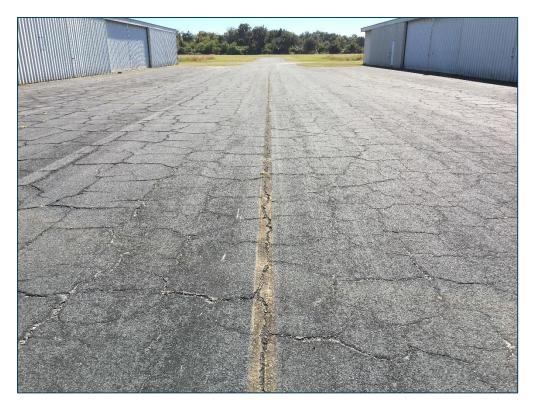
Hangar Taxiway, Section 230, Sample Unit 101 – Medium Severity (43) Block Cracking, High Severity (43) Block Cracking, Low Severity (52) Raveling, Medium Severity (52) Raveling

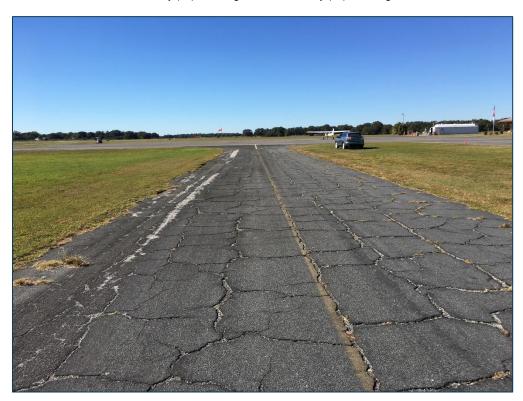
Hangar Taxiway, Section 210, Sample Unit 101 - Medium Severity (43) Block Cracking, High Severity (43) Block Cracking, Low Severity (52) Raveling, Medium Severity (52) Raveling

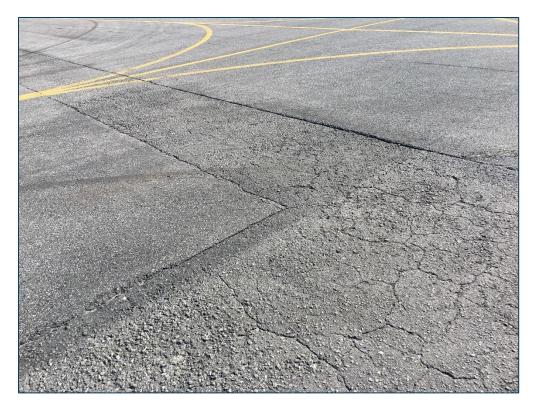
Taxiway, Section 115, Sample Unit 300 – Low Severity (48) Longitudinal and Transverse Cracking, Medium Severity (50) Patching, Low Severity (52) Raveling, Low Severity (57) Weathering

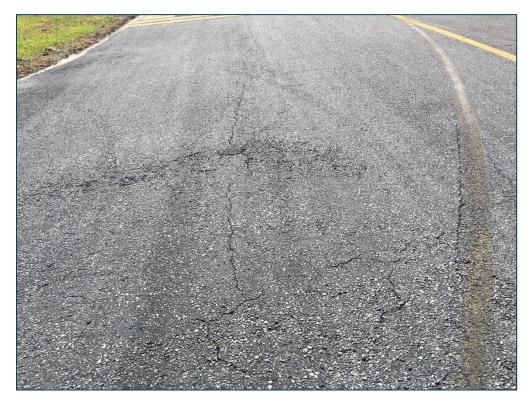
Taxiway, Section 110, Sample Unit 201 – Low Severity (48) Longitudinal and Transverse Cracking, Low Severity (52) Raveling, Low Severity (57) Weathering

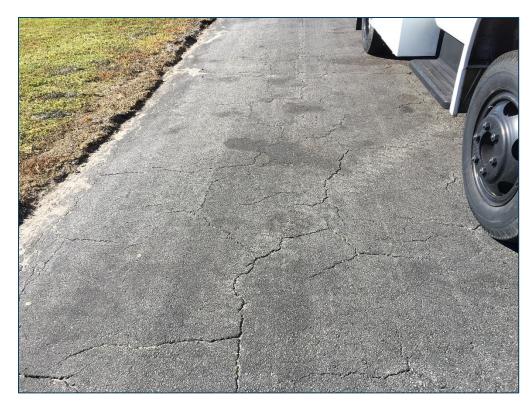
Apron, Section 4110, Sample Unit 401 - Low Severity (43) Block Cracking, Low Severity (57) Weathering

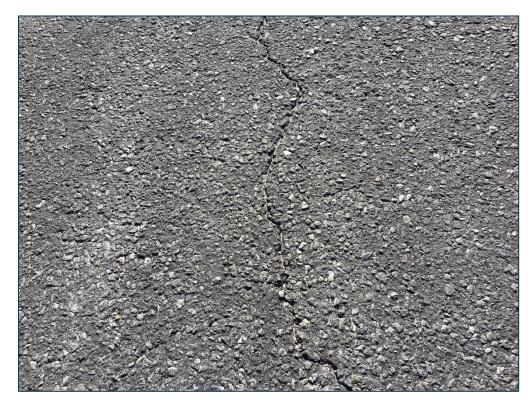
Apron, Section 4105, Sample Unit 100 – Low Severity (48) Longitudinal and Transverse Cracking, Low Severity (52) Raveling, Low Severity (57) Weathering
