Florida Department of Transportation

Statewide Airfield Pavement Management **Program**

Summary of Lake Wales Municipal Airport

Lake Wales Municipal Airport was inspected in March 2017 – the overall weighted PCI value was 73, a condition rating of Satisfactory. The results of the maintenance, repair, and major rehabilitation analysis identified \$724,810 in localized M&R needs based on current conditions and a 10-Year major rehabilitation need of \$4,676,000 based on forecasted conditions. The current major rehabilitation needs based on the latest inspection consist of \$4,676,000 for pavements below critical condition.

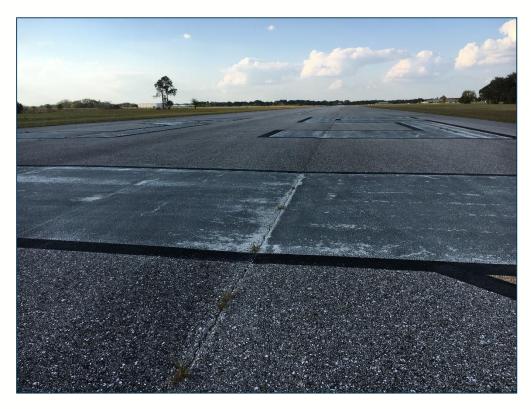
Runway 17-35, Section 6205, Sample Unit 103 - Low and Medium Severity (48) Longitudinal and Transverse Cracking, Low Severity (52) Raveling

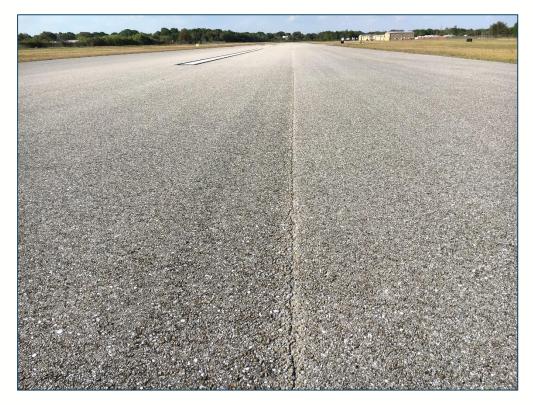
Runway 17-35, Section 6205, Sample Unit 142 - Low and Medium Severity (48) Longitudinal and Transverse Cracking, Low Severity (52) Raveling, Medium Severity (52) Raveling

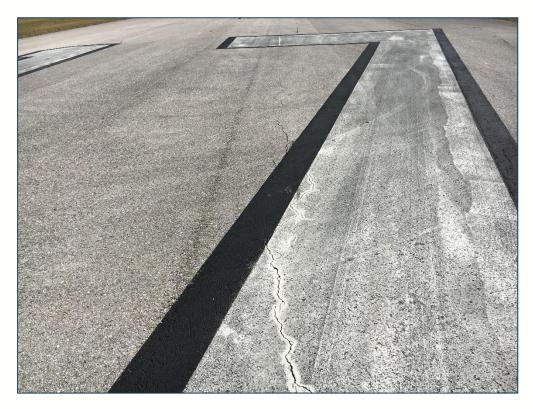
Runway 17-35, Section 6205, Sample Unit 179 - Low and Medium Severity (48) Longitudinal and Transverse Cracking, Low Severity (52) Raveling, Medium Severity (52) Raveling

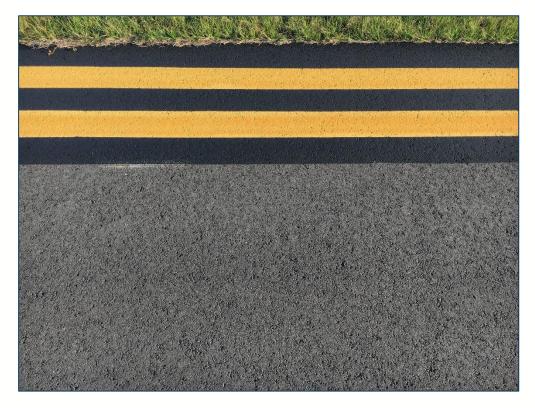
Taxiway A, Section 130, Sample Unit 114 - Low Severity (57) Weathering

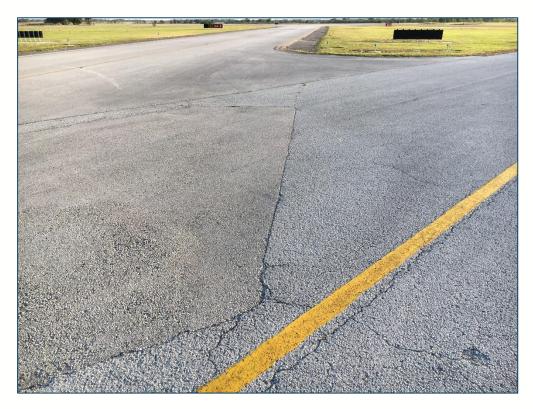
Taxiway A, Section 105, Sample Unit 118 – Low Severity (43) Block Cracking, Low Severity (48) Longitudinal and Transverse Cracking, Low Severity (50) Patching, Low Severity (52) Raveling, Medium Severity (52) Raveling

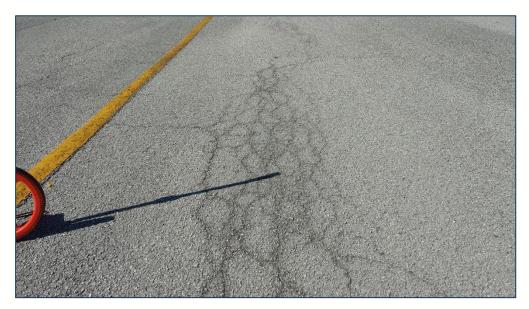
Taxiway A, Section 105, Sample Unit 104 – Low Severity (41) Alligator Cracking, Low and Medium Severity (48) Longitudinal and Transverse Cracking, Low Severity (52) Raveling, Medium Severity (52) Raveling

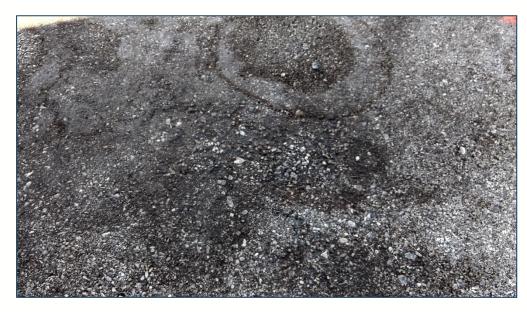
Apron, Section 4205, Sample Unit 602 - (49) Oil Spillage

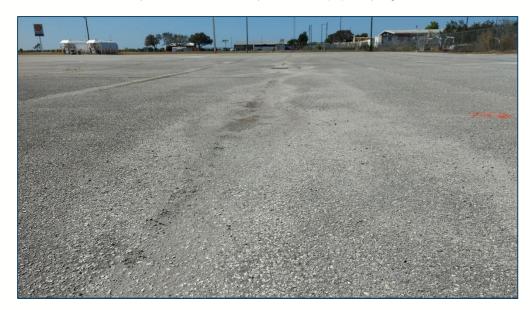
Apron, Section 4105, Sample Unit 105 – Low Severity (45) Depression, Low Severity (48) Longitudinal and Transverse Cracking, Low Severity (52) Raveling, Medium Severity (52) Raveling

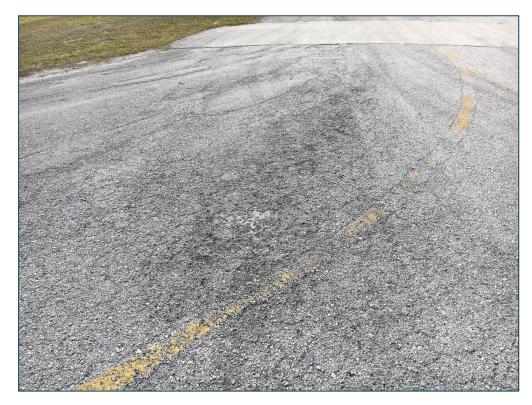
Apron, Section 4110, Sample Unit 301 – Low Severity (41) Alligator Cracking Low Severity (48) Longitudinal and Transverse Cracking, Low Severity (50) Patching, Low Severity (52) Raveling, Medium Severity (52) Raveling, High Severity (52) Raveling
