# **Statewide Airfield Pavement Management Program**

**Airport Pavement  
Evaluation Report  
September 2017**

**LaBelle**  
**Municipal Airport (X14)**  
General Aviation Airport  
District 1

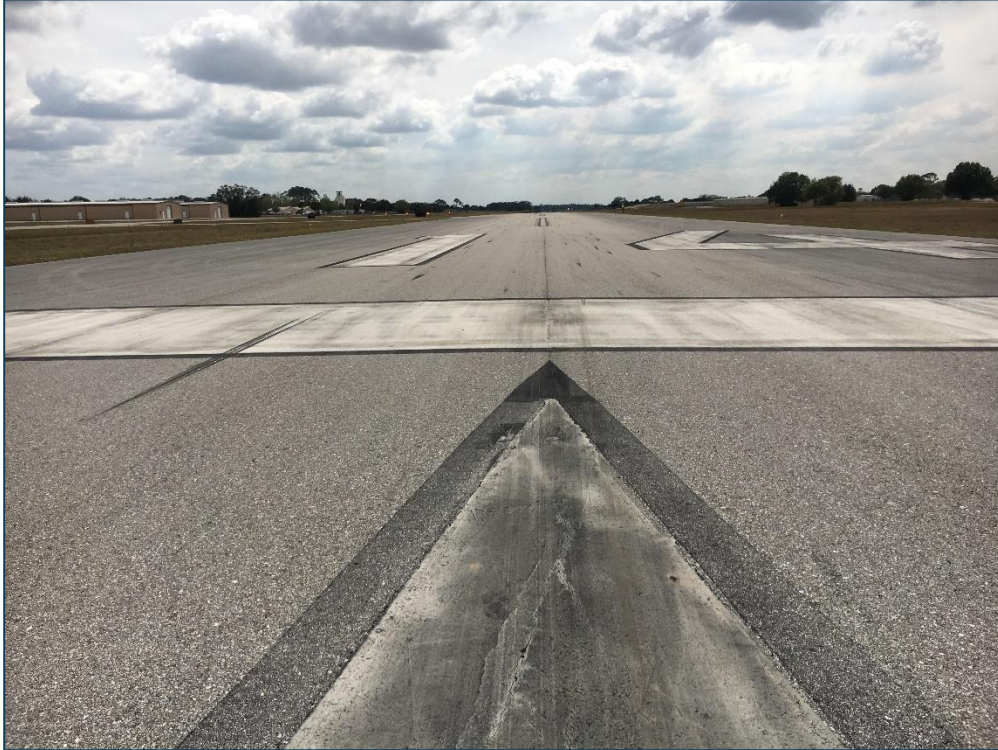
Runway 14-32, Section 6105, Sample Unit 108 – Low Severity (48) Longitudinal and Transverse Cracking Low Severity (57) Weathering

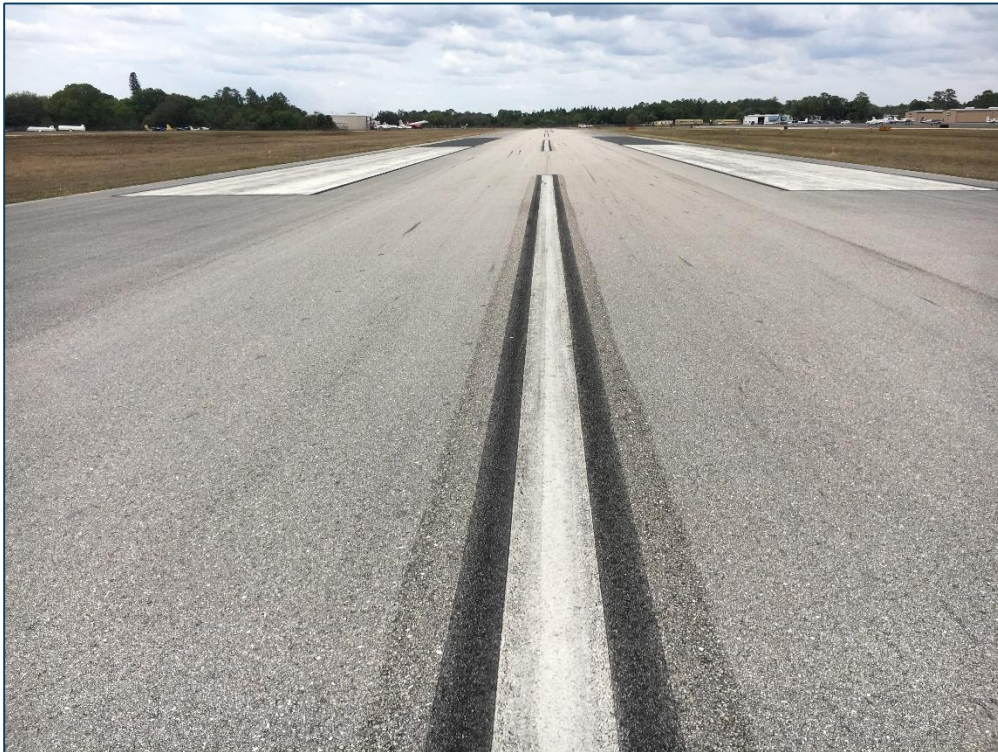
Runway 14-32, Section 6105, Sample Unit 124 – Low Severity (48) Longitudinal and Transverse Cracking, Low Severity (52) Raveling, Low Severity (57) Weathering

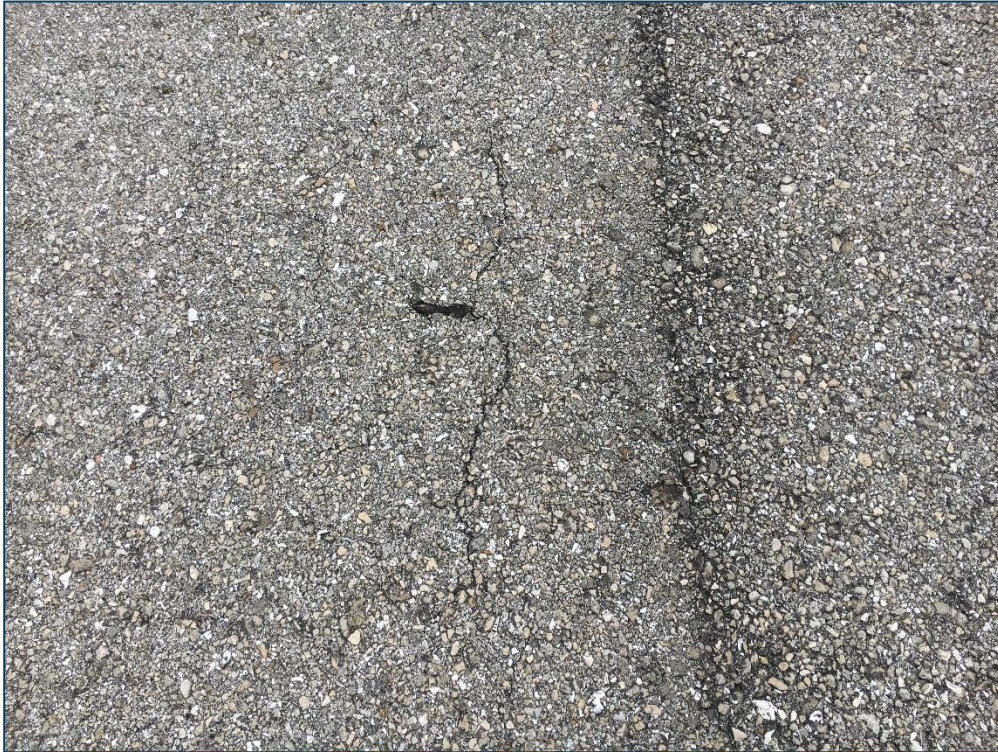
Runway 14-32, Section 6105, Sample Unit 114 – Low Severity (48) Longitudinal and Transverse Cracking, Low Severity (52) Raveling, Low Severity (57) Weathering

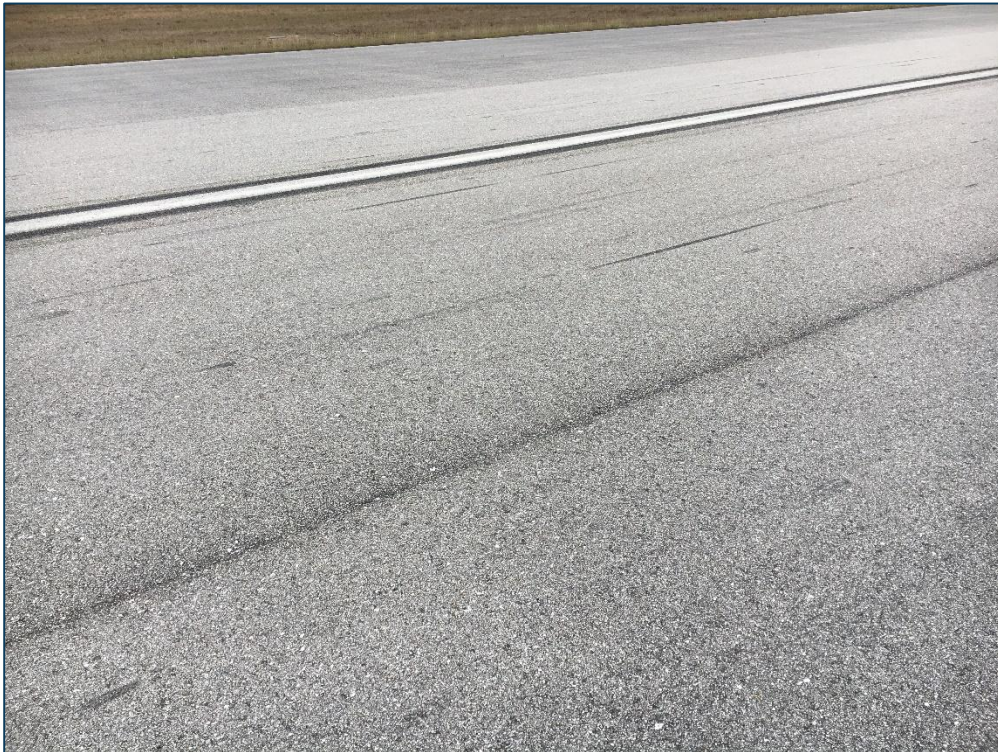
Runway 14-32, Section 6105, Sample Unit 119 – Low Severity (48) Longitudinal and Transverse Cracking, Low Severity (52) Raveling, Low Severity (57) Weathering

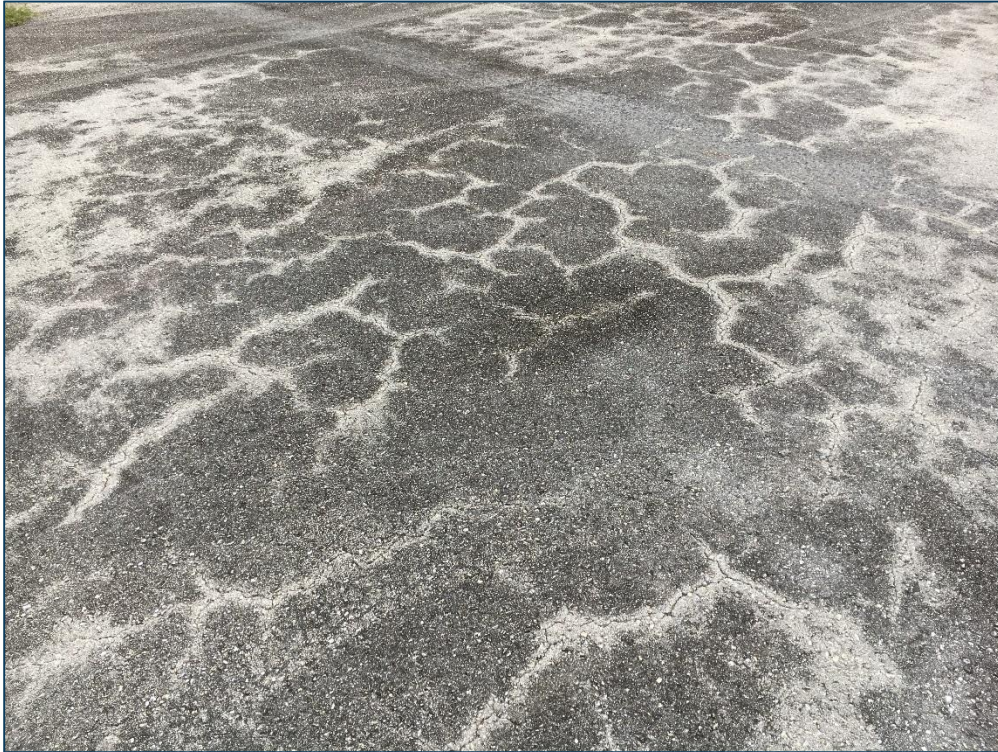
Taxiway to Runway, Section 905, Sample Unit 100 - Low Severity (43) Block Cracking, Low Severity (52) Raveling, Medium Severity (52) Raveling

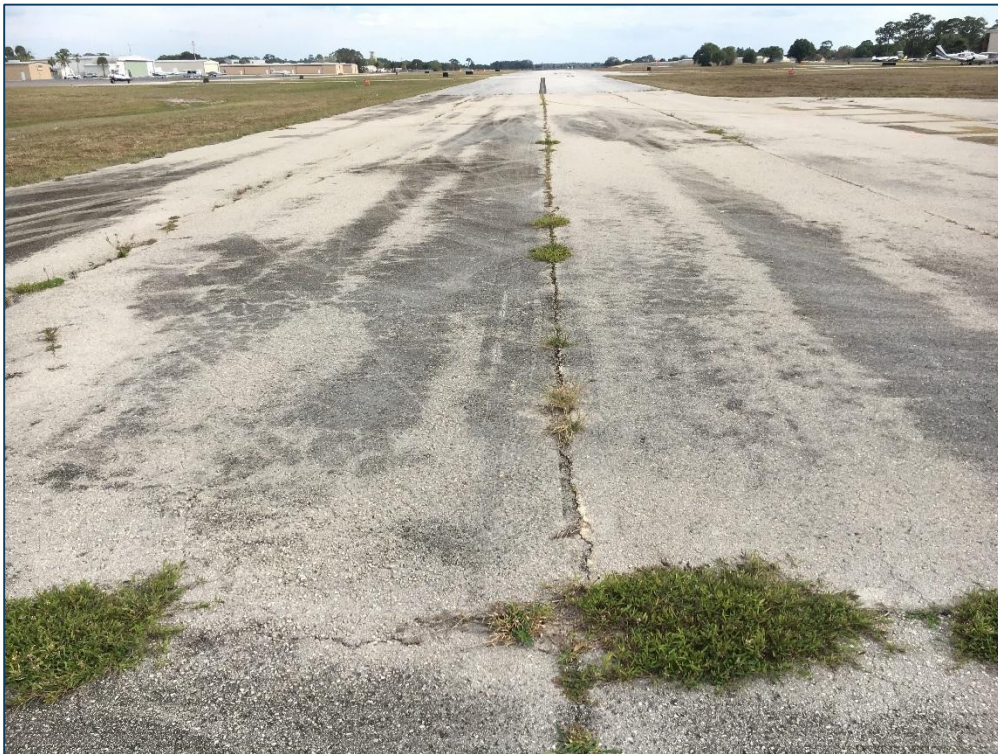
Taxiway to Runway, Section 905, Sample Unit 100 - Medium Severity (48) Longitudinal and Transverse Cracking, Low Severity (52) Raveling, Medium Severity (52) Raveling

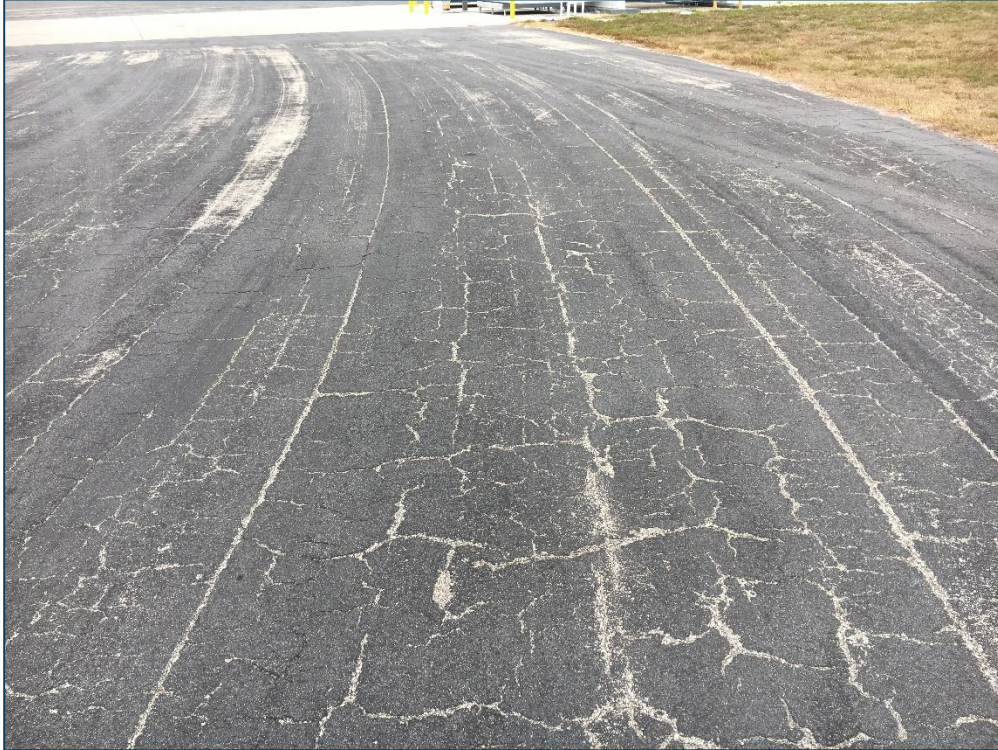
Taxiway SE to NR, Section 705, Sample Unit 202 – Medium Severity (43) Block Cracking, Low Severity (57) Weathering

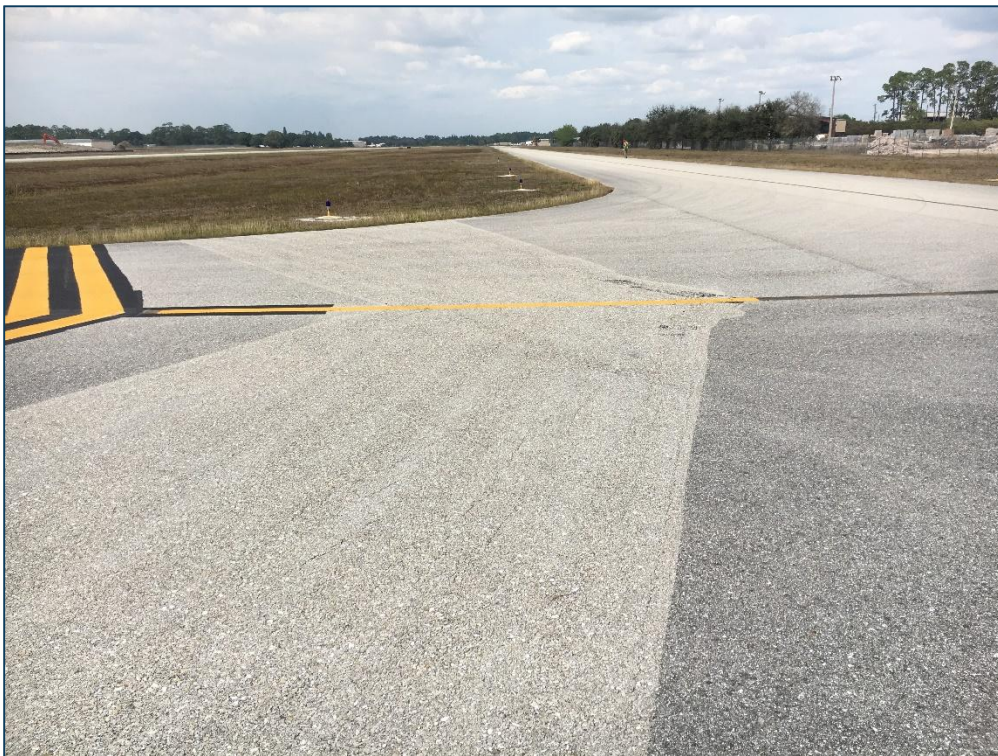
Taxiway A4, Section 115, Sample Unit 101 – Low Severity (48) Longitudinal and Transverse Cracking, Low Severity (52) Raveling, Low Severity (57) Weathering.

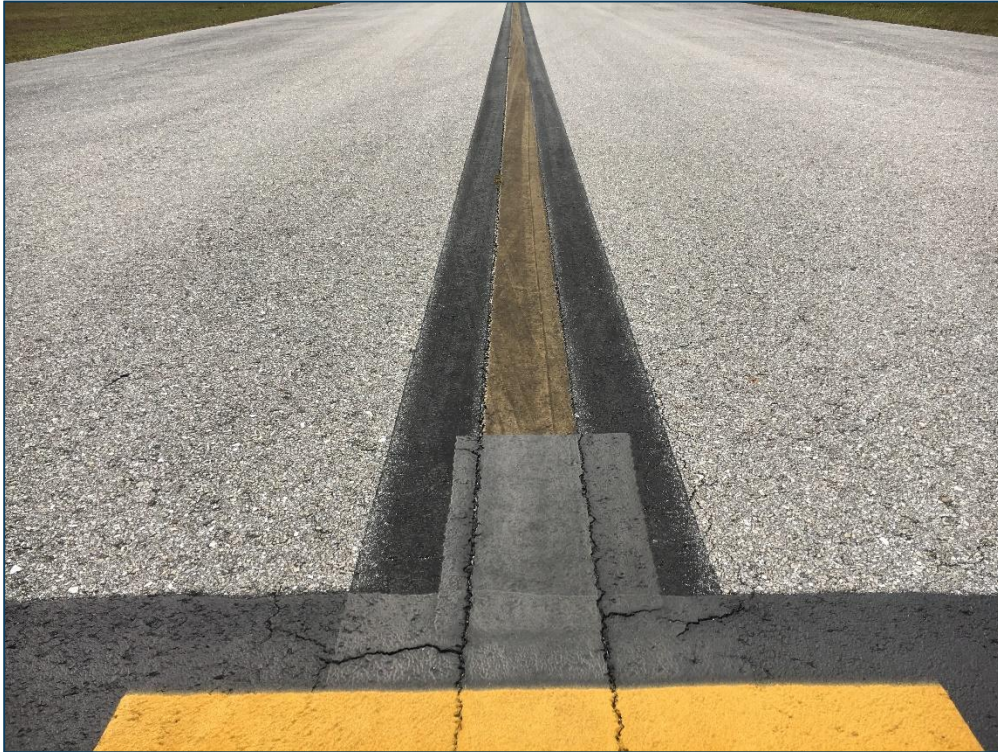
Taxiway A2, Section 205, Sample Unit 101 – Low Severity (48) Longitudinal and Transverse Cracking, Low Severity (52) Raveling, Low Severity (57) Weathering

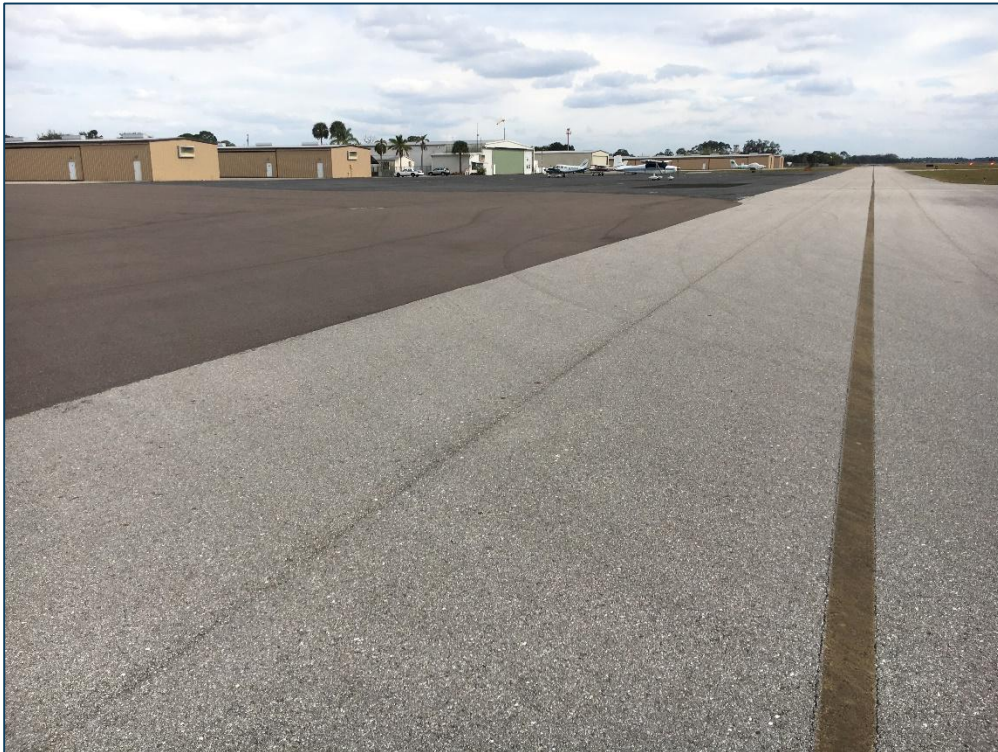
Taxiway A, Section 405, Sample Unit 101 – Low Severity (48) Longitudinal and Transverse Cracking, Low Severity (57) Weathering

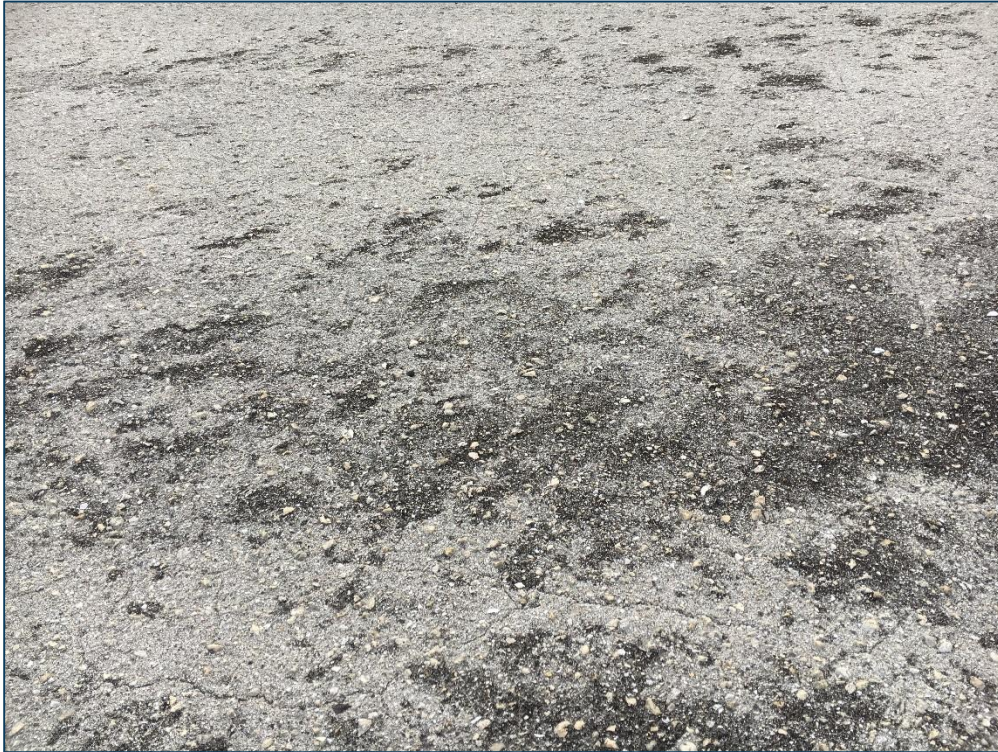
Northwest Apron, Section 4160, Sample Unit 105 - Medium Severity (52) Raveling

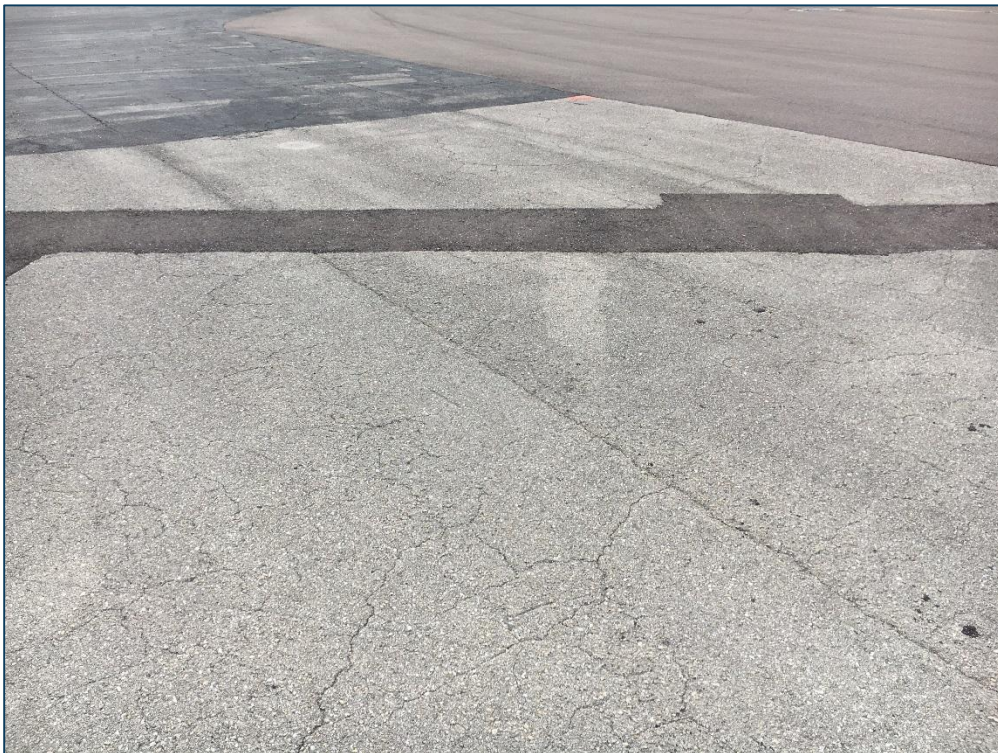
North Apron, Section 4135, Sample Unit 600 - Low Severity (43) Block Cracking, Low Severity (45) Depression, Low Severity (50) Patching, Medium Severity (52) Raveling

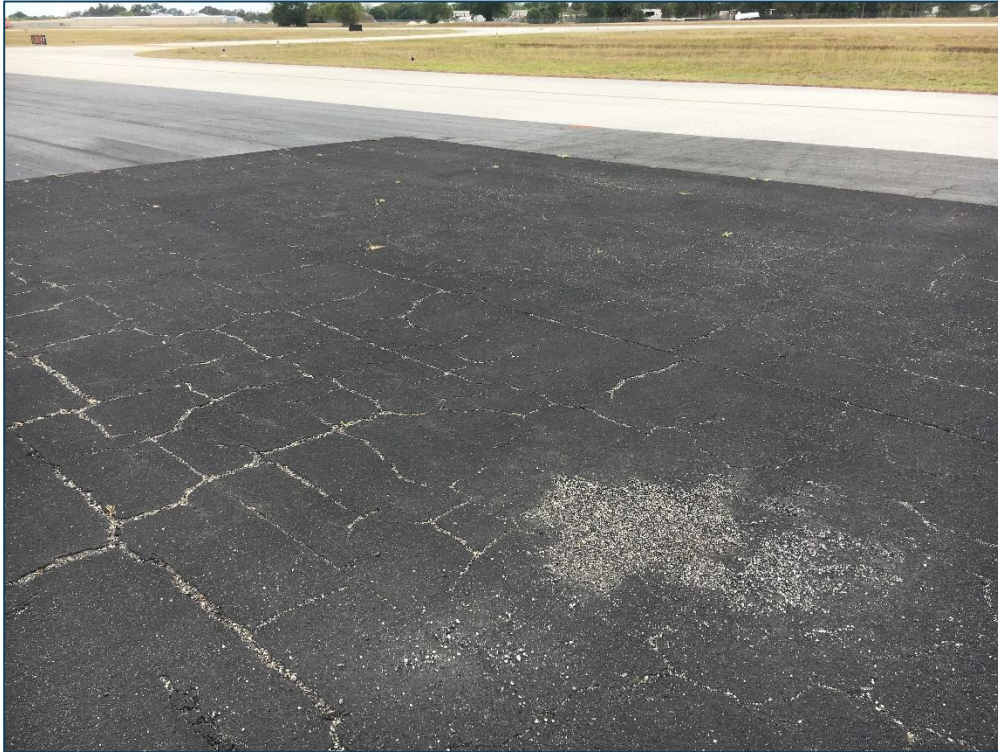
North Apron, Section 4110, Sample Unit 202 - Low Severity (43) Block Cracking, Medium Severity (43) Block Cracking, Low Severity (45) Depression, Low Severity (52) Raveling

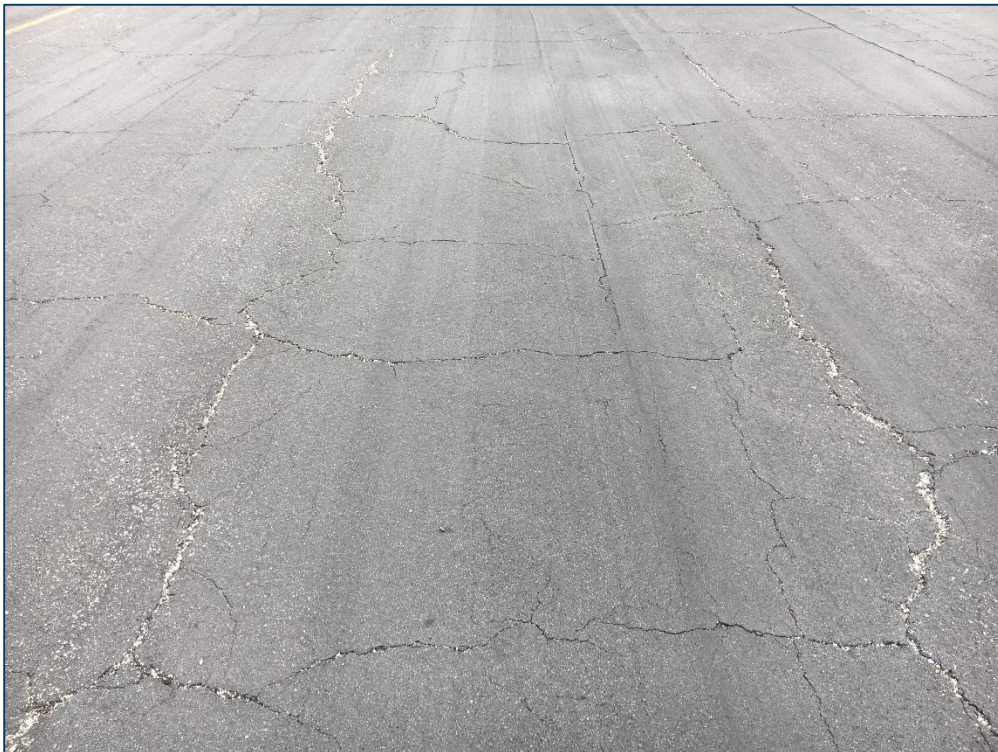
North Apron, Section 4110, Sample Unit 503 - Low Severity (43) Block Cracking, Medium Severity (43) Block Cracking, Low Severity (52) Raveling
