Florida Department of Transportation

# Statewide Airfield Pavement Management Program

## Summary of Arthur Dunn Airpark

Arthur Dunn Air Park was inspected in September 2016 - the overall weighted PCI value was 76, a condition rating of Satisfactory. The results of the maintenance, repair, and major rehabilitation analysis identified \$36,140 in localized M&R needs based on current conditions and a 10-Year major rehabilitation need of \$3,001,000 based on forecasted conditions. The current major rehabilitation needs based on the latest inspection consist of \$651,000 for pavements below critical condition.

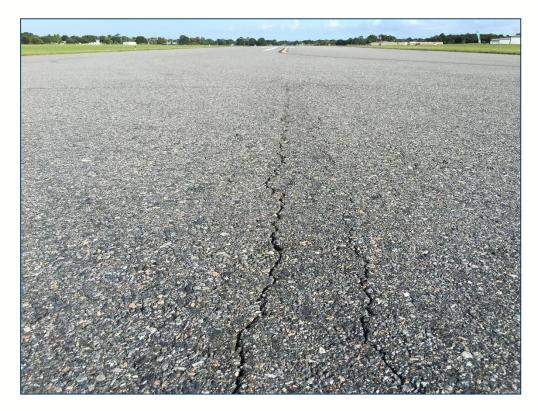
Runway 15-33, Section 6105, Sample Unit 129 - Low Severity (48) Longitudinal and Transverse Cracking Low Severity (56) Swelling, Low Severity (57) Weathering

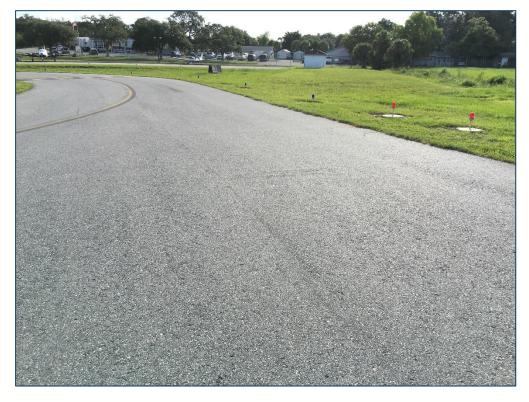
Runway 15-33, Section 6105, Sample Unit 129 - Low Severity (48) Longitudinal and Transverse Cracking, Low Severity (57) Weathering

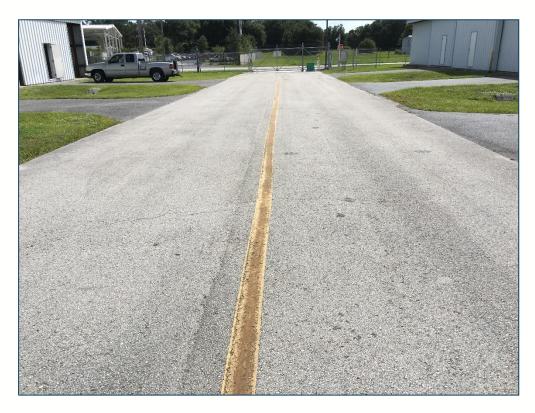
Taxiway C, Section 320, Sample Unit 104 - Low Severity (48) Longitudinal and Transverse Cracking, Low Severity (57) Weathering, Low Severity (52) Raveling

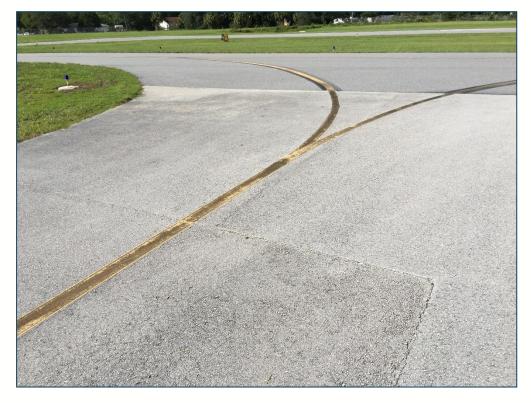
Taxiway AP, Section 115, Sample Unit 115 – Low Severity (48) Longitudinal and Transverse Cracking, Low Severity (57) Weathering, Medium Severity (57) Weathering

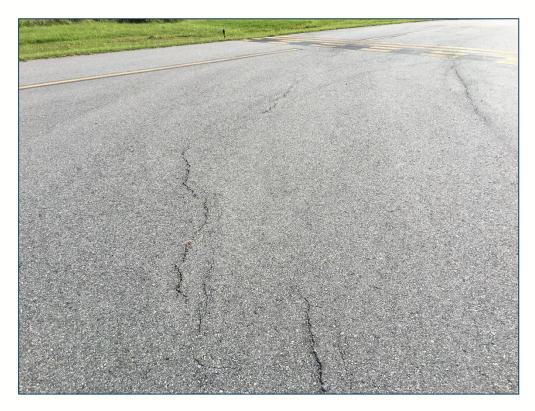
Taxiway A, Section 105, Sample Unit 100 - Low Severity (48) Longitudinal and Transverse Cracking, Low Severity (57) Weathering, Medium Severity (57) Weathering

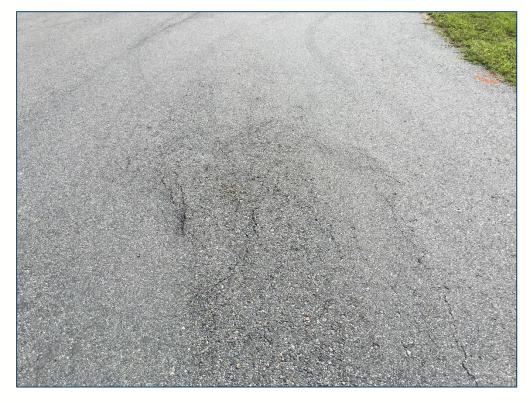
Taxiway A, Section 105, Sample Unit 100 - Low Severity (48) Longitudinal and Transverse Cracking, Low Severity (57) Weathering, Medium Severity (57) Weathering

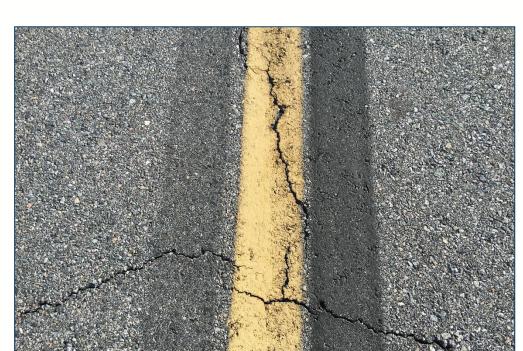
Taxiway A, Section 110, Sample Unit 100 – Low Severity (57) Weathering, Low Severity (52) Raveling, Low Severity (48) Longitudinal and Transverse Cracking

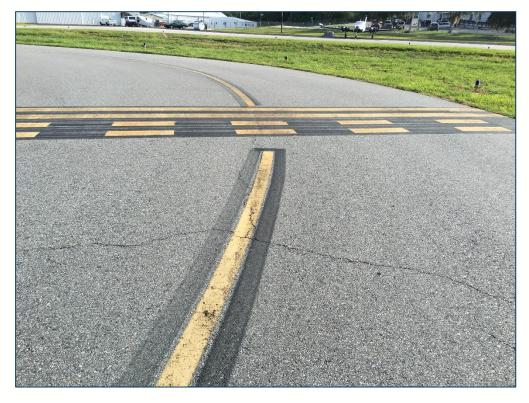
Taxiway A, Section 110, Sample Unit 100 - Low Severity (57) Weathering, Low Severity (52) Raveling, Low Severity (48) Longitudinal and Transverse Cracking

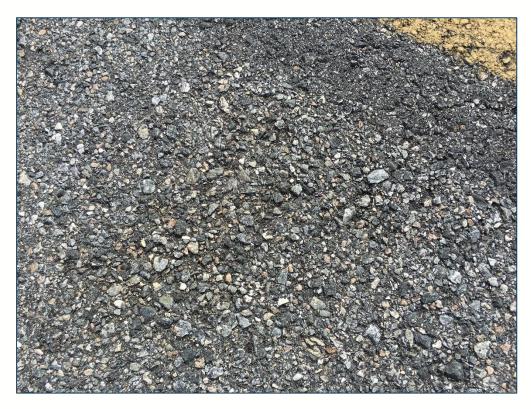
Taxiway B, Section 210, Sample Unit 100 - Low Severity (52) Raveling

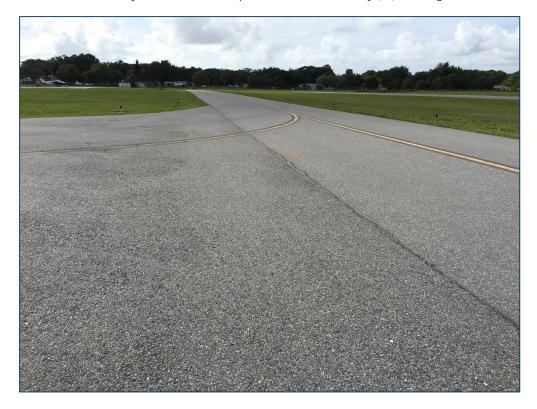
Taxiway B, Section 210, Sample Unit 100 - Low Severity (48) Longitudinal and Transverse Cracking, Low Severity (57) Weathering, Low Severity (52) Raveling

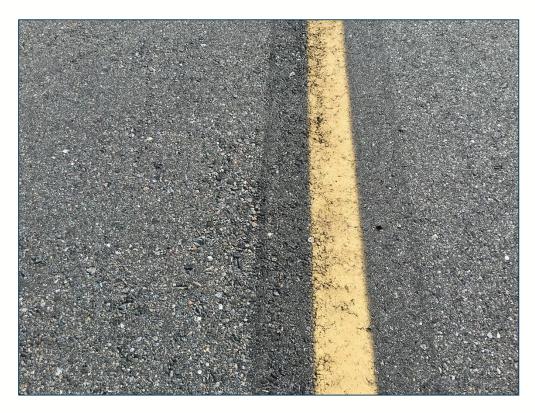
Taxiway D, Section 405, Sample Unit 100 – Low Severity (57) Weathering, Low Severity (52) Raveling, Low Severity (48) Longitudinal and Transverse Cracking

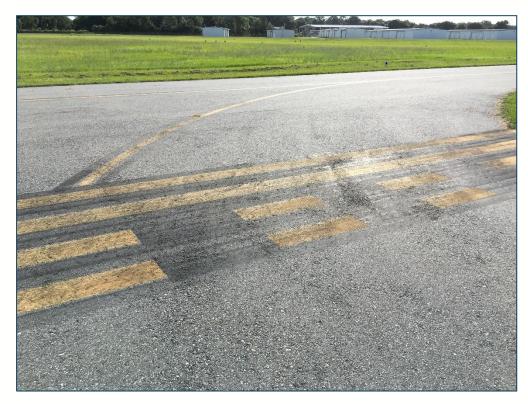
Taxiway D, Section 405, Sample Unit 100 - Low Severity (57) Weathering, Low Severity (52) Raveling

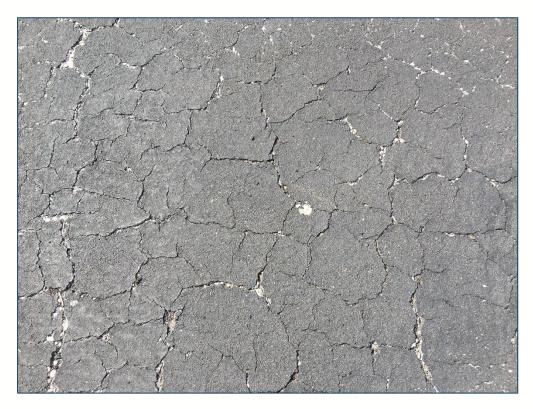
Apron AP, Section 4107, Sample Unit 203 - Low Severity (43) Block Cracking, Low Severity (52) Raveling

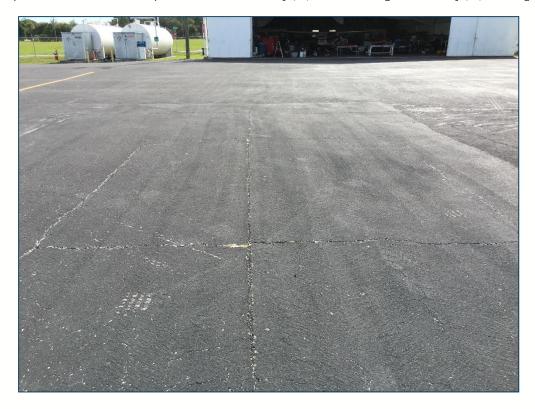
Apron AP, Section 4107, Sample Unit 203 - Low Severity (43) Block Cracking, Low Severity (52) Raveling

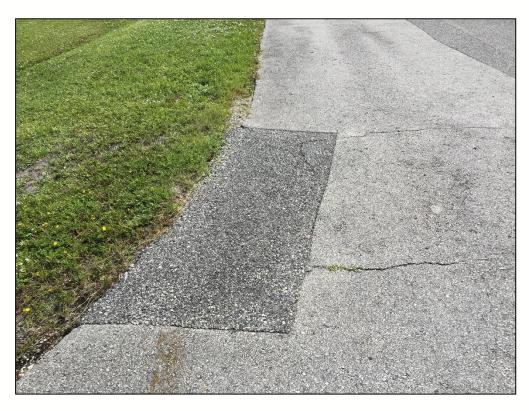
Apron AP T-HANG, Section 4205, Sample Unit 600 – Low Severity (52) Raveling, Low Severity (48) Longitudinal and Transverse Cracking, Low Severity (50) Patching, Low Severity (57) Weathering

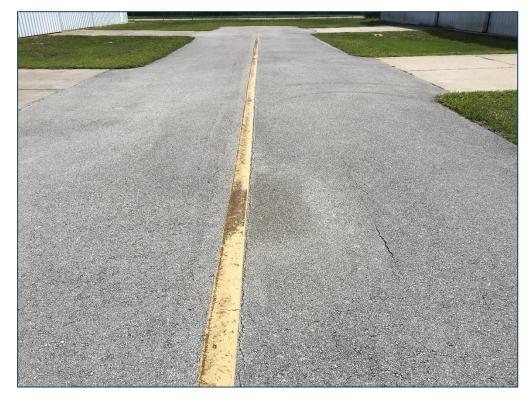
Apron AP T-HANG, Section 4205, Sample Unit 300 – Low Severity (52) Raveling, Low Severity (48) Longitudinal and Transverse Cracking, Low Severity (57) Weathering
