# Statewide Airfield Pavement Management Program

**Airport Pavement  
Evaluation Report  
September 2017**

**Sebastian Municipal  
Airport (X26)**  
General Aviation Airport  
District 4

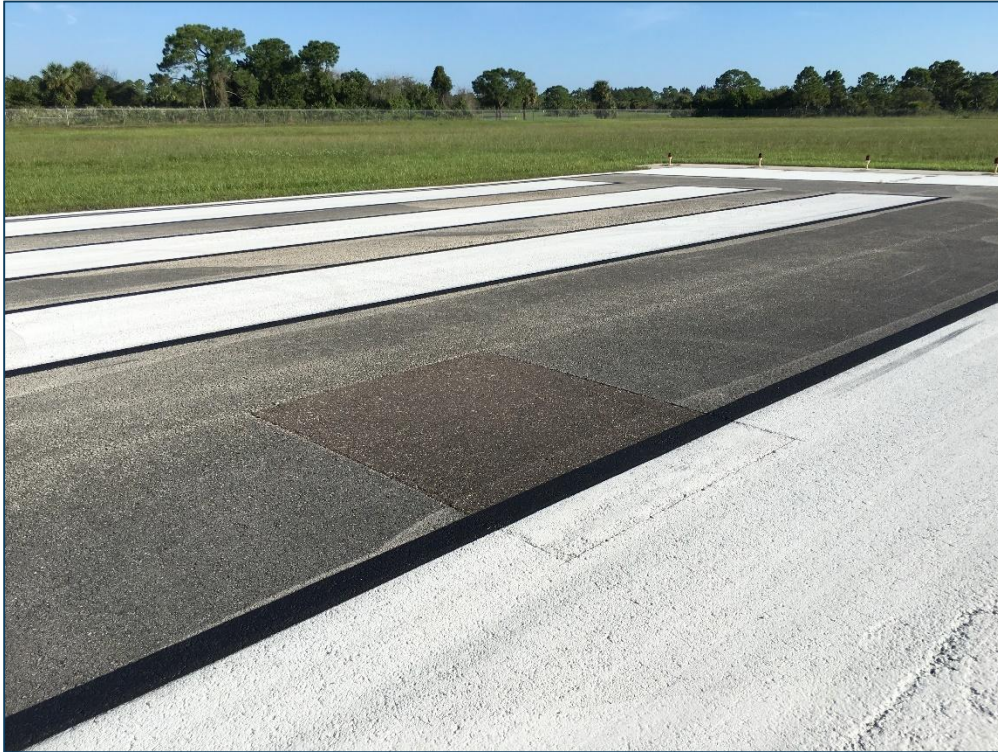
Runway 5-23, Section 6205, Sample Unit 379 – Low Severity (48) Longitudinal and Transverse Cracking, Low Severity (50) Patching, Low Severity (57) Weathering

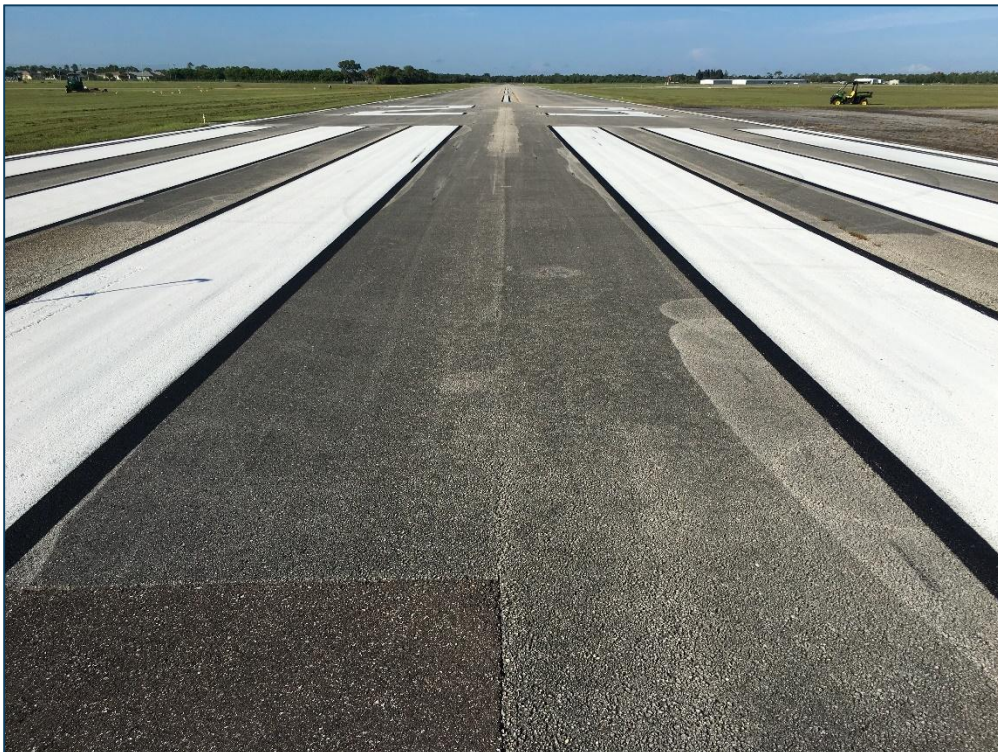
Runway 5-23, Section 6205, Sample Unit 379 – Low Severity (48) Longitudinal and Transverse Cracking, Low Severity (50) Patching, Low Severity (57) Weathering, Low Severity (52) Raveling

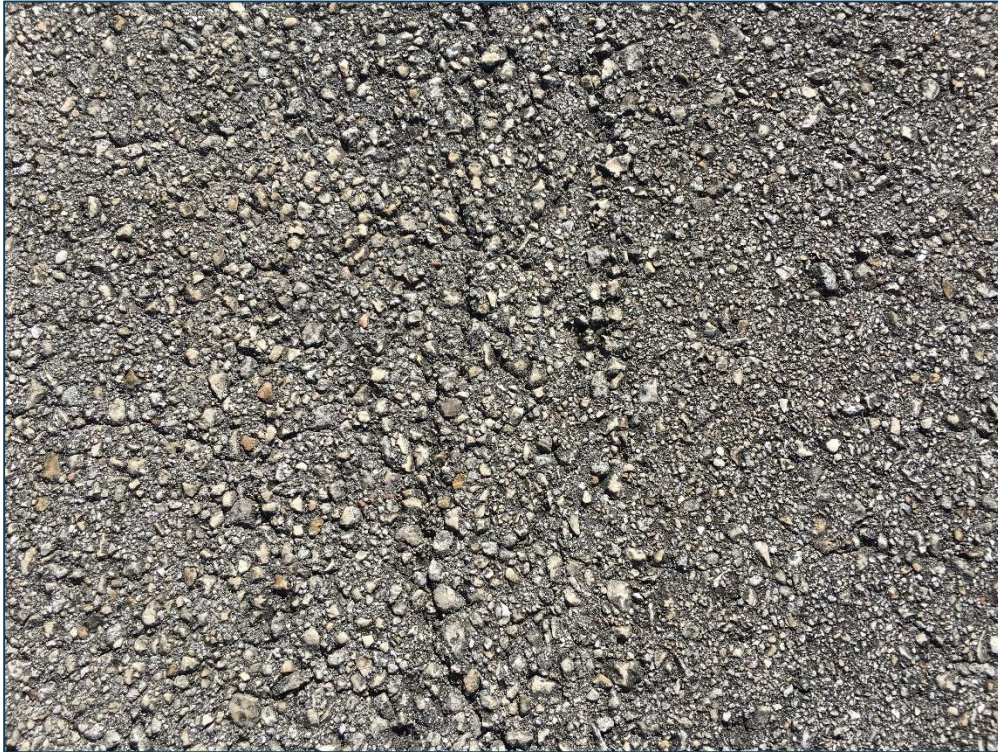
Runway 10-28, Section 6305, Sample Unit 514 – Low Severity (52) Raveling

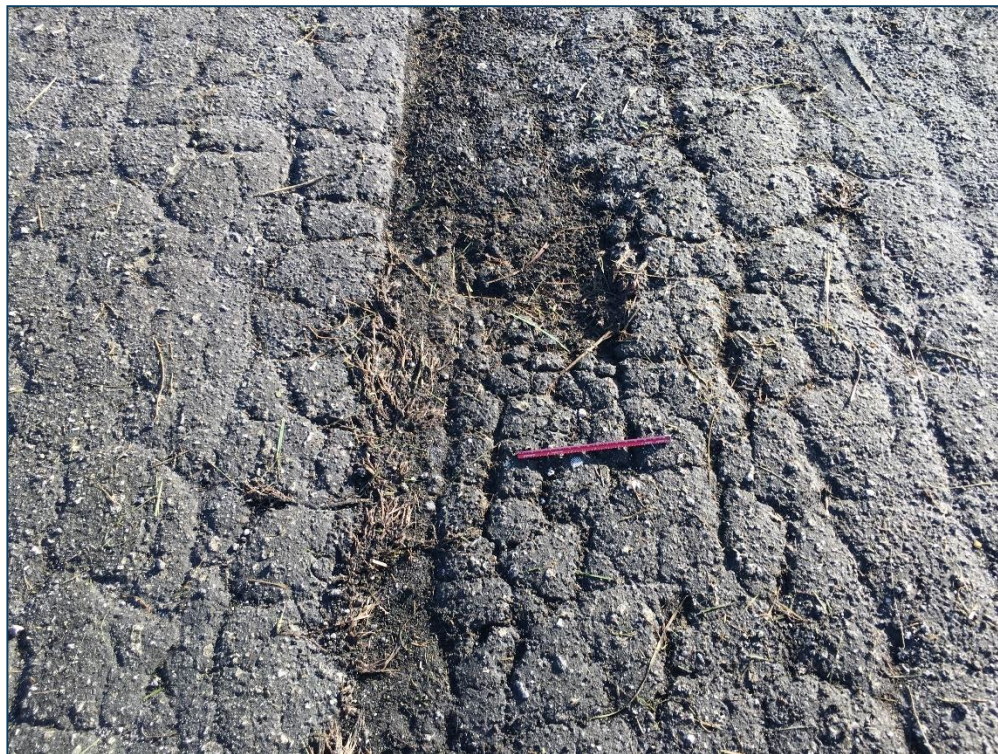
Taxiway C, Section 305, Sample Unit 300 – Medium Severity (41) Alligator Cracking, Medium Severity (52) Raveling

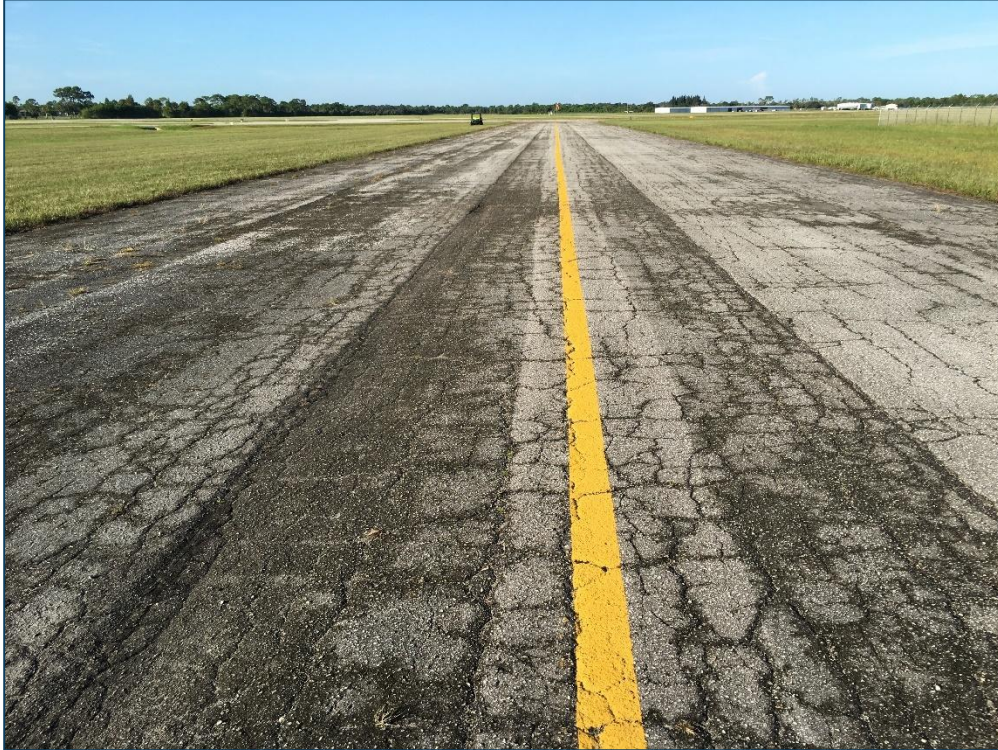
Taxiway C, Section 305, Sample Unit 305 – Medium Severity (43) Block Cracking, Medium Severity (41) Alligator Cracking, Low Severity (53) Rutting, Low Severity (52) Raveling

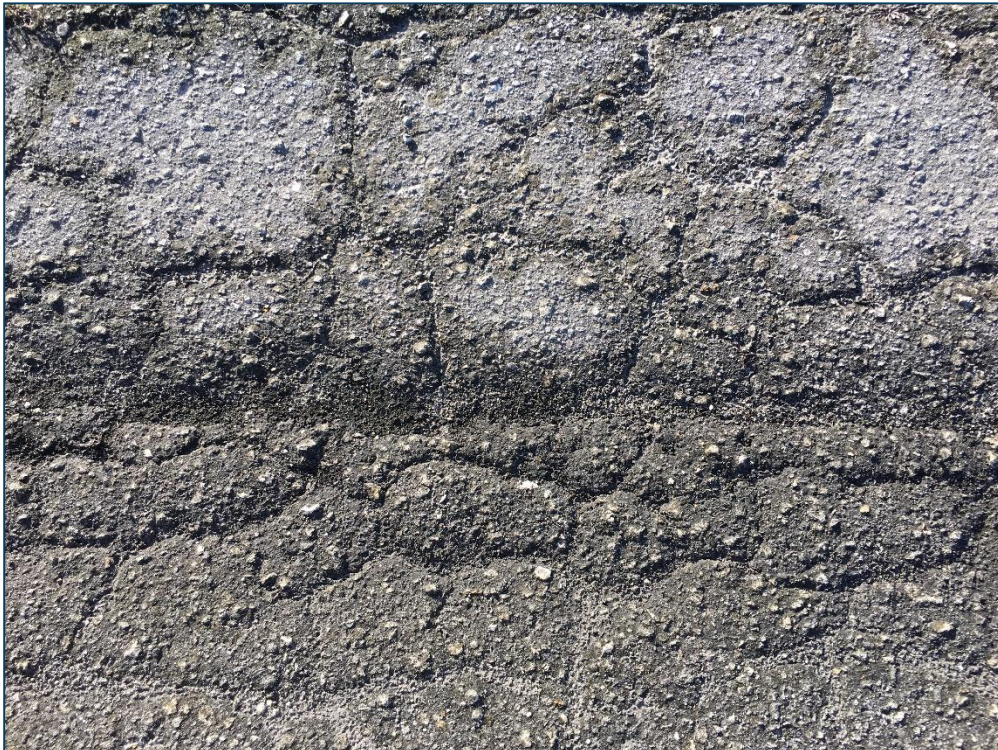
Taxiway C, Section 305, Sample Unit 305 – Medium Severity (41) Alligator Cracking, Low Severity (53) Rutting, Low Severity (52) Raveling

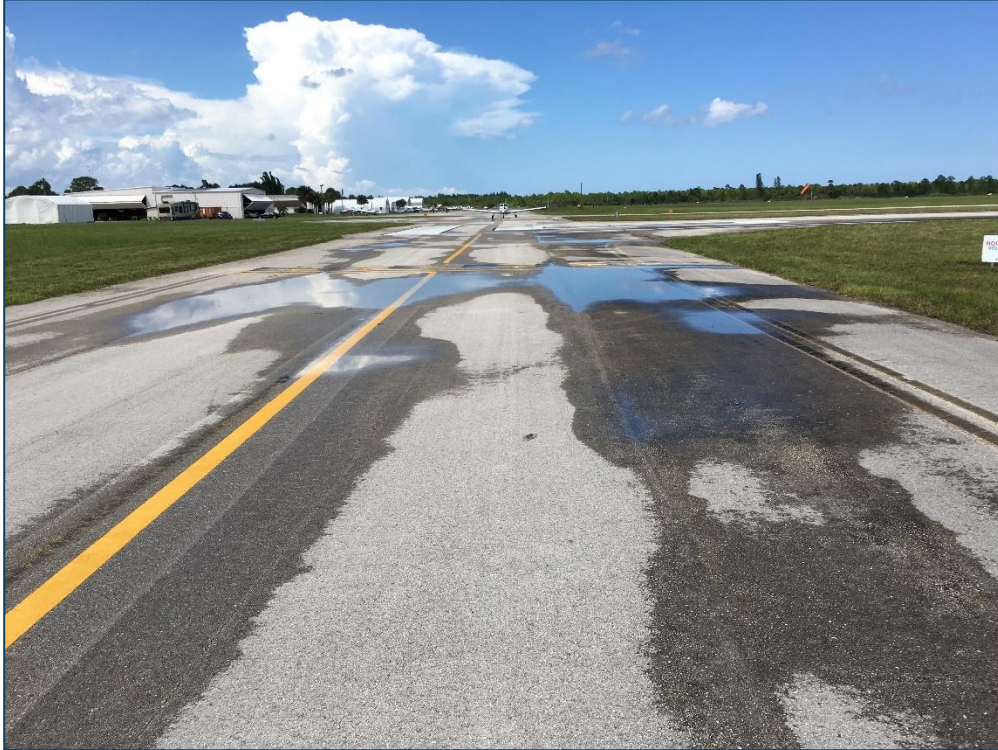
Taxiway A, Section 425, Sample Unit 99 – Low Severity (45) Depression, Low Severity (52) Raveling, Low Severity (48) Longitudinal and Transverse Cracking, Low Severity (57) Weathering

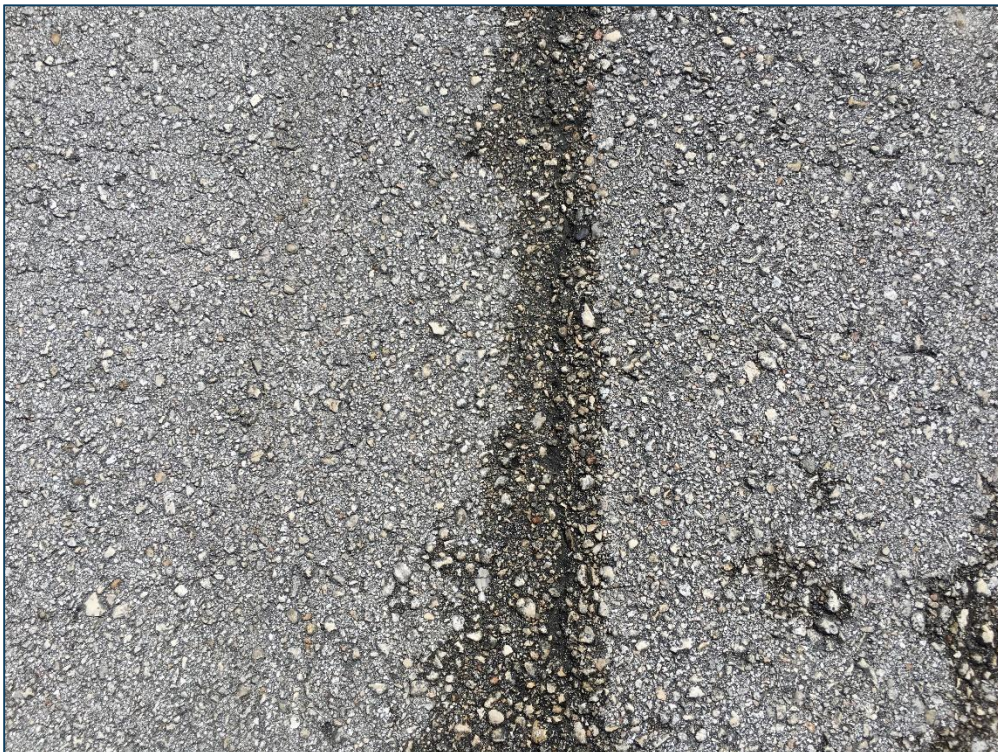
Taxiway A, Section 425, Sample Unit 99 – Low Severity (48) Longitudinal and Transverse Cracking, Low Severity (57) Weathering, Low Severity (52) Raveling

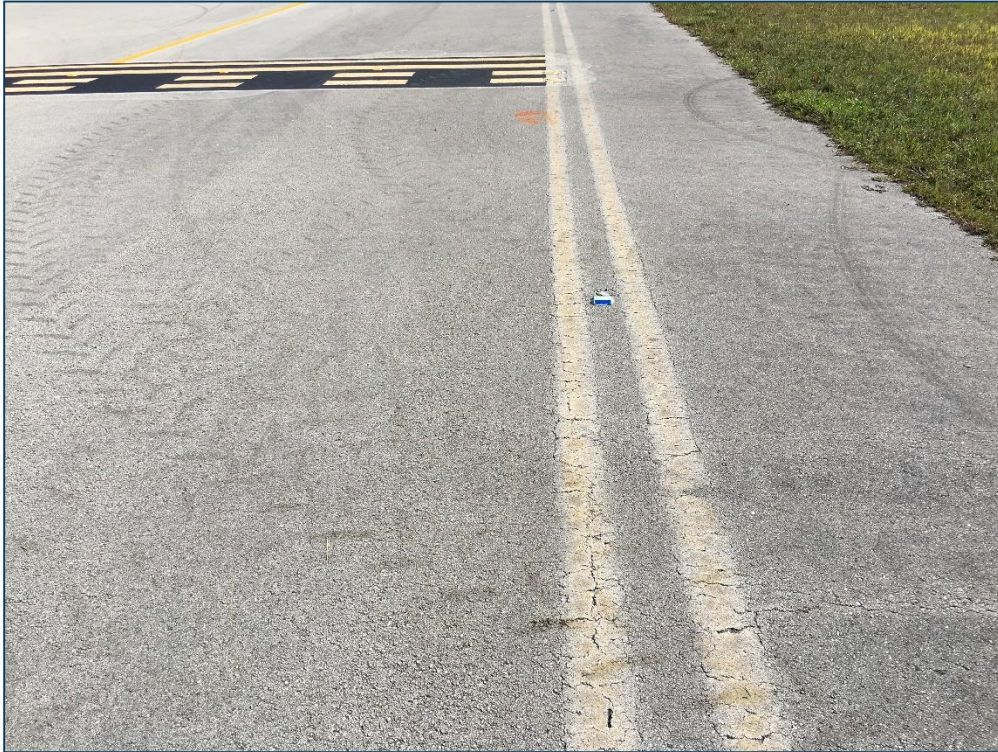
Taxiway CONN, Section 515, Sample Unit 100 – Low Severity (48) Longitudinal and Transverse Cracking, Low Severity (57) Weathering, Low Severity (52) Raveling

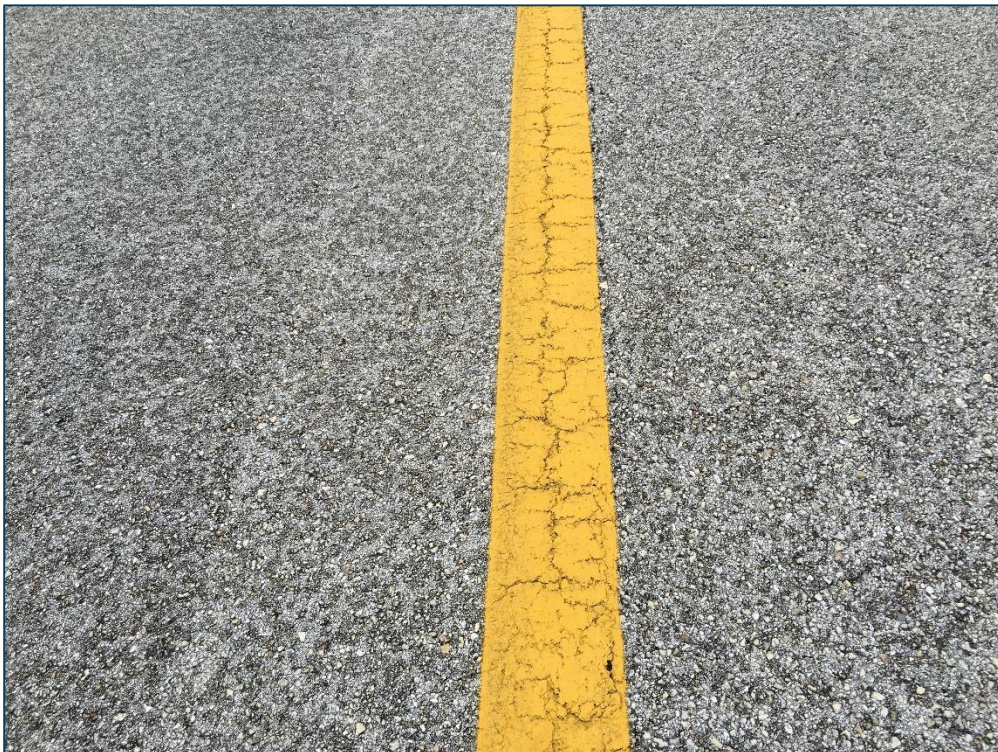
Taxiway B, Section 610, Sample Unit 105 – Low Severity (48) Longitudinal and Transverse Cracking, Low Severity (52) Raveling, Low Severity (57) Weathering

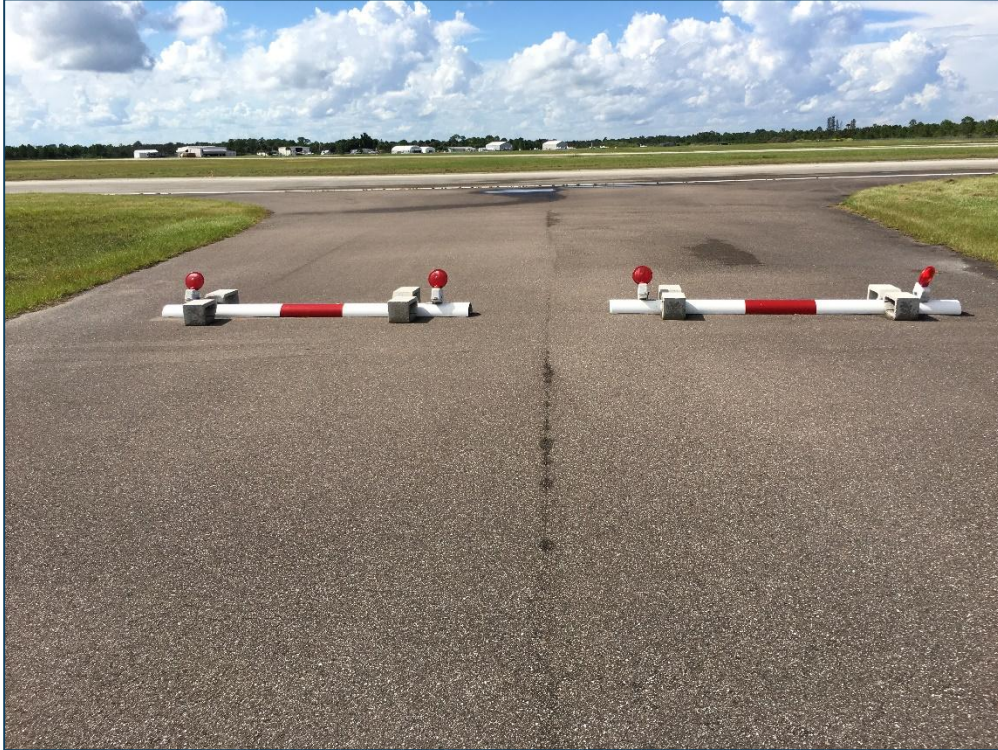
Taxiway E, Section 700, Sample Unit 101 – Low Severity (48) Longitudinal and Transverse Cracking, Low Severity (57) Weathering

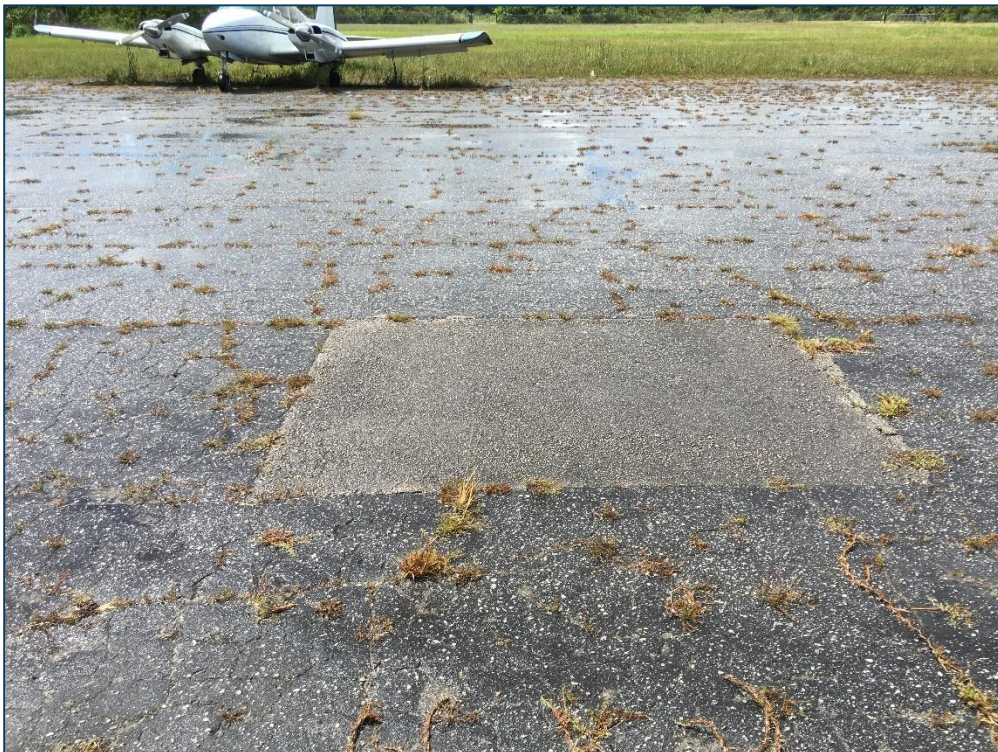
Apron W, Section 5115, Sample Unit 435 – Medium Severity (43) Block Cracking, Low Severity (50) Patching, Low Severity (52) Raveling

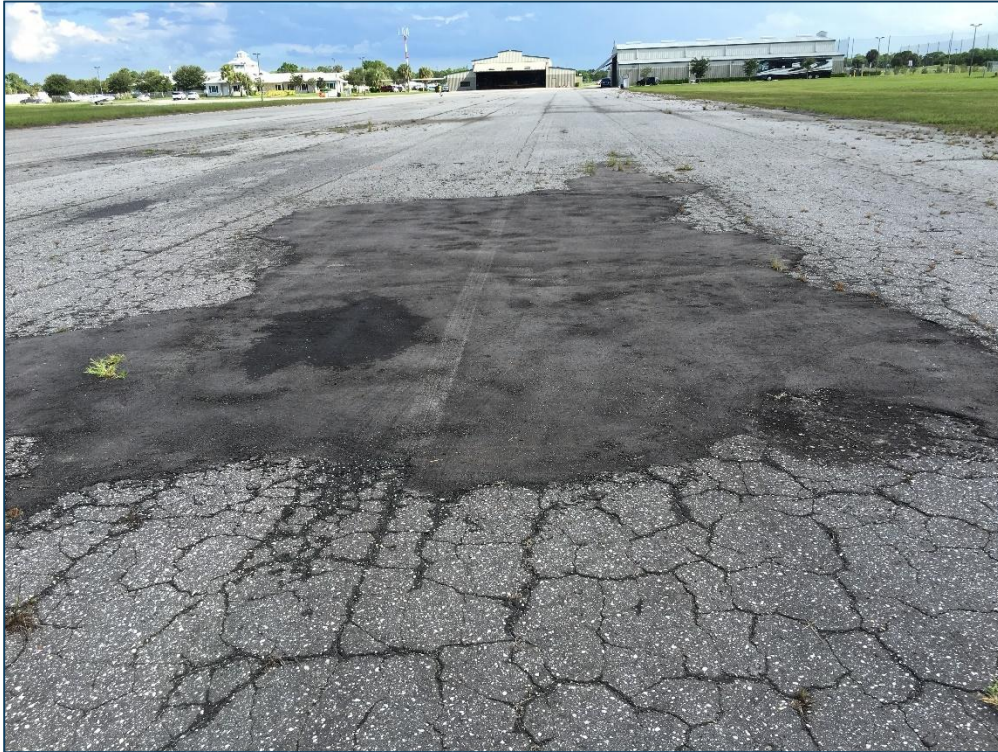
Apron SE, Section 5605, Sample Unit 101 – Low Severity (43) Block Cracking, Medium Severity (50) Patching, Medium Severity (41) Alligator Cracking, Low Severity (52) Raveling

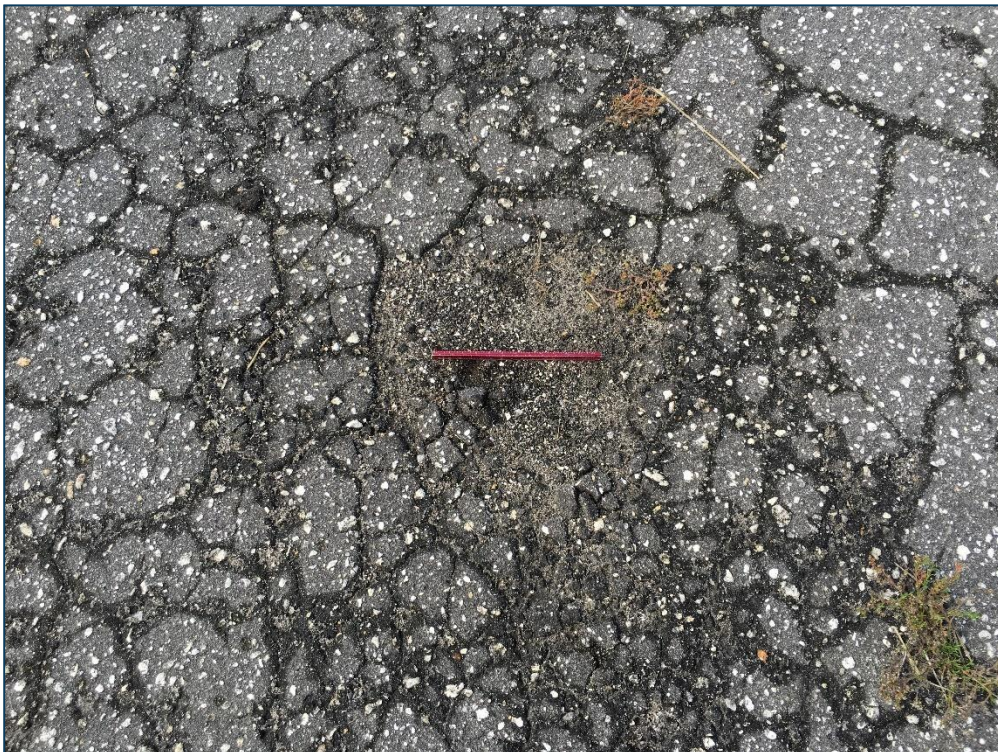
Apron SE, Section 5605, Sample Unit 101 – Low Severity (52) Raveling and Medium Severity (41) Alligator Cracking

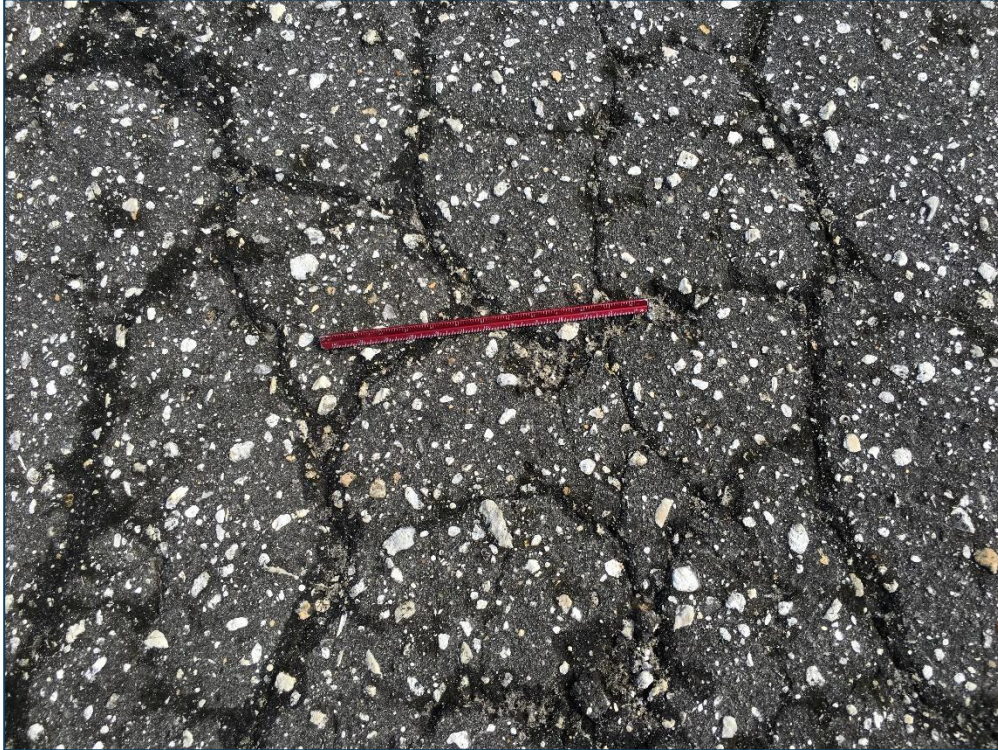
Apron SE, Section 5605, Sample Unit 203 – Low Severity (41) Alligator Cracking, Low Severity (43) Block Cracking, Low Severity (52) Raveling

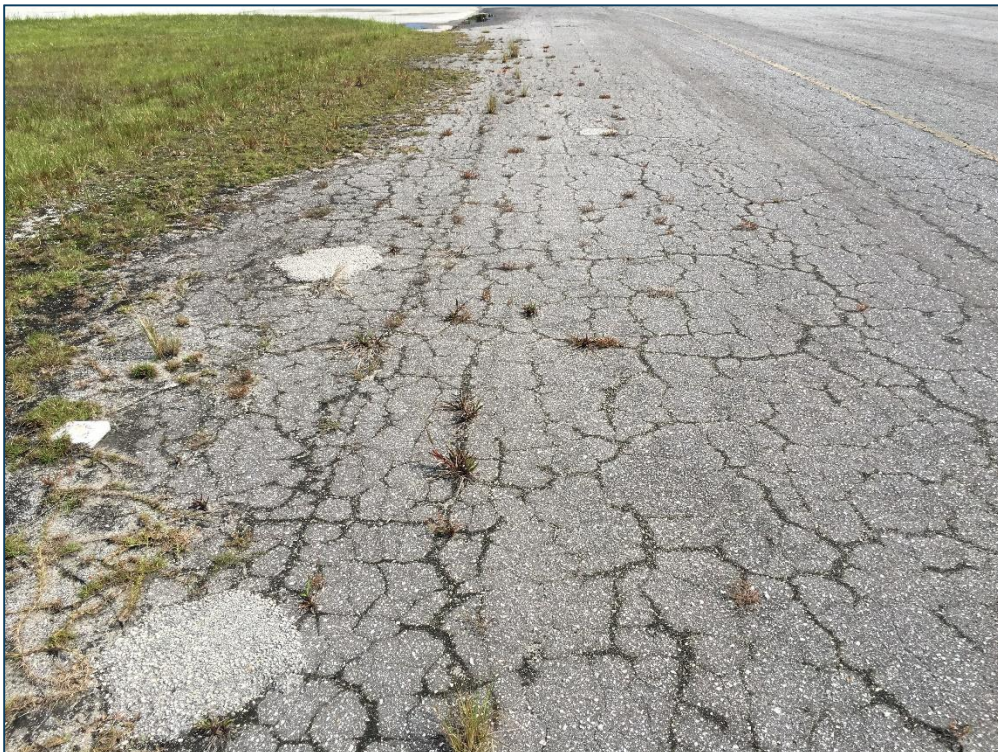
Apron SE, Section 5605, Sample Unit 305 – Low Severity (41) Alligator Cracking and Low Severity (50) Patching, Low Severity (52) Raveling

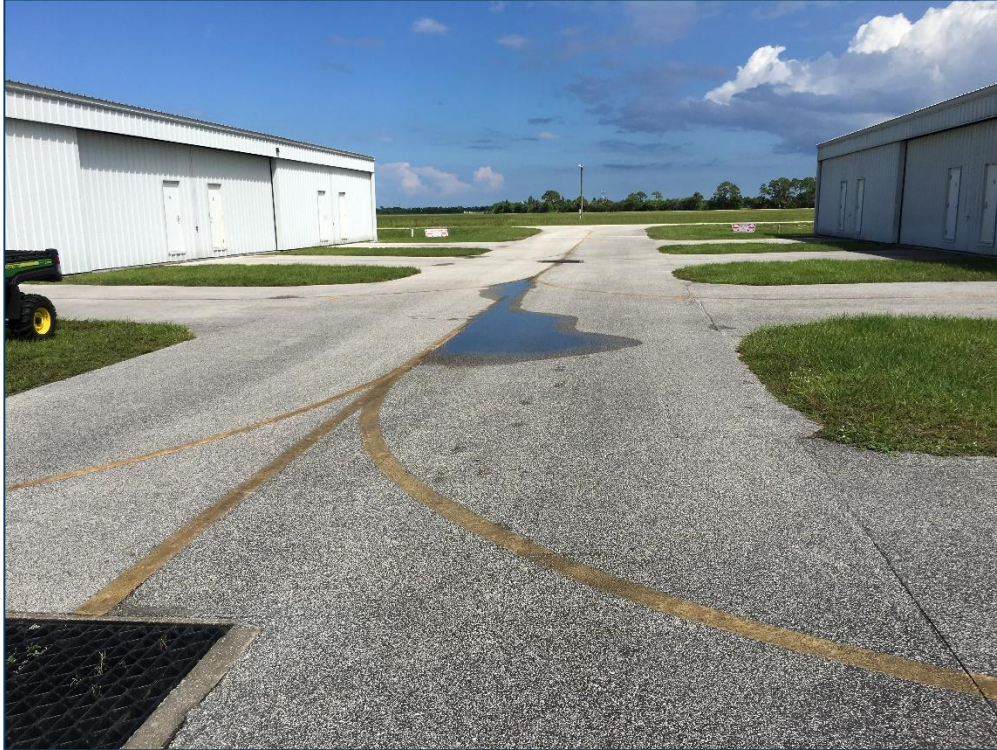
Apron T-Hang, Section 5305, Sample Unit 301 – Low Severity (48) Longitudinal and Transverse Cracking, Low Severity (45) Depression, Low Severity (57) Weathering

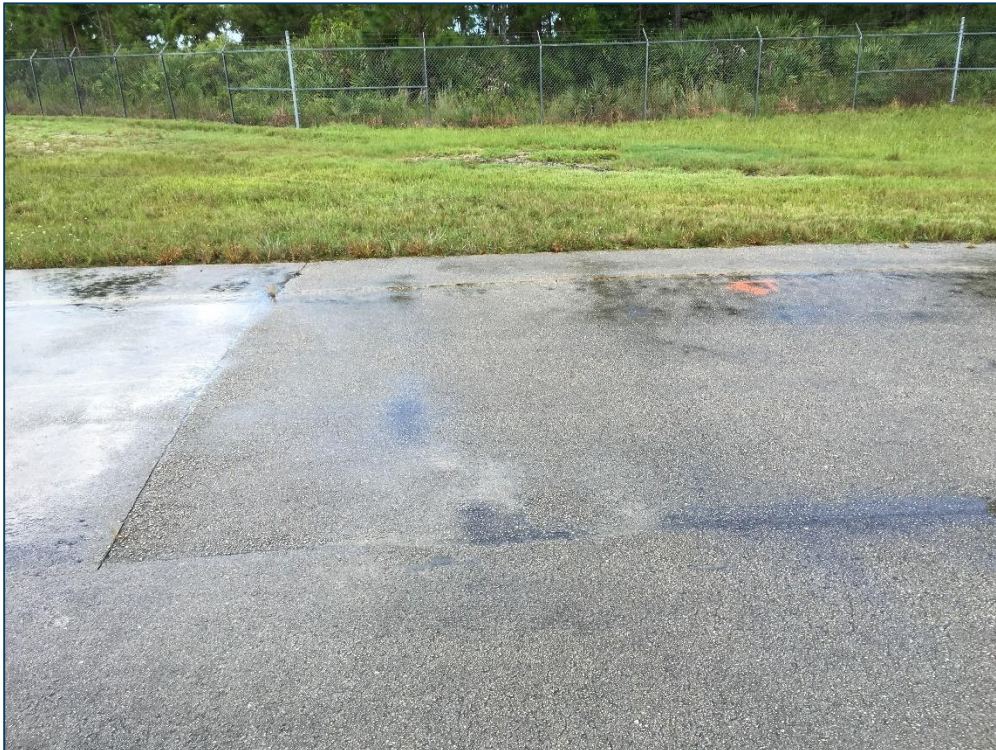
Apron RU E, Section 5510, Sample Unit 302 – Low Severity (50) Patching and Low Severity (57) Weathering

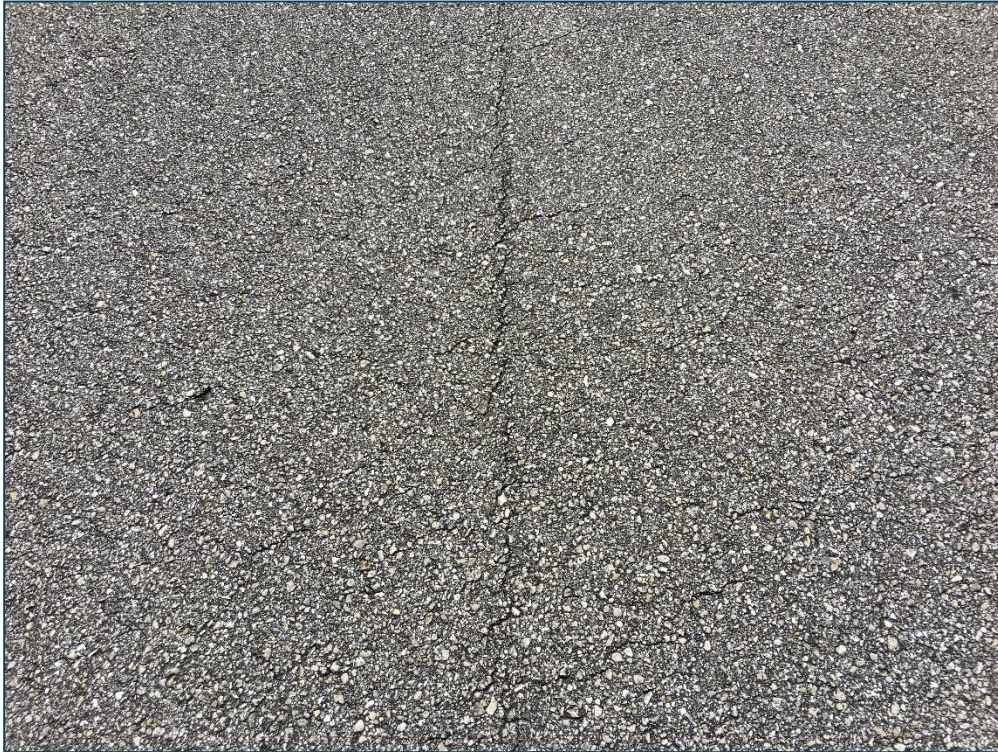
Apron RU SW, Section 5405, Sample Unit 301 – Low Severity (48) Longitudinal and Transverse Cracking, Low Severity (57) Weathering

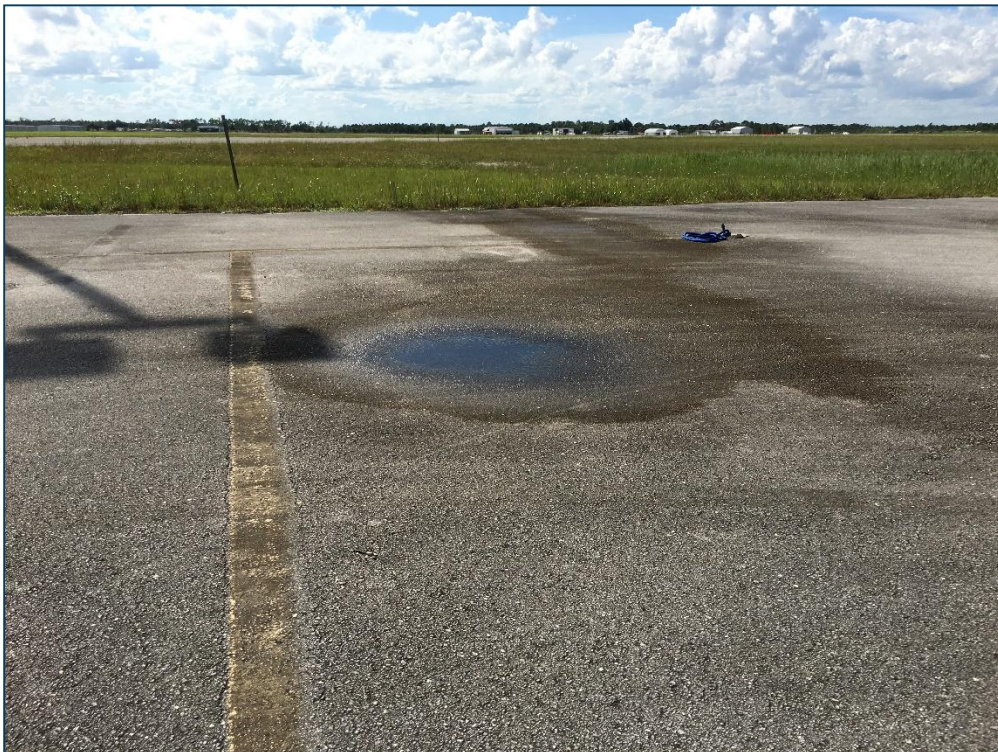
Apron Term, Section 5705, Sample Unit 101 – Low Severity (45) Depression, Low Severity (57) Weathering
