Statewide Airfield Pavement Management Program

**Airport Pavement
Evaluation Report
September 2017**

**Marion County
Airport (X35)**
General Aviation Airport
District 5

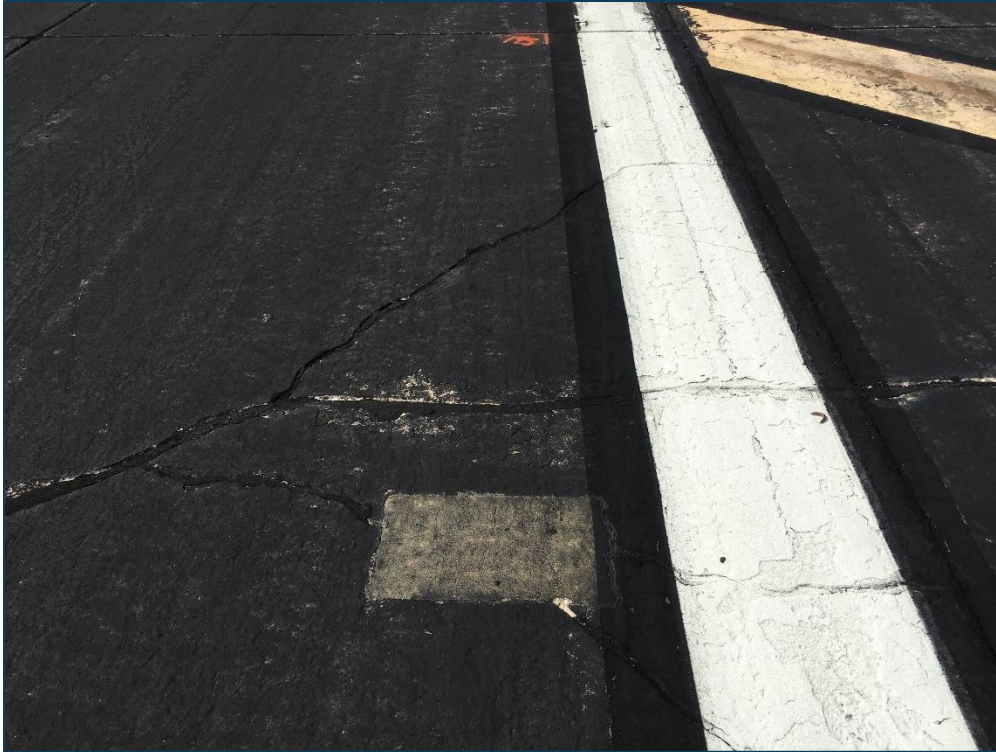
Runway 5-23, Section 6215, Sample Unit 195 – Low Severity (65) Joint Seal Damage, Medium Severity (63) Longitudinal, Transverse, and Diagonal Cracking, Low Severity (66) Small Patching

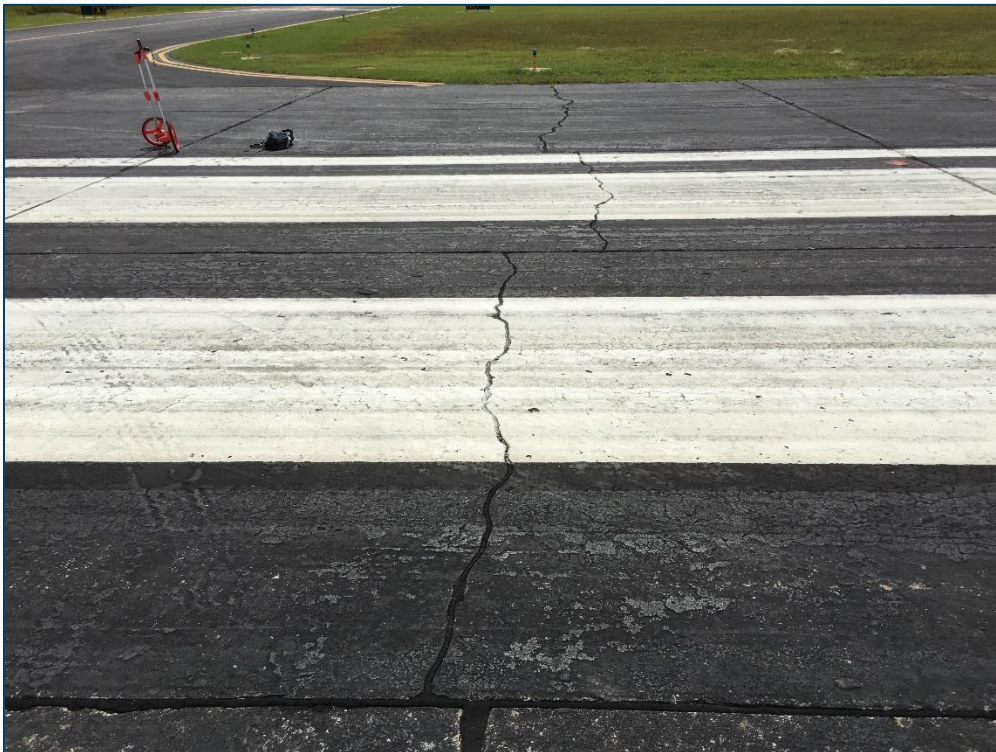
Runway 5-23, Section 6215, Sample Unit 198 – Low Severity (63) Longitudinal, Transverse, and Diagonal Cracking, Low Severity (65) Joint Seal Damage

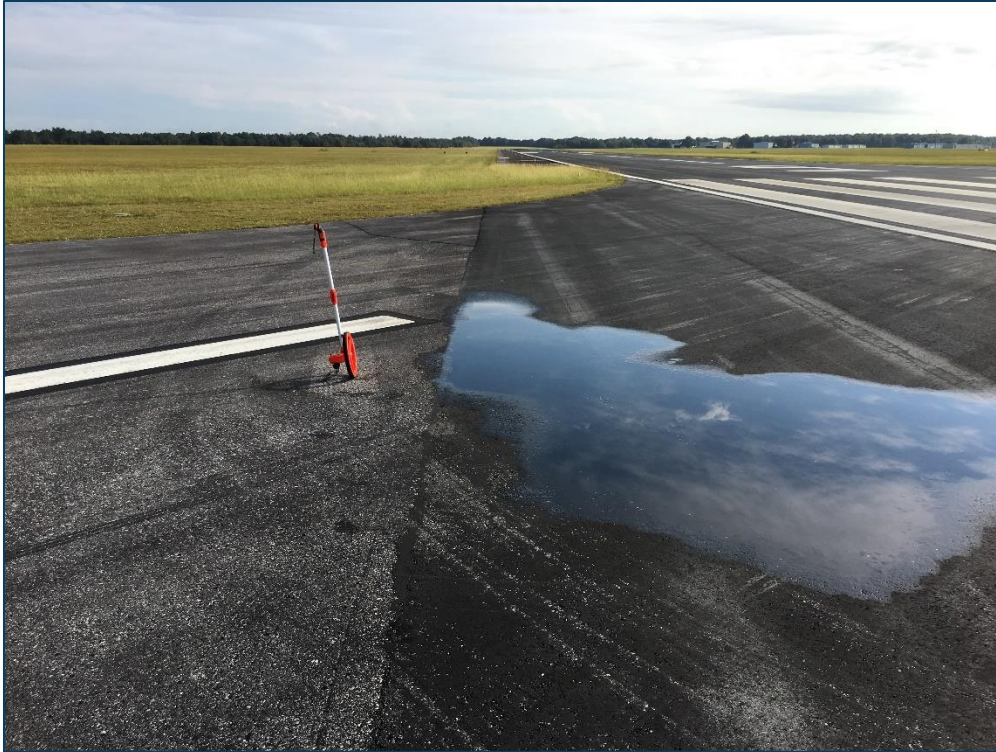
Runway 10-28, Section 6105, Sample Unit 177 – Low Severity (48) Longitudinal and Transverse Cracking, Low Severity (52) Raveling, Low Severity (57) Weathering

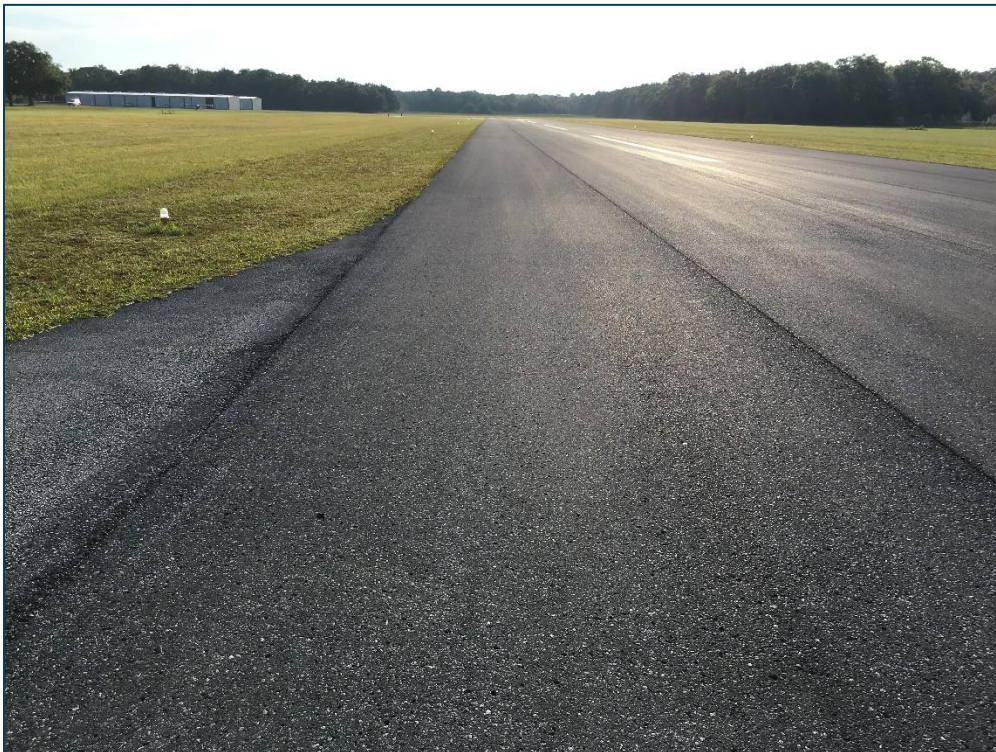
Runway 10-28, Section 6105, Sample Unit 118 – Low Severity (48) Longitudinal and Transverse Cracking, Low Severity (57) Weathering

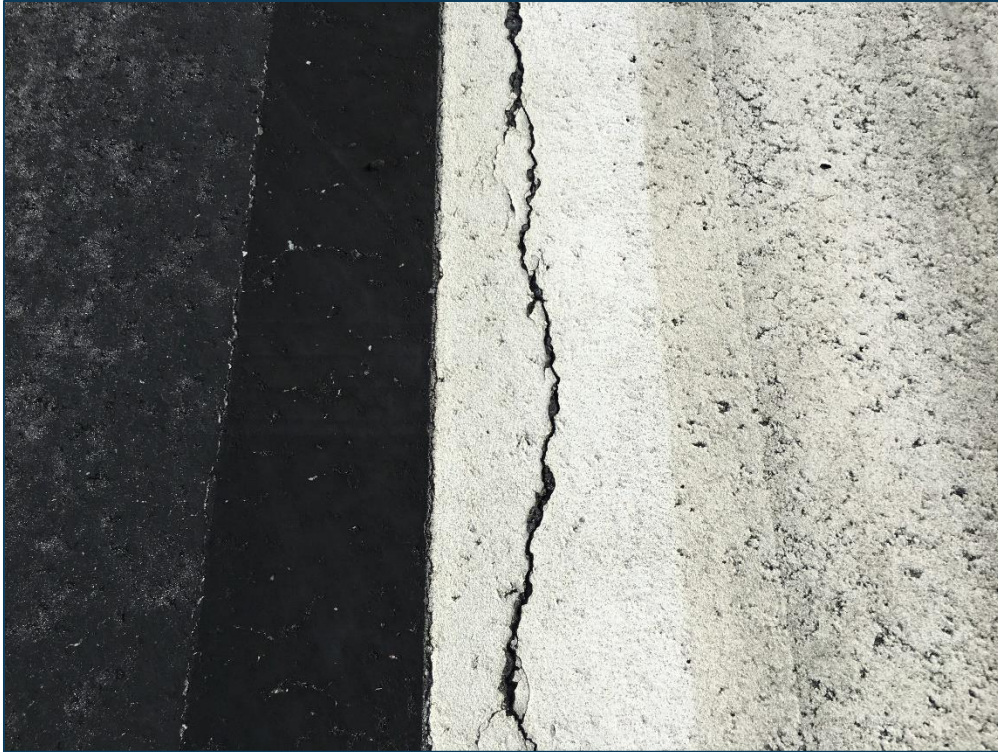
Runway 10-28, Section 6105, Sample Unit 101 – Low Severity (48) Longitudinal and Transverse Cracking, Low Severity (57) Weathering

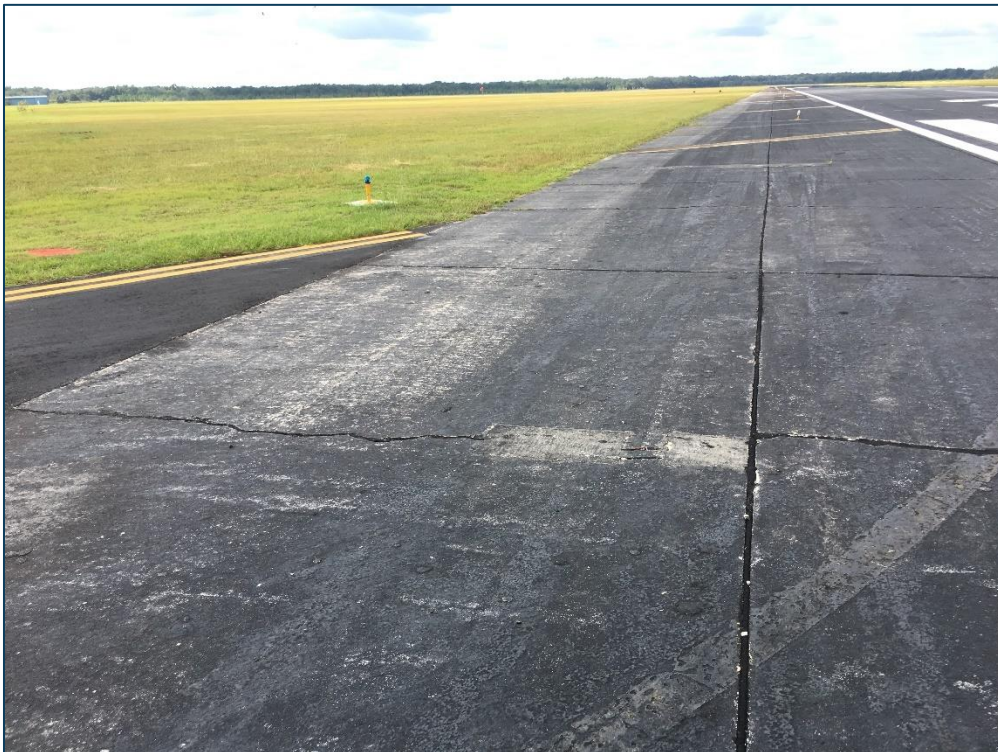
Taxiway A, Section 115, Sample Unit 135 – Low Severity (63) Longitudinal, Transverse, and Diagonal Cracking, Low Severity (65) Joint Seal Damage, Low Severity (66) Small Patching

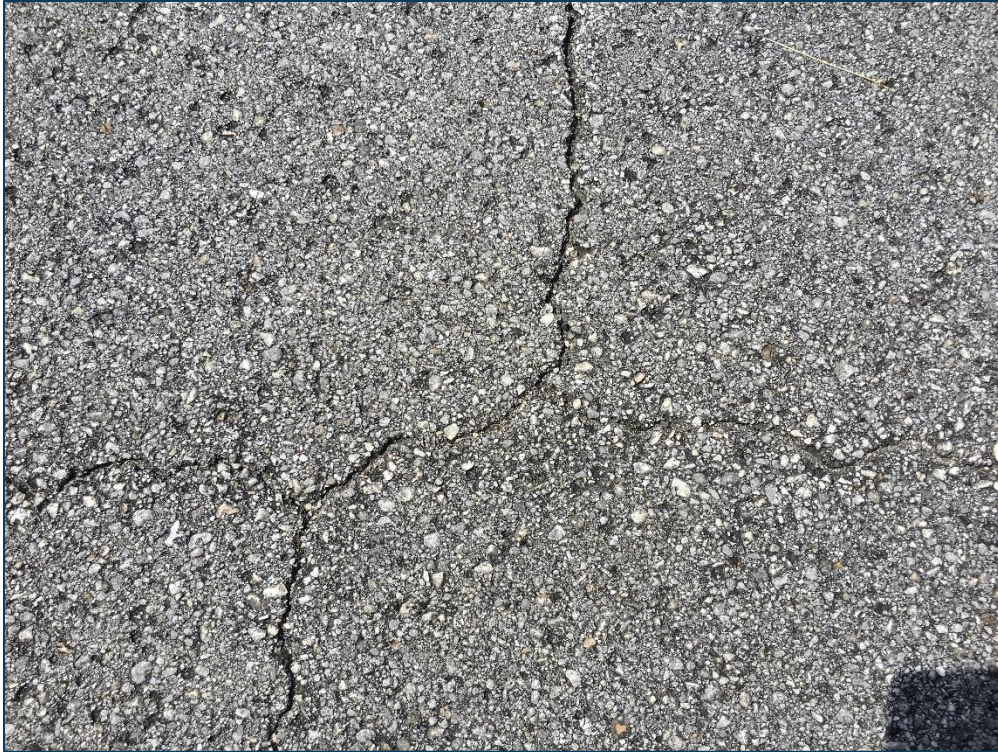
Apron, Section 4105, Sample Unit 307 – Low Severity (48) Longitudinal and Transverse Cracking, Medium Severity (48) Longitudinal and Transverse Cracking, Low Severity (52) Raveling

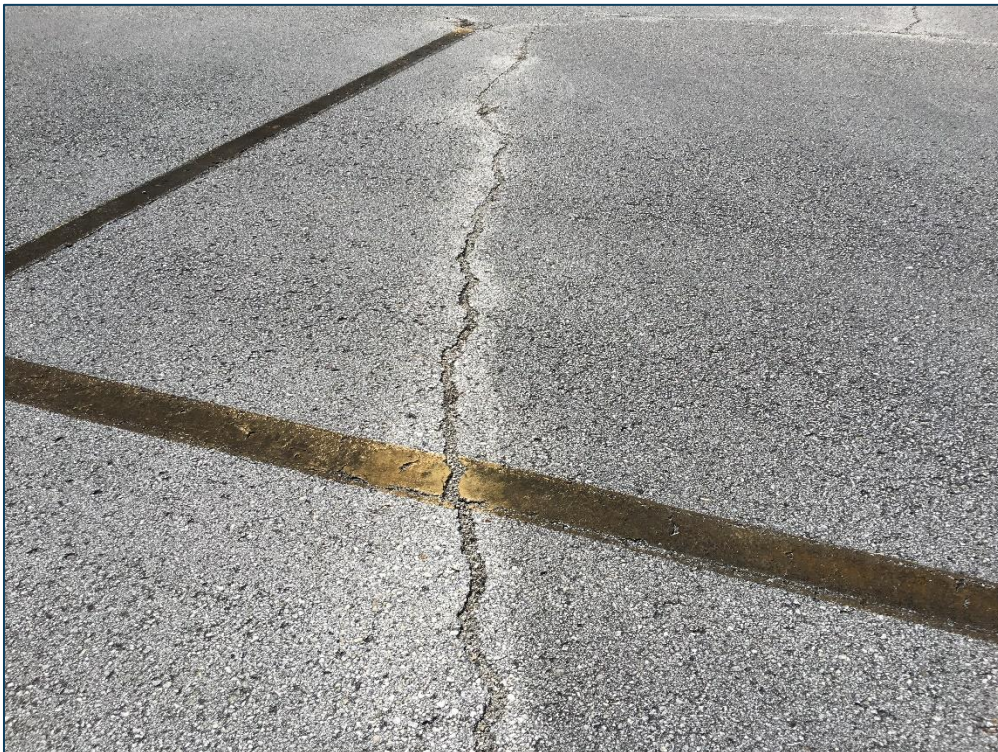
Apron AP, Section 4105, Sample Unit 204 – Medium Severity (48) Longitudinal and Transverse Cracking, Low Severity (52) Raveling

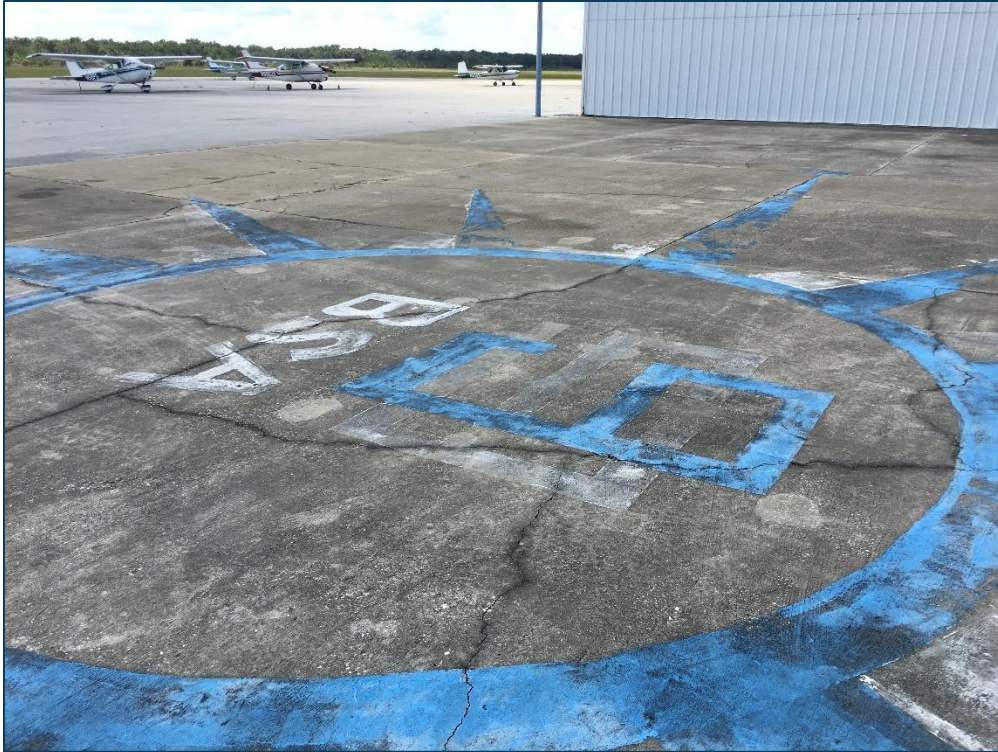
Hangar Apron, Section 4230, Sample Unit 401 – Low Severity (65) Joint Seal Damage, (73) Shrinkage Cracks, Low Severity (72) Shattered Slab

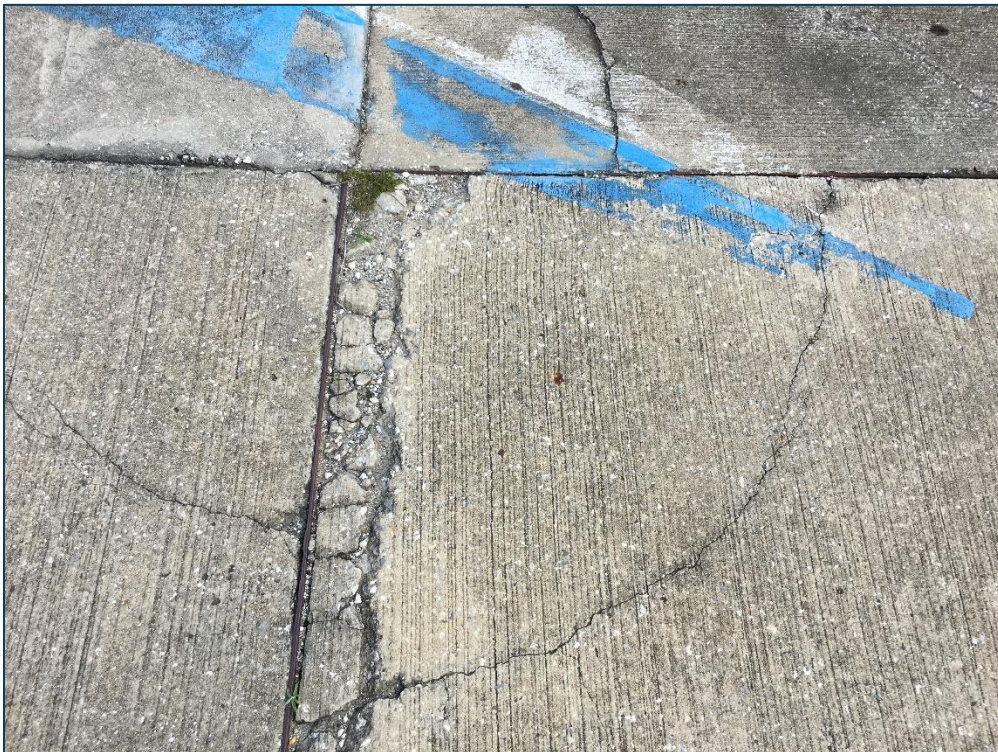
Hangar Apron, Section 4230, Sample Unit 401 – Low Severity (65) Joint Seal Damage, (73) Shrinkage Cracks, Medium Severity (74) Joint Spalling, Low Severity (62) Corner Break

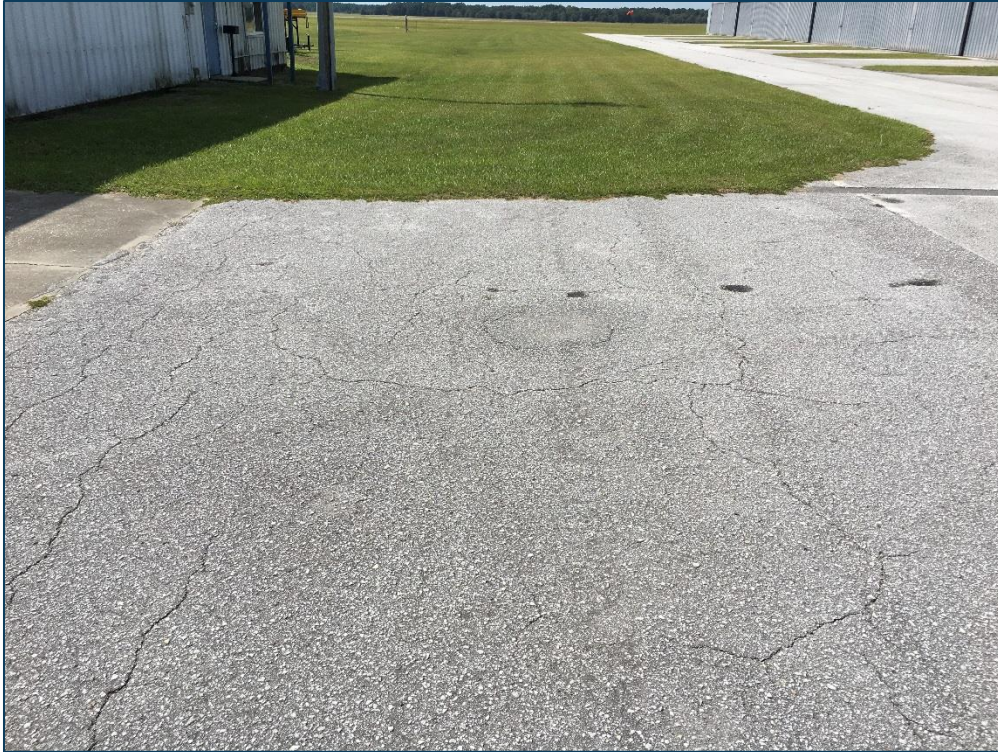
Hangar Apron, Section 4235, Sample Unit 400 – Low Severity (45) Depression, Low Severity (48) Longitudinal and Transverse Cracking, Low Severity (45) Depression, Low Severity (52) Raveling

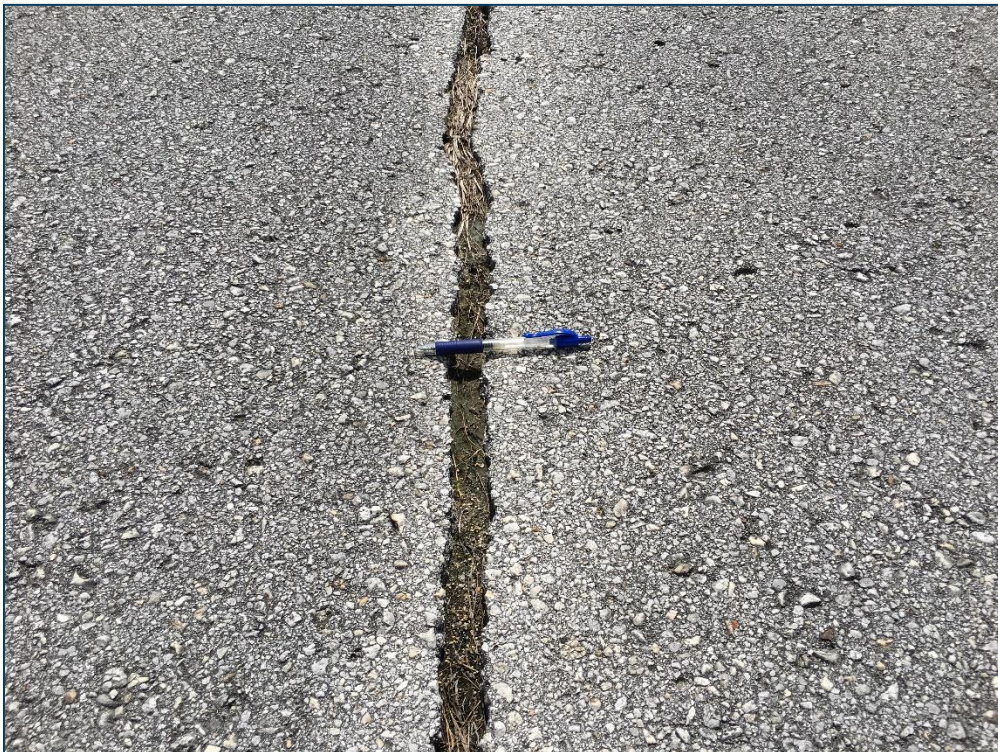
Hangar Apron, Section 4220, Sample Unit 300 – Low and Medium Severity (48) Longitudinal and Transverse Cracking, Low Severity (52) Raveling, Low Severity (57) Weathering

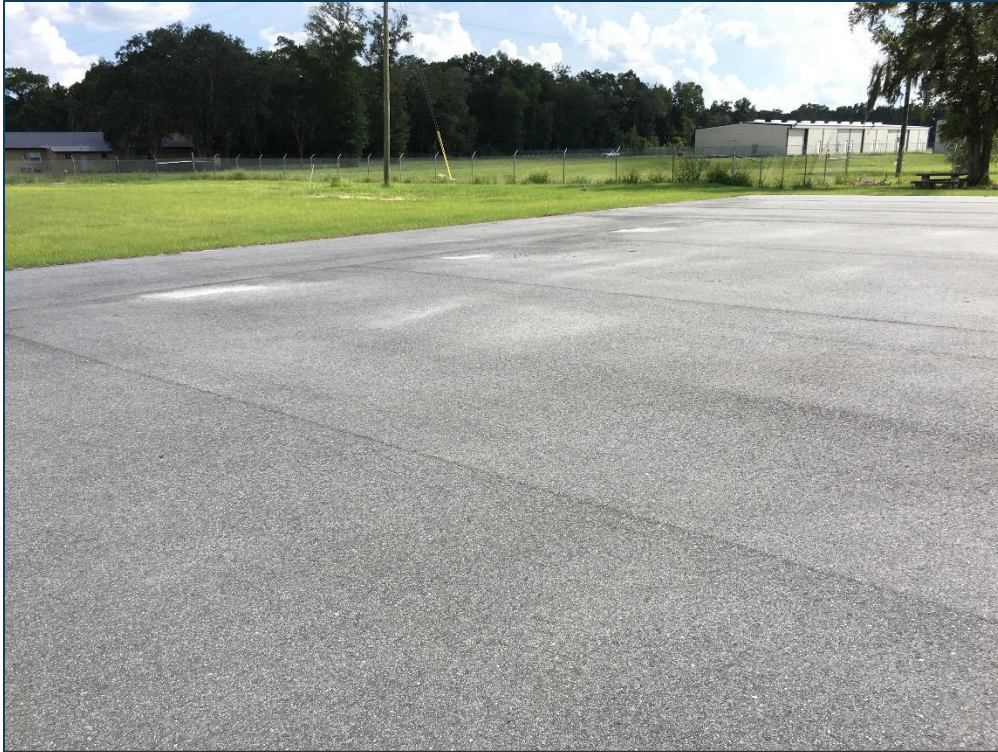
Terminal Apron, Section 4305, Sample Unit 203 – Low Severity (57) Weathering
