# **Statewide Airfield Pavement Management Program**

## **Airport Pavement Evaluation Report September 2017**

**Miami Homestead  
General Aviation  
Airport (X51)**

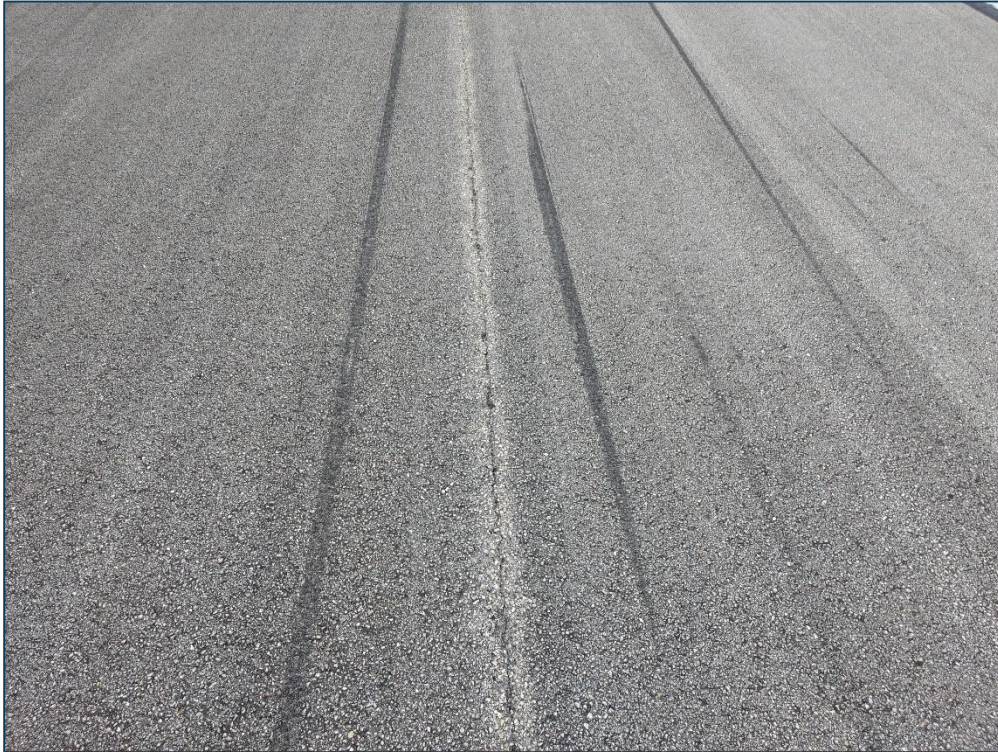
Runway 18-36, Section 6105, Sample Unit 305 – Low Severity (48) Longitudinal and Transverse Cracking, Low Severity (52) Raveling, Low Severity (57) Weathering

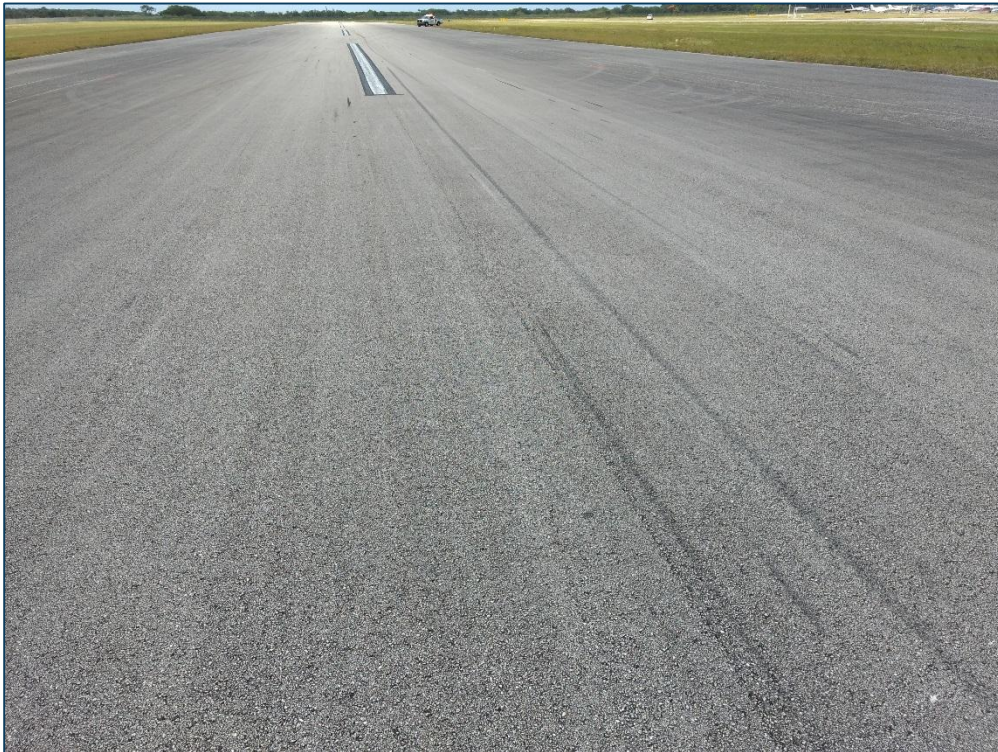
Runway 18-36, Section 6105, Sample Unit 329 – Low Severity (48) Longitudinal and Transverse Cracking, Low Severity (57) Weathering

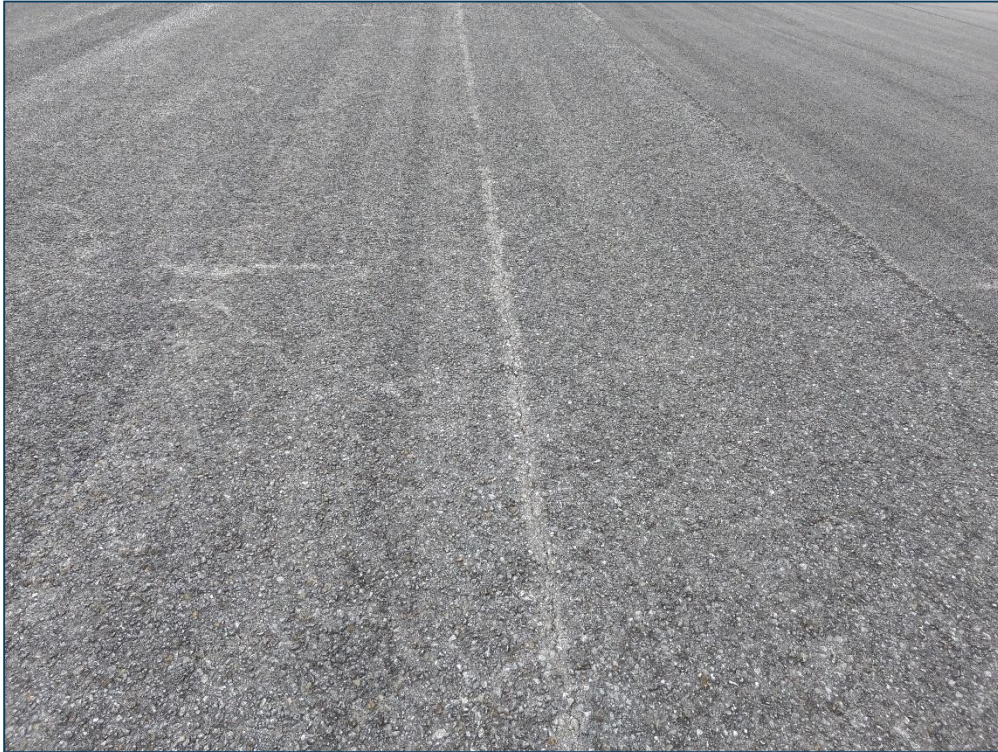
Runway 18-36, Section 6110, Sample Unit 128 – Low Severity (48) Longitudinal and Transverse Cracking, Low Severity (52) Raveling

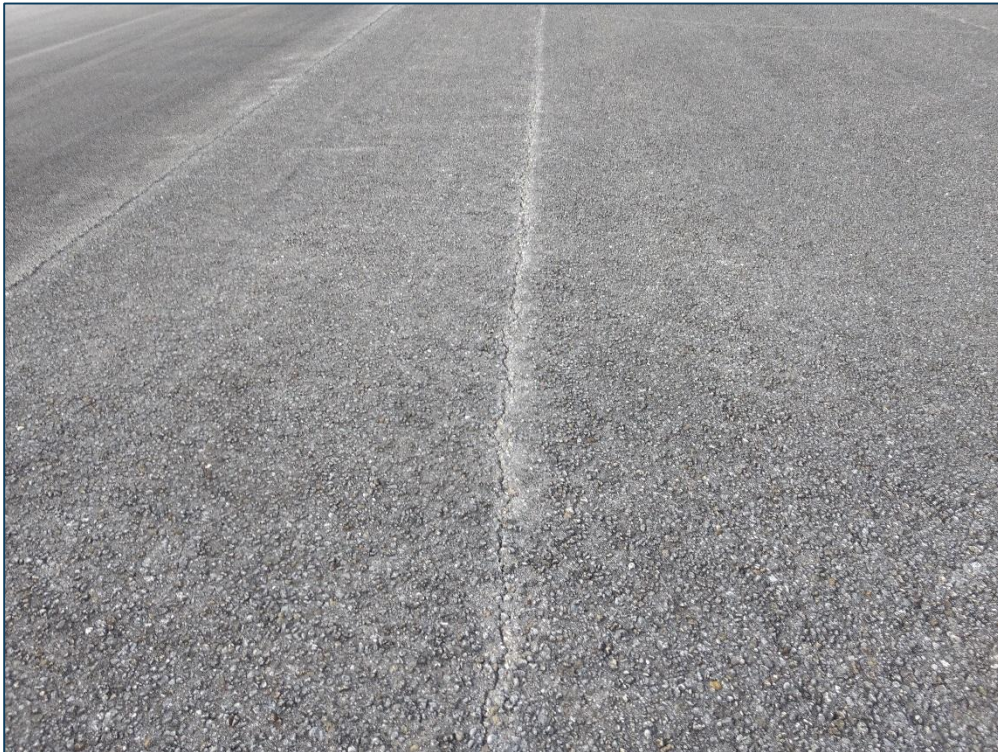
Runway 18-36, Section 6110, Sample Unit 572 – Low Severity (48) Longitudinal and Transverse Cracking, Low Severity (52) Raveling

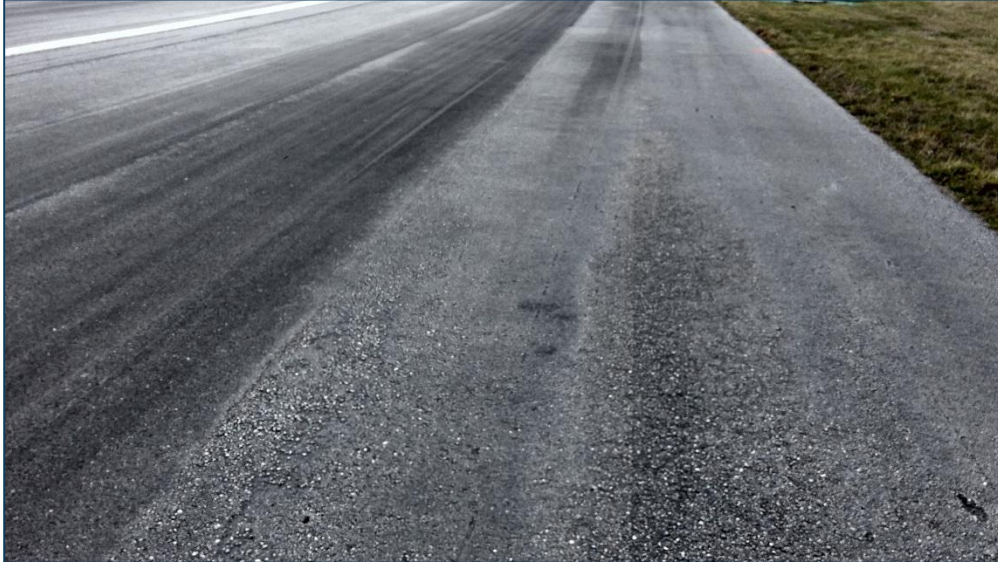
Runway 10-28, Section 6205, Sample Unit 143 – Low Severity (48) Longitudinal and Transverse Cracking, Low Severity (52) Raveling, Low Severity (57) Weathering

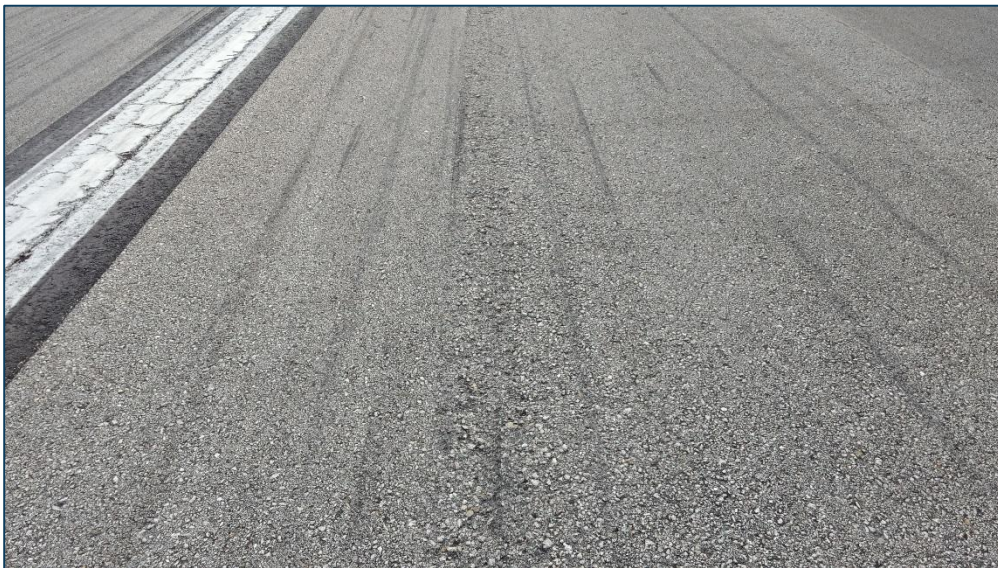
Runway 10-28, Section 6205, Sample Unit 119 – Low Severity (48) Longitudinal and Transverse Cracking, Low Severity (52) Raveling, Low Severity (57) Weathering

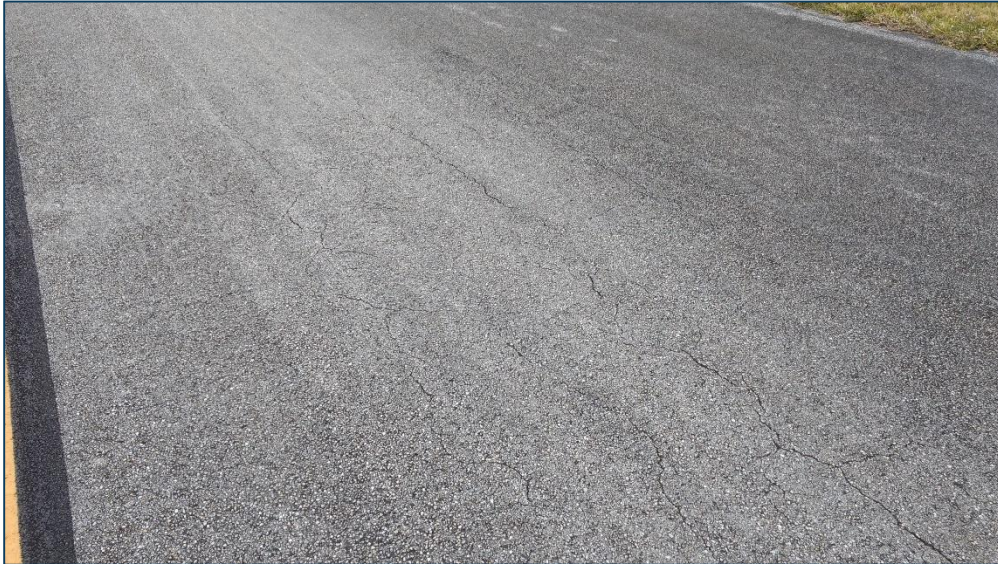
Taxiway A, Section 215, Sample Unit 117 – Low Severity (43) Block Cracking, Low Severity (48) Longitudinal and Transverse Cracking, Low Severity (52) Raveling

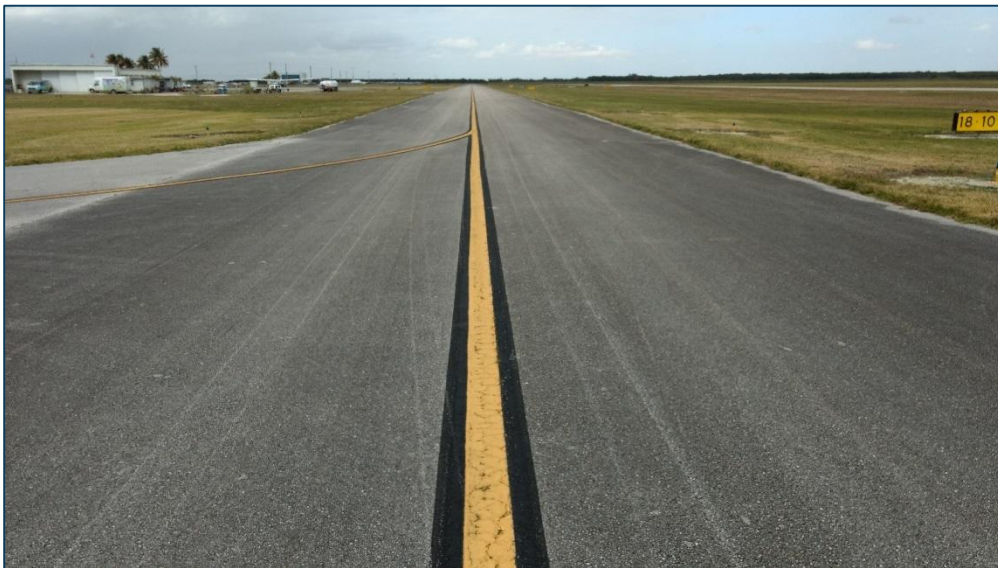
Taxiway A, Section 215, Sample Unit 123 – Low Severity (48) Longitudinal and Transverse Cracking, Low Severity (52) Raveling

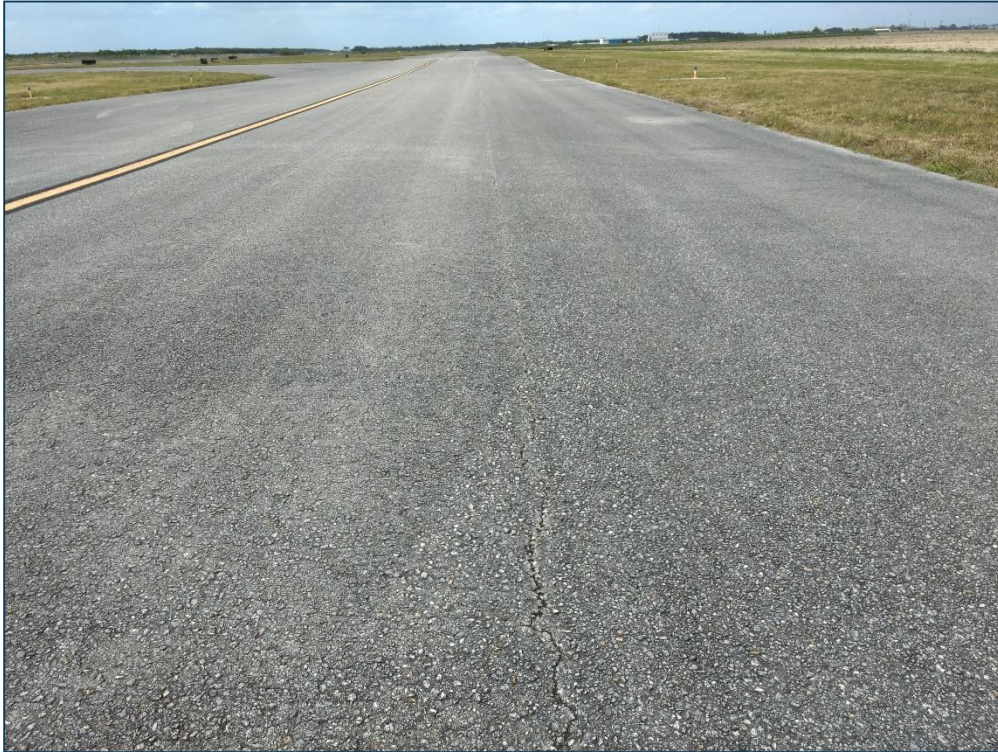
Taxiway B, Section 105, Sample Unit 103 – Low Severity (48) Longitudinal and Transverse Cracking, Low Severity (52) Raveling

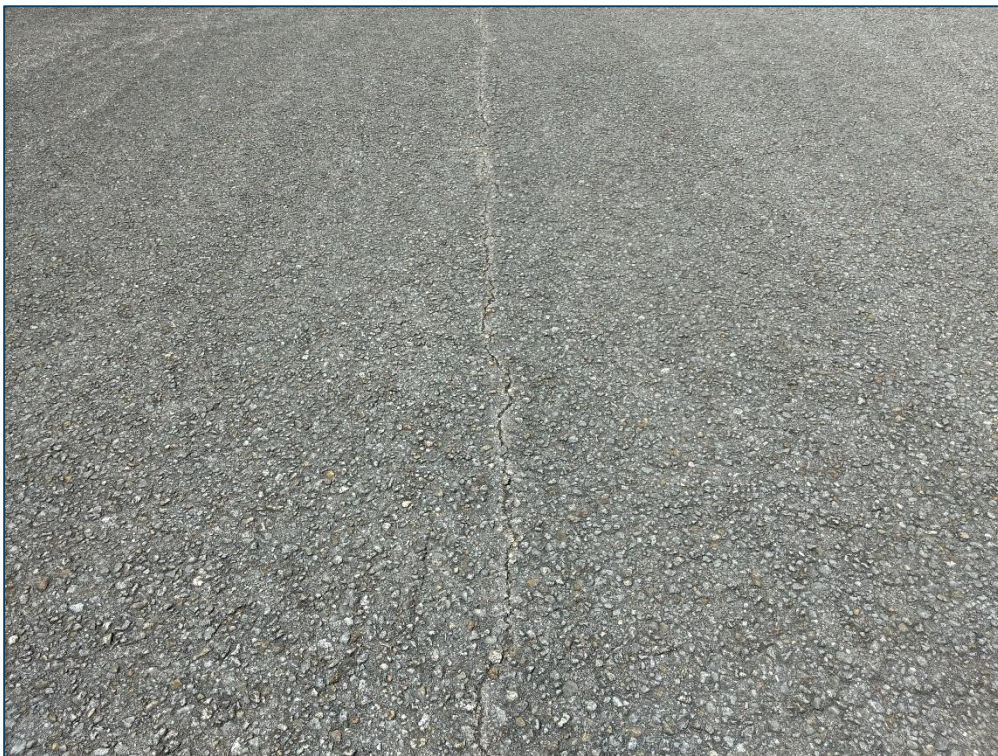
Taxiway B, Section 105, Sample Unit 132 – Low Severity (48) Longitudinal and Transverse Cracking, Low Severity (52) Raveling

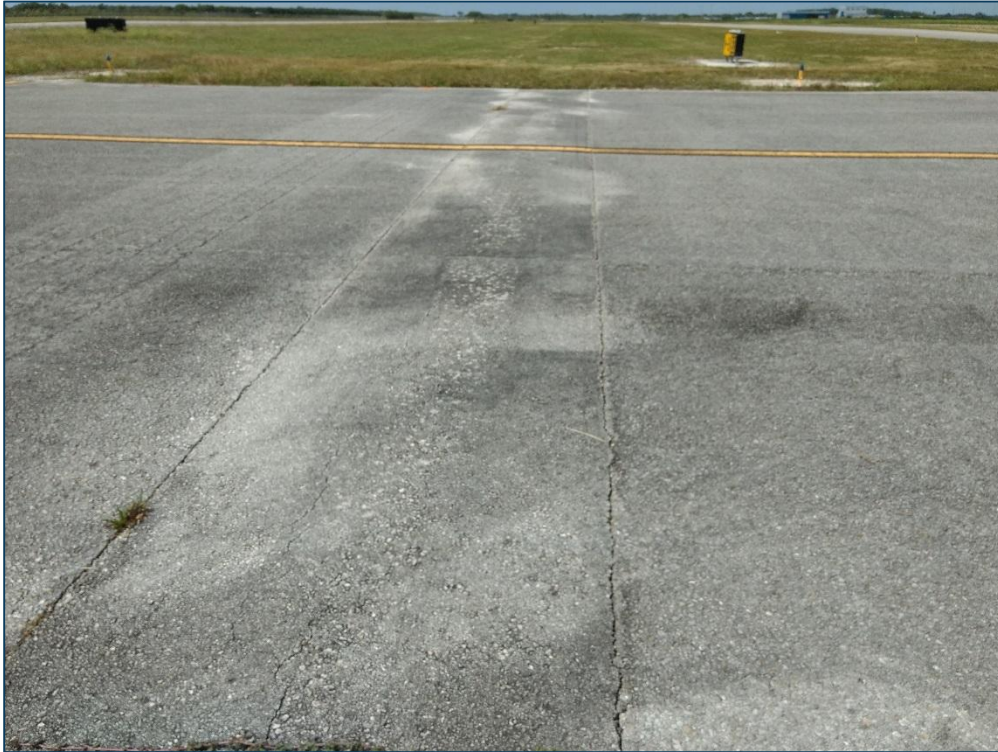
Taxiway B3, Section 130, Sample Unit 302 – Low Severity (48) Longitudinal and Transverse Cracking, Low Severity (50) Patching, Low Severity (52) Raveling, Medium Severity (52) Raveling

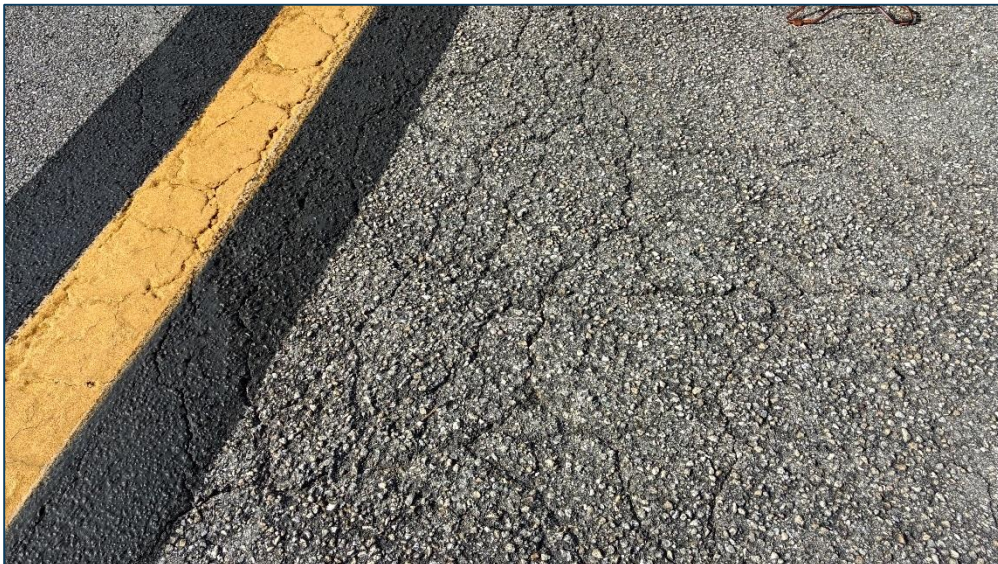
Taxiway A1, Section 230, Sample Unit 100 – Low Severity (41) Alligator Cracking, Medium Severity (52) Raveling

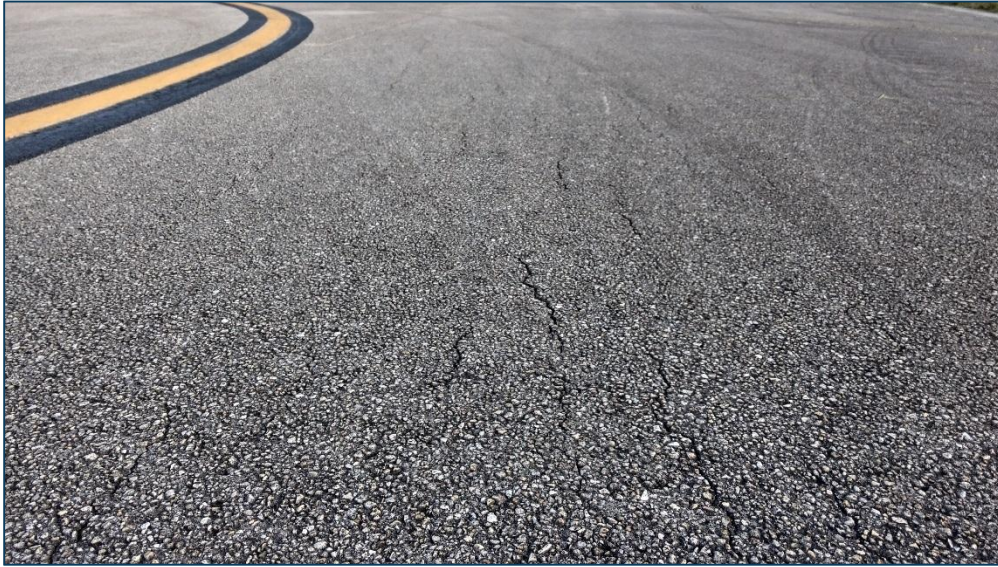
Taxiway A3, Section 250, Sample Unit 301 – Low Severity (41) Alligator Cracking, Low Severity (52) Raveling, Low Severity (57) Weathering

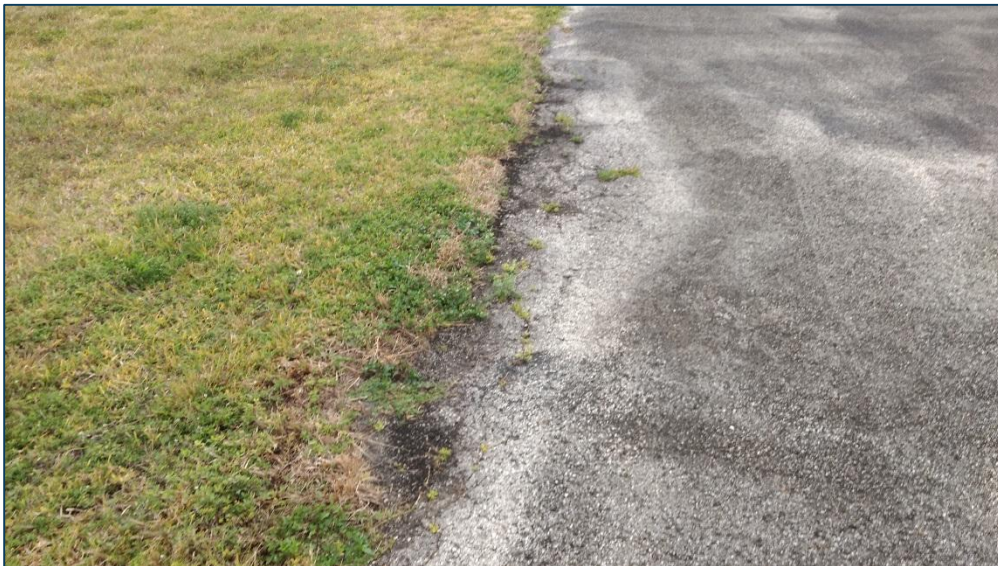
NW Apron, Section 4105, Sample Unit 100 – Low and Medium Severity (48) Longitudinal and Transverse Cracking, Low Severity (52) Raveling

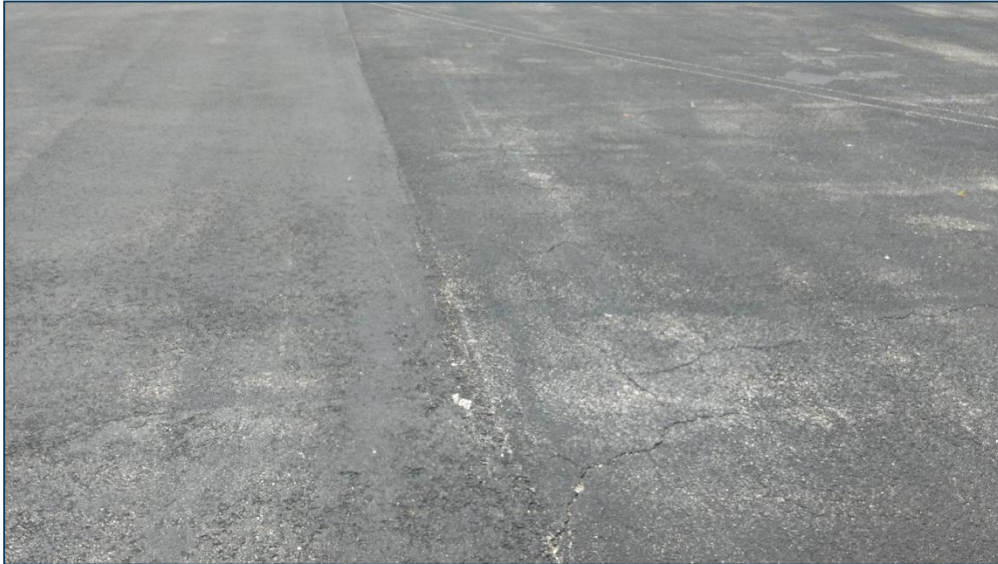
NW Apron, Section 4105, Sample Unit 454 – Low Severity (48) Longitudinal and Transverse Cracking, Low Severity (50) Patching, Low Severity (52) Raveling

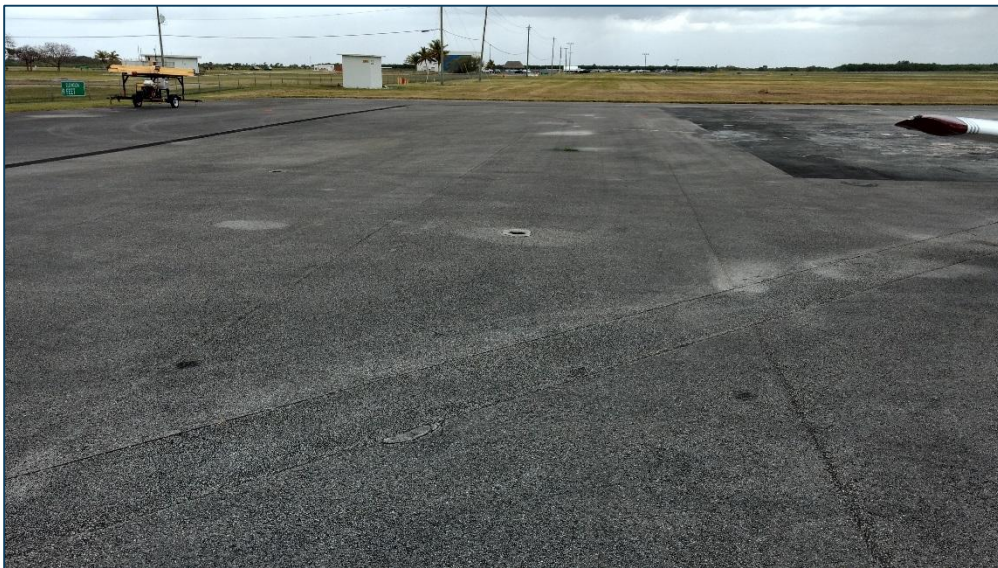
North Apron, Section 4205, Sample Unit 403 – Low Severity (48) Longitudinal and Transverse Cracking, Low Severity (50) Patching, Low Severity (52) Raveling
