FLORIDA DEPARTMENT OF TRANSPORTATION
AVIATION AND SPACEPORTS OFFICE

Statewide Airfield Pavement Management Program

**Airport Pavement
Evaluation Report
September 2017**

Valkaria Airport (X59)
General Aviation Airport
District 5

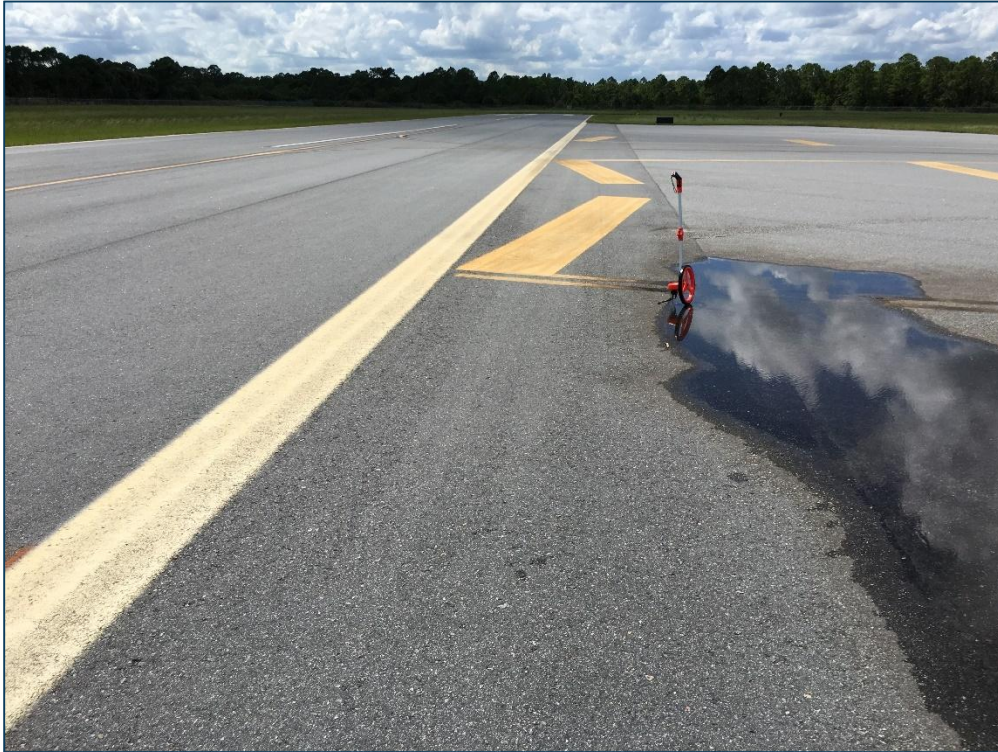
Runway 10-28, Section 6205, Sample Unit 106 – Low Severity (45) Depression, Low Severity (57) Weathering

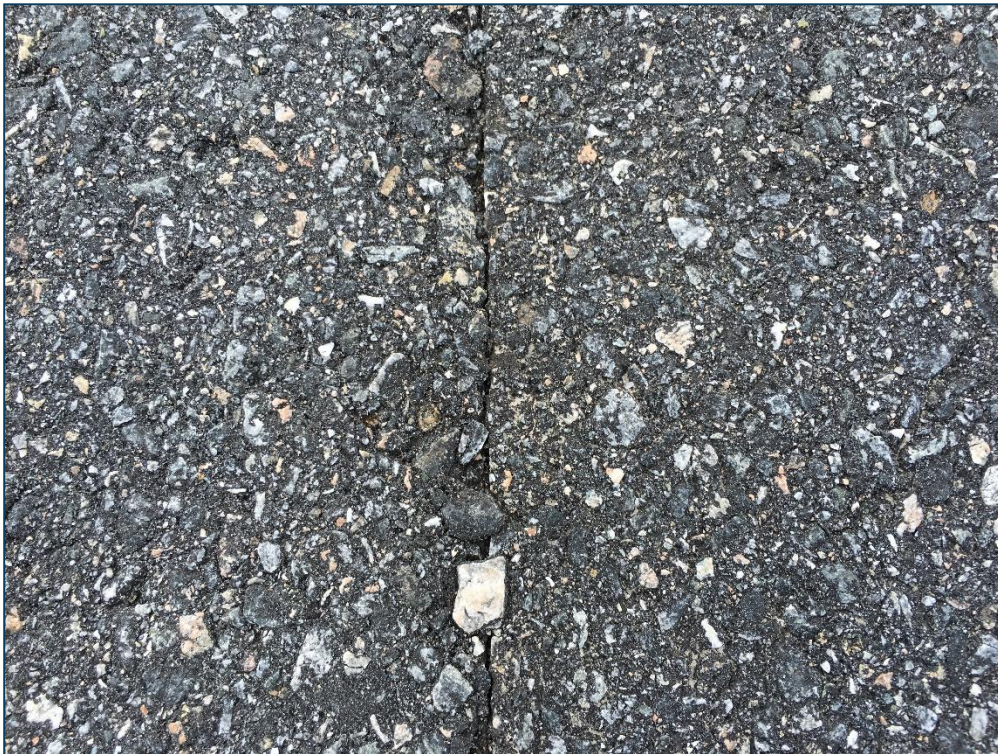
Runway 10-28, Section 6205, Sample Unit 141 – Low Severity (48) Longitudinal and Transverse Cracking, Low Severity (52) Raveling, Low Severity (57) Weathering

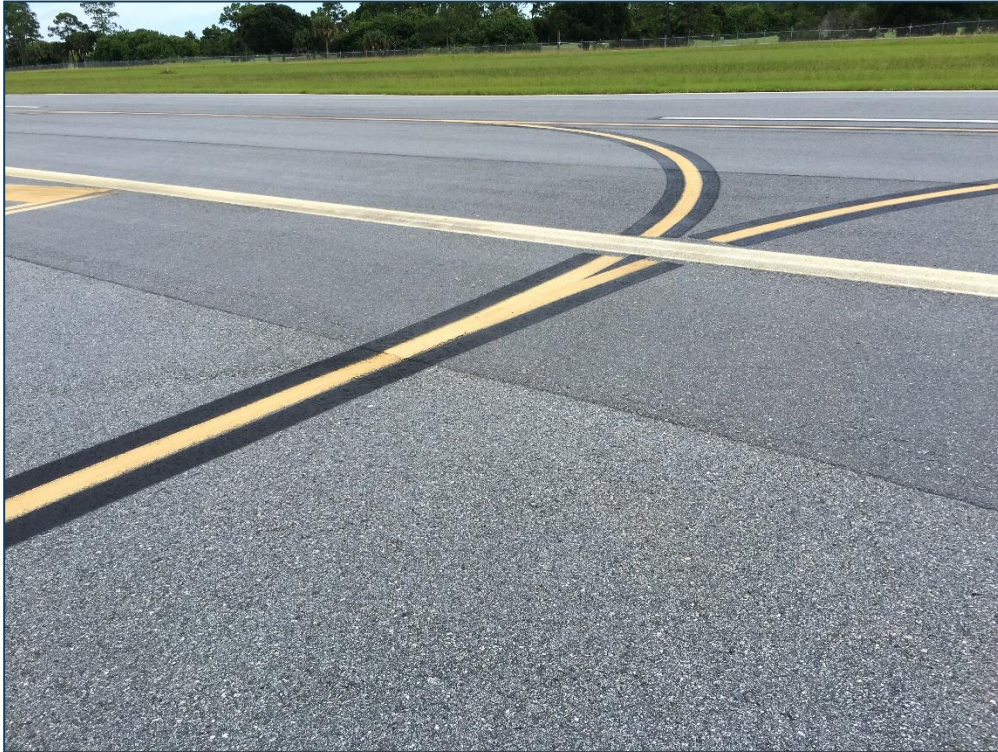
Taxiway C1, Section 605, Sample Unit 100 – Low Severity (57) Weathering

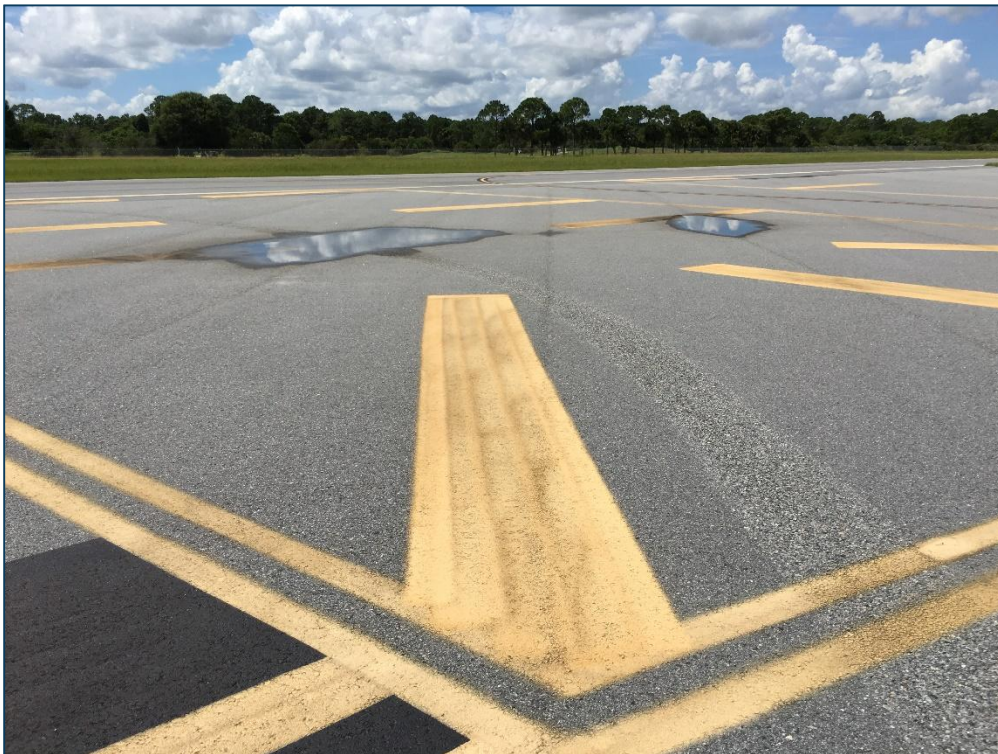
Taxiway C2, Section 705, Sample Unit 200 – Low Severity (45) Depression, Low Severity (57) Weathering

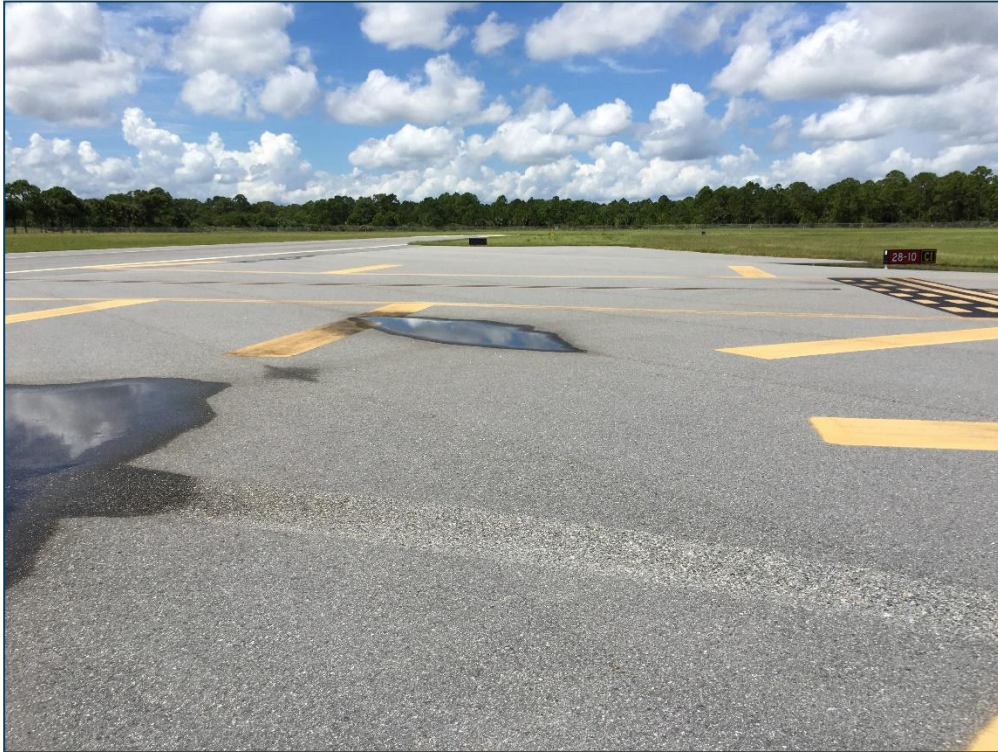
Taxiway C2, Section 705, Sample Unit 200 – Low Severity (45) Depression, Low Severity (57) Weathering

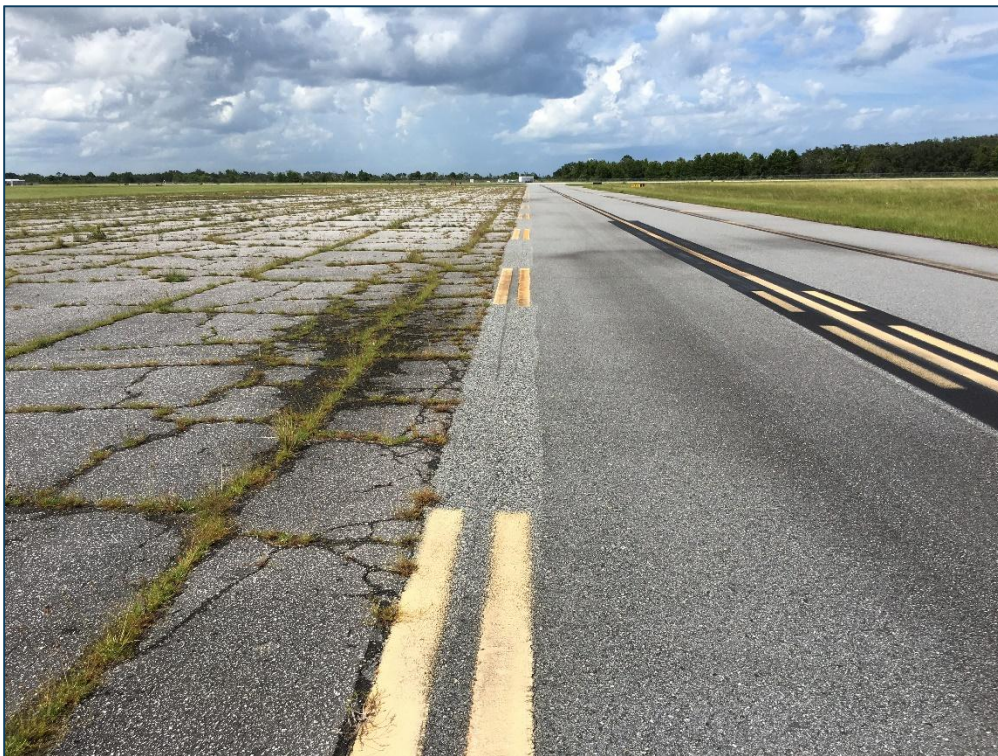
Taxiway B, Section 110, Sample Unit 101 – Low Severity (48) Longitudinal and Transverse Cracking, Low Severity (52) Raveling, Low Severity (57) Weathering

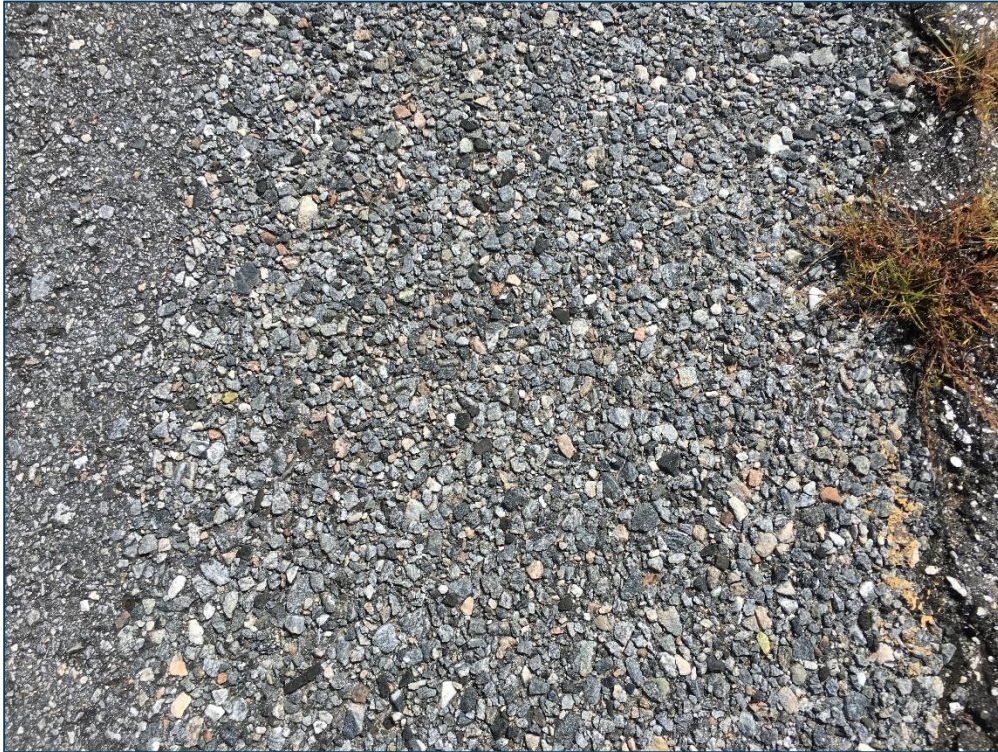
Taxiway B, Section 110, Sample Unit 101 – Low Severity (52) Raveling, Low Severity (57) Weathering

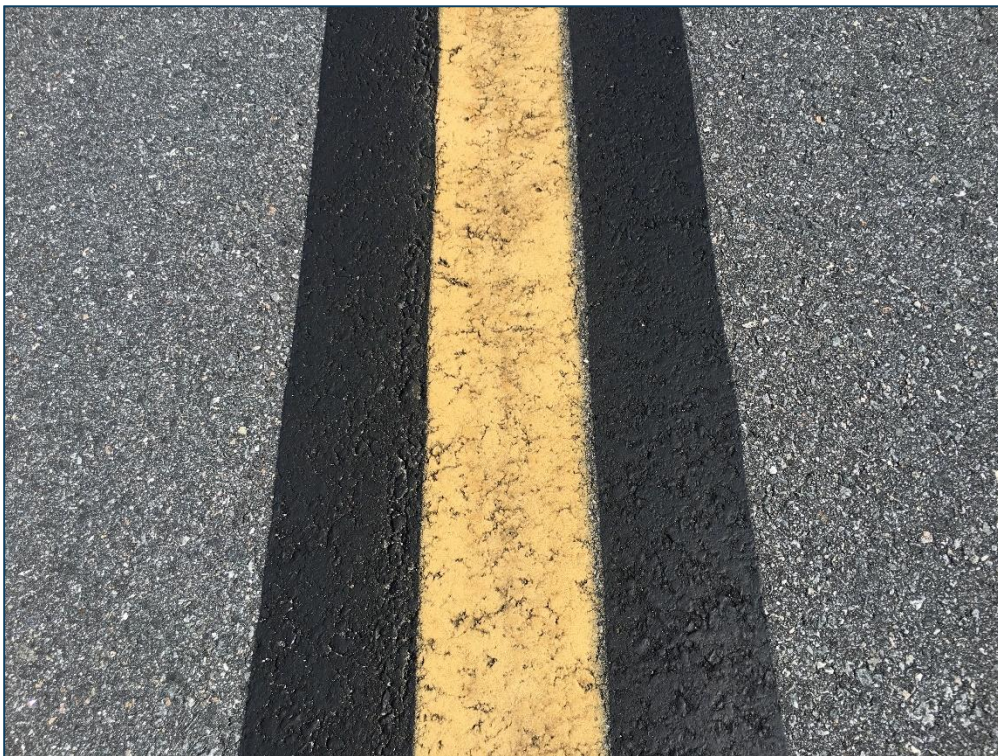
Taxiway A, Section 305, Sample Unit 116 – Low Severity (48) Longitudinal and Transverse Cracking, Low Severity (57) Weathering

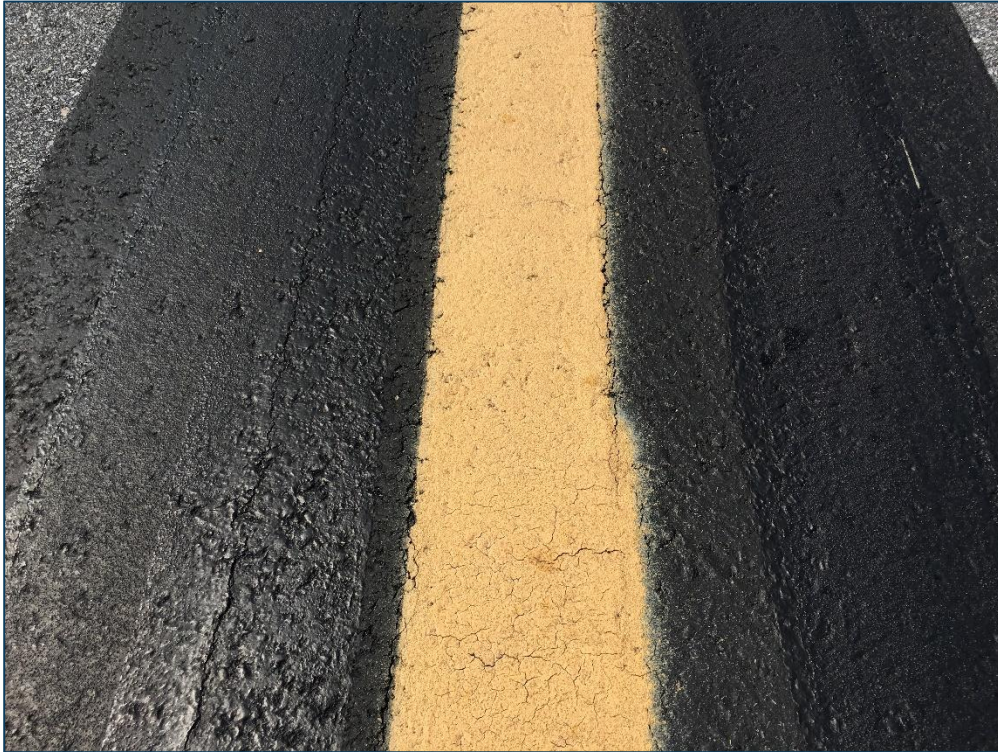
Taxiway A, Section 305, Sample Unit 106 – Low Severity (48) Longitudinal and Transverse Cracking, Low Severity (57) Weathering

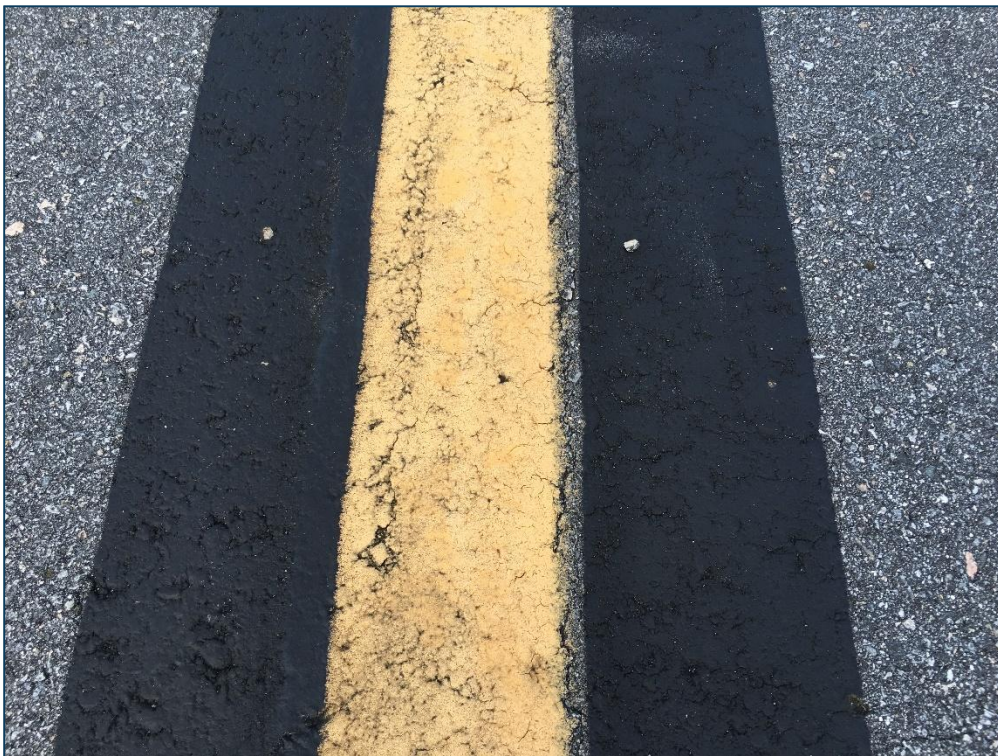
Taxiway A, Section 310, Sample Unit 200 – Low Severity (48) Longitudinal and Transverse Cracking, Low Severity (57) Weathering

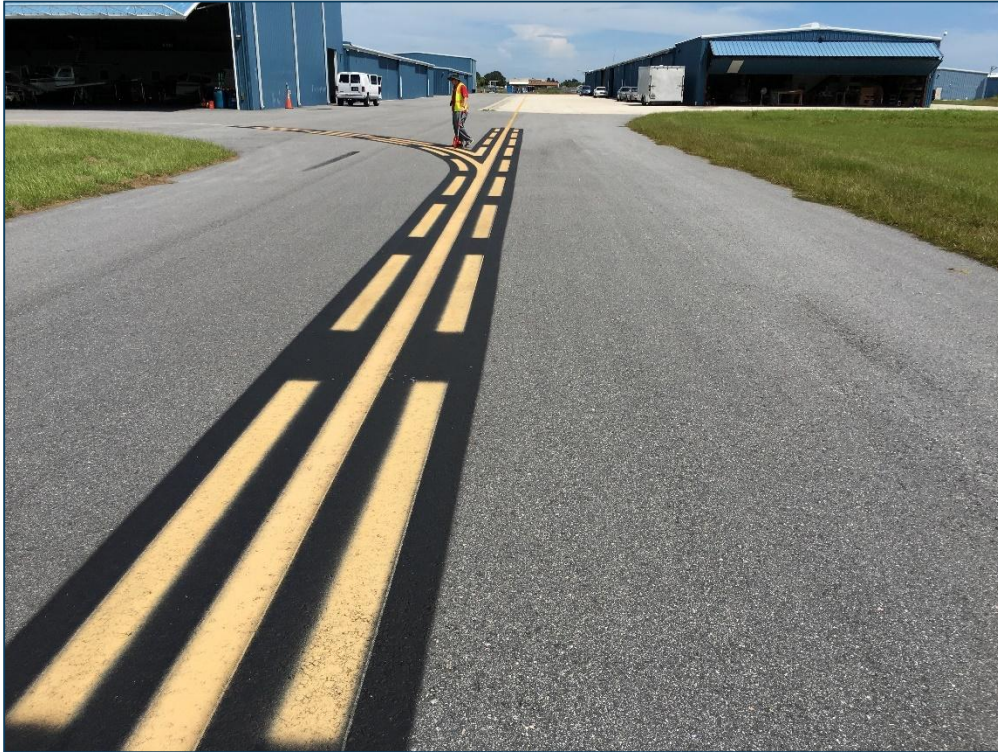
Taxiway D, Section 505, Sample Unit 101 – Low Severity (48) Longitudinal and Transverse Cracking, Low Severity (57) Weathering

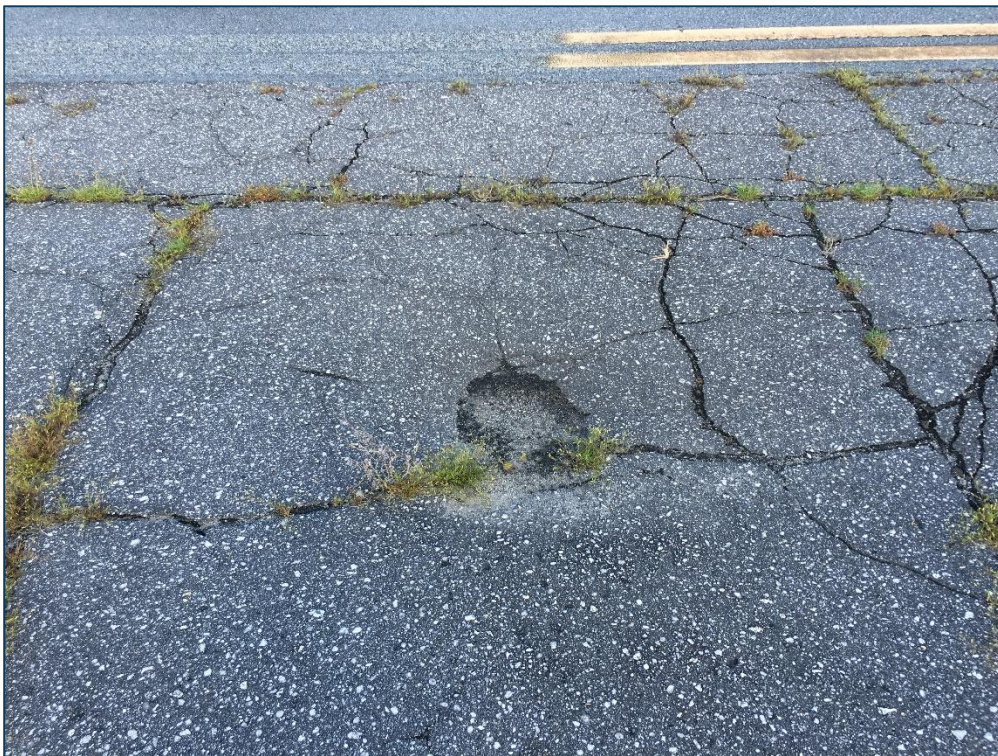
Apron AP, Section 4130, Sample Unit 306 – Medium Severity (41) Alligator Cracking, High Severity (43) Block Cracking, Medium Severity (45) Depression, Low Severity (52) Raveling

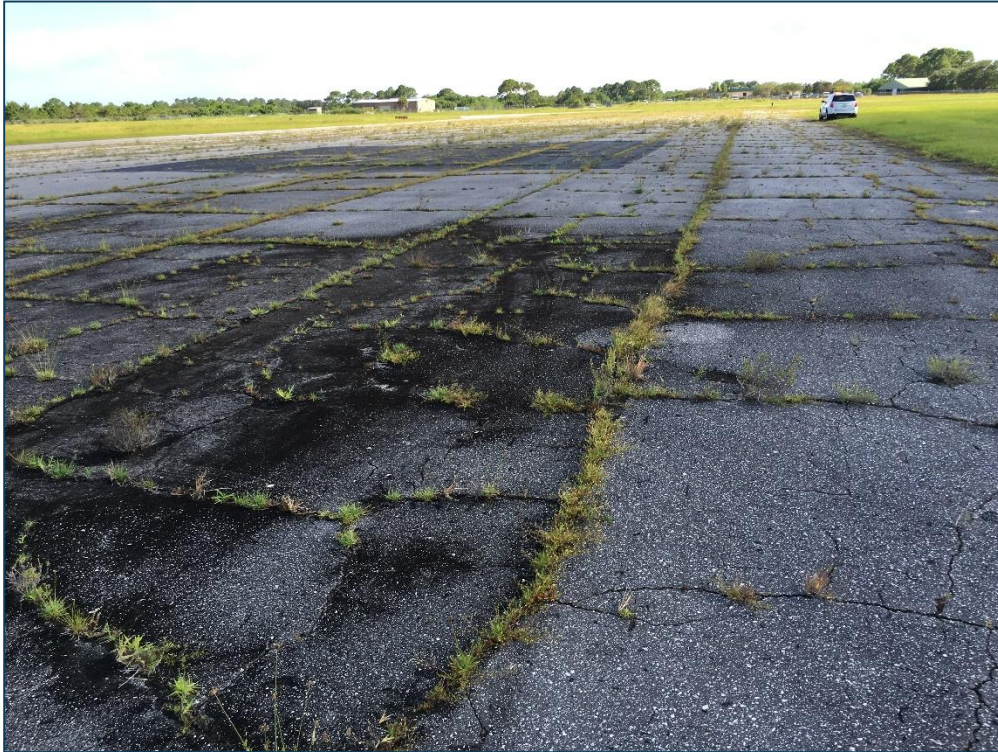
Apron AP, Section 4130, Sample Unit 104 – High Severity (43) Block Cracking, Low Severity (52) Raveling

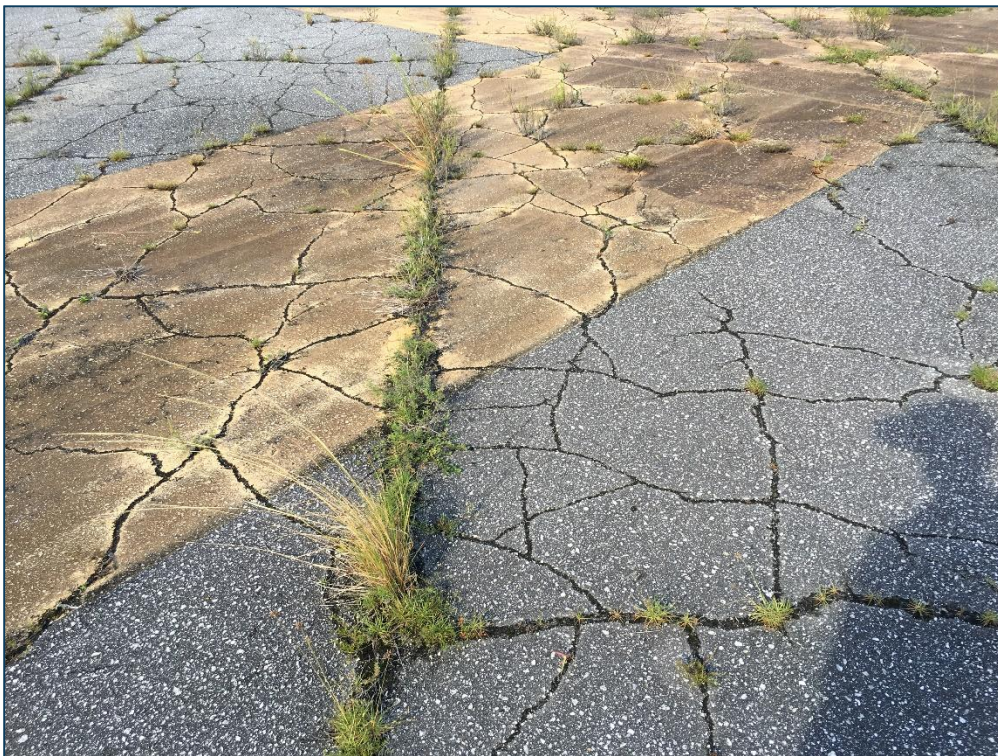
Apron AP, Section 4145, Sample Unit 400 – High Severity (43) Block Cracking, Medium Severity (41) Alligator Cracking, Low Severity (52) Raveling

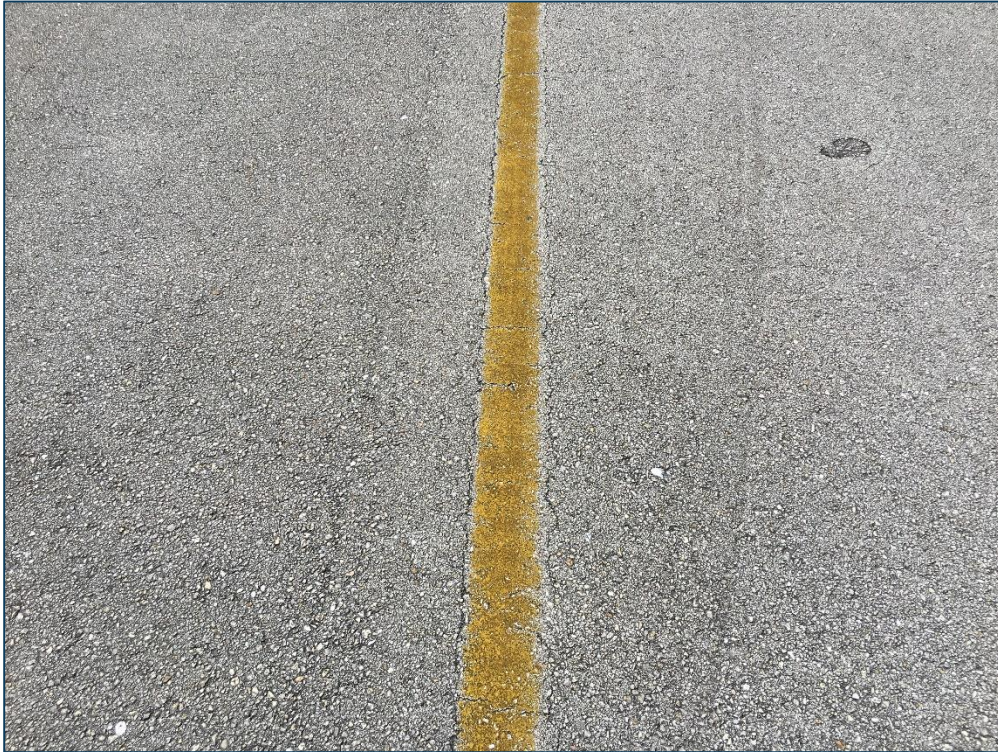
Apron AP, Section 4115, Sample Unit 100 – Low Severity (48) Longitudinal and Transverse Cracking, Medium Severity (52) Raveling, Low Severity (52) Raveling

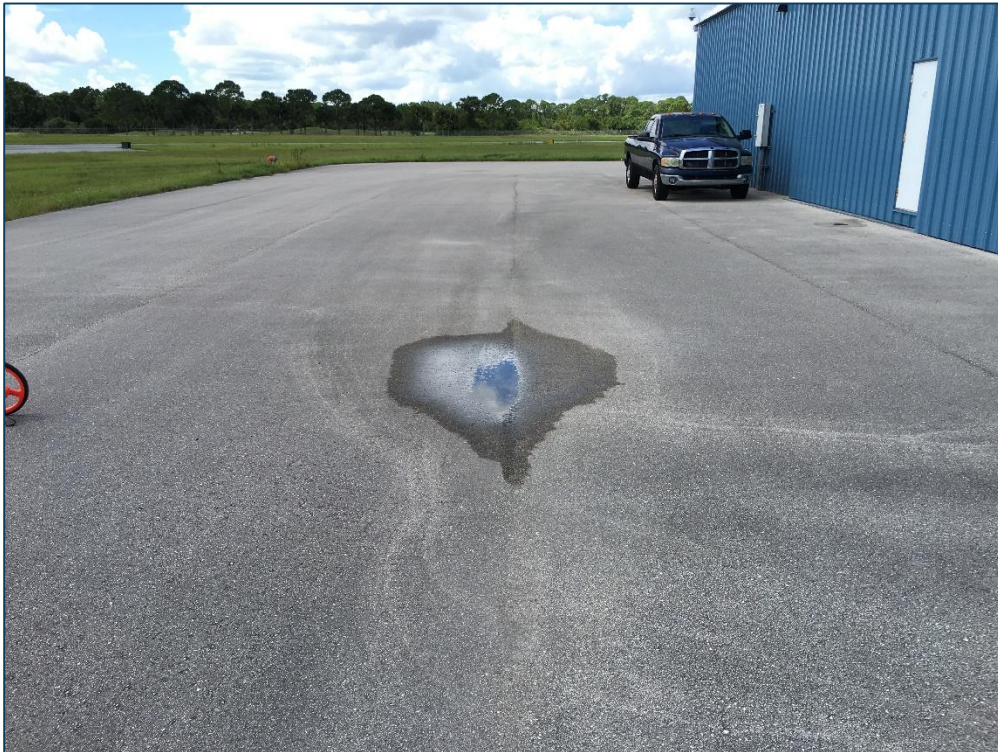
Apron AP, Section 4120, Sample Unit 301 – Low Severity (45) Depression, Low Severity (48) Longitudinal and Transverse Cracking, Low Severity (57) Weathering, Low Severity (52) Raveling
