Florida Department of Transportation

Statewide Airfield Pavement Management Program

Summary of Okeechobee County Airport

Okeechobee County Airport was inspected in April 2017 – the overall weighted PCI value was 71, a condition rating of Satisfactory. The results of the maintenance, repair, and major rehabilitation analysis identified \$170,050 in localized M&R needs based on current conditions and a 10-Year major rehabilitation need of \$8,139,000 based on forecasted conditions. The current major rehabilitation needs based on the latest inspection consist of \$3,644,000 for pavements below critical condition.

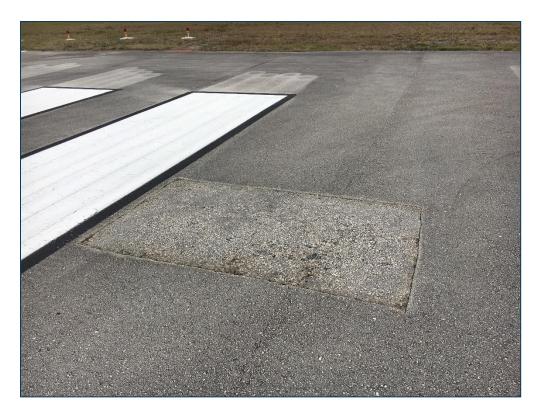
Runway 5-23, Section 6105, Sample Unit 300 – Low Severity (50) Patching, Medium Severity (50) Patching, Low Severity (52) Raveling, Low Severity (57) Weathering

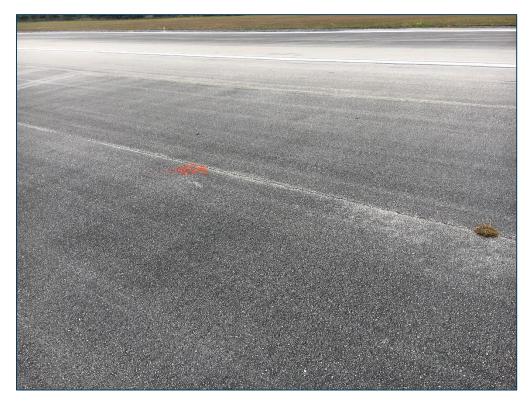
Runway 5-23, Section 6107, Sample Unit 124 – Low and Medium Severity (48) Longitudinal and Transverse Cracking, Low Severity (57) Weathering

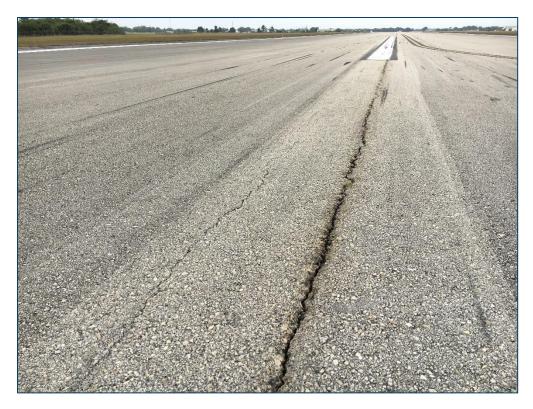
Runway 5-23, Section 6105, Sample Unit 335 – Low Severity (48) Longitudinal and Transverse Cracking, Low Severity (56) Swelling, Low Severity (57) Weathering

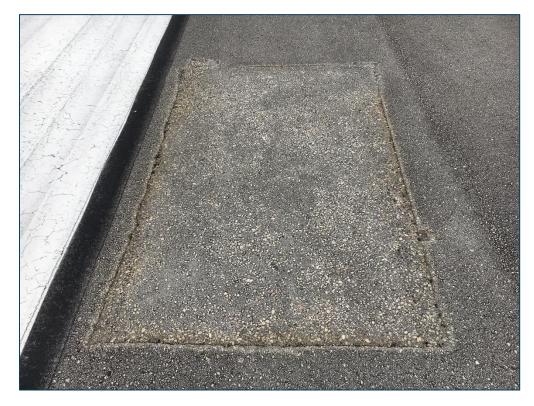
Runway 5-23, Section 6105, Sample Unit 349 – Medium Severity (50) Patching, Low Severity (52) Raveling, Low Severity (57) Weathering

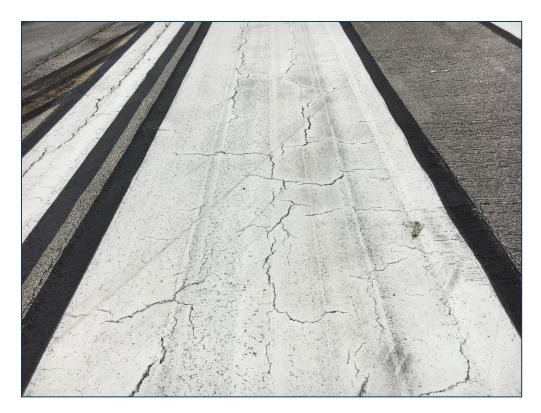
Runway 14-32, Section 6205, Sample Unit 301 – Low Severity (43) Block Cracking, Low Severity (48) Longitudinal and Transverse Cracking, Low Severity (52) Raveling, Medium Severity (52) Raveling

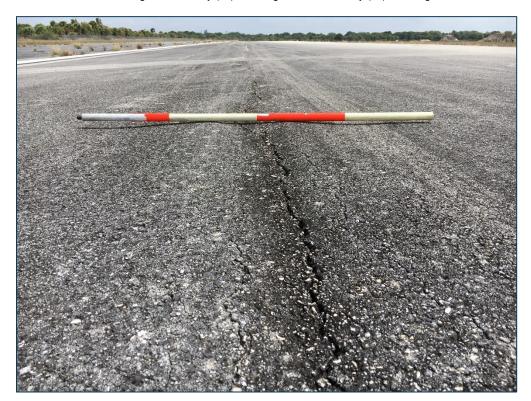
Runway 14-32, Section 6205, Sample Unit 333 - Low and Medium Severity (48) Longitudinal and Transverse Cracking, Low Severity (52) Raveling, Low Severity (56) Swelling, Low Severity (57) Weathering

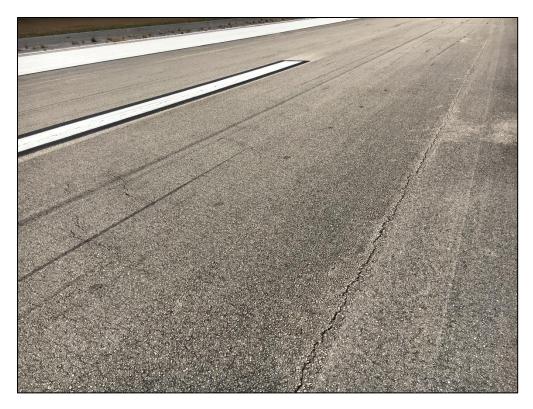
Runway 14-32, Section 6205, Sample Unit 357 – Low Severity (48) Longitudinal and Transverse Cracking, Low Severity (52) Raveling, Low Severity (57) Weathering

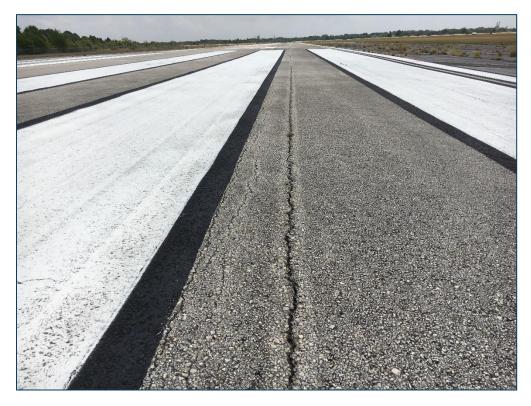
Runway 14-32, Section 6205, Sample Unit 378 - Low Severity (48) Longitudinal and Transverse Cracking, Low Severity (57) Weathering, Low Severity (56) Swelling, Low Severity (57) Weathering

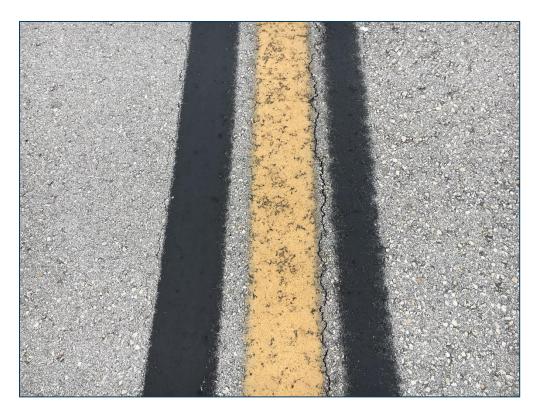
Taxiway A, Section 105, Sample Unit 109 – Low Severity (48) Longitudinal and Transverse Cracking, Low Severity (57) Weathering

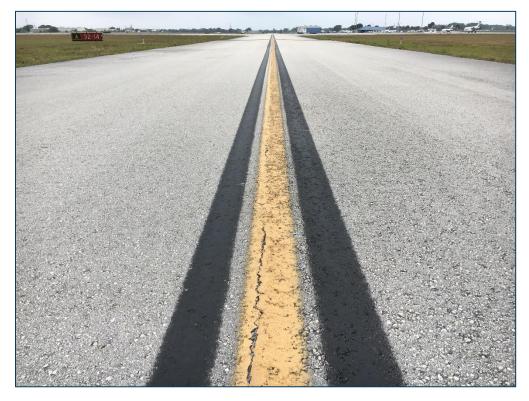
Taxiway A, Section 110, Sample Unit 231 – Low Severity (48) Longitudinal and Transverse Cracking, Low Severity (57) Weathering

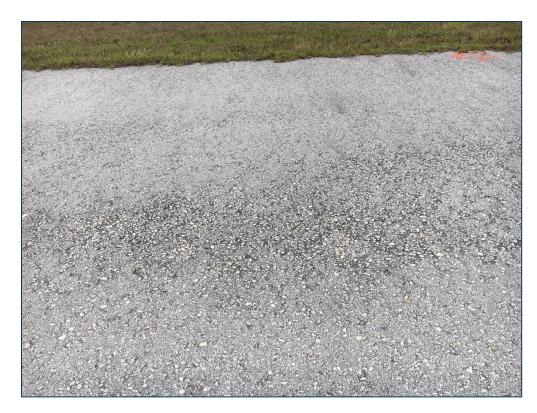
Taxiway A, Section 110, Sample Unit 212 - Low Severity (57) Weathering

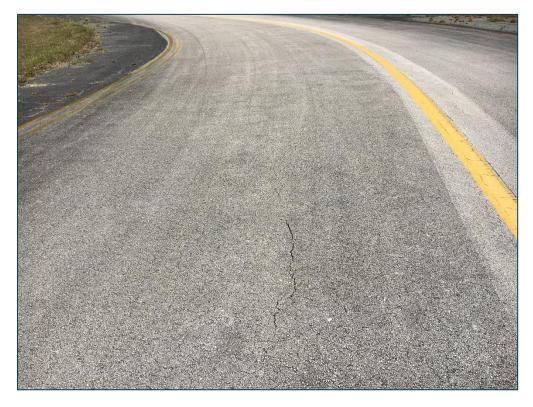
Taxiway B, Section 205, Sample Unit 105 – Low Severity (48) Longitudinal and Transverse Cracking, Low Severity (52) Raveling, Low Severity (57) Weathering

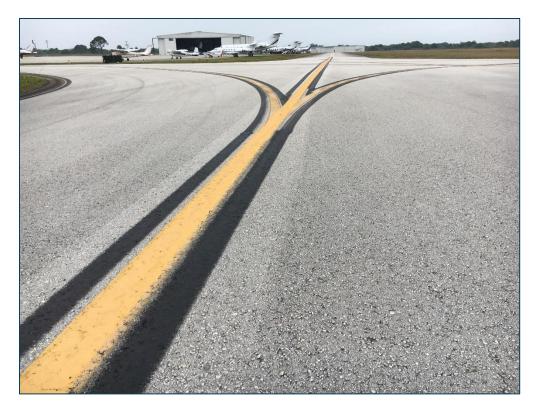
Taxiway B, Section 210, Sample Unit 126 - Low Severity (57) Weathering

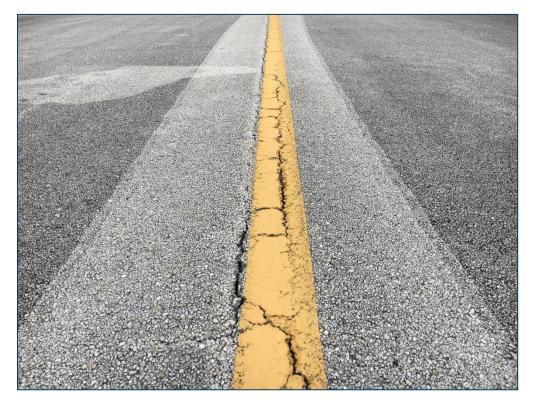
Taxiway B, Section 205, Sample Unit 142 – Low and Medium Severity (48) Longitudinal and Transverse Cracking, Low Severity (52) Raveling, Low Severity (56) Swelling, Low Severity (57) Weathering

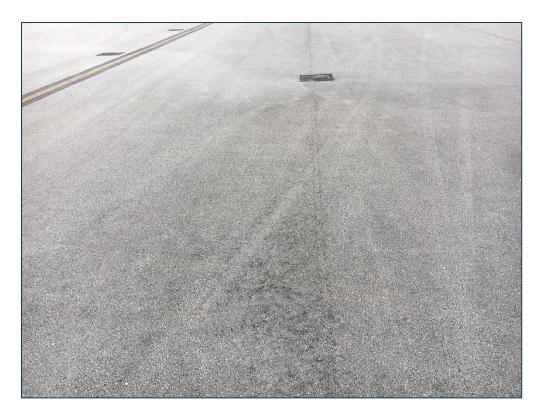
Apron, Section 4105, Sample Unit 500 - Low Severity (57) Weathering

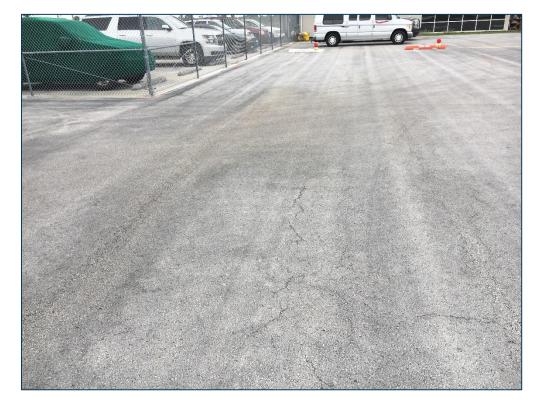
Apron, Section 4110, Sample Unit 70 – Low Severity (48) Longitudinal and Transverse Cracking, Low Severity (52) Raveling, Low Severity (57) Weathering

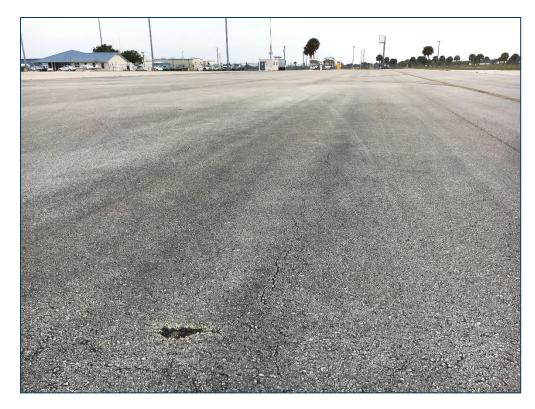
Apron, Section 4110, Sample Unit 604 – Low Severity (48) Longitudinal and Transverse Cracking, Low Severity (52) Raveling, Low Severity (57) Weathering
