Florida Department of Transportation

Statewide Airfield Pavement Management Program

Summary of Calhoun County Airport

Calhoun County Airport was inspected in September 2018 – the overall weighted PCI value was 85, a condition rating of Satisfactory. The results of the maintenance, repair, and major rehabilitation analysis identified \$104,140 in localized M&R needs based on current conditions and a 10-Year major rehabilitation need of \$3,745,000 based on forecasted conditions. The current major rehabilitation needs based on the latest inspection consist of \$472,000 for pavements below critical condition.

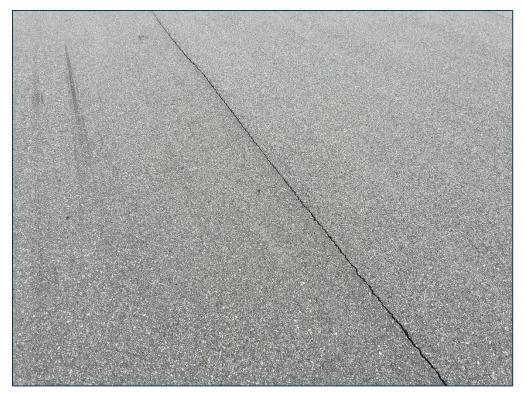
RW 18-36, Section 6105, Sample Unit 148 - Low Severity (48) Longitudinal & Transverse Cracking and Low Severity (57) Weathering

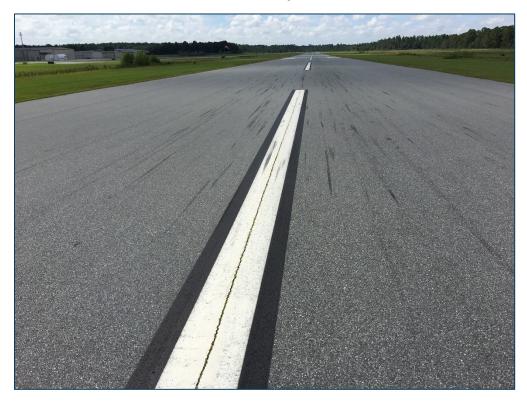
RW 18-36, Section 6105, Sample Unit 160 - Low Severity (48) Longitudinal & Transverse Cracking, Low Severity (52) Raveling, and Low Severity (57) Weathering

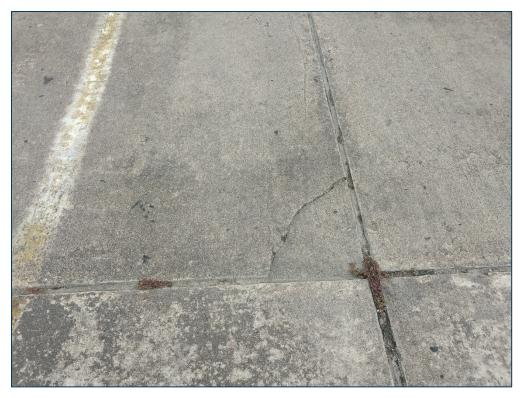
AP GA, Section 4105, Sample Unit 214 - Low Severity (65) Joint Seal Damage and Medium Severity (75) Corner Spall

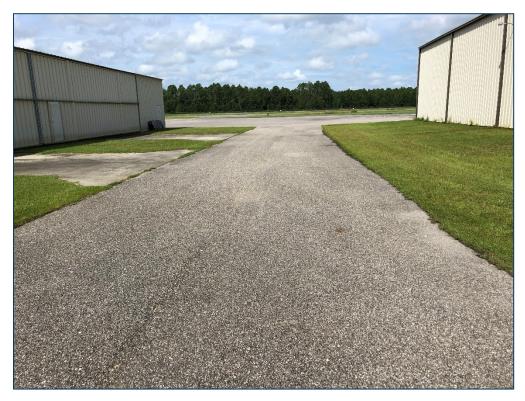
AP T-HANG, Section 805, Sample Unit 101 - Low Severity (52) Raveling and Low Severity (57) Weathering
